Second Quarter, 1997

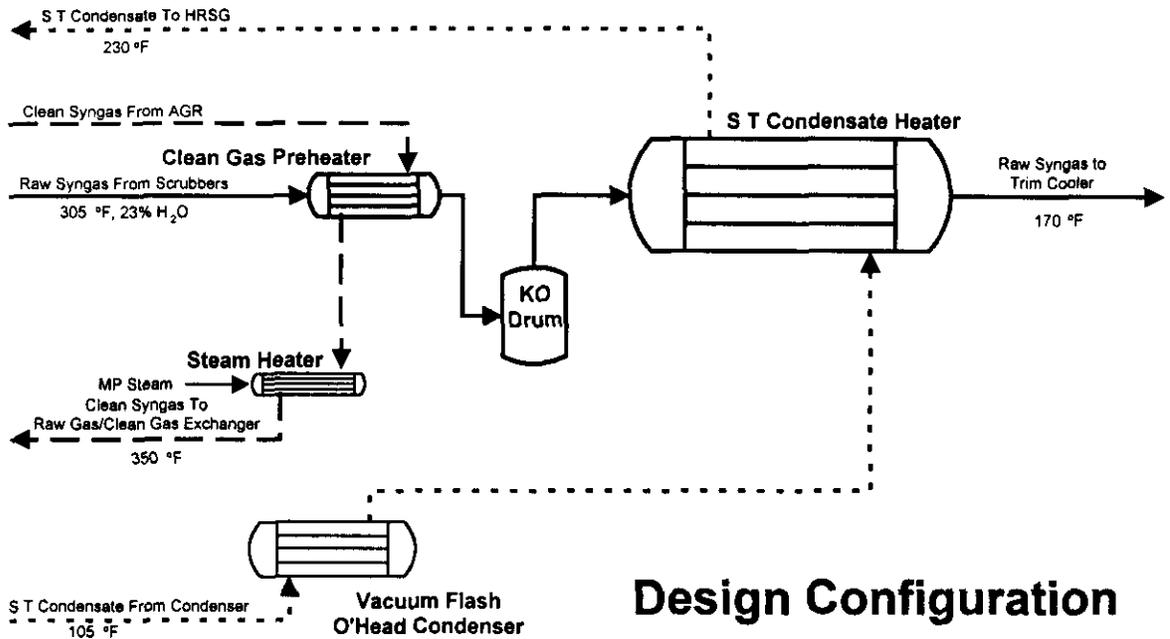
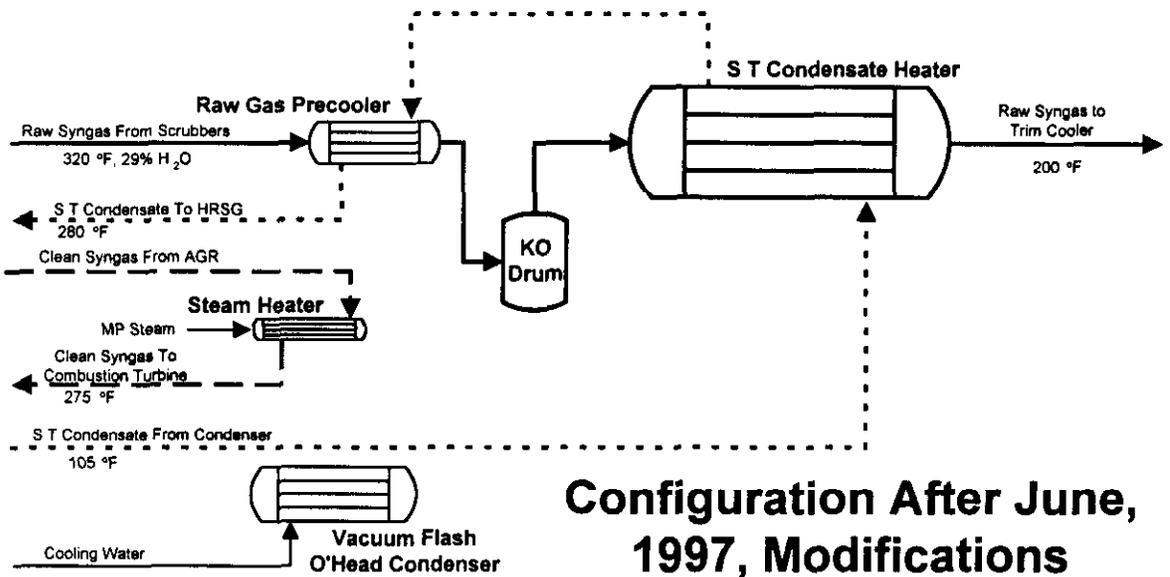
Low Temperature Gas Cooling - Front End

- 1) The Clean Gas Preheater (which exchanged heat between the raw syngas leaving the syngas scrubber and the clean syngas) was reconfigured to avoid damage to the CT from a potential tube leak. Although no leak, thinning, pitting, or cracking of any tube in the clean gas preheater had ever occurred, and the raw gas entering the Clean Gas Preheater had been through the syngas scrubbers to remove virtually all particles, experience with leaks in the raw gas / clean gas exchangers and resulting damage to the combustion turbine convinced the project that bypassing the Clean Gas Preheater was advisable.

- 2) Cooling flows had to be reconfigured for the Vacuum Flash Overhead Condenser, Clean Gas Preheater, and Steam Turbine Condensate Heater to accommodate the additional heat rejection from removal of the gas to gas exchangers in high temperature gas cooling (38 MMBTU/Hr) and bypassing the Clean Gas Preheater (19 MMBTU/Hr). Steam Turbine condensate was replaced with open loop cooling water on the Vacuum Flash Overhead

Condenser. This left the steam turbine condensate with more heat rejection capacity, so, after exiting the Steam Turbine Condensate Heater, it replaced the raw syngas on the tube side of the Clean Gas Preheater (now referred to as the Raw Gas Precooler).

The figures below show the configurations before and after the modifications.

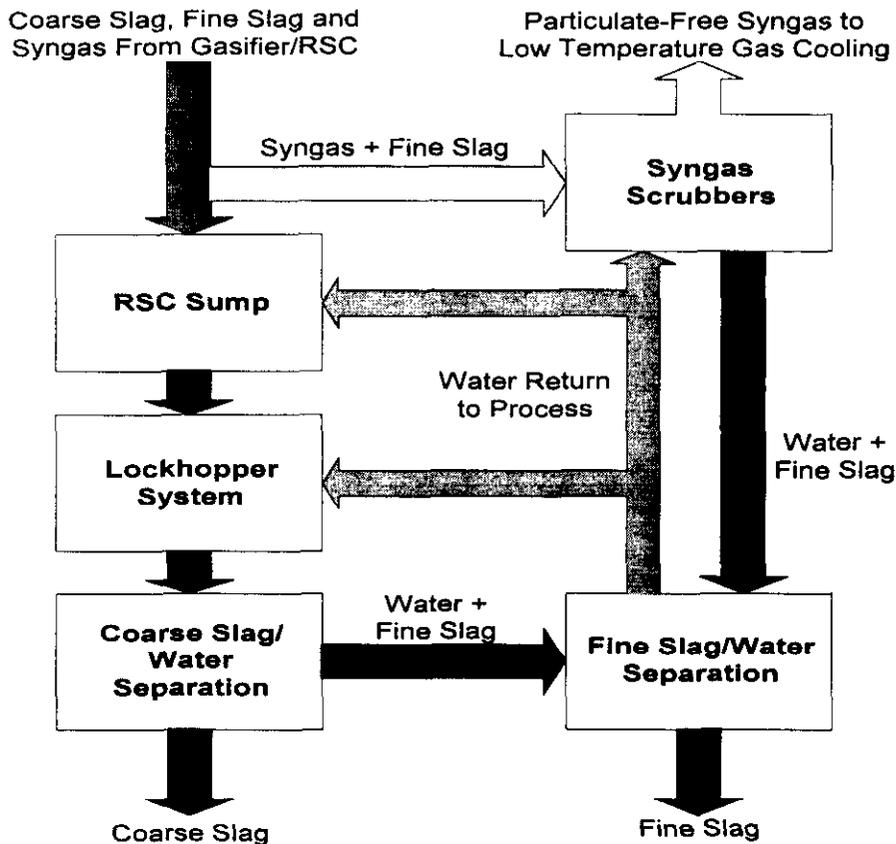
Process Water Systems, Fine and Coarse Slag Handling

Since carbon conversion has not improved significantly, the fine slag/water separation system performance continues to be marginal, and the slag handling system continues to be labor intensive. Design concepts are being reviewed for modifications in these areas.
