# Tidd Hot Gas Clean Up Program

## Final Report

October 1995

By  
Ohio Power Company  
Columbus, Ohio

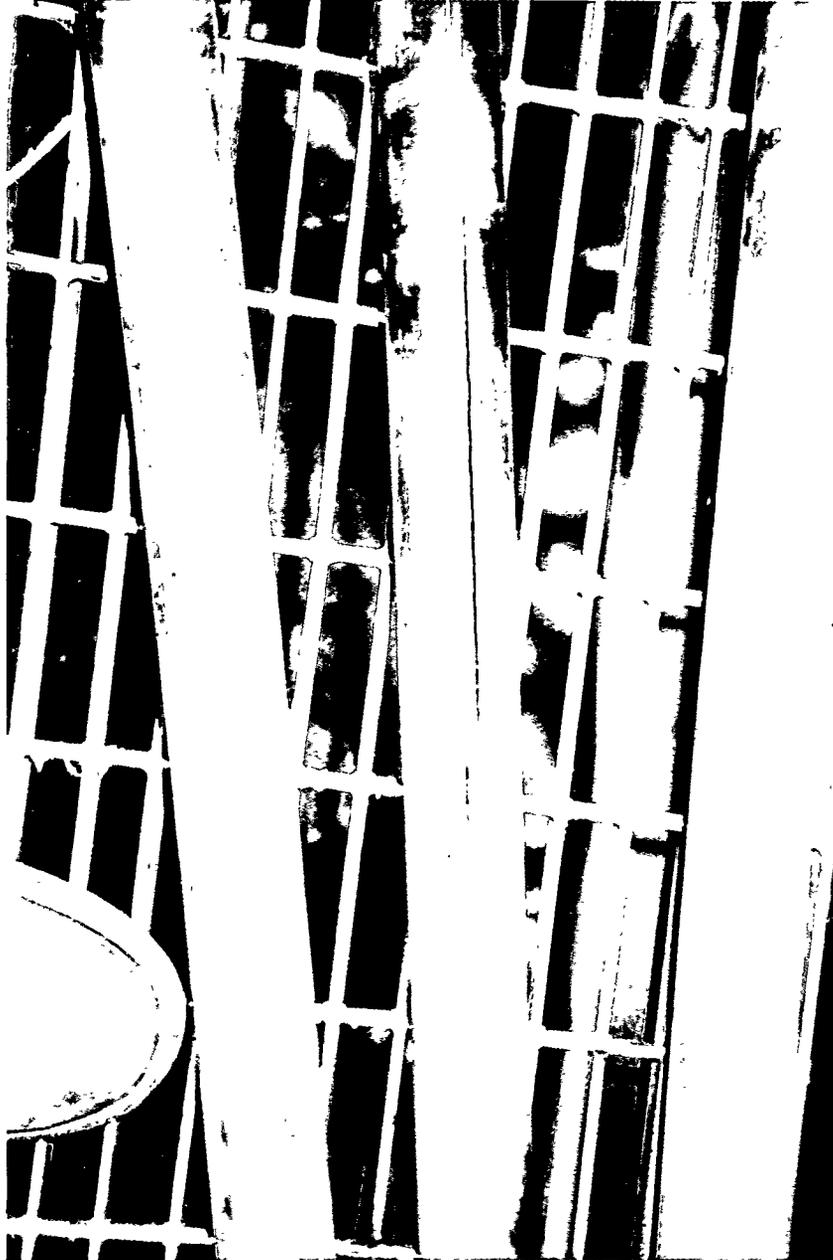
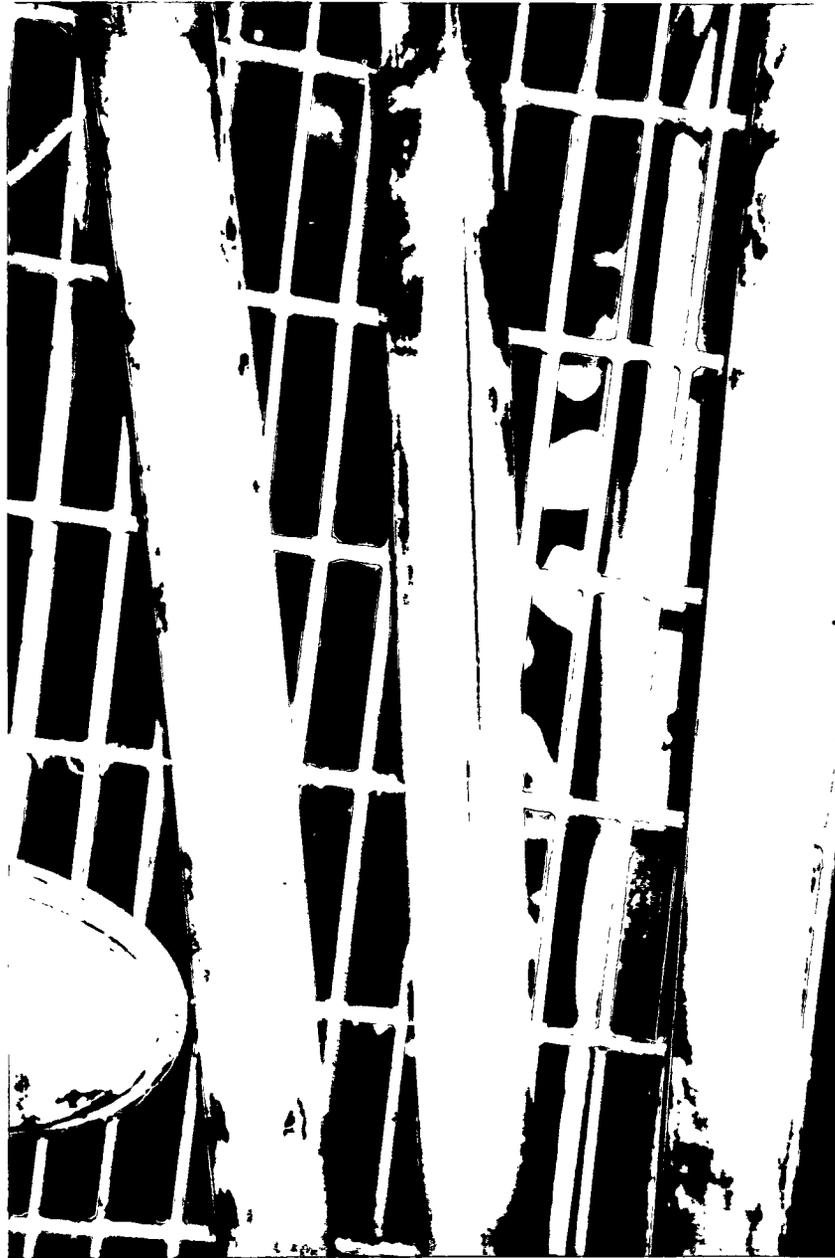
Two of the nine backpulse tubes were found to have longitudinal cracks, believed to be due to thermal fatigue. All nine tubes were replaced in kind following this test series.

**Figure 4.6.17 - Photograph of Crack in Back Pulse Tube**

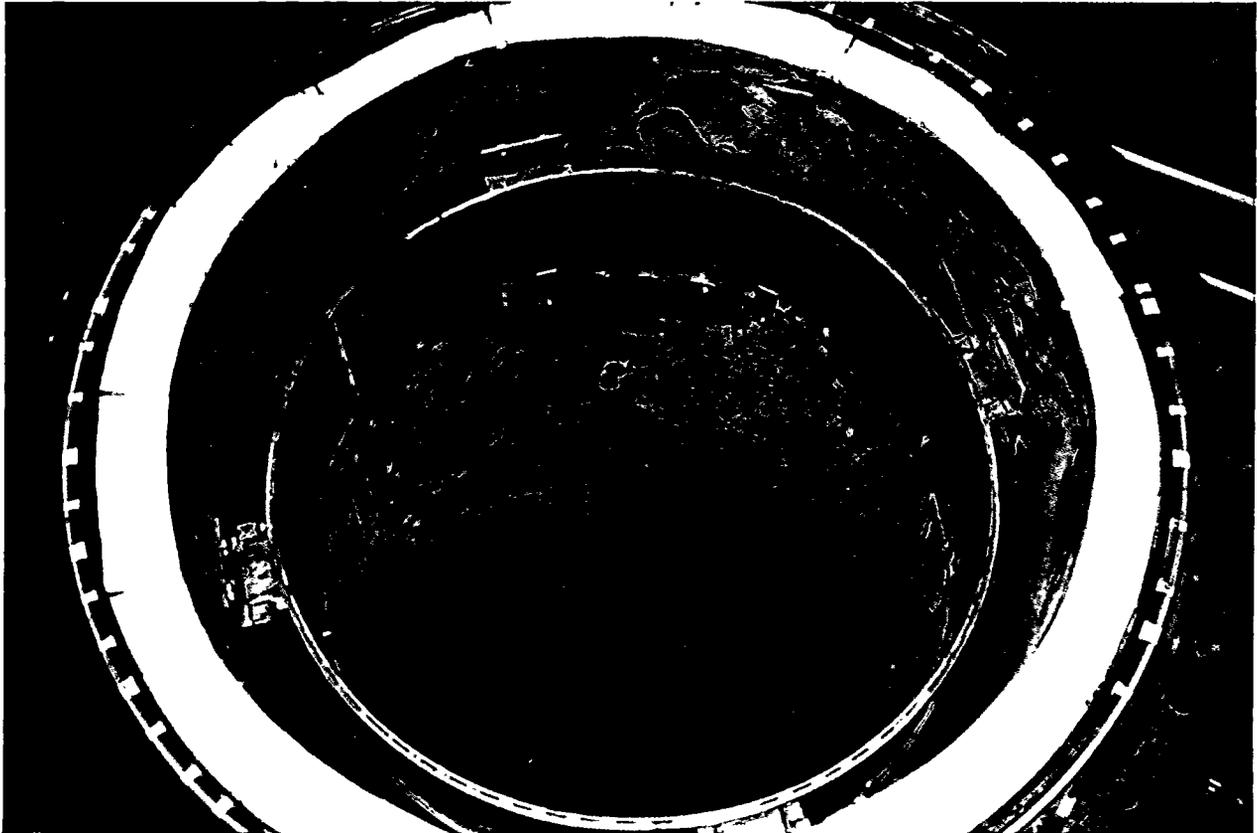
**Figure 4.6.22 - Photograph of APF Shroud After Replacement of Upper Portion**

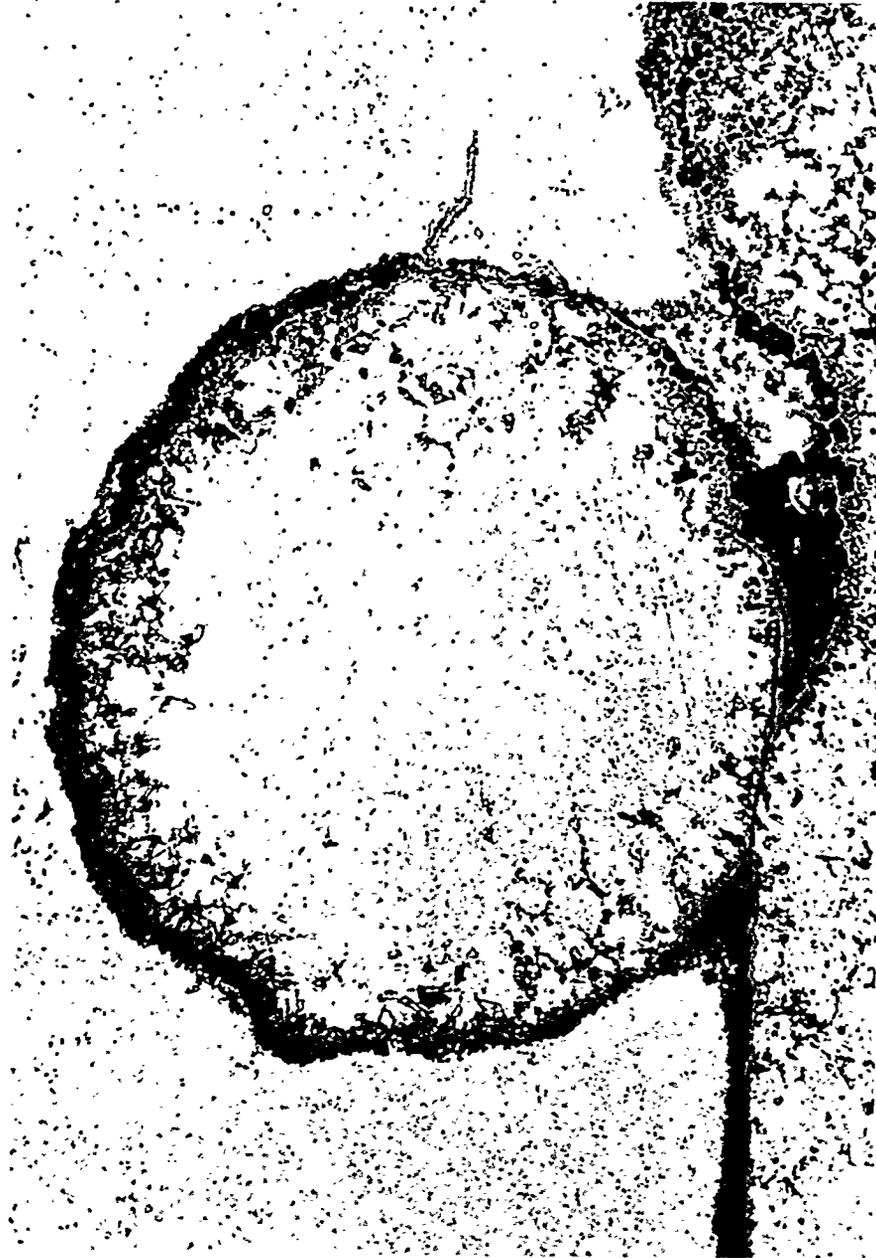
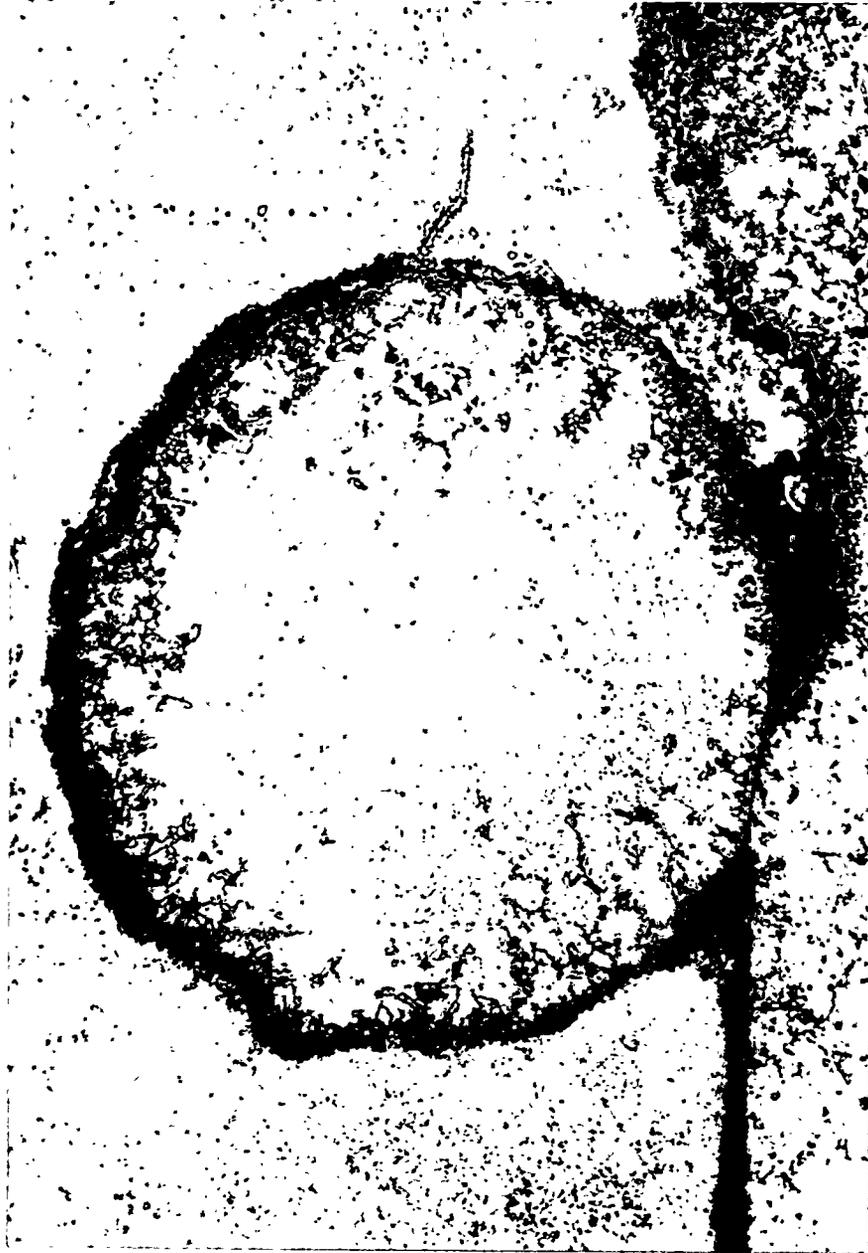
**Figure 4.9.3 - Cross Section of 0.005-inch Wire from Fine Fail-safe Mesh After 1110 hours at Tidd-700X**
