POLK POWER STATION - 6TH COMMERCIAL YEAR OF OPERATION

John E. McDaniel - Senior Engineering Fellow (Speaker)

Mark Hornick - General Manager, Polk Power Station

2002 GASIFICATION TECHNOLOGIES CONFERENCE

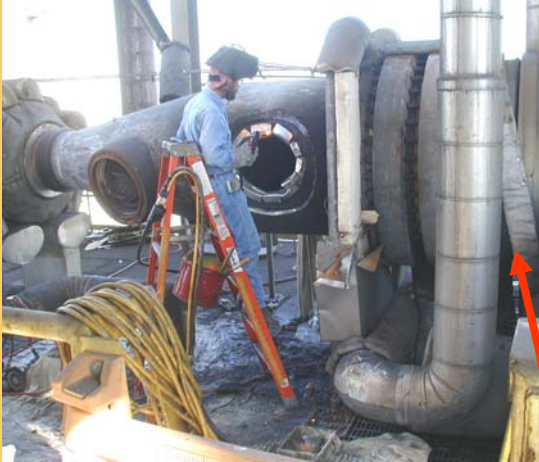
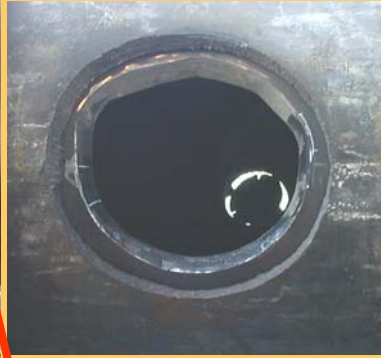
Convective Syngas Cooler

478 Unplanned Outage Hours
269 (56%) Due to Weld Failure in Inaccessible Back-End

CSC problems cost 478 unplanned outage hours in 3 incidents.

The worst was a weld failure in an inaccessible location which required 269 hours to repair. It occurred at the outlet tubesheet in a tube that had previously been replaced. The tubesheet is to the right of the large flange shown on the photo. It was faster to cut access holes into the double walled CSC exit chamber, make the tubesheet repair, and patch the holes than to disassemble and move the chamber out of the way. We don't expect more failures of this type. The access holes were cut so as to remove the nozzle which was to have been the take-off point for hot gas cleanup. Eliminating that nozzle and the associated dead-leg eliminated a potential point of failure.

The other two CSC forced outages resulted from gas-side inlet tubesheet plugging. The first was late in 2001 while we were still gasifying 100% coal. The second occurred recently while processing the petroleum coke blend. The deposit pattern was different in this latest case, and it was accompanied by a tube leak in an unusual location. This incident is still under investigation.

CSC inlet tubesheet plugging had been much worse in the past, so year 6 was a considerable improvement. However, we can expect some CSC plugging to continue. If the sale of the gasifier to take advantage of Section 29 tax credits proceeds as expected, 100% coal operation will be required. This will probably lead to more frequent CSC plugging than we experienced with the pet coke blend in year 6. Also, the CSC tubes have experienced 6 years of localized erosion, and retubing is planned. But until this is done, we might experience a slightly higher rate of tube failure.

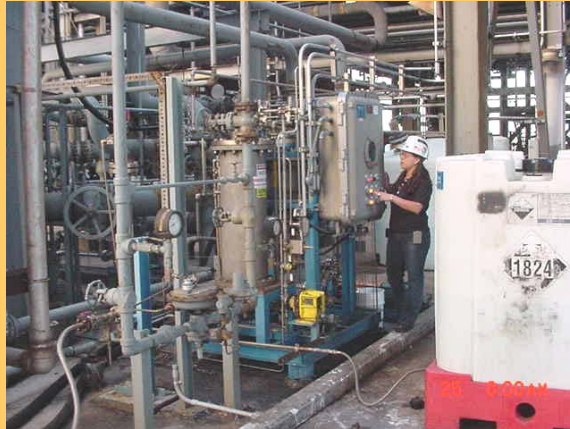
Sulfur Removal

281 (77%) Due to Oxilate - Now Removed by Ion Exchange

86 (23%) Due to Placing COS Hydrolysis In Service Too Soon

367 unplanned outage hours were due to 2 sulfur removal issues.

281 hours were lost to due to oxilate corrosion in the MDEA sulfur removal system. Oxilate $\{(CO_2)_2^-\}$ is a specific heat stable salt formed when MDEA comes in contact with traces of oxygen, typically from purge nitrogen or from contact with air in poorly purged tanks. Oxilates have always been present in the MDEA, but they have not been a problem before. Our previous approach to controlling heat stable salts (caustic neutralization plus electrolytic removal) must have preferentially removed the oxilates even at a relatively high overall heat stable salt concentration. The ion exchange system quickly proved effective in controlling heat stable salts generated from formates produced in the COS hydrolysis reactor, but it is apparently less effective on the oxilate salts. The ion exchange unit now controls the oxilates and corrosion coupons and probes indicate no detectable corrosion, but the overall heat stable salt level must be kept much lower. The corrosion was centered in the MDEA reboiler which is being replaced.

86 hours were lost to catalyst damage from placing COS hydrolysis in service too soon after gasifier startup, before stable operation was achieved in the syngas scrubbers immediately upstream. This will be prevented in the future by automatic and procedural controls.

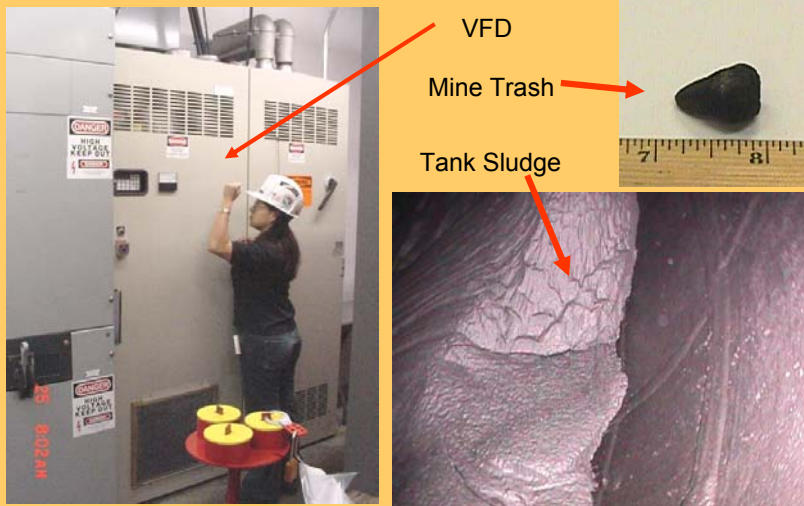
Slurry Feed Pump

321 Unplanned Outage Hours
244 (76%) Due to Variable Frequency Drive

76% of the unplanned outage hours attributable to the slurry feed pump were caused by the variable frequency drive (VFD). All VFD components were replaced when these nuisance shutdowns first began occurring, but this was to no avail. We later discovered that one of the replacement cards was incorrectly wired at the factory. There have been no subsequent VFD-related shutdowns since the defective replacement card was rewired. The factory no longer supports our VFD model, so a complete replacement is on order.

Most of the rest of the unplanned outage hours attributable to the pump were due to check valve damage from foreign objects such as the mine trash shown in the photo, or from suction line obstruction. A 3" to 5" thick layer of hardened slurry occasionally forms on the lower walls of the slurry tanks as shown in the photo. When pieces of it dislodge, they can plug the tank outlet or the long horizontal suction line. We are now learning how to more effectively deal with this phenomenon before it causes a shutdown.

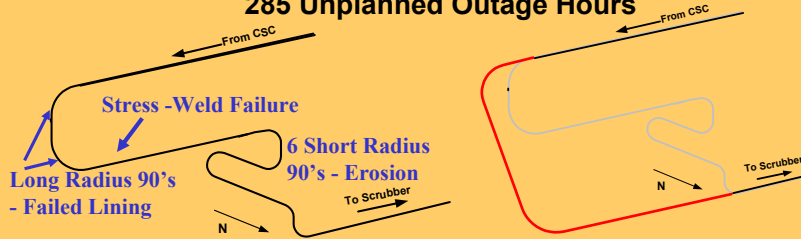
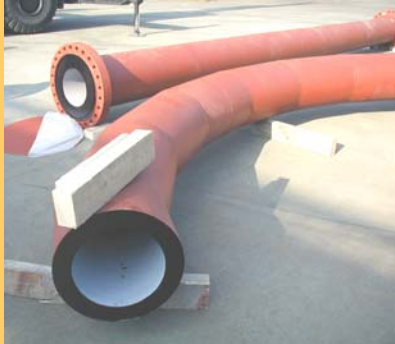
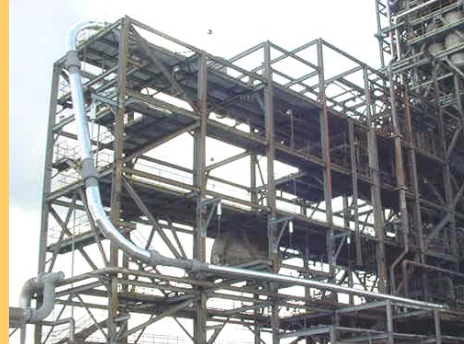
Raw Gas Piping - CSCs to Scrubbers

285 Unplanned Outage Hours

The raw syngas piping run from the outlet of the convective syngas coolers to the inlet of the scrubbers accounted for 285 unplanned outage hours. See the isometric sketch in the upper left corner. The piping run begins at the CSC exit. First is a long straight run which replaced the first gas/gas exchanger shell which was removed in 1997. It then drops down vertically via two long radius 90° elbows through a second long straight run which replaced the second gas/gas exchanger shell. Next were 6 short radius 90° elbows to reduce piping stress. They were hard-faced for erosion protection. These ells were followed by the straight run to the scrubbers.

The long radius 90's were lined with a concrete for erosion protection. Failures in the liner led to 43 unplanned outage hours for a temporary repair. New 90's were procured with what we expect to be a superior lining system (photo lower left).

The piping arrangement created stresses just downstream of the lower long radius 90. This caused a weld crack which led to 28 more unplanned outage hours.

The most serious problem with this piping system was in the short radius ells which caused 194 unplanned outage hours. Their brittle hard-facing would crack and a small piece would spall, leading to local turbulence and accelerated local erosion.

The piping system was completely reconfigured (isometric sketch and photo on the right side of the slide) to eliminate the troublesome short radius 90° elbows. An improved support system was included to eliminate the stresses which had caused the weld crack. We believe most problems with this piping system are now resolved.

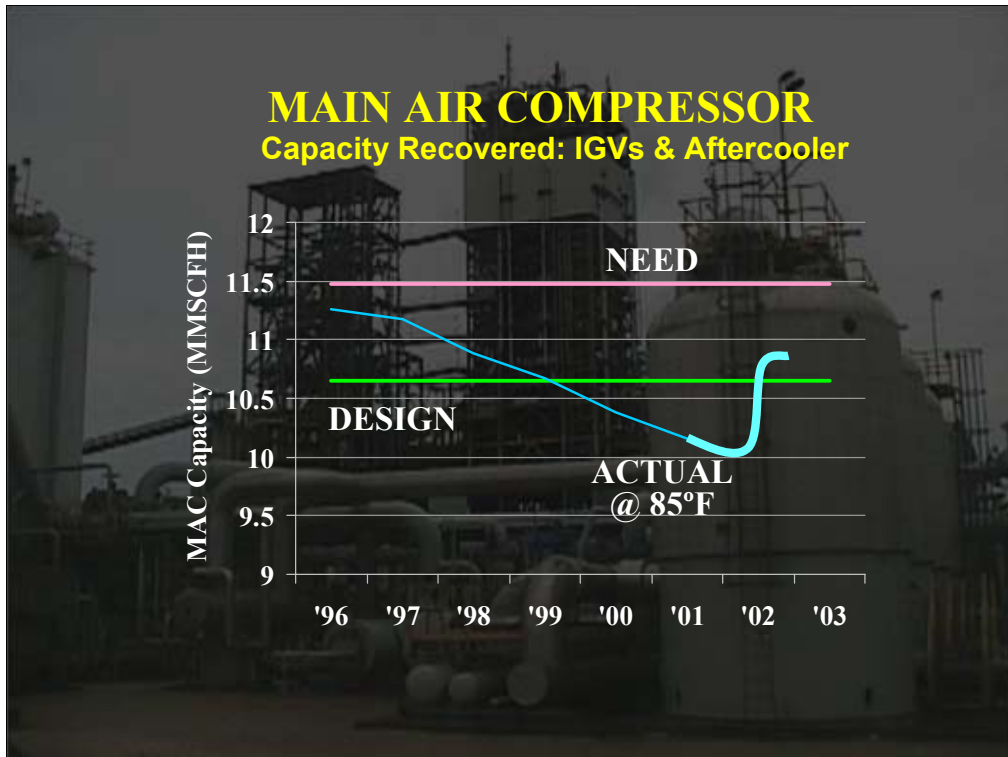
As reported last year, Polk's oxygen plant requires about 11½ MMSCFH of air to produce enough oxygen for full load operation on a variety of fuels over the normal ambient temperature range and to simultaneously reprocess enough fines to generate a slag product suitable for cement industry. This is about 8½% more than design.

The main air compressor (MAC) could almost meet these requirements when it was new, but its output had declined at a rate of about 2% per year. Part of this loss was attributable to pluggage of its aftercooler and the resulting backpressure. This was remedied by replacing the aftercooler bundle and coating all carbon steel parts to prevent further deterioration. Another significant part of the loss was found to be binding of the inlet guide vanes. This problem was very difficult to diagnose because it occurred only when the machine was operating - the vanes moved freely whenever we tested the mechanism when the machine was shut down and no forces were acting on the vanes.

Replacing the aftercooler bundle and fixing the guide vanes restored the machine to slightly above the design point. We are still about 5% short of meeting the overall system requirements under some conditions, so we are investigating ways to debottleneck the machine.

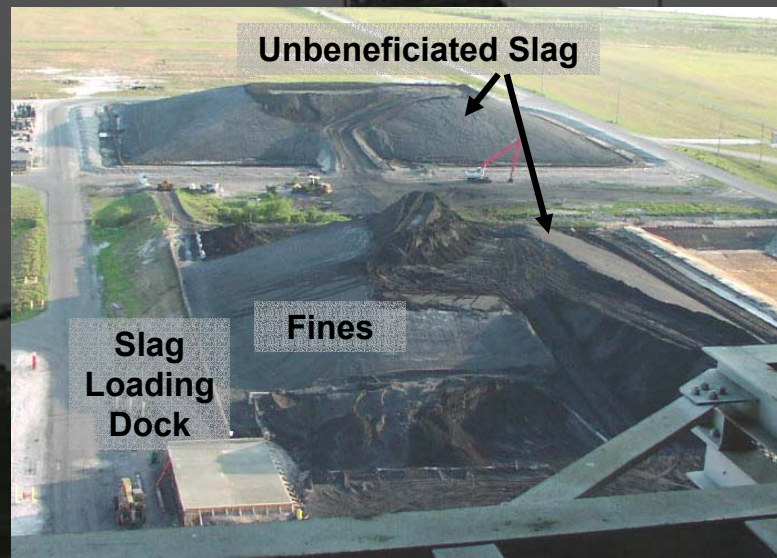
SLAG PILE - SLOWLY SHRINKING

Slag has been a significant problem throughout Polk's operating history. The Charah system, discussed in another paper at this conference, is separating the accumulated slag into three components, two of which are useful. Refer to their paper for the details on their process. This enables us to remove a significant fraction of the slag from site at a cost significantly lower than landfilling, and the slag pile is slowly receding.

The fines is the third constituent of the slag for which no use has yet been found. Consequently, the fines continue to accumulate as indicated in the above photo. Now that some of the MAC capacity has been restored, we have the opportunity to try to return some of this material to gasification. Tests are scheduled to begin in early November.
