DEMONSTRATION OF INNOVATIVE APPLICATIONS
OF TECHNOLOGY FOR THE CT-121 FGD PROCESS

Plant Yates

Final Report

Materials Test and Evaluation Program

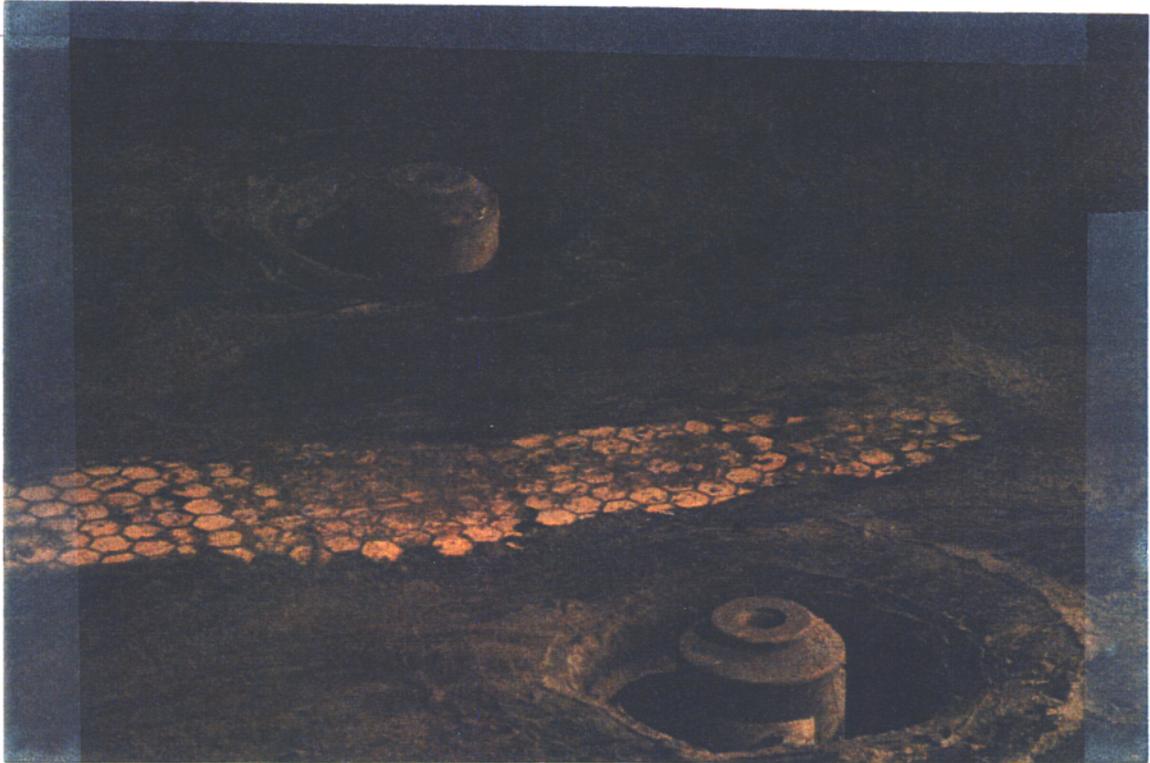
Figure 3-18. Abrasion Resistant Coatings in the Inlet Duct Area

Figure 3-18 shows several of these solutions after installation and again after several months of operation. It is important to note that each solution proved to be effective in controlling a particular type of abrasion attack. For example, abrasion in areas of high shear flow have been better controlled by coatings that have large amounts of fillers. Abrasion due to normal flow, on the other hand, were controlled by more compliant polyurethane mixes. The only remaining issue in this area has been the control of adhesion between the coating system and the FRP. The difficulty is associated with control of humidity, temperature, and surface cleanliness. It is anticipated that the adhesion problem may not exist if the coats are applied in a controlled construction setting prior to scrubber start-up.
