Environmental Impact and Risk Modeling of Petroleum and Gas Transmission Lines Using High Resolution Imagery from Satellite and Airborne-Based Remote Sensing Systems

Digital Globe Inc., PG&E, LLNL, and Chevron Texaco

Donald G. Price, PG&E

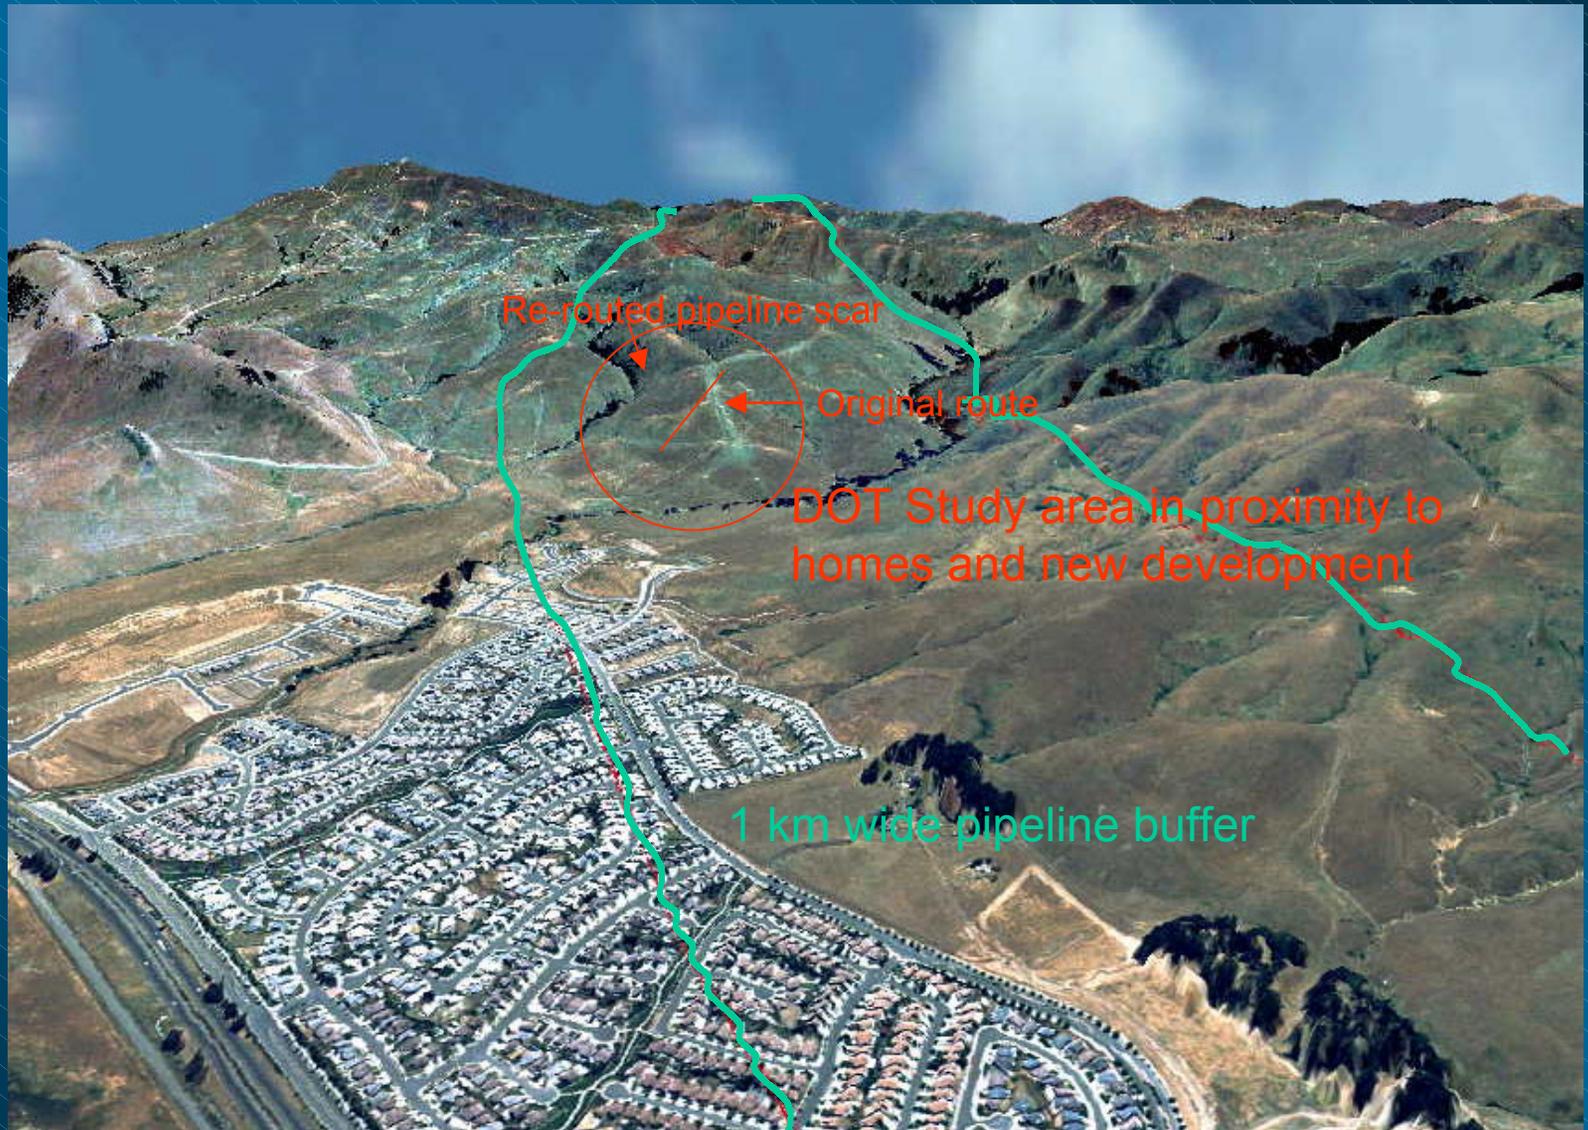
3D image – air photo draped over high resolution DEM Cordelia, California

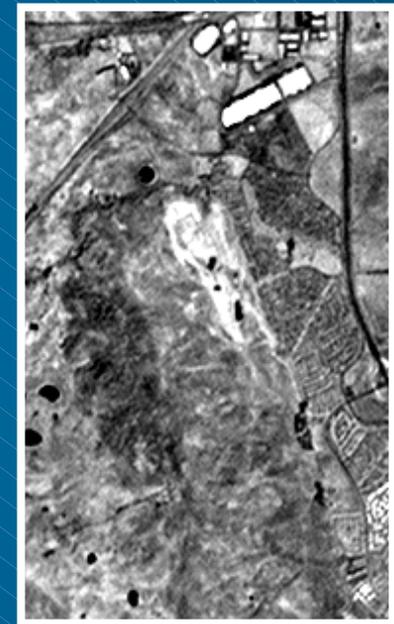
*Subset of Landsat Panchromatic
15 meter data taken over study area*

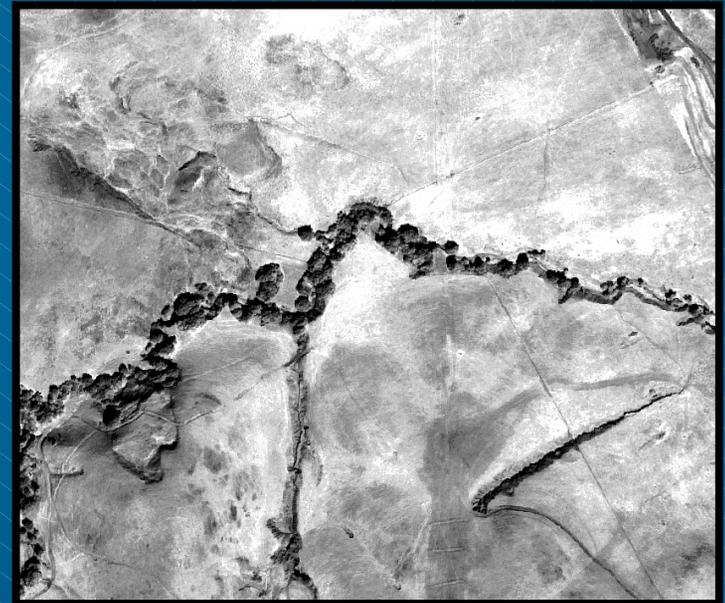
*Subset of IKONOS Panchromatic
1 meter data taken over study area*

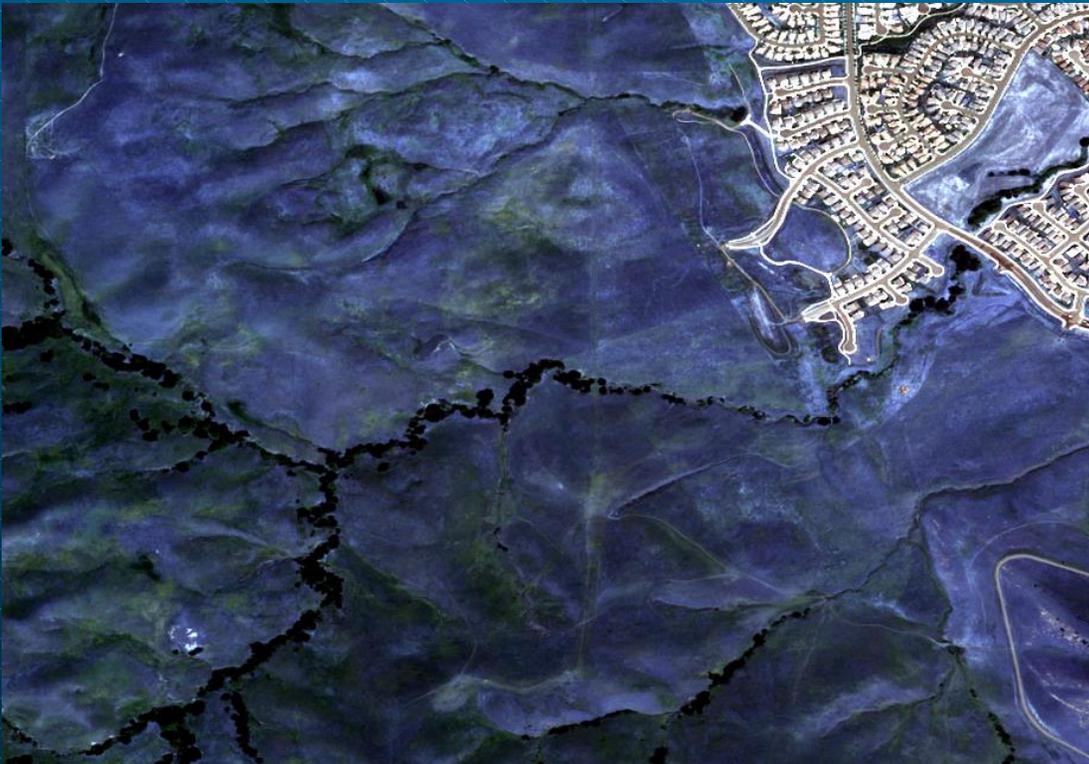
*Subset of QuickBird
Multispectral 2.44 meter
data taken over study
area in May of 2002*

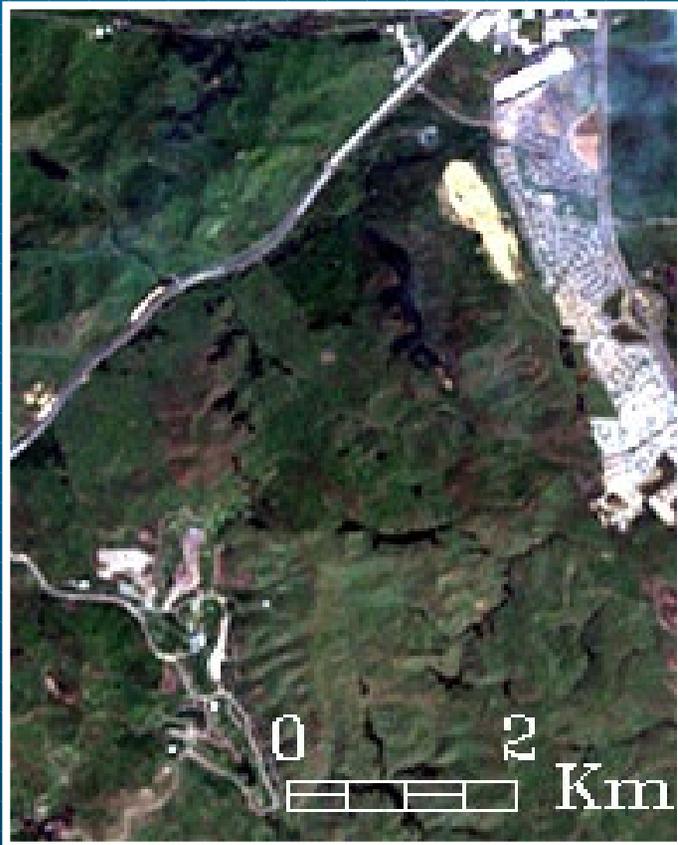
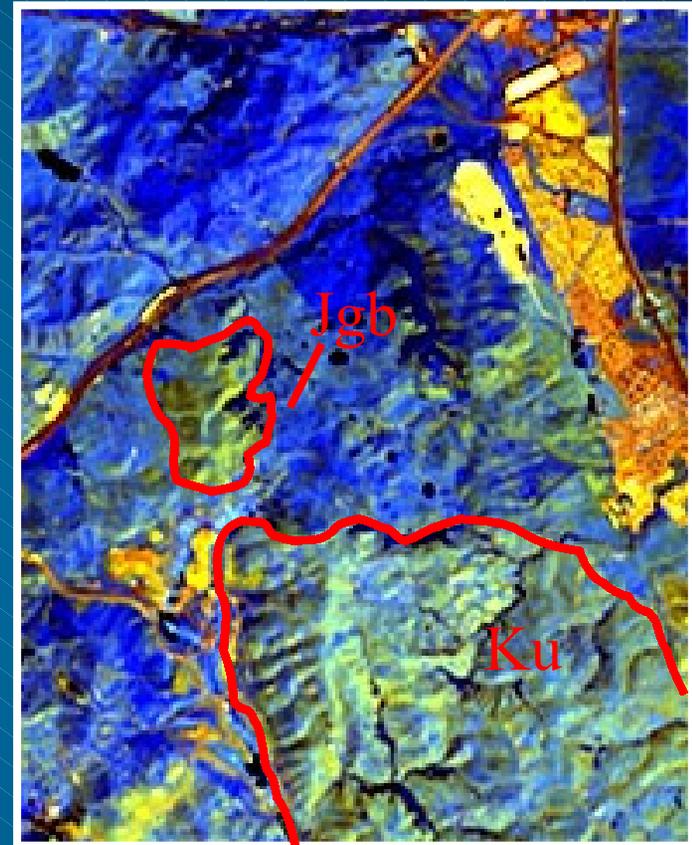
Simple analysis enhances major rock units – Linear Stretching

- Major rock units are identified including Jgb, a gabbro which is NOT highly susceptible to sliding and
- Ku, sandstone and shale, which IS highly susceptible to sliding

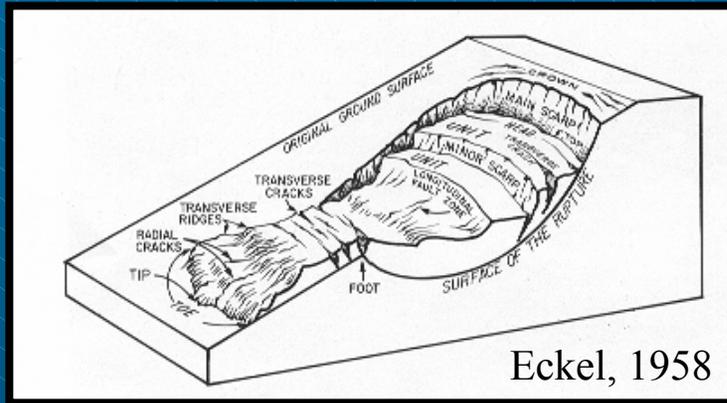
- Main head scarp
- Minor scarps internal to the slide
- Longitudinal fault zones
- Transverse cracks
- Transverse ridges
- General “hummocky topography”

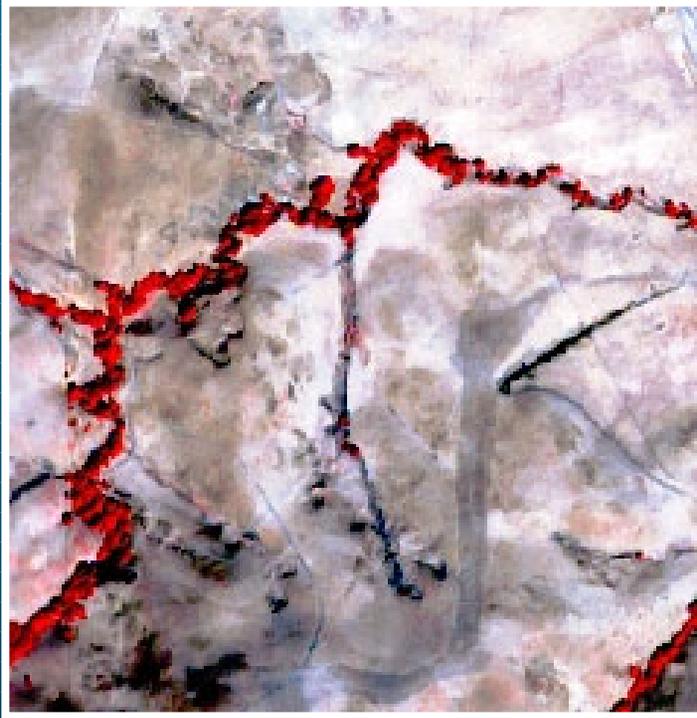
IKONOS 4m color-infrared, bands 4,3,2

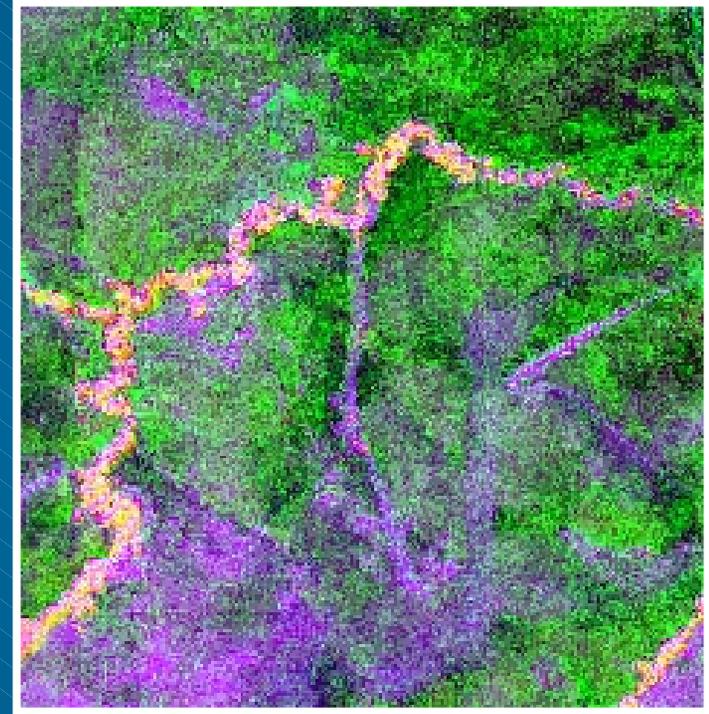
Minimum Noise Fraction image

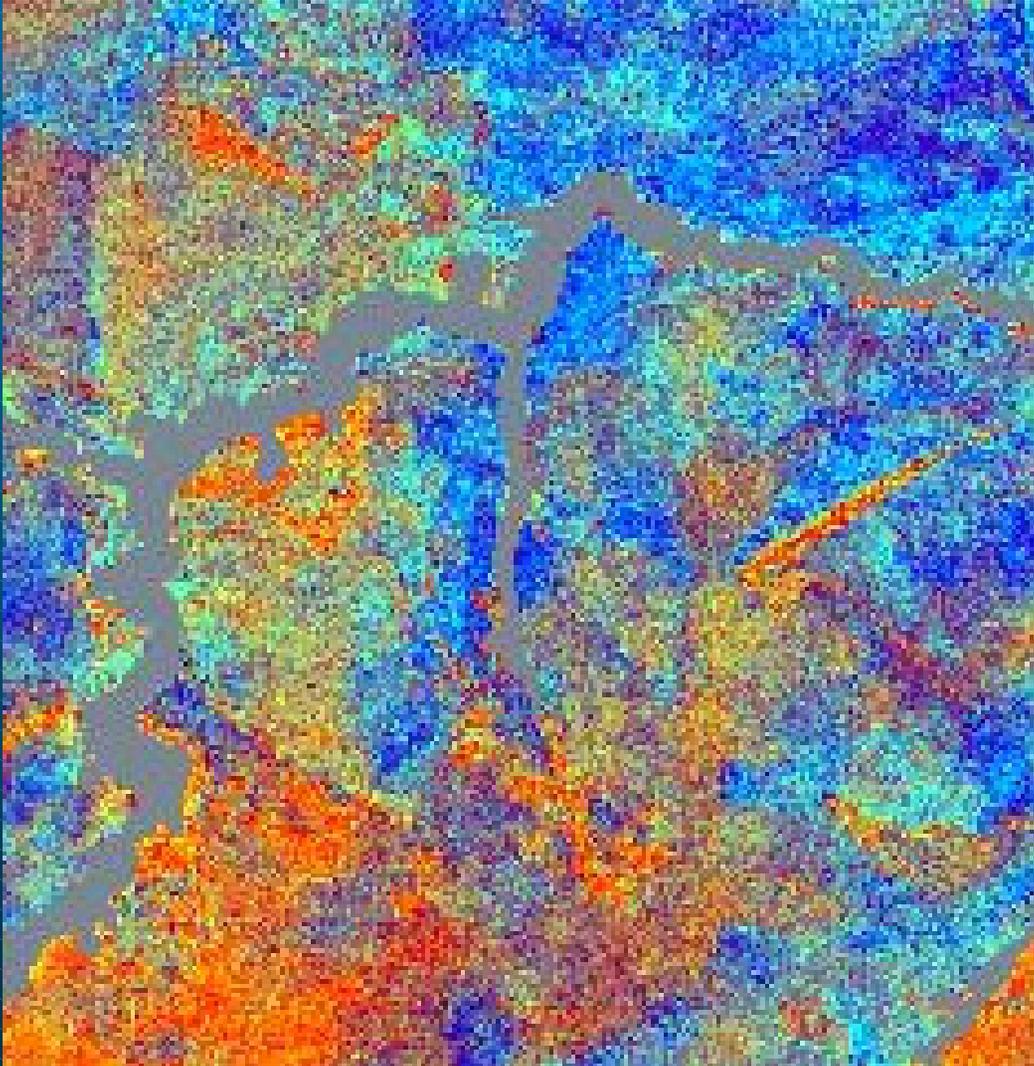
Results of the Selective PCA on the IKONOS 4 meter satellite imagery with a tree mask applied before analysis. Erosional features are more emphasized in this image. Orange and red colors correspond to erosional features (landslides and gullies), while the blues are undisturbed soil and bedrock.

In order to reduce the spectral variability encountered by the Selective PCA and enhance landslide detection, a mask was prepared that attempts to remove the tree populations in this field area.

The resultant Selective PCA image shown in the last slide was then thresholded to emphasize those values in the digital image analysis that correspond to erosional features, especially landslides. Interactive density slicing was used within the ENVI software program to complete this thresholding. Those regions with values falling into the thresholds that appeared to correspond to landslides, were exported to a region of interest (ROI) file and overlaid on the original 1 m panchromatic gray-scale image.

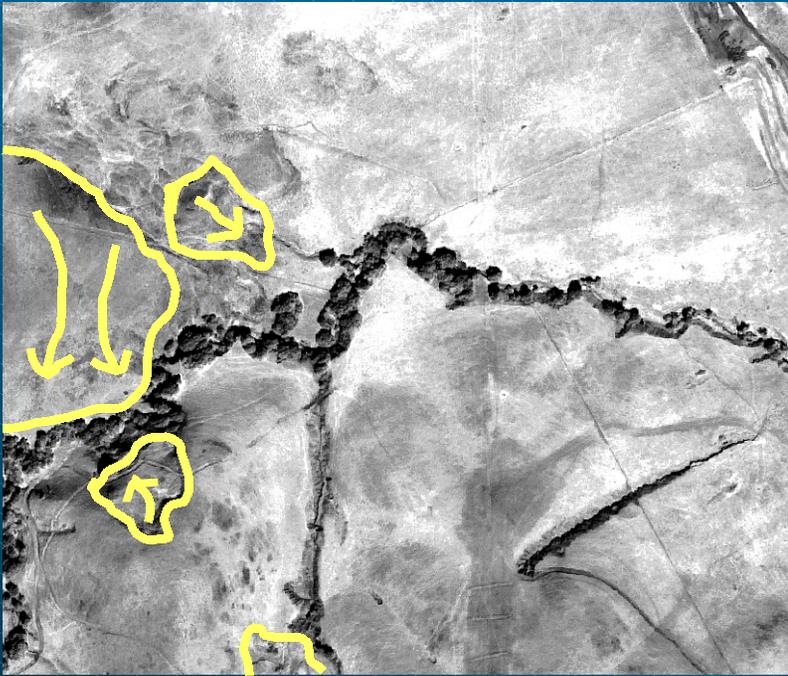
IKONOS 1 m data shown in greyscale

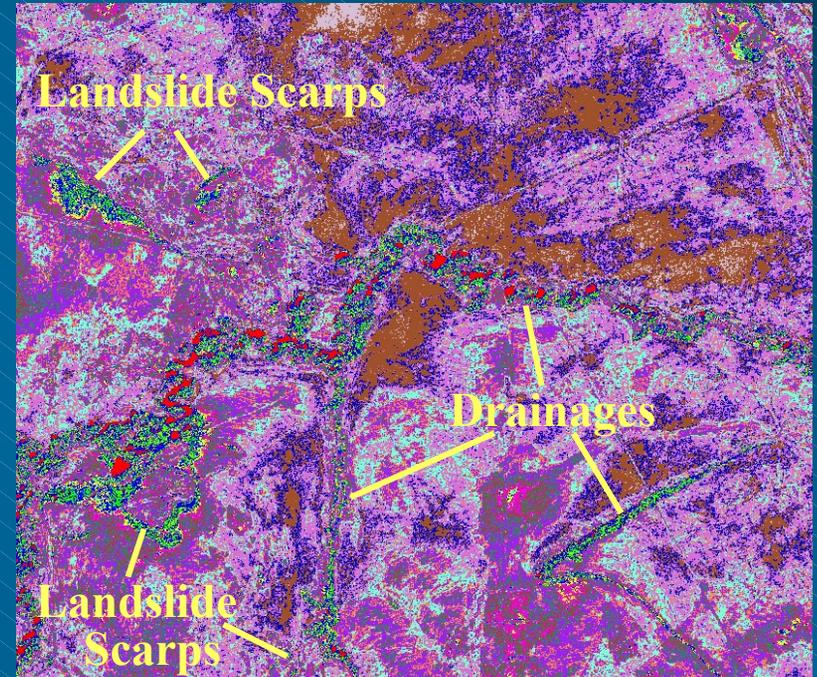
Edge-enhanced unsupervised classification

Edges, including landslides, gullies, roads and trees

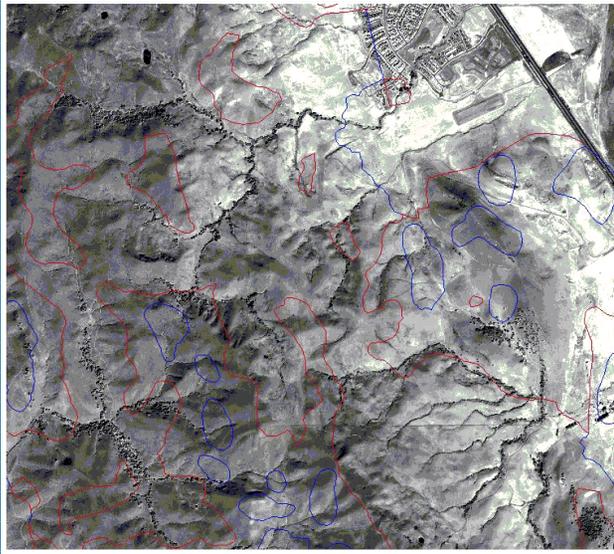
Vector overlay of landslide distribution (Nilsen and Wright, 1979)

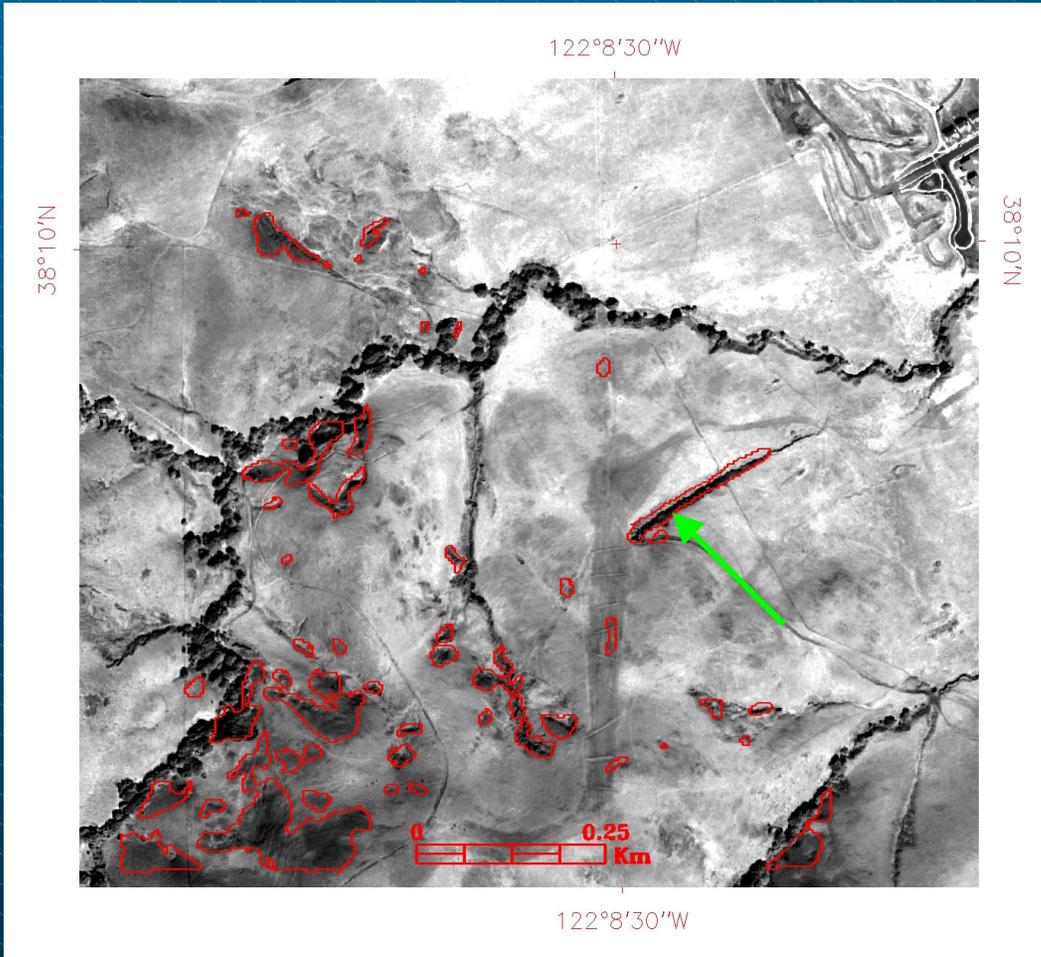
The ROI of landslide distribution overlaid on 1m Panchromatic IKONOS imagery. A major gully in the field area is highlighted and indicated by the green arrow.

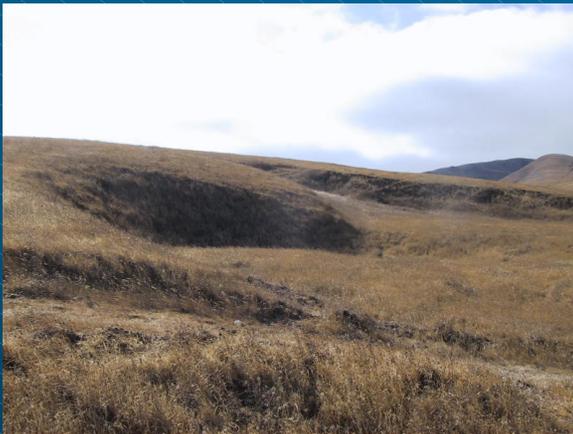
Field photo of the landslide.

For example, a small landslide that was previously visited in the field, was located in the imagery and analysis results. The landslide was spatially small (~12.5m in length), but was mapped quite well by the Selective PCA.

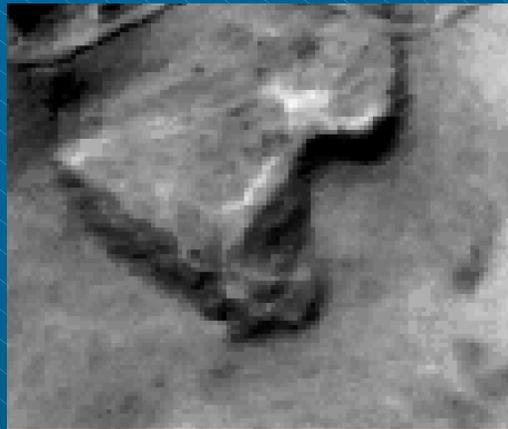
1 m IKONOS imagery subset.

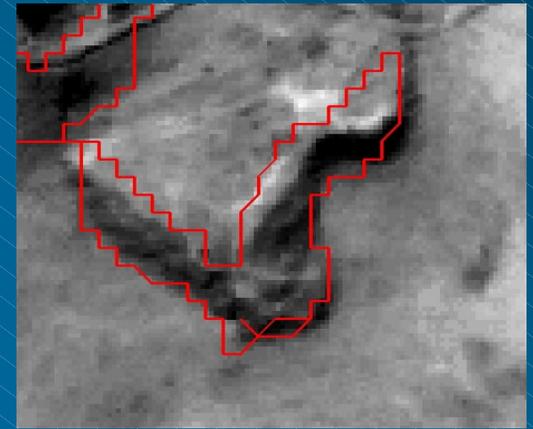
The image ROI of the landslide superimposed on top of the 1 m image.

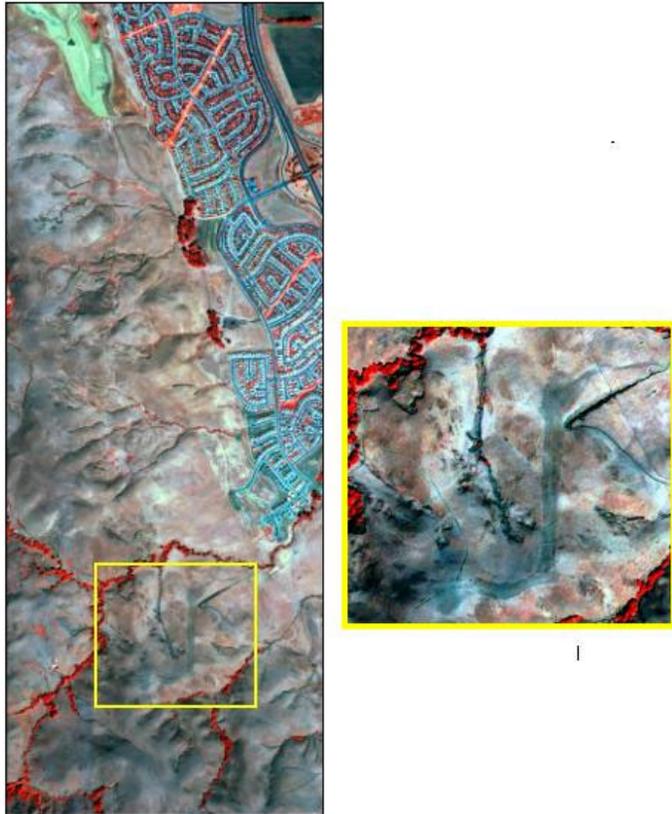
Color-infrared IKONOS multispectral

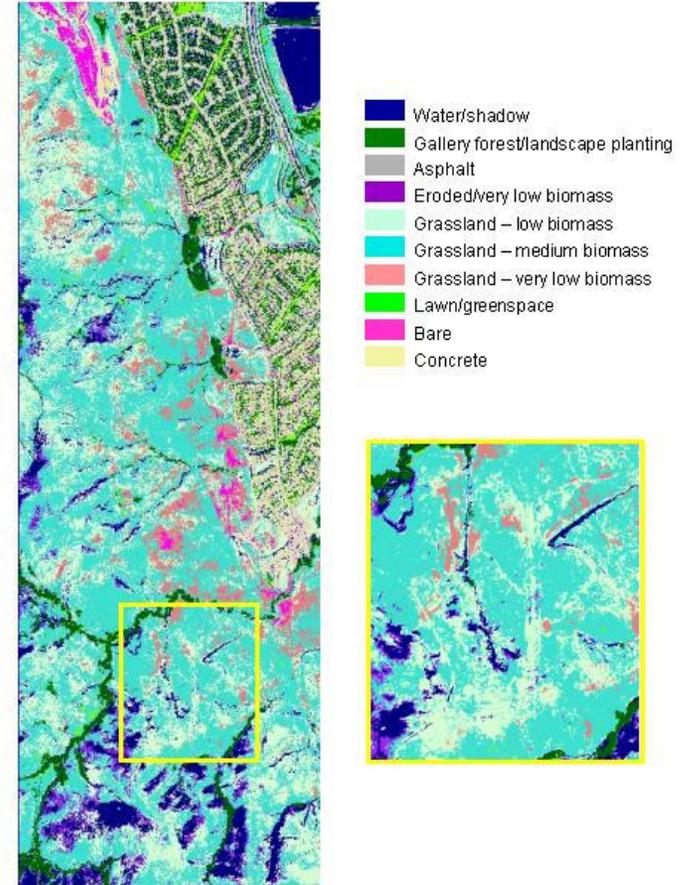
Unsupervised classification

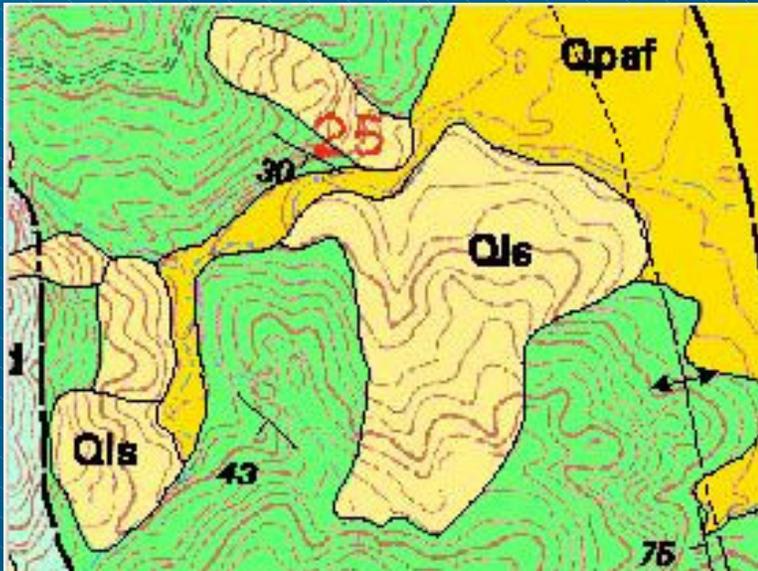
This figure shows a subset of the USGS geological map (Graymer, 1999) that covers the study area. All four units shown in this map are susceptible to landsliding, though of special note are the abundant Qls units which are mapped landslides that may or may not be currently active.

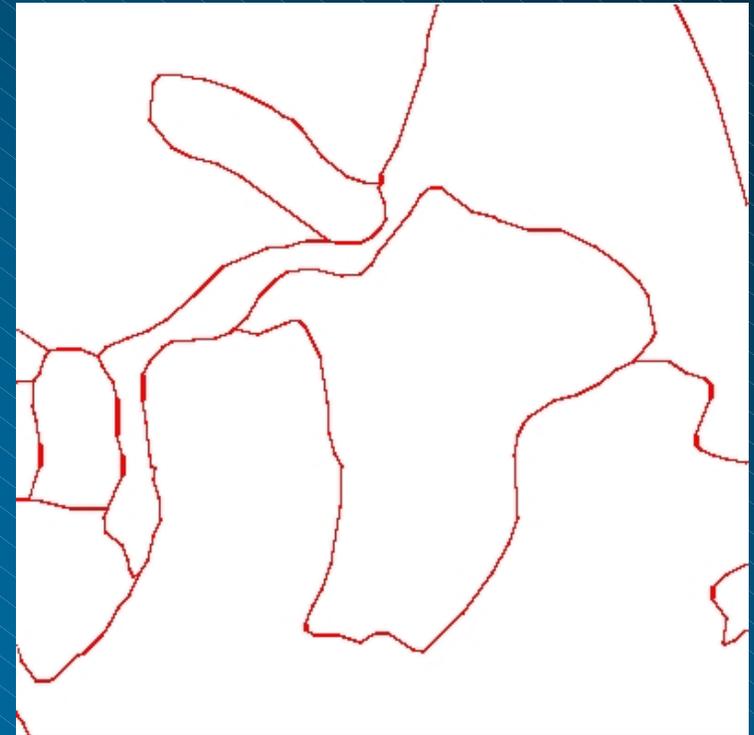
This figure is the vector shapefile from the adjacent geologic map. This vector file can be directly input into the GIS database with other vector layers such as the IKONOS-based landslide distribution map.

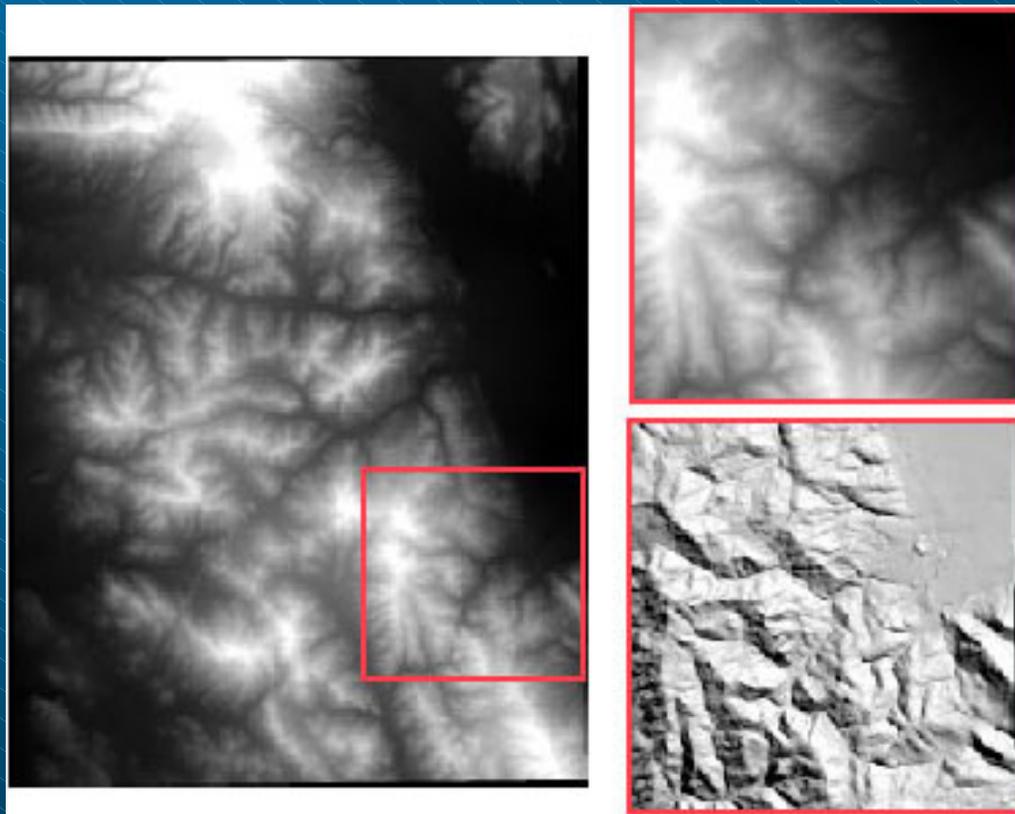
USGS 10 meter DEM of the Cordelia, CA region shown on the left. On the right are subsets of the DEM showing the test study area both in its raw form (top), and with a grayscale shaded relief drape (bottom). Sun is at 45° from nadir and coming from 045° azimuth in the bottom shaded relief version.

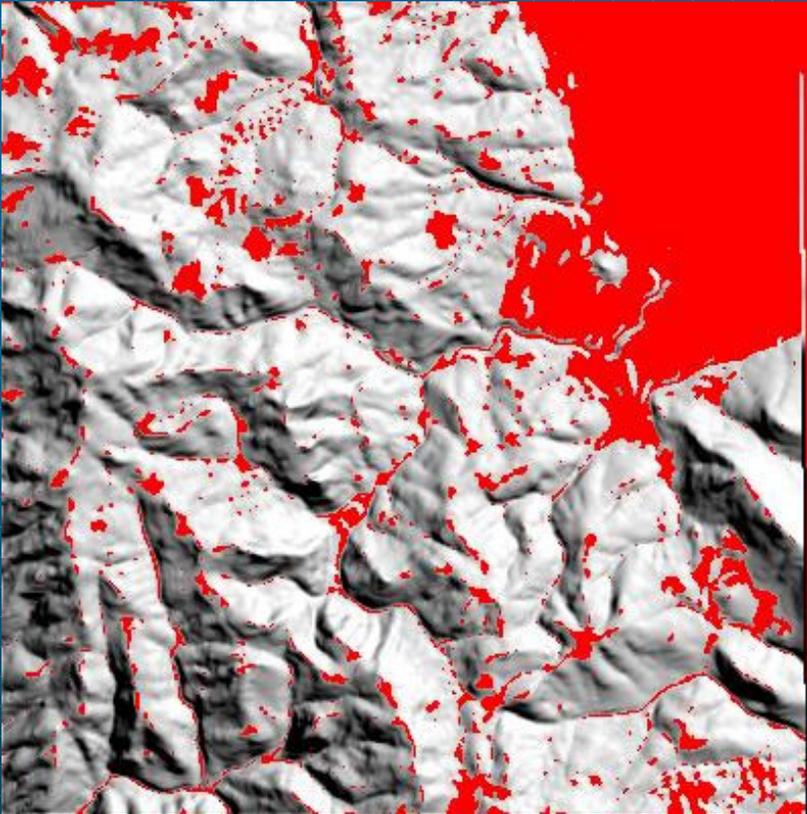
The image on the left shows regions in red where the slope is less than 15%. For most analyses, these regions would be masked and removed in order to cut down data storage size requirements and processing time.

Conversely, those regions with slopes less than 15% can be effectively masked out of further analysis efforts.

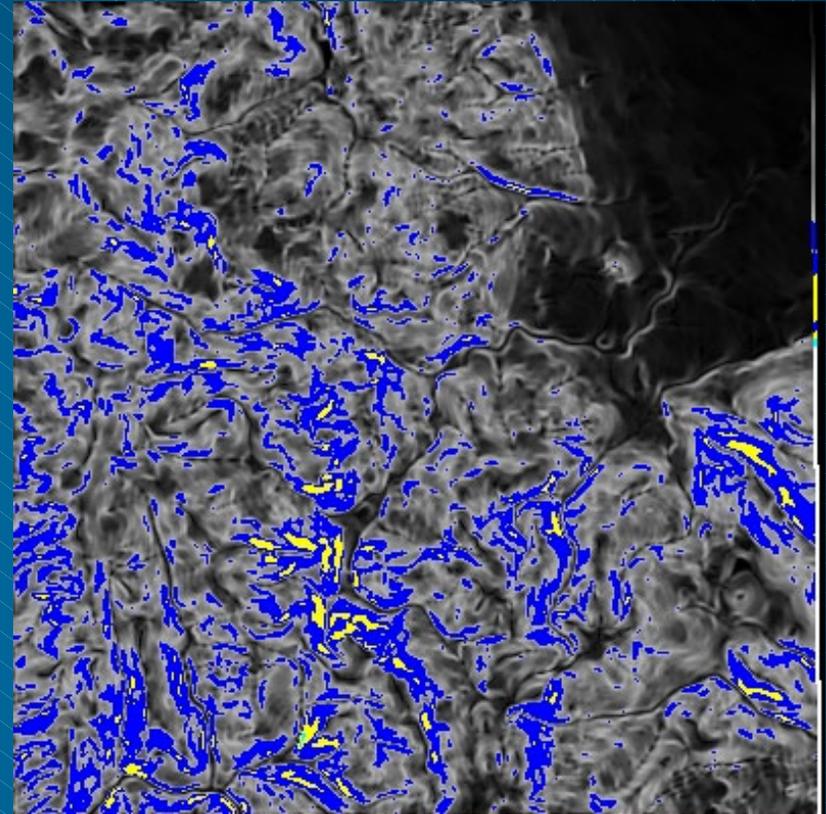
The image on the right shows those regions with slopes higher than 30%. These are the slopes most likely to fail given other conducive landsliding variables (such as sparse vegetation).

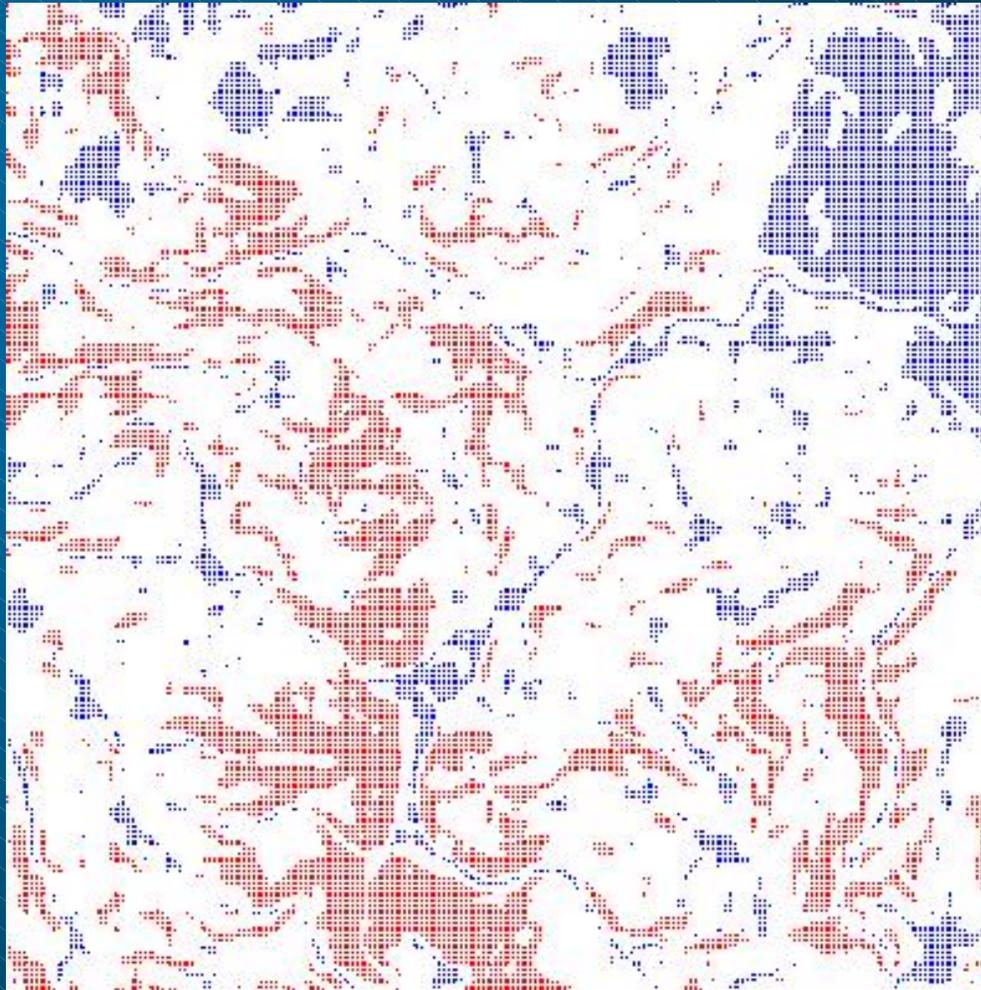
This is a vectorized version of the highest (in red) and the lowest (in blue) slopes. Such vector files can be integrated as shape files into a GIS domain with other vector files such as the geology, path of the pipeline, biomass estimates, etc.

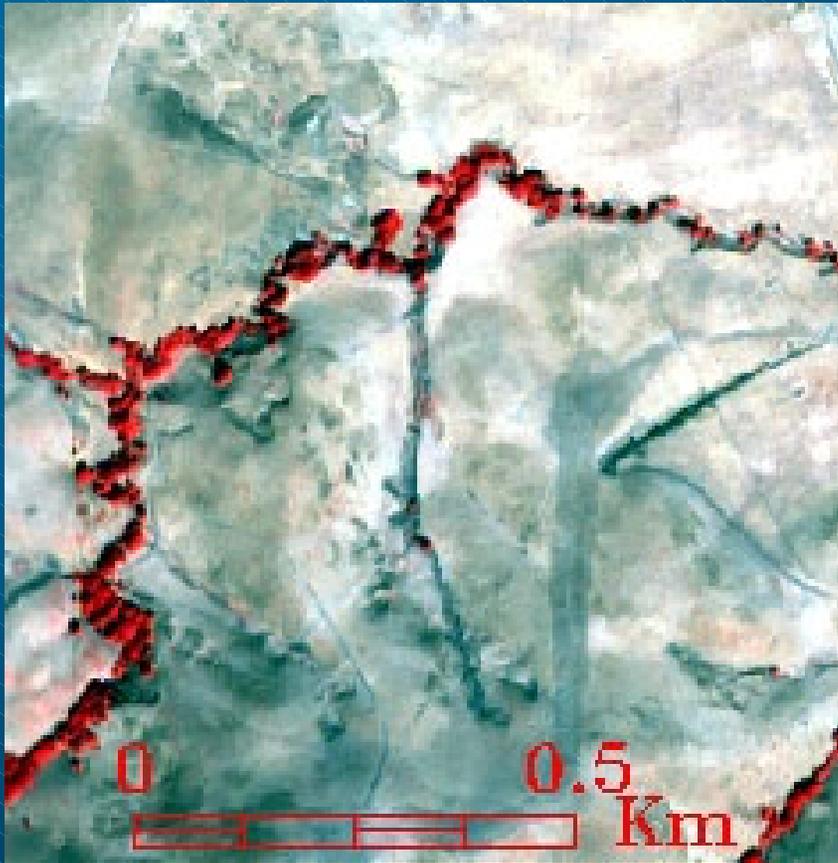
This is the near-infrared color image of the field test area.

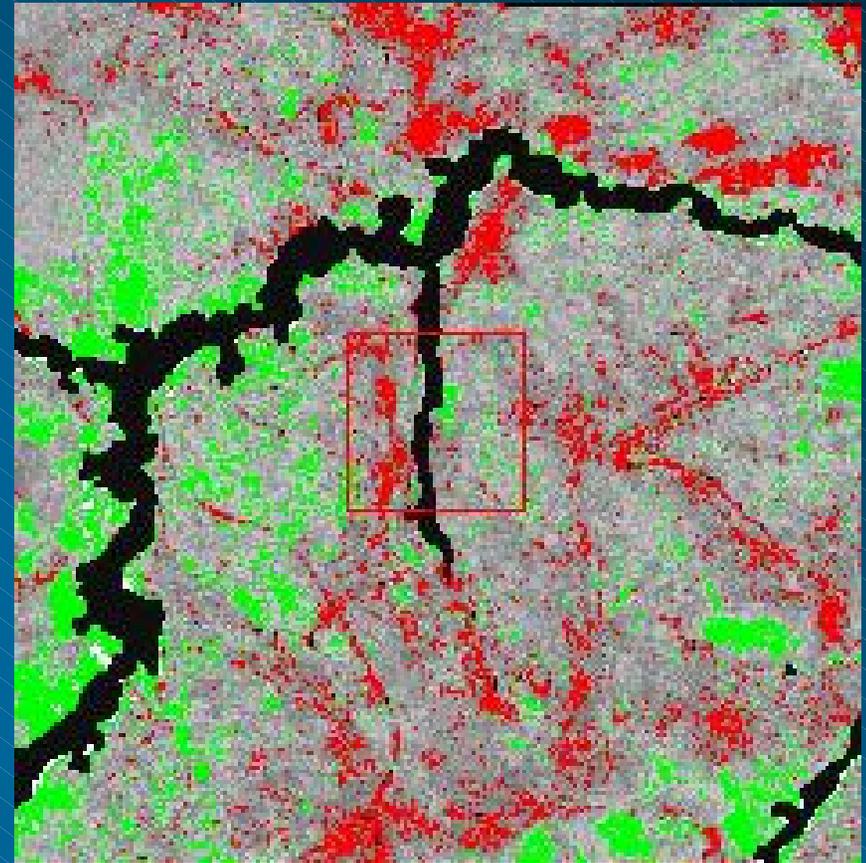
This shows two separate biomass classes. The red represents areas of bare ground to very low biomass (NDVI values of 0.01 to 0.04). Conversely, the green represents areas of much higher relative biomass (NDVI values of 0.08 to 0.12).

One way to characterize this variable, is to make relative biomass measurements using the simple Normalized Difference Vegetation Index (NDVI) ratio analysis.

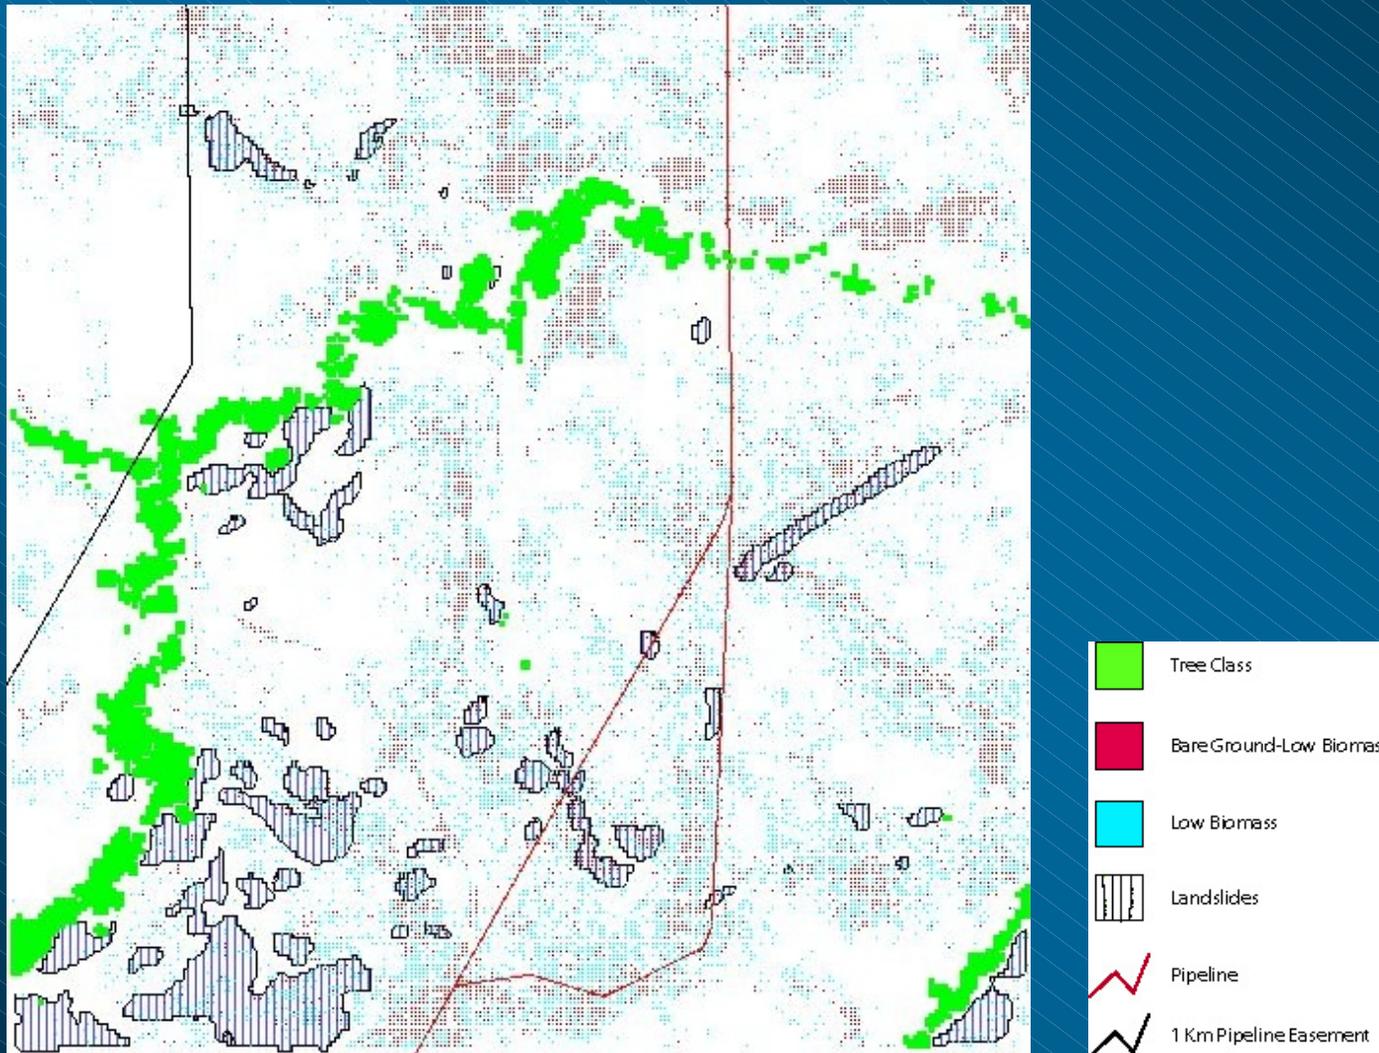
Example showing six of the twelve vector variables used in landslide susceptibility determinations for pipeline risk assessment.

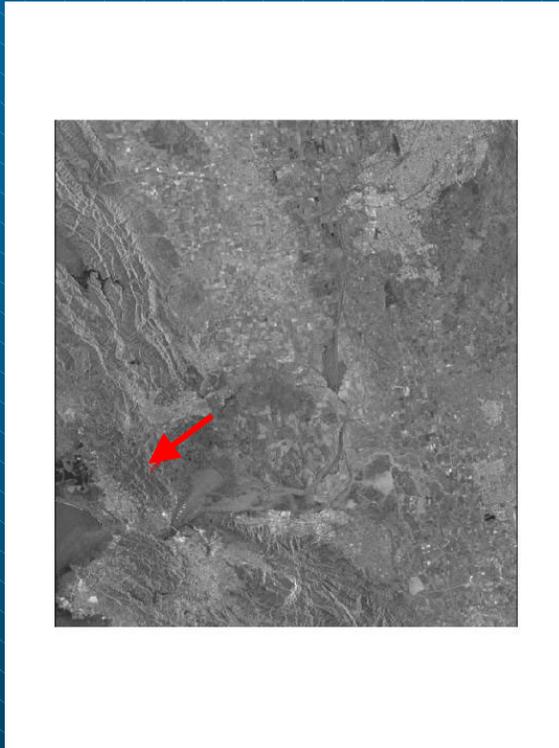
Raw data has been processed to backscatter intensity and phase images for four summer pairs

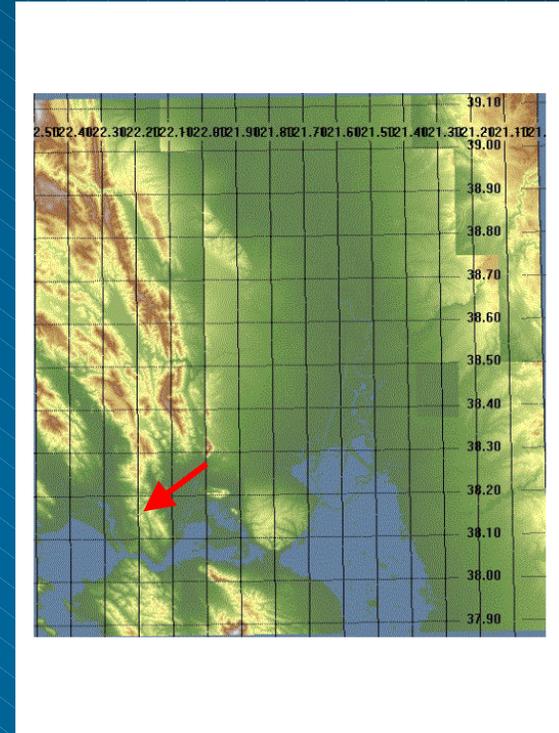
Final interferometric processing requires the removal of topography.

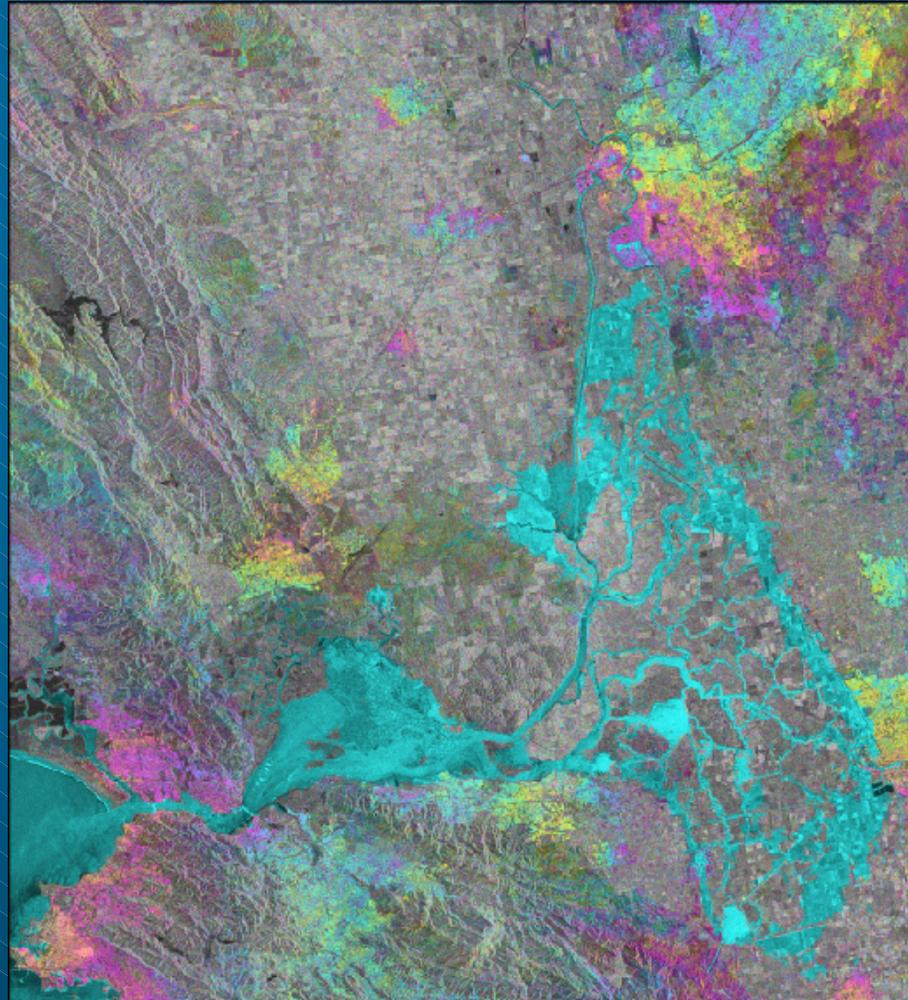
Figure 3: Orbits 17960-22469 differential (topography removed) interferogram (color) superimposed on backscatter intensity; radar coordinates. One color cycle (red-violet) represents 2π difference in phase.

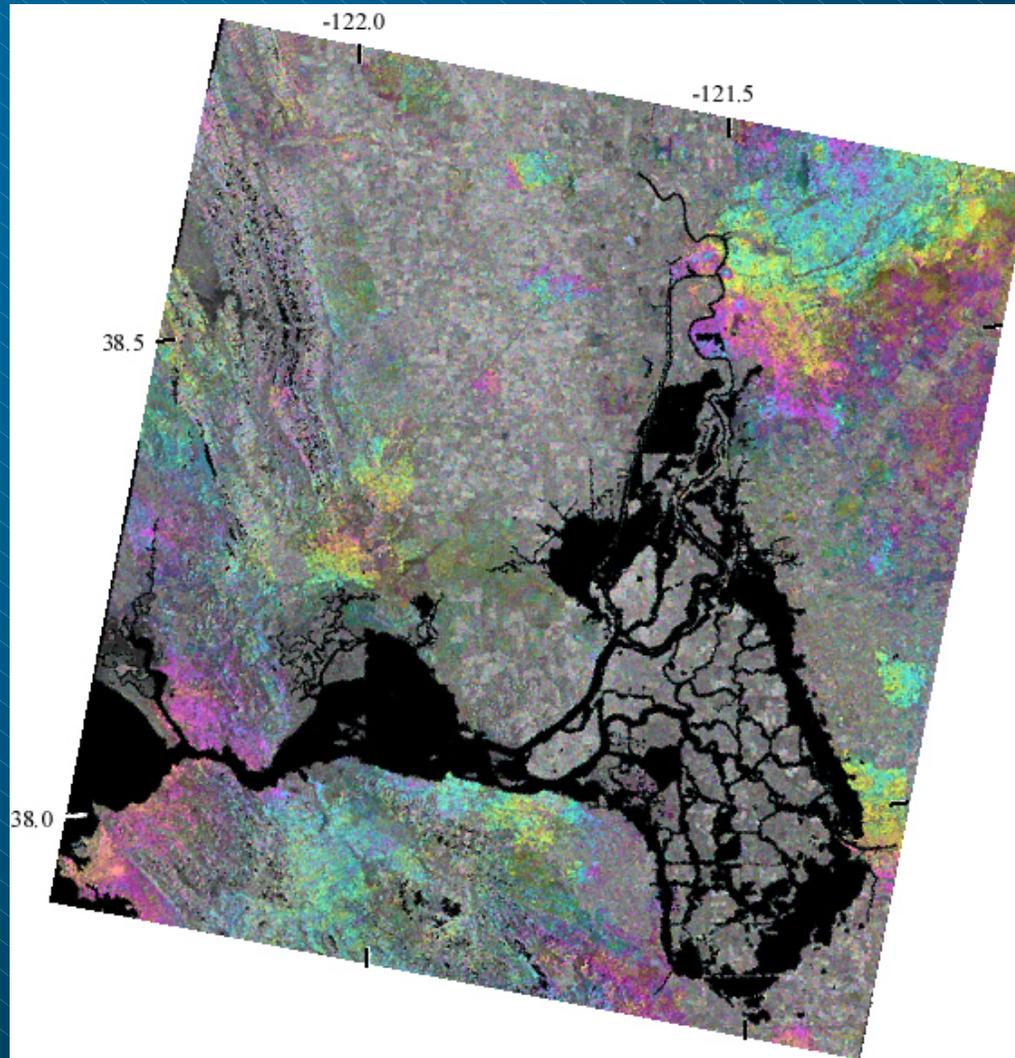
Figure 4: Orbits 17960-22469 differential interferogram geo-referenced to UTM coordinates (North American Datum 1927, Zone 10). Color scale as in Figure 3.
