Environmental Impact and Risk Modeling of Petroleum and Gas Transmission Lines Using High Resolution Imagery from Satellite and Airborne-Based Remote Sensing Systems

Digital Globe Inc., PG&E, LLNL, and Chevron Texaco

Donald G. Price, PG&E

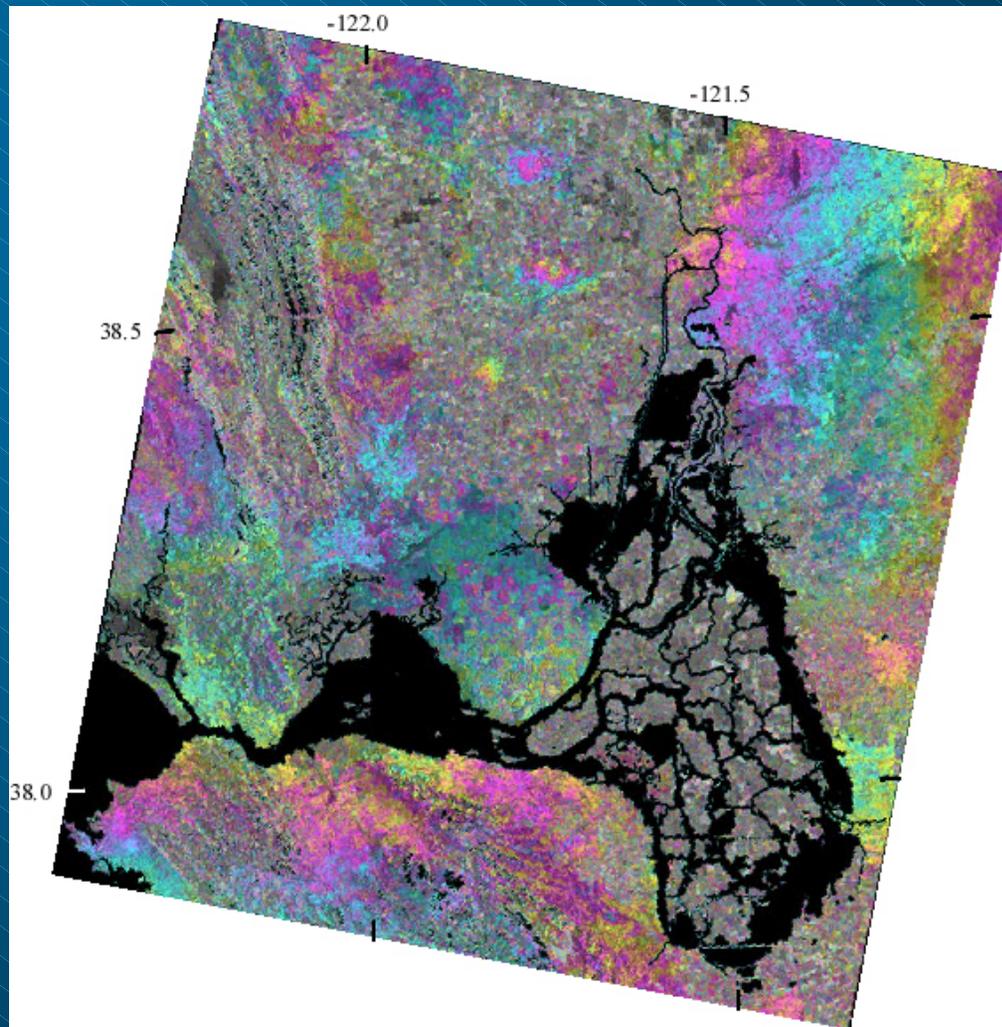
Figure 6: Orbits 21467-22469 differential interferogram; UTM. Color scale as in Figure 3.

- **The results of this evaluation study indicate that InSAR is not a viable technique for detecting landslide movement in an environment subject to seasonal growth of vegetation like that at the target landslide location.**
- **While the temporal decorrelation from one summer to the next might be expected, it is somewhat surprising that decorrelation also occurred over a two-month interval during an arid northern California summer.**
- **While the results are discouraging for this particular site, they demonstrate that good coherence can be preserved within non-vegetated environments for periods up to several years.**
- **Therefore, the potential of InSAR for monitoring land deformation along pipeline corridors within arid regions or built-up areas remains very promising.**

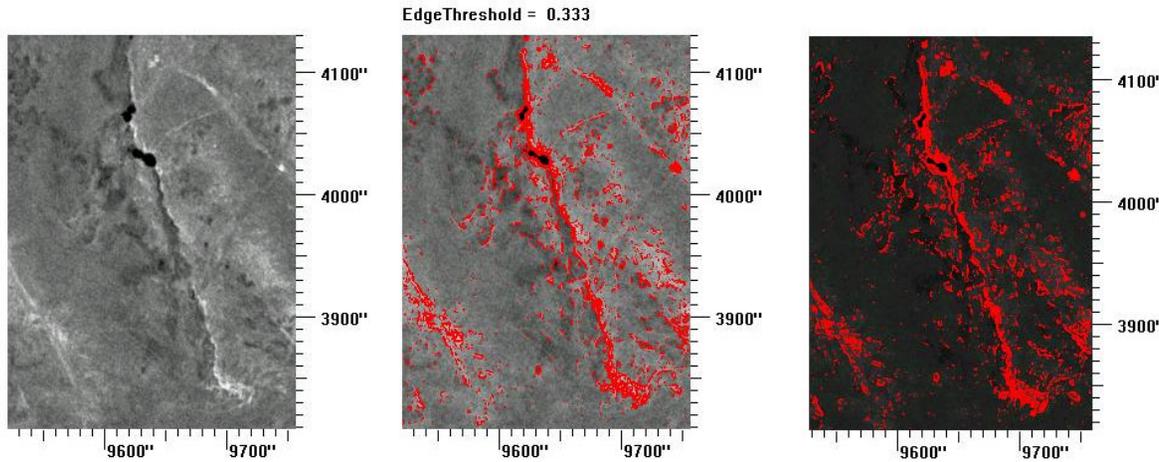
Bounding boxes are automatically put around connecting pixels with similar features. Features of interest include edges associated with erosion (landslides, gullies, etc.)

The size of boxes, skew angle, Appearance, etc. are recorded and numerical values extracted For each feature.

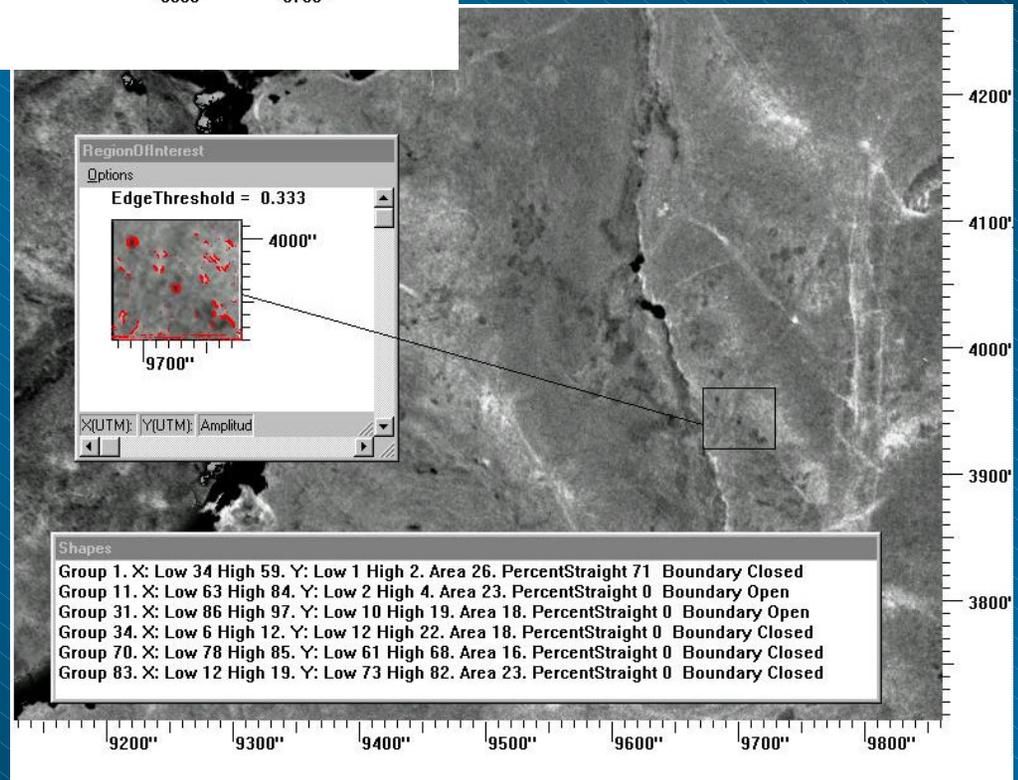
Various shapes and edge features are reviewed during post processing

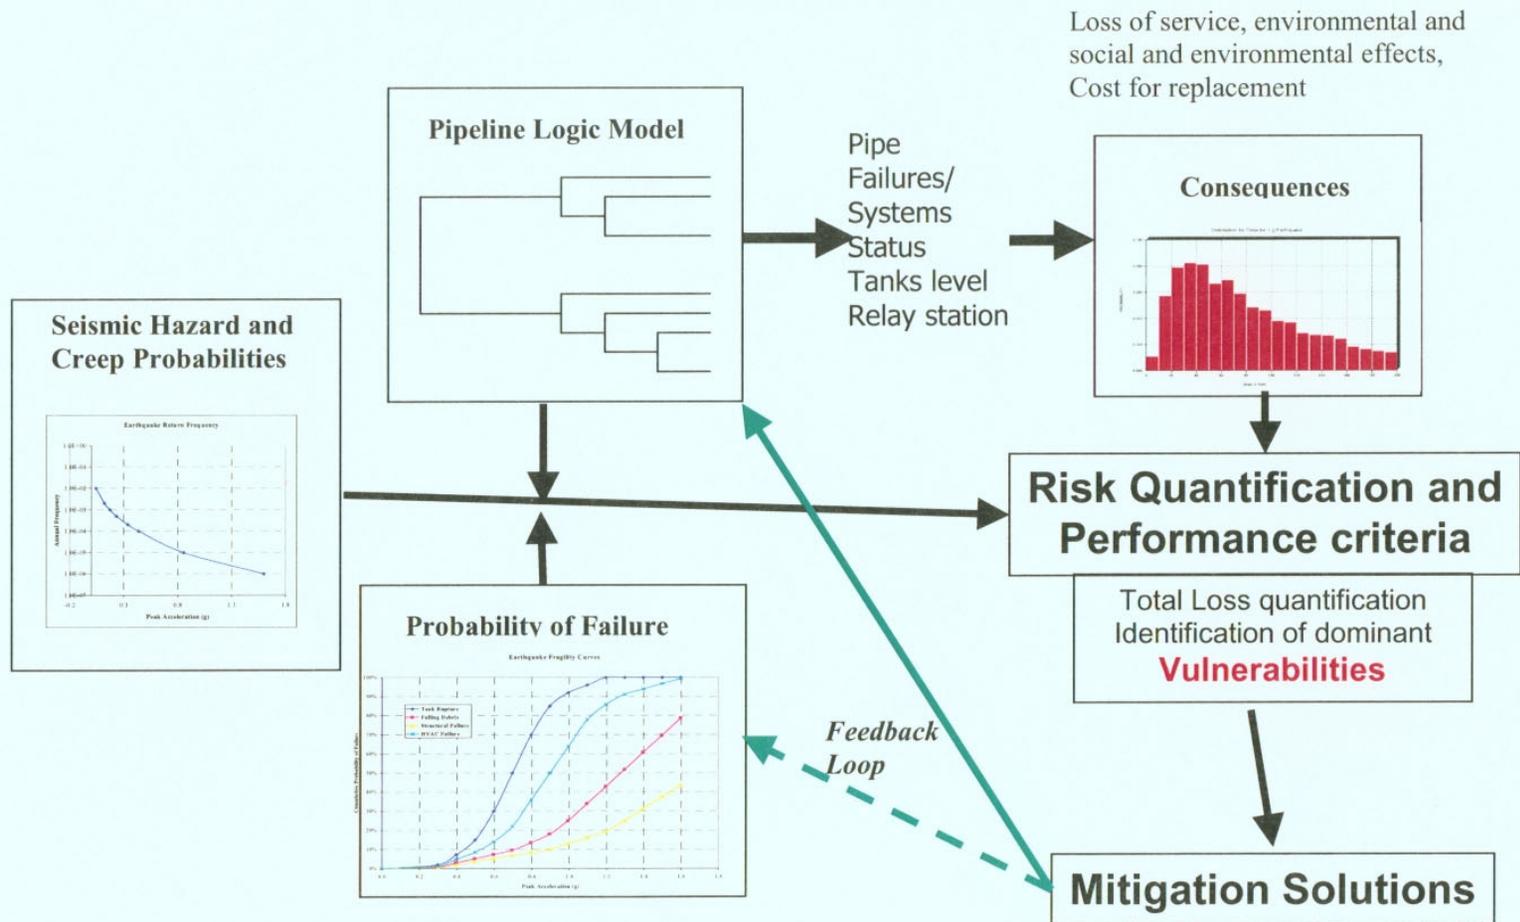
Figure X*.1 Conceptual Approach for estimating losses, identifying vulnerabilities and proposing mitigation solutions
