GEOENERGY CORPORATION

Surface Features Associated with
Lineaments, EGSP Area

(Cottageville Field, West Virginia)

EGSP
OPEN FILE # 172

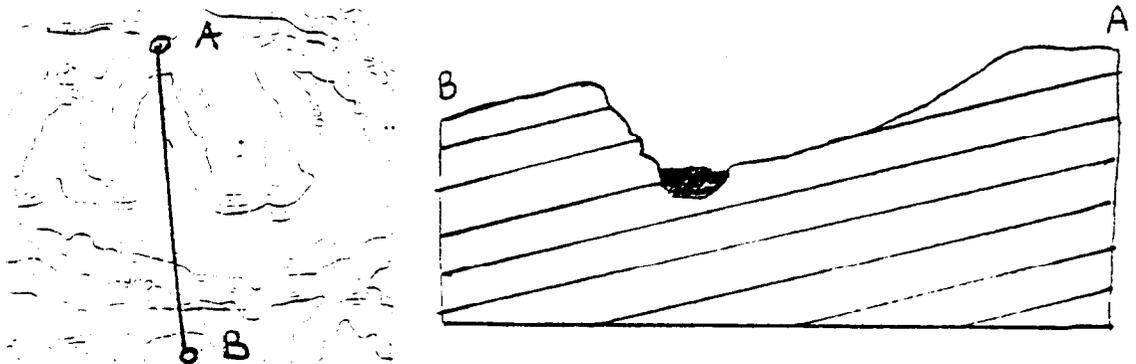
A number of topographic features in the Cottageville area seem to provide a dip direction, i.e. a measure of structural control. Valleys with tributaries on only one side frequently occur where stream direction parallels the strike direction. The stream cuts into the face of the dipping strata and the tributaries are developed on the dip slopes.

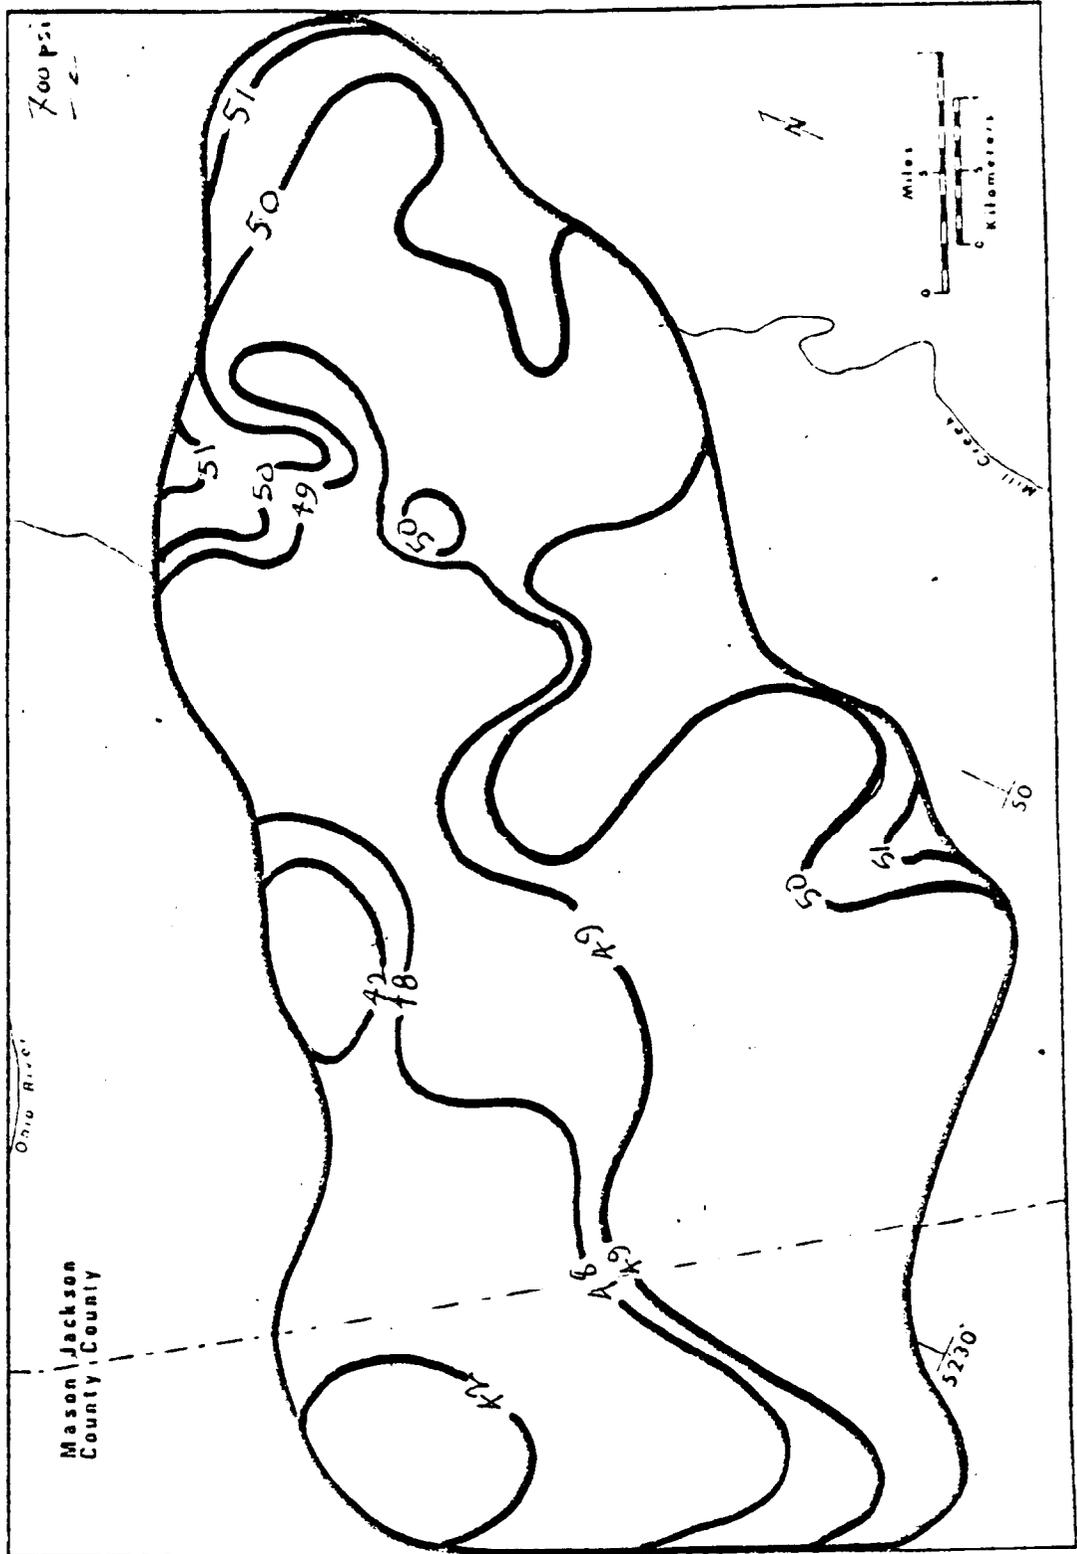
FIGURE 18. Estimated Location of 700 psi isobar Pressure Contour 1942 (42) to 1951 (51) (Data From deWys and Shumaker, 1978)

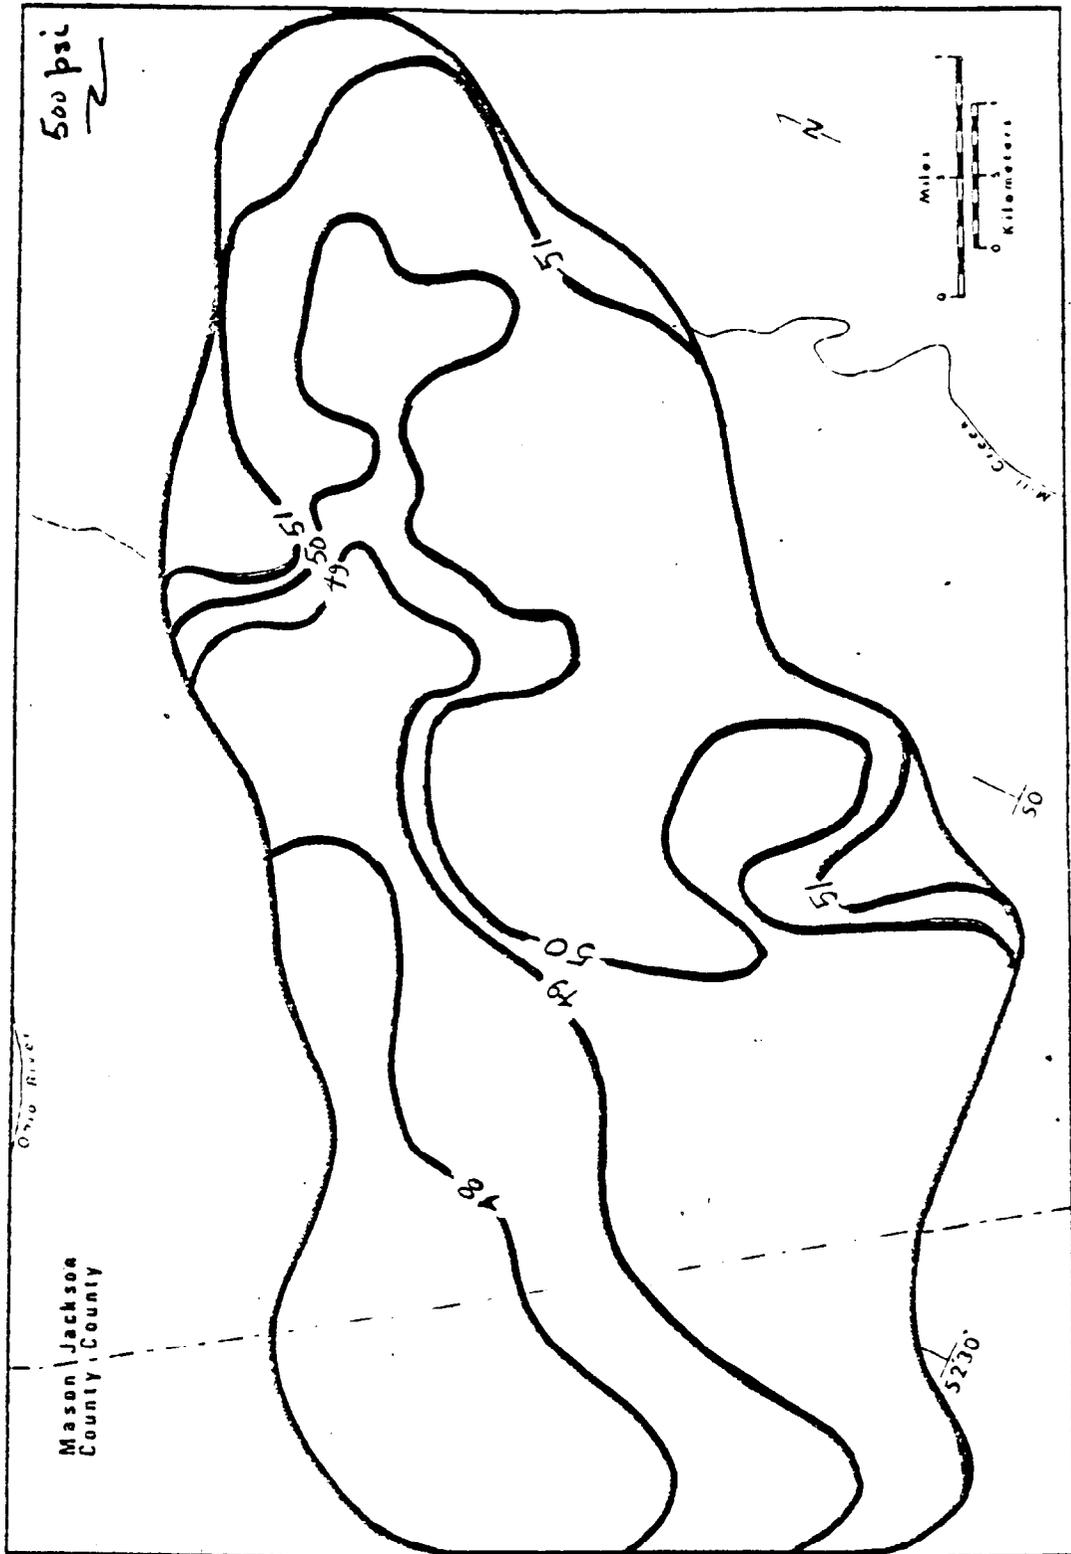
FIGURE 19. Estimated Location of 500 psi Is O Pressure Contours 1948 (48) to 1951 (51) (Data From deWys and Shumaker, 1978)

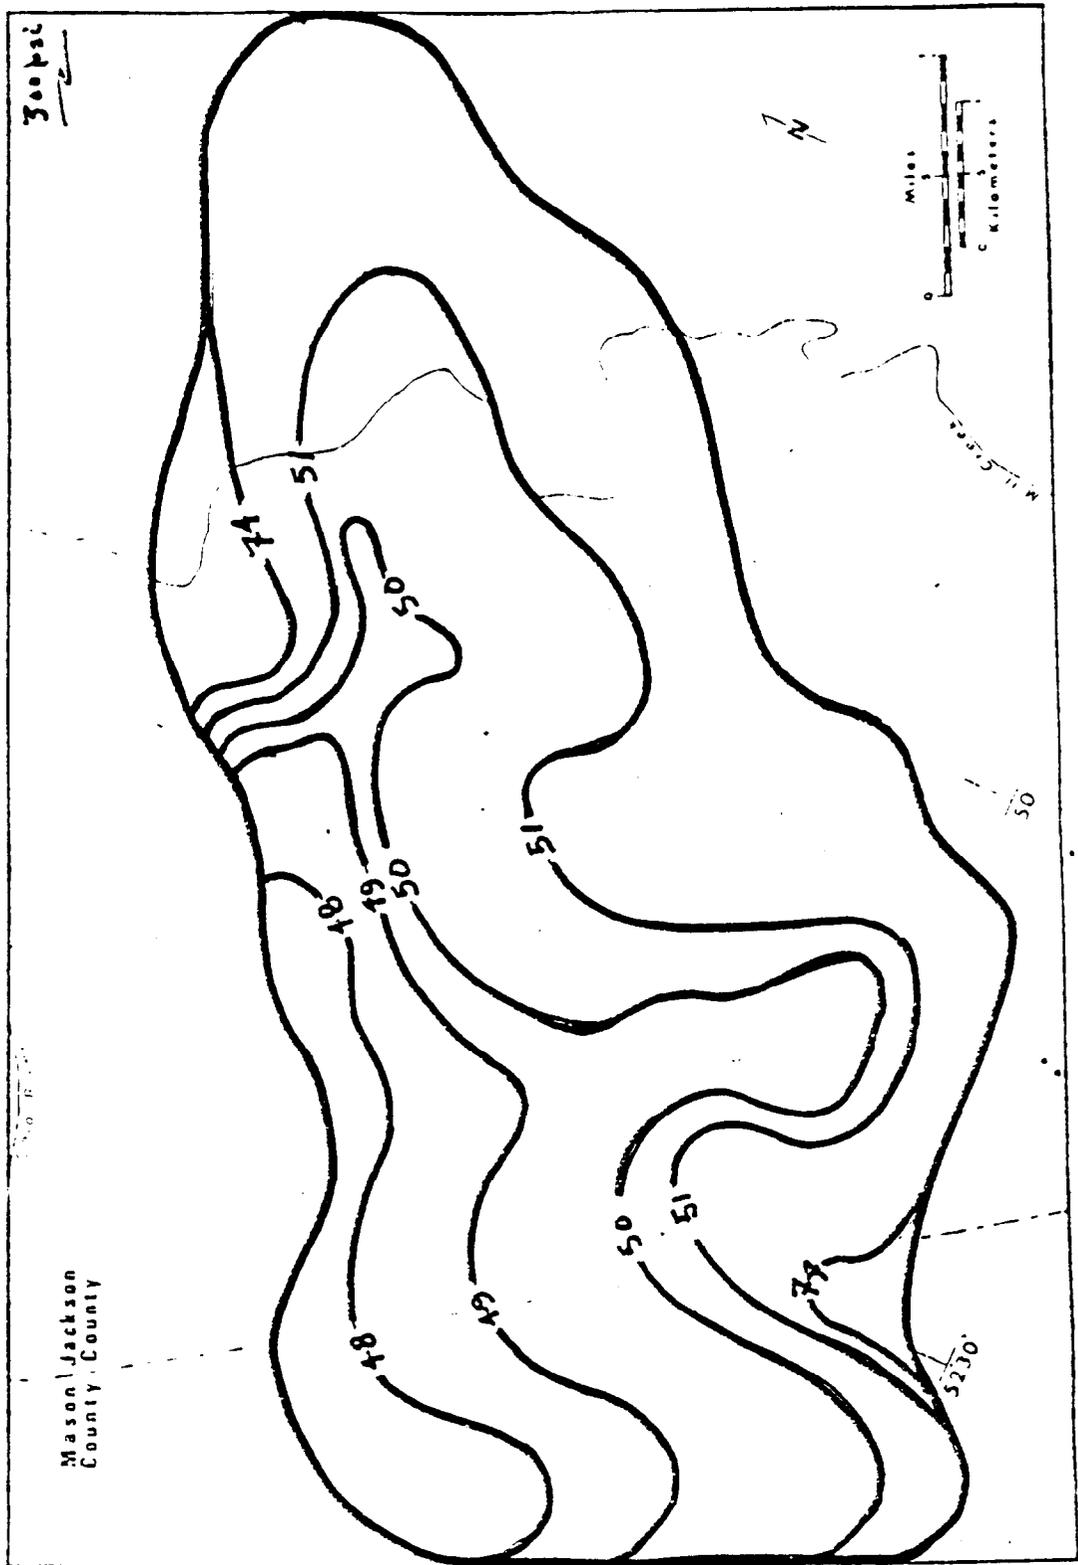
FIGURE 20. Estimated Location of 300 psi isobar Pressure Contours, 1948 (48) to 1974 (74). (Data From deWys and Shumaker, 1978)

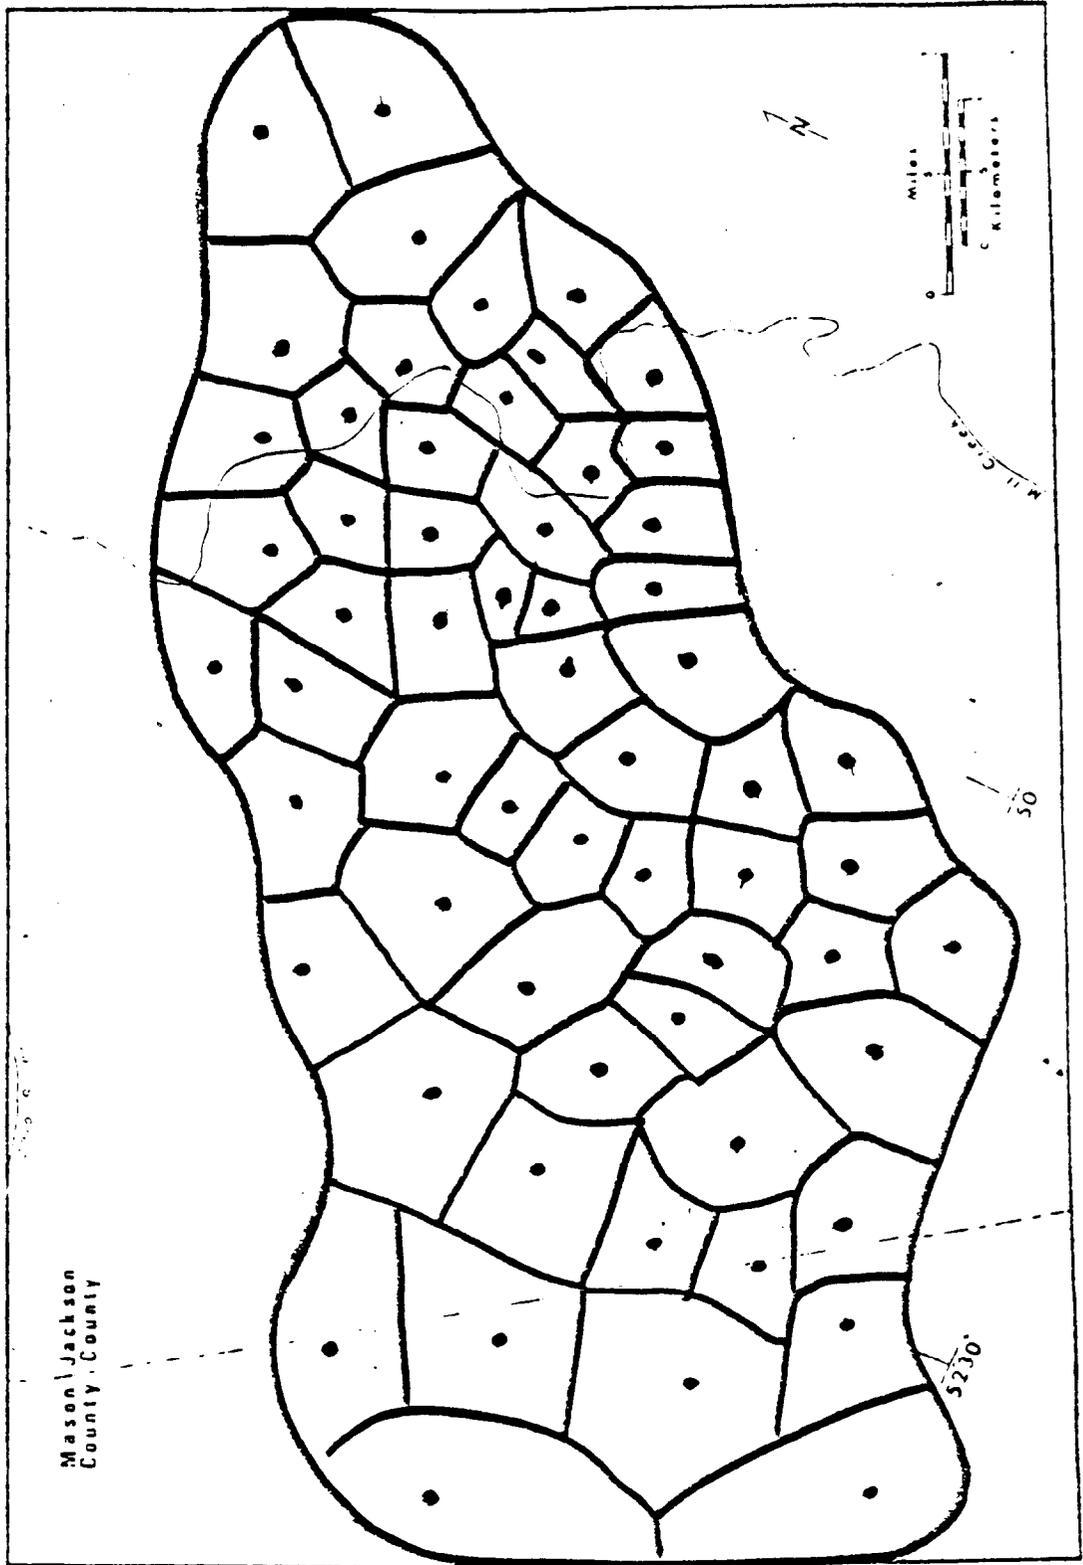
FIGURE 21. Polygon Map of Wells In Cottageville Field (Data From deWys and Shumaker, 1978)

drop. A simple material balance can be made with a computer using a polygon well spacing, Figure 21, and matching withdrawals with flow paths and estimates of porosity. From the "eyeballed" analysis it would appear that there has been significant Devonian gas production either from multiply completed wells not listed in the data set, or there has been "leakage" into other reservoirs.

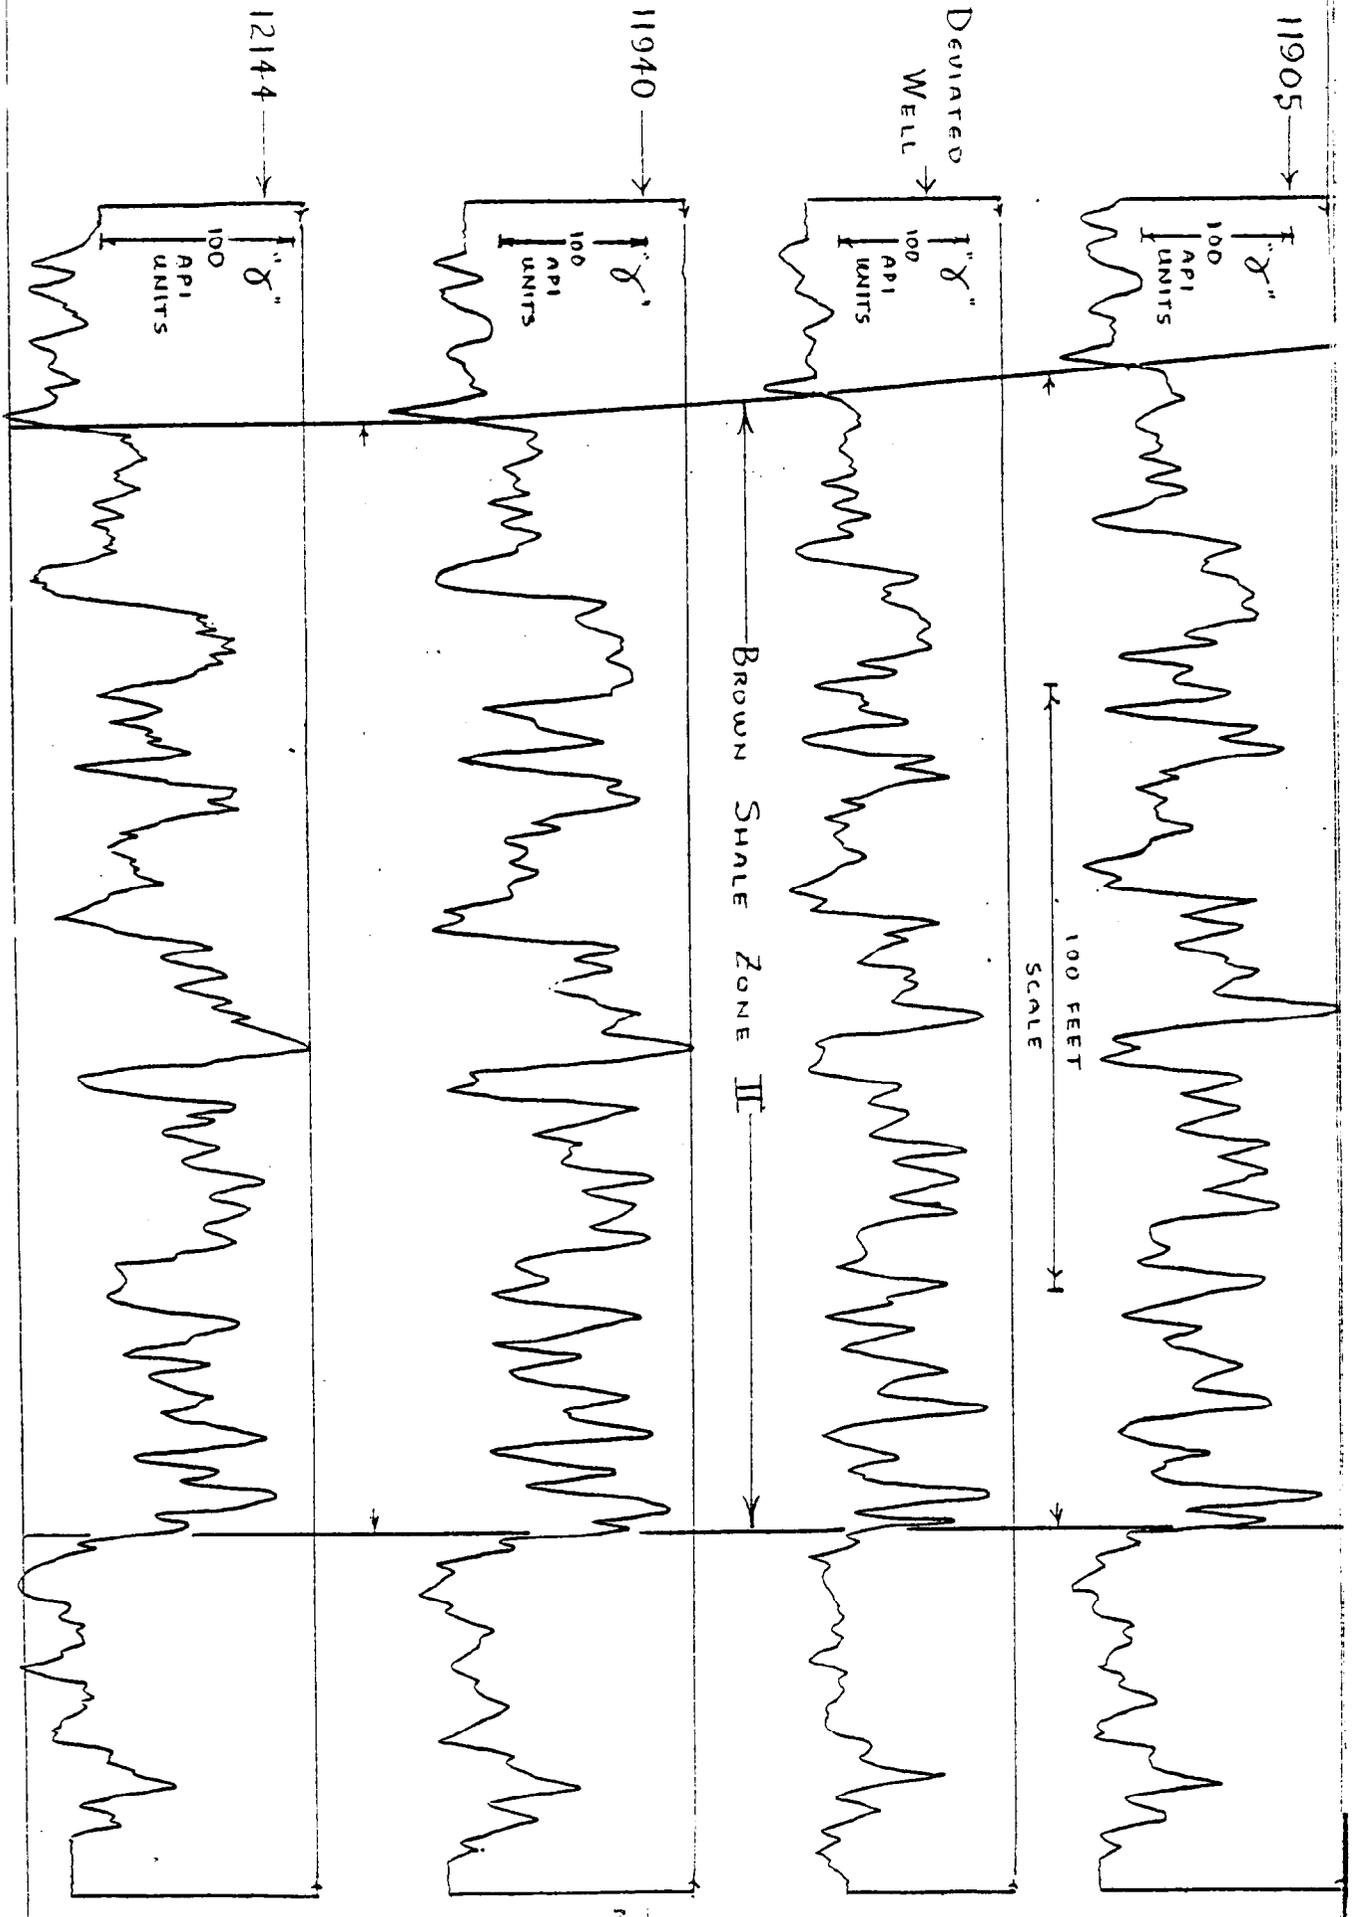
CROSS SECTION DEVIATED WELL AREA

The logs in the deviated well were correlated to determine if a fault might be present to explain the water production, Figure 22. A comparison of the deviated well log corrected to a true vertical relation* with wells north west and south east of the Brown Shale Zone II (location in the deviated well) certainly shows no cut out or repeated section that would indicate a fault.
