# Evaluation of Gold MerCAP™ Process for Flue Gas Mercury Removal

Mercury Control Technology R&D  
Program Review Meeting  
July 12-14, 2005

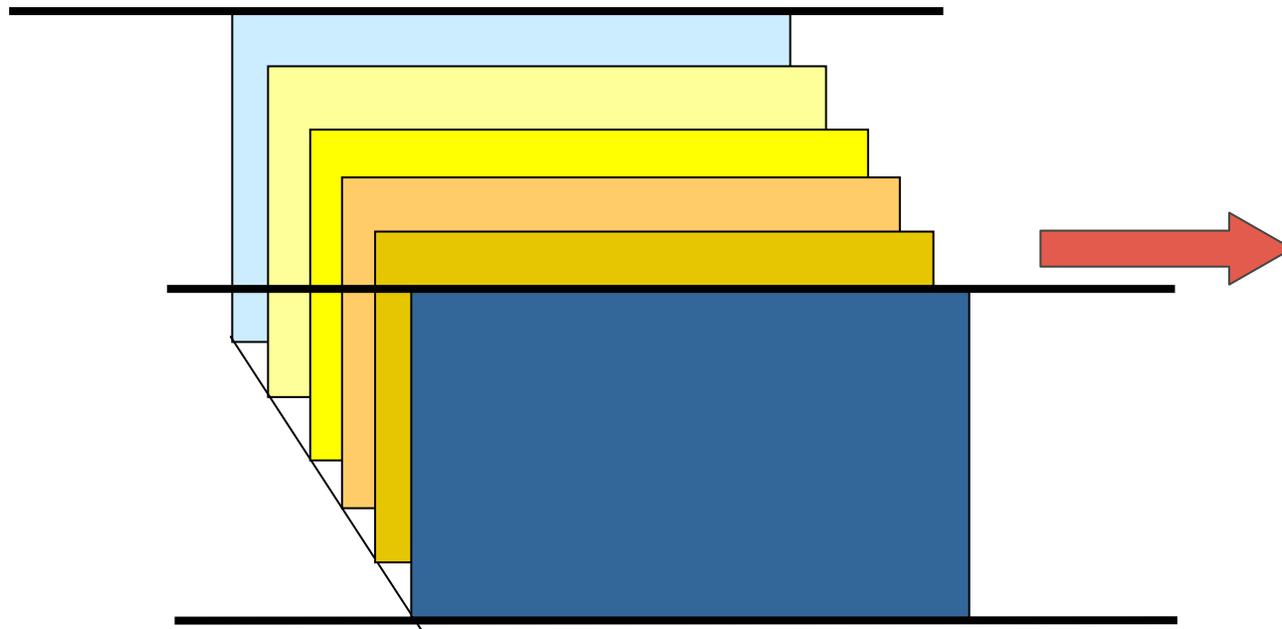
# MerCAP™ Basic Concept

(Mercury Control via Adsorption Process)

Parallel plates with  
sorbent-coated surfaces

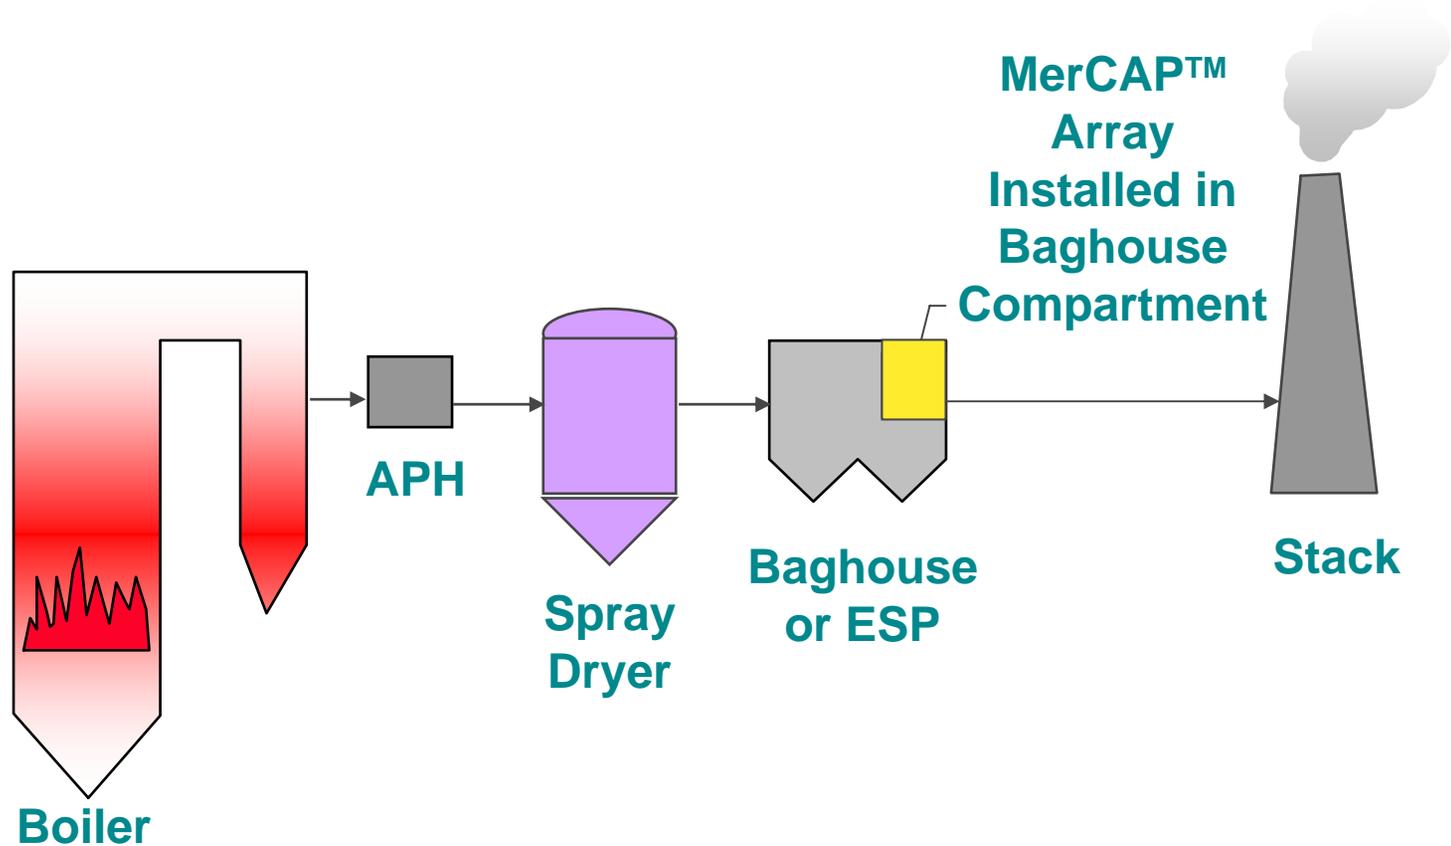
# MerCAP™ Installation - Stanton Unit 10 Baghouse Outlet

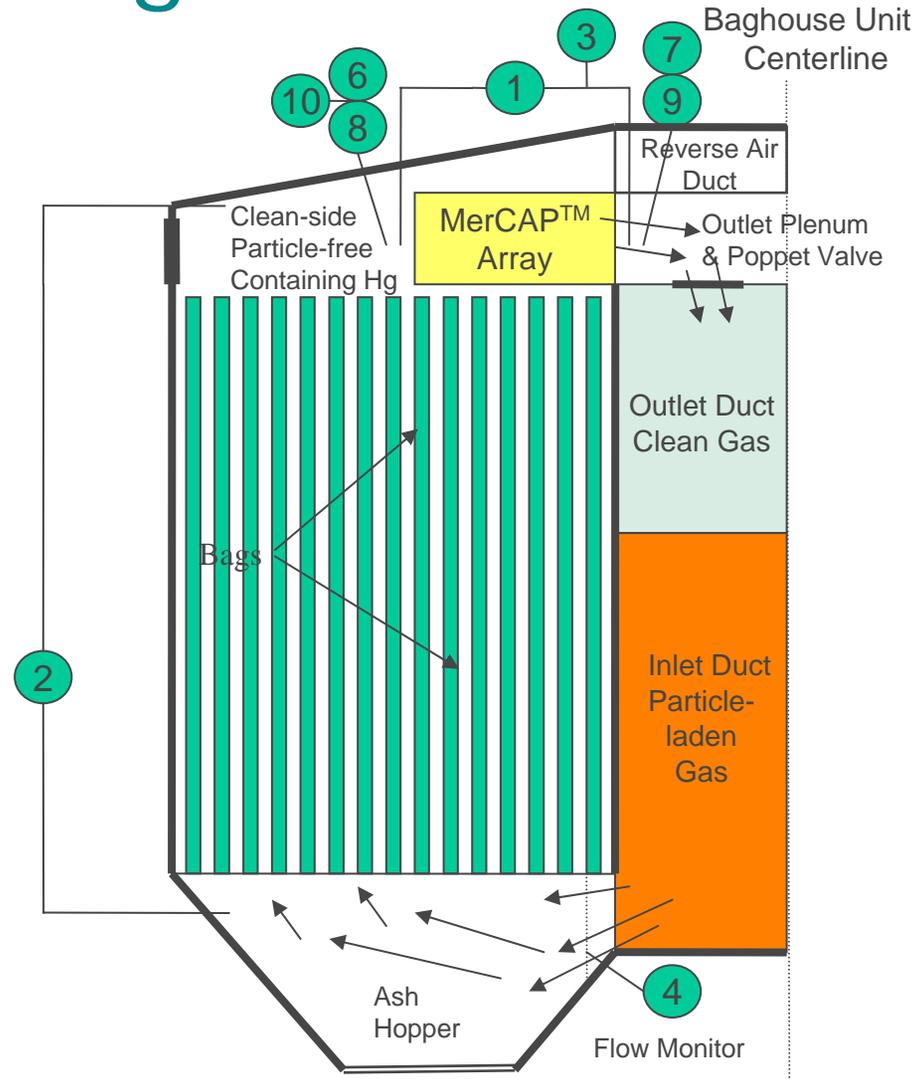
# MerCAP™ Installation - Stanton Unit 10 Baghouse Outlet

## Measurements and Sampling Locations

1. MerCAP™ Array dP
2. Compartment dP
3. Compartment Static Pressure
4. Compartment Flow
5. Adjacent Compartment dP  
(not shown)
6. MerCAP™ Inlet Temperature
7. MerCAP™ Outlet Temperature
8. Inlet MerCAP™ Hg  
Concentration
9. Outlet MerCAP™ Hg  
Concentration
10. HCl Measurement Location

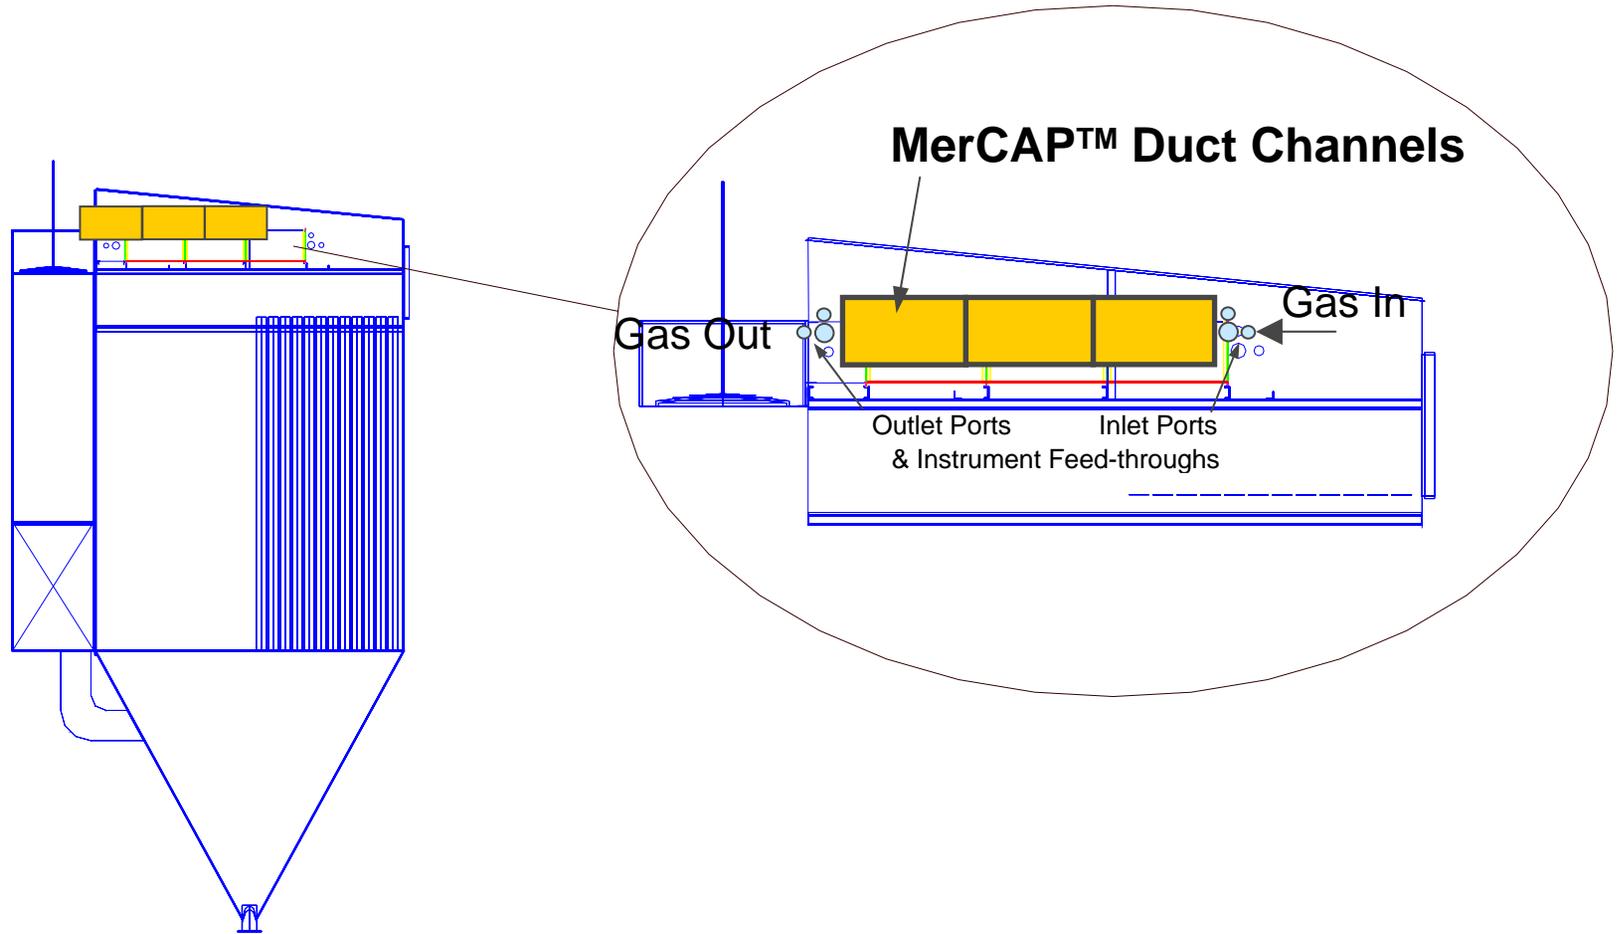
# Baghouse Cross-Section

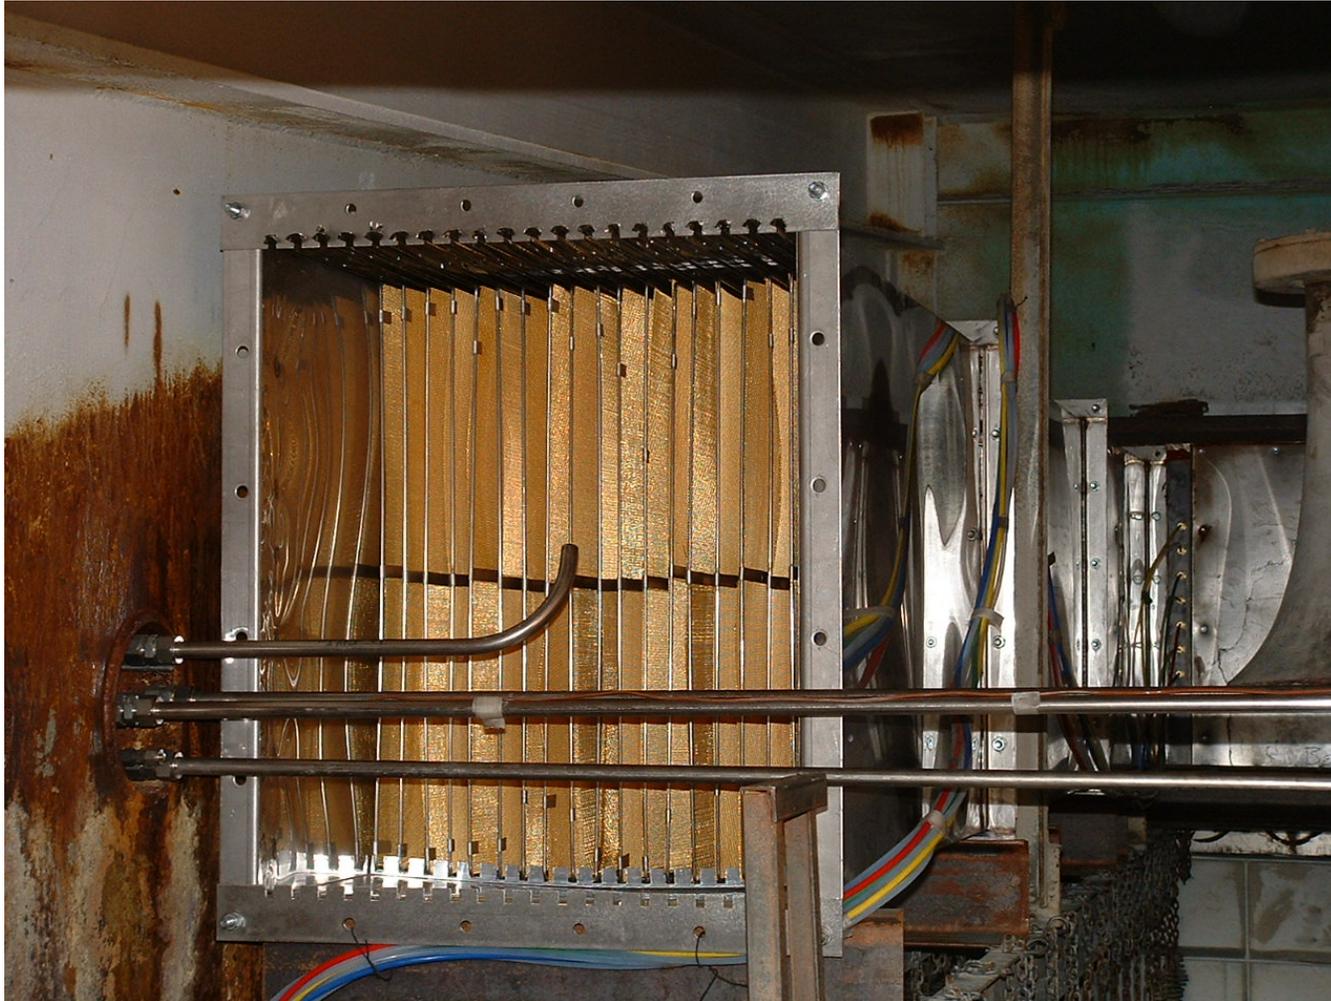
## Duct 1 of 4

# MerCAP™ Installation - Stanton

- **Target Mercury Removal Rate of 55%**
- **10-foot Active Length**
- **1-inch Spacing Between Substrates**
- **25-feet per Second Gas Face Velocity**
- **Expected Pressure Drop of 0.3 inches H<sub>2</sub>O**

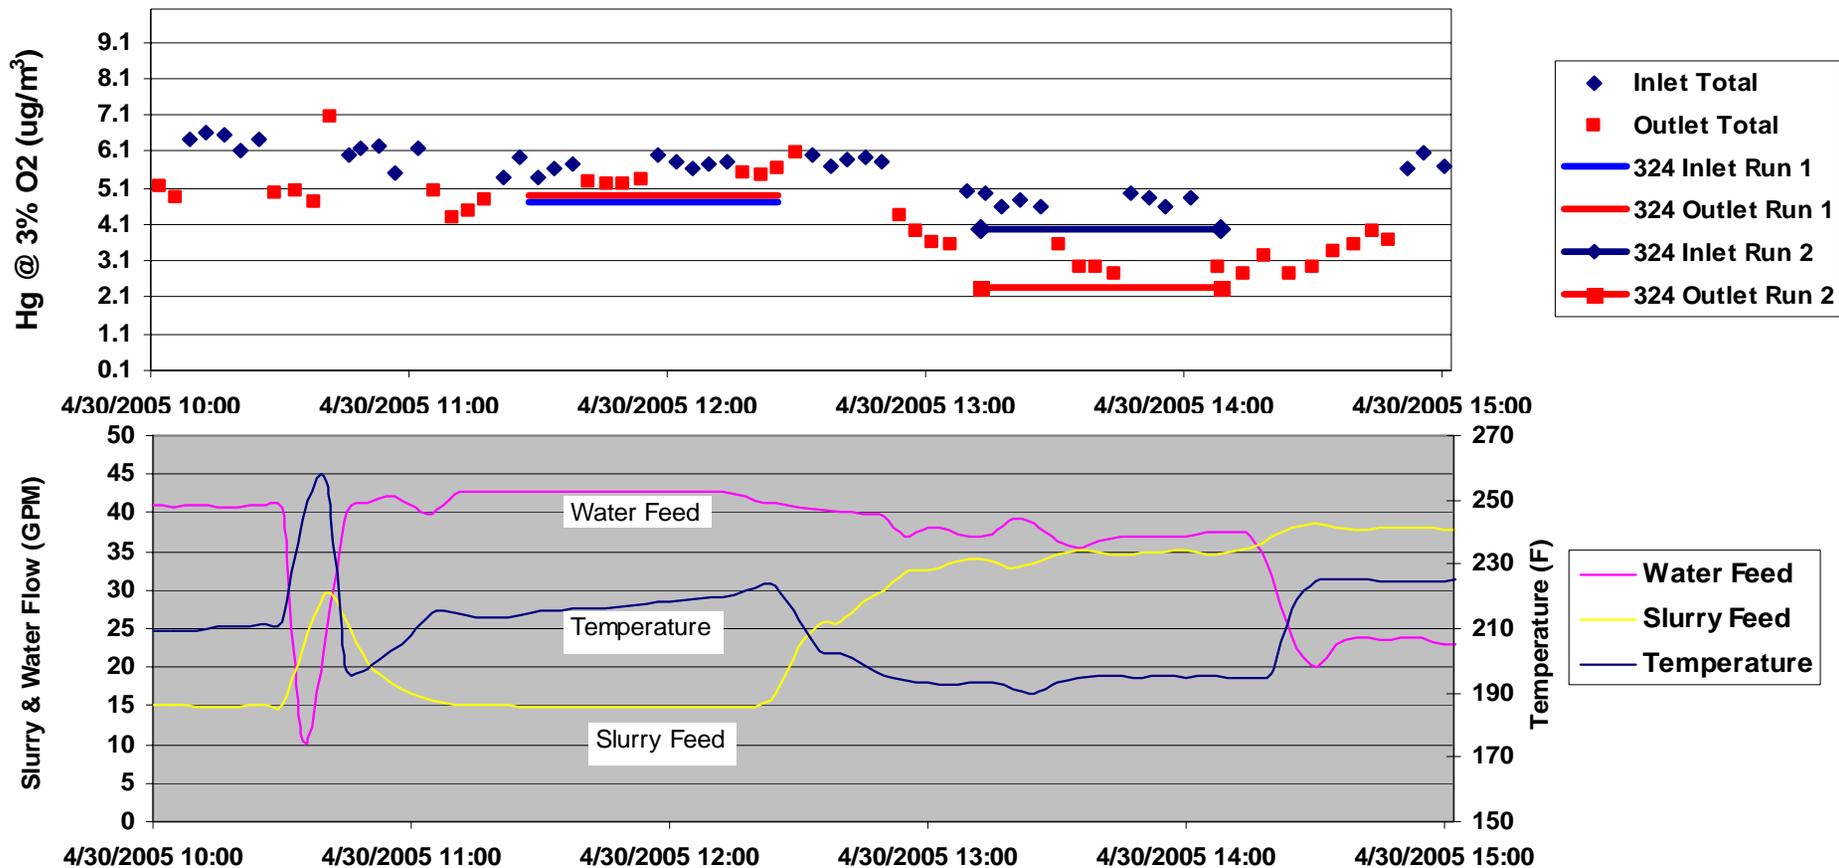
# Hg Removal Performance related to SD Operation

- Over 7000 Hours of Operation
  - 1700 Hours on North Dakota Lignite
  - 5300 Hours on Subbituminous (PRB)
- Removal levels ranging from 65%-5%
- Removal performance demonstrated wide variability. The primary identified variable is slurry feed to the scrubber unit indicating a possible acid gas constituent or concentration level that limits or degrades the Hg capture performance.
- Non-ideal operating conditions do not cause permanent degradation of the gold substrate.

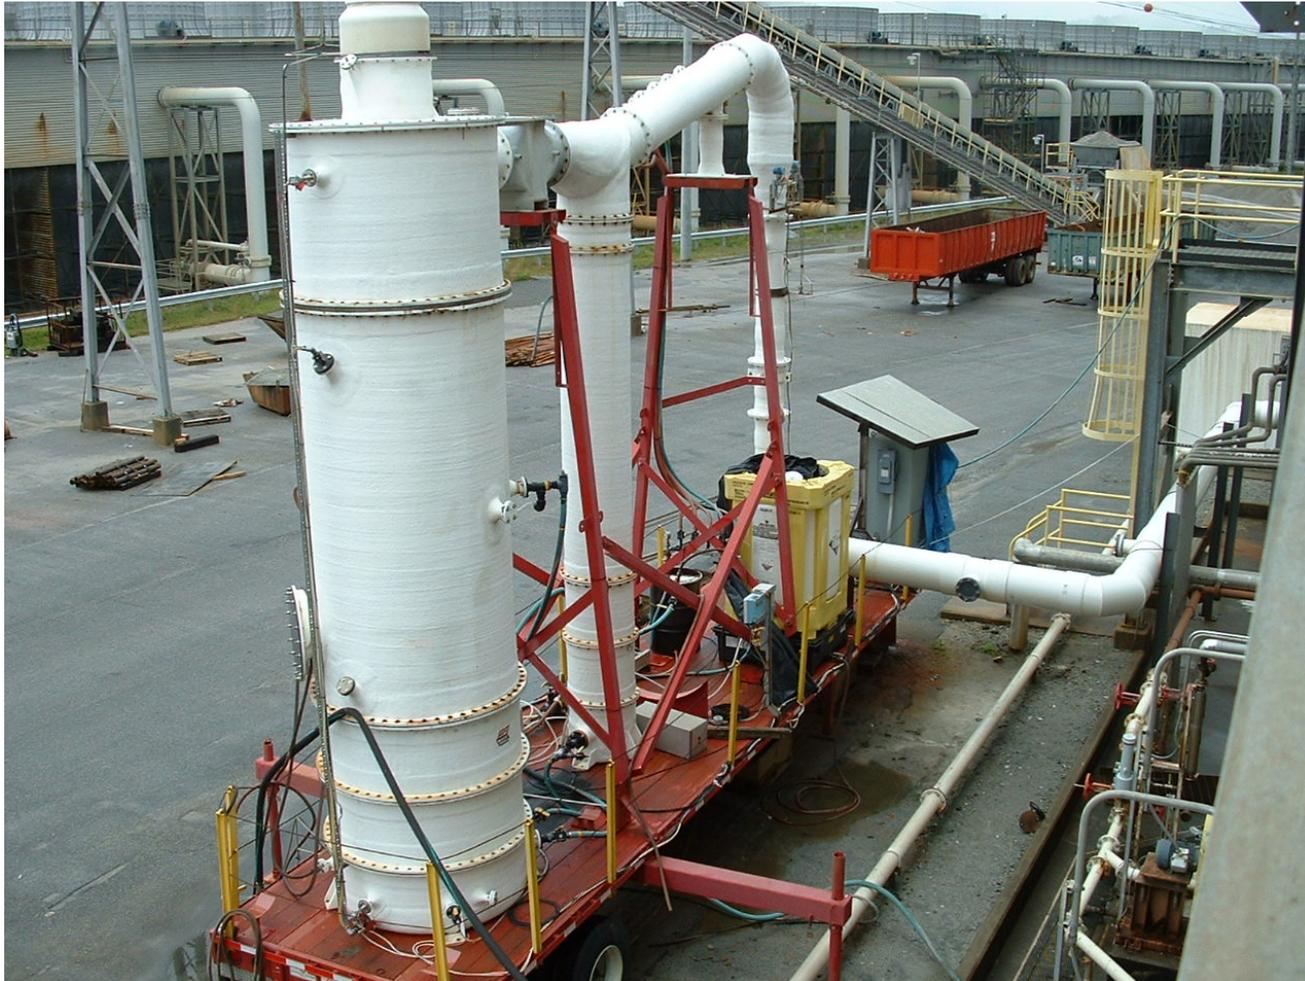
# MerCAP™ Installation-Plant Yates Southern Company Pilot Unit

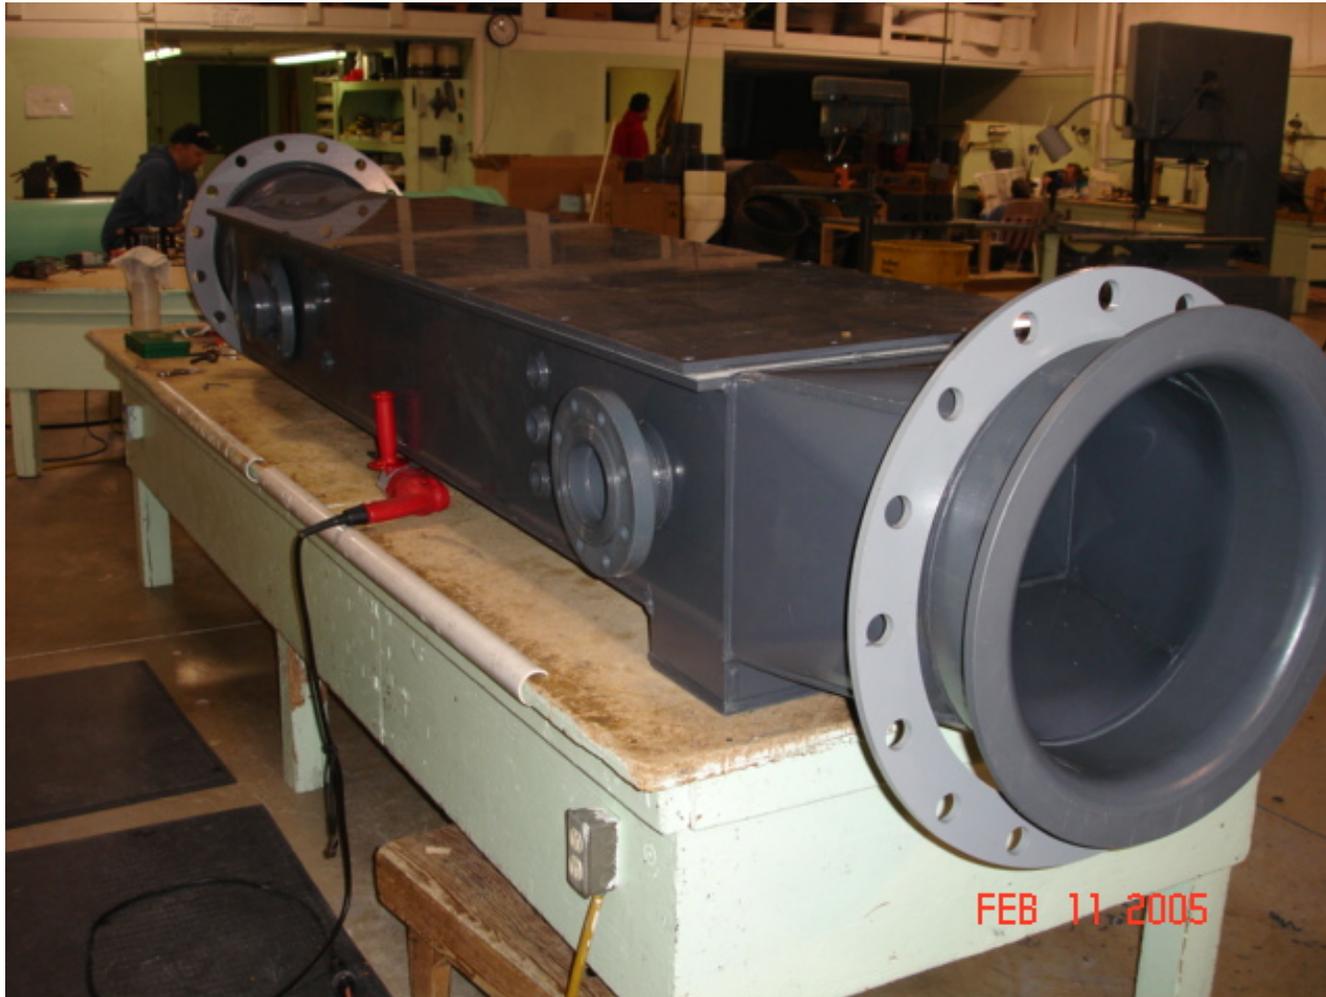
# MerCAP™ Test Setup for Wet Scrubbers

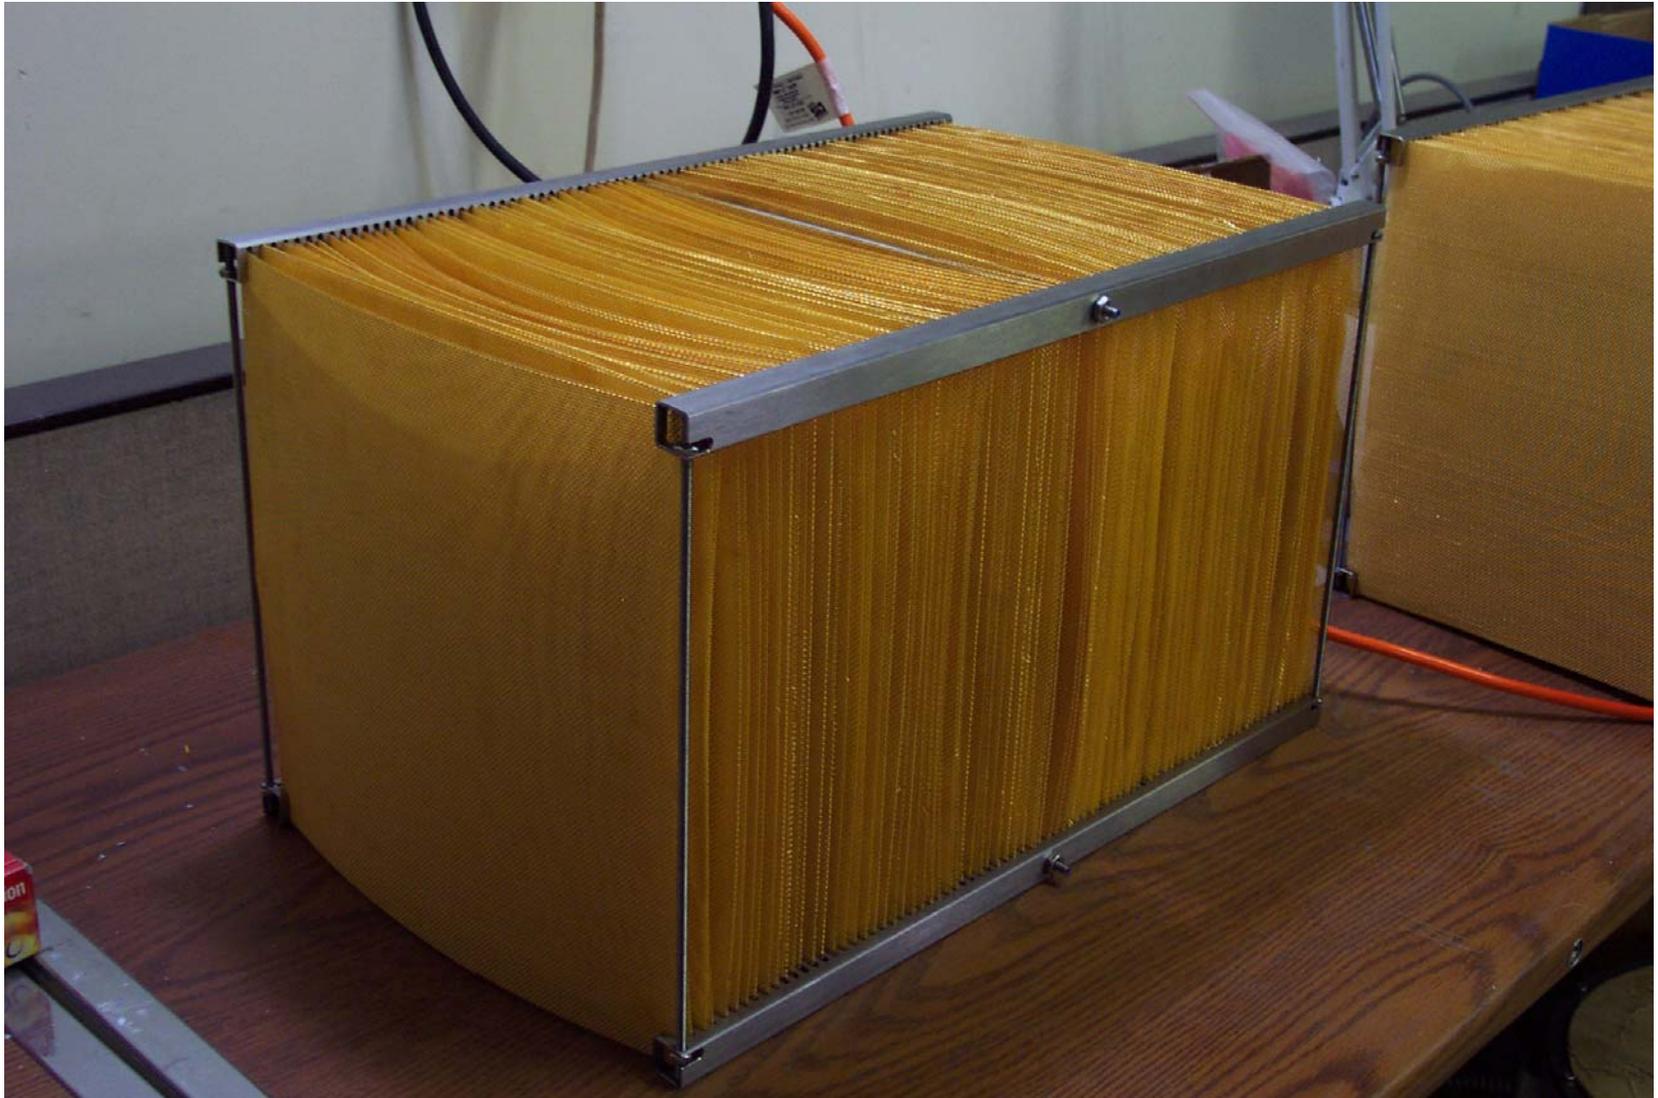
# MerCAP™ Screen Module
