Ryton Fabric Degradation at Big Brown's COHPAC Baghouse

A.K. Hindocha, Allen Casey

INTRODUCTION

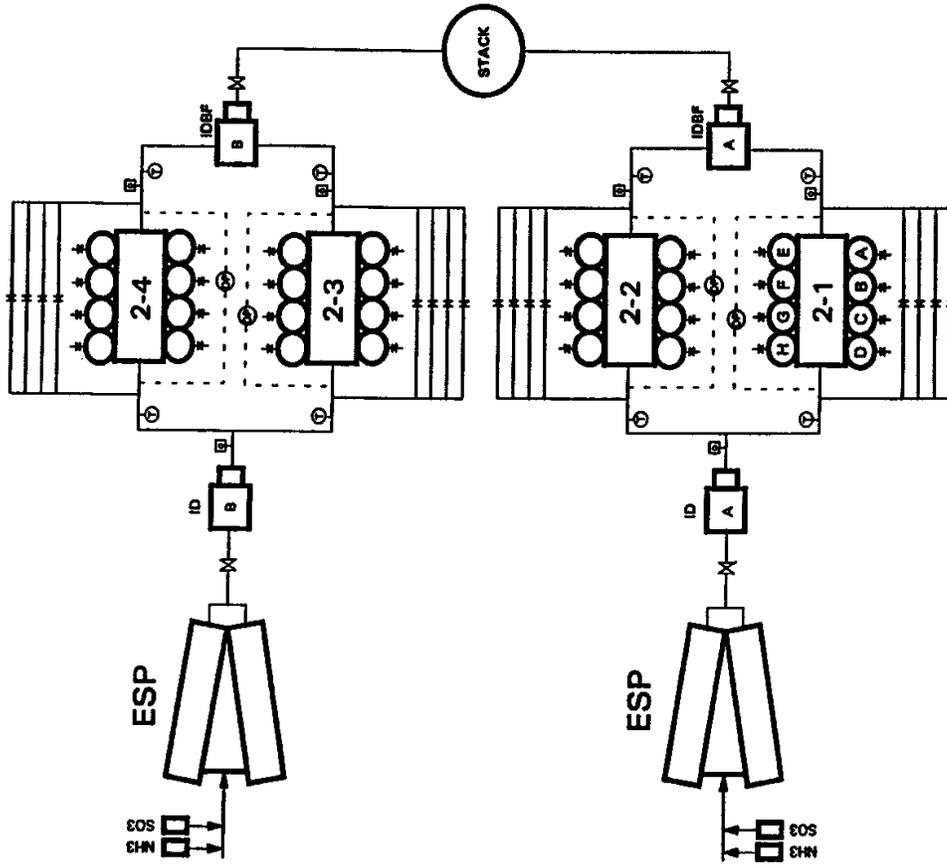
Figure 1
Big Brown Unit 2 Layout

travels either through the A-side or B-side air preheaters and air pollution control equipment. A layout of the electrostatic precipitators and COHPAC is presented in Figure 1. Coal and flue gas conditions to which the Ryton bags are exposed are summarized in Table 1.
