# Appendix F

## Stream Studies

# **Aquatic Biota and Habitat Survey of Two Streams in Rainelle, WV.**

Western Greenbrier Co-Generation (WGC) Power Plant  
**Meander Study Report**  
Boyd F. Edwards  
Department of Physics  
West Virginia University  
June 20, 2005

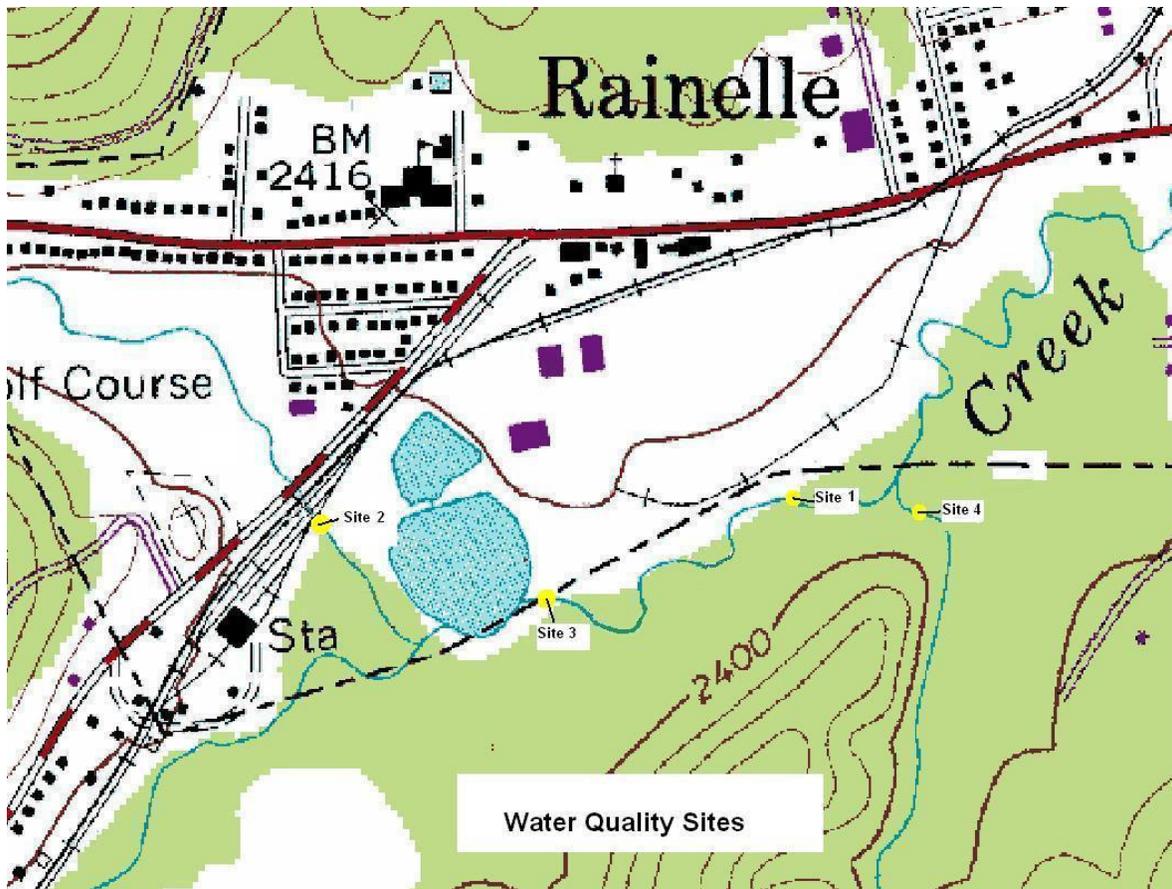
Figure 2. Locations of water quality sampling sites.

A field technician from Acculab, Inc. completed field testing and laboratory testing of water chemistry. This is an EPA certified laboratory. All standard QA/QC procedures were followed. Water samples were collected from four locations (Figure 2).

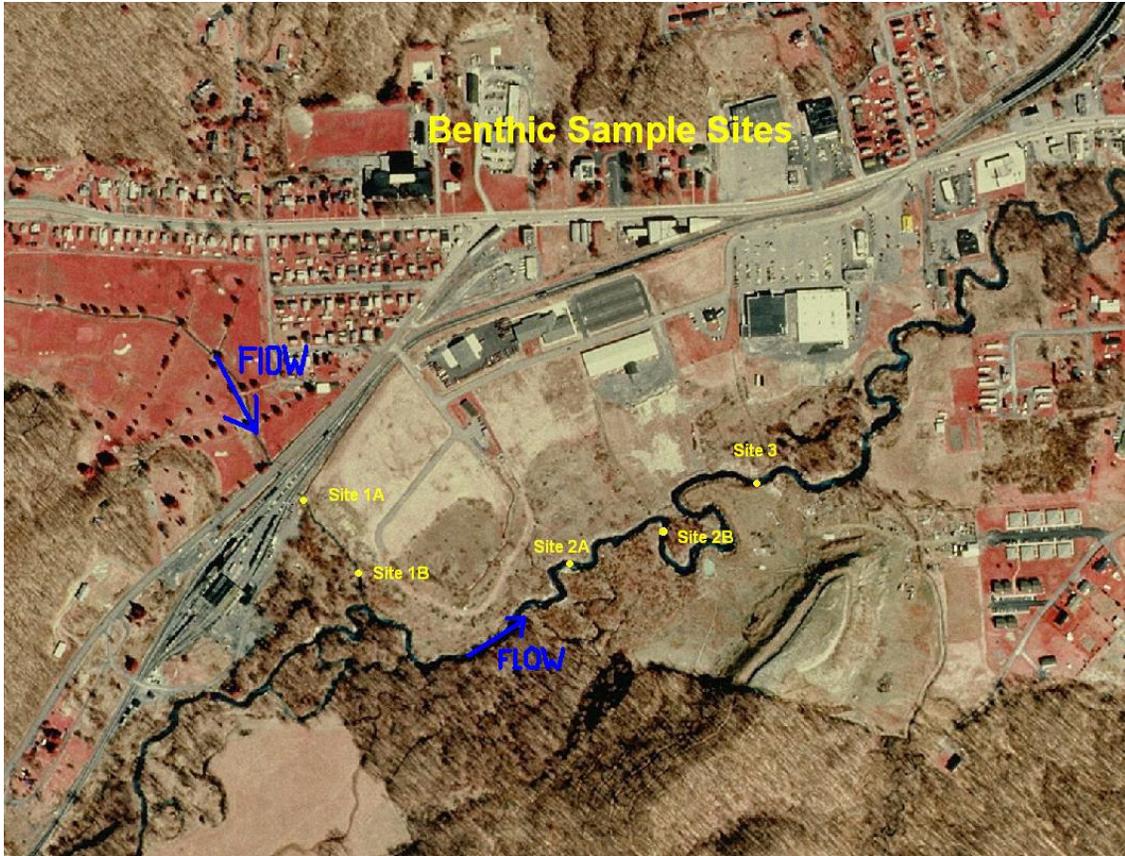
Figure 3. Benthic invertebrate sampling sites on Wolfpen (site 1a & 1b) and Sewell Creeks (sites 2a, 2b, and 3) near Rainelle, WV.

Five samples were collected, three on Sewell Creek and two on Wolfpen Creek (Figure 3, Table 5). Although the fish and benthic samples were collected in similar locations, specific habitat requirements did cause these sampling sites to differ slightly. Our protocols are directly quoted from the WV DEP's West Virginia Stream Index Protocol. The following are standard protocols (slightly modified) developed by the U.S. Environmental Protection Agency for conducting biological assessments of streams and rivers. A detailed description of the protocol is given in EPA 841-B-99-002 Rapid Bioassessment Protocols for Use in Wadeable Streams and Rivers (RBP).

Five benthic invertebrate samples were collected from Wolfpen and Sewell Creeks near Rainelle, WV (Figure 3, Table 5, and Appendix 2). Stream habitat data were collected from all five sites. Five sites were chosen to assess some measure of in stream variability. The EPA's RAPID protocol habitat score sheets, which were modified by the WVDEP, was used to measure the gradient score. The high gradient score sheet was used since Wolfpen Creek best fits this scoring procedure and therefore direct comparisons could be made between sites. Sewell Creek was judged borderline between high and low gradient. If low gradient scores were utilized, then the mean habitat scores would increase slightly. The high gradient scoring procedure is the most commonly utilized scoring procedure in WV. The RAPID protocol includes ten metrics calculated for each site with a possible maximum of 20 pts per metric (Table 6). Three of the ten metrics, bank stability, vegetative protection, and riparian vegetative zone width are measured along both banks and their cumulative, right and left bank scores can total a maximum 20 pts. Wolfpen Creek sites 1a and 1b scored 117 and 122, respectively. The total possible score is 200. These represent below average stream habitats. The site images found in Appendix 1 shows high gradient rocky bottom locations. These images represent the best benthic habitat in along the stream segment. Benthic samples are collected from a series of riffles within a 100 meter reach. Habitat scores are based on the cumulative habitat across the entire reach. The three sites on Sewell Creek were scored even lower at 94, 88, and 85. All three scores suggest degraded stream habitats.

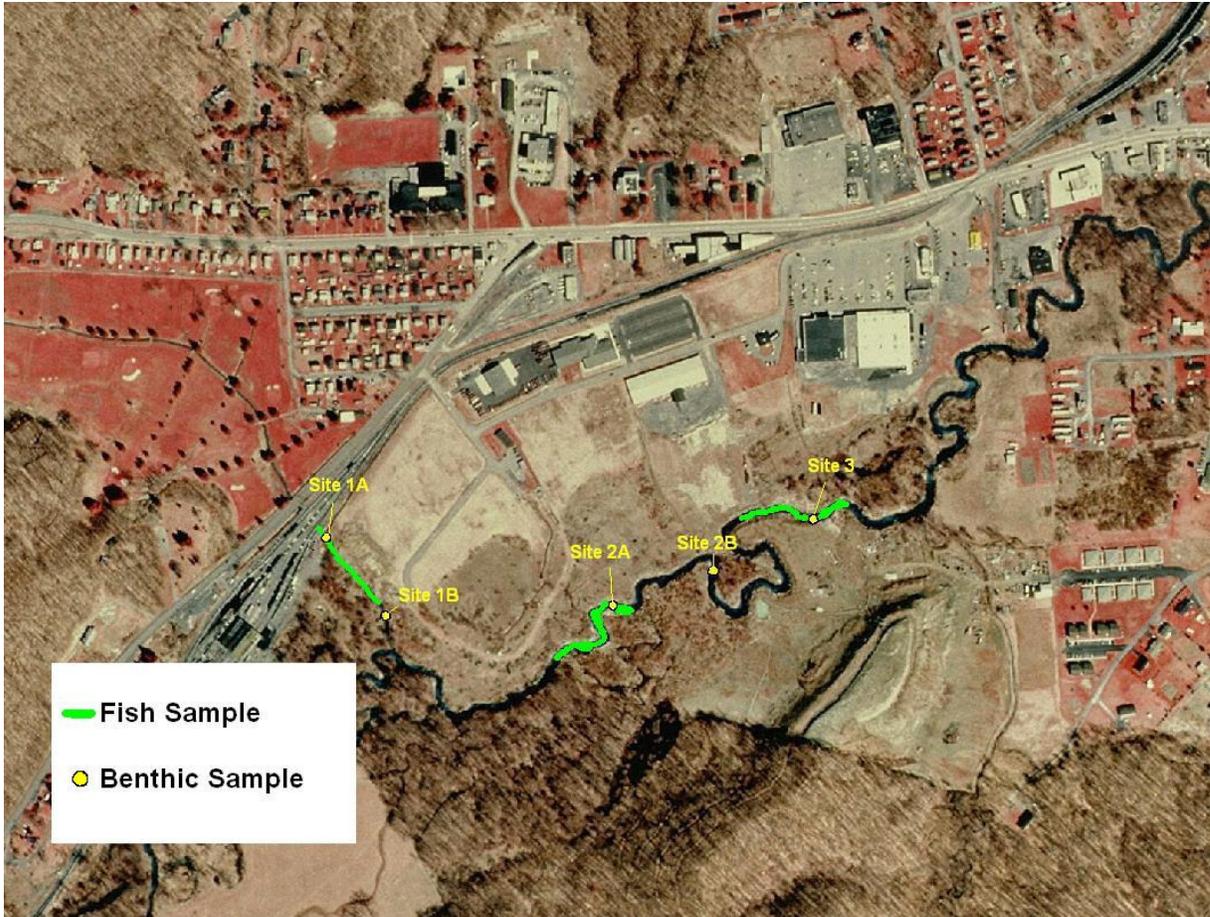
Figure 4. Fish sampling transects on Wolfpen and Sewell Creeks near Rainelle, WV.

Three electrofishing transects were sampled, site 1a from Wolfpen Creek, sites 2a and 3 from Sewell Creek. (Figure 4, Table 8, Appendix 3). Fish communities at all sites were numerically dominated by creek chubs, stone rollers, blunt nose minnows, and rock bass (Appendix 3). These species are found in small streams that are regularly impacted by low water conditions. They are considered pioneer species. The greatest number of fish species occurred at site 1A (11 species) and site 3 contained the least number of species (1). No fishes of special interest were located during this study. Table 8 lists the

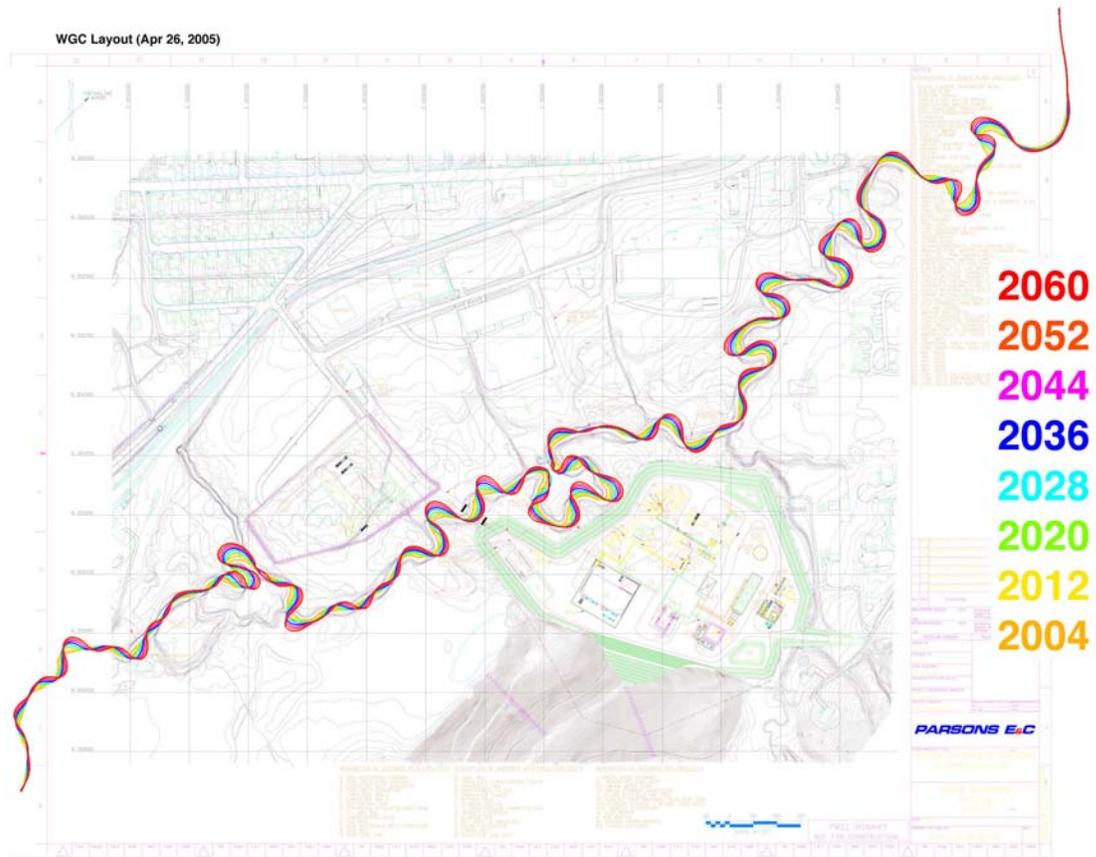
Figure 1. Future Locations of Sewell Creek (topographic survey)

Figure 1 shows future locations of Sewell Creek (colored traces, by calendar year) predicted by the river meandering model (see Section 4, below). Figure 2 shows the same predictions as Figure 1; however, it is set against the background of a 2004 aerial photograph. In Figure 1, Sewell Creek flows from lower left (southwest) to upper right (northeast). The proposed bridge is planned to be located in quadrant F10. According to the the predictions, Sewell Creek will migrate southeast where it passes under the bridge. This migration is consistent with general features of meander bends, which typically migrate downstream and bulge laterally away from the center of the river valley, until cutoff occurs and an oxbow lake is created.

Two black rectangles superposed on the proposed bridge in quadrant F10 of the image in Figure 1 give one possible location of the bridge piers, separated by 100'. This location would not interfere with the predicted river migration. If instead the bridge were divided into three equal-length spans, then the southeast pier would be standing in the present location of Sewell Creek. Hence, some adjustment in the pier locations must be made from this simple arrangement.

Another place where the migration of Sewell Creek might potentially be affected by the construction is in quadrant F7, where the river is predicted to contact the fill area from the WGC plant, but not until the year 2060.

The large meander loop in quadrant F8 will likely cut off by the year 2060, since the neck is predicted to become smaller and smaller in each successive year. The exact date of the cutoff depends on the extent of flooding each spring, during which most migration

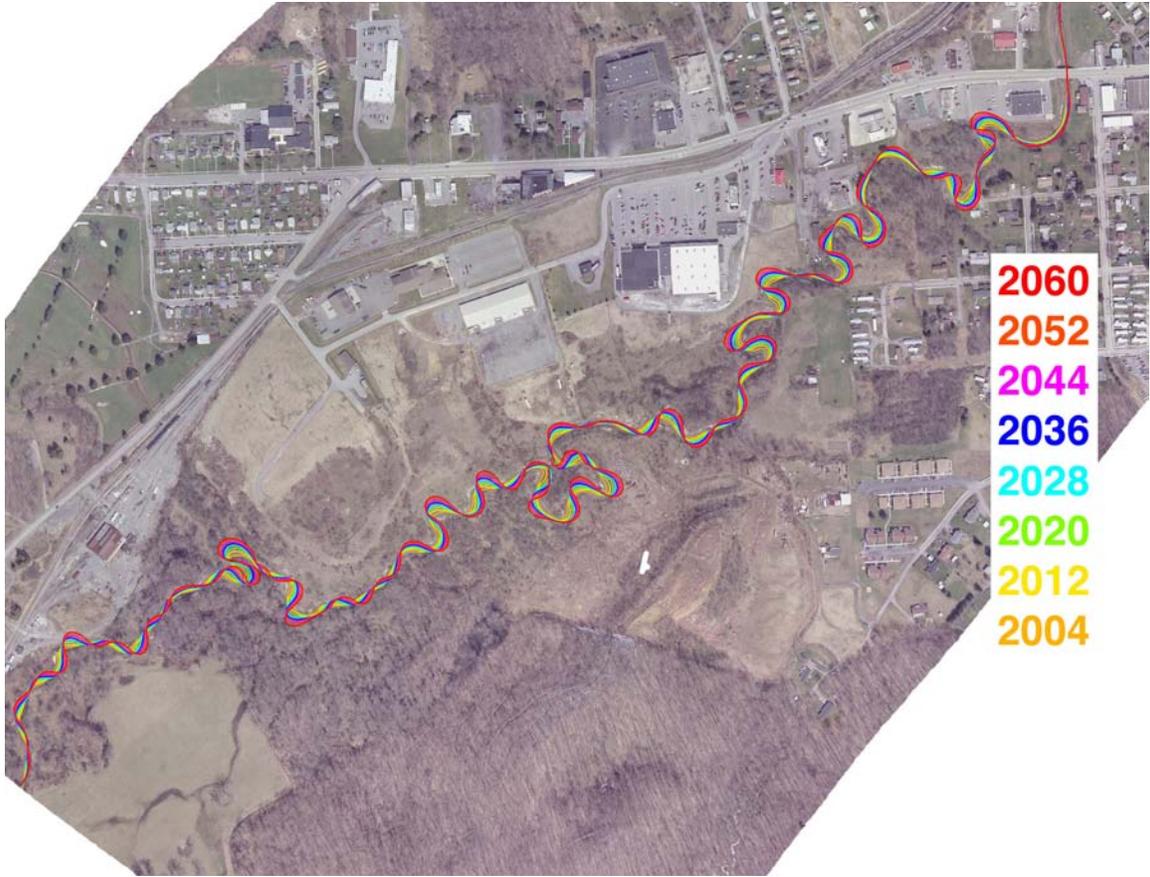
Figure 2. Future Locations of Sewell Creek (2004 aerial)

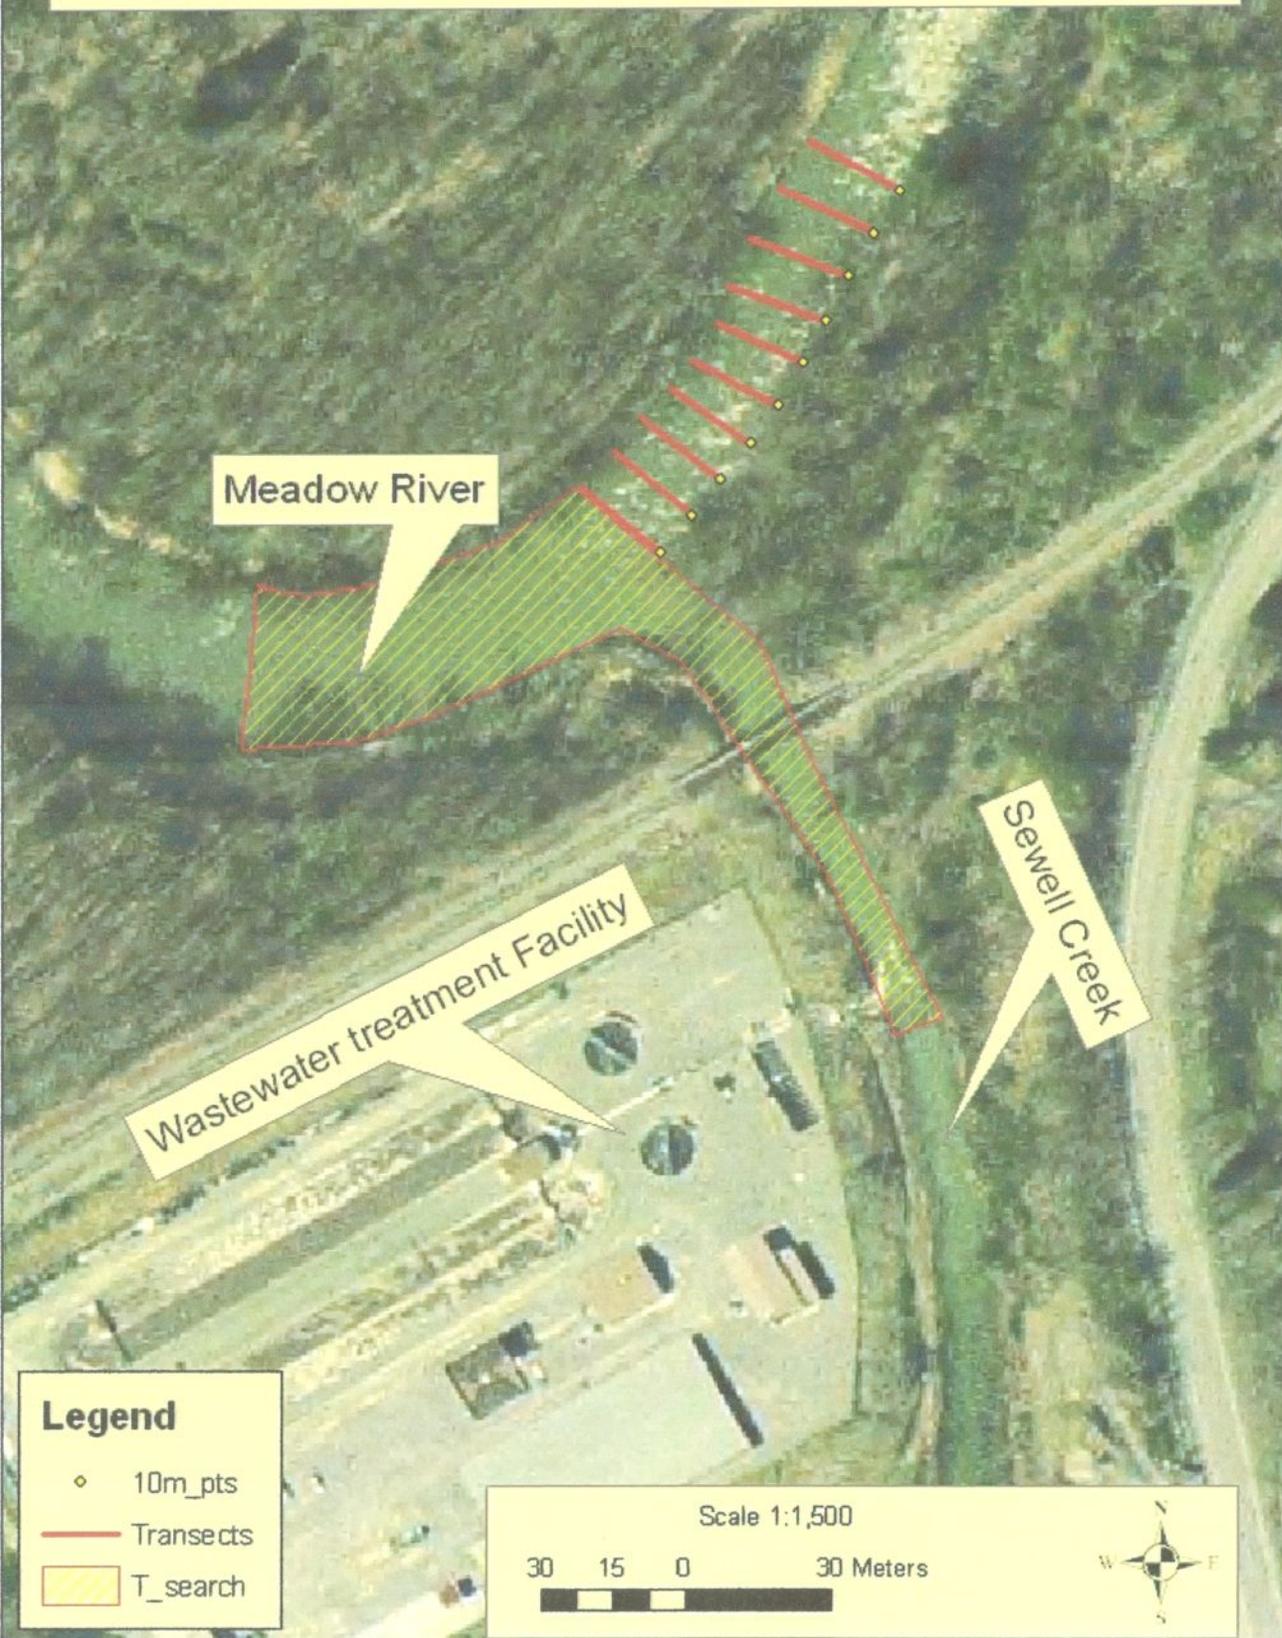
# Freshwater Mussel Survey on Meadow River

The River above Sewell Creek was surveyed by putting in bank – to – bank transects (ropes) and having a diver on each side of the rope search for mussels. The divers were attached to the transect by a one meter rope. They then extended to search from finger tip to finger tip thus covering an area of approximately 2 Meters. Ten of these transect ropes were placed at 10 meter intervals. We therefore covered one hundred meters of river above Sewell Creek. The river is approximately 25 meters wide here so we effectively searched 1,000 sq meters. The transect lines are represented on the accompanying map by red lines.

The area covered by green parallel lines represents the area searched without SCUBA gear. This searched area included Sewell Creek up to the current treated outfall and approximately 60 meters below Sewell Creek. The substrate of Meadow River
