**TOXECON™ RETROFIT FOR MERCURY AND  
MULTI-POLLUTANT CONTROL ON THREE  
90-MW COAL-FIRED BOILERS**

**Quarterly Technical Progress Report  
Reporting Period: April 1, 2006 – June 30, 2006  
Report No. 41766R09**

**Prepared by  
Steven T. Derenne  
Wisconsin Electric Power Company  
333 West Everett Street  
Milwaukee, WI 53203**

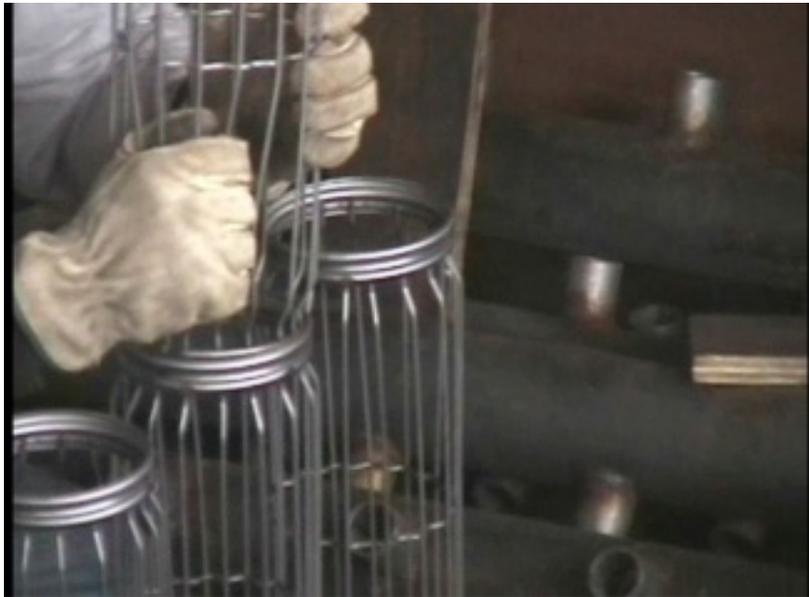
**Figure 1. Baghouse Cage Connection.**

Figure 1 shows the installation of the upper section of the cage with the connecting collar welded to the lower section. Figure 2 shows the connecting portion of the upper section of the cage. This figure shows the locking pin that should be seated flush with the ring after the connection of the two sections.

During the inspections for damaged bags described in the 1Q06 Quarterly Technical Progress Report (DOE Report Number 41766R08), We Energies personnel noticed when replacing damaged bags that several of the cages were separated at the connecting collar. A more detailed inspection of the cages in one compartment was initiated. This inspection showed that a majority of the cages had some kind of defect, such as separation at the connection of the two cage pieces or broken welds. A decision was made to inspect and repair, as needed, every cage in every compartment. The items that were checked and repaired during inspections included the following:

- Connecting rings – check for separation and broken welds
- Locking pins – check for proper seating
- Cage separation – check for separation at the middle of the cage, whether due to a defect or an unknown reason

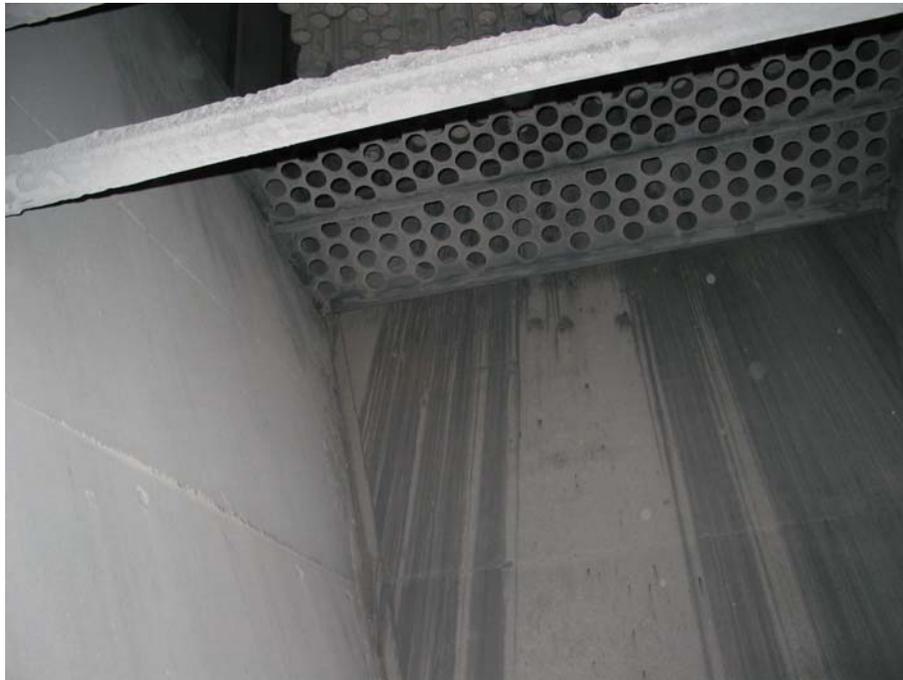
**Figure 3. Water Marks in Baghouse Hoppers.**

After the inspections and repairs were completed, the baghouse was brought back online on May 12, 2006, with flue gas from Unit 7. The hopper heaters remained off during the startup and subsequent operation. There was an additional deviation from the normal startup procedure. After the initial two compartments were in service and a 1-mill load was reached, four additional compartments were opened without pausing. The correct procedure is to open one compartment, let the compartment come up to temperature, and then open the next one. This procedure is intended to minimize condensation in the baghouse. After pulling ash from the hoppers on May 15, water was seen in the bottom of eight hoppers. Flue gas was diverted from the compartments and an inspection performed. Figure 3 shows evidence of water flowing down the walls of the compartments.

After several inspections, it was determined that condensation from the cold startup of the baghouse was the likely cause of water in the hoppers. The hopper heaters were turned on and the baghouse taken off bypass and returned to normal operation with flue gas from Unit 7. Instructions were given to the operating staff on the importance of following the startup procedure to allow each compartment to come to operating temperature before adding additional compartments, thus building up the heat in a controllable fashion.

The baghouse compartments (except for #4) were brought back in service (taken off bypass) on May 22 and there was no evidence of free water in the hoppers. On May 25, the hopper heaters were turned off because of the concern they might be causing overheating of the PAC/ash. On May 26, operations found water in three hoppers (#1, #2, and #3). The set points for the hopper heaters were reduced by 25 °F on all compartments except for #4 (the test compartment) and all heaters were returned to service.

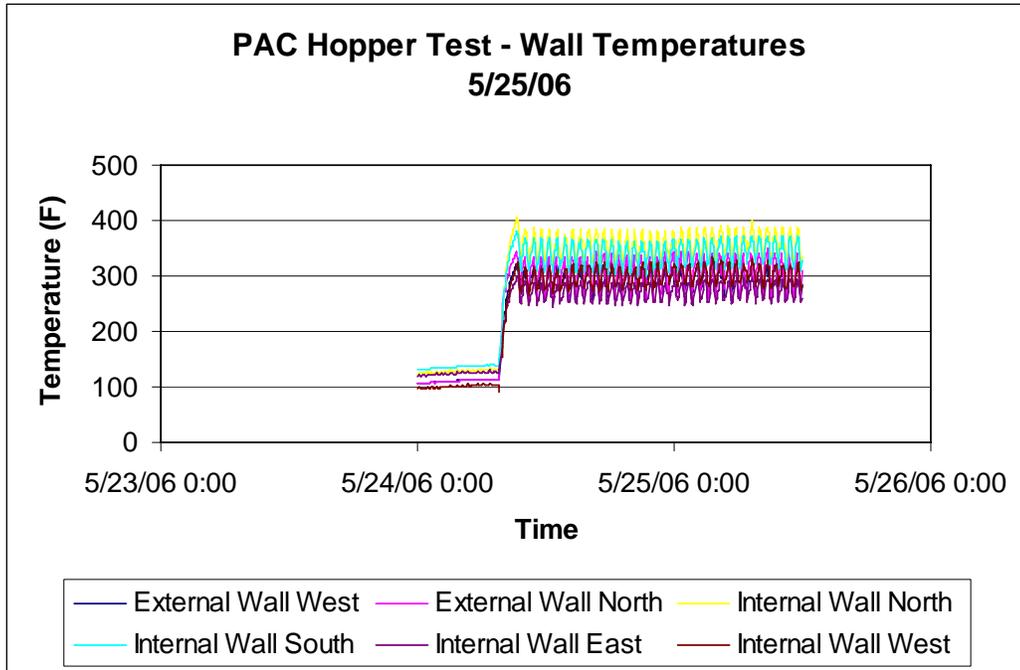
**Figure 4. PAC Hopper Test—PAC Bed Temperatures.**

On May 24, 2006, We Energies performed a second test in compartment #4 hopper. The first test was described in the previous Quarterly Technical Progress Report and occurred when the baghouse was not online, so no flue gas was present in the hopper. For this test, four thermocouples were welded to each interior hopper wall and 360 pounds of fresh PAC was placed in the hopper. The thermocouples were placed so that they would be six inches below the upper surface of PAC. Two thermocouples were also placed between heaters and the outside wall of the hopper.

This second test was identical to the first test with the exception that the baghouse was on-line with flue gas from Unit 7. A total of 360 pounds of PAC was again loaded into the hopper. This was approximately four feet of material. The hopper heaters were turned on May 24 (Figure 4). The temperature in the hopper reached a maximum of 407 °F. There was no sign of overheating during this time. Cycling of the hopper heaters is evident during this test.

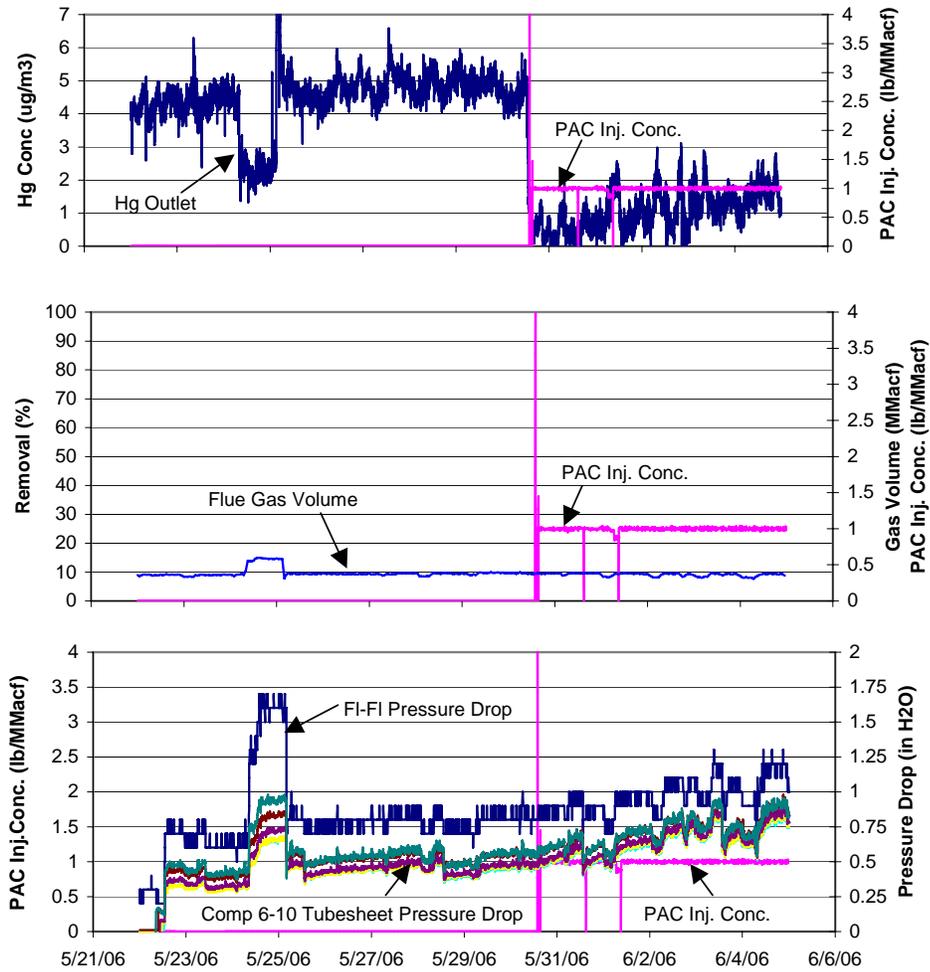
**Figure 5. Baghouse Performance Data for 5/22/06 to 6/5/06.**

PAC injection began on May 30, 2006, at 0.5 lb/MMacf, then was increased to 1.0 lb/MMacf after about an hour. Figure 5 shows the baghouse data from May 22 through June 5, including flange-to-flange pressure drop, tubesheet pressure drops, PAC injection concentration, outlet mercury concentration, and mercury removal. There is no mercury inlet number since the CEM was tied into Unit 8, which was offline for a scheduled outage. The mercury outlet reading responded quickly to the PAC injection, but the signal was very noisy compared to earlier parametric tests. Figure 6 shows the effect of flue gas temperature on the mercury reading. As noted last quarter, the outlet mercury value is affected by flue gas temperature when using DARCO<sup>®</sup> Hg sorbent.

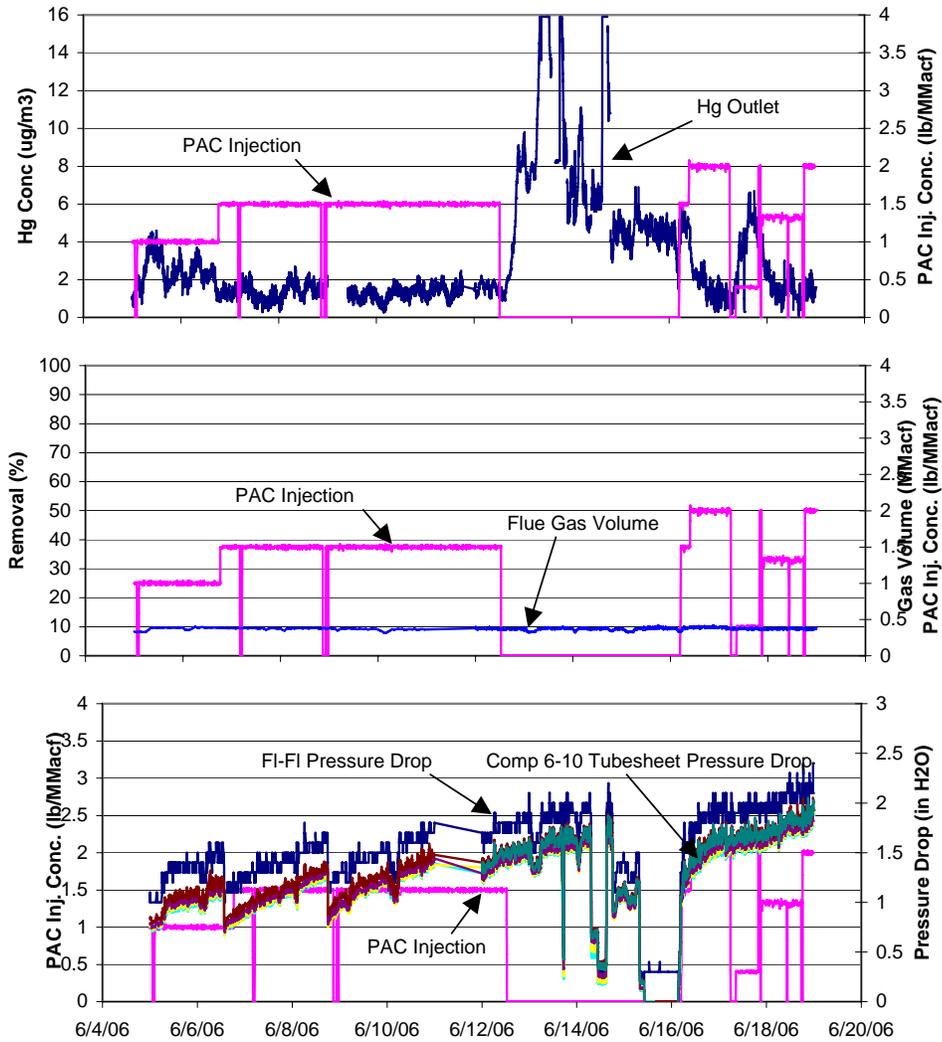
**Figure 7. Baghouse Performance Data for 6/5/06 to 6/19/06.**

The injection concentration was increased to 1.5 lb/MMacf on June 6, as seen in Figure 7. The PAC was shut off from June 12 through June 16 to allow the plant to perform particulate tests. Injection was resumed at 2 lb/MMacf on June 16. Figure 8 is a comparison of outlet mercury with flue gas temperature. The effect of temperature is more noticeable in this figure.

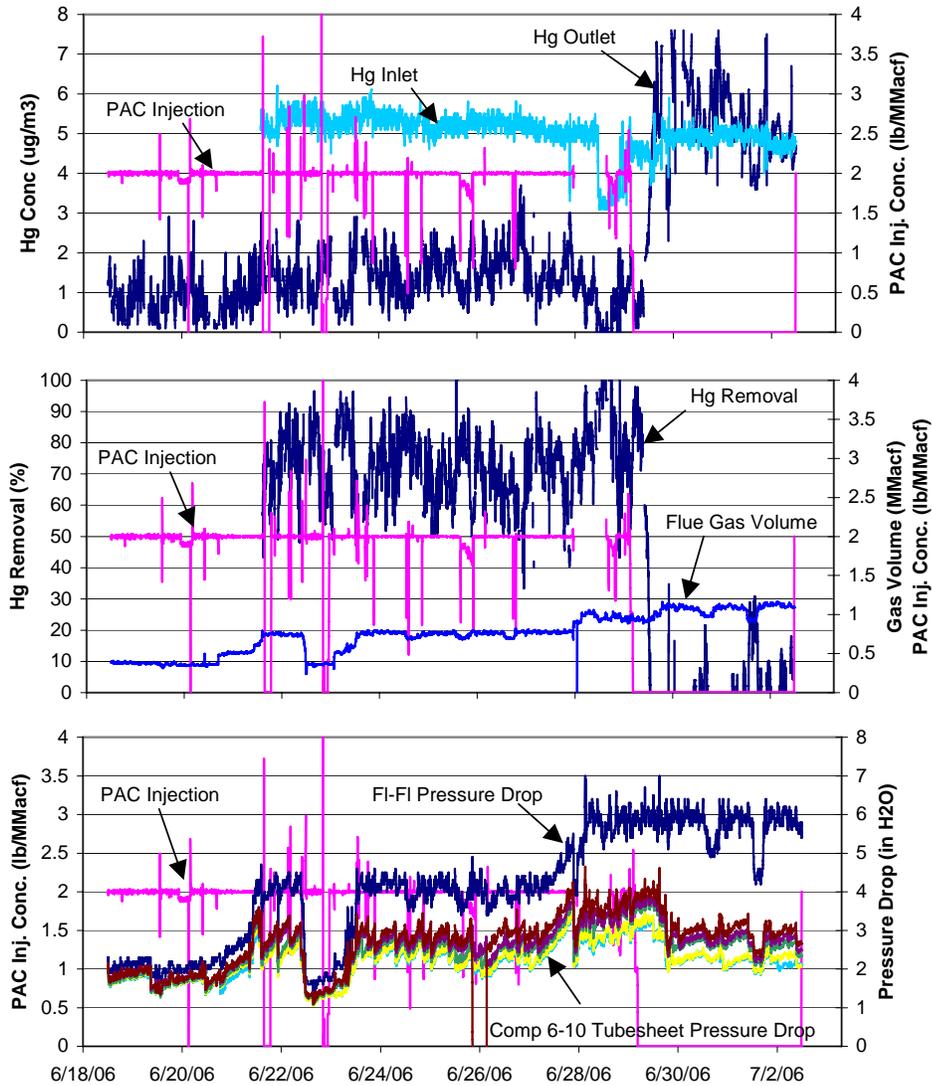
**Figure 9. Baghouse Performance Data for 6/19/06 to 7/1/06.**

PAC injection was kept at 2 lb/MMacf until June 29, as seen in Figure 9. At that time, plant personnel attempted to remove ash and PAC from the ash silo and encountered problems with excessive dusting. The new flow control valve to the dustless unloader was unable to provide the required steady flow of PAC/ash to the mixer. In addition, there appeared to be problems with adequate fluidizing airflow to the bottom of the ash silo. PAC injection was stopped until the problem can be fixed. The problem with the ash silo and unloader remains an outstanding issue as of the end of the quarter. Unit 8 was tied into the baghouse on June 21, resuming inlet mercury readings. Unit 9 was tied into the baghouse on June 29. Figure 10 shows the effect of temperature on outlet mercury readings for this time period.

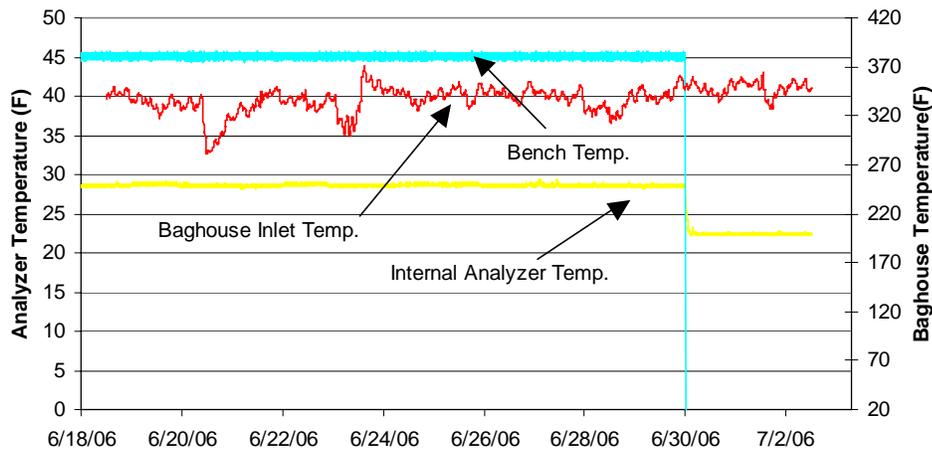
**Figure 11. Effect of Flue Gas Temperature on CEM Temperatures.**

A check on the effect of flue gas temperature on the outlet analyzer function was investigated to rule out any effect on mercury readings. Figure 11 is a comparison of flue gas temperature with two temperatures in the outlet analyzer. The internal (ambient) analyzer temperature is the temperature near the electronics. The bench temperature is taken near the measurement cell of the analyzer. This figure shows very steady temperature readings when compared with flue gas temperature.

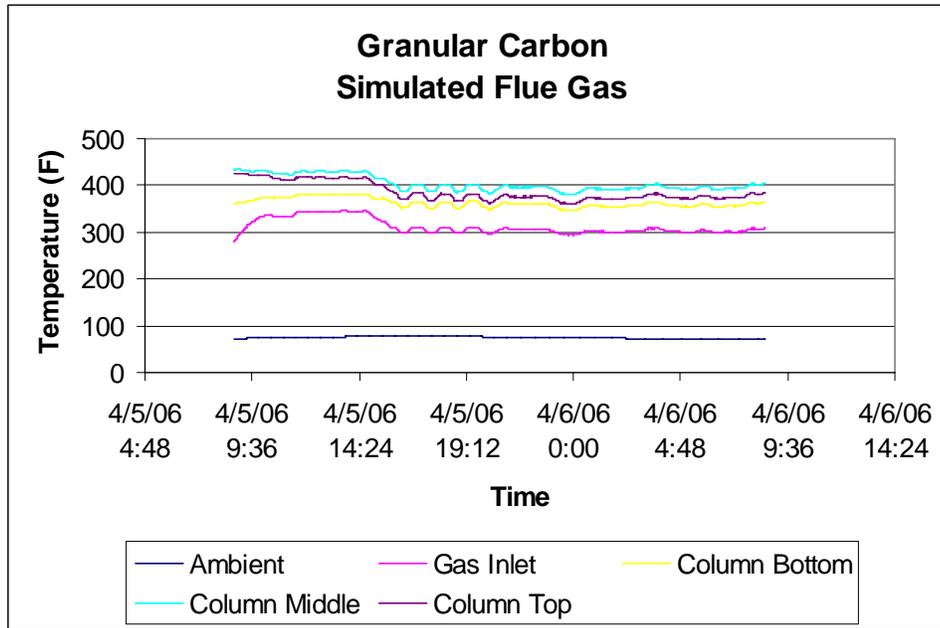
**Figure 12. Column Reactor Test Using Granular Carbon.**

In 1Q06, ADA-ES tested PAC from the silo at Presque Isle in a two-inch column reactor using simulated flue gas. The purpose of these tests was to determine if there was a measurable heat of adsorption created from the flue gas contacting the carbon. During this quarter, the tests were repeated using a granular carbon. This was performed to determine if particle size would have an effect on any heat buildup in the column. Figure 12 shows no noticeable temperature increase in the column.

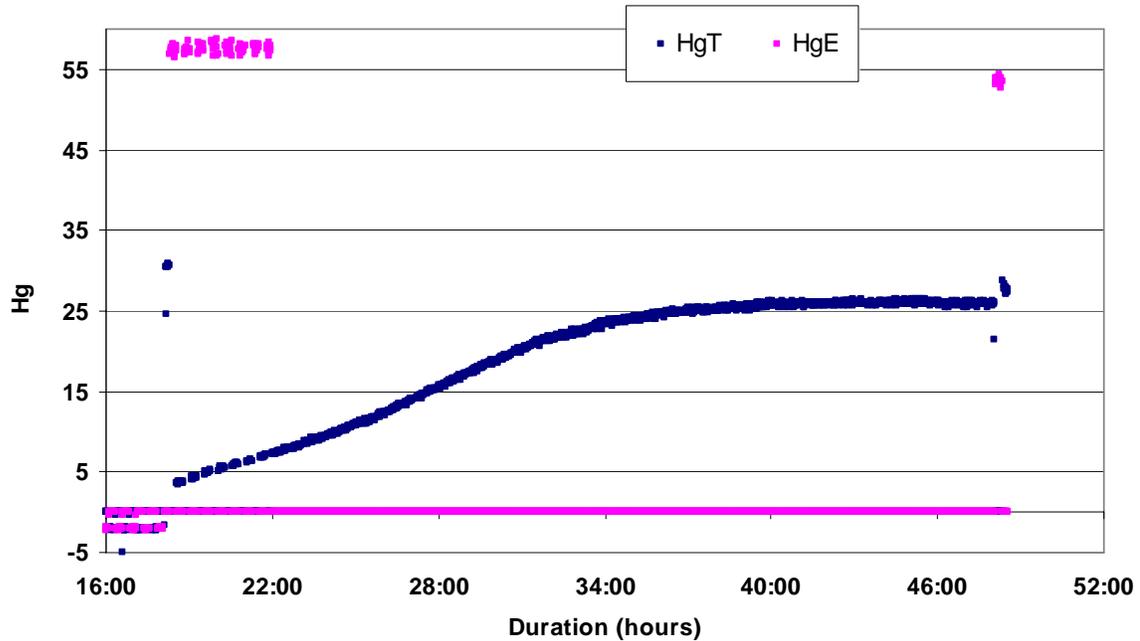
Figure 13. Mercury Breakthrough Curve using the MQI Apparatus.

Design and fabrication of the MQI apparatus began last quarter. Initial trials indicated that modifications to the apparatus were needed and further shakedown tests were required to ensure that all components were working properly. Work this quarter consisted of implementing modifications to improve performance and continued testing. An example of a recent mercury breakthrough curve, with a bed consisting of 0.001 grams DARCO<sup>®</sup> Hg-LH and 2.5 grams sand, is shown in Figure 13.

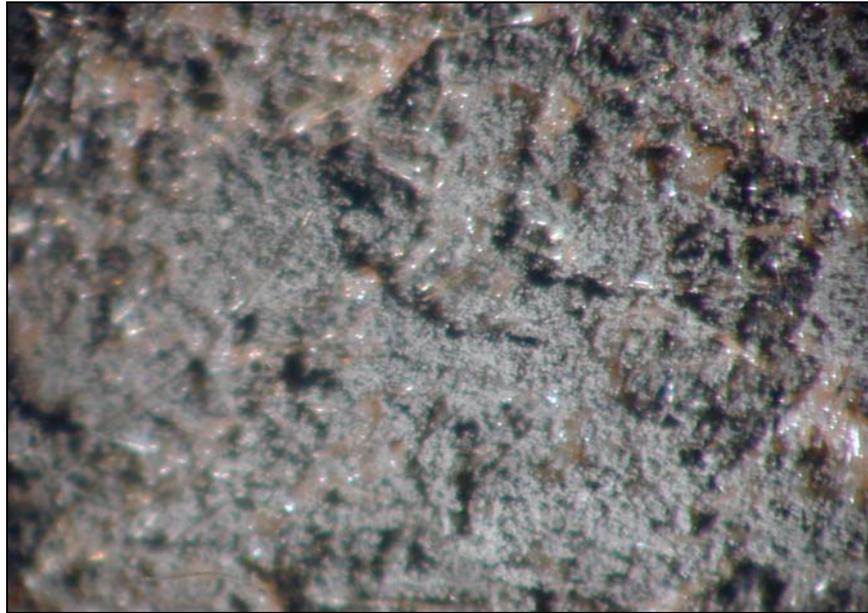
The ash cake as received is of a very non agglomerated structure with low retained weight levels.

**Photo A** is a view of the low retained ash cake.

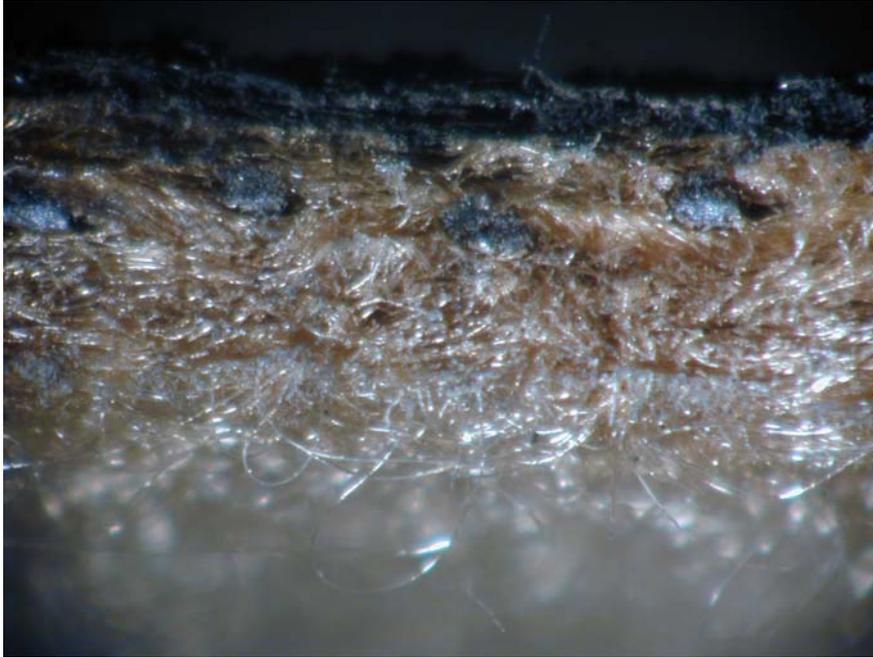
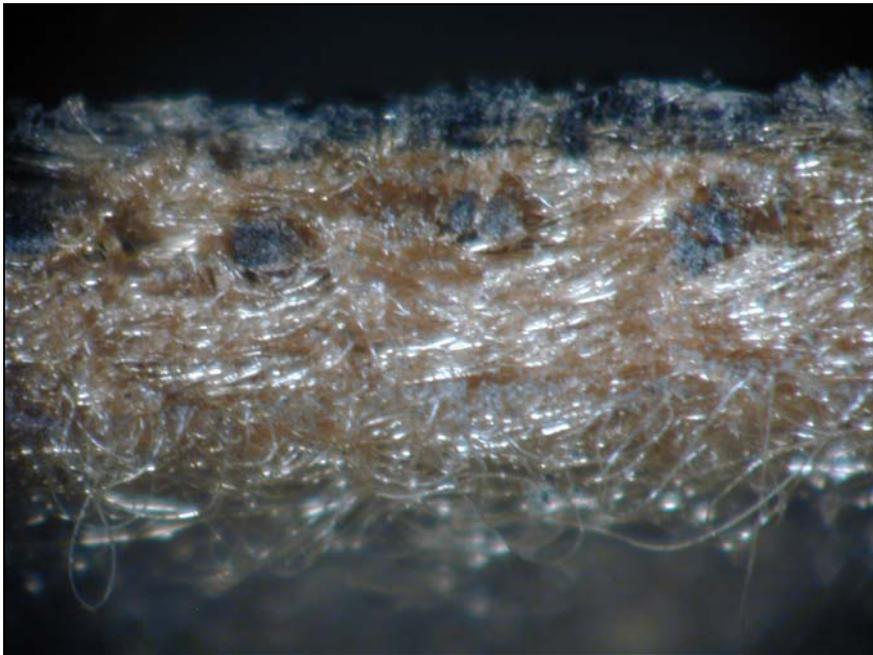
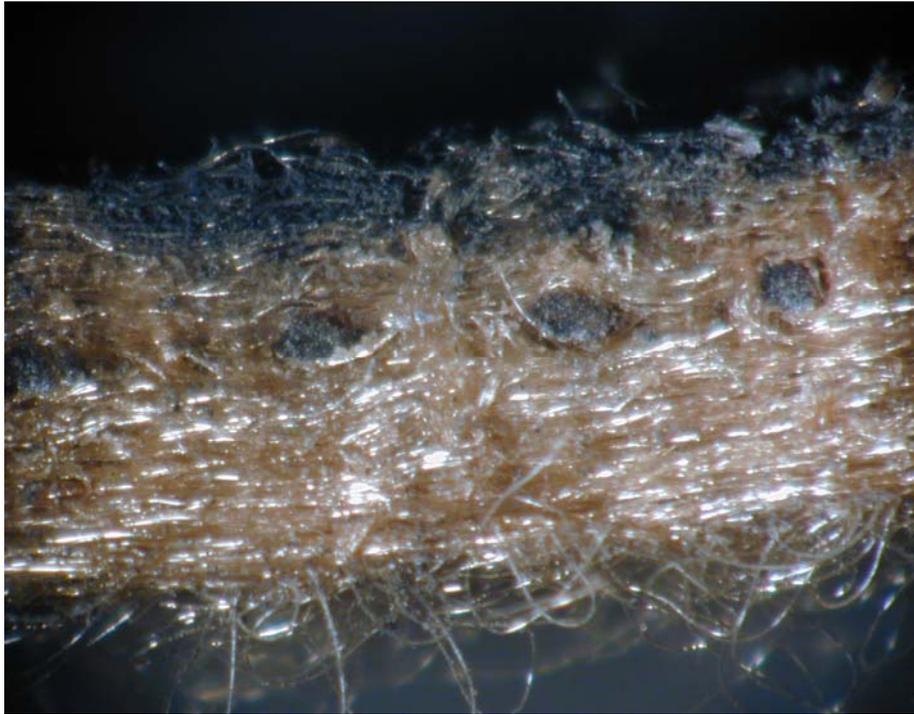
Cross sectionals **Photo B** (top) **Photo C** (middle) and **Photo D** (bottom) reveal the ash collection occurring within the minimal depths of the collection surface.

There is no evidence of any fine micron penetration/ leakage through.
