DEMONSTRATION OF INNOVATIVE APPLICATIONS
OF TECHNOLOGY FOR THE CT-121 FGD PROCESS

Plant Yates

Final Report

Volume 3a Materials and Maintenance

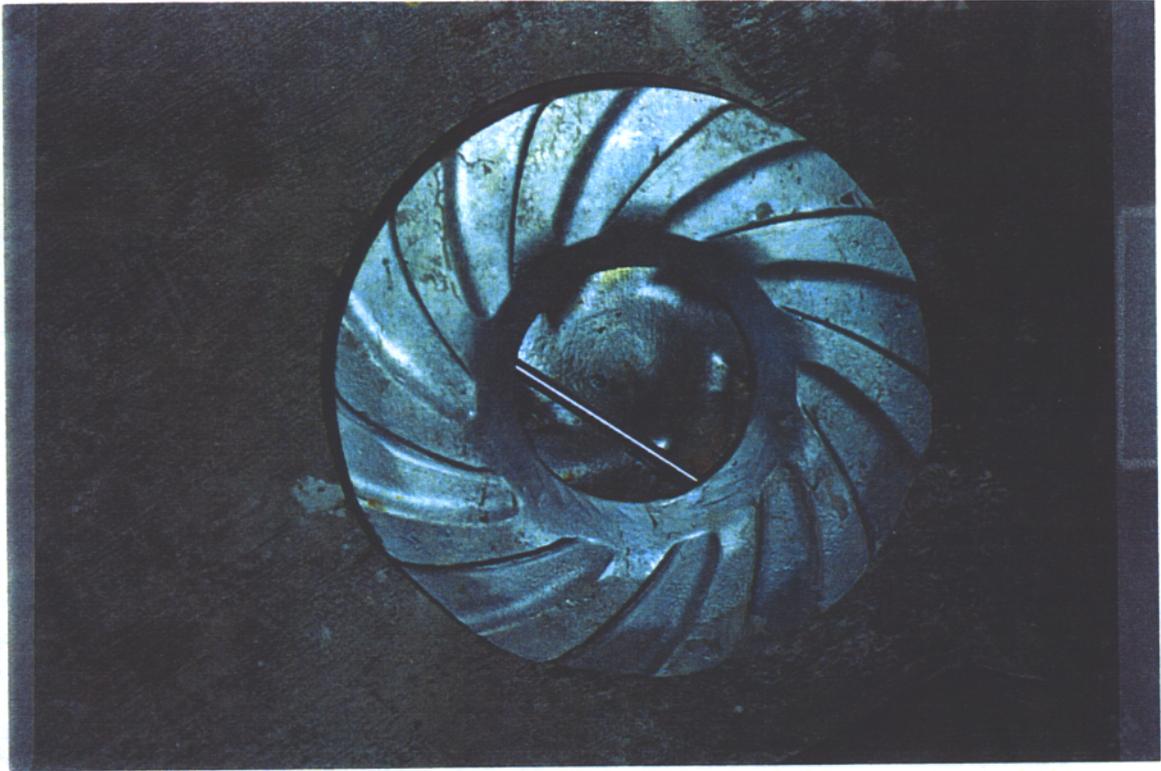
Figure 3-10. Gypsum Slurry Transfer Pump Impeller (View 1)

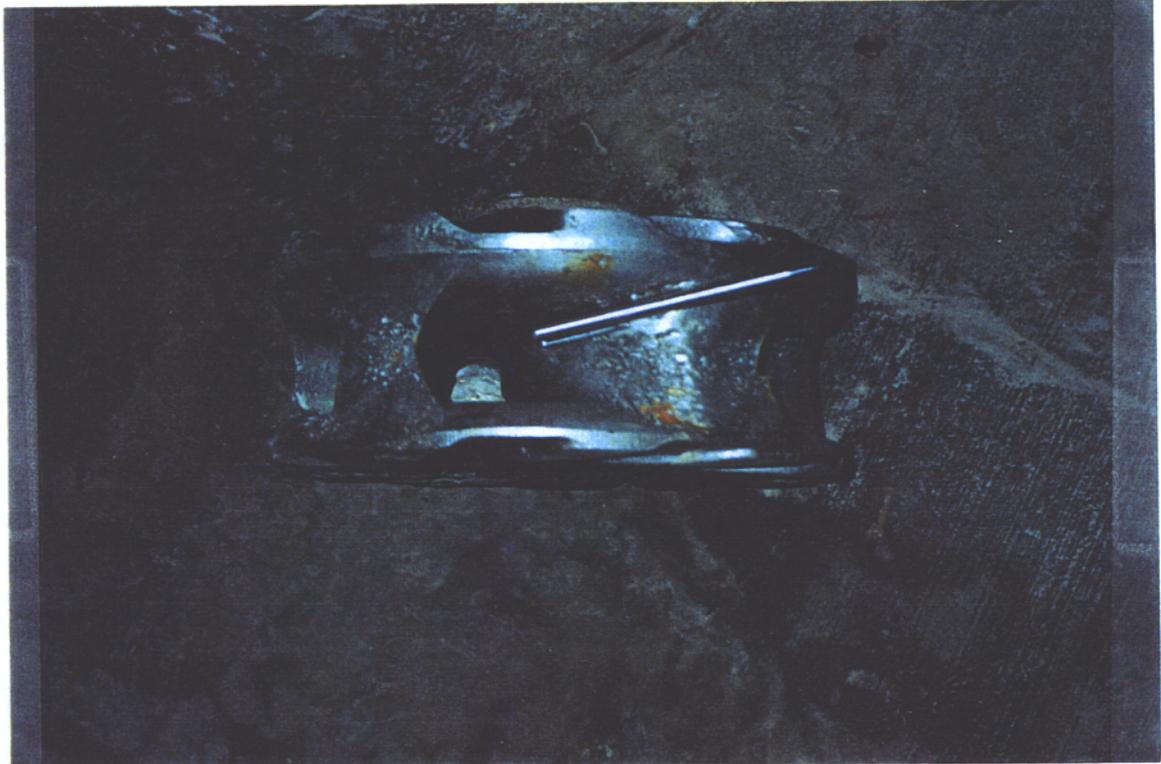
Figure 3-11. Gypsum Slurry Transfer Pump Impeller (View 2)

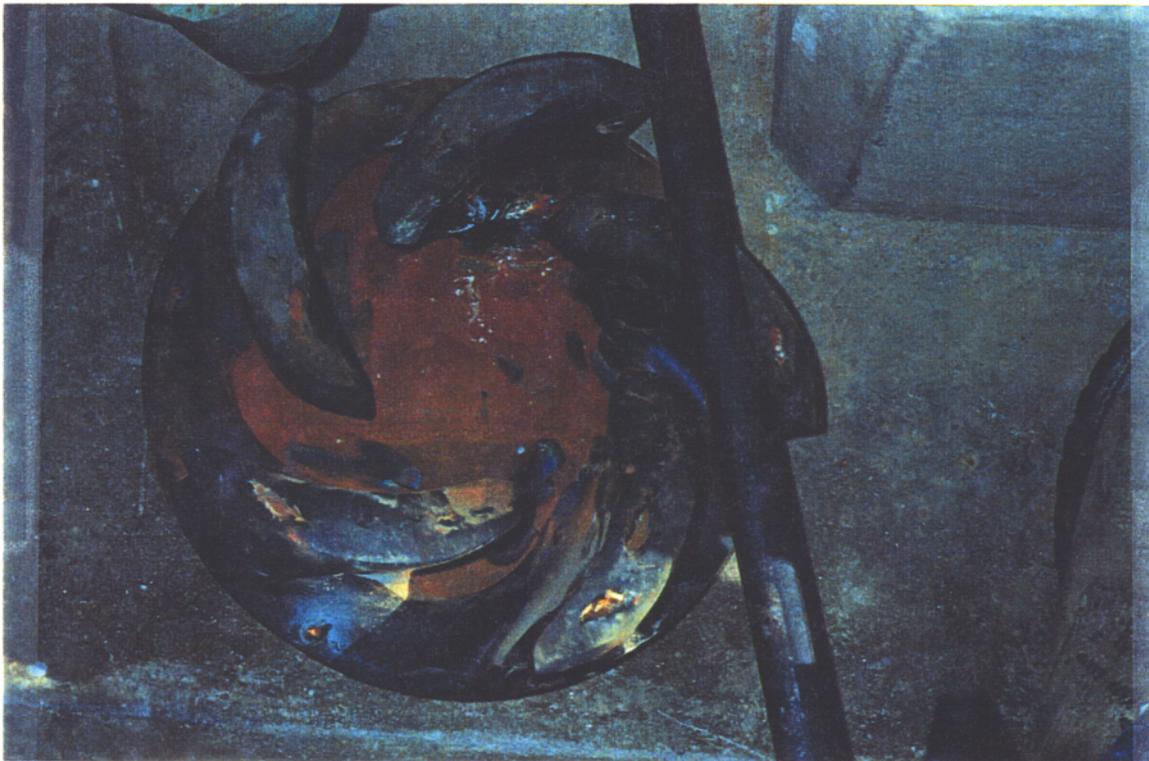
Figure 3-16. Limestone Classifier Pump Impeller

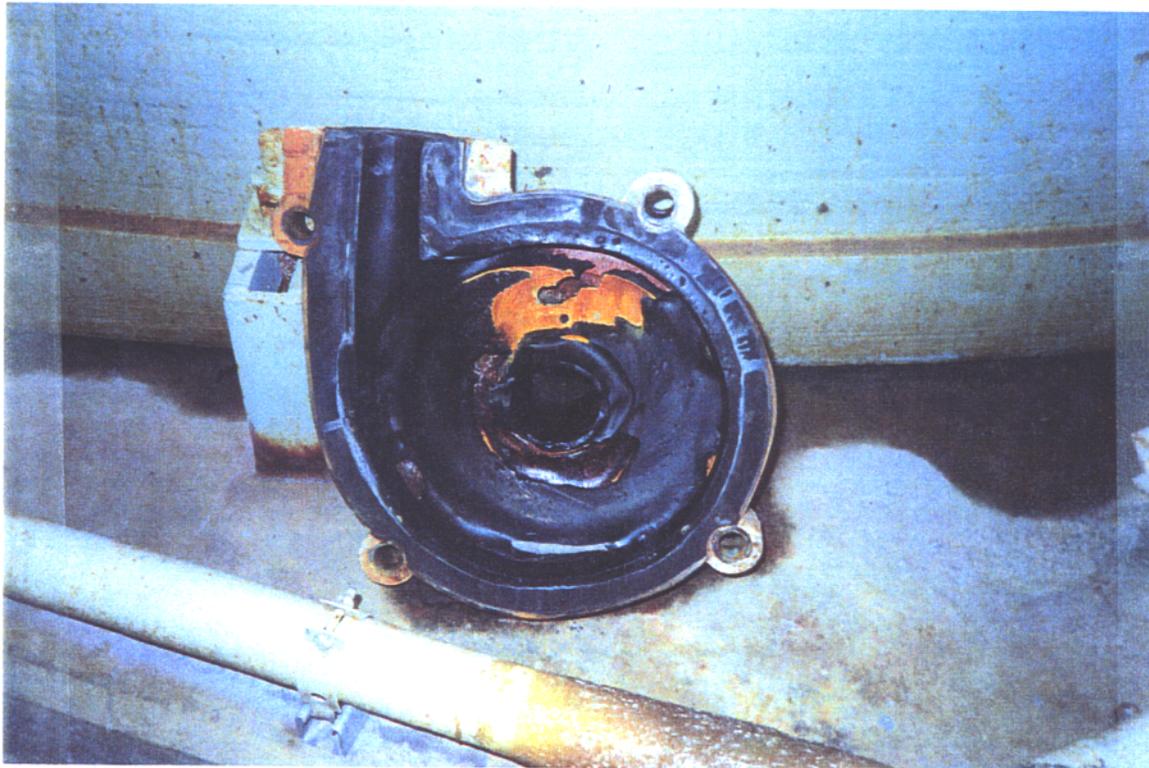
Figure 3-17. Limestone Classifier Pump Casing

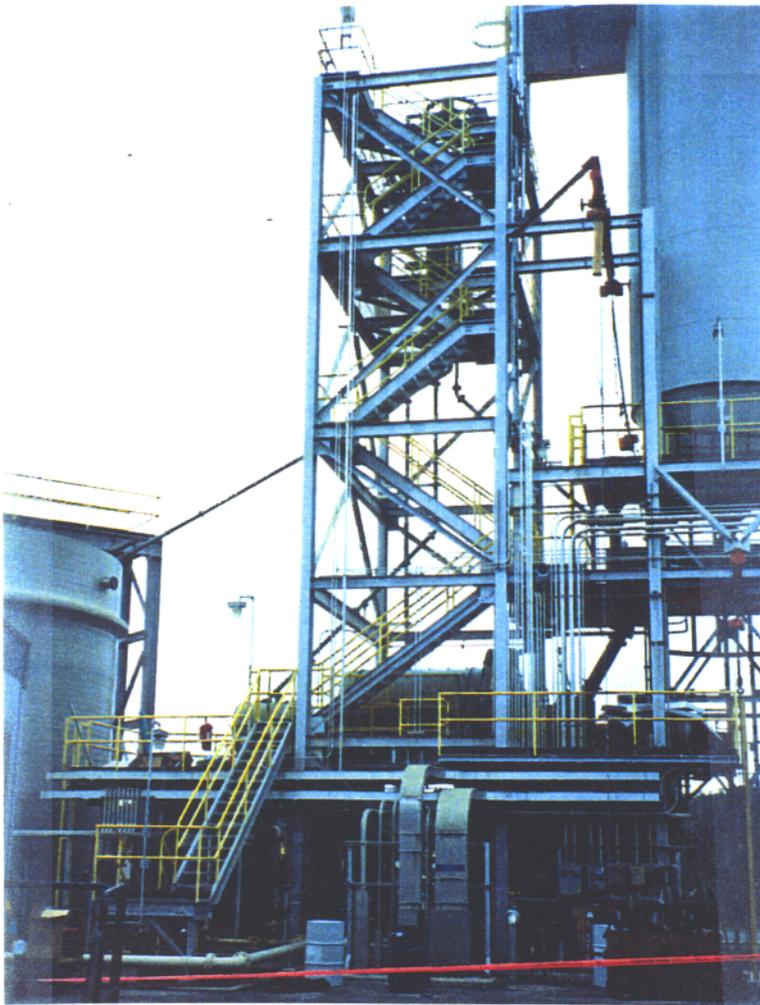
Figure 3-18. Limestone Preparation Area Arrangement

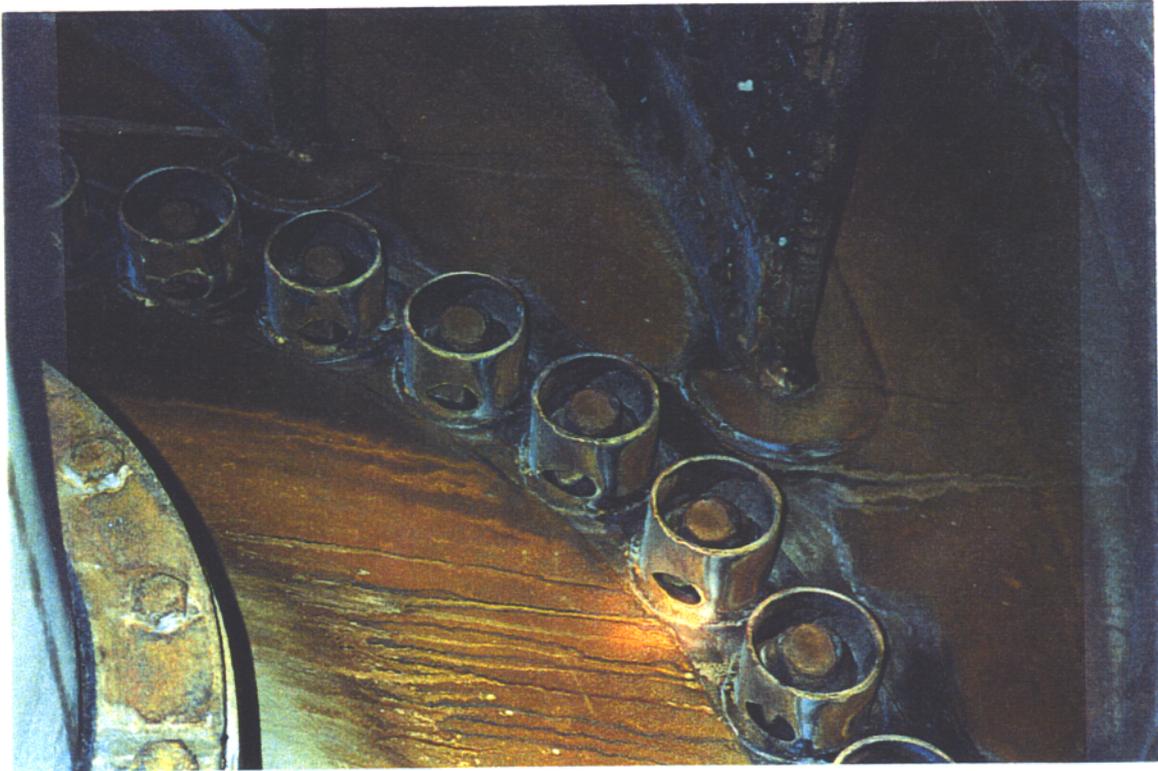
The fan hub bolts are shielded by ASTM A120 and A53 carbon steel pipe stubs, as shown in Figure 3-21. The shields have been penetrated on some bolts. These were intended to be sacrificial per the fan manufacturer. There are plans to cover these shields with rubber or some other material that can withstand abrasion and corrosion in the future. For now, the eroded shields will be patched.

Figure 3-21. ID Fan Hub Bolts and Shields

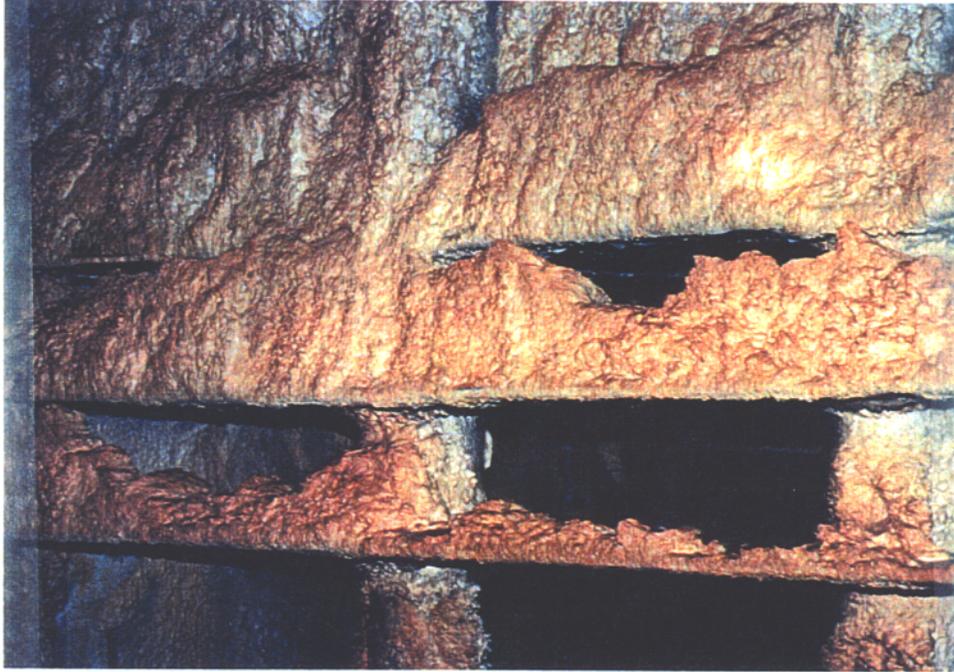
Figure 3-22. JBR Outlet Horizontal Turning Vanes

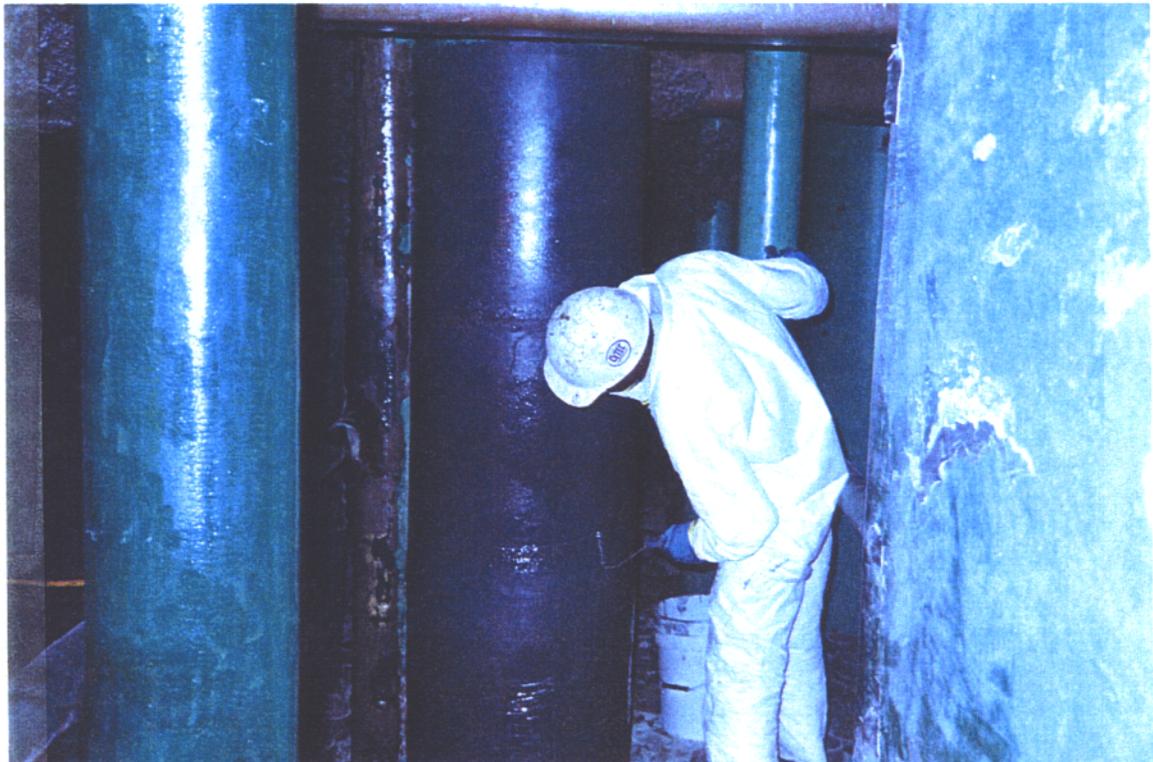
Figure 3-23. Silicon Carbide Coating Application

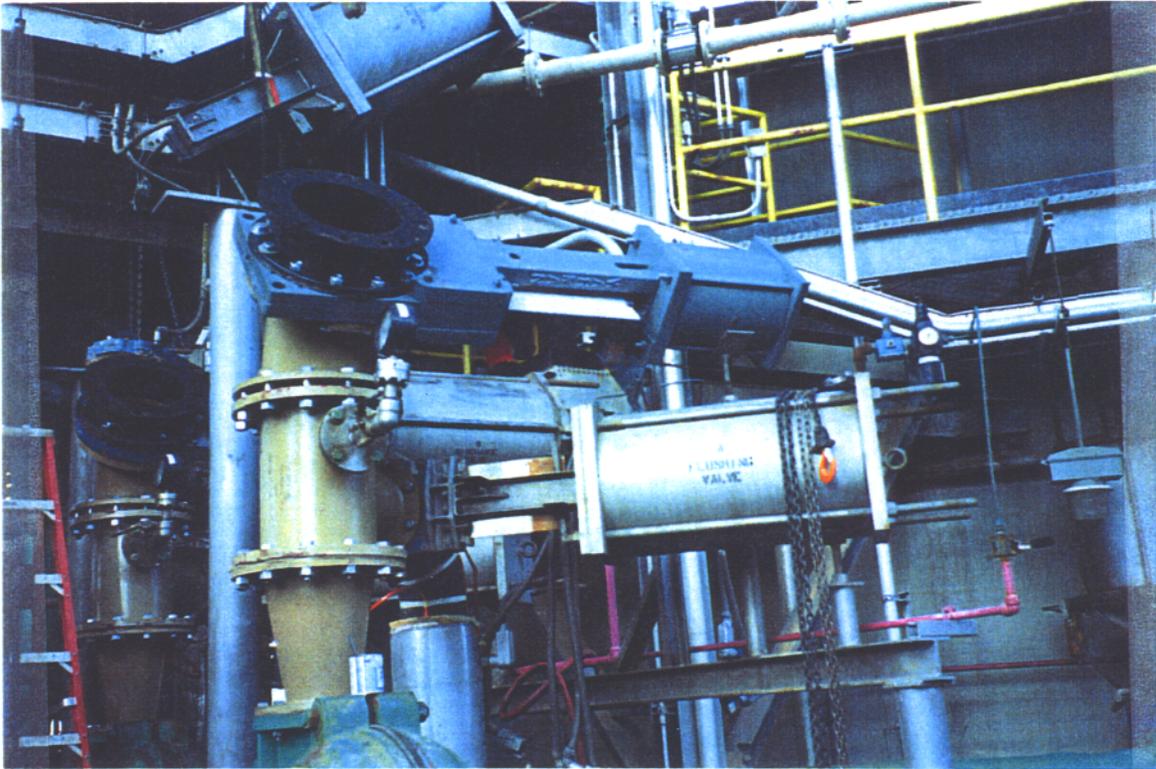
Figure 3-25. Knife Gate Valve Actuator Arrangement
