Turbine Material Studies

(Supported by DOE-NETL)

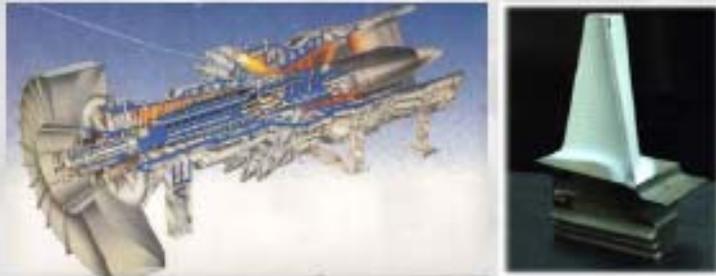
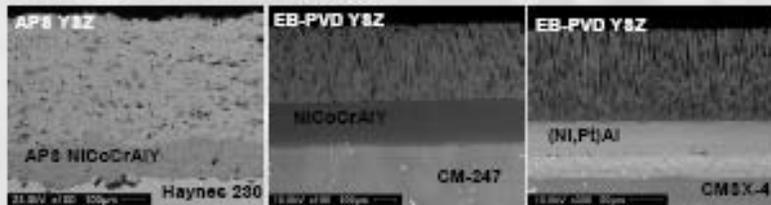
Gas Turbine Needs: Reliable and Durable Thermal Barrier Coatings (TBCs)

- TBCs Provide Thermal Protection of Hot Components in Advanced Gas Turbine Engines
 - Increase in Performance, Efficiency, Reliability and Maintainability.
 - Reduction Life Cycle Costs.
- Reliable and Durable TBCs Needed as An Integral Part of Component Design.
- Needs Refined Understanding of **Failure Mechanisms** to Develop a Mechanisms-Based Lifetime Prediction Models.
- Develop **Non-Destructive Evaluation** Techniques for Quality Assessment, Life Prediction and Life-Remain Assessment.

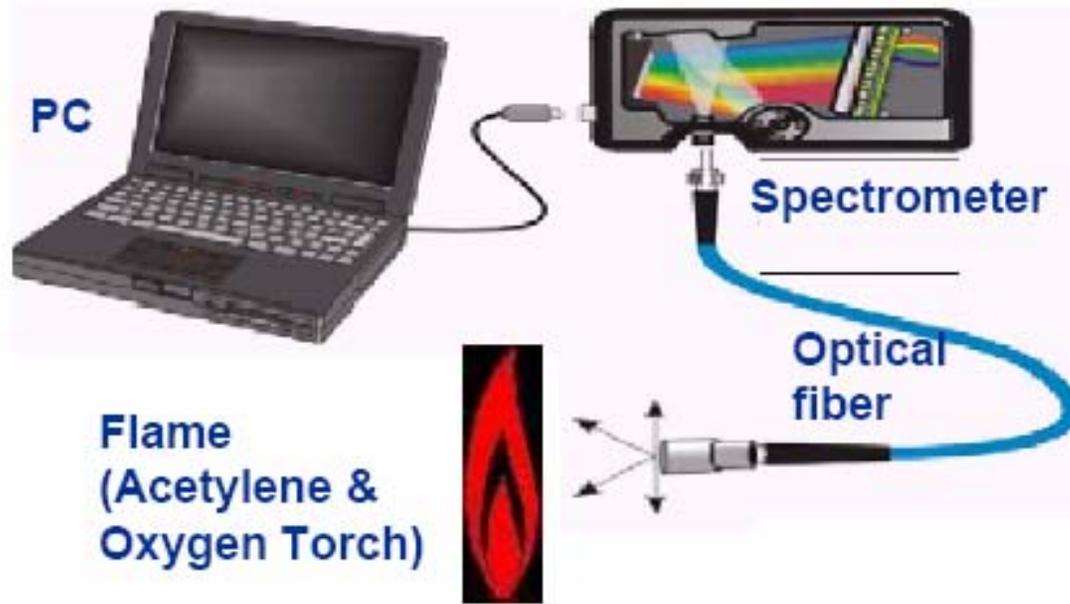
Emission Spectroscopy Setup

- The emitted light from lithium atoms in flame travels into an input fiber, which carries the light information to the spectrometer. The spectrometer then transmits the information to the PC for data acquisition of measured spectra

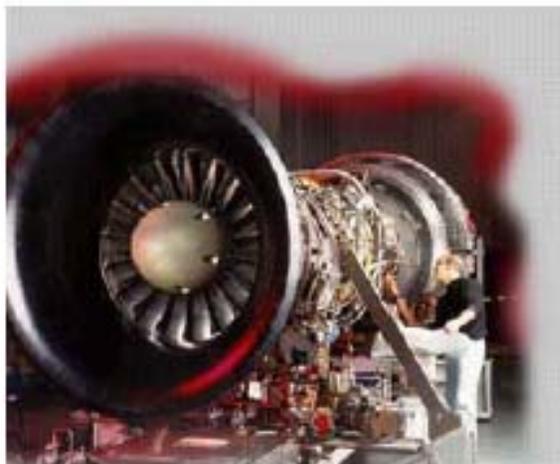
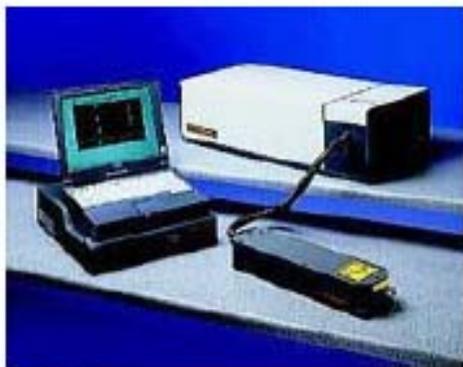
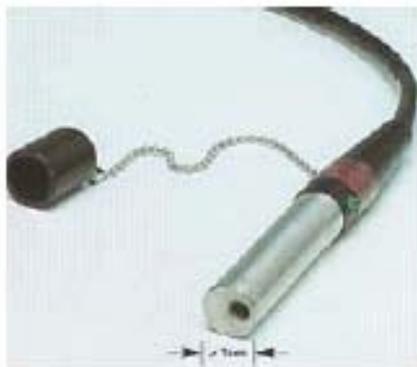
Portable PLPS NDI Instrument Available
