Project Final Report Remediation of Leon Water Flood, Butler County, Kansas

Project Report: Applied Phyto-Remediation Techniques Using Halophytes for Oil and Brine Spill Scars

Final Report

Reporting Period: August 2000 to March 2003

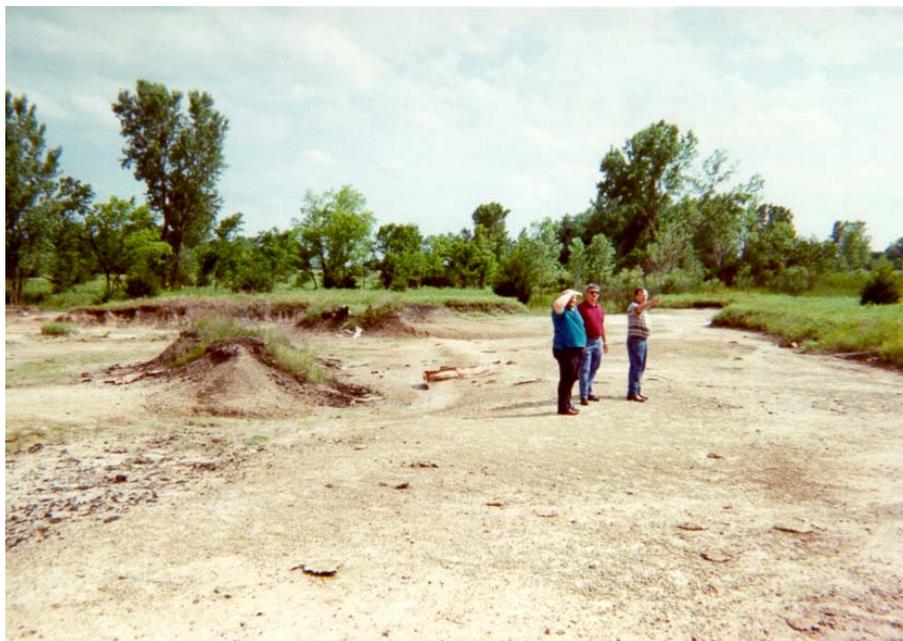
Figure 1: Salt scarring and deep erosion within the Large Scar at the Leon Waterflood site

- Erosion will then become a problem; gullies and rills will be visible in the site. After only one year, remediation has become a challenge. In the rare event that the site has very good drainage, coarse soil, and high rainfall, nature may be able to take its course in repairing the site, but these conditions are rare in Kansas. If drainage is poor, the soil is fine textured, and rainfall is low, the site can only be remediated through great effort.

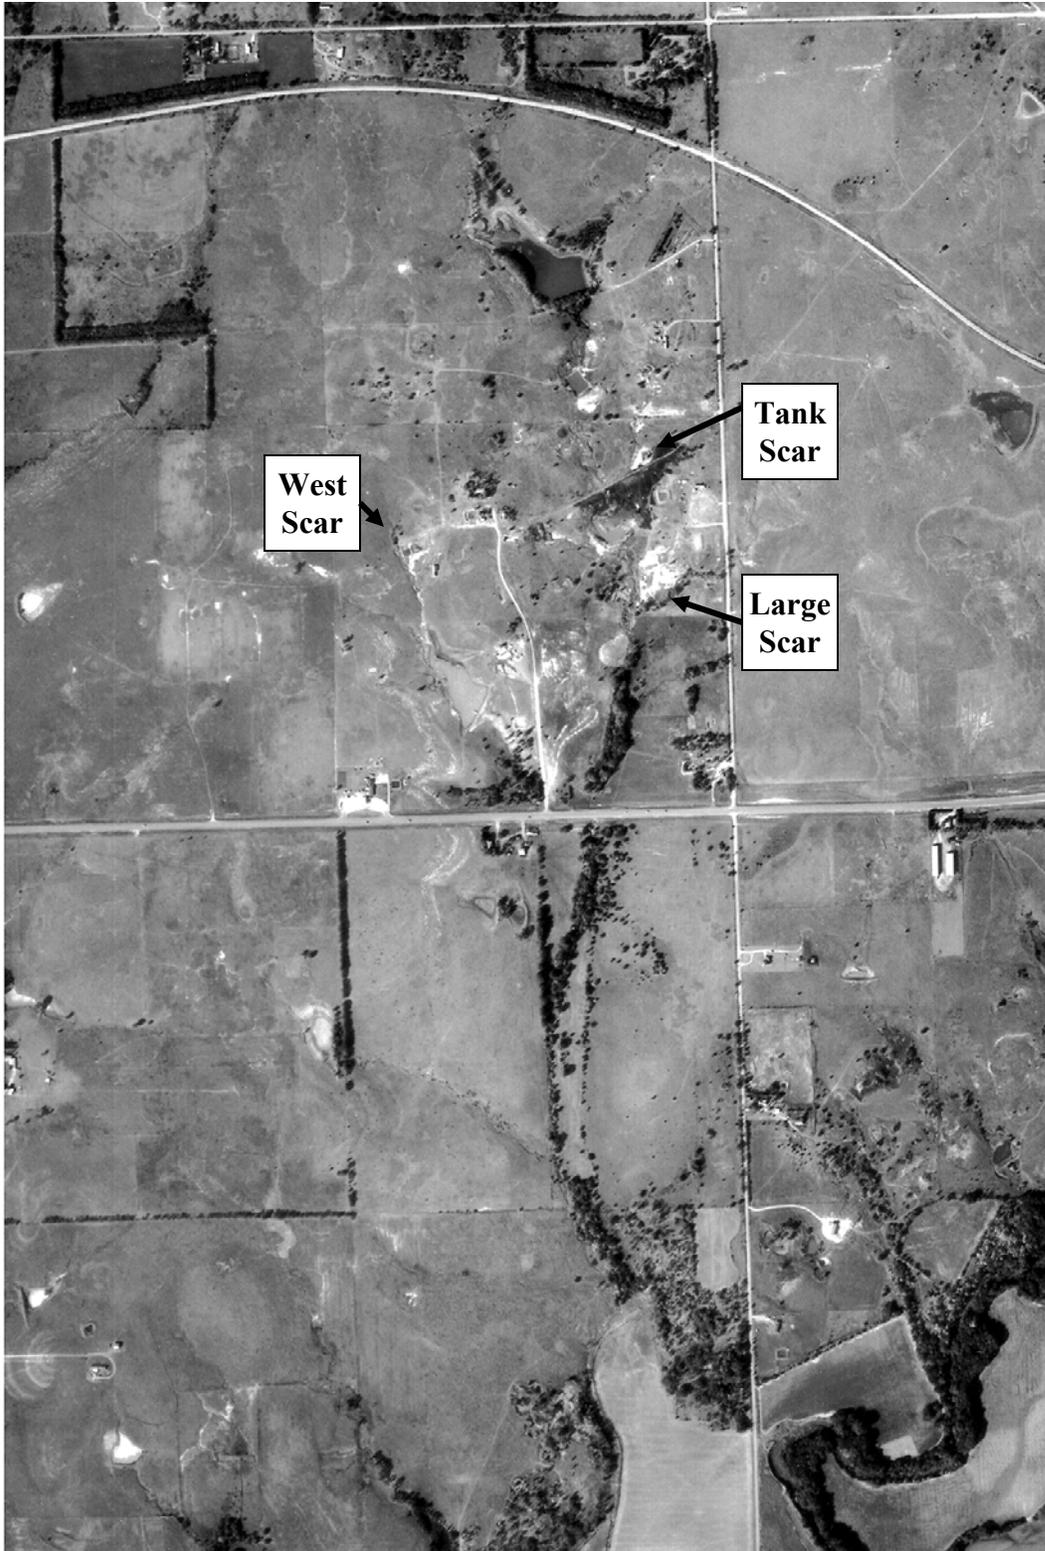
Figure 2: Leon Waterflood Site Showing Areas of Remediation Effort.

The area around the Leon Waterflood has produced oil for over 60 years. The area contains numerous small and large scars caused by various historic oilfield activities. A large portion of the general area was covered by oil production, tank batteries, pipelines, and lease roads. The Leon site itself was dominated by three prominent salt scars caused by historical oil production – the West Scar, the Large Scar, and the Tank Scar. These areas are shown in the aerial photo shown as Figure 2 and described below.

The three scarred areas show similar effects of brine impact. Surface soil is bare of vegetation and cracked. Over much of the scarred areas, erosion has removed most of the soil down to bedrock or the transition from soil to bedrock. Hard, angular chunks of bitumen-impregnated soil are scattered across the surface of these scars. It was decided early to remediate the Tank and Large scars and install a stock-pond over the West scar rather than attempt to fill the deep gullies at that site.

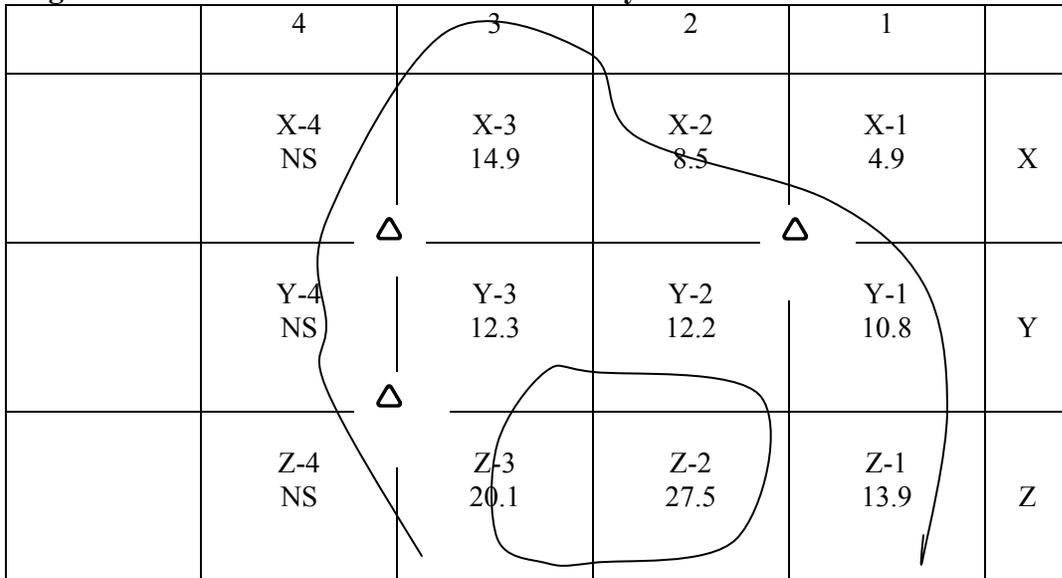
Figure 3: Surface Soil Electrical Conductivity

**Tank Scar – Leon Water Flood
EC – Surface (0 to 6”) Soil (mmhos/cm)
△ = Soil Boring**

Soil sampling was done in April, 2001. Contour Interval is 10 mmhos/cm.

Electrical Conductivity (EC) is a measure of total dissolved salts in soil; salinity is the major source of stress for plants. Threshold levels for salinity stress will vary between plant species. EC values in excess of 4.0 are considered saline (Richards, 1954) and potentially stressful for some varieties of common vegetation. All surface soil samples at the Tank Scar show excessive to very excessive salinity levels and this is corroborated in that only scattered sprouting can be seen at the seeded and mulched scar. Exchangeable sodium is shown in Figure 4 below:

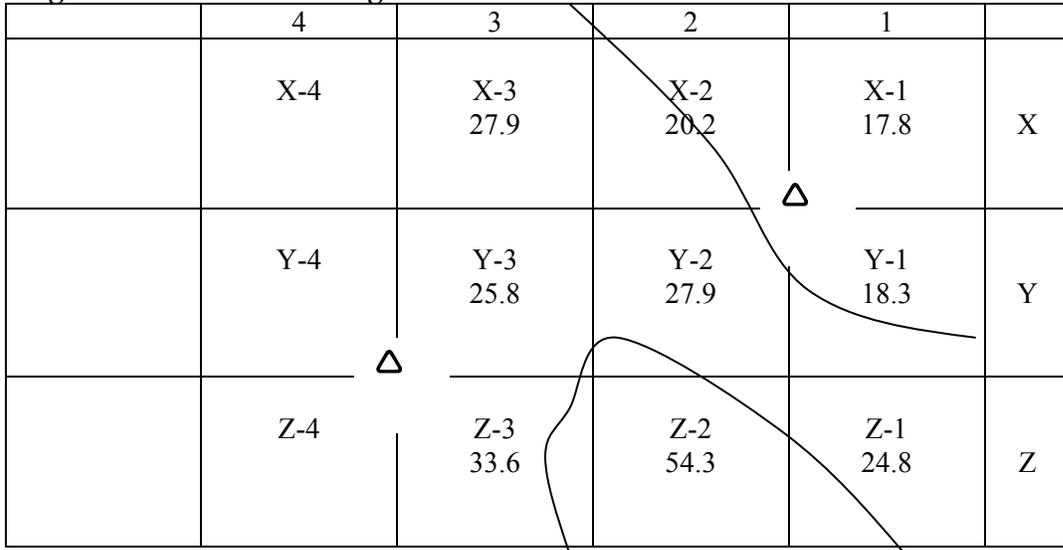
Figure 4: Surface Exchangeable Sodium in %

**Tank Scar – Leon Water Flood
Surface Exchangeable Sodium in % April 2001
Δ = Soil Boring**

Soil sampling was done in April 2001. Contour interval is 20%.

Exchangeable Sodium Percentage (ESP) is a measure of the sodicity of clays within the soil matrix and the potential for destruction of soil texture from dispersion of the clay particles. Soil ESP is excessive at a value of 15%; virtually the entire Tank Scar is in excess of 15%. Nevertheless, the site shows little sign of erosion and soil texture shows good infiltration of water and little puddling of rainwater.

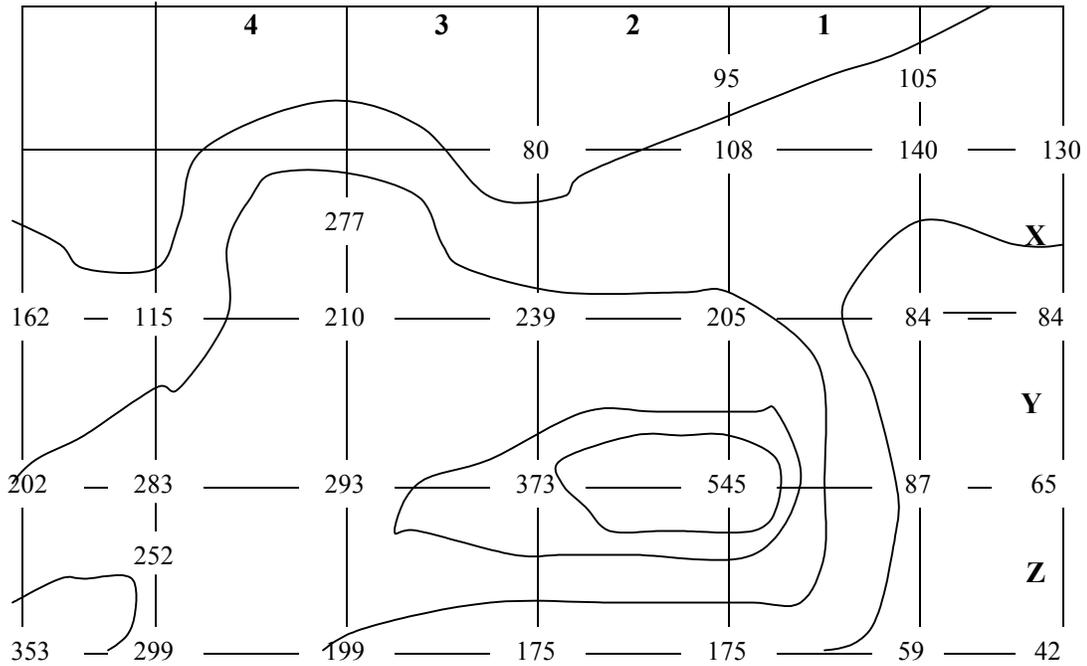
Figure 5: Horizontal Conductivity from EM Survey

Tank Scar – Leon Water Flood

Horizontal Conductivity from Electro-Magnetics
In millisiemens/meter

On April 25, 2001 the NRCS ran a detailed Electro-Magnetic Survey over both scarred areas. Figures 5 and 6 are the E-M results over the Tank Scar. Conductivity closely parallels soil EC results with the largest impact shown beneath the X-Y – 2 location on both E-M Survey data and soil data.

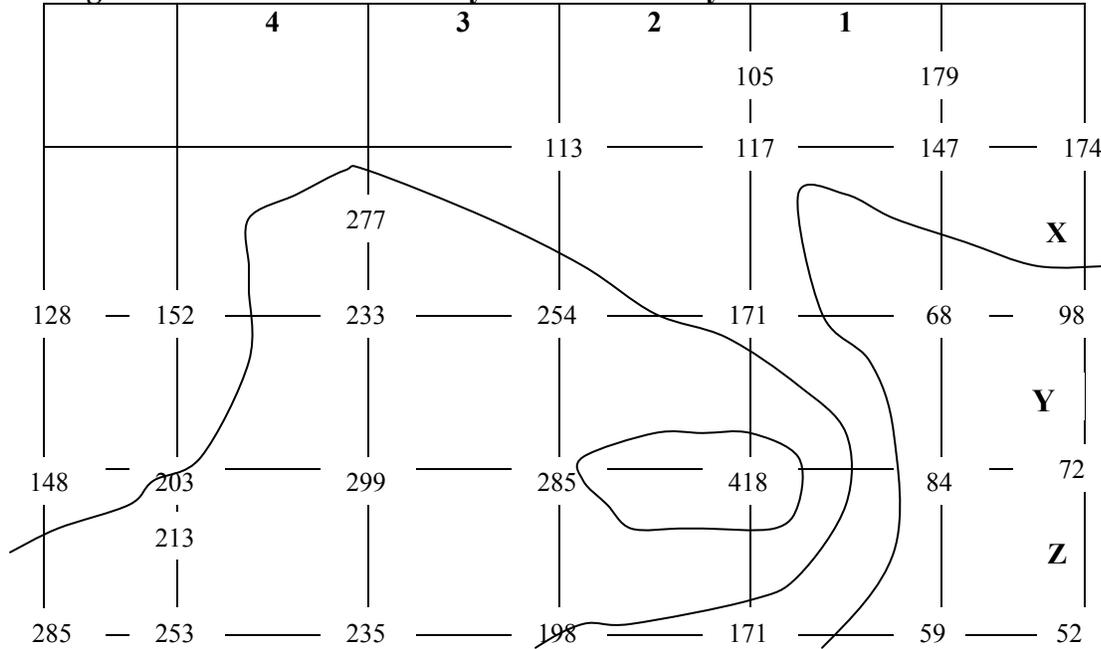
Figure 6: Vertical Conductivity from EM Survey

Tank Scar – Leon Water Flood

Vertical Conductivity from Electro-Magnetics
In millisiemens/meter

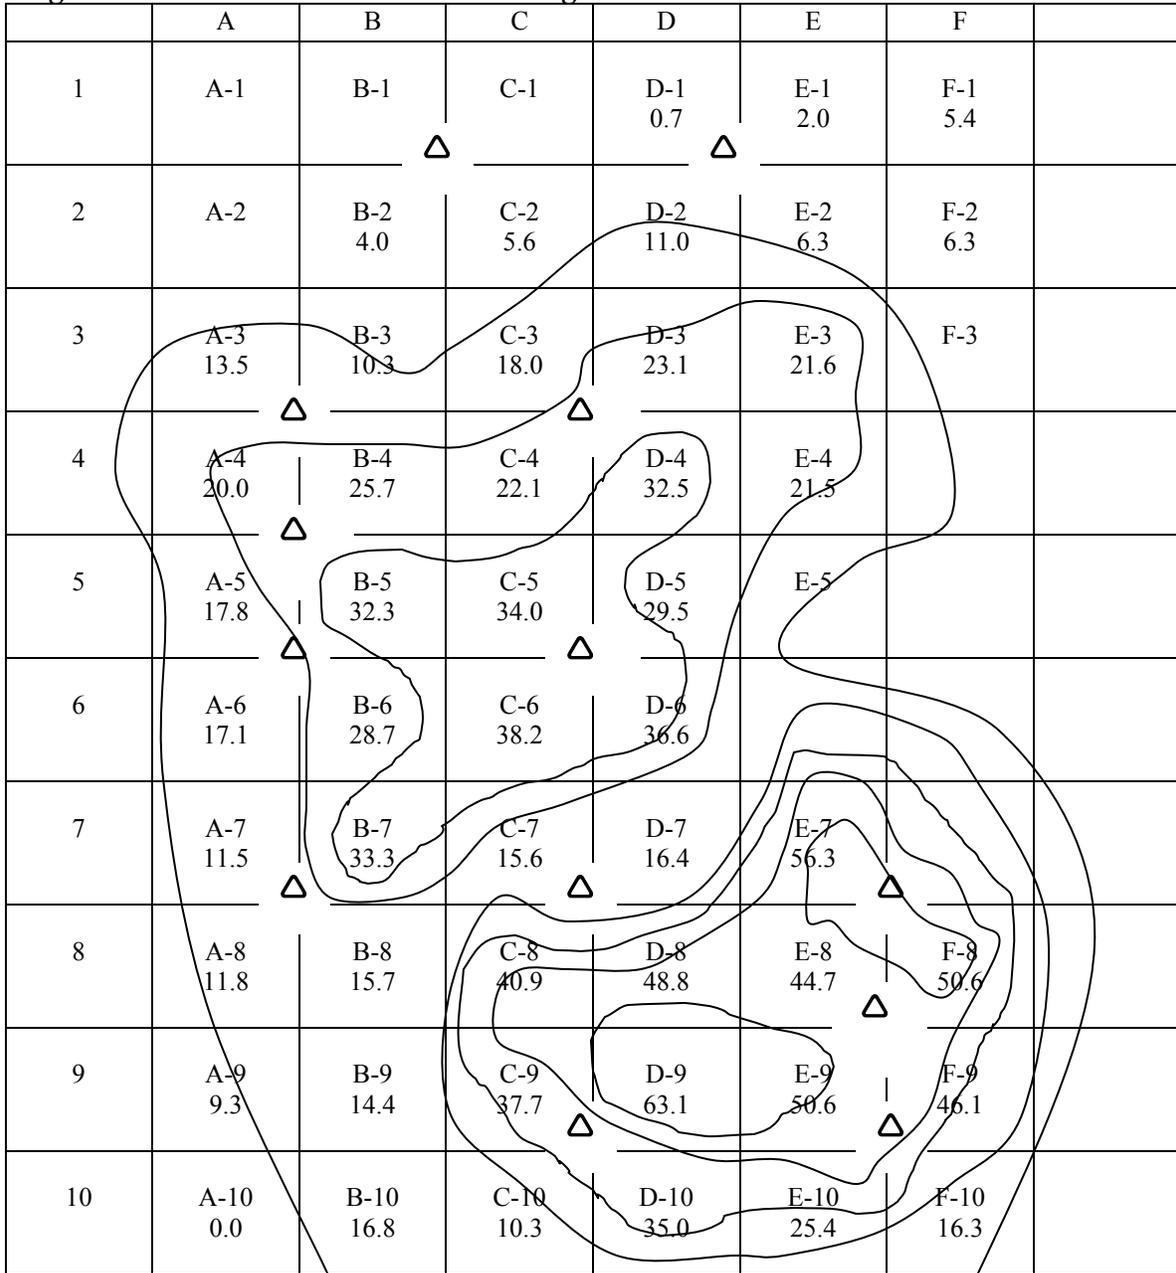
Figure 8: ESP in Surface Soil at the Large Scar

**Large Scar – Leon Water Flood
Exchangeable Sodium in % Surface Soil
△ = Soil Boring**

Surface soil sampling was done in April 2001. Contour interval is 10%.

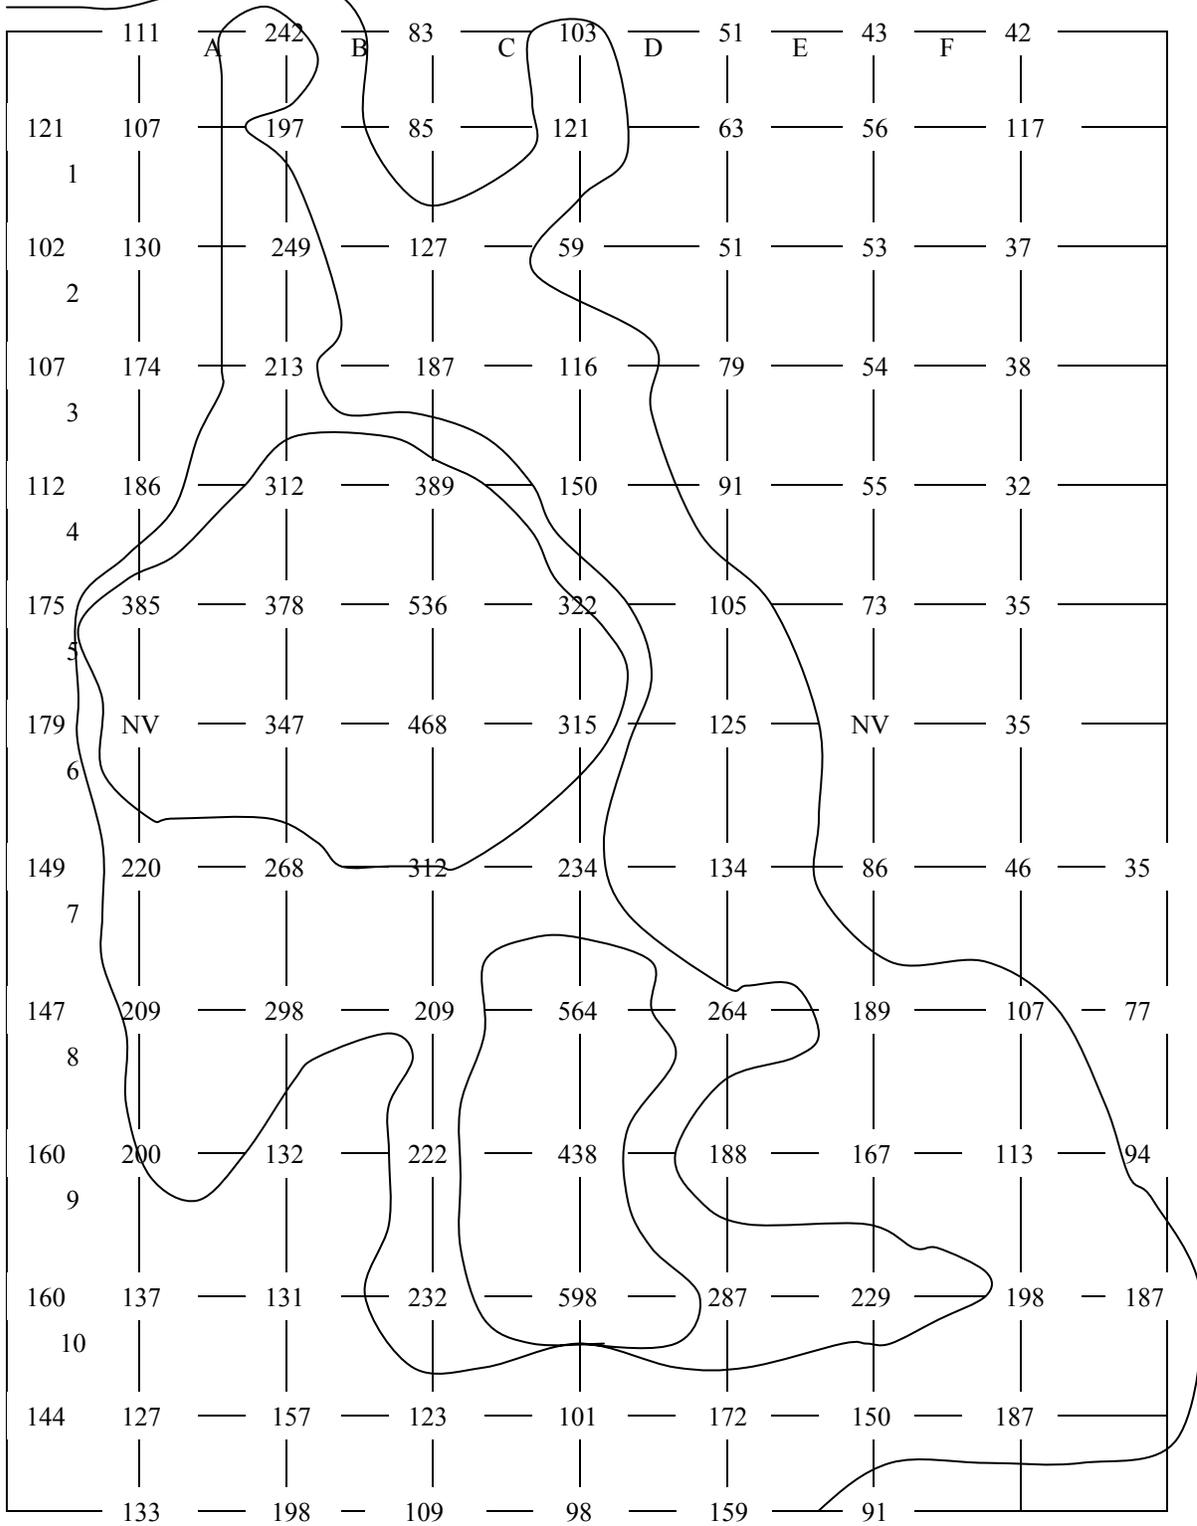
Figure 9: Vertical EC from EM Survey

**Large Scar – Leon Water Flood
Vertical EC from Electro-Magnetic Survey**

EC and ESP in the soil can also be corroborated by remote sensing, including Electro-Magnetic Surveys as shown in Figures 9 and 10.

The EC data derived from Electro-Magnetic survey on April 25, 2001 show rough correlation with soil chemical data. An exception is the highly impacted area shown documented in soil data at approximately block E-7 to F-8. This area is not highlighted on EC data derived from the E-M survey; suggesting that the impacted soil is only shallow. This portion of the Large Scar appears to hold only a shallow soil profile resting on limestone bedrock.

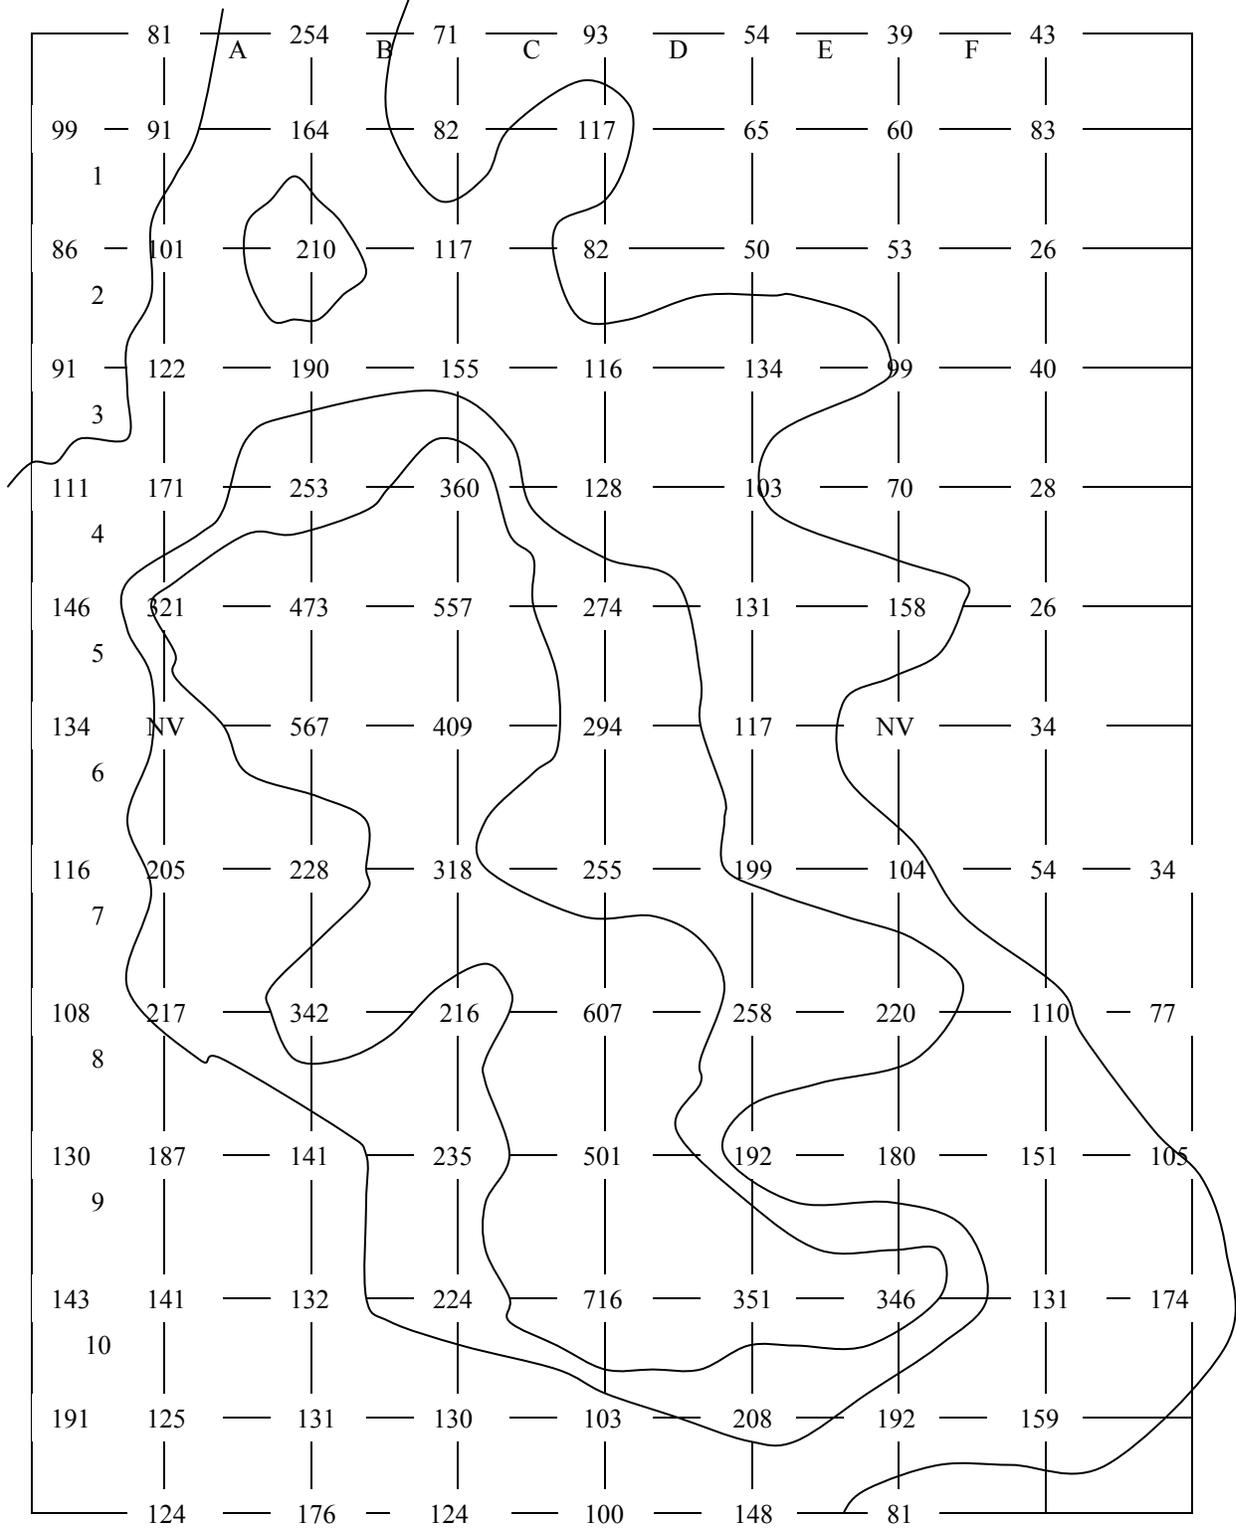
Figure 10: Horizontal EC from E-M Survey

**Large Scar – Leon Water Flood
Horizontal EC from Electro-Magnetic Survey**

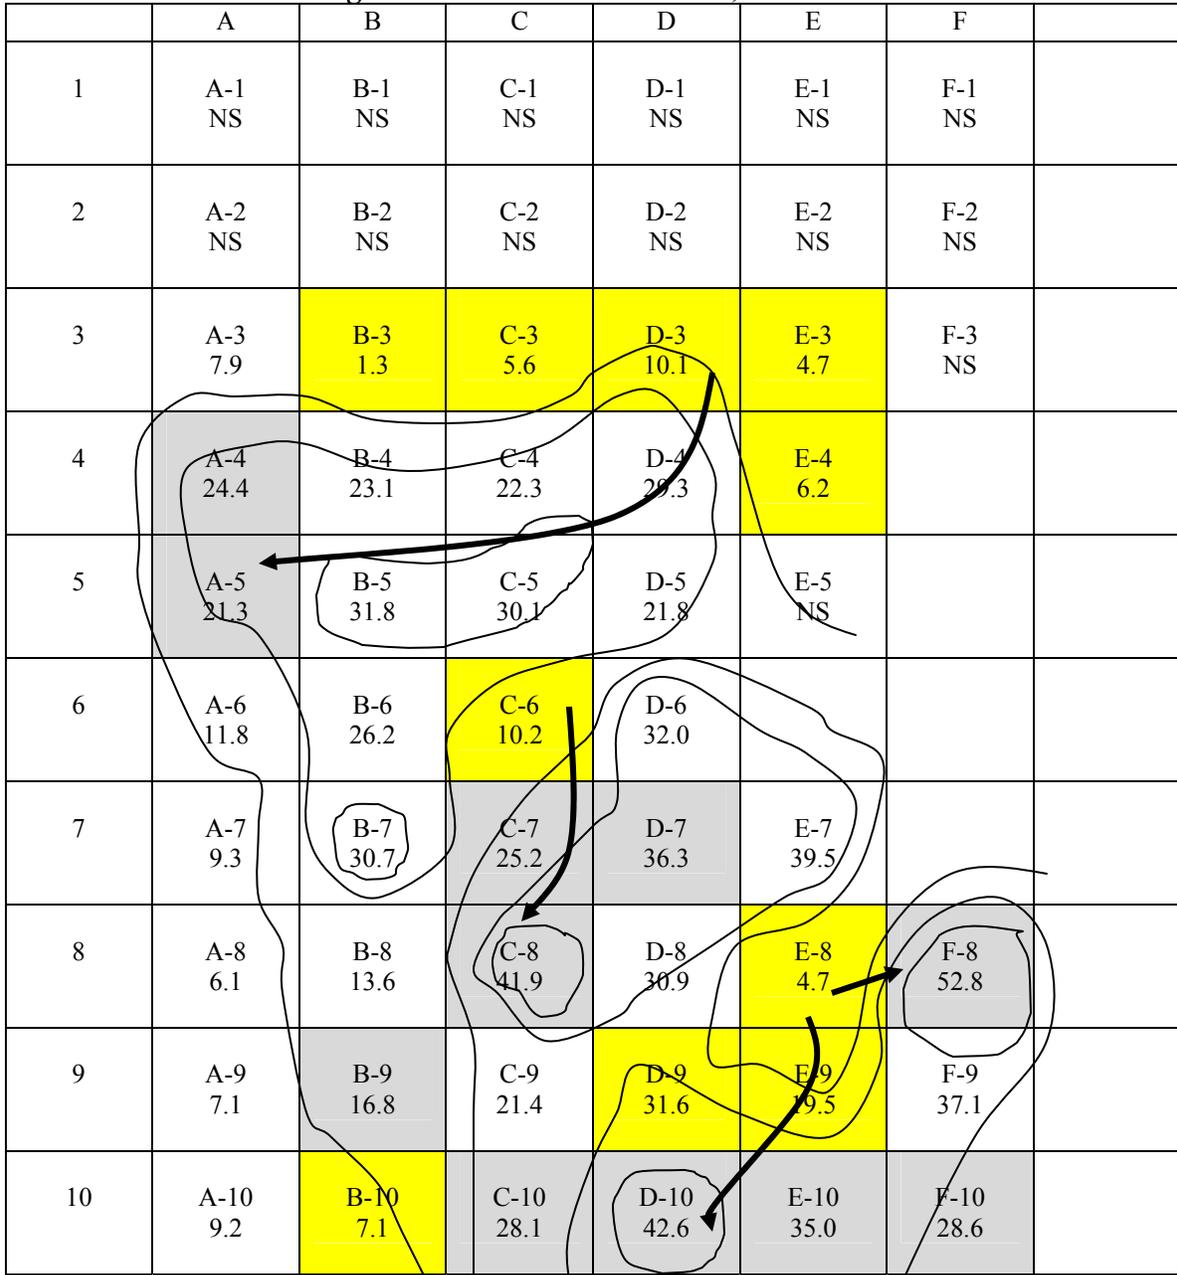
Figure 14: ESP in Surface Soil, Oct 2001

**Large Scar – Leon Water Flood
Surface Soil (0” – 6”) Exchangeable Sodium Percent (October 2001)**

= Increased since April 2001 Sampling

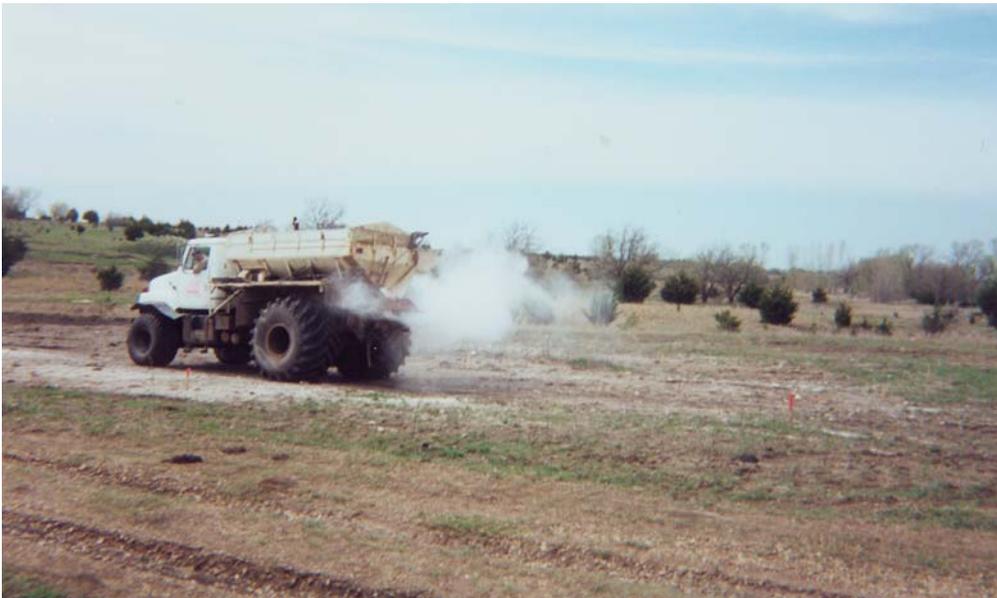
Figure 15: Spreading agricultural gypsum at the Large Scar at Leon Waterflood

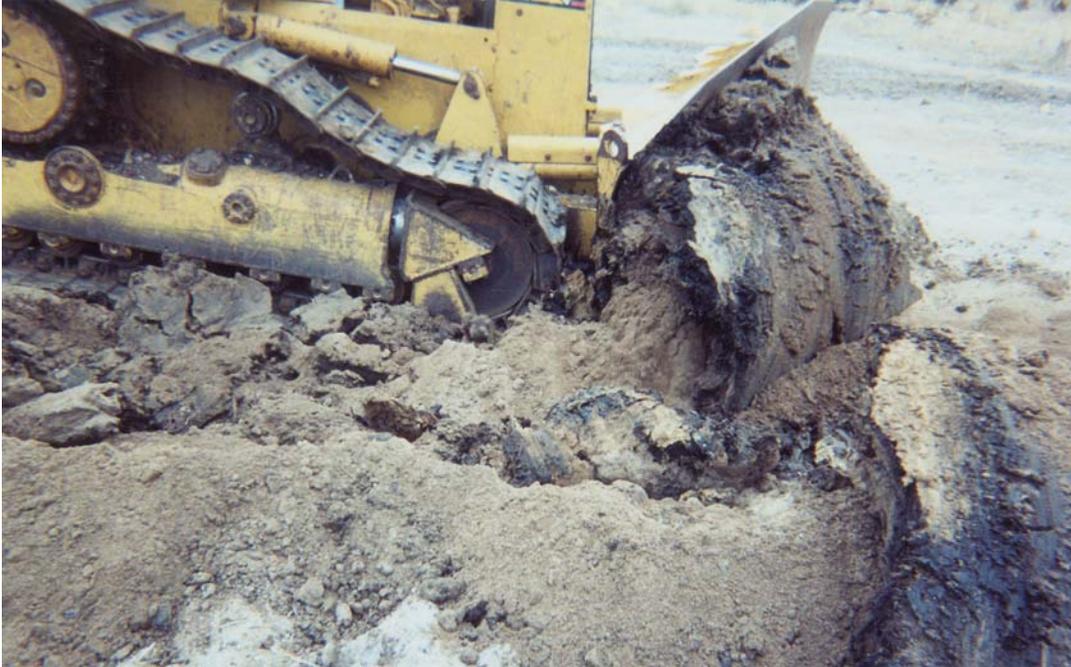
Figure 16: Deep tilling at an individual test-plot on the Large Scar

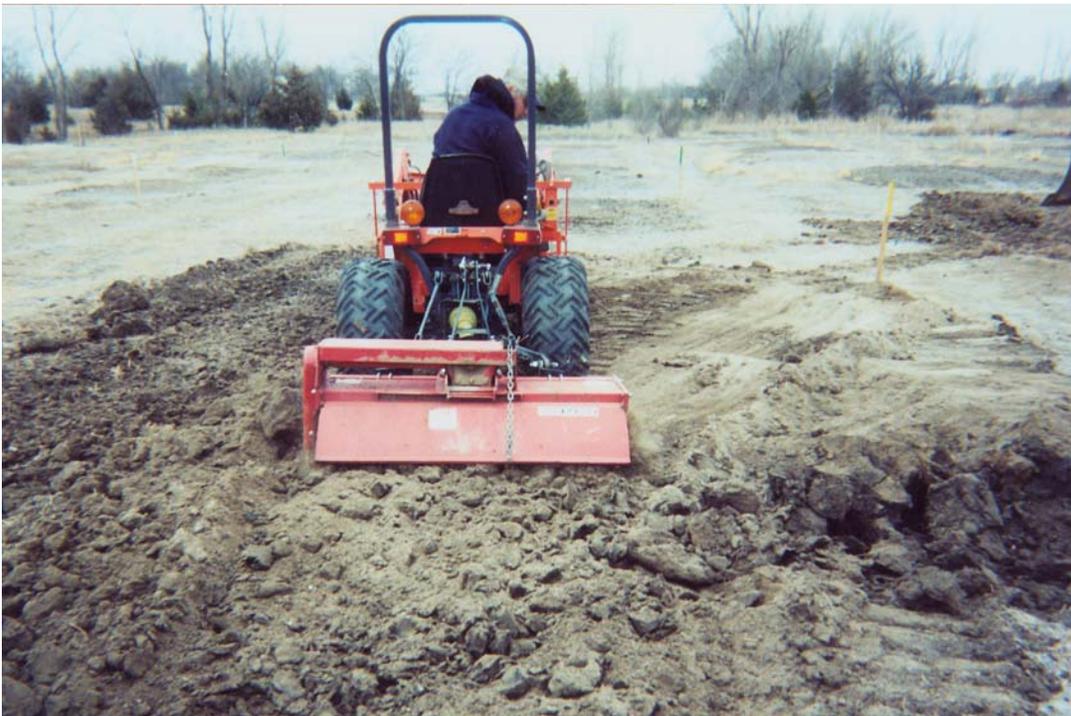
Figure 17: Shallow tilling at an individual test-plot on the Large Scar

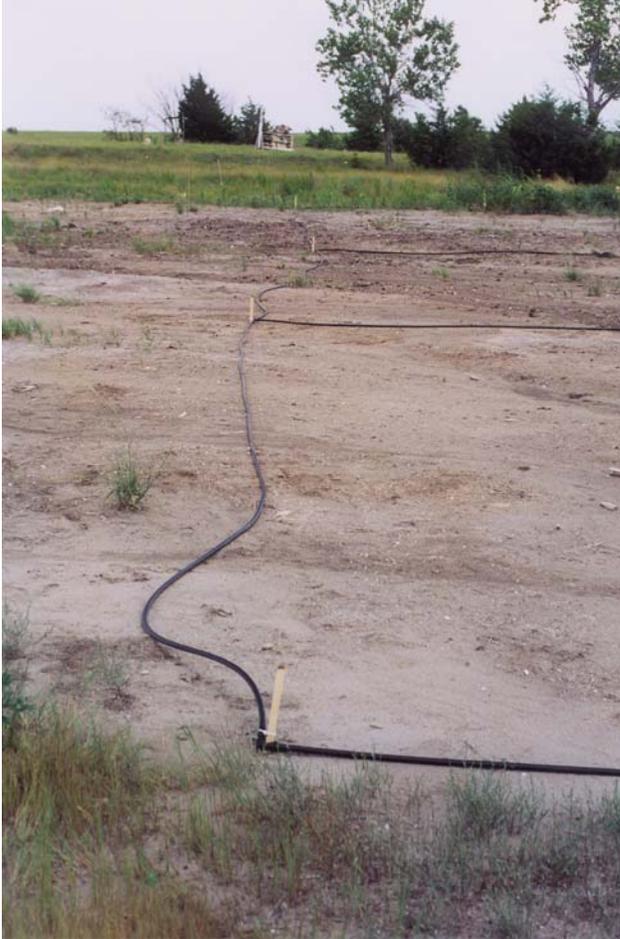
Figure 18: Irrigation system at the Large Scar

Because of the importance of irrigation in reducing soil salts, we have included it in the experimental design described below as a treatment in its own regard. It is added into the design as the soil treatments are repeated: with irrigation, and without. Irrigation was accomplished with a drip system to deliver water directly to the selected test-plots.

During the summer of 2002, the test-plots were watered four times for approximately four hours each time. Each watering episode allowed approximately 40 gallons of water to be released directly to each 5-meter by 5-meter square plot, equivalent to approximately 0.37 inches of water over each test-plot.

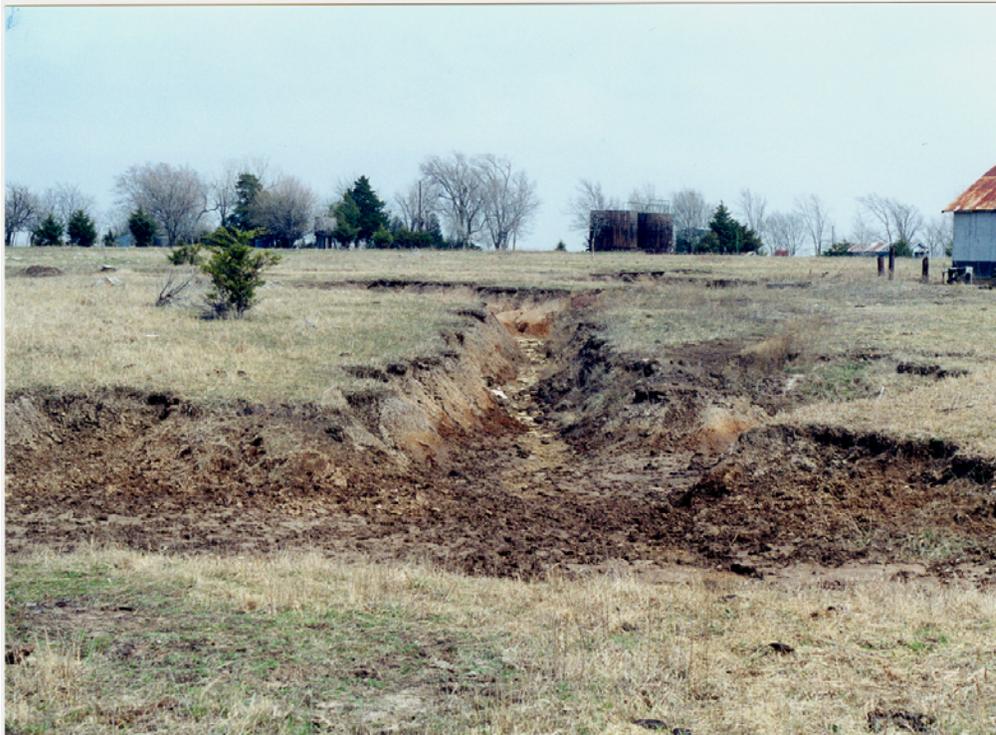
Figure 20: West Scar Gullying

During the winter of 2001 the impoundment was constructed over the deeply eroded gullies of the West scar. The extent of the gullying is shown in Figure 20.

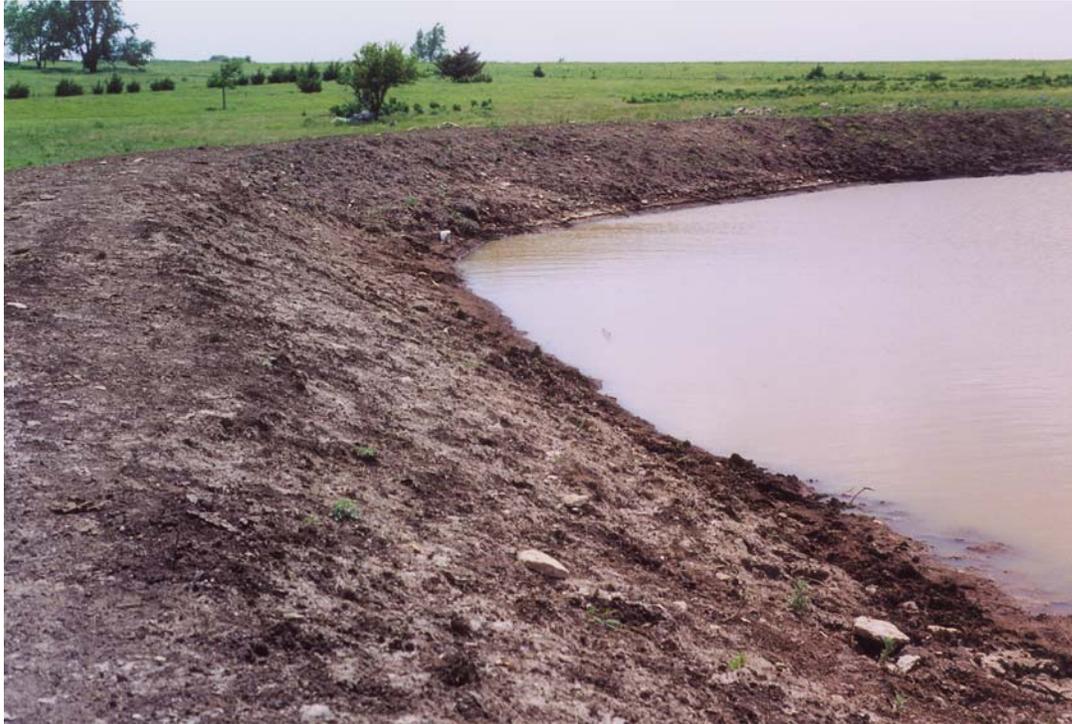
Figure 21: Impoundment constructed over the West Scar at the Leon Waterflood

The objective of this method was two fold: to research an alternative to soil amendments and monitor water quality changes downgradient of the West Scar. The design was supplied by the USDA – Natural Resources Conservation Service and is attached in the Appendix. The impoundment is expected to be approximately 8.0 feet deep, cover approximately 1.0 acre, and is designed to hold approximately 2.8 ac-ft of water when full. The finished impoundment is shown in Figure 21. The impoundment is not expected to express suspended material or saline water downstream but is expected to be a supplementary source of livestock water for the landowner. The sides of the dam and the embankment around the pond have been seeded with an appropriate prairie grass mix. Cost of the impoundment was approximately \$8,175 to achieve approximately 1.0 acres of remediation. The only other option would have been to fill in the gullies with

imported fill and seed the area – a much more costly option. Costs for other impoundments will be different depending upon size and location.

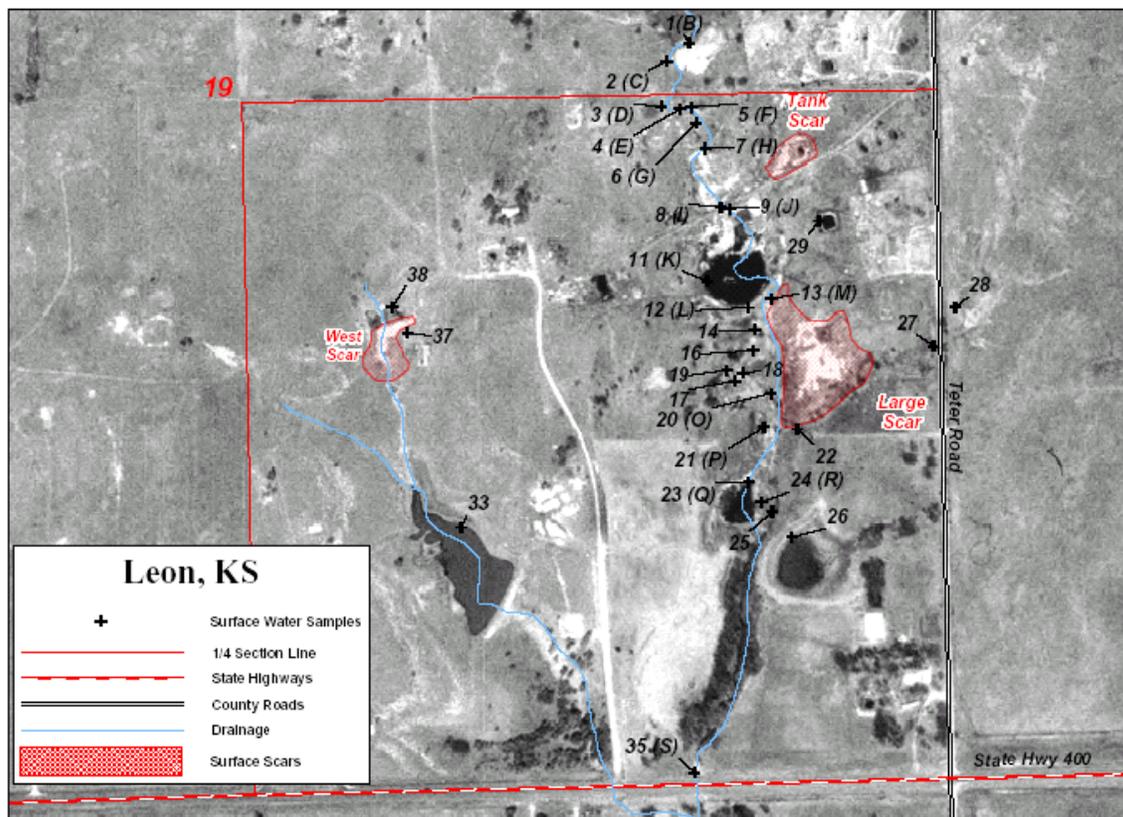
Figure 23: Digital Ortho Quad Map of Leon Project Site with Surface Water Sampling Sites

An assessment of surface water quality was chosen to gauge the relative effects to the watershed from conditions present on the Leon Site, and quantify the transport processes of salts and sediment in runoff associated with different experimental treatments. A small, intermittent creek beginning about 1.5 miles above the Leon Site passes through the salt scar areas before emptying into the Little Walnut River approximately 1.2 miles below the Leon Site. Nineteen sampling stations were established along the general flow of this creek, while an additional 22 stations were established elsewhere at various distances but still in close proximity to the study area as shown in the map on Figure 23.

Each of the 41 sampling stations is identified numerically. In addition, the 19-station subset is cross-referenced alphabetically and sequentially from higher to lower portions of the small, un-named creek that passes through the study area. Water quality was examined five times in 2001 and eight times in 2002 across the study area to assess the impacts of the salt scars to surface waters. Seasonal variations in precipitation and unusually prolonged drought periods in both 2001 and 2002 caused many of the stations to dry up completely thus making sampling impossible at these times for certain locations. For each sampling event where water was available the parameters Specific Conductance, Dissolved Oxygen, pH, Turbidity, Salinity, and Temperature were measured *in situ* using a Horiba U-10 water quality checker. The surface water quality data is collected in Appendix II at the end of this report. An evaluation of these parameters provides important information in oilfield impact assessment wherever watershed impacts are of potential concern.

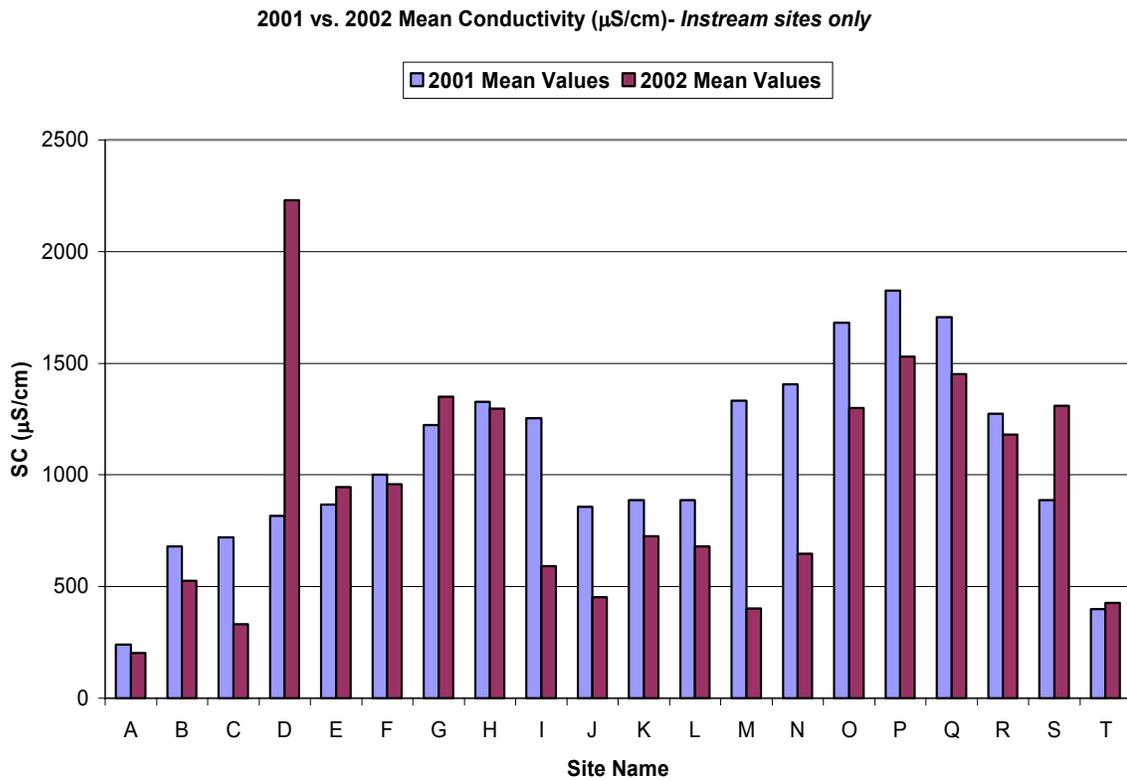
Figure 24: Specific Conductivity Comparison

Instream yearly data comparisons for SC are summarized in Figure 24; the sample sites are shown on the map in Figure 23. Site names (A through T) indicate sequential sampling points from uppermost to lowermost portions of the watershed along the small creek. Station A, located above any oilfield activity, was chosen as a benchmark control site. Moving downstream, the creek shows a gradual increase in SC as it approaches the Tank Scar (B-H). Higher SC than might be expected in the lower part of this reach is likely attributable to contributions from one or more additional oilfield sites situated just above the study area. Station I was located immediately downstream from the Tank Scar, but consistently showed lower SC values than several stations both upstream and downstream. This can be explained by the fact water is slightly impounded at this location and was thereby more diluted, yielding lower SC values. Stations J, K, and L

What can be derived from the data is that water leaving the Leon Waterflood has considerably higher SC values than when it entered the area and intrusion from salt-impacted soil in the scar areas is the most evidenced explanation. The impact of the Leon salt scars on SC definitely contributes to water quality degradation in the small creek but is highly localized within the watershed becoming less significant upon dilution after entering the Little Walnut River. The construction of the small stock pond in the West Gully resulted in lower SC levels than formerly seen at that location by virtue of the relatively larger volume of water impounded, which is consistent with reduced conductivities found at other similar stations having impounded conditions.

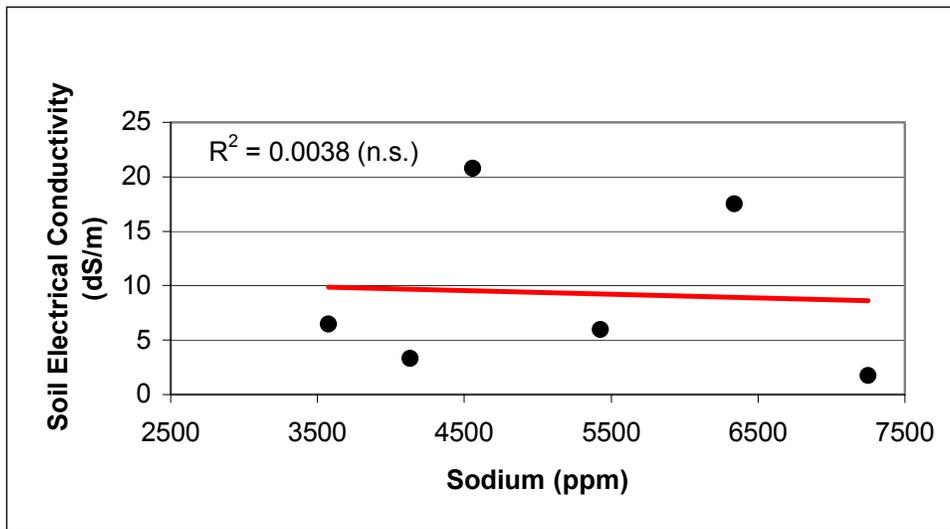
Table 9: Sodium content of inland saltgrass tissues vs. the electrical conductivity of soils at the Leon Water Flood.

Sodium content of inland salt grass ranged from 3573 ppm to 7250 ppm (mean = 5212 ppm), or roughly 0.3% to 0.7% (mean = 0.5%) of the plant weight. Sodium content of the plant tissues was not related to levels of salts in the soil, as indicated by the lack of a positive correlation between sodium content and soil EC (Table 9). This lack of a relationship indicates that inland salt grass does not increase its salt uptake with increasing soil salinity levels. The large range of salt uptake (a 2 to 1 difference in the highest and lowest values) is indicative of the mechanism by which *Distichlis spicata* processes soil salts. Inland salt grass is part of a group of plants called salt eliminators, whereby a plant copes with excess salts by incorporating salts via the roots then exuding altered salt compounds through glands, or by excreting of salts at shoot surfaces. The salt compounds can be released into the atmosphere as methyl chloride. Another way that inland salt grass releases salts is through death and shedding of older leaves that have accumulated significant amounts of salt. At different times the plant's salt content may vary, depending on the cycle of accumulation and shedding. In brine scars where inland salt grass is well established and abundant, additional salts could be removed by harvesting plant tissues mechanically or by livestock grazing.

Although sodium content and EC are not correlated with one another as is documented in Table 9, the sodium content of inland salt grass varies from 0.3% to 0.7% of the plant’s total weight.

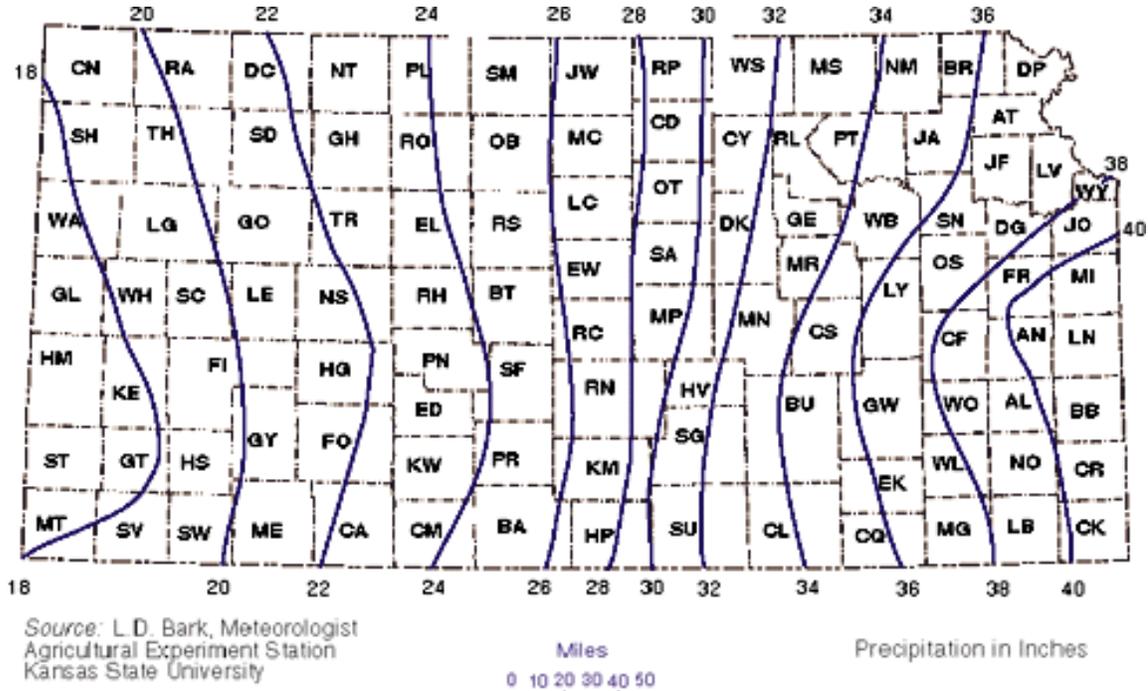
Figure 25: Average Annual Precipitation Across the State of Kansas.

In parts of Kansas, rainfall is quite sparse even in the average years. As can be seen below in Figure 25, the Leon area averages approximately 32 inches of total precipitation per year while other areas gather more than 40 inches and less than 20 inches per year. In drought years, of course, precipitation is less and the need for irrigation is more.
