Project Final Report Remediation of Leon Water Flood, Butler County, Kansas

Project Report: Applied Phyto-Remediation Techniques Using Halophytes for Oil and Brine Spill Scars

Final Report

Reporting Period: August 2000 to March 2003

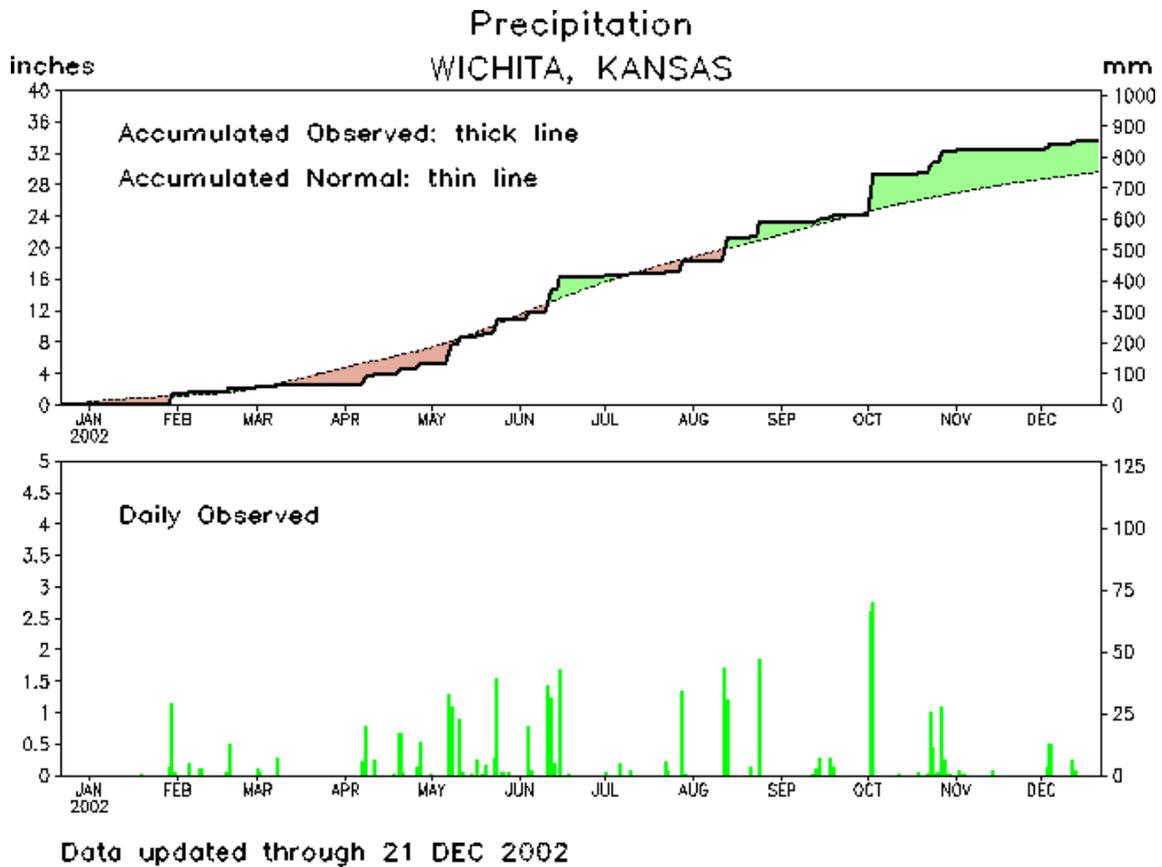
Figure 26: Annual Precipitation Summary for the Year 2002 at Wichita, Kansas.

The Leon site has received less than normal precipitation for the past several years and it was anticipated that the drought might continue through 2002. The yearly summary of precipitation (Figure 26) for Wichita, approximately 30 miles from the Leon site, shows dry conditions in the early part of 2002. For this reason, drip-irrigation was installed at the Large Scar on one-half of the test-plots. The test-plots were split in half so that one complete set was left un-irrigated while a duplicate set was irrigated. As the summer developed, however, less extra water appeared to be needed and only 1.6 inches of water was applied across the irrigated test-plots. This amount of moisture was enough to raise the actual observed precipitation line shown in Figure 26, above the average normal. More water could have been added since the soil scar is largely located on a sloping bedrock surface that drains west to the stream valley. This local condition will be different for each remediation project and could limit the amount of irrigation that would be optimal for leaching and plant growth.
