Use of Pressure Activated Sealant Technology to Cure Pipelines Leaks
Final Technical Report

Michael A. Romano
November 2004

Seal-Tite, LLC
500 Deer Cross Drive
Madisonville, Louisiana 70447

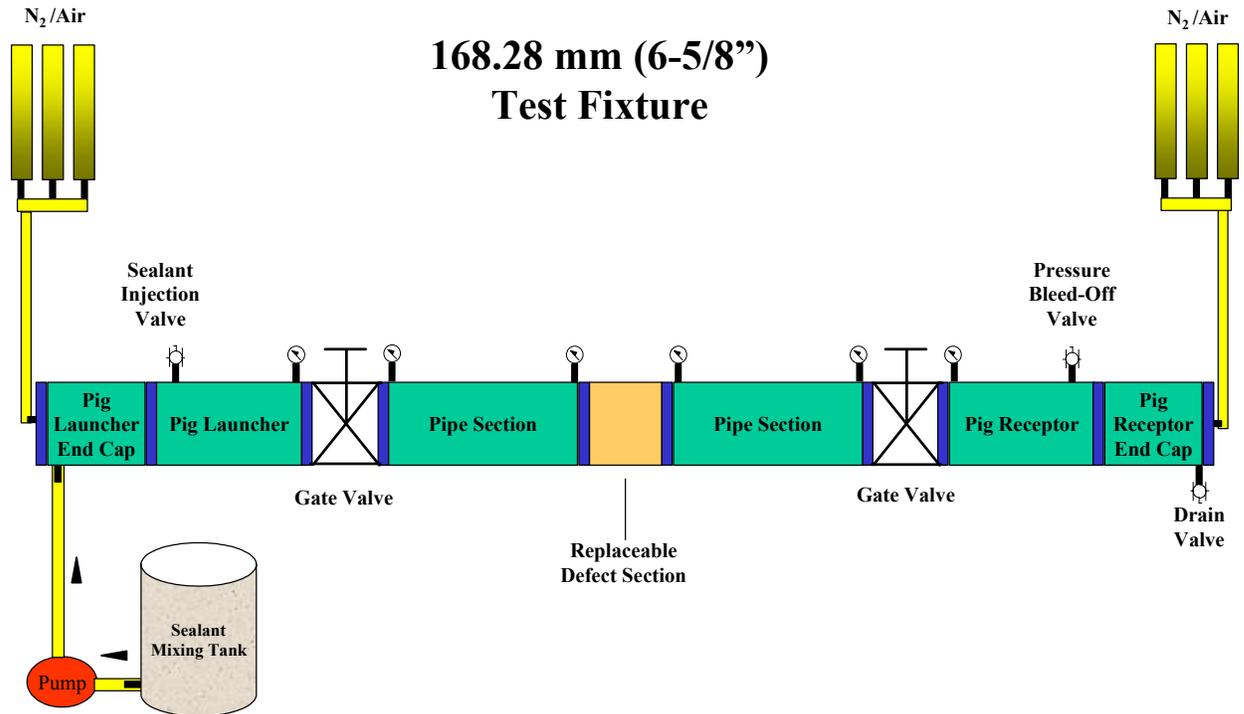
Drawing 1: Test Fixture

Two gate valves along with twelve 25.4 mm (1") nipples were incorporated into the test model to achieve varied manipulations of pressure and isolation of sections and to allow for placement of pressure gauges, bleed-off valves, pressure pop-off valves, and ball valves for the injection and discharge of nitrogen, air, water and sealant. An overview of the test fixture is seen below in Drawing 1 with dimensions in Table 3.

OD, mm	OD, in.
	168.280	6.625
	ID, mm	ID, in.
	146.000	5.761
	Length, mm	Length, in.
Launcher End Cap	543.000	21.375
Pig Launcher	1780.000	70.125
Gate Valve	565.000	22.250
Pipe Section	2530.000	99.500
Defect Section	1003.000	39.500
Pipe Section	2530.000	99.500
Gate Valve	565.000	22.250
Pig Receptor	1780.000	70.125
Receptor End Cap	543.000	21.375
Total Fixture Length	11,839.000	466.000
	11.8 meters	38 ft 10 in.

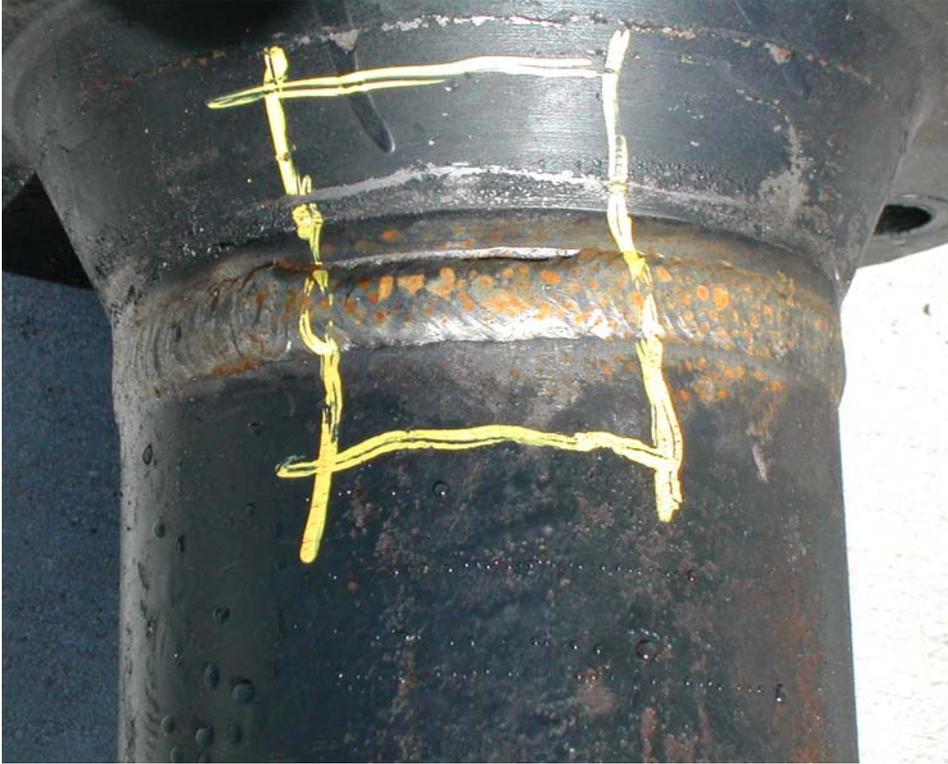
Photo 1: Weld Defect

The DFW, DGW and DPS defects were represented by a single Weld Defect Section (Photo 1, page 8) that simulated common irregularities associated with welds including cracks and wormholes. Since 68.3% of the externally corroded pipe and 64.1% of the internally corroded pipe was described as either “localized pitting”, “pinhole” or “pinhole with localized pitting”, the EC and IC defects (Photo 2, page 8 and Photo 3, page 9 respectively) simulated localized pitting with pinholes. The defect section with two (2) pinholes (Photo 4 and Photo 5, page 9) represented defects with higher leak rates. The dimensions of the 100 cm (3.29 ft) defect sections are summarized in SI units in Table 4 and inches in Table 5 on page 7.

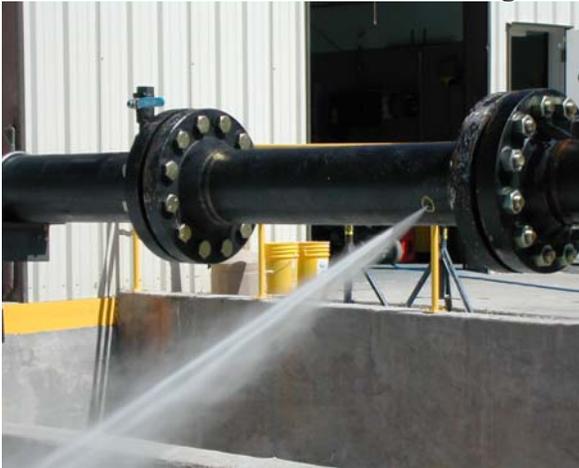
**Photo 6:
Internal Corrosion Leak Rate Testing**

The results of the leak rate testing is summarized below in tables and charts for each defect type, showing liquid and gas leak rates in both SI and English units. Examples of the leak rate tests are shown below in Photo 6 and 7.

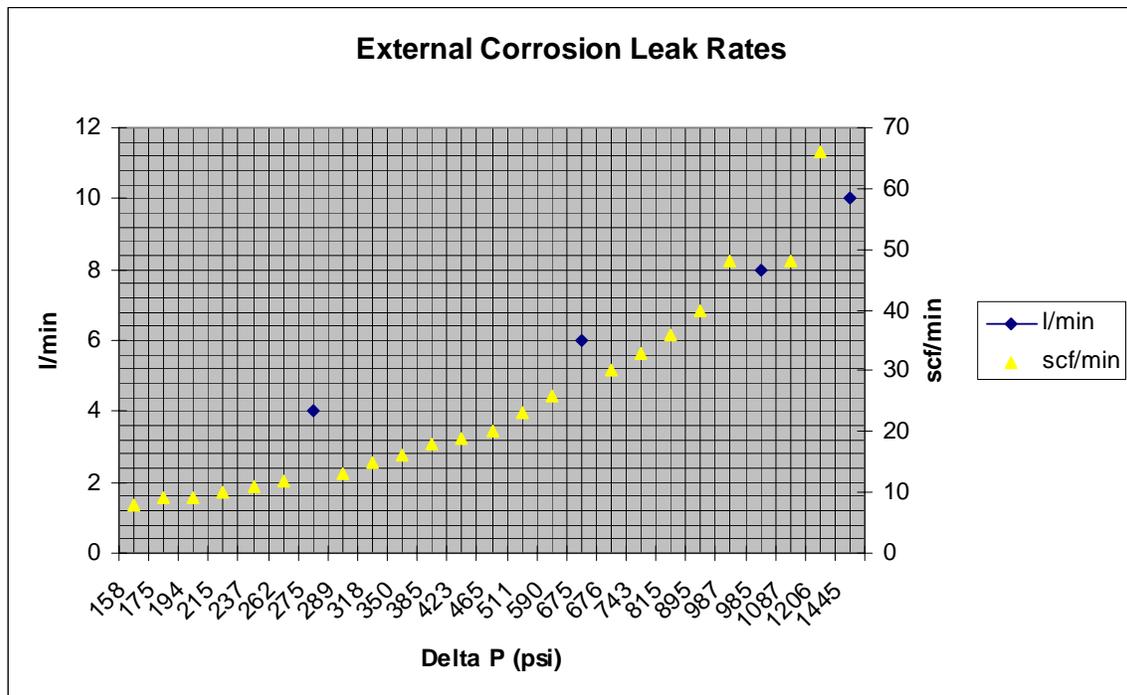
Chart 1: External Corrosion Leak Rates

Nitrogen				Water			
scf/min	scm/min	ΔP MPa	ΔP psi	l/min	gpm	ΔP MPa	ΔP psi
66	1.870	8.320	1,206	10	2.64	9.960	1,445
48	1.360	7.490	1,087	8	2.11	6.790	985
48	1.360	6.810	987	6	1.59	4.650	675
40	1.130	6.170	895	4	1.06	1.900	275
36	1.020	5.620	815				
33	0.934	5.120	743				
30	0.850	4.660	676				
26	0.736	4.070	590				
23	0.651	3.520	511				
20	0.566	3.210	465				
19	0.538	2.920	423				
18	0.510	2.650	385				
16	0.453	2.410	350				
15	0.425	2.190	318				
13	0.368	1.990	289				
12	0.340	1.810	262				
11	0.311	1.630	237				
10	0.283	1.480	215				
9	0.255	1.340	194				
9	0.255	1.210	175				
8	0.227	1.090	158

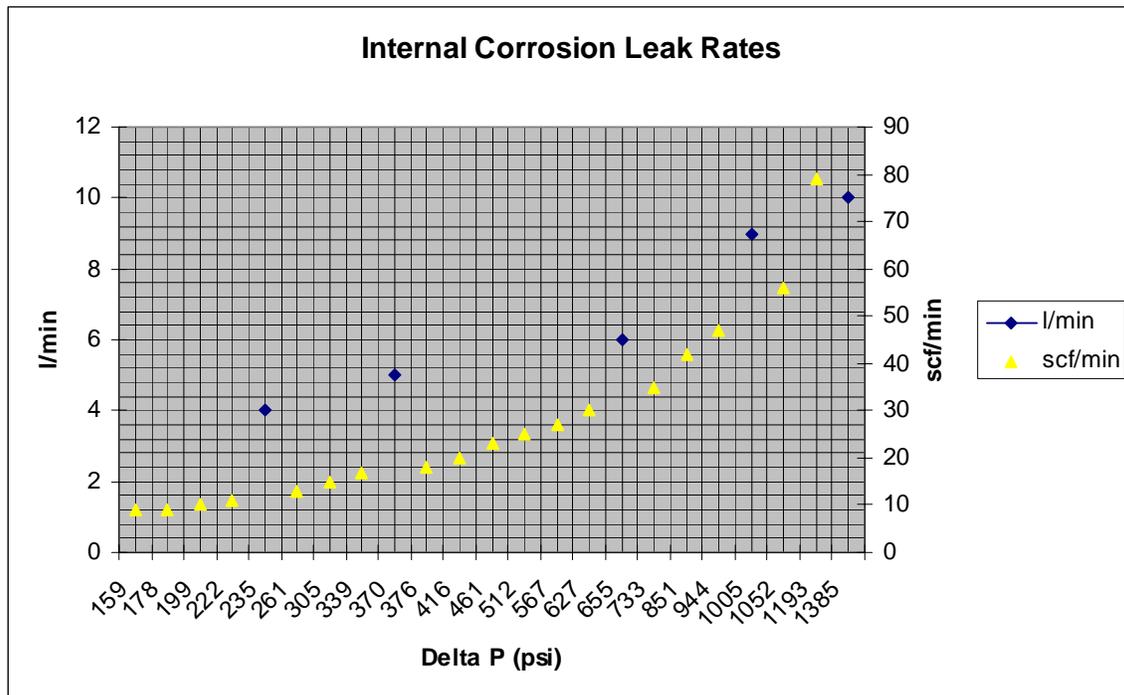
Chart 2: Internal Corrosion Leak Rates

Nitrogen				Water			
scf/min	scm/min	ΔP MPa	ΔP psi	l/min	gpm	ΔP MPa	ΔP psi
79	2.240	8.230	1,193	10	2.64	9.550	1,385
56	1.590	7.250	1,052	9	2.38	6.930	1,005
47	1.330	6.510	944	6	1.59	4.520	655
42	1.190	5.870	851	5	1.32	2.550	370
35	0.991	5.050	733	4	1.06	1.620	235
30	0.850	4.320	627				
27	0.765	3.910	567				
25	0.708	3.530	512				
23	0.651	3.180	461				
20	0.566	2.870	416				
18	0.510	2.590	376				
17	0.481	2.340	339				
15	0.425	2.100	305				
13	0.368	1.800	261				
11	0.311	1.530	222				
10	0.283	1.370	199				
9	0.255	1.230	178				
9	0.255	1.100	159

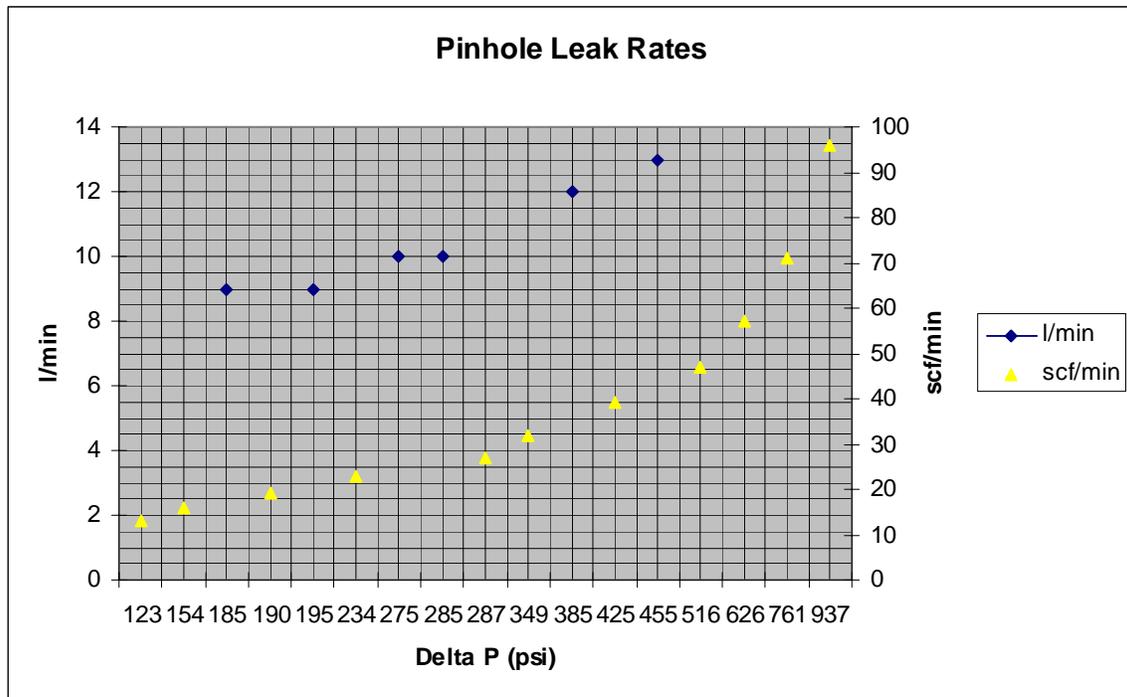
Chart 3: Pinhole Leak Rates

Nitrogen					Water			
scf/min	scm/min	ΔP MPa	ΔP psi		l/min	gpm	ΔP MPa	ΔP psi
96	2.720	6.460	937		13	3.43	3.140	455
71	2.010	5.250	761		12	3.17	2.650	385
57	1.610	4.320	626		10	2.64	1.970	285
47	1.330	3.560	516		10	2.64	1.900	275
39	1.100	2.930	425		9	2.38	1.340	195
32	0.906	2.410	349		9	2.38	1.280	185
27	0.765	1.980	287					
23	0.651	1.610	234					
19	0.538	1.310	190					
16	0.453	1.060	154					
13	0.368	0.848	123

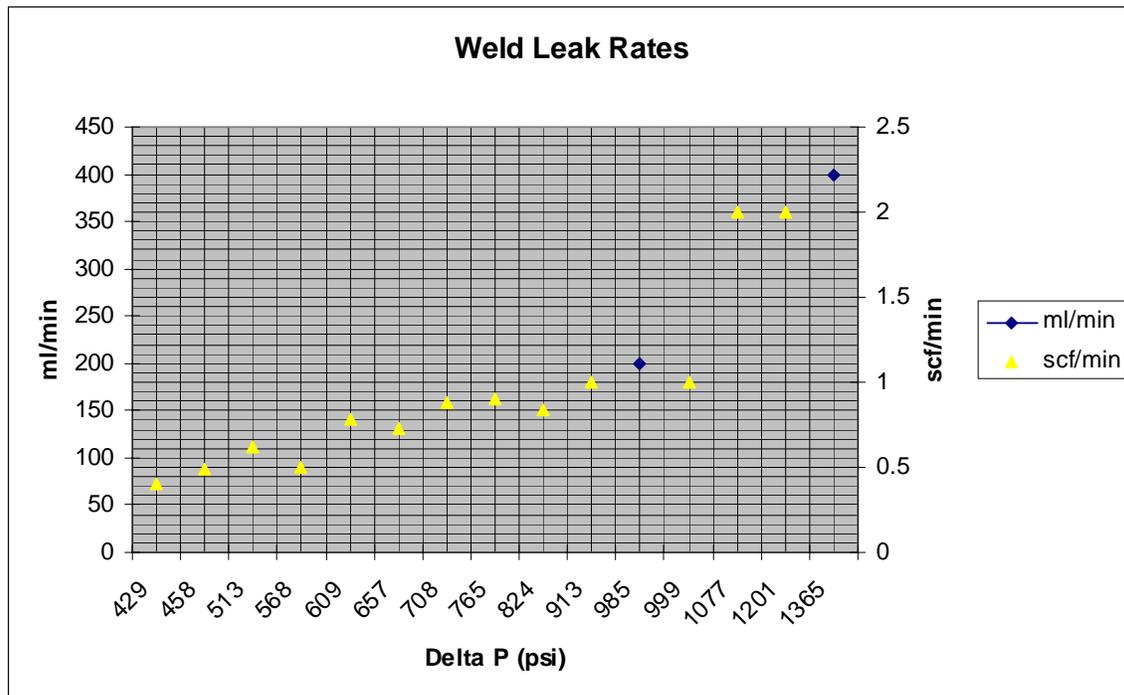
Chart 4: Weld Leak Rates

Nitrogen				Water			
scf/min	scm/min	ΔP MPa	ΔP psi	l/min	gpm	ΔP MPa	ΔP psi
2.000	0.0566	8.280	1,201	0.4	0.11	9.410	1,365
2.000	0.0566	7.430	1,077	0.2	0.05	6.790	985
1.000	0.0283	6.890	999				
1.000	0.0283	6.290	913				
0.838	0.0237	5.680	824				
0.898	0.0254	5.270	765				
0.883	0.0250	4.880	708				
0.725	0.0205	4.530	657				
0.788	0.0223	4.200	609				
0.504	0.0143	3.920	568				
0.623	0.0176	3.540	513				
0.489	0.0138	3.160	458				
0.403	0.0114	2.960	429

The leaks rates, though large, were not considered to be beyond Seal-Tite’s capabilities. Seal-Tite has previously cured downhole leaks in the 37.85 L (10 gal) per minute range. The critical factor was determined to be generating and maintaining a seal in a circular defect, as opposed to a split or crack. Circular defects are more difficult to seal since there is more open area than surface area. Also, the effect of pigging on seal integrity was unknown and needed to be explored in the full scale pipeline testing phase.

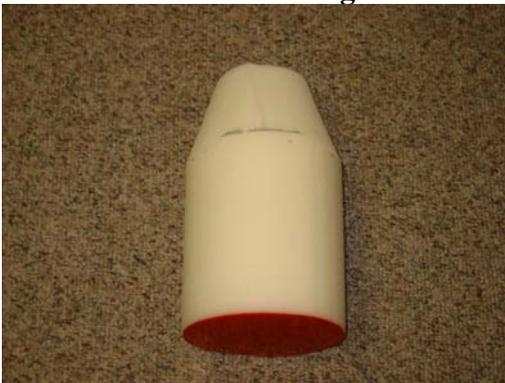
The 32 kg/m^3 (2 lbm/ft^3) density yellow swab pig (Photo 8) was tested for use in multi-diameter pipelines where more rigid pigs are not as easily transported. During preliminary testing, it was noted that while straddling the liquid sealant the swab pig acted like a sponge and became saturated, resulting in the nitrogen creating channels around the pigs and subsequently not allowing the nitrogen to move the sealant train. Higher gas rates that are experienced in the field most likely would have moved the sealant train.

Photo 8
 2 lbm/ft^3 Yellow Swab Pig with Nose

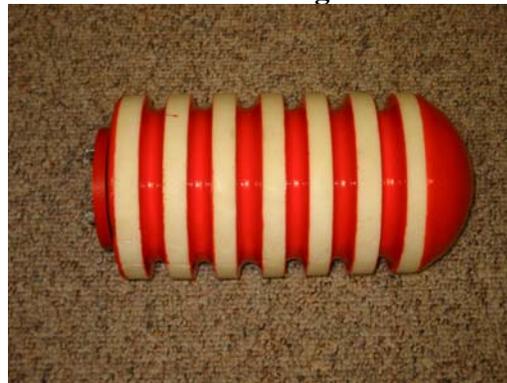
The 80 kg/m^3 (5 lbm/ft^3) density foam disc pigs (Photo 9) on the other hand formed a tight seal against the pipe internal diameter and were very easily moved by nitrogen with only a 20 psi differential.

Photo 9
 5 lbm/ft^3 Foam Disc Pig with Nose

1. Foam Disc pigs are the preferred pigs for isolation and transporting sealant to the leak site.
2. All leaks were successfully sealed to 9.93 MPa (1440 psi).
3. Leak orientation had no effect on quality of seal generated.
4. At the low curing pressure of 9.93 MPa (1440 psi) pigging did affect seal integrity.
5. Leak geometry played a large role in maintaining seal integrity after pigging operations.
6. The effect of curing time on seal quality of a low pressure seal was still unknown.

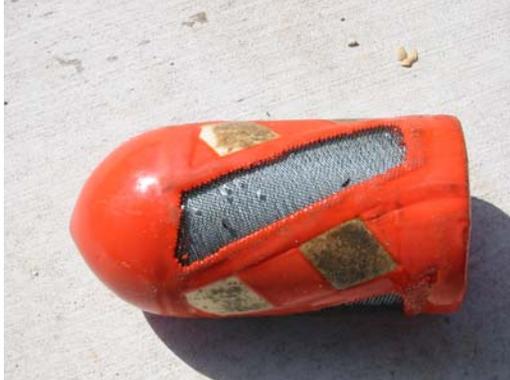
¹wiper/Crisscross wire-brush scraper (Photo 10)/wiper

Photo 10: 5 lbm/ft³ Foam Crisscross Wire Brush Pig with Nose

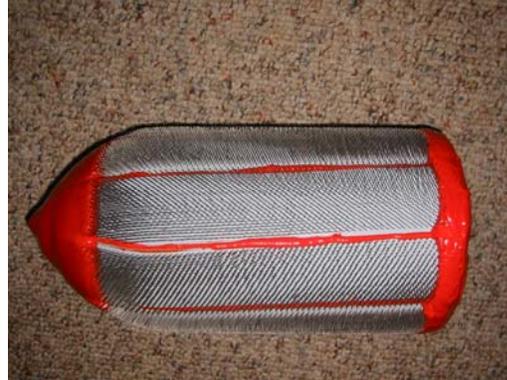
Photo 11: 5 lbm/ft³ Foam Super Javelina Brush Pig with Nose

There were three objectives for the full scale pipeline testing: First, to test the feasibility of transporting the sealant between two pigs; secondly, to test sealant formulations necessary to seal the leak(s); and finally, to test the ability of the newly formed seal to withstand the effects of pigging. Based on operator and service company input, two different wire brush pigs were utilized in the testing: the Crisscross Wire Brush (Photo 10, page 18) for use in coated pipe and the Super Javelina Brush (Photo 11, page 18) for aggressive scraping in non-coated pipe.

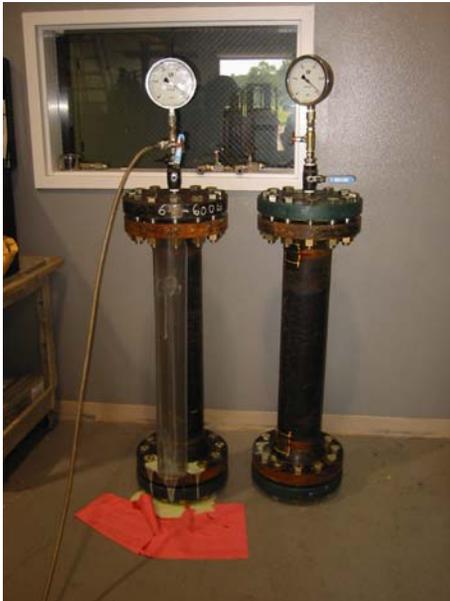
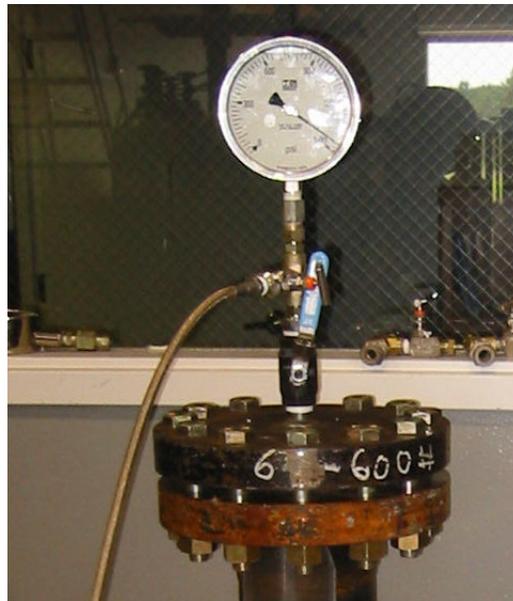
Photo 12: Full Scale Lab Fixture

The defect sections utilized were the same as previously described under Creation of Simulated Leaks. In addition, as seen in Photo 12 and Photo 13 below, the defect sections were fitted with a blind flange on bottom and a ported flange with a ball valve, needle valve with 6.35 mm (1/4”) JIC connection for nitrogen injection, and gauge on top.

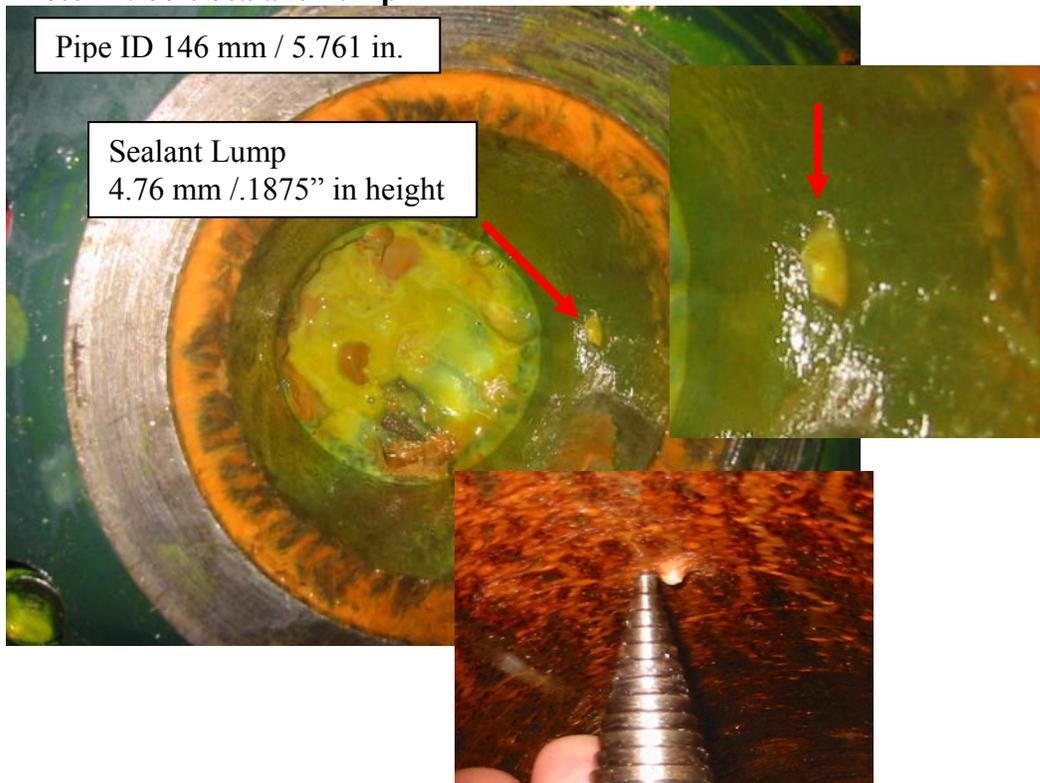
Photo 14: Soft Sealant Lump

The soft lump of sealant in the pinhole (Photo 14) indicated that we were not achieving penetration into the leak site with the particulates and the seal that was being generated was a superficial seal across the interior wall. The same was concluded on the weld leak. Although there was not an internal soft lump of sealant on the weld leak due to the low leak rate, there was also no indication of cured sealant extruding through the leak site.

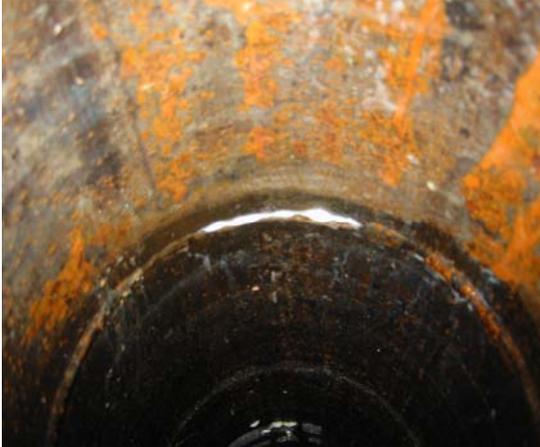
It can also be noted that Gly-Flo "G" had a strip of medium consistency, as seen in Photo 15, page 23. The other sealant formulations resulted in either a soft lump, which was wiped off with the swab wiper pig (Photo 16 and Photo 17, page 23), or a hardened strip of sealant, which resulted in the seal being pulled out of the defect by the wiper pig.

**Photo 15:
Gly-Flo "G" Sealant Strip**

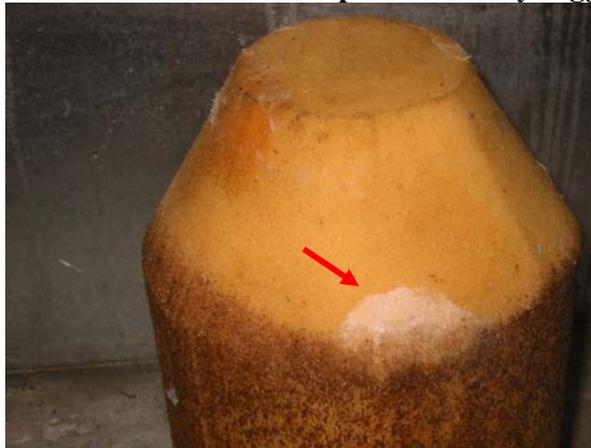
Photo 17: Soft Sealant Lump Removed by Pigging

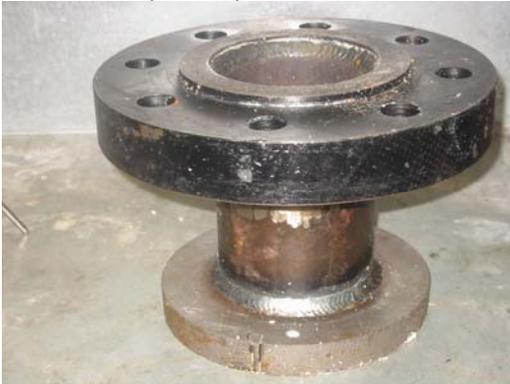
Photo 18:
114.3 mm (4-1/2") Test Fixture

The internal corrosion defect used in this testing stage was the same described in Creation of Simulated Leaks. For the pinhole defects in varying sizes we made 114.3 mm OD x 97.2 mm ID x 152.4 mm L (4-1/2" OD x 3.826" ID x 6" L) Schedule 80 test fixtures. The fixtures had a steel plate on bottom that would allow the test fixture to stand vertically and a ported flange on top for connection of a nitrogen injection and gauge manifold (Photo 18 and Photo 19). The pinhole defects tested were 1.59 mm (1/16"), 1.19 mm (3/64"), 0.79 mm (1/32") and 0.40 mm (1/64") holes in pipe body and 1.59 mm (1/16") hole in pipe weld.

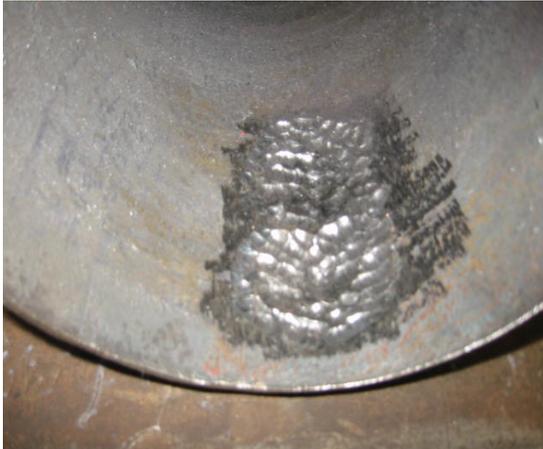
Photo 20:
Internal Corrosion Defect - Bare

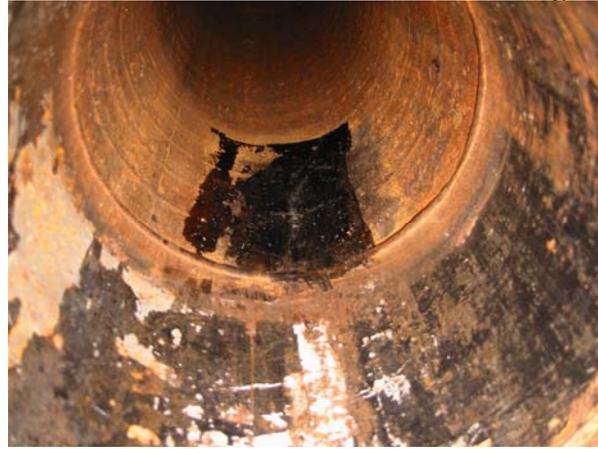
Photo 21:
Internal Corrosion Defect with Flex-Plug

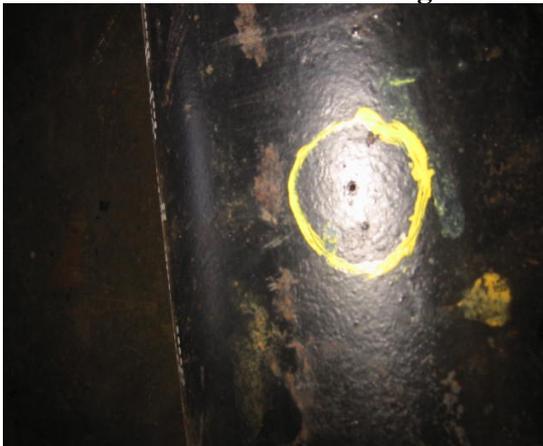
Photo 22:
External View before Flex-Plug

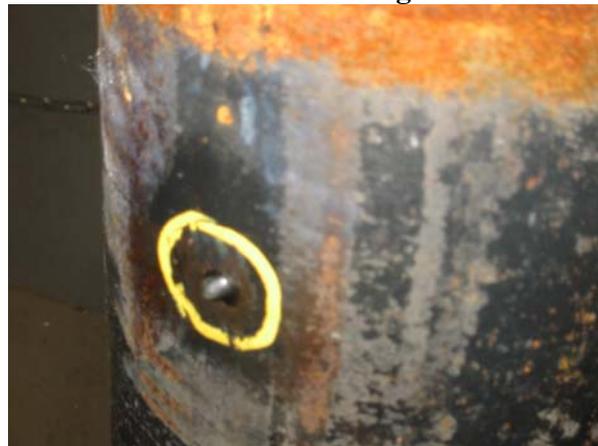
Photo 23:
External View with Flex-Plug Extrusion

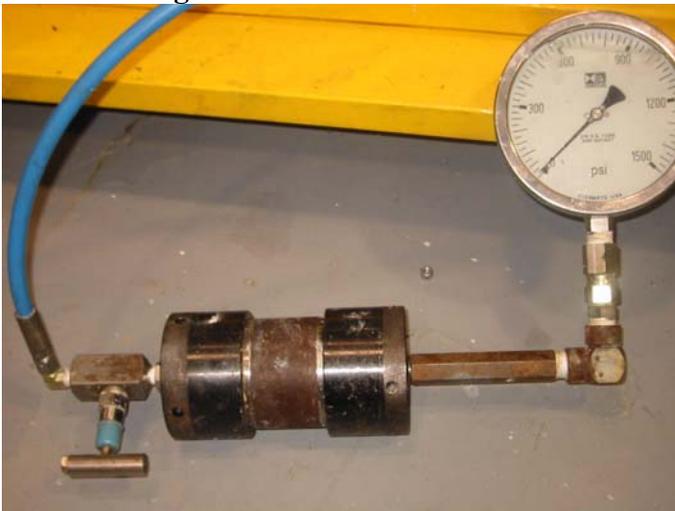
Photo 25: High Pressure Test Fixture

An 88.9 mm OD x 73.7 mm ID x 177.8 mm L (3-1/2" x 2.90" x 7") 4140 carbon steel test fixture was made with a 1.59 mm (1/16") pinhole in pipe body. End caps (57.2 mm long) were threaded on each end for an overall length of 190.5 mm (7-1/2"). Each end cap was threaded to accept a gauge on one end and a needle valve with a connection for nitrogen injection on the opposing end, as seen in Photo 25.
