# High Temperature Glass Seal

**Y-S Chou, J.W. Stevenson, X. Li, G. Yang, and P. Singh  
K2-44, Materials Division  
Pacific Northwest National Laboratory**

**Funded under the SECA Core Technology Program  
through US Department of Energy's  
National Energy Technology Laboratory**

**August 7-9, 2007, San Antonio, Texas**

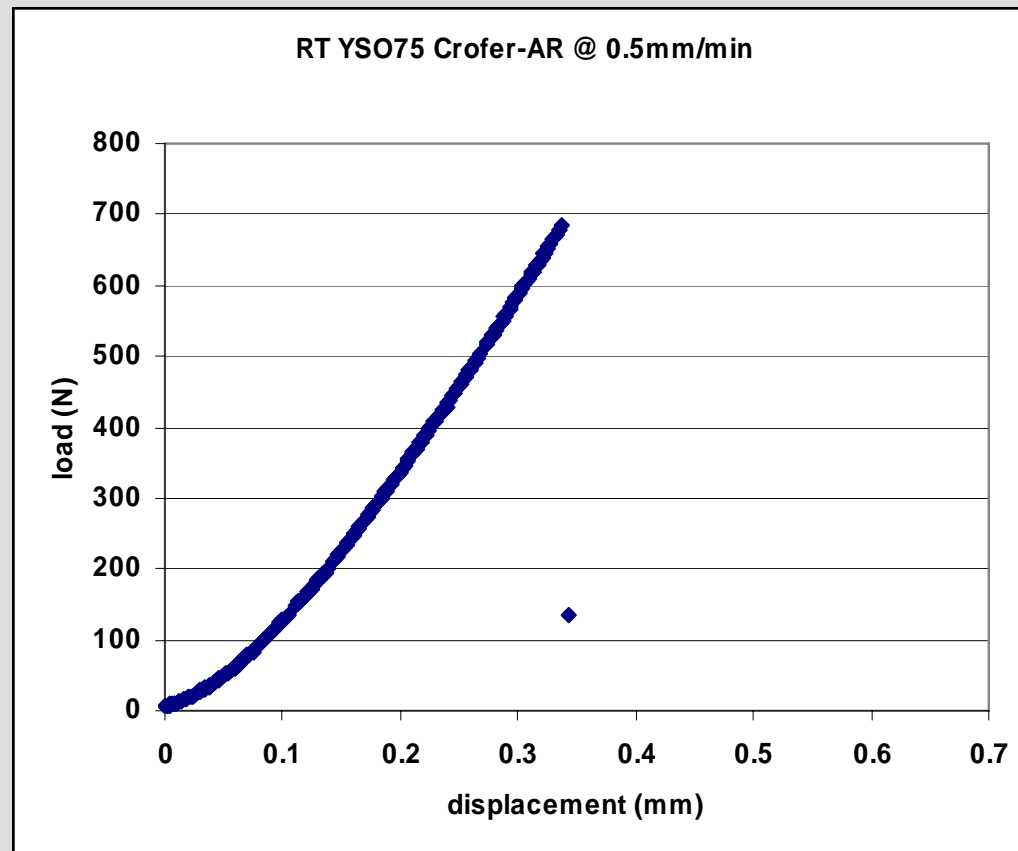
# Load-displacement curve showed typical brittle failure

All showed brittle failure: coating, aging, oxide layer thickness, environment

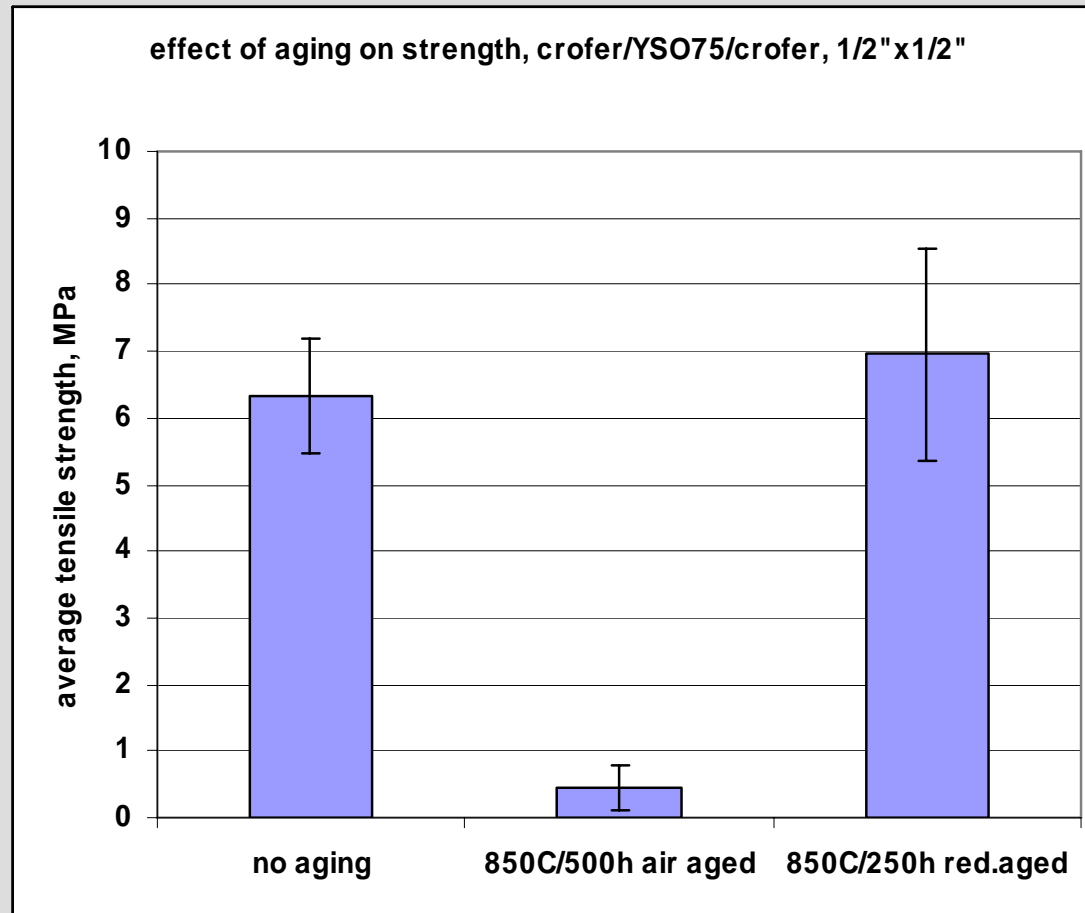
# Effect of aging and environment

Air: 850°C/500h

Wet and reducing: 30% $H_2O$ , 70%(2.7 $H_2$ /Ar) 850°C/250h

- ▶ **Completed seal strength evaluation of high-temperature glass. Evaluated pre-oxidation, aging, coating, and environmental effects on strength.**
- ▶ **Without coating, strength would degrade if a thick  $\text{Cr}_2\text{O}_3$  oxide layer present or aged in air. No strength reduction if aged in reducing gas. Cause for strength degradation was  $\text{SrCrO}_4$  formation.**

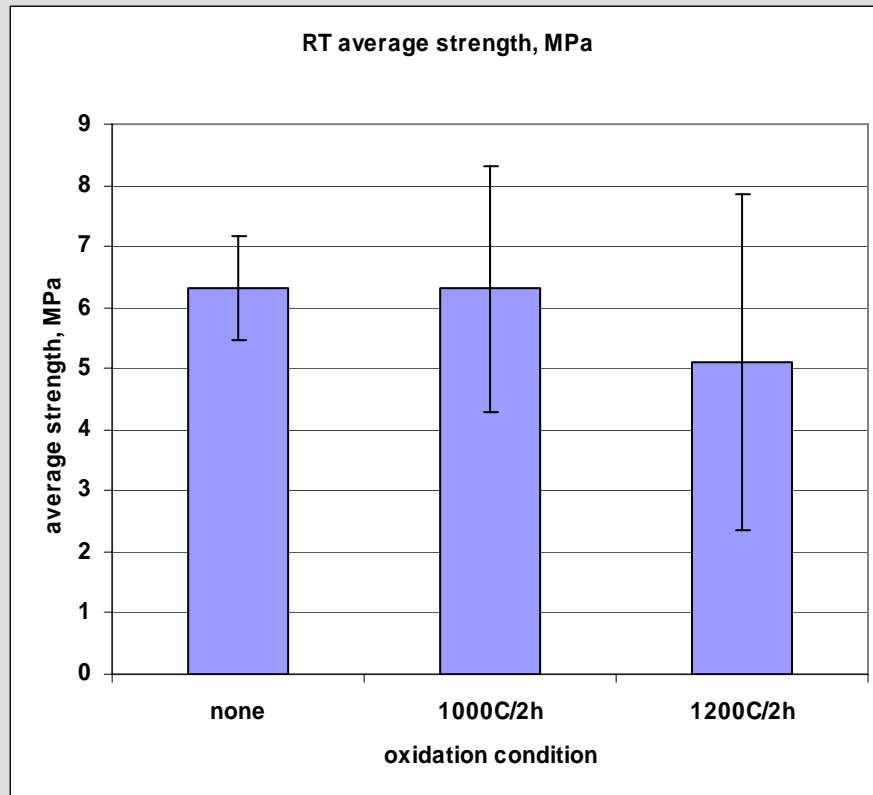
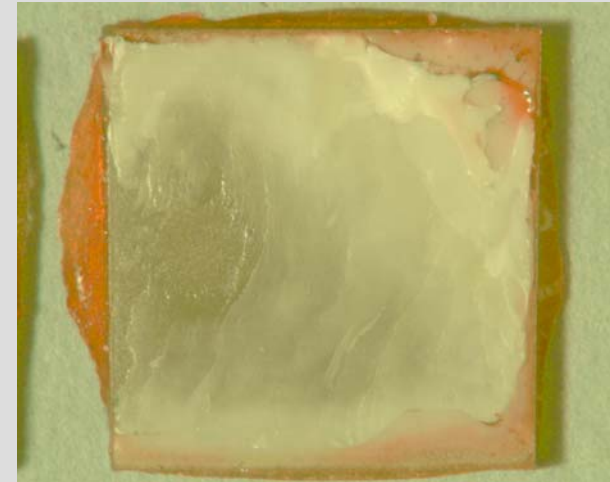
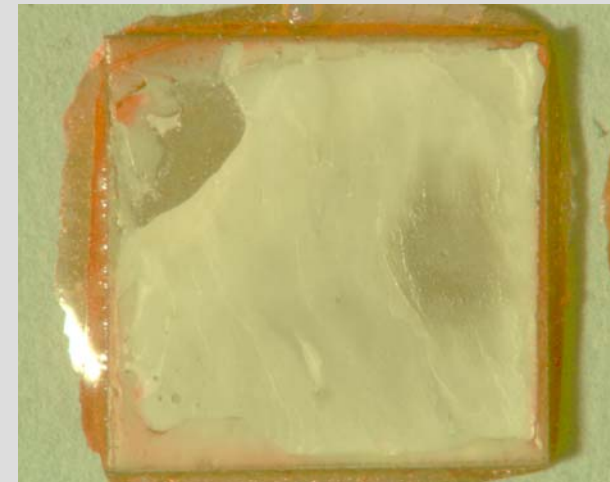
# Tensile strength of aluminized crofer from pack cementation

Pack cementation, followed by heat-treatment in air

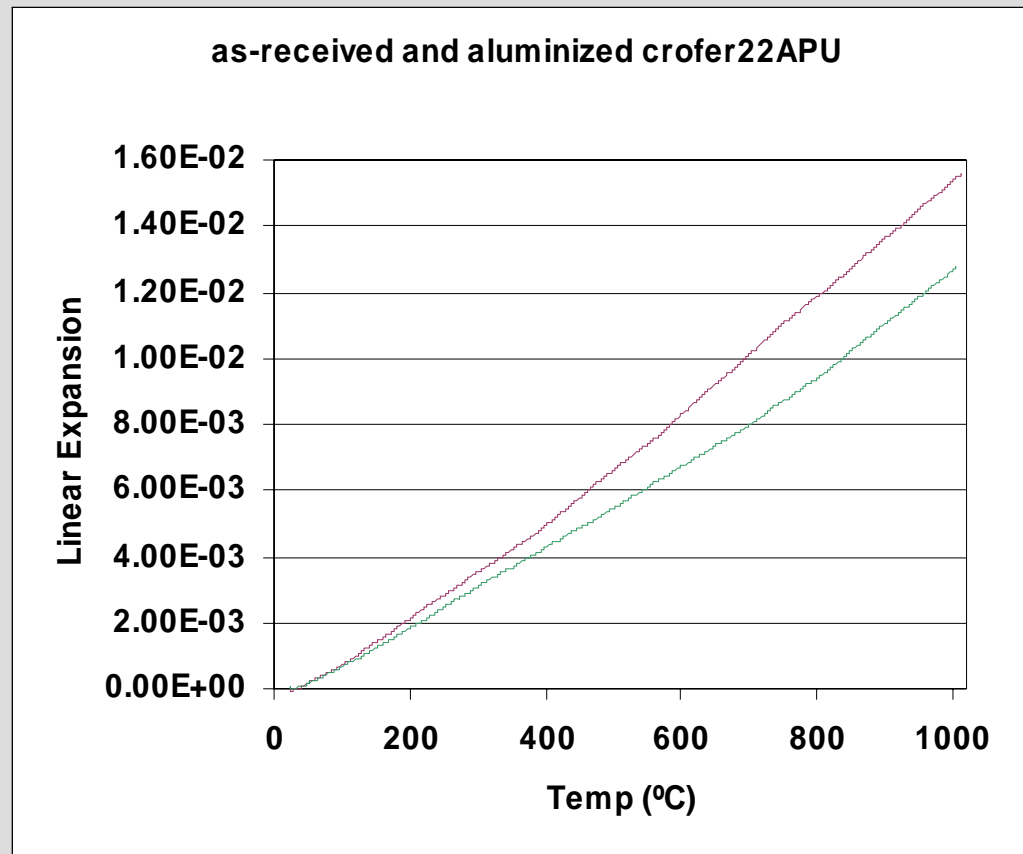
# Issue of overdosing Al

Aluminizing by vapor phase deposition followed by heat-treatment at 1000-1100°C/2h air

- ▶ **Alumina coating is effective in blocking Cr; however, the deposition process needs to be optimized to minimize overdose.**
- ▶ **Spinel coating showed best results with minimum strength reduction even aging in air.**

- ▶ Mechanical strength tests of M/G/M coupons showed strength degradation for uncoated crofer22APU only if aged in air or started with thick  $\text{Cr}_2\text{O}_3$  surface layer.
- ▶ Aluminizing is effective in blocking Cr; however, overdosing would increase CTE for thin samples and leads to seal failure.
- ▶  $(\text{Mn,Co})_3\text{O}_4$ -coated crofer showed similar initial seal strength as plain crofer or aluminized ones. Minimal strength degradation when aged in air.
- ▶ HT glass showed very good electrical stability in SOFC and DC loading at  $850^\circ\text{C}$  up to  $\sim 1200\text{h}$ .
- ▶ Successful demonstration of 2"x2" single cell test at  $800^\circ\text{C}$  with candidate materials set: HT glass, spinel coating, SS441, and LSM contact paste.

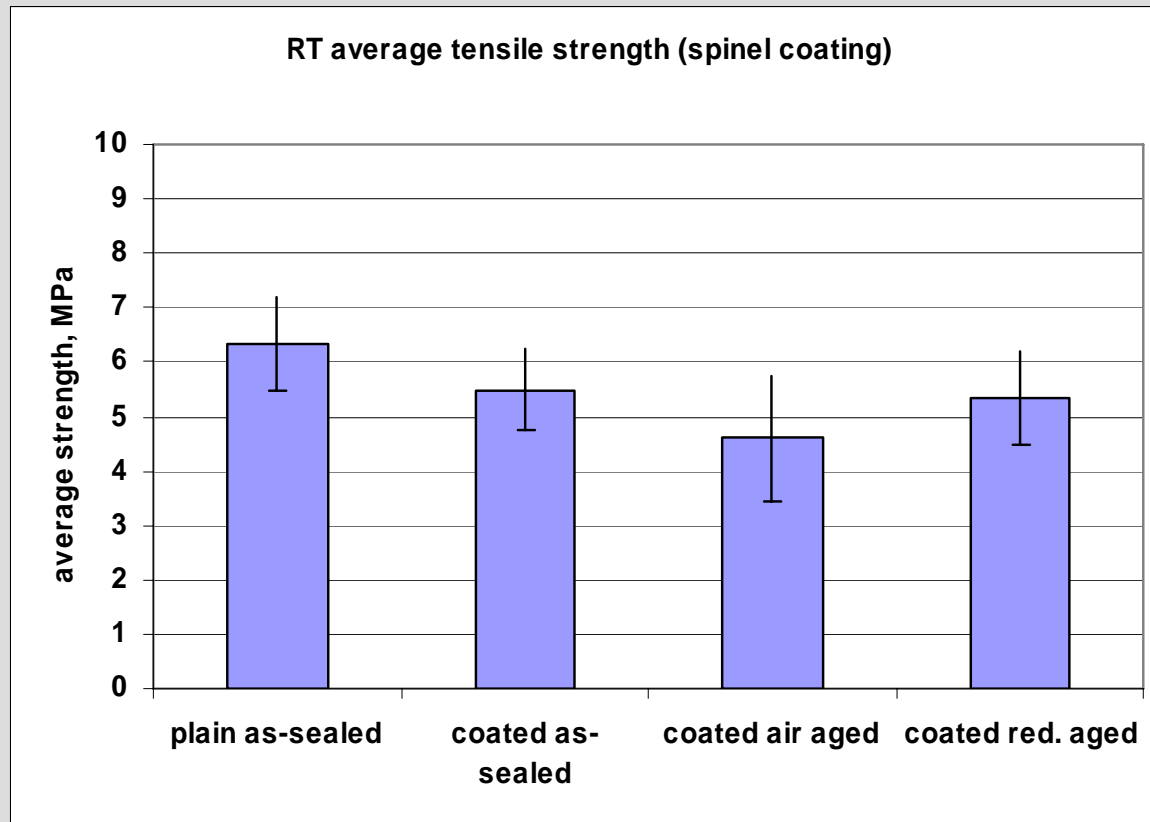
# RT seal strength of spinel-coated crofer/YSO75 glass

$(\text{Mn,Co})_3\text{O}_4$  coated crofer22APU

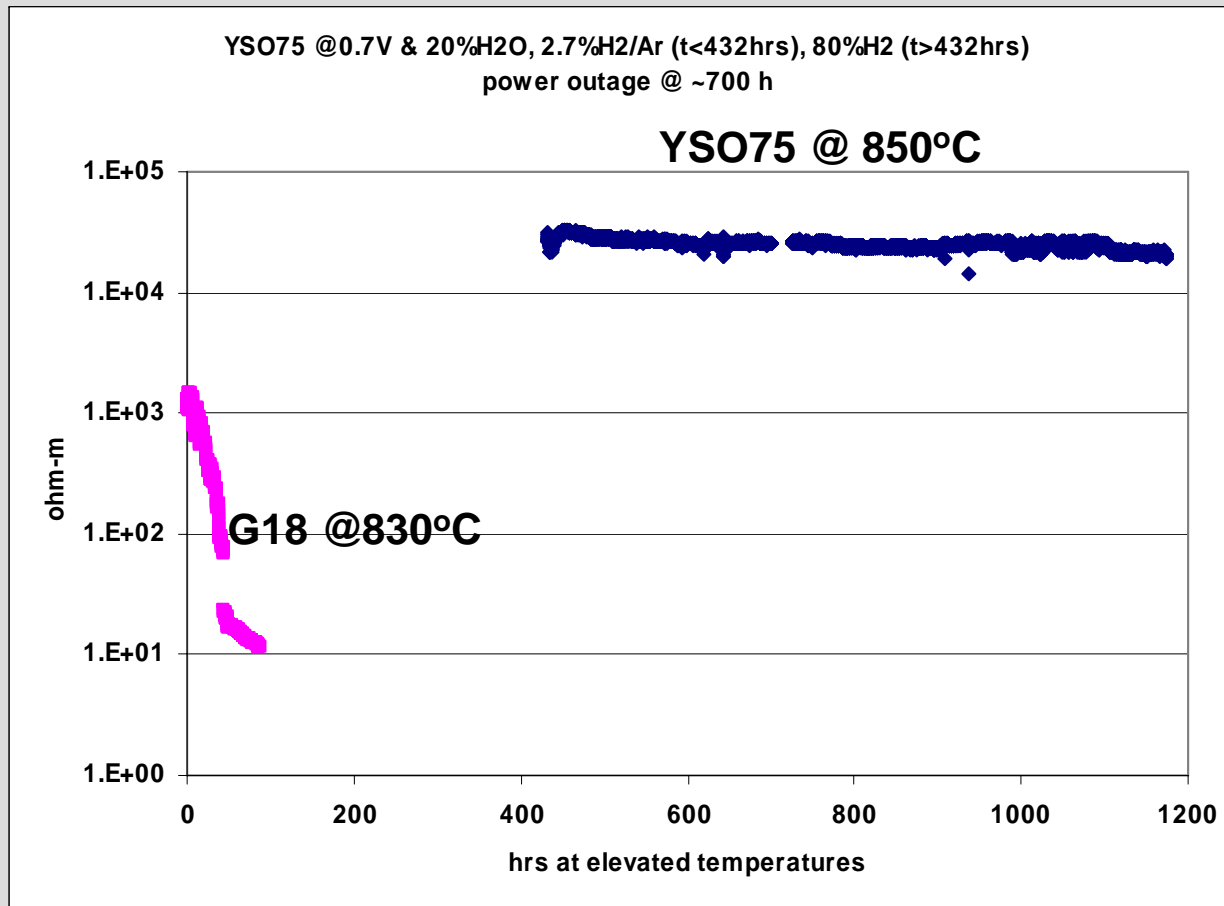
# Good electrical stability for HT glass on plain crofer22APU

Crofer(as-received)/glass/crofer(as-received) @ 0.7V

- ▶ **Tested conventional and high-temperature sealing glasses in SOFC environment and 0.7 V DC loading. Conventional glass showed severe Fe diffusion and rapid increase in conductivity ( $830^\circ\text{C}/\sim 80\text{hr}$ ), while high-temperature glass showed excellent electrical stability over  $\sim 1200\text{hr}$  at  $850^\circ\text{C}$ .**

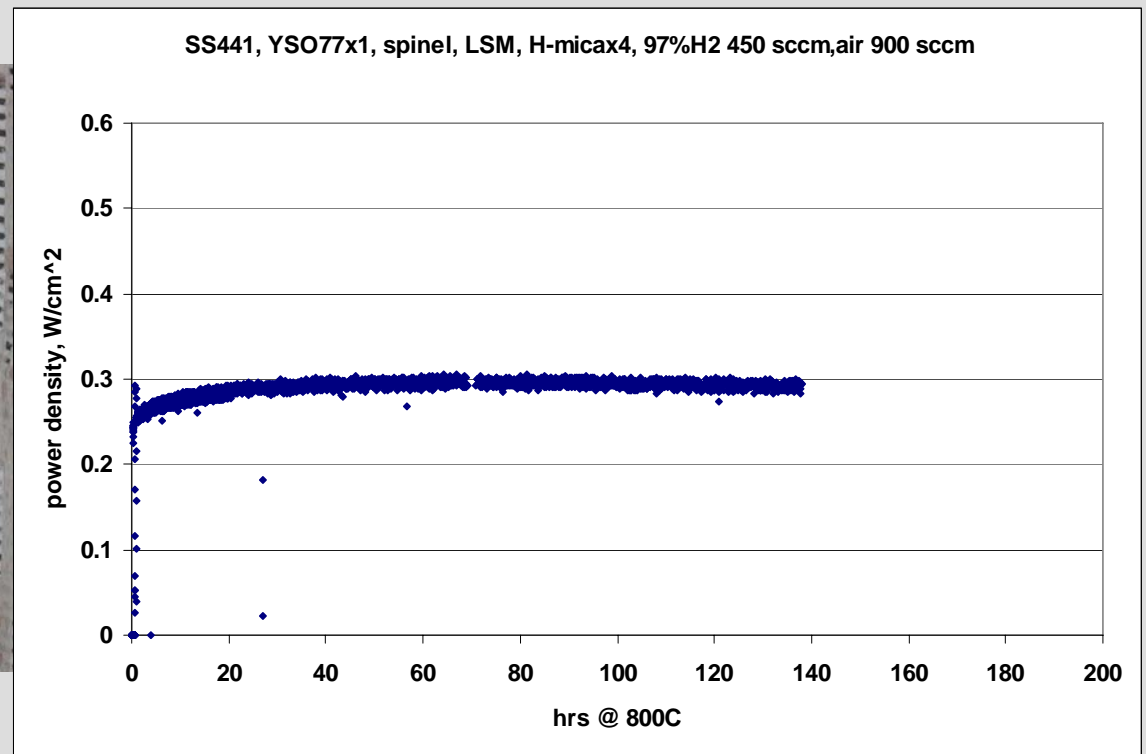
# Materials set evaluation in 2"x2" singel cell test @ 800°C

INDEC cell, SS441, spinel coating, LSM contact paste, aluminizing
