EPRI

Computational Modeling and Assessment of Nanocoatings for USC Boilers

DOE Sponsored Program: DE-FC26-07NT43096

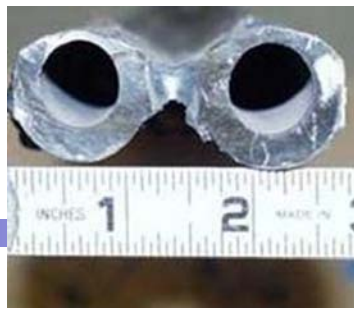
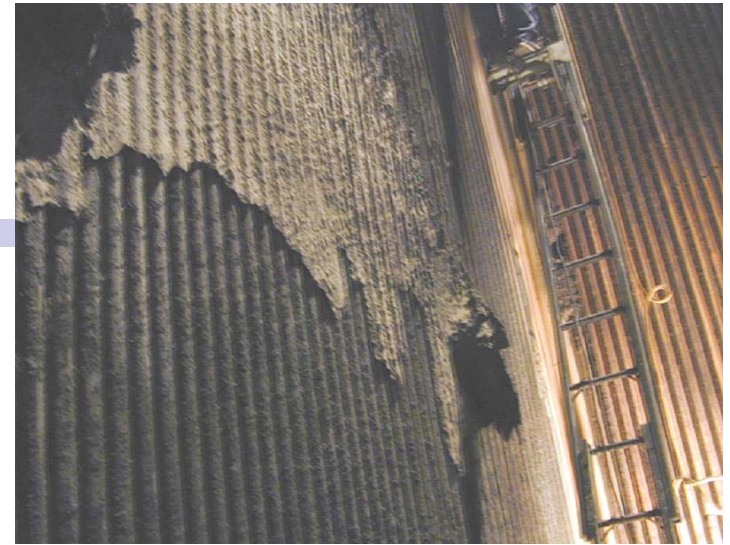
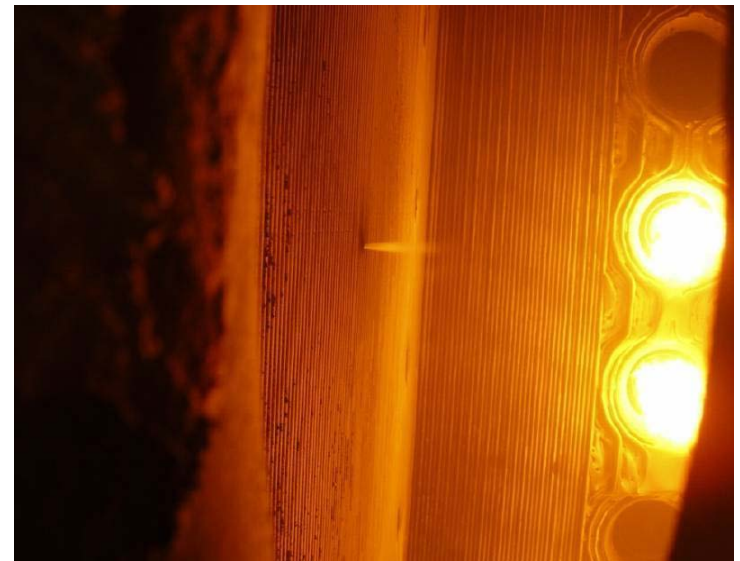
- Typical boiler wastage rates:
 - Subcritical – 20 mils (0.5mm)/year
 - Supercritical – 40-100 mils (1.0-2.5mm)/year
- Corrosion rates tend to increase with increasing temperatures.
- Higher operating metal temperature of supercritical boiler tubes tend to increase corrosion rates by 2-5X

Equivalent Availability Loss from Boiler Tube Failures in US is 2.5-3.0%

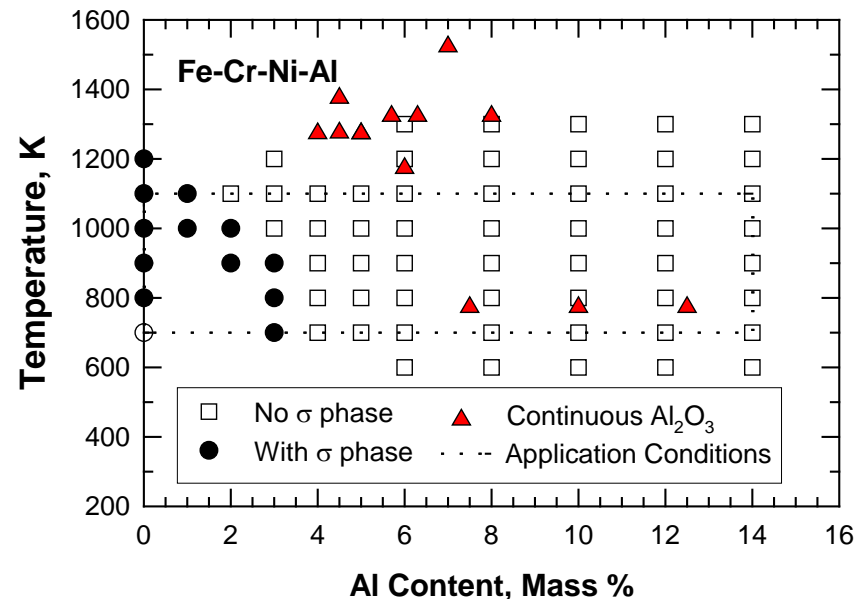
- Computations based on **FeNiCrAlx**
- Developed phase diagrams; then grain growth, sintering, diffusion models, and interface toughness
