# **Demonstration of Innovative Applications of Technology for Cost Reductions to the CT-121 FGD Process**

**DOE ICCT PROJECT DE-FC22-90PC89650**

## **FINAL REPORT**

**Volume 6-B of 6: Appendices**

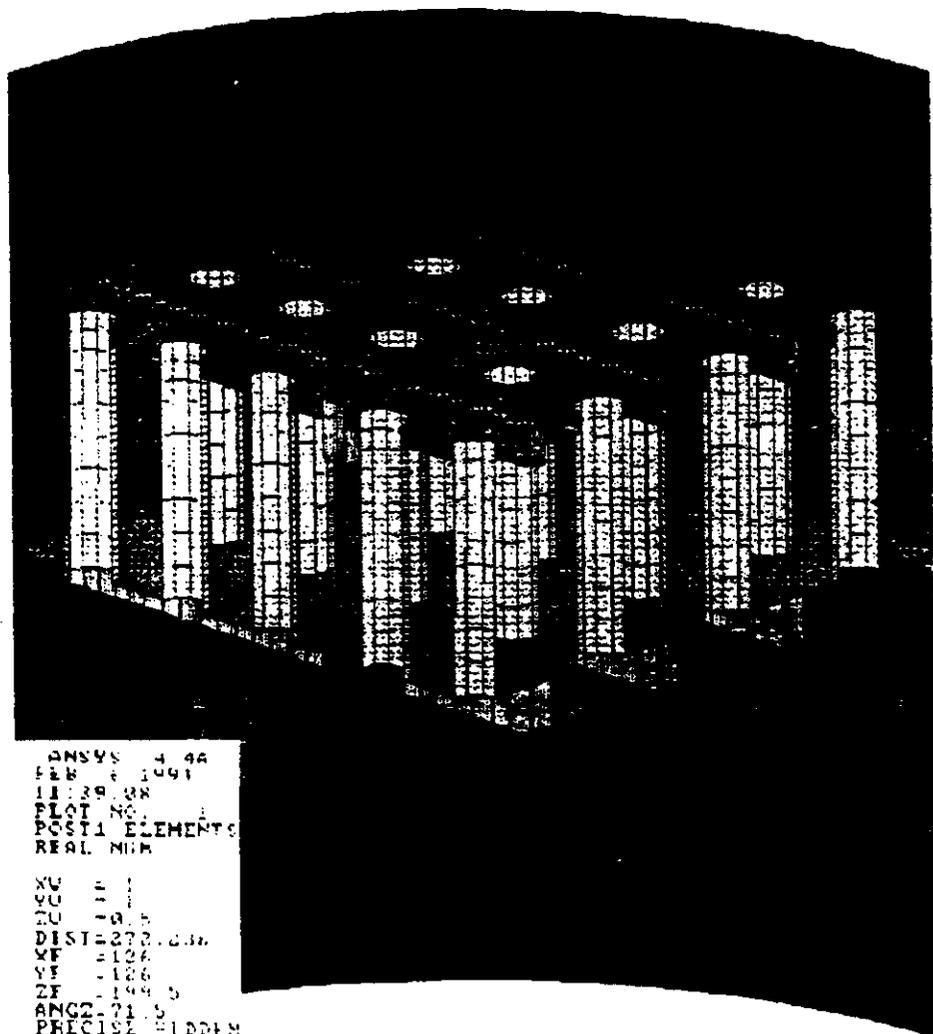
Bottom Deck - Principal stresses on top surface

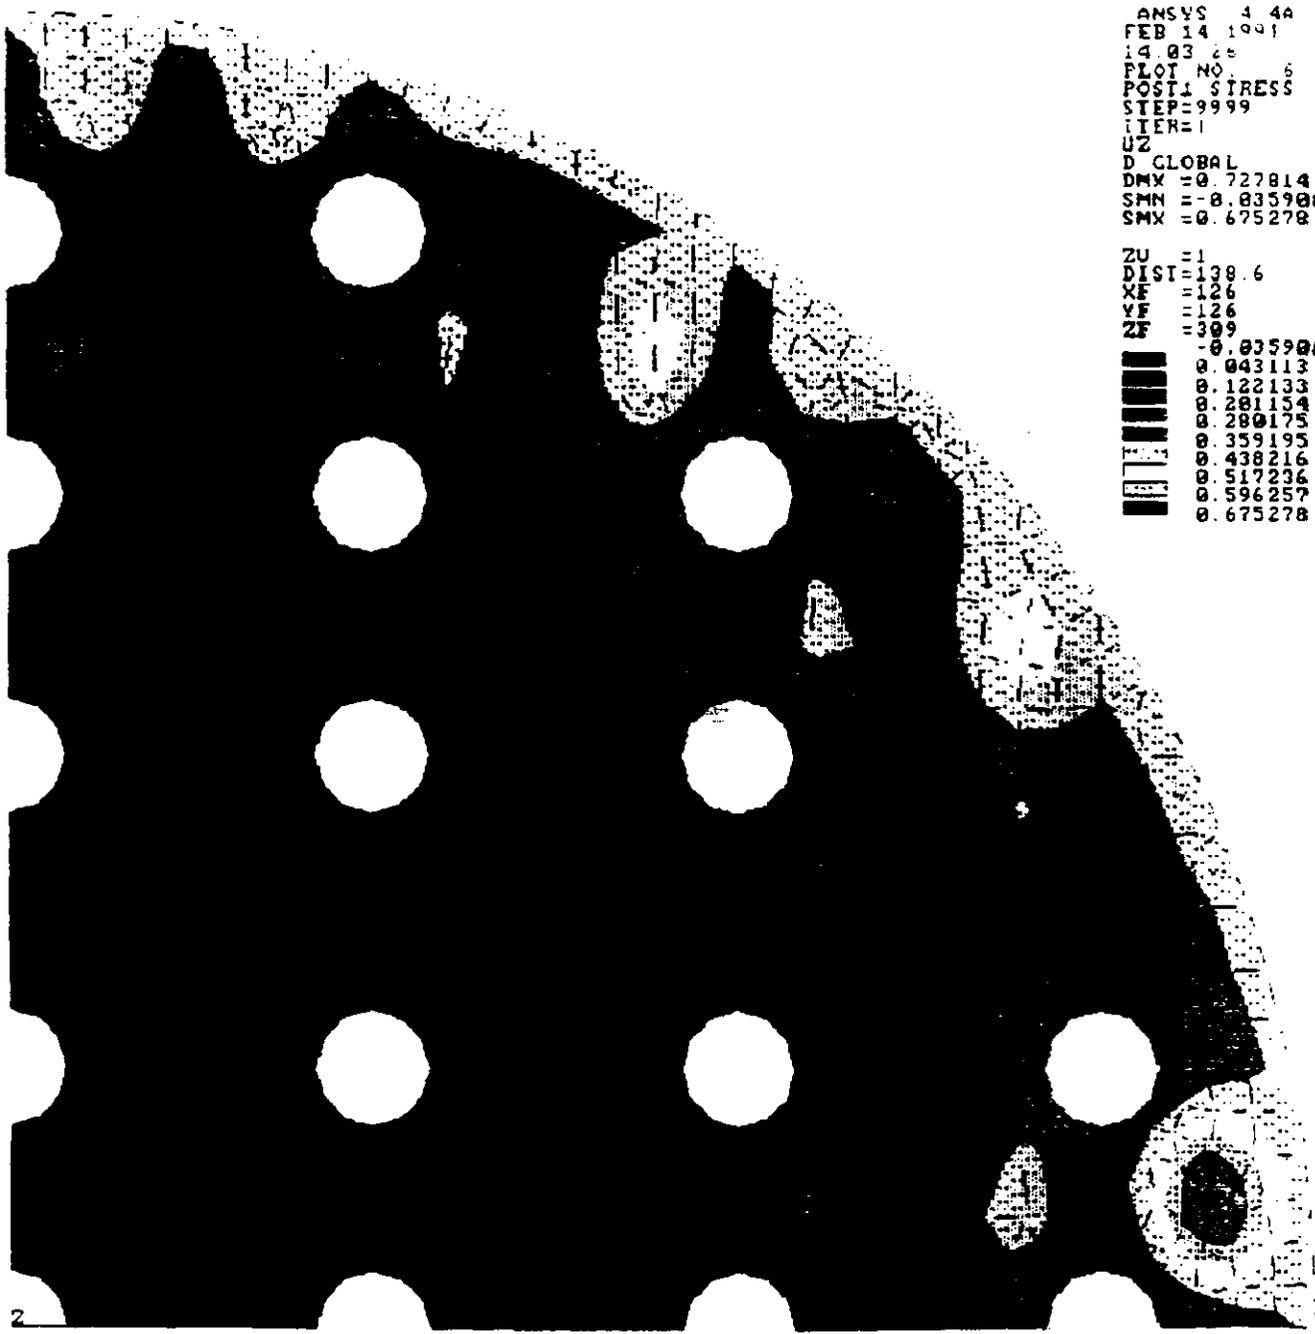
Top Deck - Displacements in Z (Vertical) Direction

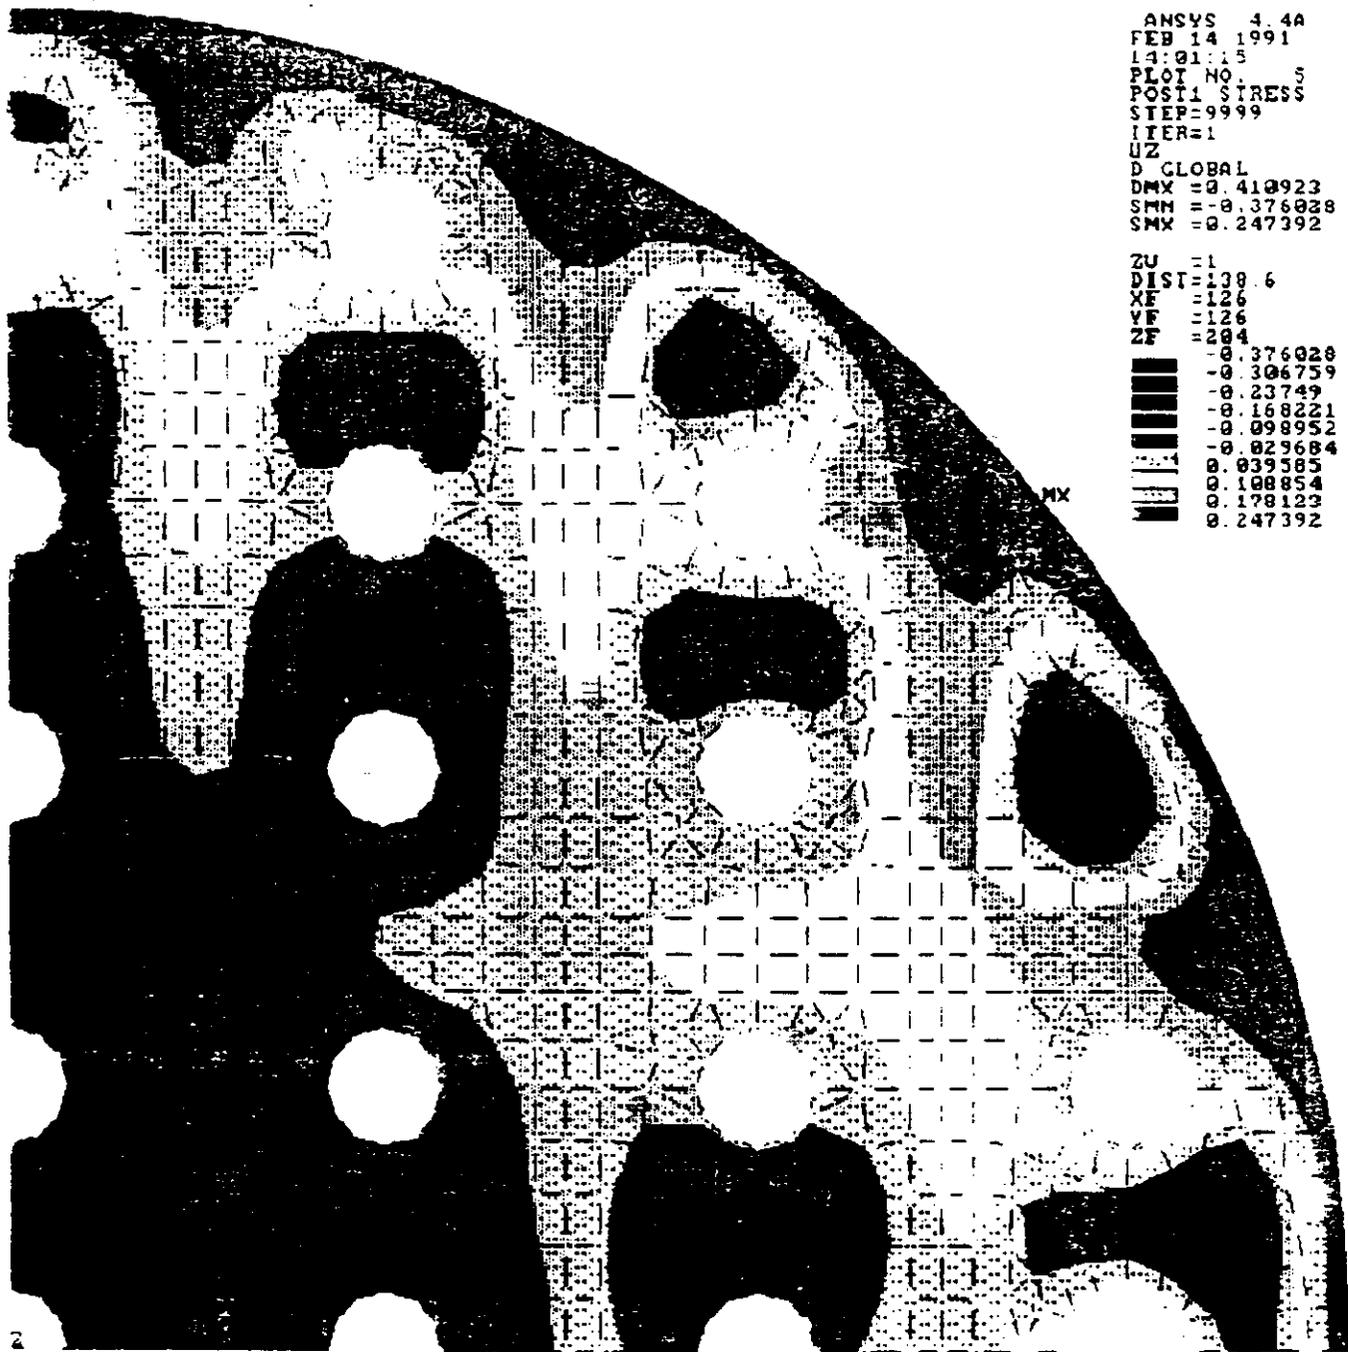
Bottom Deck - Displacements in Z (Vertical) Direction

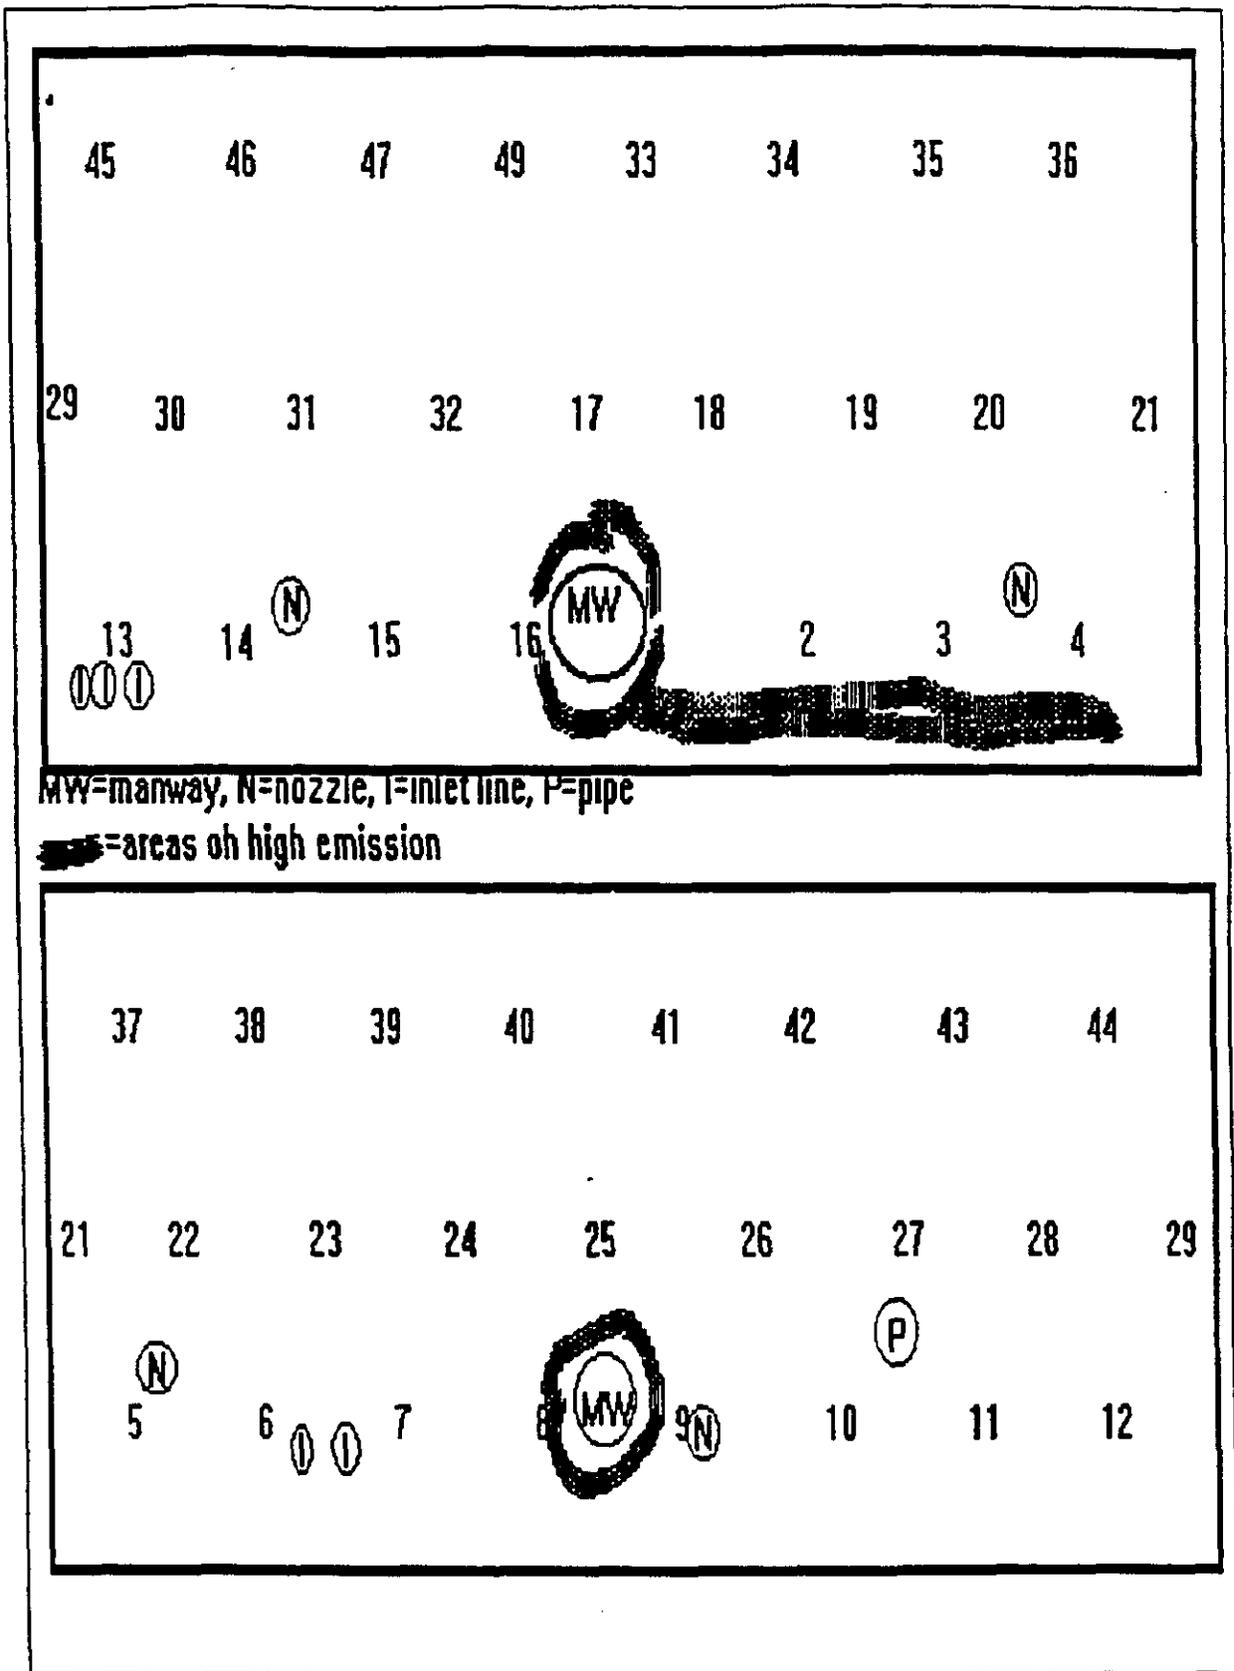
FIGURE 1  
 Tank Sketch and Sensor Location Map

1) Manway, positioned between sensors 16, 17 and 1; This area produced high activity but there are no visual indications of delamination or damage. The inside of the manway should be examined carefully at the next opportunity. Note that high stresses on bolts that attach the manway can cause slipping. In the future, bolts should be tightened to the manufacturers recommendations.

1, 2, 3 and 4; This area produced a great deal of emission. This may be the result of a recently applied patch in the tank floor adjacent to the knuckle. The tank floor and knuckle in this area should be examined from the inside.

3) The small manway adjacent to sensor 8 produced significant activity. There is no indication of damage on the outside. The noise may have been produced by weakness in the secondary bond or possibly by loose and slipping bolts. This area should be examined visually from the inside at the next opportunity.

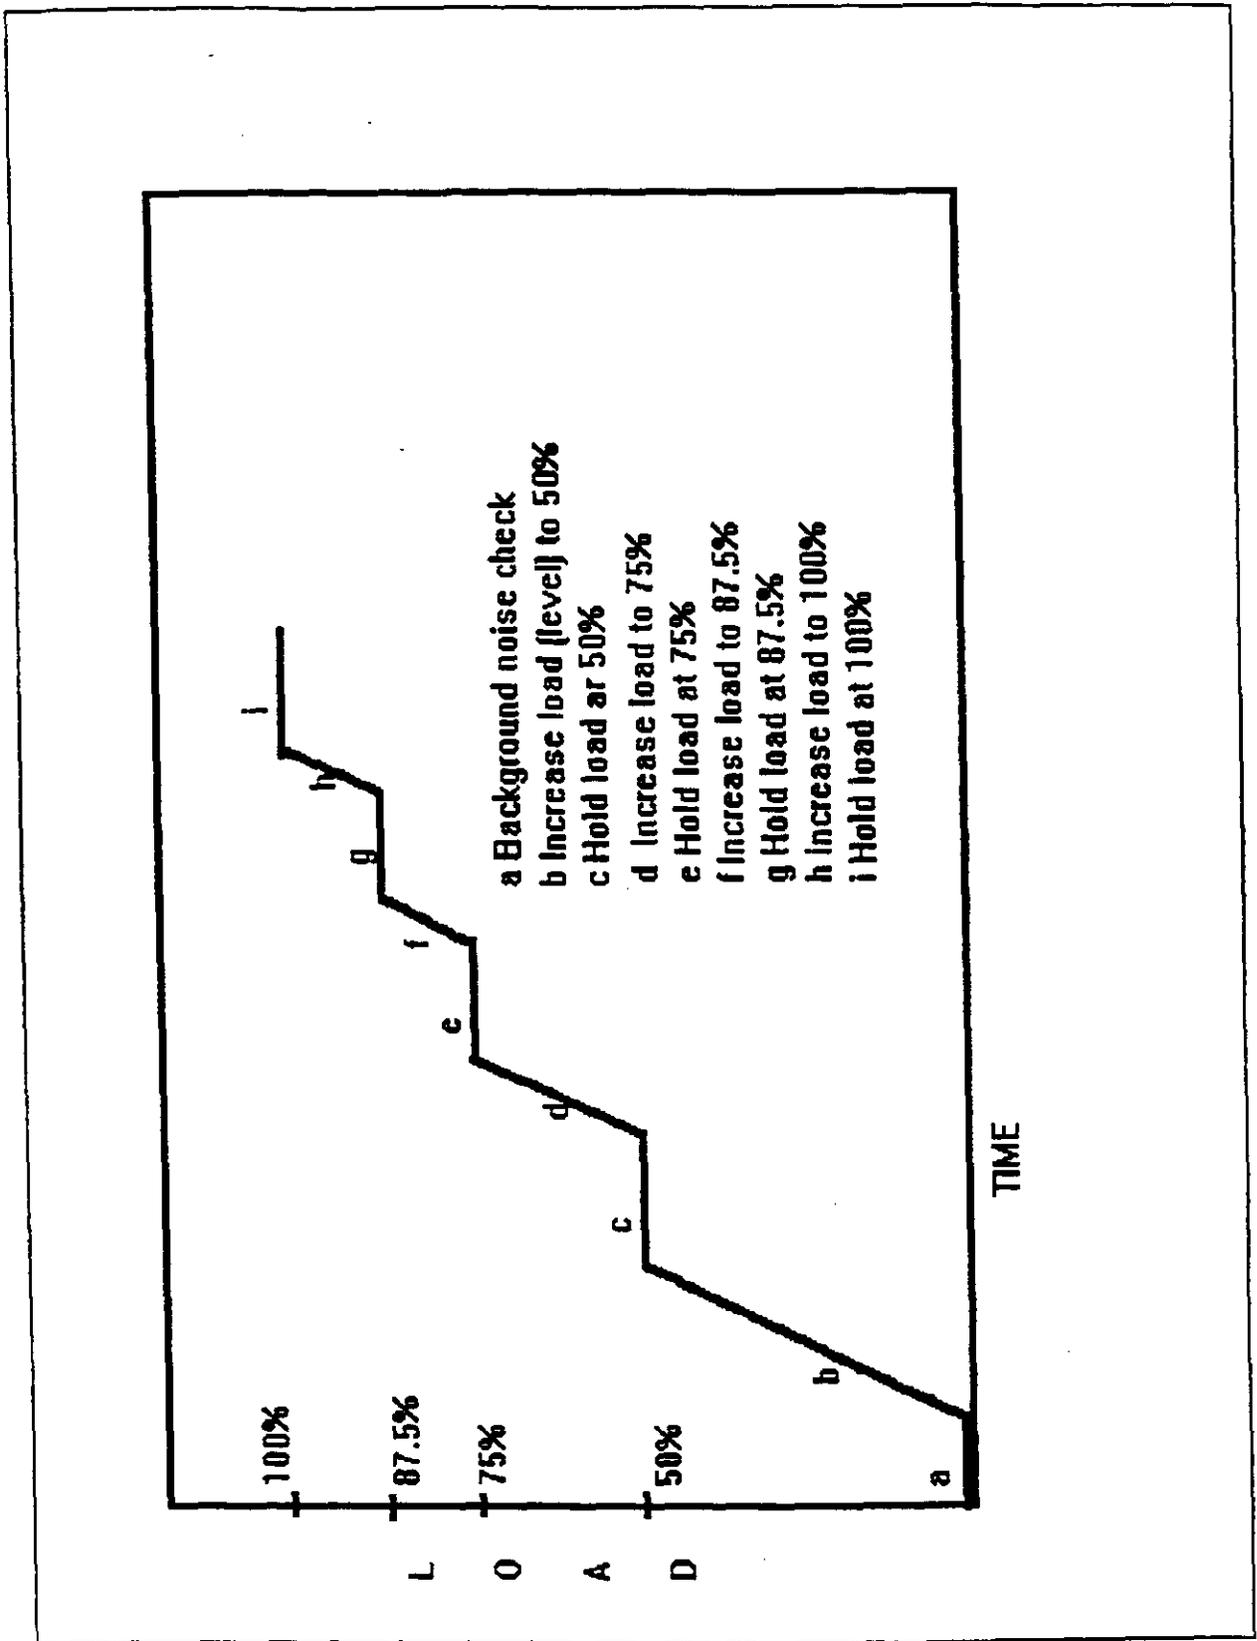
FIGURE 2  
Load Ramp

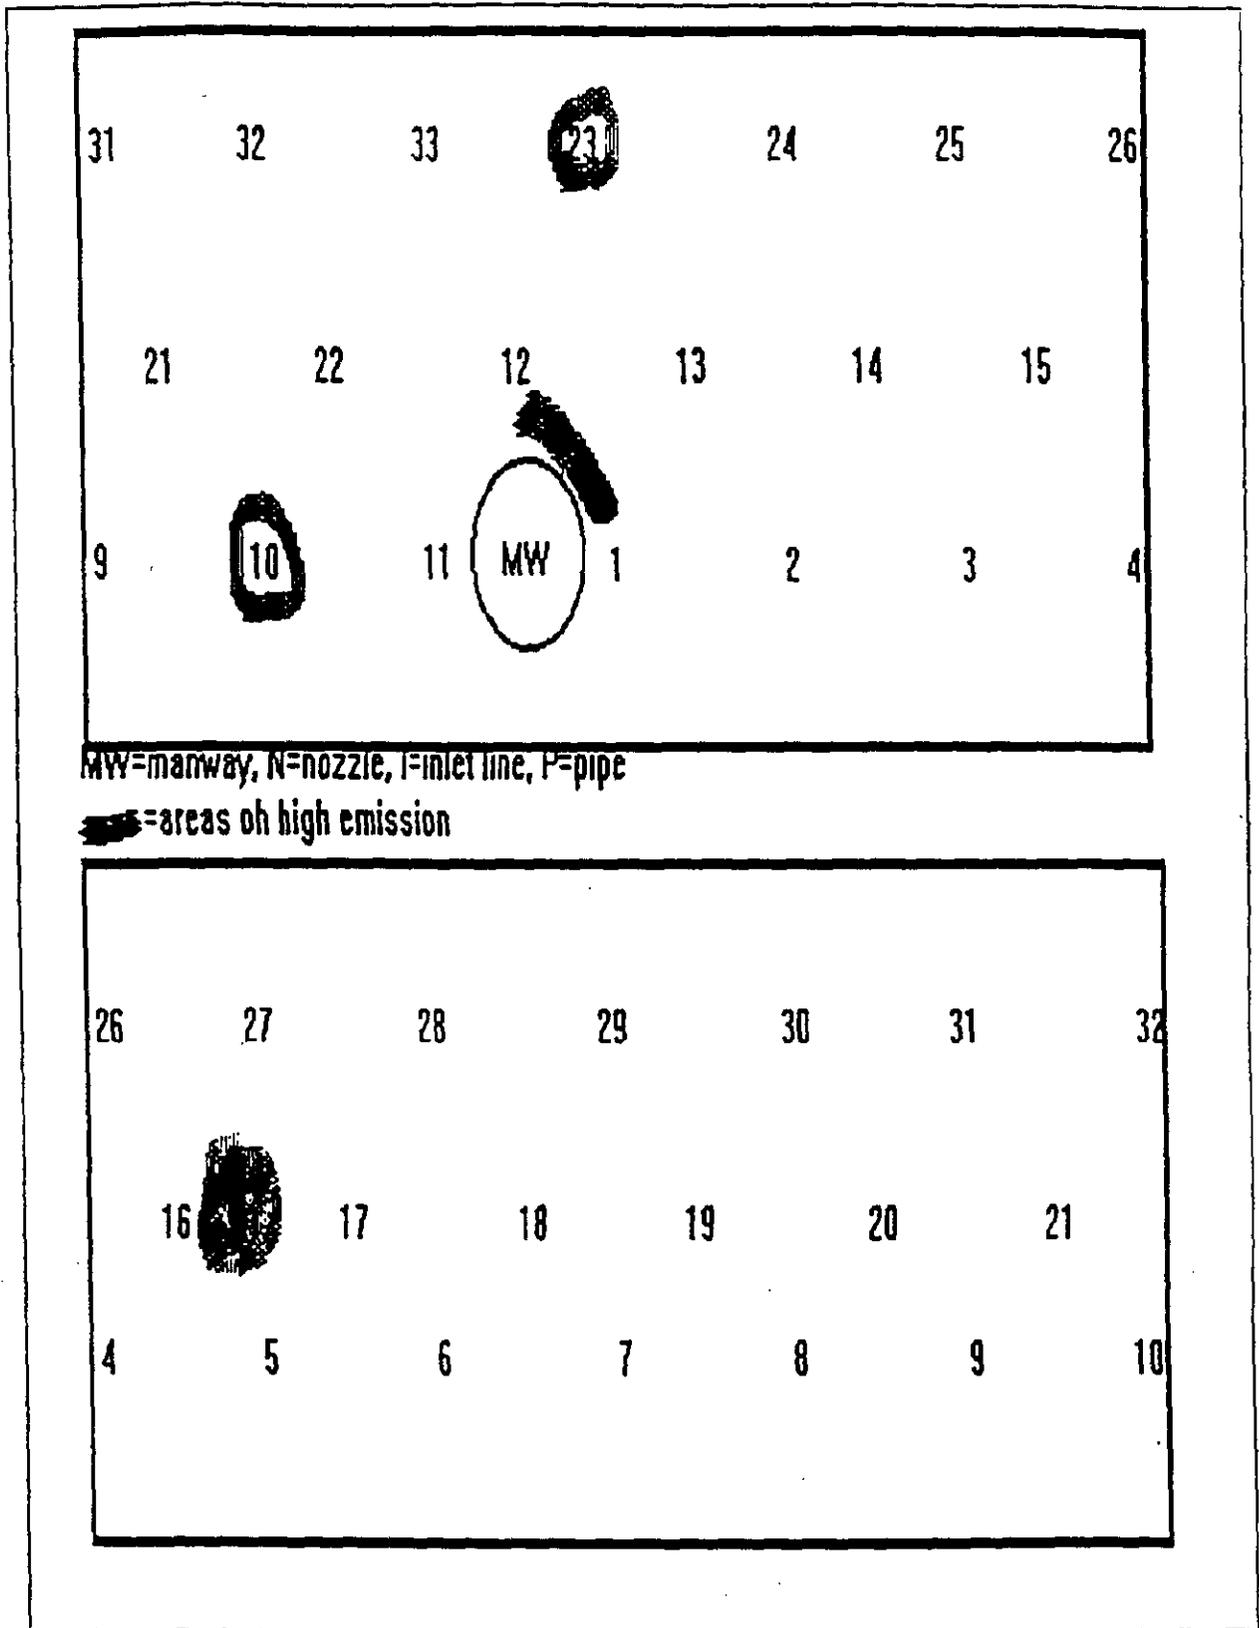
FIGURE 1  
 Tank Sketch and Sensor Location Map

1) Manway, positioned between sensors 11, 12 and 1; This area produced high activity but there are no visual indications of delamination or damage. The inside of the manway should be examined carefully at the next opportunity. Note that high stresses on bolts that attach the manway can cause slipping. In the future, bolts should be tightened to the manufacturers recommendations.

- 1) Baffels positioned at 22 foot intervals; One baffle is aligned with sensors 16 and 17. This area produced excessive emission and it is suggested that the baffle may be weak or coming loose from the wall.

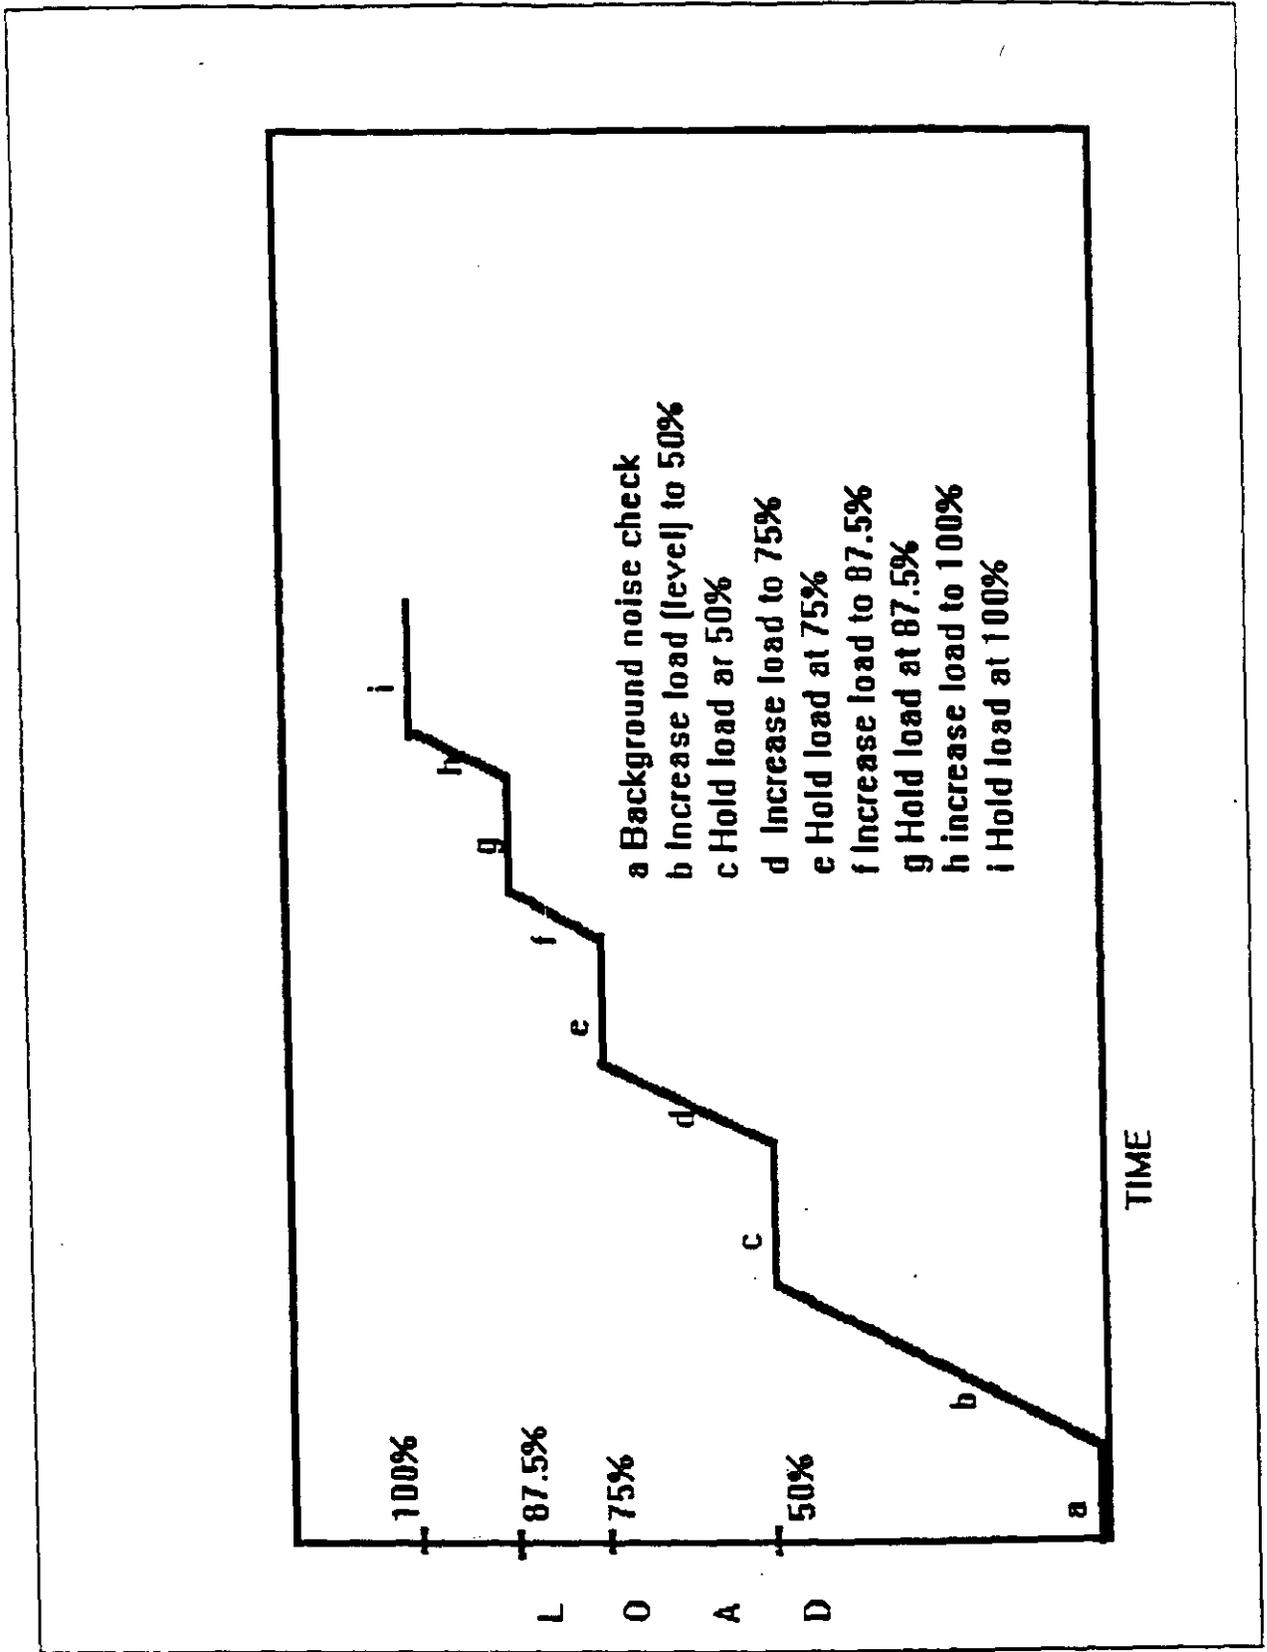
**FIGURE 2**  
 Load Ramp

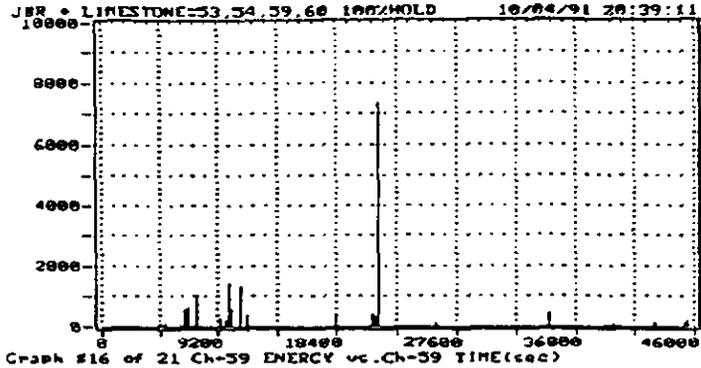
Figure 11. Channel 59 Energy vs Time for third 100% hold of LS

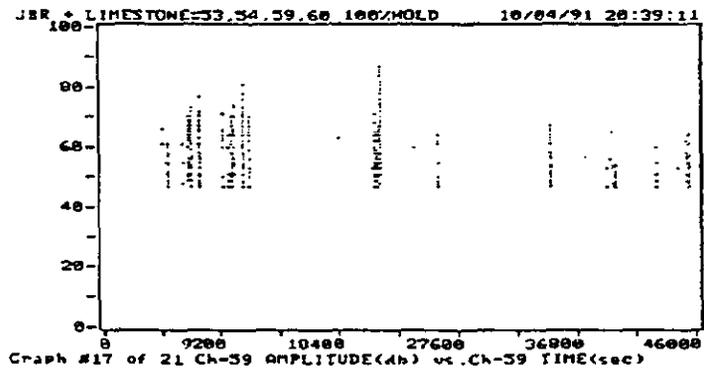
Figure 12. Channel 59 Amplitude vs Time for third 100% hold of LS

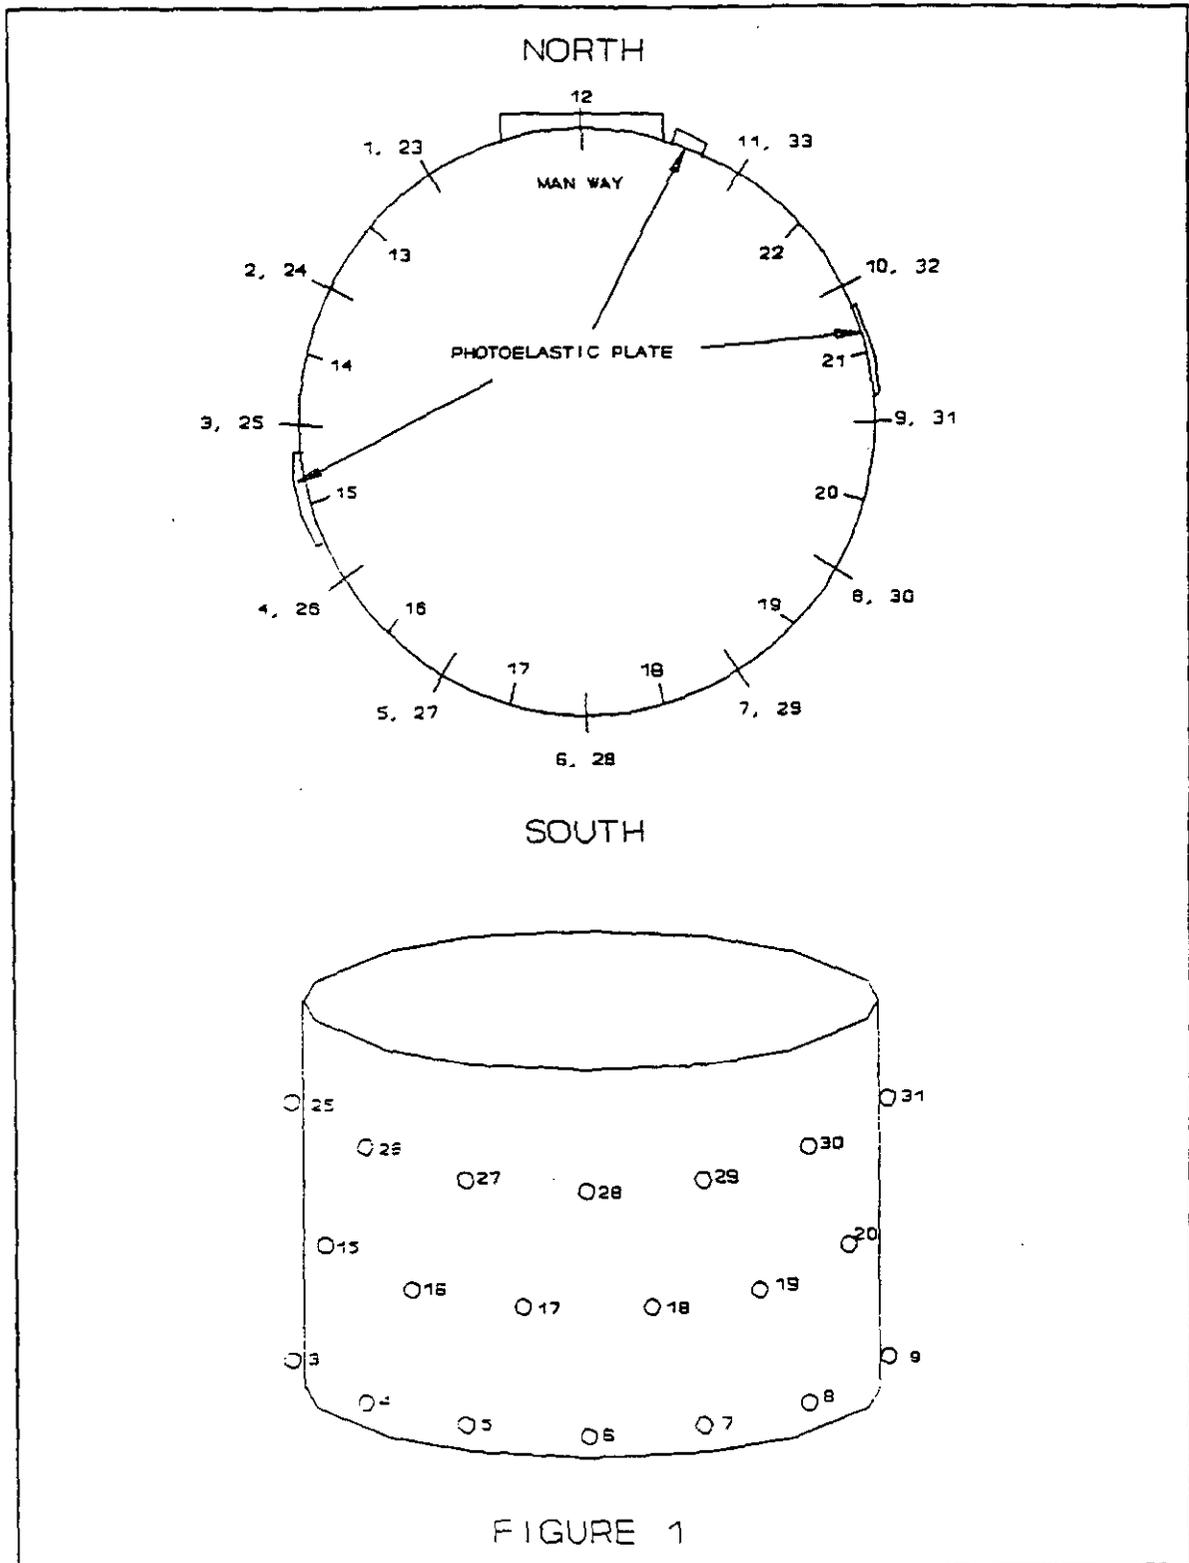
Figure 1: AE Sensor and photoelastic plate location on the vessel.

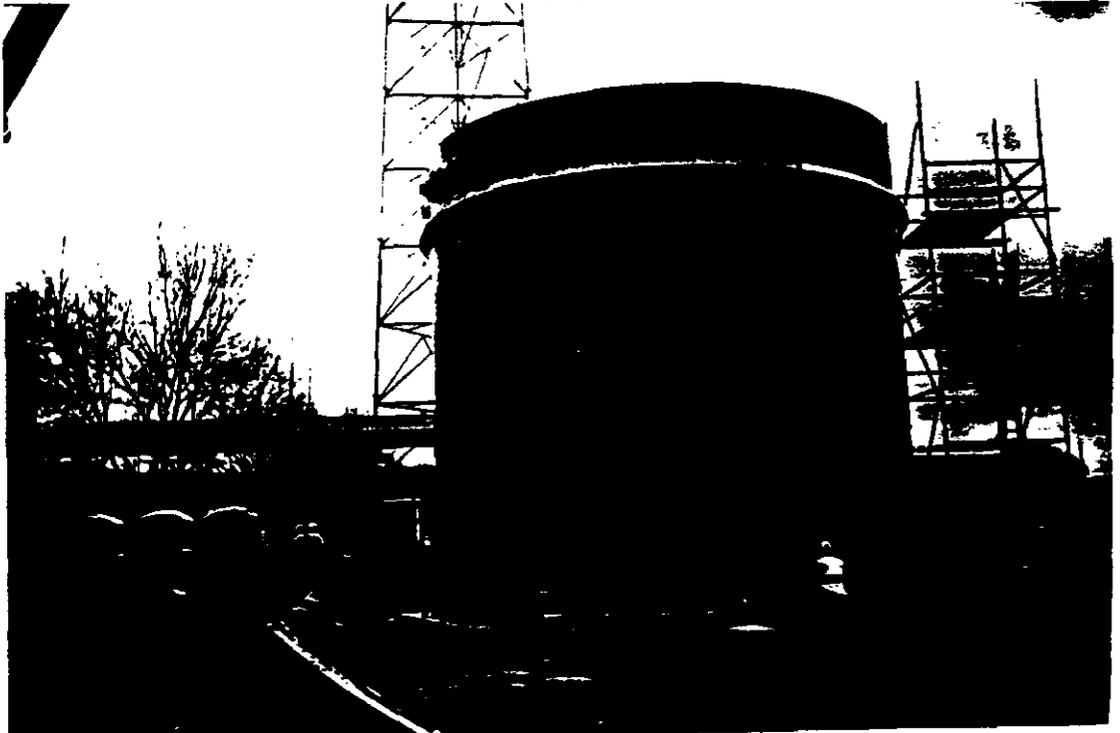
**Photo 2 : Photograph of Limestone Slurry Vessel prior to Piping**

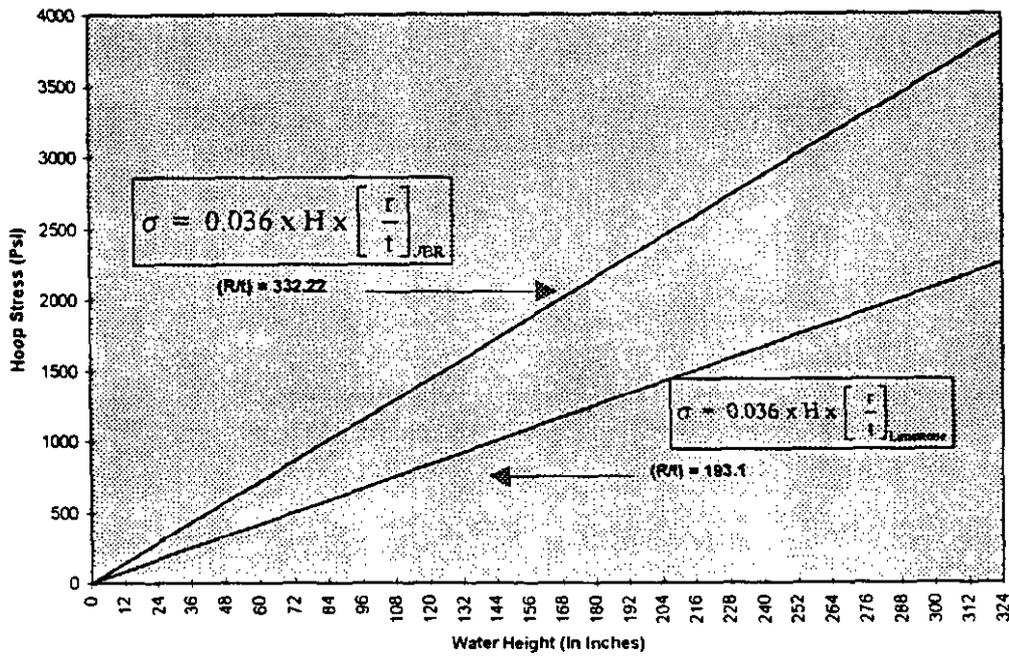
Theoretical Relationship for Water Height vs. Hoop Stress

Therefore, the theoretical hoop stress can be calculated or looked up from Figure 36. This relationship is generally found in the experimental test data. Comparison plots between the theoretical stresses and the experimental obtained stresses can be found in Figures 30 to 35.

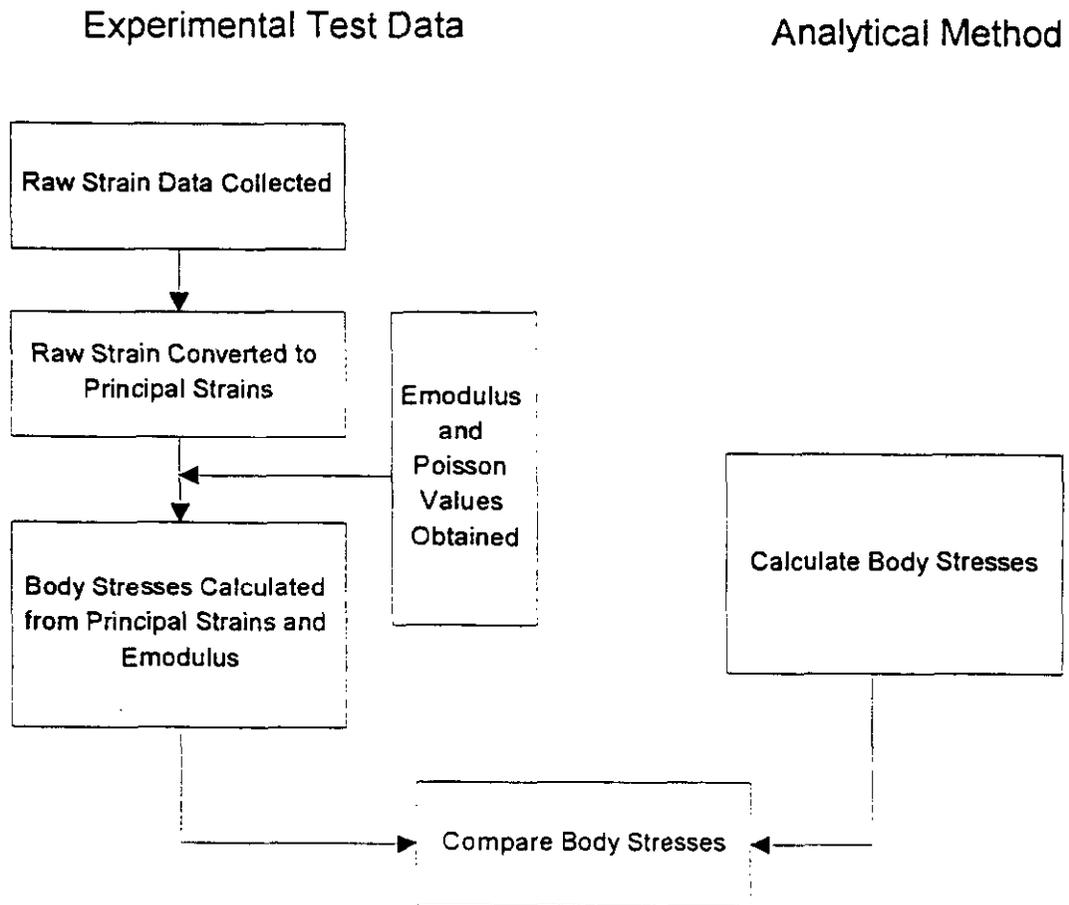
Figure 37

## Comparison of Test Data with Calculated Stresses

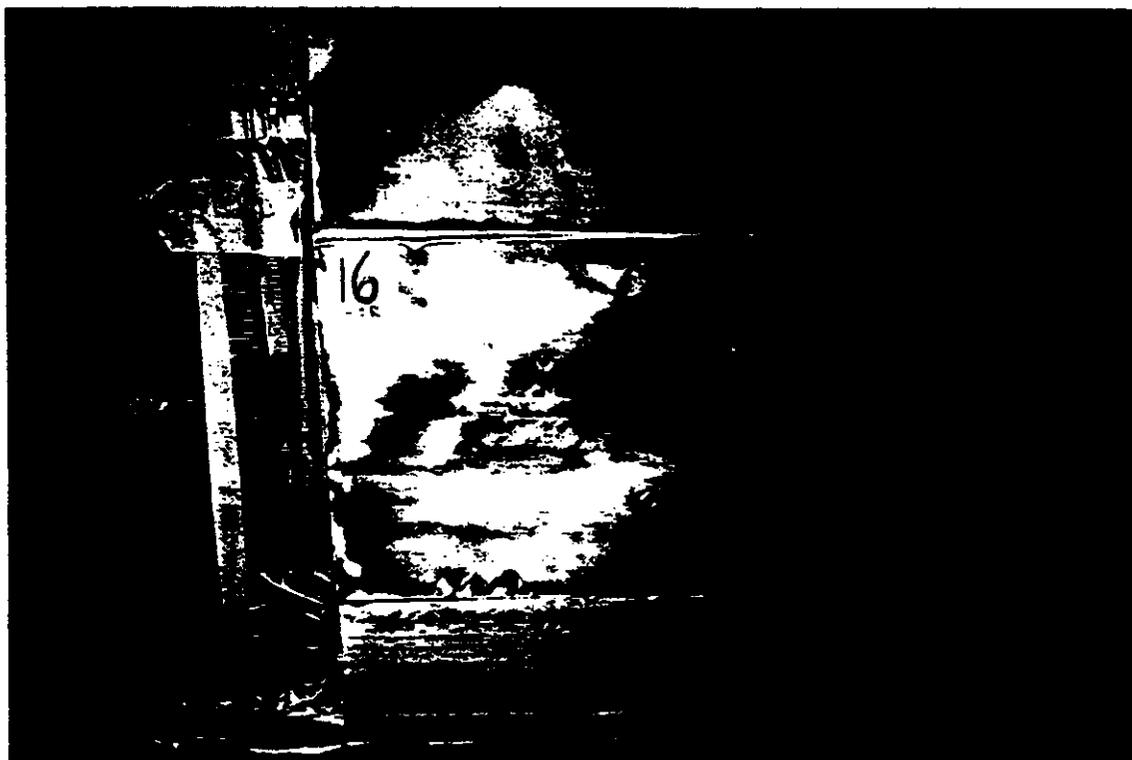
Photo 8: Photolaminant Layout on Vertical Section of JBR Vessel

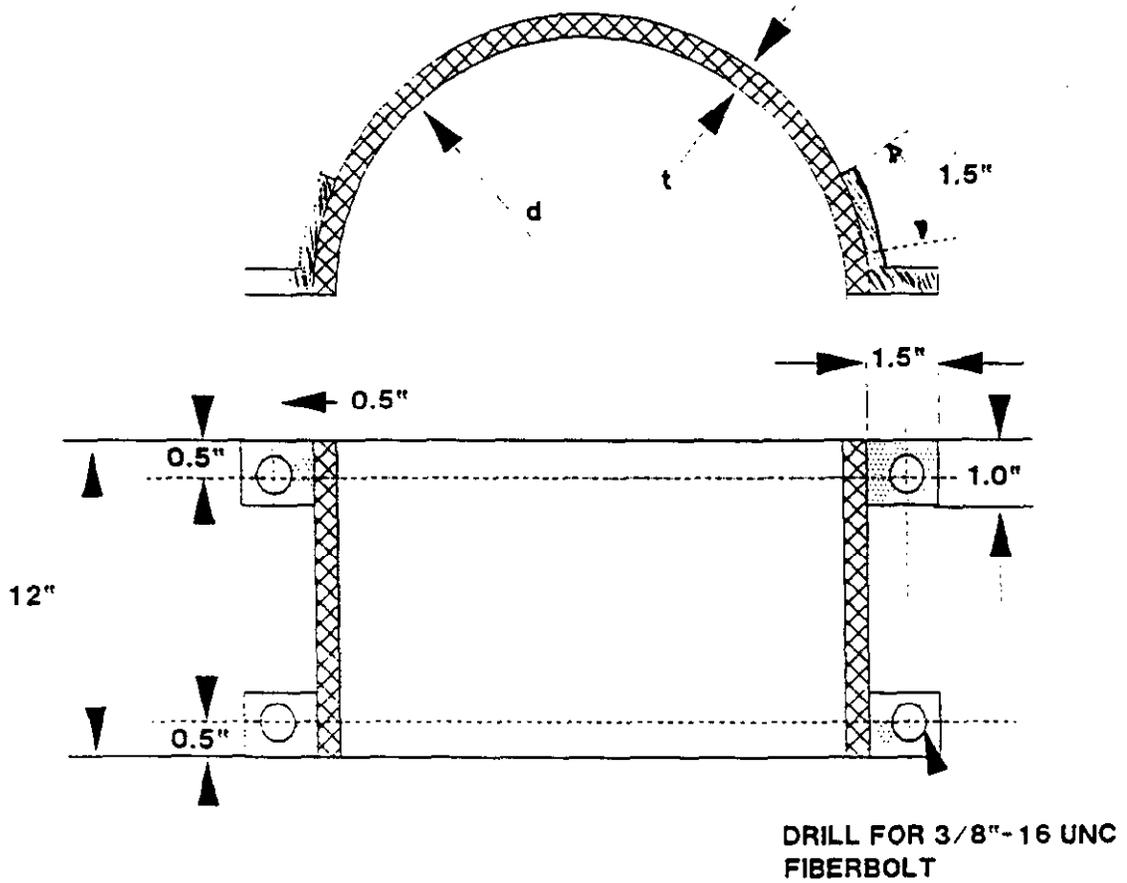
ABRASION SAMPLES FOR JBR REACTION ZONE POSTS

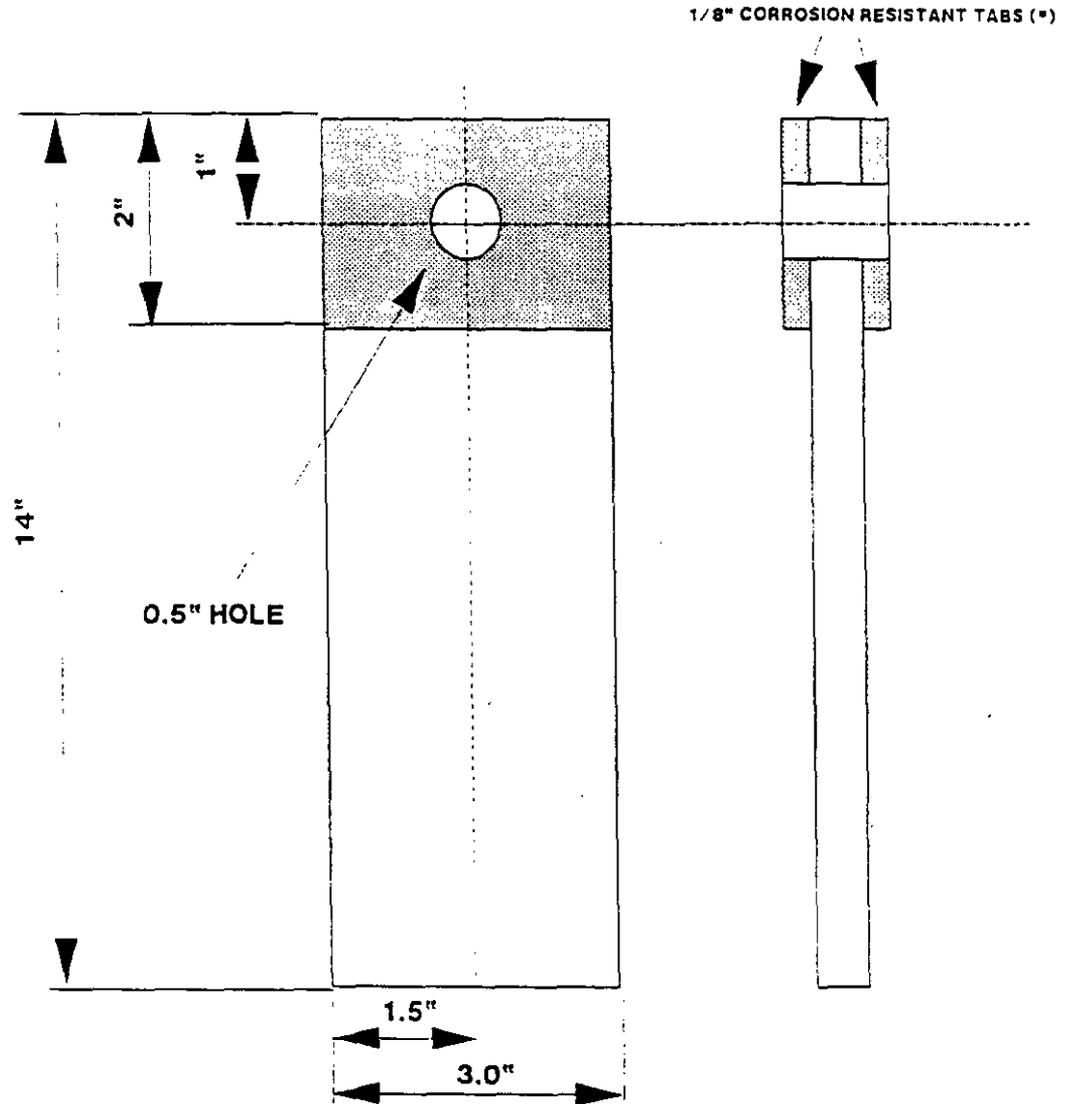
FIGURE 1: CORROSION SAMPLES FOR JBR REAC. ZONE, INLET AND EXHAUST PLENUMS, AND PRE-QUENCH DUCT AREA.

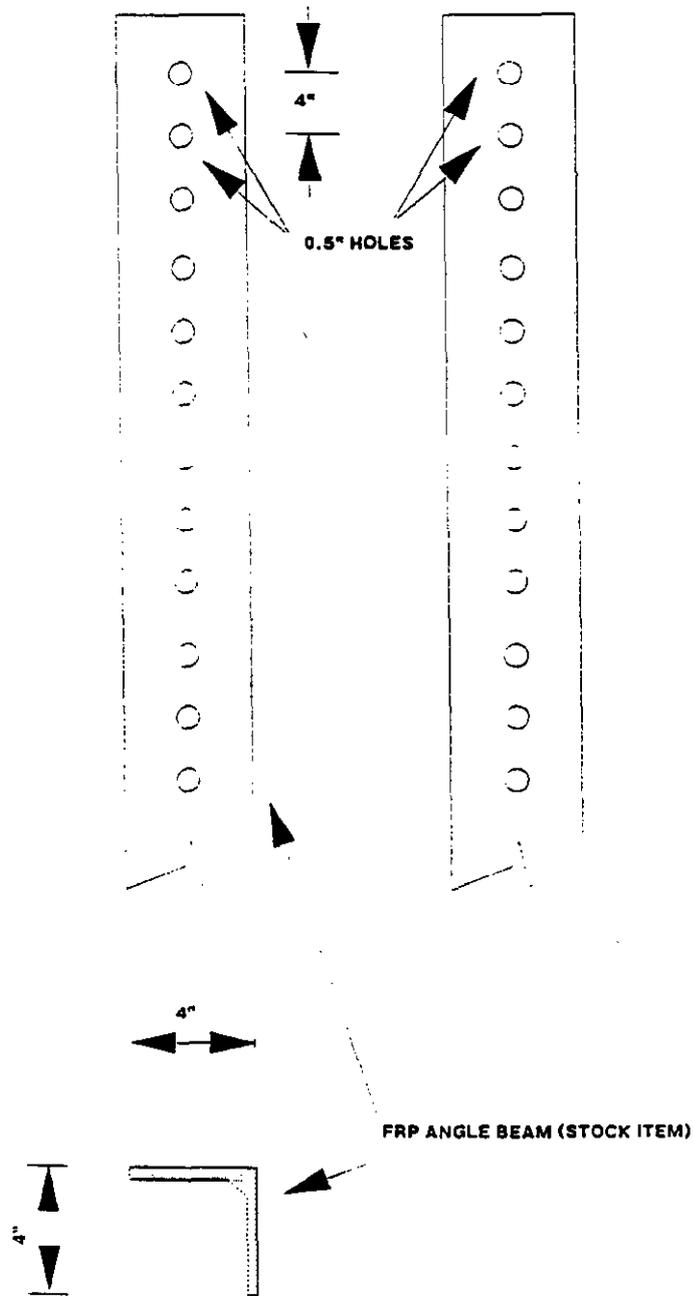
**FIGURE 3: SPACING OF THE HOLES ON THE SAMPLE MOUNTING BRACKETS**
