# **Demonstration of Innovative Applications of Technology for Cost Reductions to the CT-121 FGD Process**

**DOE ICCT PROJECT DE-FC22-90PC89650**

## **FINAL REPORT**

**Volume 6-B of 6: Appendices**

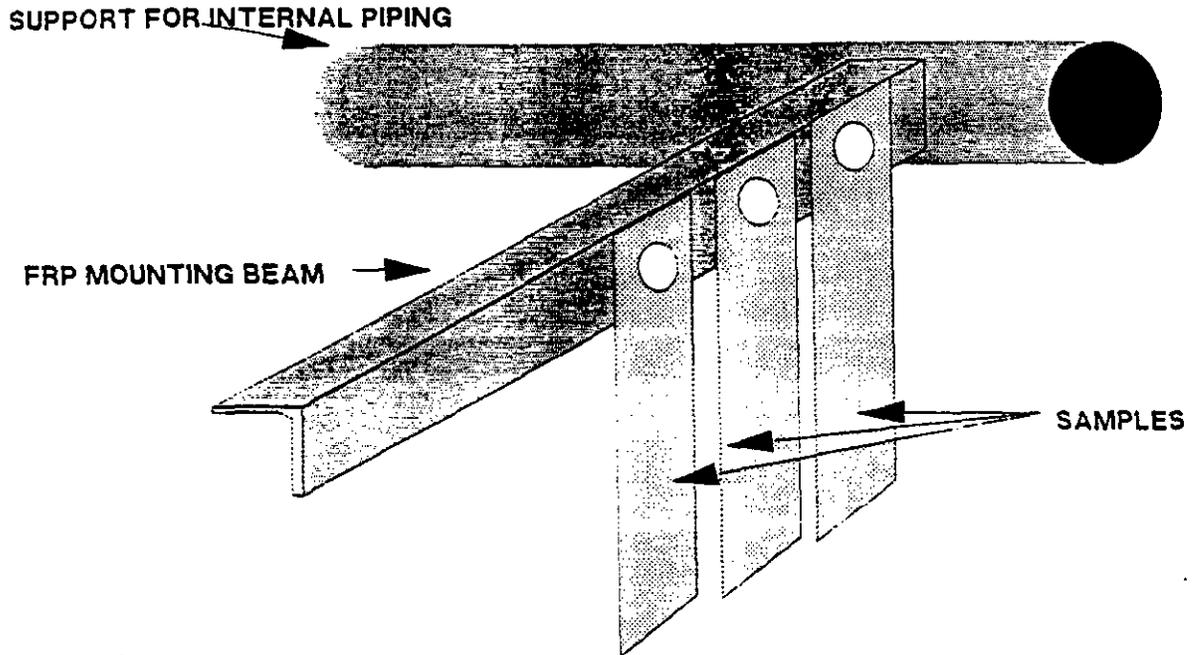
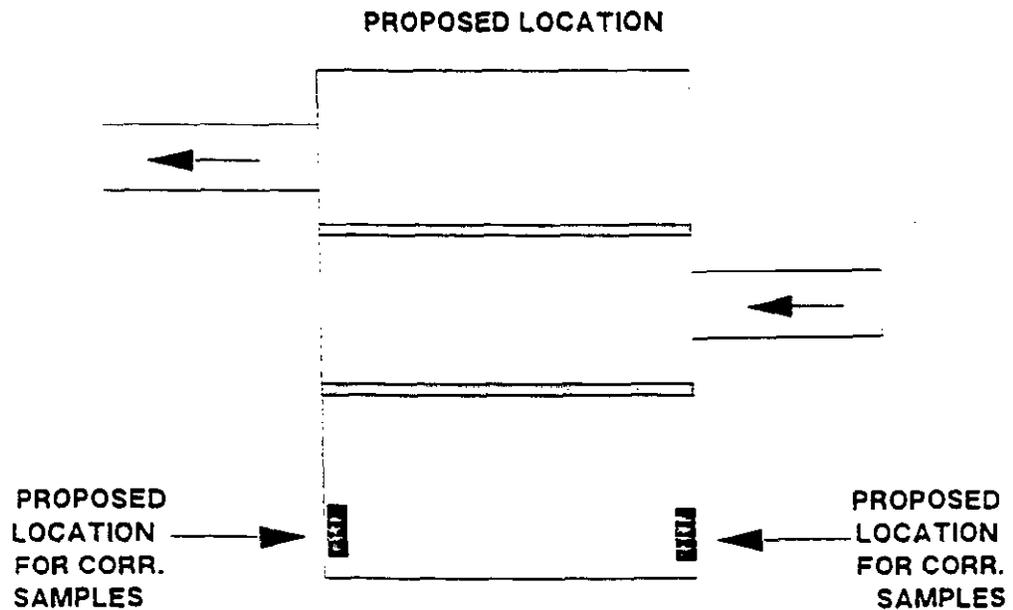
**FIGURE 2: ASSEMBLY OF CORROSION SAMPLES IN JBR REACTION ZONE**  
SAMPLES IMMERSSED IN CHLORINE-LADEN (14,000 PPM) SLURRY OF GYPSUM AND LIMESTONE.

- CRITERIA FOR LOCATION:**
- EASY TO REACH
  - AWAY FROM MAIN FLOW
  - SUSPENDED IN LIQUID SLURRY

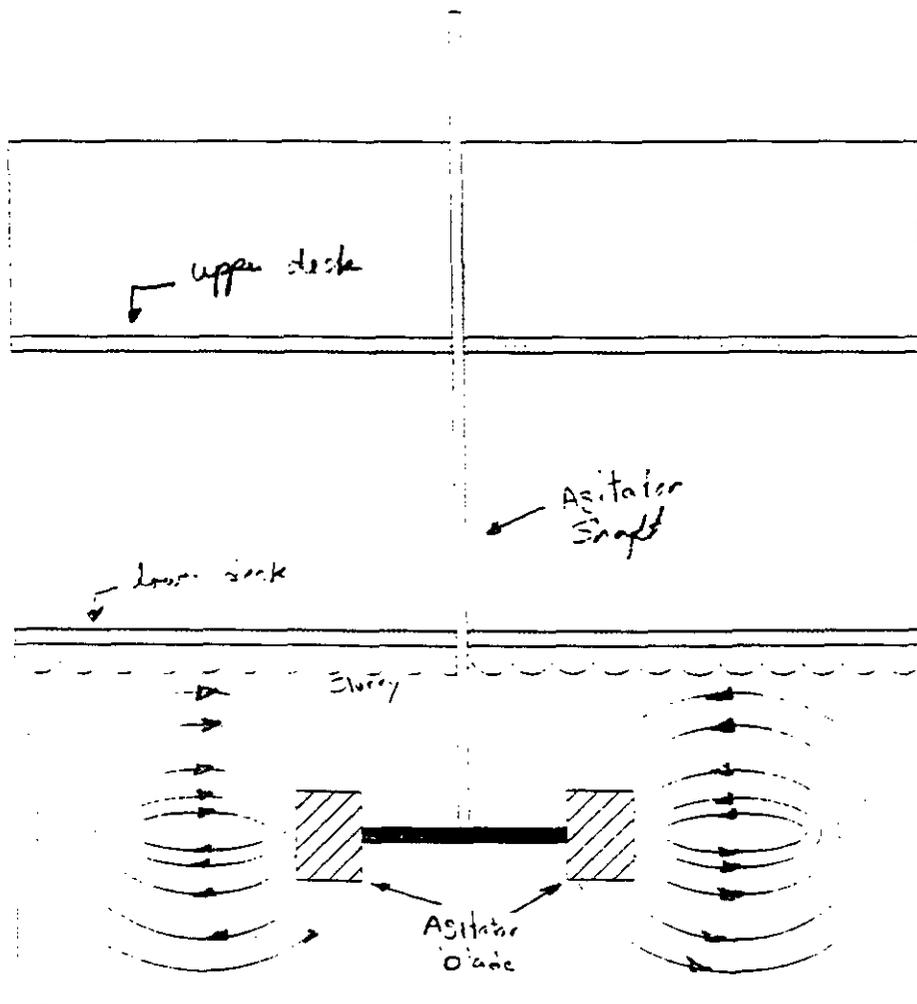
FIGURE 7: VELOCITY PROFILE IF NO SPARGER TUBES WERE PRESENT. VELOCITY NEAR WALL AREA IS PROBABLY VERY SMALL BECAUSE OF VISCOSITY. BOUNDARY LAYER THICKNESS IS ALSO EXPECTED TO BE LARGE. SO VELOCITY GRADIENT IS FLOW SHEAR RATES ARE ALSO SMALL. WITH THE SPARGER TUBES, THE FLOW PATTERN IS NOT KNOWN. THE FLOW IS, HOWEVER, EXPECTED TO BE SMALL NEAR THE VESSEL WALL.

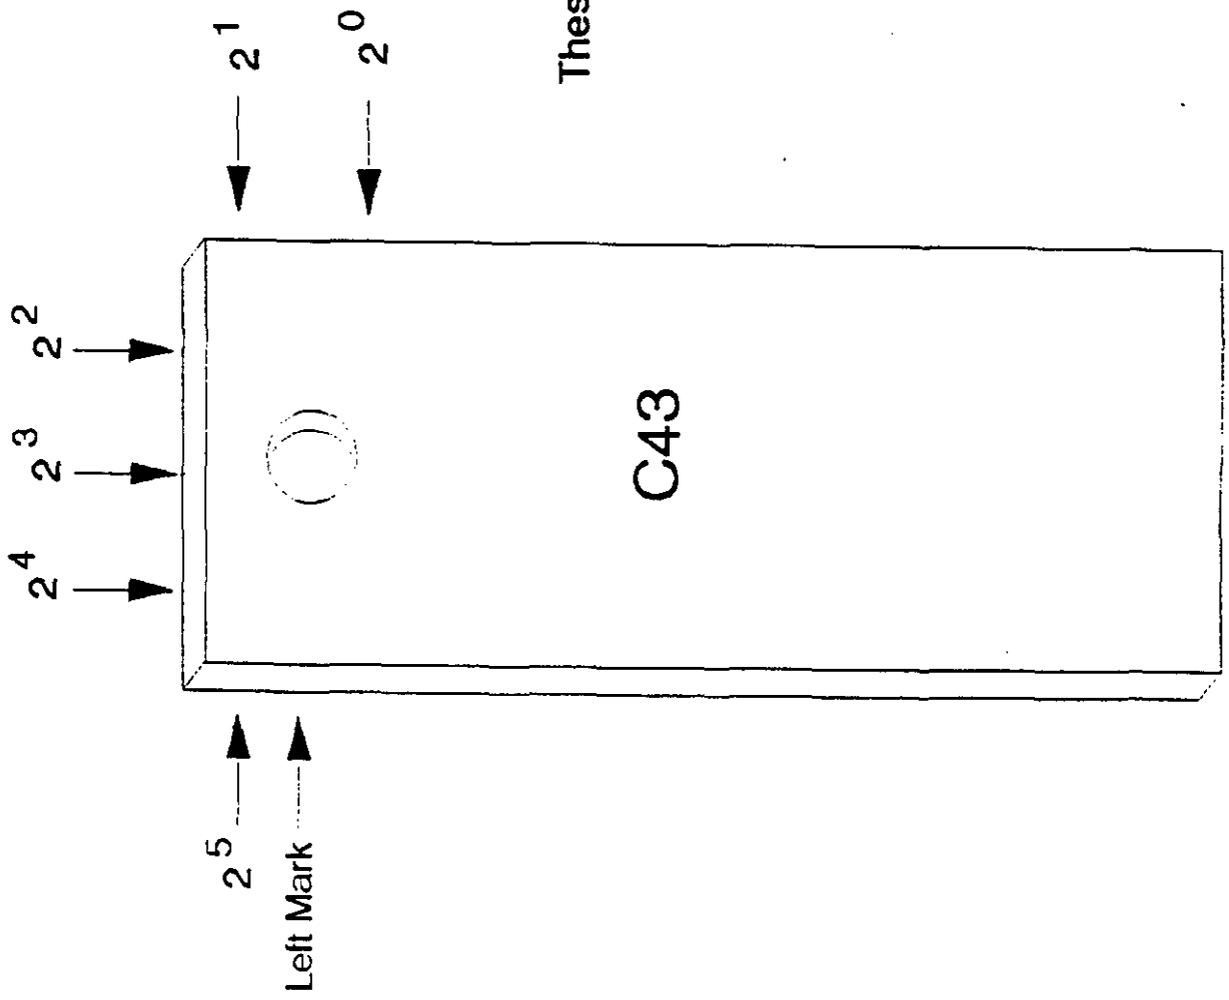
# NOTCHING CORROSION SAMPLES

These notches should be read as:  
 $1 + 2 + 8 + 32 = 43$

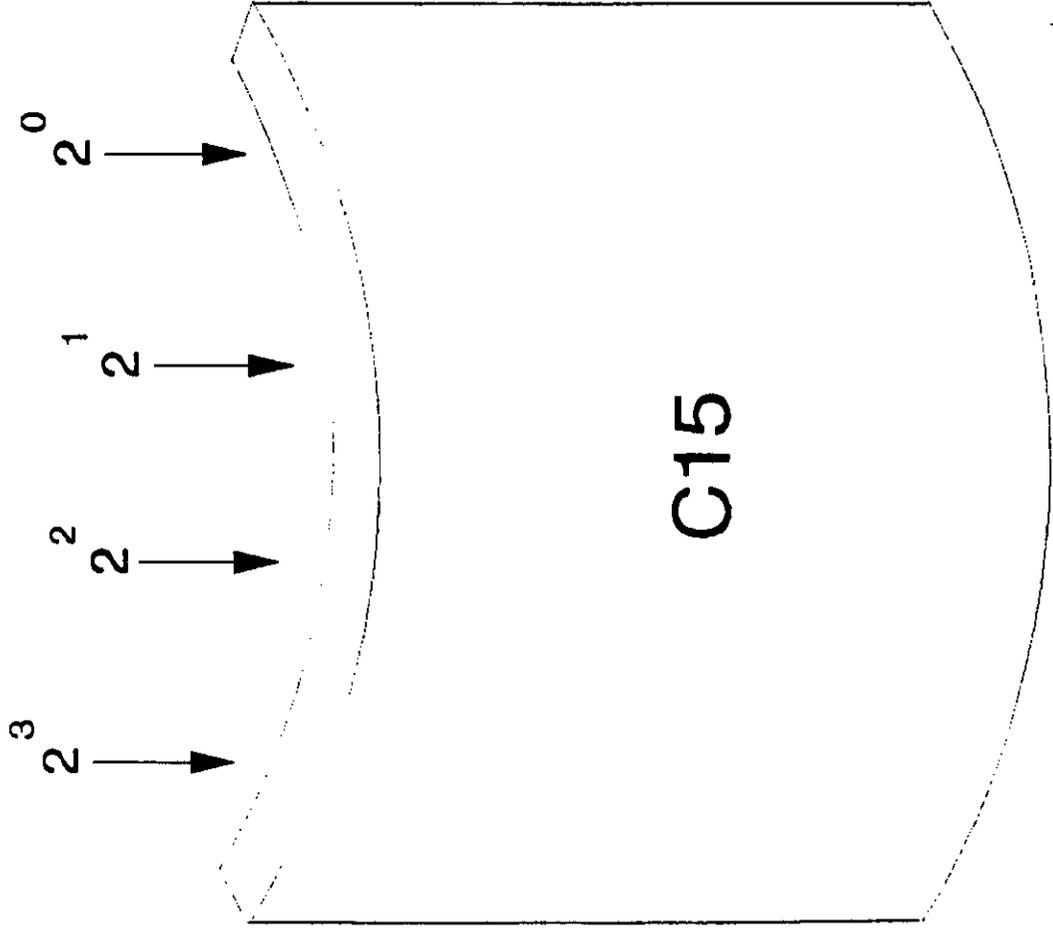
# NOTCHING ABRASION SAMPLES

$$1 + 2 + 4 + 8 = 15$$

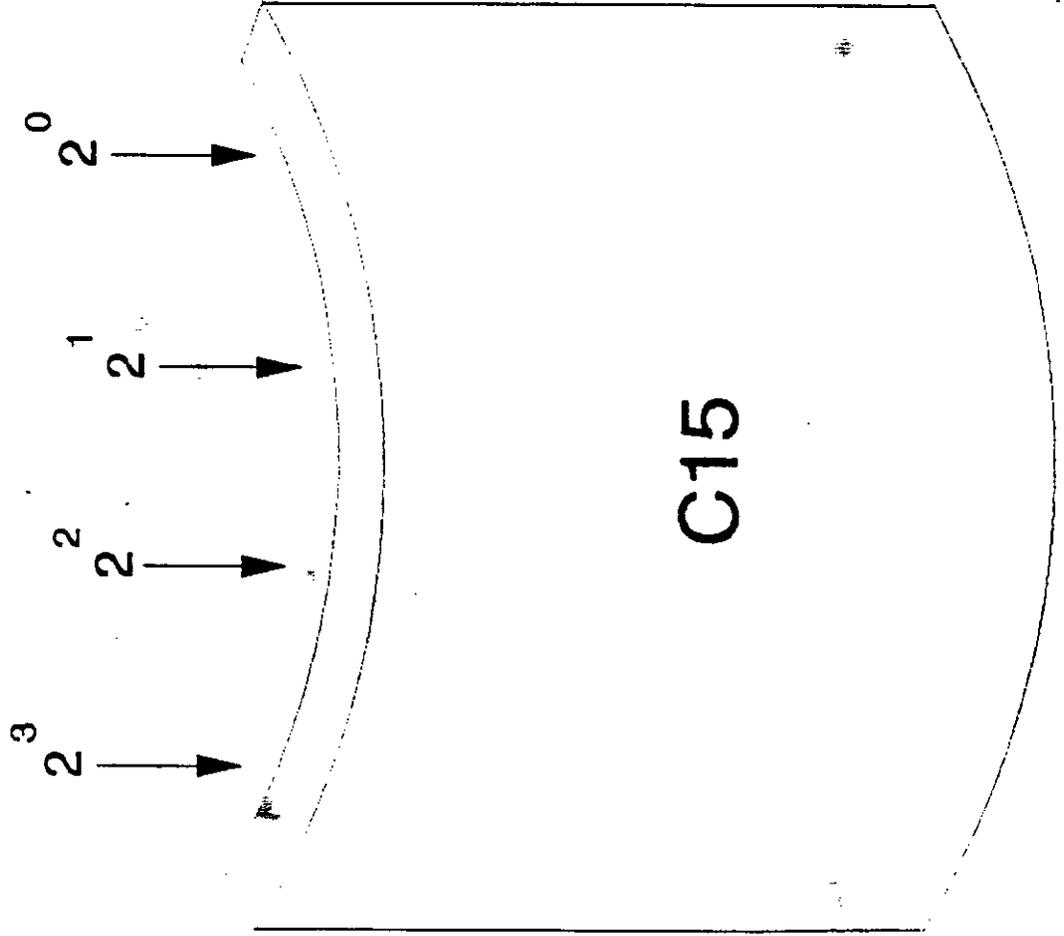
# NOTCHING ABRASION SAMPLES

$$1 + 2 + 4 + 8 = 15$$

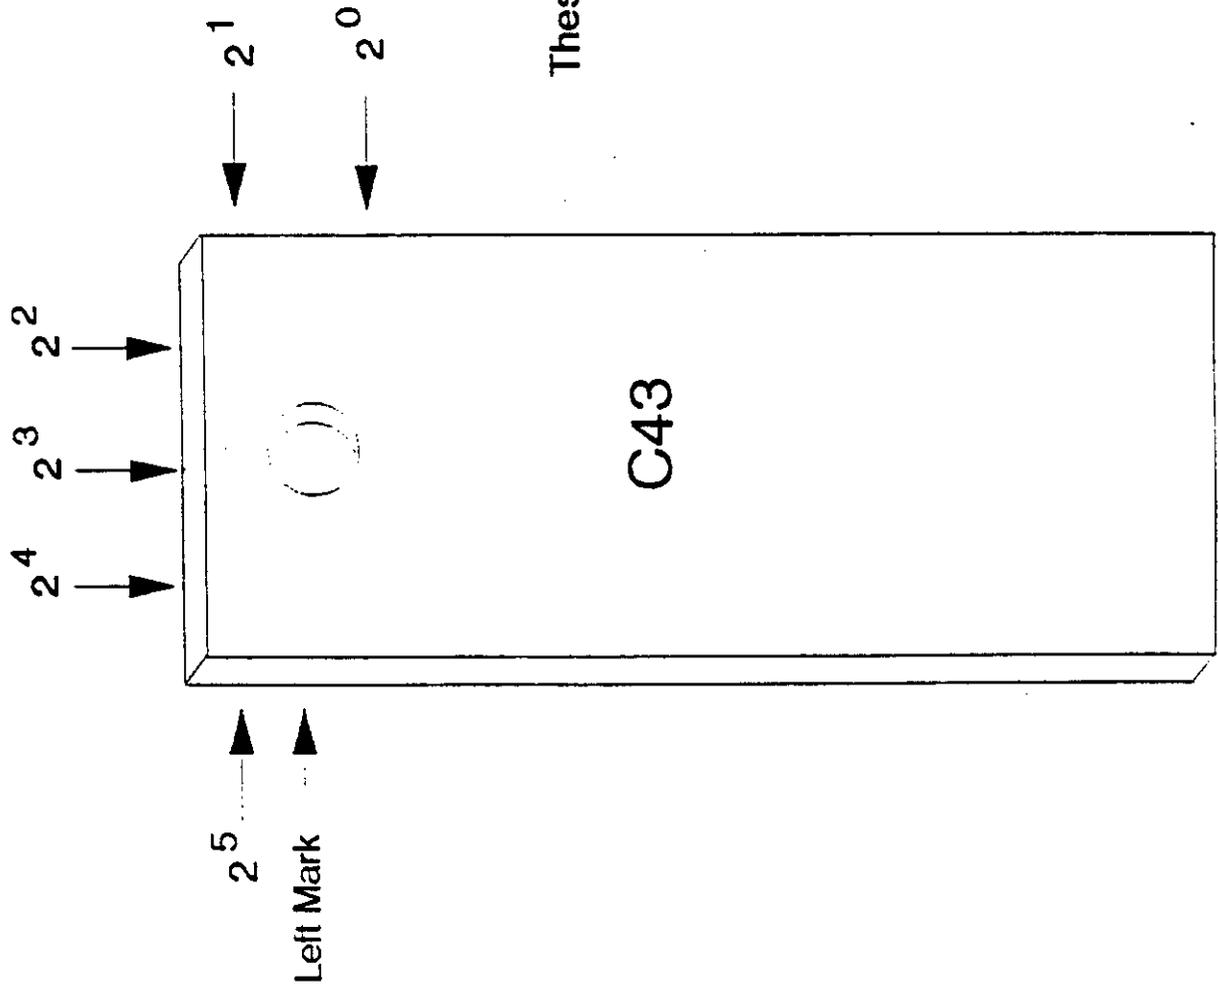
# NOTCHING CORROSION SAMPLES

These notches should be read as:  
 $1 + 2 + 8 + 32 = 43$
