REPORT

EWI Project No. 46211GTH
Electronic File Name: 41633R47.pdf

Internal Repair of Pipelines Review & Evaluation of Internal Pipeline Repair Trials Report

Report Issued: September 2004

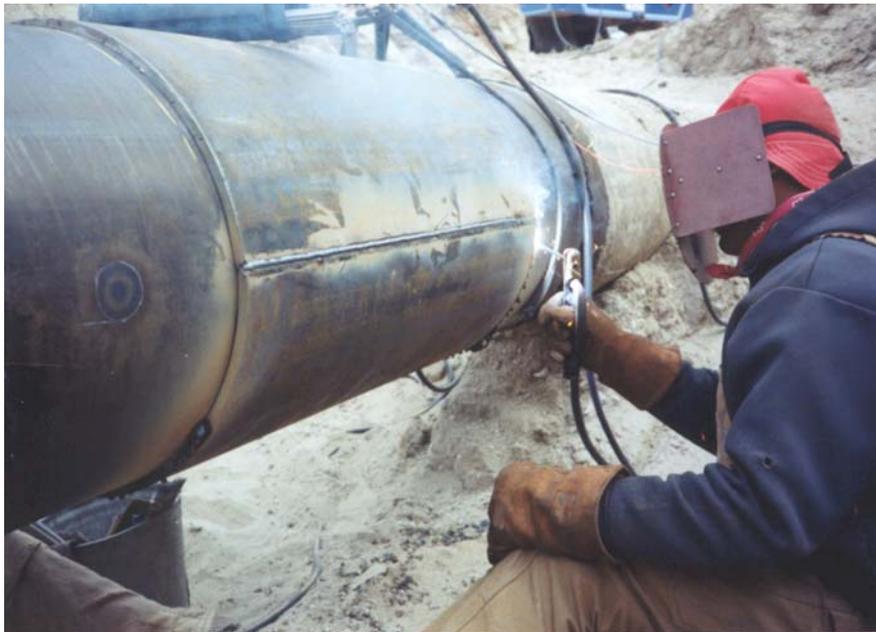
Figure 1 - Installation of a Full-Encirclement Repair Sleeve

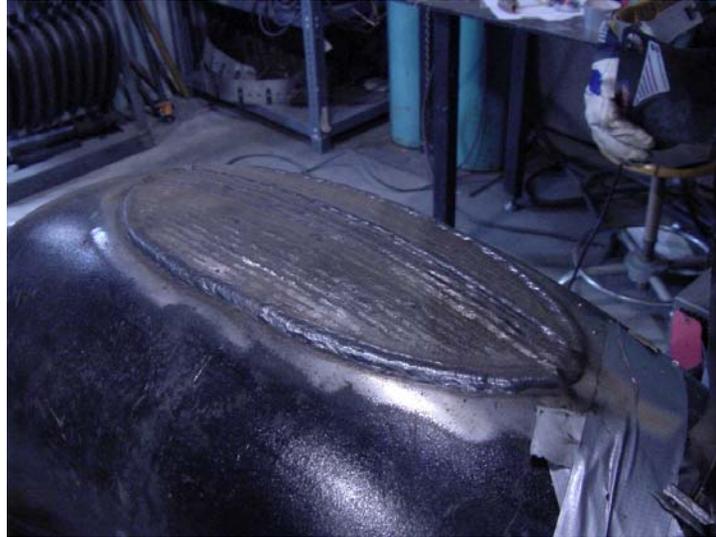
Figure 2 - External Weld Deposition Repair of Internal Wall Loss in 90° Elbow

Gas transmission pipeline repair by direct deposition of weld metal, or weld deposition repair, is a proven technology that can be applied directly to the area of wall loss (e.g., external repair of external wall loss - Figure 1) or to the side opposite to the wall loss (e.g., external repair of internal wall loss - Figure 2).

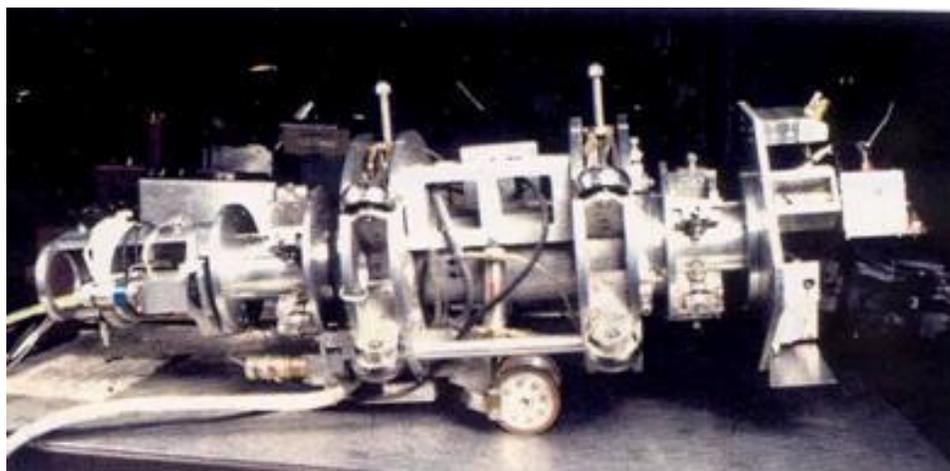
Figure 3 - Osaka Gas System for Remote Robotic Internal Repair of Root Weld Defects in Gas Transmission Pipelines

There are no apparent technical limitations to applying this repair method to the inside of an out-of-service pipeline. It is direct, relatively inexpensive to apply, and requires no additional materials beyond welding consumables. However, application of this repair method to the inside of an in-service pipeline would require that welding be performed in a hyperbaric environment. Deposited weld metal repairs are also used to repair circumferentially oriented planar defects (e.g., intergranular stress corrosion cracks adjacent to girth welds) in the nuclear power industry. Remote welding has been developed primarily to meet needs in the nuclear power industry, though working devices have been built for other applications, including repair of gas transmission pipelines. An example of such equipment is shown in Figure 3.

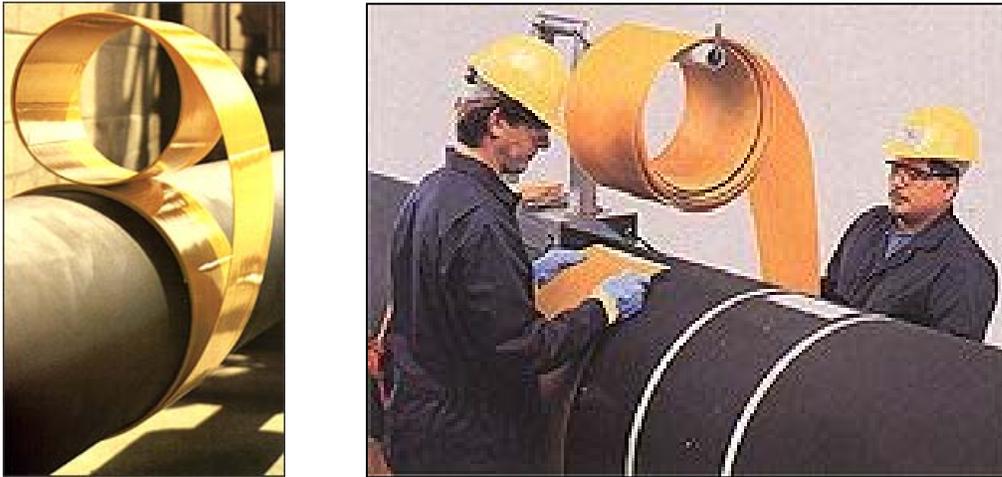
Figure 4 - Clock Spring® Fiber-Reinforced Composite Device for Pipeline Repair

Fiber-reinforced composite repairs are becoming widely used as an alternative to the installation of welded, full-encirclement sleeves for repair of gas transmission pipelines. These repairs typically consist of glass fibers in a polymer matrix material bonded to the pipe using an adhesive. Adhesive filler is applied to the defect prior to installation to allow load transfer to the composite material. The primary advantage of these repair products over welded, full-encirclement sleeves is the fact that welding is precluded. An illustration of the most commonly used of the fiber-reinforced composite devices, Clock Spring®, is shown in Figure 4.

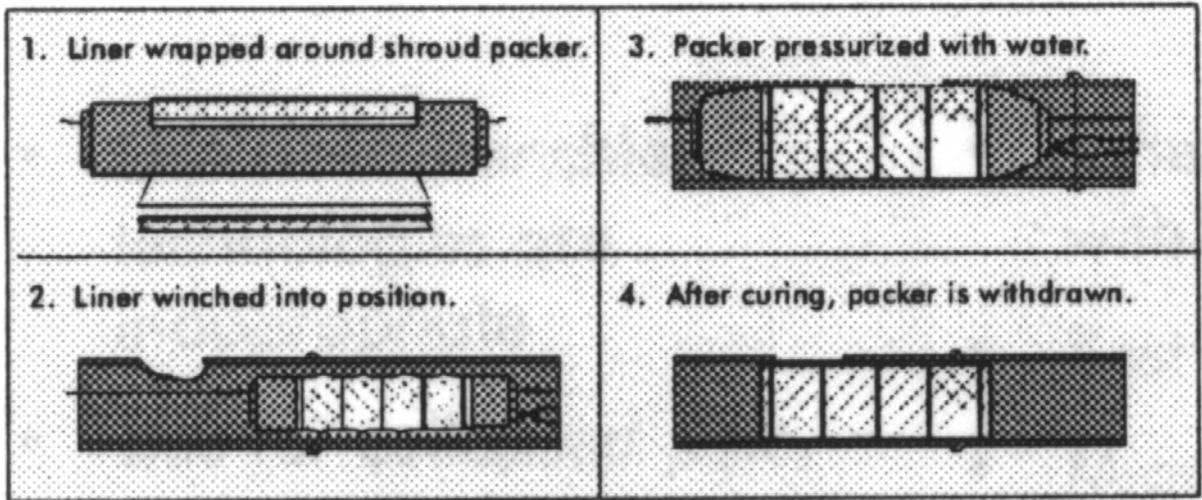
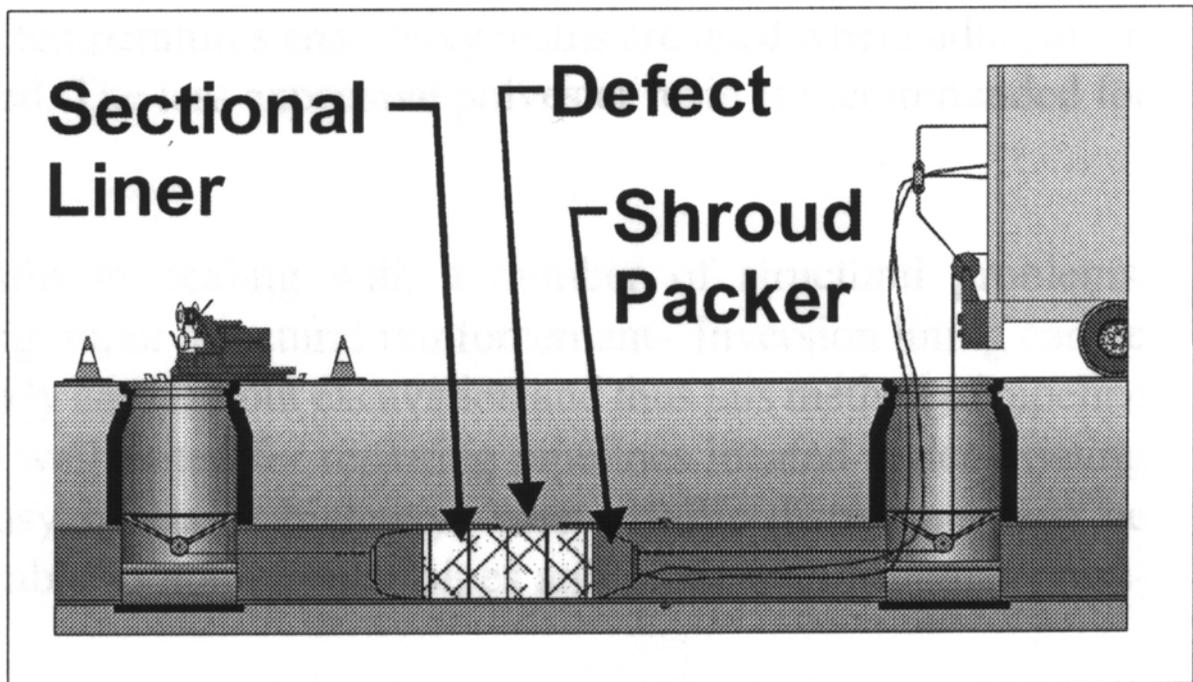
Figure 5 - Installation of a Sectional Liner in Low-Pressure Pipeline

A variety of liners are commonly used for repair of other types of pipelines (e.g., gas distribution lines, sewers, water mains, etc.). Of these, the three that are potentially applicable to internal repair of gas transmission pipelines are sectional liners, cured-in-place liners, and fold-and-formed liners. Sectional liners are typically 0.9 m (3 ft.) to 4.6 m (15 ft.) in length and are installed only in areas that require repairs. Cured-in-place liners and fold-and-formed liners are typically applied to an entire pipeline segment. Cured-in-place liners are installed using the inversion process, while fold-and-formed liners are pulled into place and then inverted so that they fit tightly against the inside of the pipe. The installation of a sectional liner is illustrated in Figure 5.

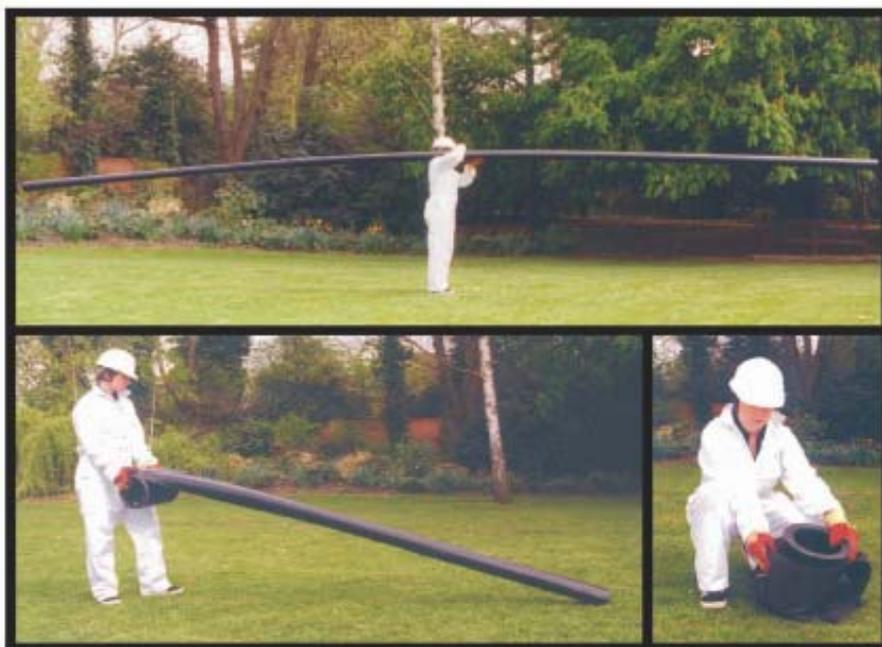
Figure 6 - RolaTube Bi-Stable Reeled Composite Material

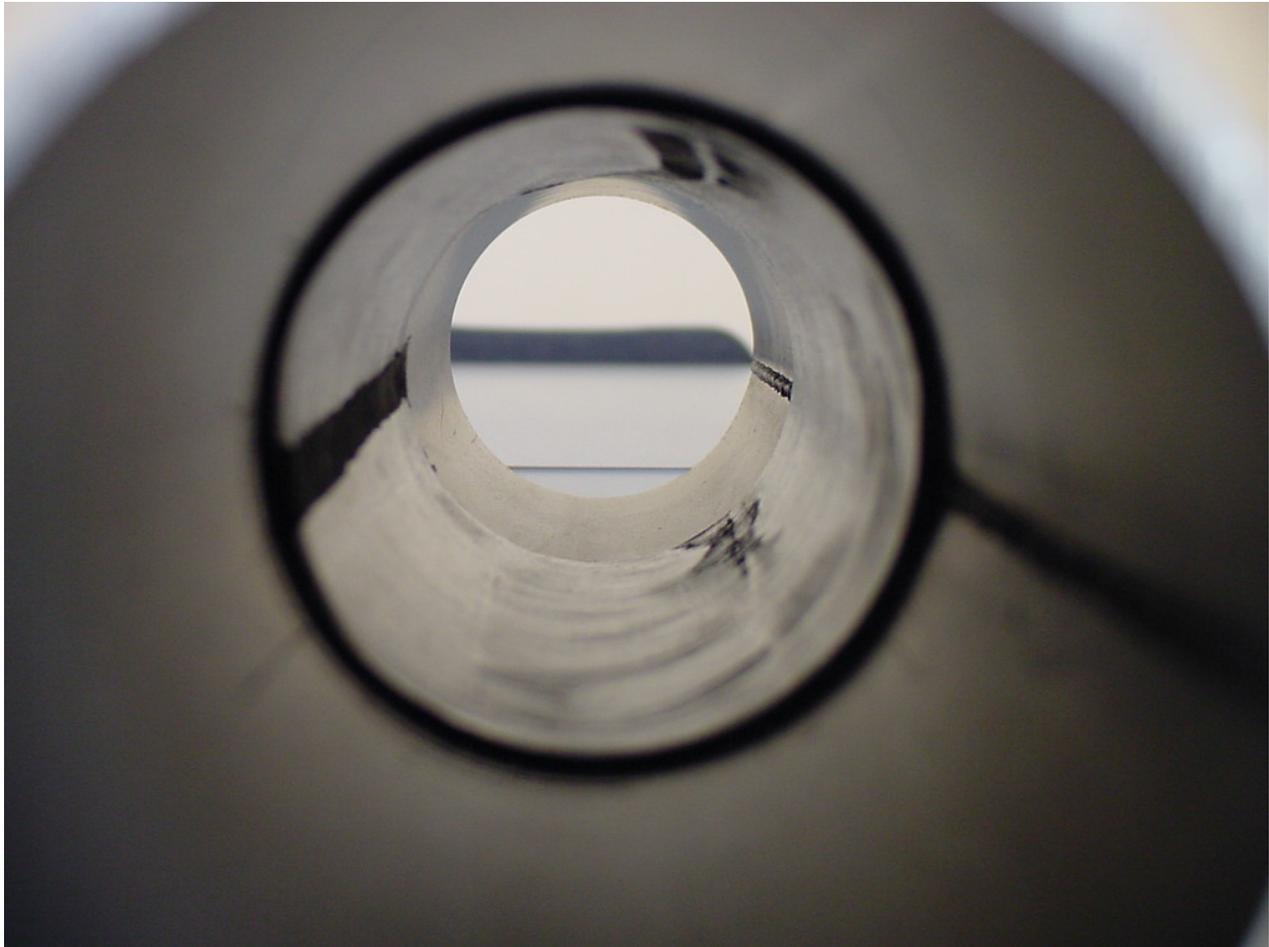
Figure 11 - Liner Inserted into Center of 114.3 mm (4.5 in.) Diameter Pipe

Possible choices for liner installation in the field include infrared (IR) heaters on an expansion pig or a silicon bag inflated using hot air. An installed liner is shown in Figure 11.

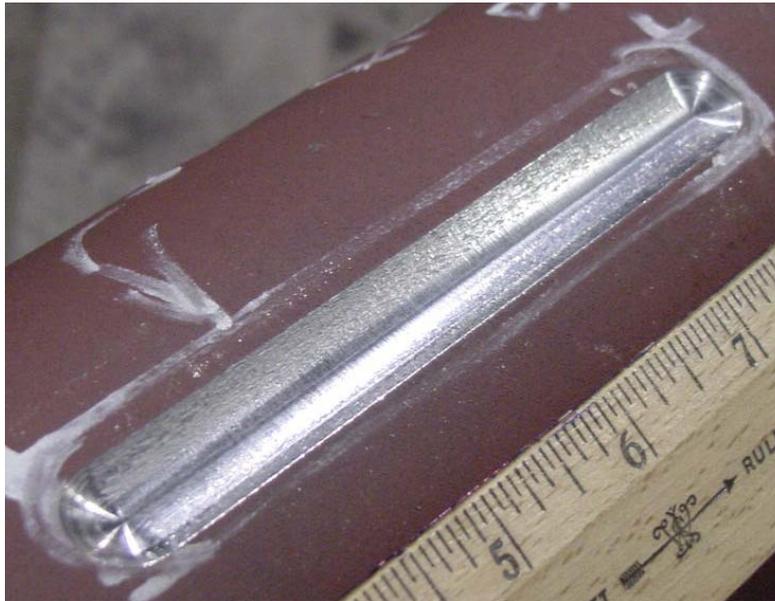
Figure 12 - Long, Shallow Simulated Corrosion Damage

Using the RSTRENG software⁽¹⁾, dimensions of simulated general corrosion and a deep, isolated corrosion pit both with a 30% reduction in burst pressure were calculated then introduced into pipe sections with a milling machine. Using an end mill, long shallow damage representative of general corrosion (Figure 12) was introduced into one pipe section lined with fiber-reinforced composite liner and one without.

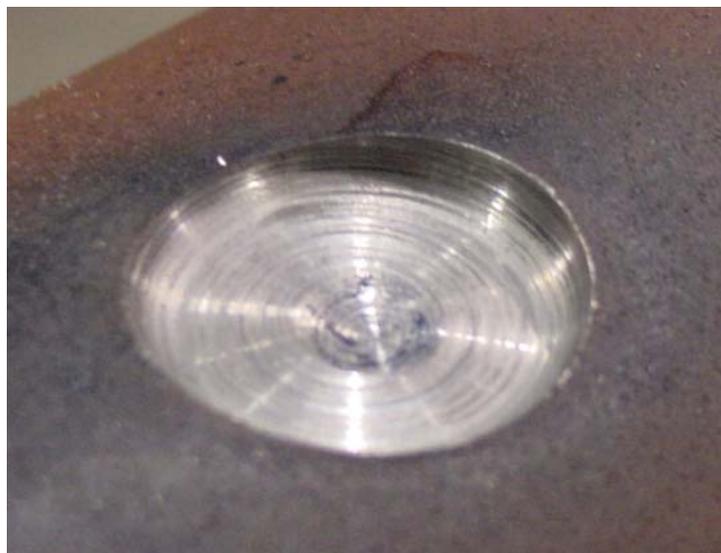
Figure 13 - Short, Deep Simulated Corrosion Damage

Using an end mill with rounded corners, short, deep damage representative of a deep isolated corrosion pit (Figure 13) was introduced into the second pair of pipe sections; one lined, one not lined.

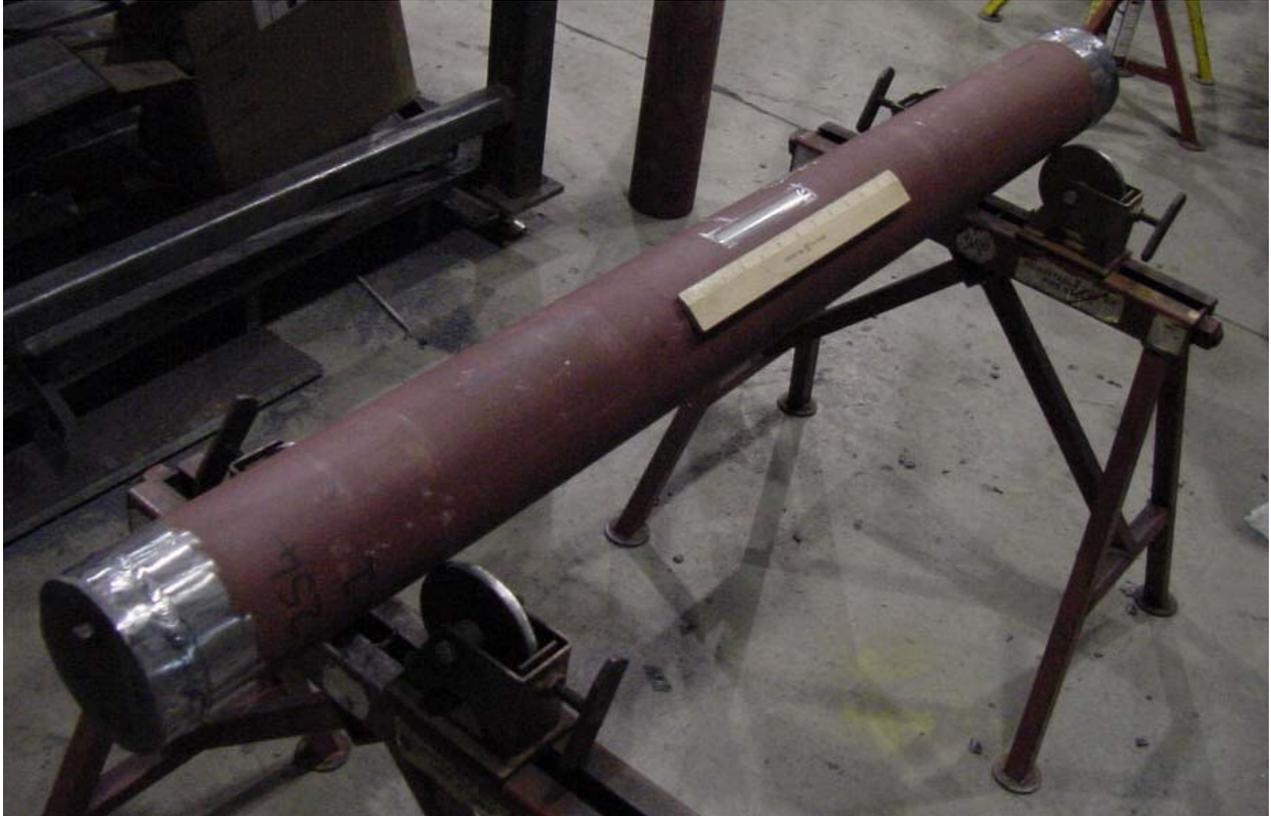
Figure 14 - 114.3 mm (4.5 in.) Diameter Pipe Section with End Caps Welded and Simulated Corrosion Damage

End caps were then welded to all four pipe sections as shown in Figure 14. Following the installation of end caps, all four pipe sections were hydrostatically pressurized to failure.

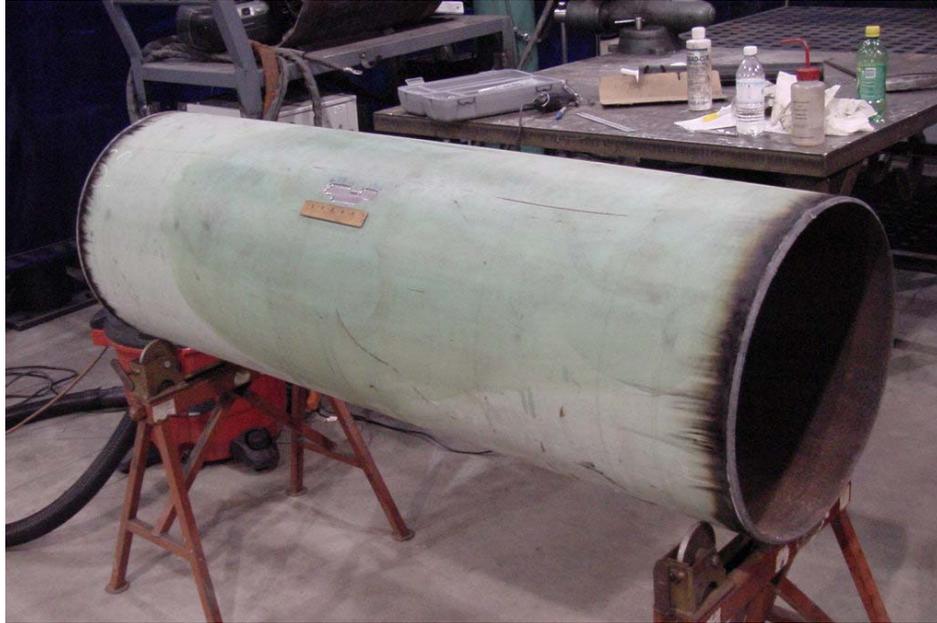
Figure 15 - 508 mm (20 in.) Diameter API 5L-X52 Pipe Section Used for Carbon Fiber Liner Repair Test

Using pipe sections with simulated corrosion damage, EWI hydrostatically tested a pipe section that was repaired with a carbon fiber-reinforced liner, which was fabricated in-house. EWI procured raw carbon fiber material and fabricated a 11.42 mm (0.45 in.) thick reinforcement patch using a "wet lay-up" process with a vinylester resin system. For the carbon fiber-reinforced liner repair simulation, a 508 mm (20 in.) diameter by 6.35 mm (0.25 in.) wall, API 5LX-52 pipe section was used (Figure 15).

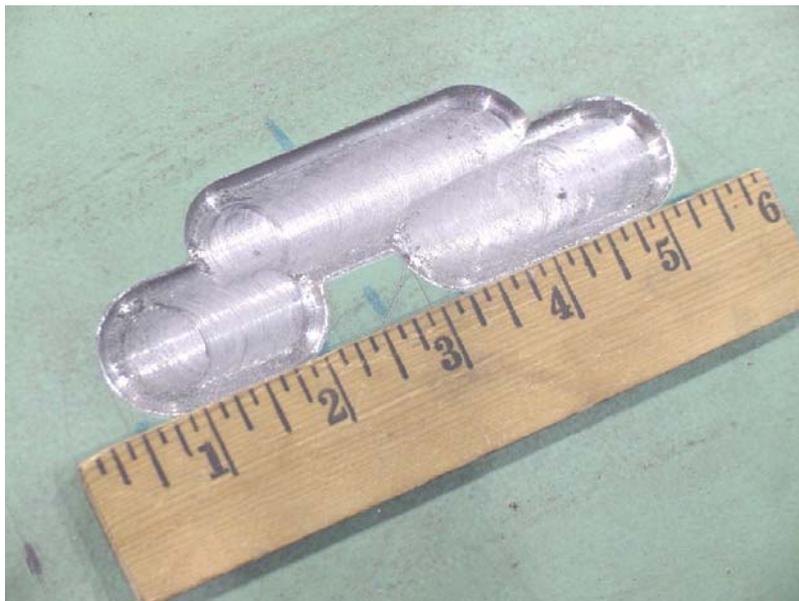
Figure 16 - Simulated Corrosion Defect for Carbon Fiber Liner Repair Test in 508 mm (20 in.) Diameter Pipe

With a ball end mill, long shallow damage representative of general corrosion was introduced into the pipe section. The simulated defect was 127 mm (5 in.) long and 3.45 mm (0.136 in.) deep (Figure 16) and effectively reduces the wall thickness down to 54%. The predicted burst pressure for this pipe material with a similar un-repaired defect is 6.72 MPa (974 psi).

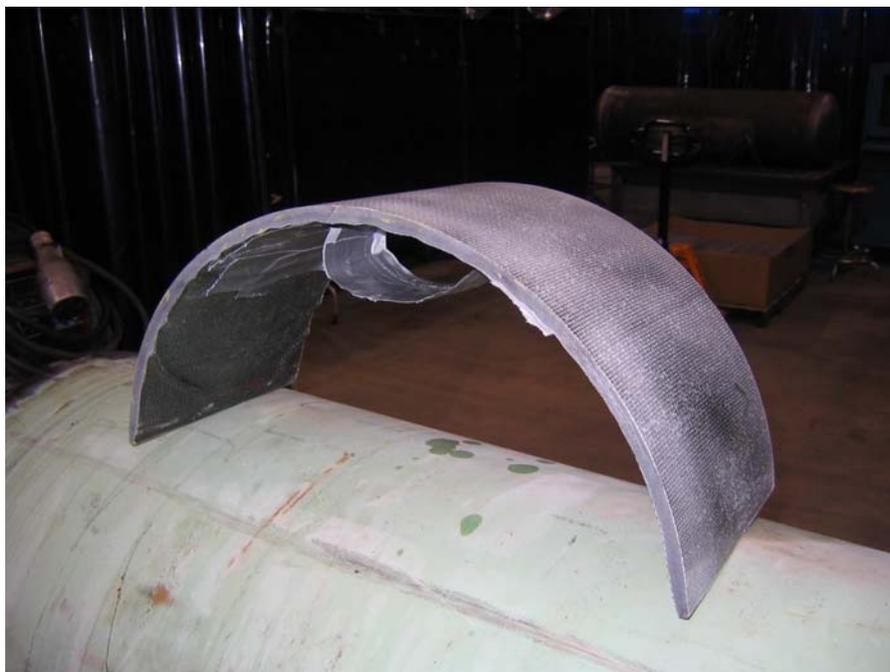
Figure 22 - Completed Repair Patch with Grit-Blasted Outer Diameter

To facilitate patch installation, the outer surface of the patch was grit-blasted using 50 - 80 grit Alumina to remove surface resin (Figure 22). Similarly, the installation area inside the pipe was grit-blasted to a near-white blast with 50 - 80 grit Alumina (Figure 23). After cleaning, a liberal coating of 3M DP460 epoxy adhesive was applied to the internal faying surface and a thin coating was applied to the patch faying surface (Figure 24).

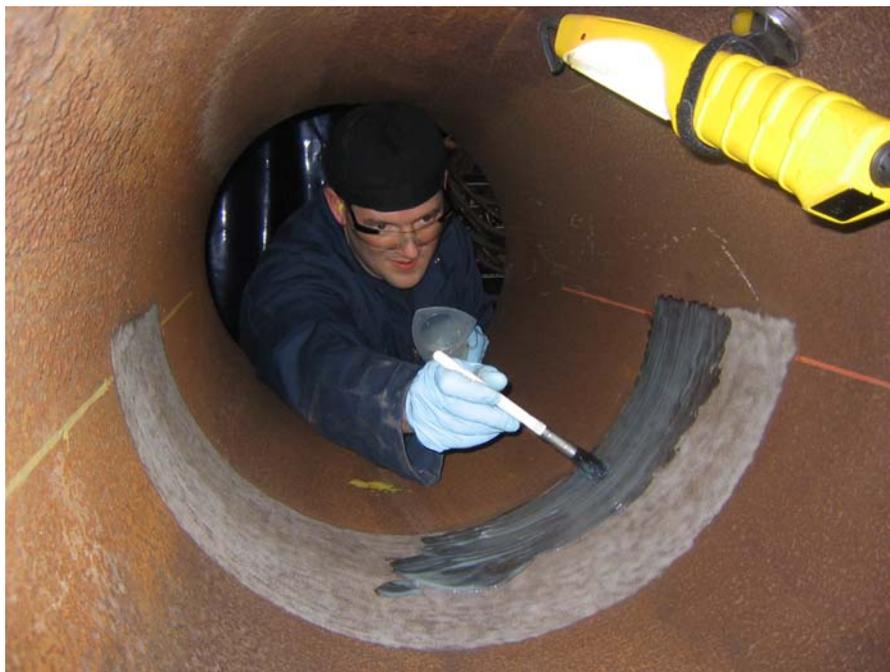
Figure 23 - Application of 3M DP460 Adhesive to Grit-Blasted Inside Diameter of Pipe

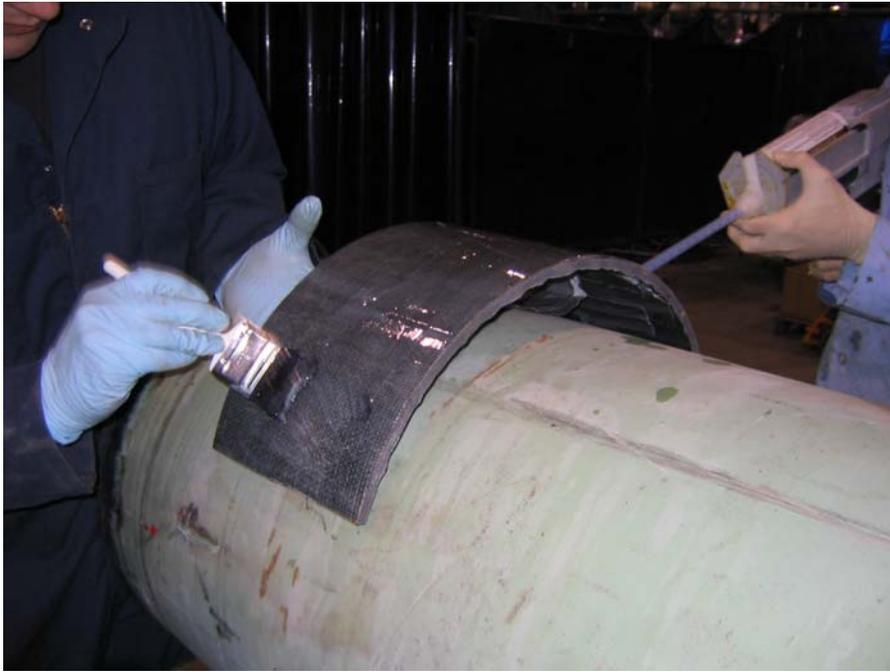
Figure 24 - Application of Adhesive to Repair Patch

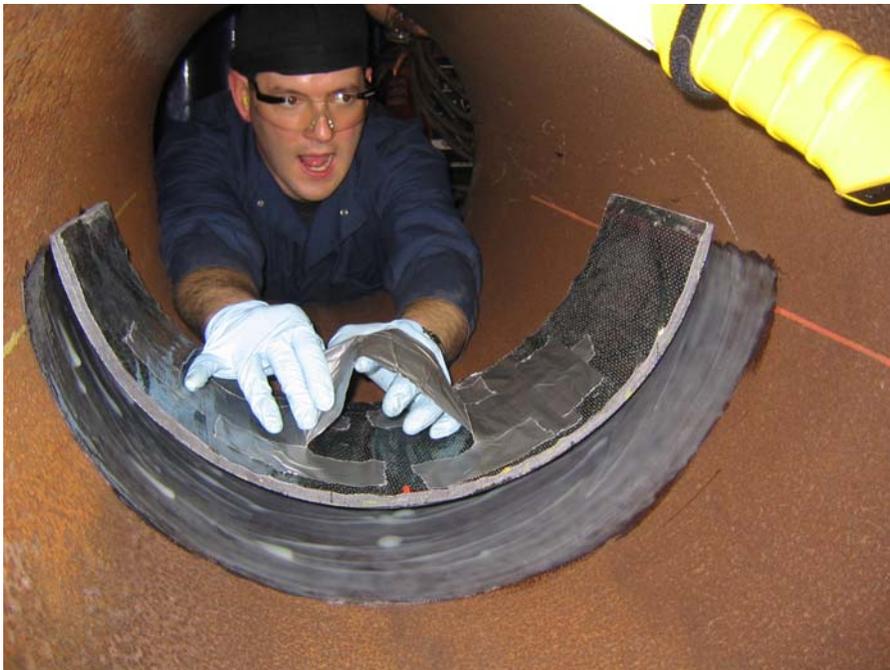
Figure 25 - Installation of Repair Patch

The patch and pipe section were mated as shown in Figure 25.

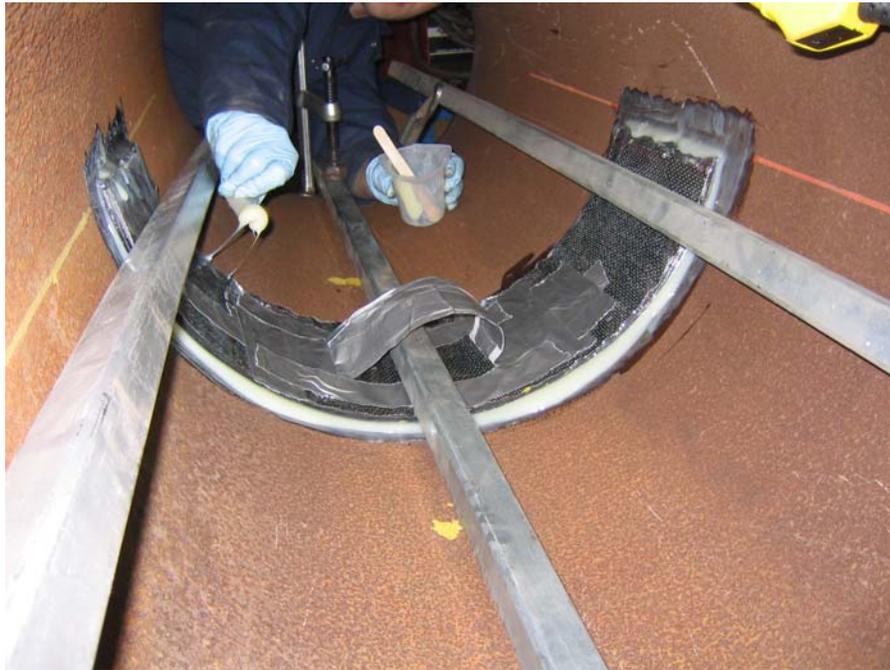
Figure 26 - Clamping Bars Used to Hold Repair Patch in Place

Bar clamps were used along the axis of the pipe to hold the patch in place for cure. Figure 26 shows the adhesive squeeze-out being removed prior to forming a fillet as shown in Figure 27

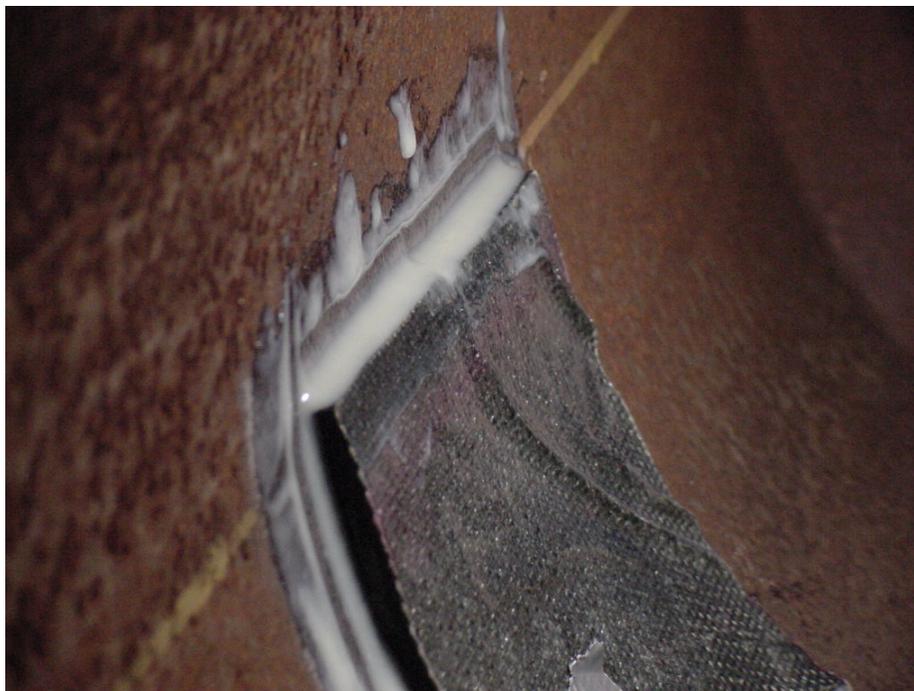
Figure 27 - Adhesive Fillet Around Repair Patch

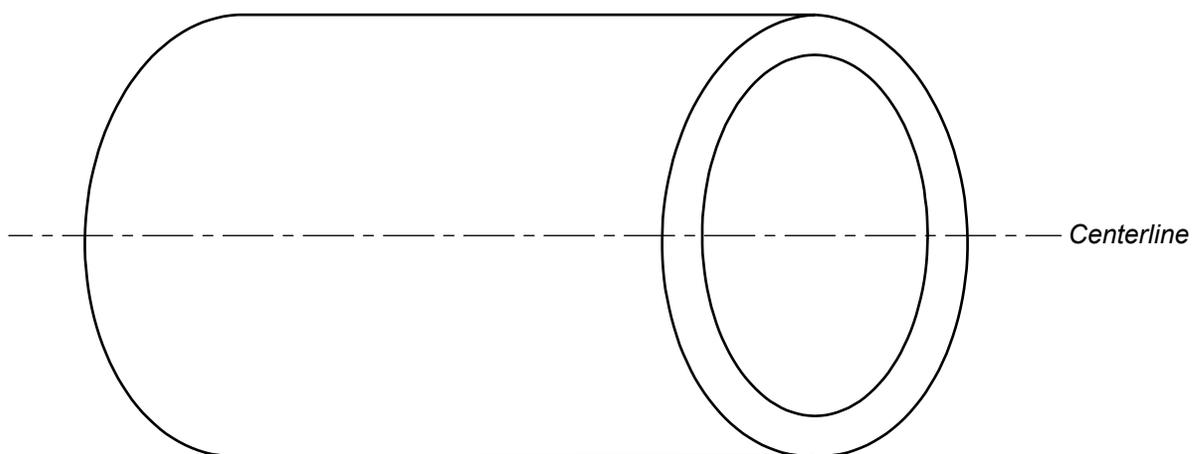
Figure 28 - Pipe in the 5G Horizontal and Fixed Position

The project plan includes evaluations of different pipeline repair conditions, such as soil and coating type, on weld deposition repairs. Baseline welding procedures were needed to support these evaluations. Several welding systems were evaluated for internal weld deposition using GMAW and used to develop baseline welding procedures. These evaluations focused on determining whether the systems could make a good internal weld deposit. The pipe axis was fixed in the 5G horizontal position (Figure 28). As welding progressed around the inside diameter, welding position transitioned between flat, vertical, and overhead. The types of envisioned repairs were ring deposits to reinforce a defective weld, spiral deposits to repair an entire pipeline section, and patches to repair local corrosion damage. Weld deposit motion for the first two types would best be achieved using orbital type welding procedures where welding clocks around the circumference. The patch repair could be accomplished using deposit motion that was either orbital or axial. Motion also required the use of torch weaving, a technique that improves out-of-position (i.e., vertical and overhead) weld pool shape. This is common in vertical-up welding to provide an intermediate shelf upon which to progressively build the weld pool deposit. The effects of deposit motion on productivity and quality also required evaluation for this application. With the different welding systems, the preferred metal transfer mode for GMAW was short-circuiting transfer. This mode assures drop transfer in all welding positions. Open arc droplet transfer that is provided by spray, pulse spray, and globular transfer are not suitable for spiral overhead welding where gravity promotes spatter instead of metal transfer.

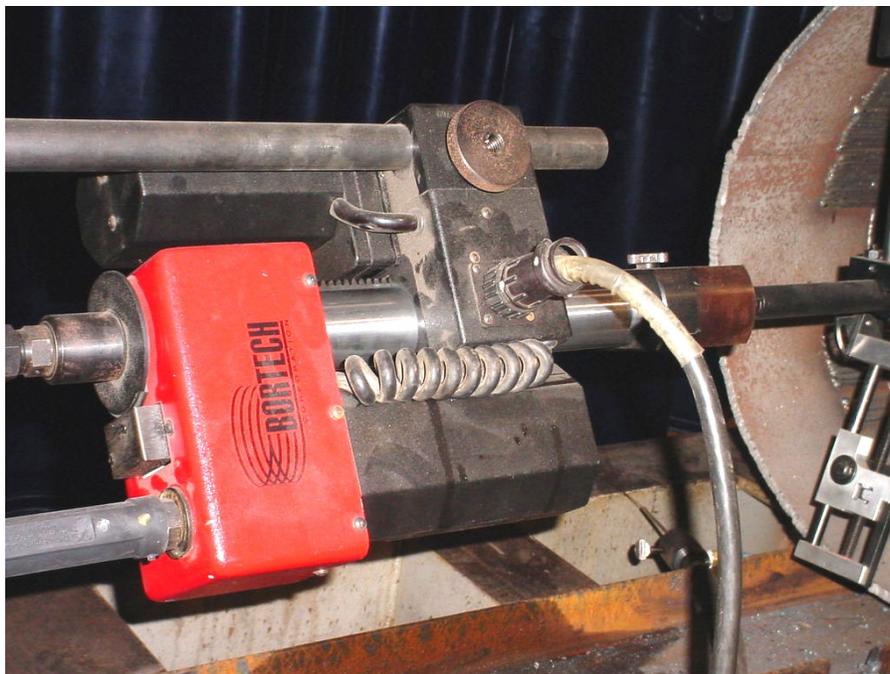
Figure 29 - Bortech Motion Mechanism for Continuous Spiral Deposition

Each system had motion control limitations and individually would not be appropriate candidates for an internal repair welding system. The internal bore cladding system manufactured by Bortech (Figure 29 and Figure 30) was designed for spiral cladding the inside of pipe that is preferably in the vertical position.

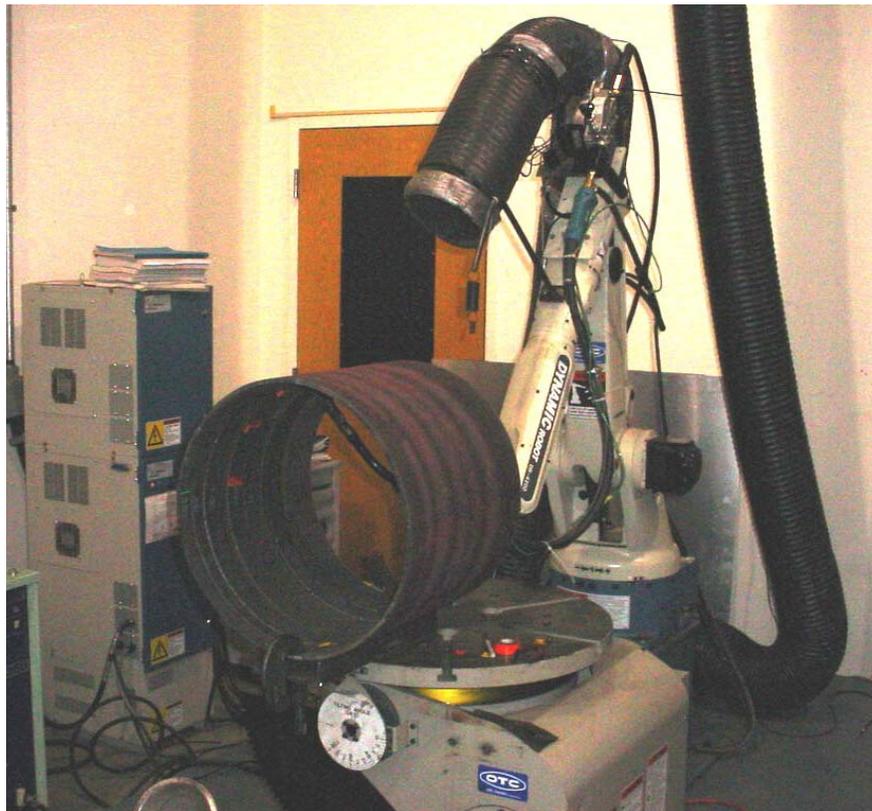
Figure 32 - OTC Robot Set-Up for Internal Welding

Based on the results experienced with the Bortech system, it was decided to develop preliminary welding procedures using a robotic GMAW system. A 6-axis coordinated motion robot (Figure 32) permitted the application of weave beads for spiral cladding or stringer beads in either direction. An observed limitation was the fact that the system did not have a welding torch current commutator to permit continuous spiral welding.

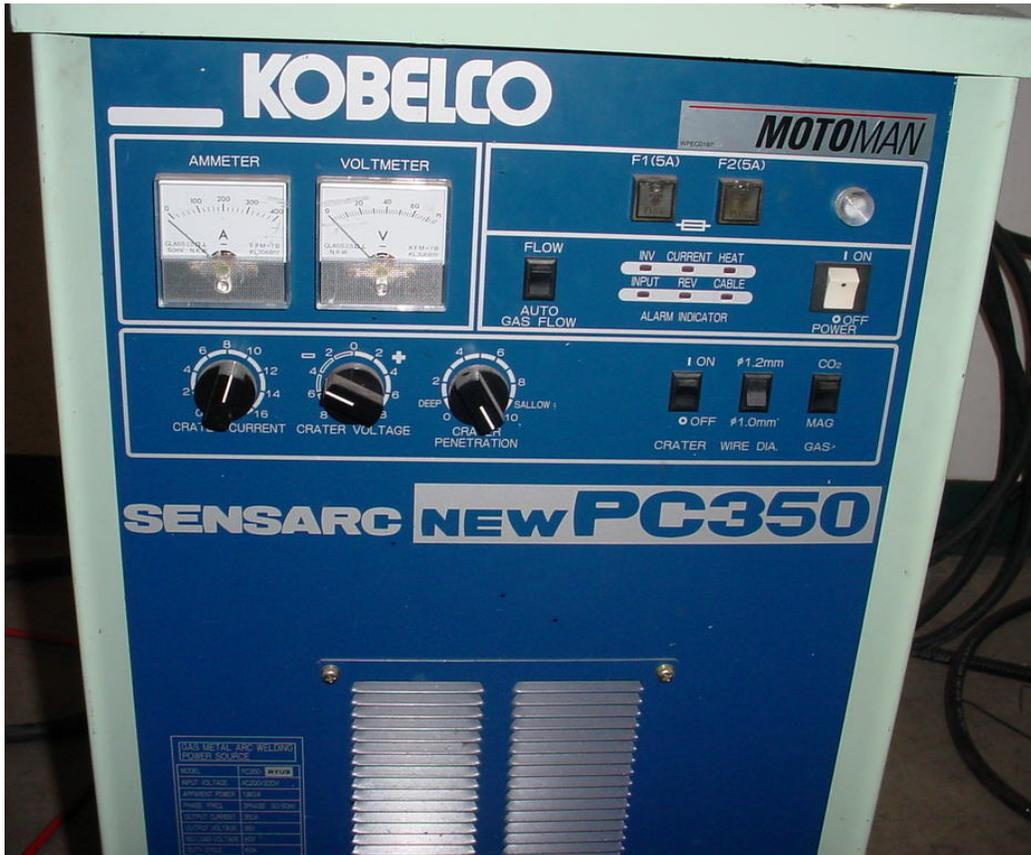
Figure 34 - Kobelco PC-350 Variable Polarity Fuzzy Logic Power Supply

0.8 mm (0.035 in.) or 1.2 mm (0.045 in) diameter electrodes. The waveform was simply modified by changing the electrode negative ratio on the pendant. Arc length and heat input is changed by an arc length knob on the pendant, which varies the pre-programmed pulse frequency.

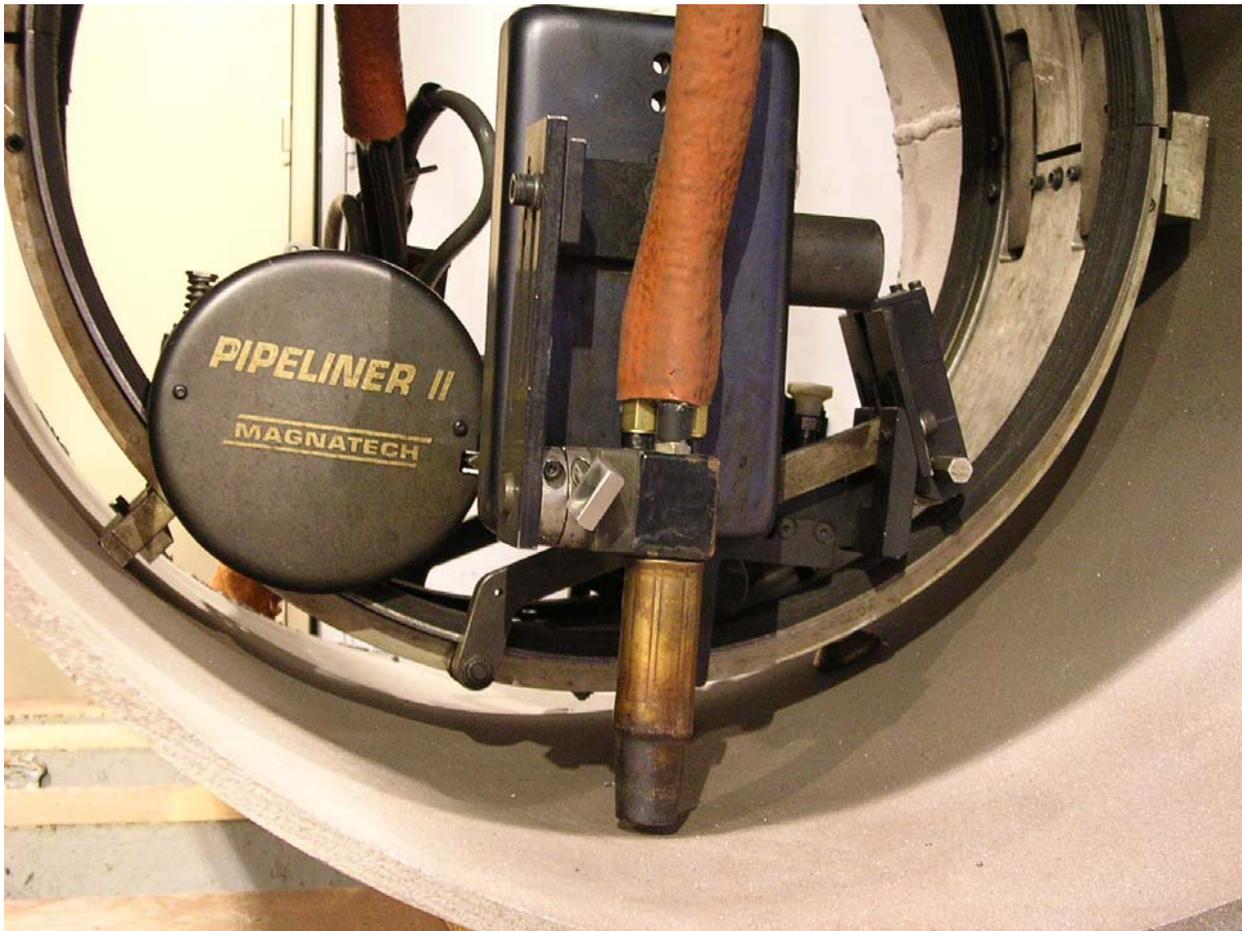
Figure 35 - Magnatech ID Welding Tractor Capable of Spiral & Ring Motion with Oscillation

Several years ago, PG&E purchased a welding tractor (Figure 35) from Magnatech for internal weld repair procedure development. This system was sent to EWI for this project so it could be used for pipeline repair testing and demonstrations, since this equipment is portable where the robot welding system is not portable.

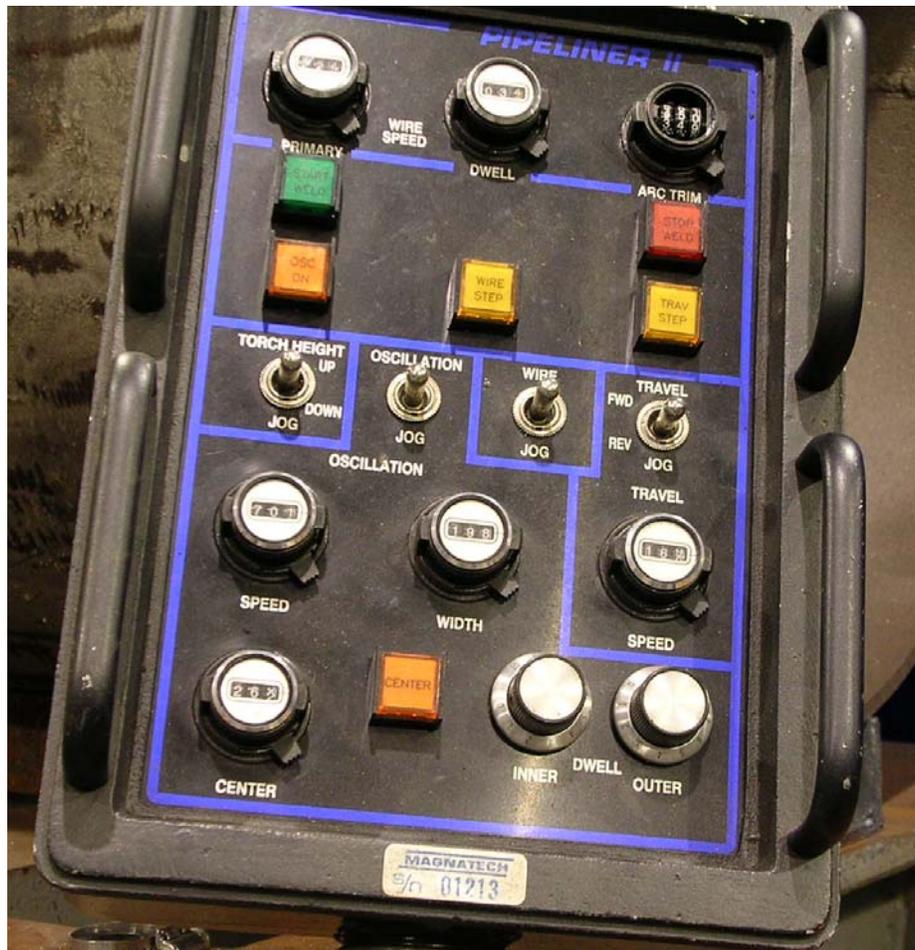
Figure 36 - Magnatech Control Pendant Showing Control Parameters

The Magnatech welding tractor has orbital motion with controls (Figure 36) for torch oscillation. The system is limited to a finite number of revolutions that can be made before cables need to be unwound. The controls are analog and do not have high accuracy, however, they are sufficient for preliminary parameter development and demonstration welding. Programmable controls would be required for an internal repair welding system using a Magnatech tractor. In addition, numerous mechanical changes would be required to accommodate a range of pipeline diameter sizes.

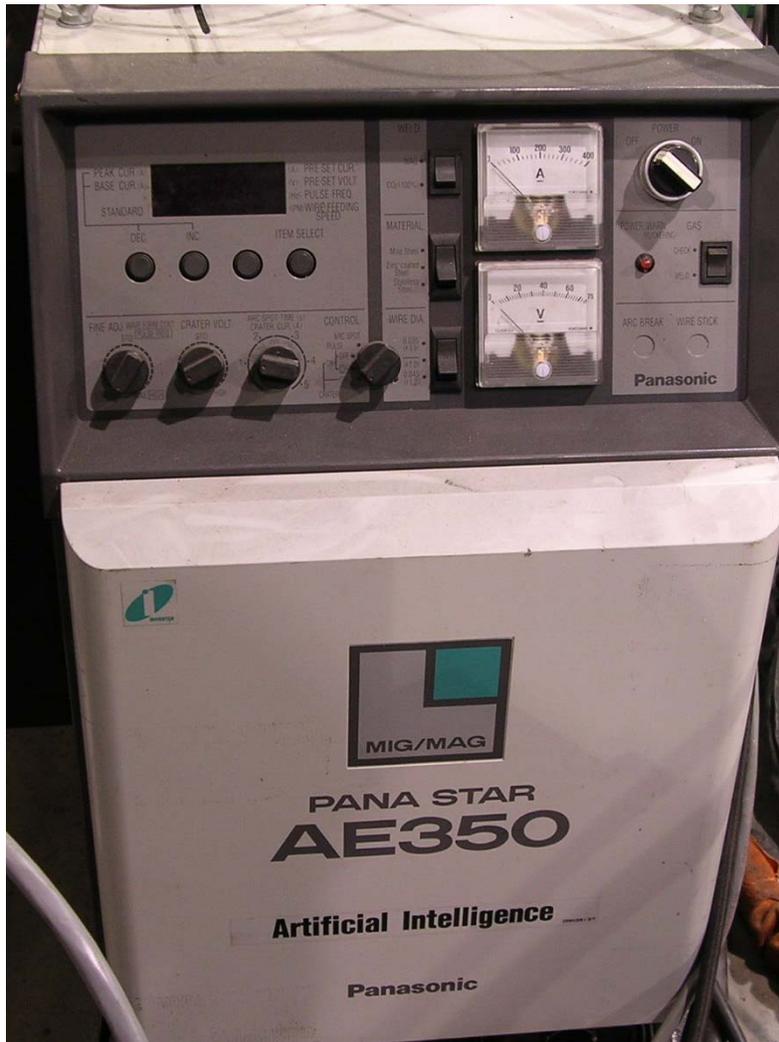
Figure 37 - Panasonic AE 350 Power Supply with Pulse Short-Circuit Metal Transfer Control

The Magnatech tractor was interfaced to a Panasonic AE 350 power supply (Figure 37). This power supply provides pulse waveforms and can be operated in a short-circuit mode where artificial intelligence is used to minimize spatter. The current pulsing and short circuiting helps lower heat input and improve deposition rate in out-of-position welds. Pre-programmed current waveforms are provided by algorithms for steel electrodes, and many other materials.

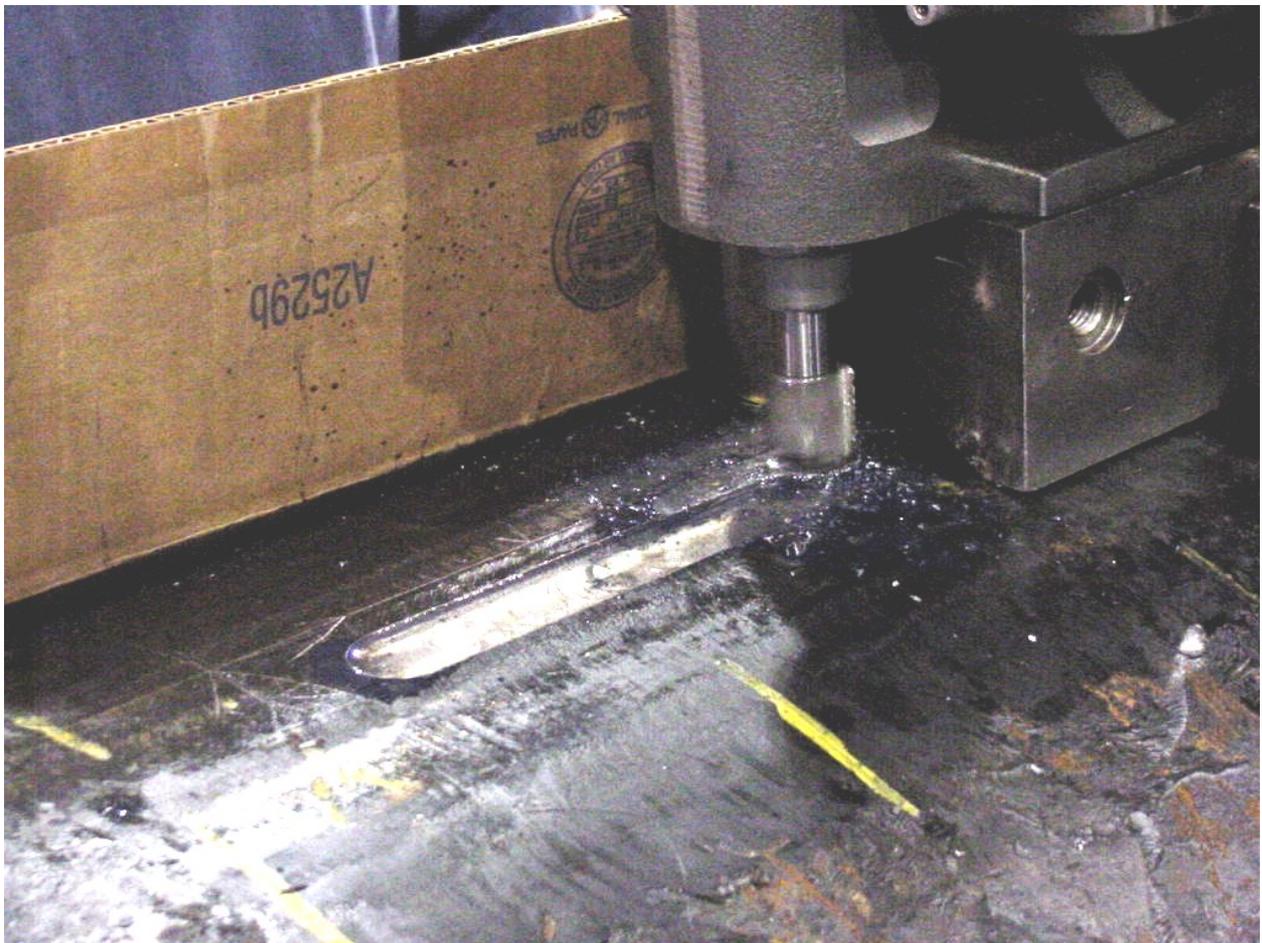
Figure 38 - Milling Machine Set-Up Used to Simulate Corrosion on Pipe Sections

The simulated corrosion in the pipe was introduced by milling a slot into a 559 mm (22 in.) OD pipe with a wall thickness of 7.9 mm (0.312 in.) using the set-up as shown in Figure 38. The dimensions of the corrosion damage are shown in Figure 39; finished simulated damage is found in Figure 40; and a magnified view of the damage is located in Figure 41.

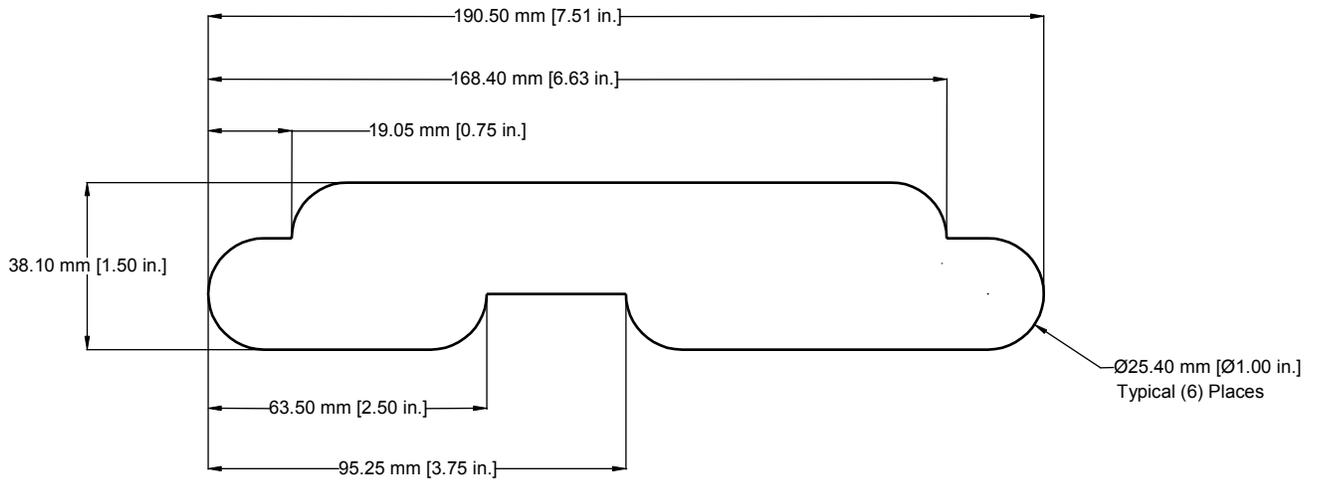
Figure 39 - Dimensions of Simulated Corrosion on 558.80 mm (22 in.) Pipe
