REPORT

EWI Project No. 46211GTH
Electronic File Name: 41633R47.pdf

Internal Repair of Pipelines Review & Evaluation of Internal Pipeline Repair Trials Report

Report Issued: September 2004

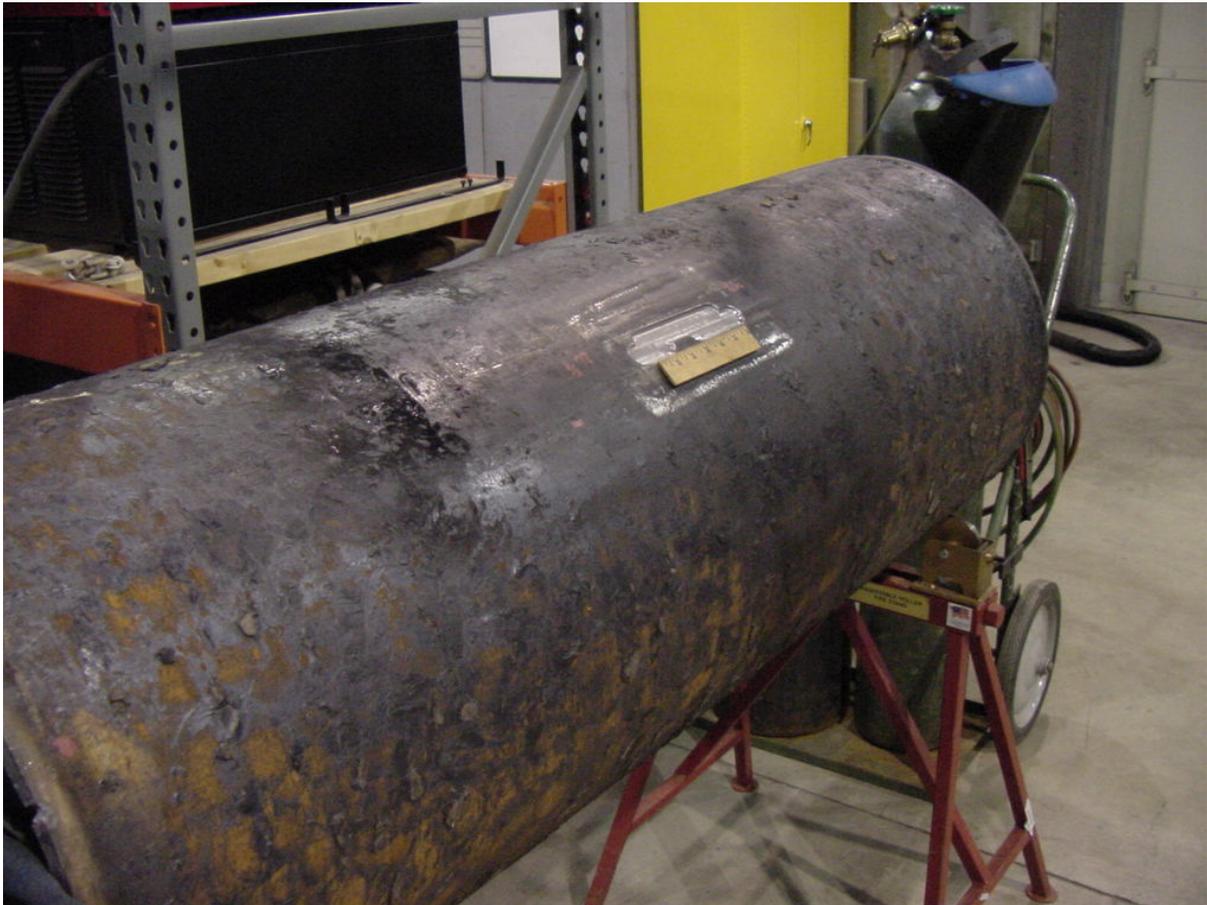
Figure 40 - Simulated Corrosion on 558.80 mm (22 in.) Pipe

The simulated corrosion in the pipe was introduced by milling a slot into a 559 mm (22 in.) OD pipe with a wall thickness of 7.9 mm (0.312 in.) using the set-up as shown in Figure 38. The dimensions of the corrosion damage are shown in Figure 39; finished simulated damage is found in Figure 40; and a magnified view of the damage is located in Figure 41.

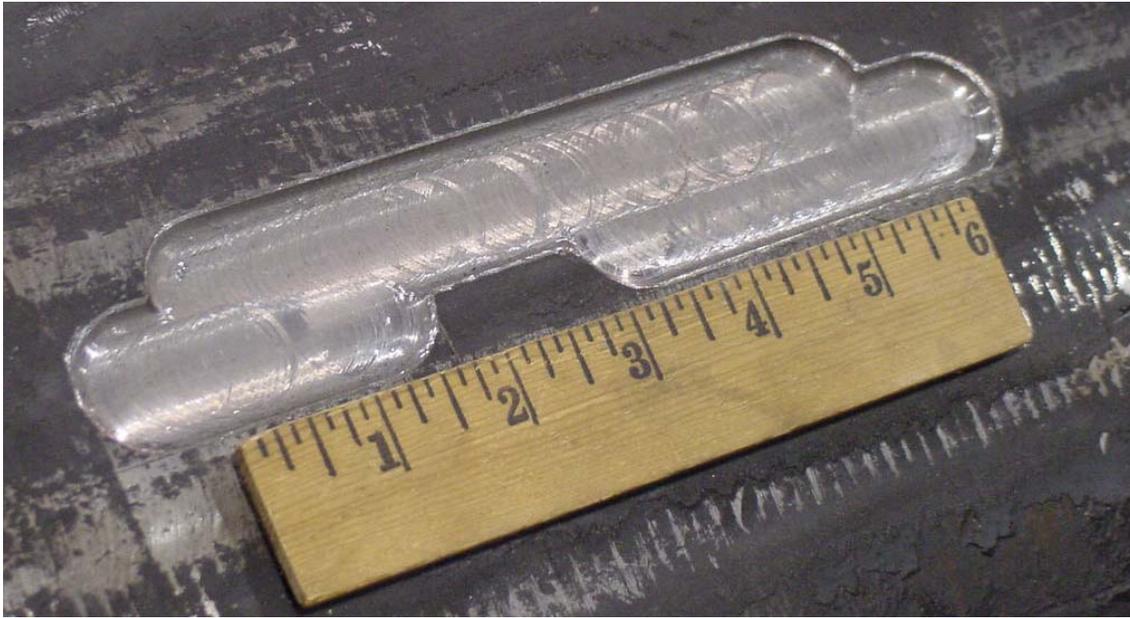
Figure 41 - Magnified View of Simulated Corrosion on 558.80 mm (22 in.) Pipe

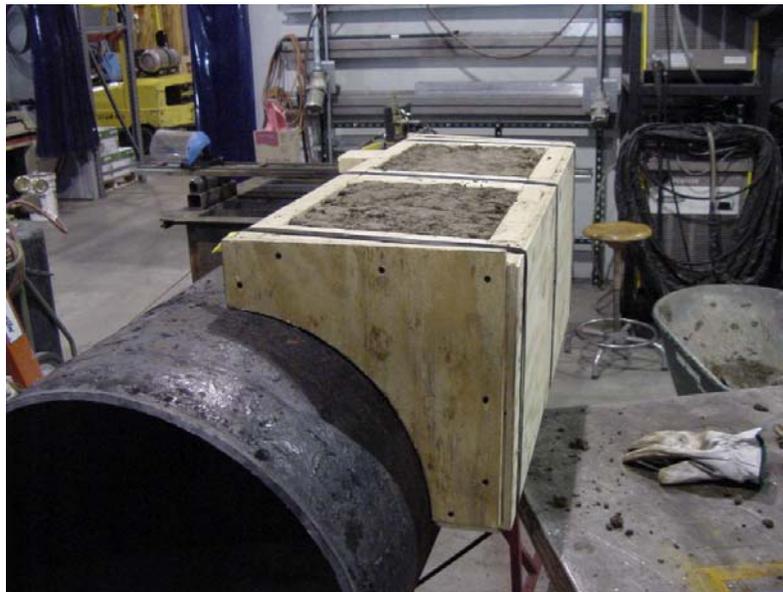
Figure 42 - Dirt Box for Weld Deposition Repair

The dirt box in Figure 42 was used to simulate in-service welding conditions and cooling rates for weld deposition repair evaluation trials.

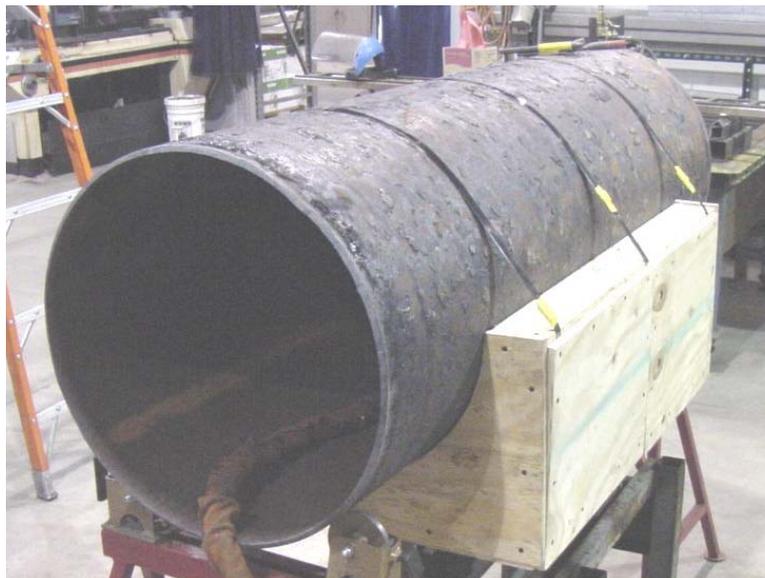
Figure 43 - Orientation of Pipe Section with Dirt Box for Weld Deposition Repair

The pipe section with the dirt box was rotated as shown in Figure 43 to facilitate welding on the inside of the pipe section from the 6:00 position where the weld passes were initiated to the 9:00 position where the weld passes were terminated.

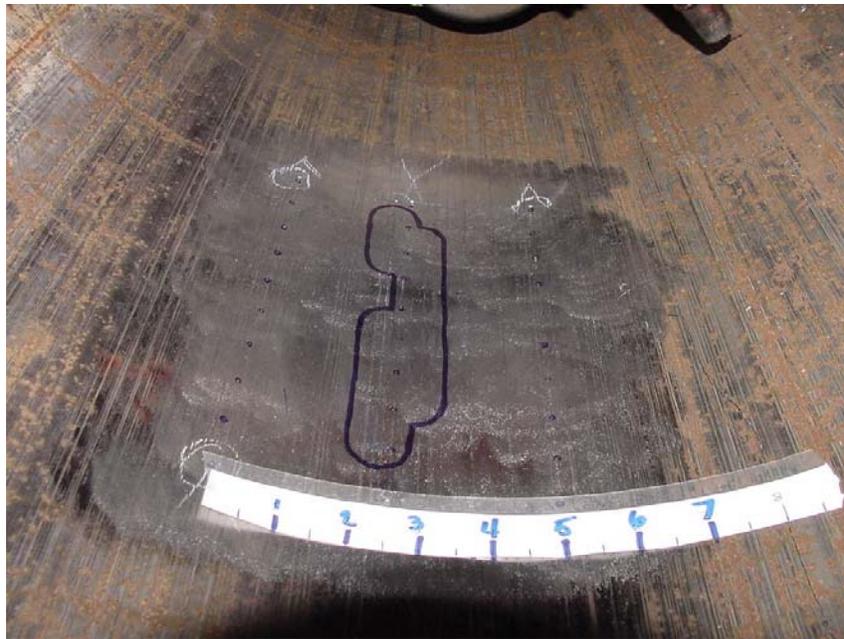
Figure 44 - Outline of Simulated Corrosion on Inside Diameter of Pipe Section

An outline of the simulated corrosion was made on the ID of the pipe (Figure 44) to assure the deposited weld metal completely covered the area of simulated corrosion on the inside of the pipe.

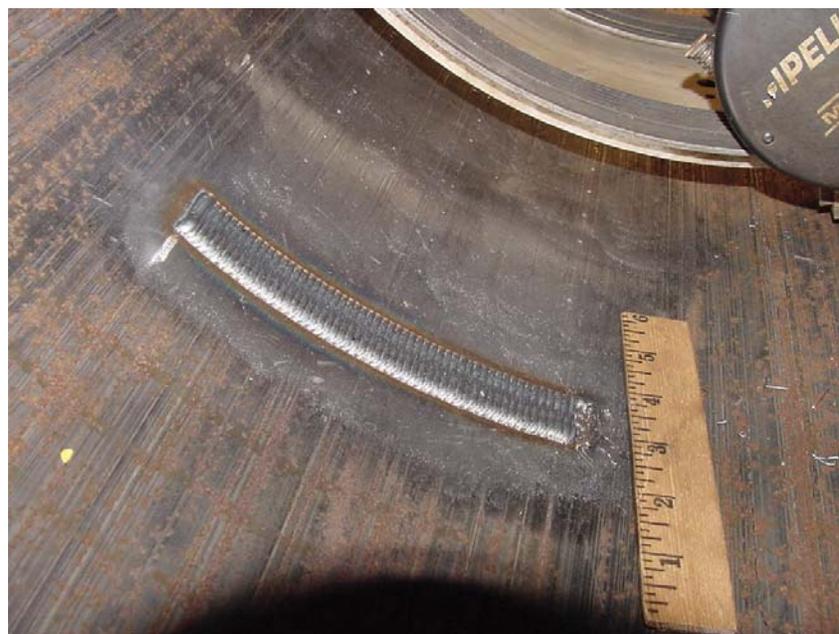
Figure 45 - First Pass of First Layer of Deposited Weld Metal on Inside Pipe Diameter

The first pass of the first layer of the ID weld repair is shown in Figure 45.

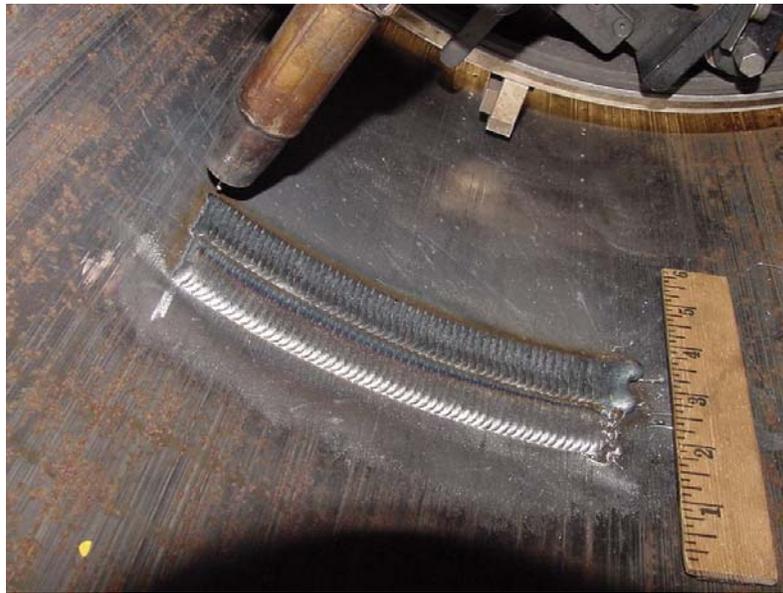
Figure 46 - Second Pass of First Layer of Deposited Weld Metal on Inside Pipe Diameter

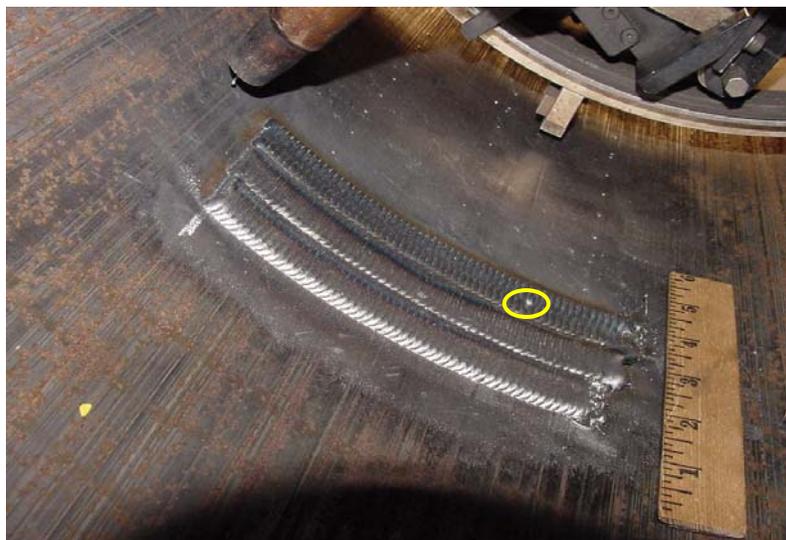
Figure 47 - Third Pass of First Layer of Deposited Weld Metal on Inside Pipe Diameter

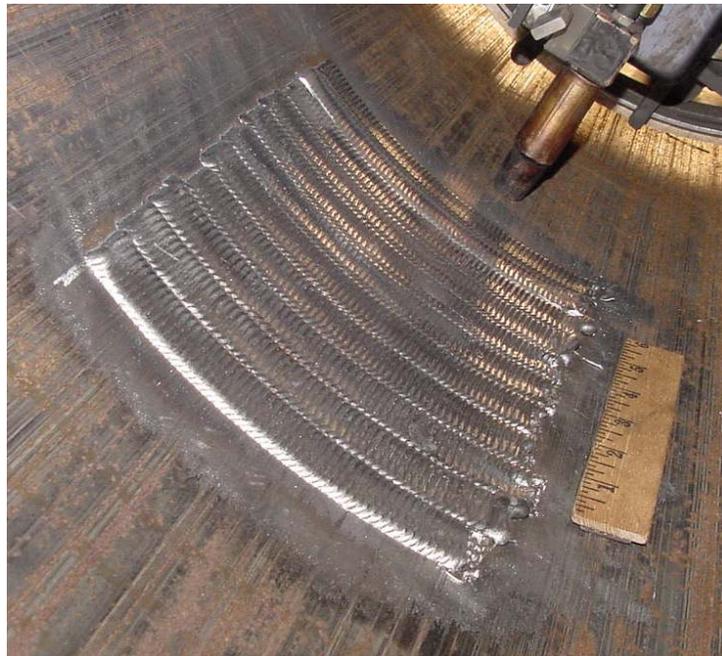
Figure 48 - Finished First Layer of Deposited Weld Metal on Inside Pipe Diameter

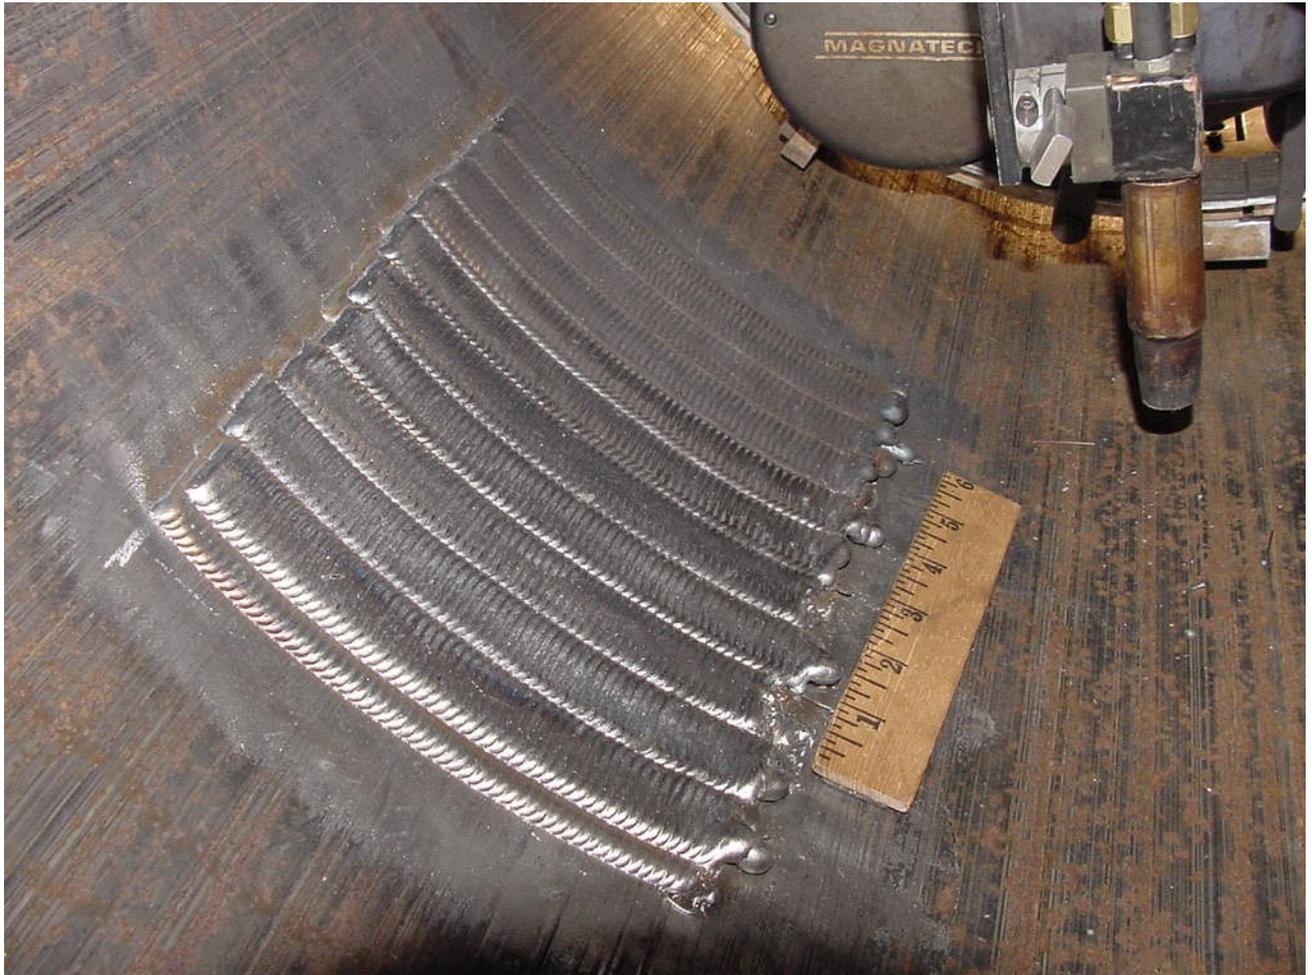
Figure 50 - Finished Second Layer of Deposited Weld Metal on Inside Pipe Diameter

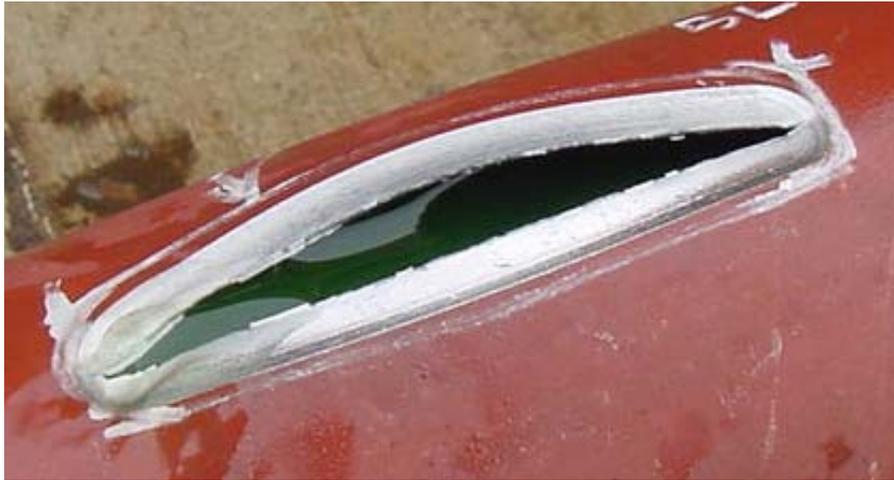
Figure 51 - Pipe Section with Long, Shallow Simulated Corrosion Damage – Without Liner – Following Hydrostatic Pressure Test

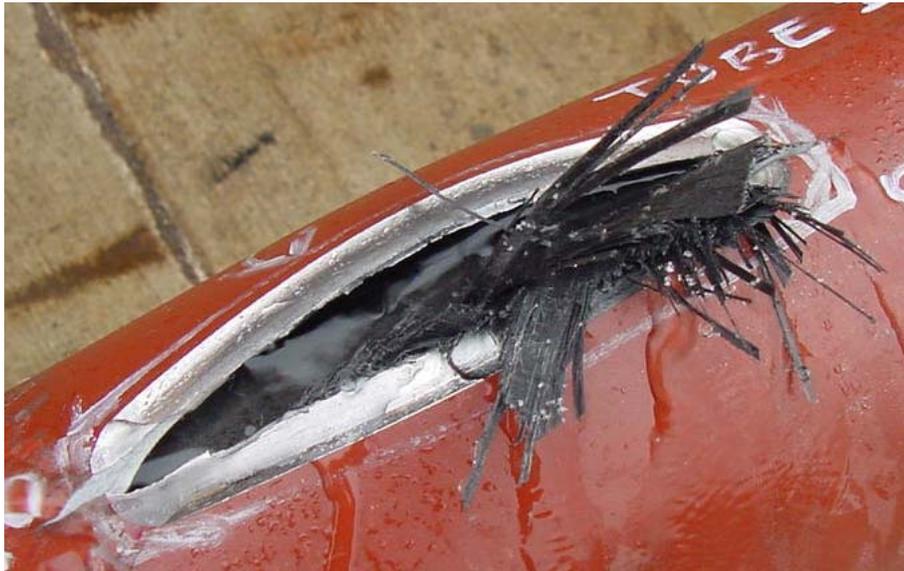
Figure 52 - Pipe Section with Long, Shallow Simulated Corrosion Damage – With Liner – Following Hydrostatic Pressure Test

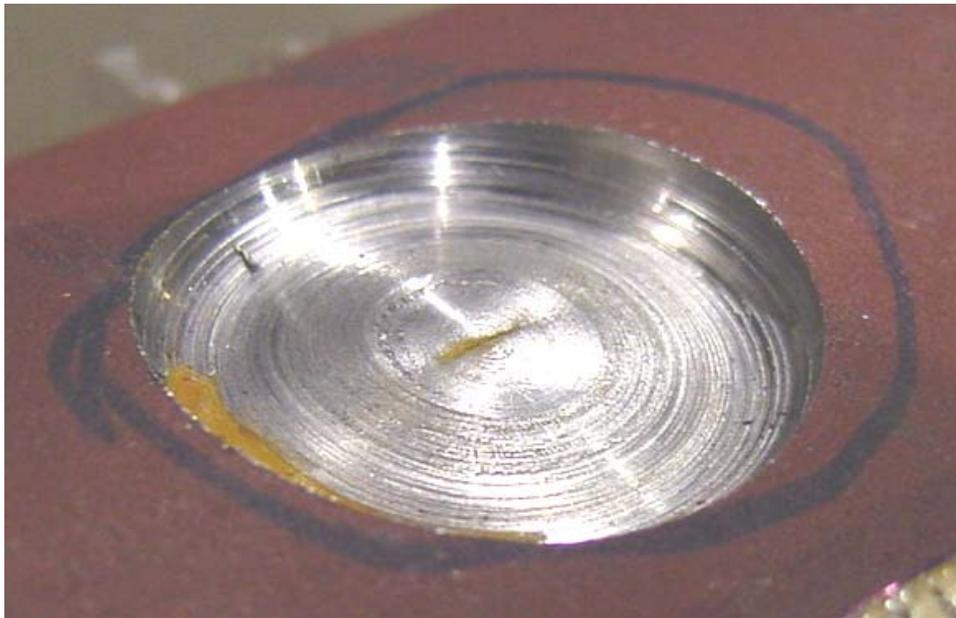
Figure 53 - Pipe Section with Short, Deep Simulated Corrosion Damage – Without Liner – Following Hydrostatic Pressure Test

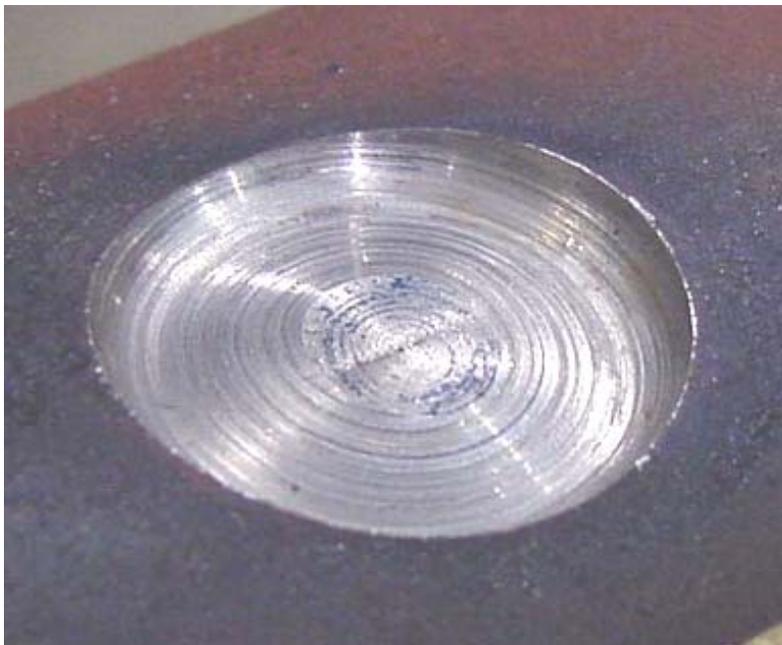
Figure 54 - Pipe Section with Short, Deep Simulated Corrosion Damage – With Liner – Following Hydrostatic Pressure Test

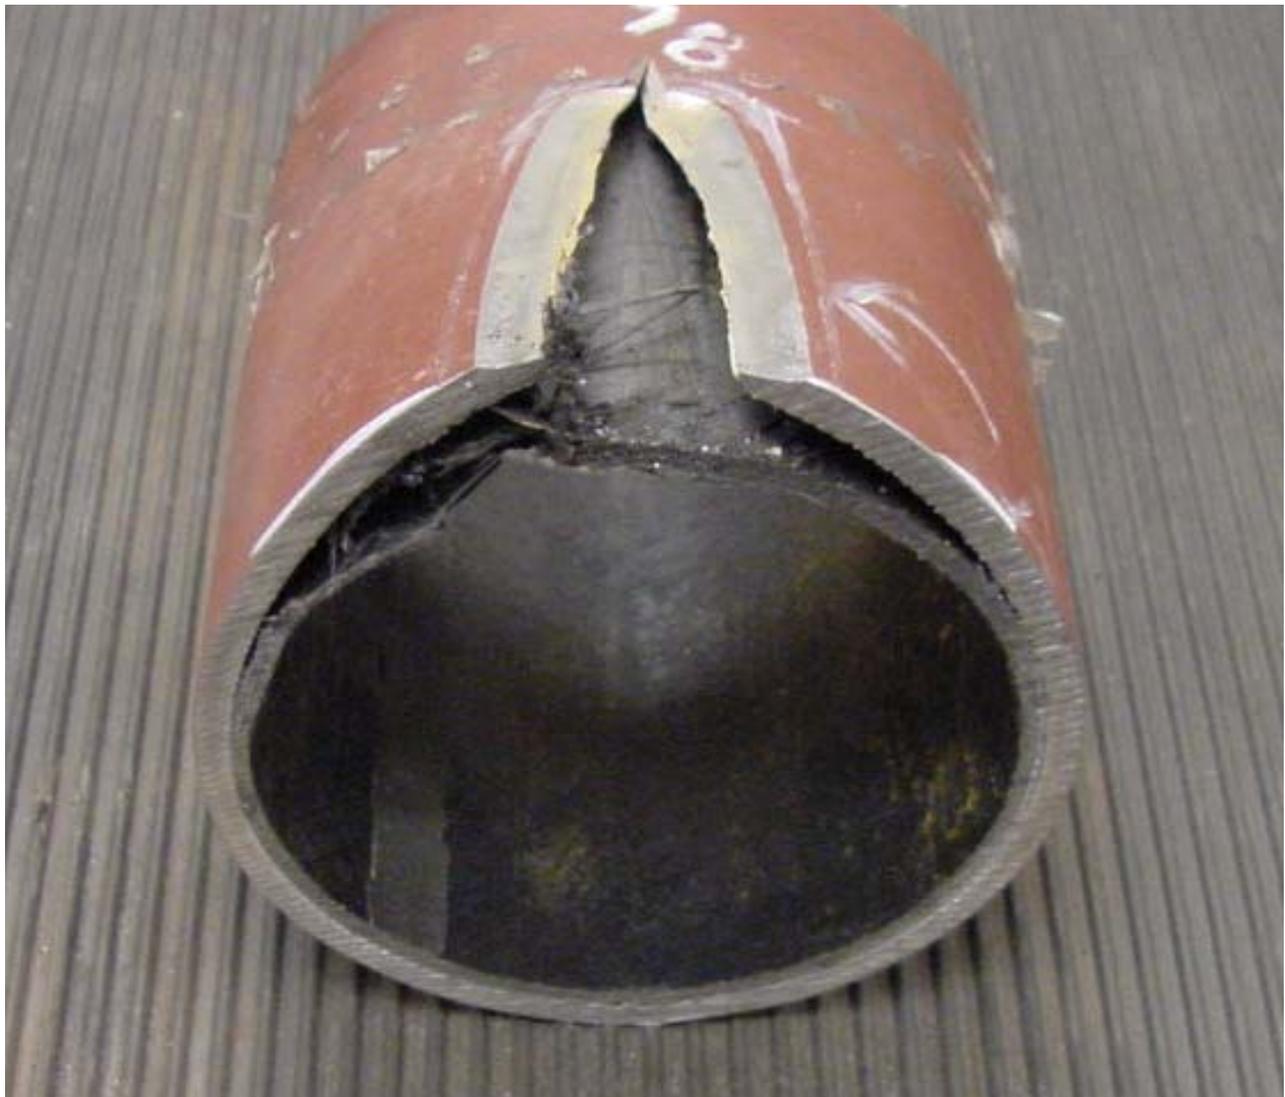
Figure 55 - Water-Jet Cut Section through Pipe Sample Containing Round-Bottom Longitudinal Slot with Liner Installed

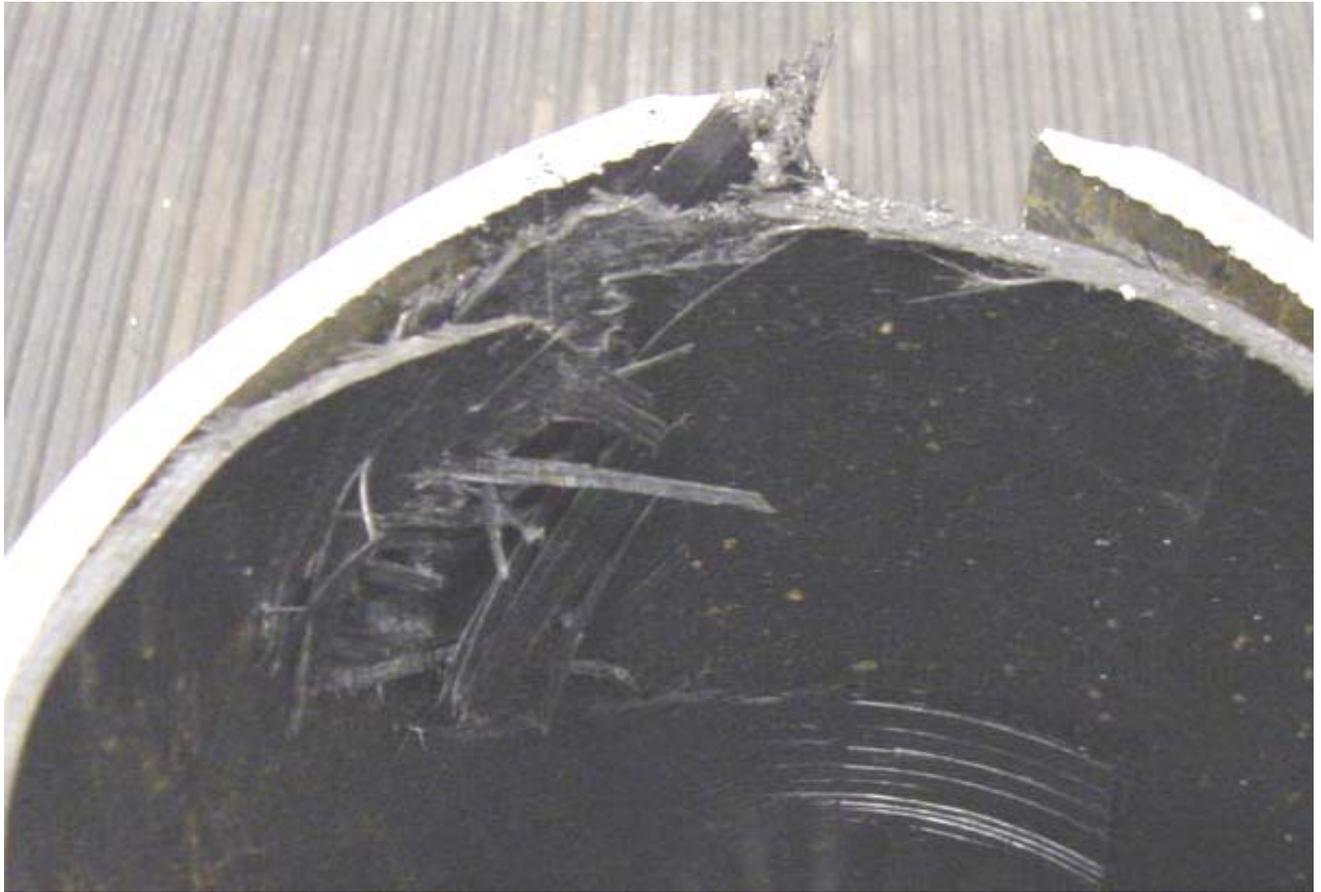
Figure 56 - Pipe Sample Containing Round-Bottom Longitudinal Slot Showing Rupture of Liner Material

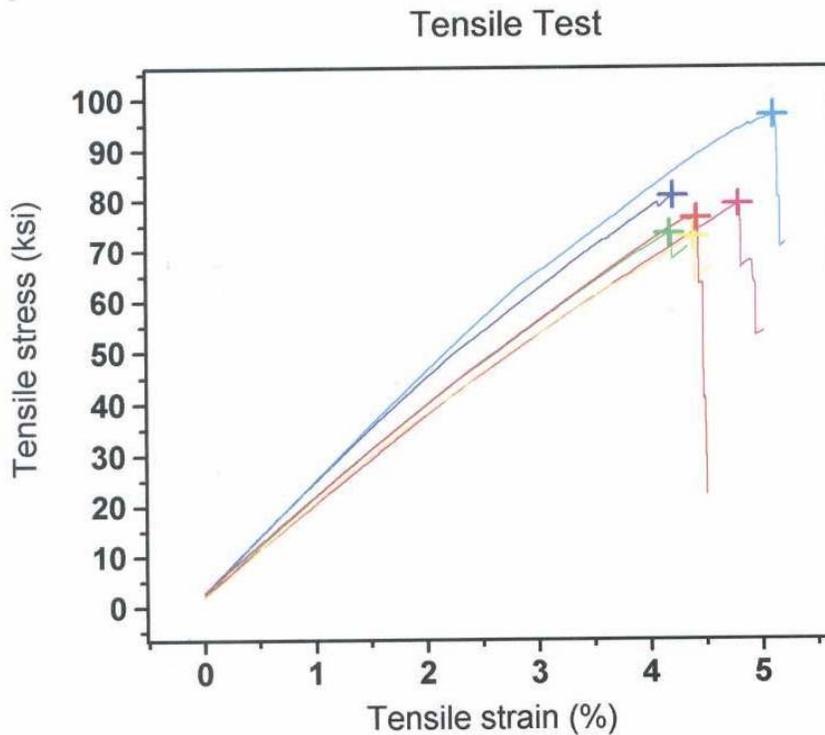
Figure 57 - Tensile Testing Results for Glass/Polypropylene Liner Material

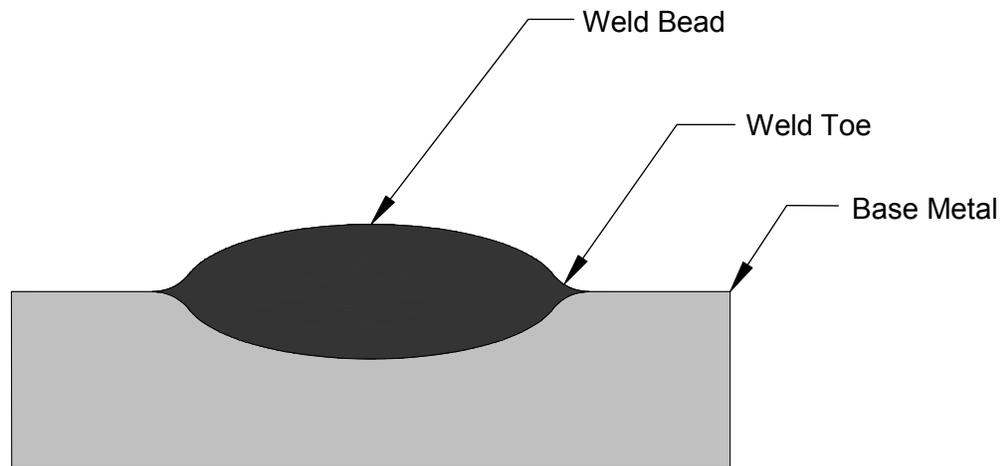
Figure 58 - Weld Bead Shape Diagram

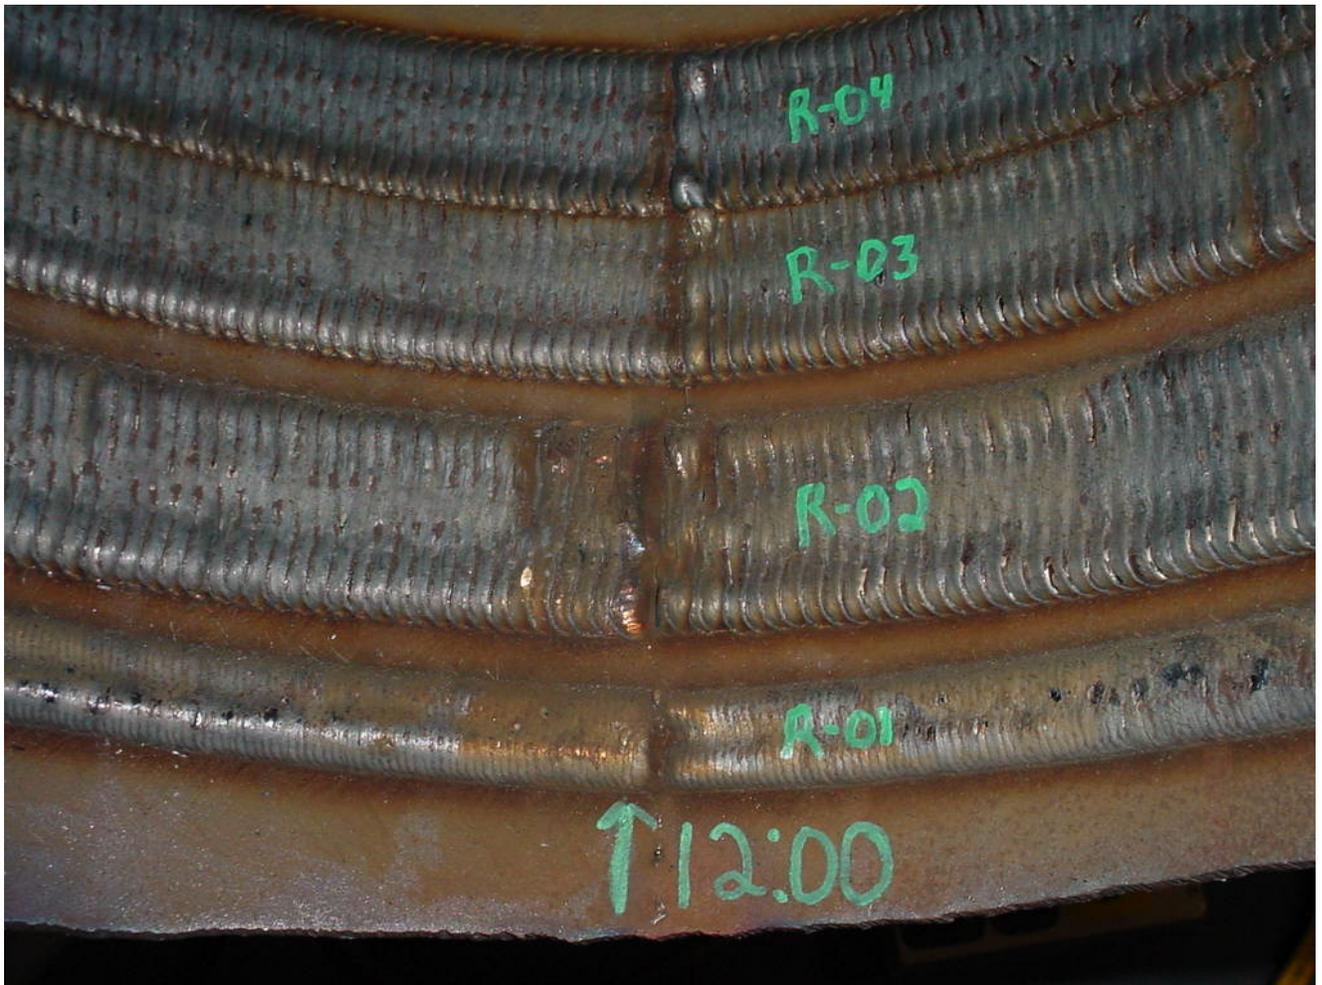
Figure 59 - Tests R-01 through R-04 at 12:00 (Note the Poor Tie-Ins for R-01 through R-03)

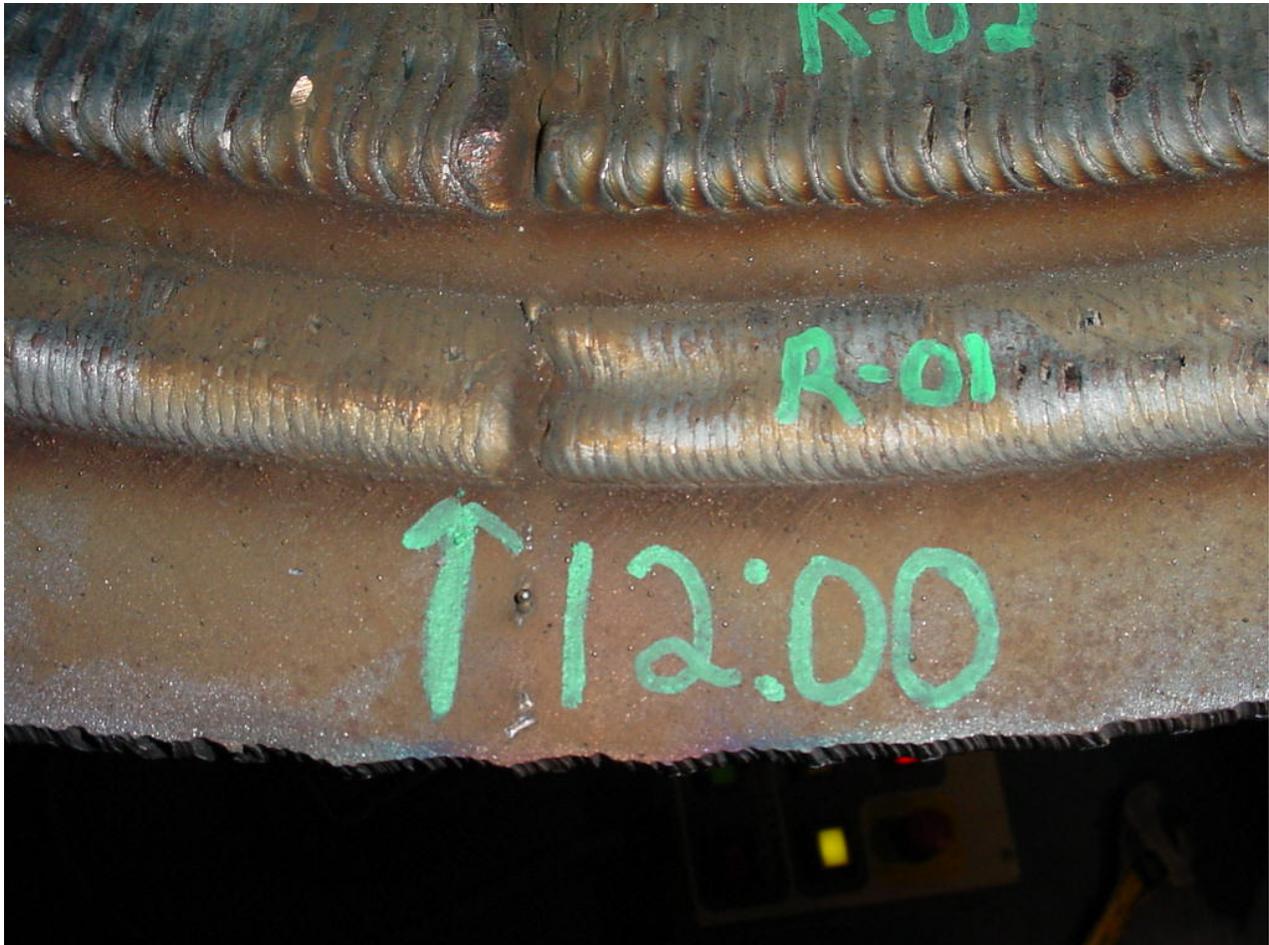
Figure 60 - Test R-01 at 12:00 Showing Poor Stop-Start Tie-In

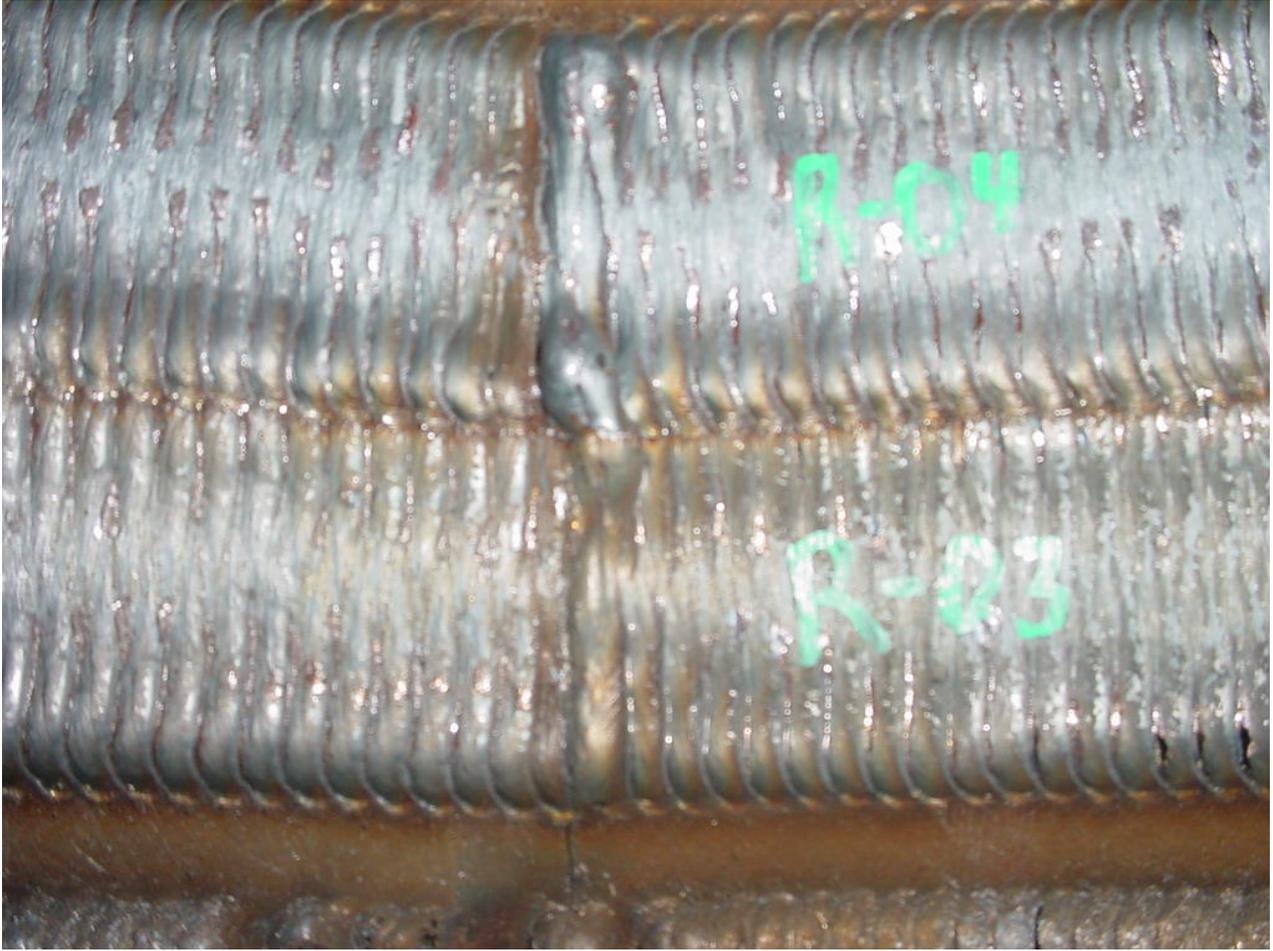
Figure 61 - Tests R-03 and R-04 at 12:00 Showing Better Stop-Start Overlap.

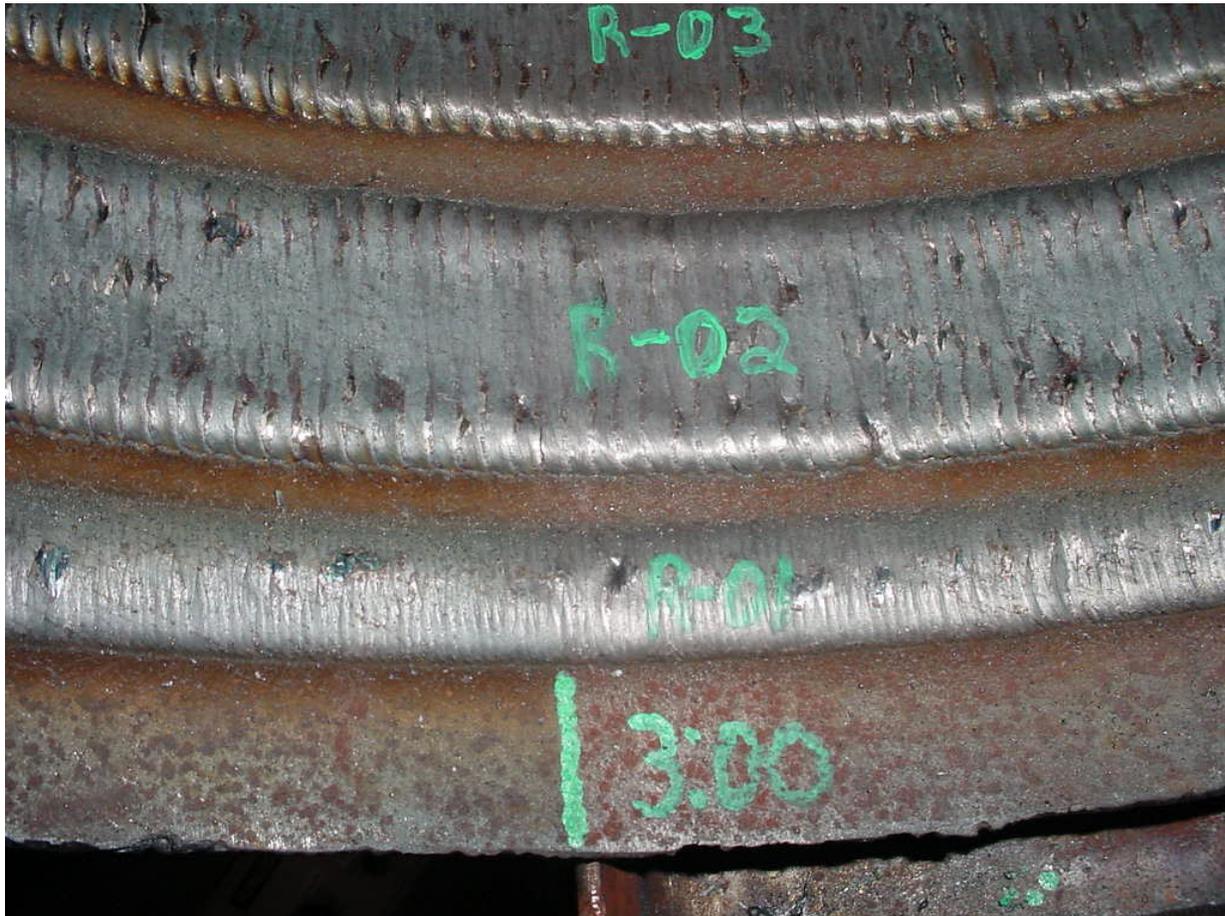
Figure 62 - Tests R-01 and R-02 at 3:00 Showing Steady-State Bead Shape

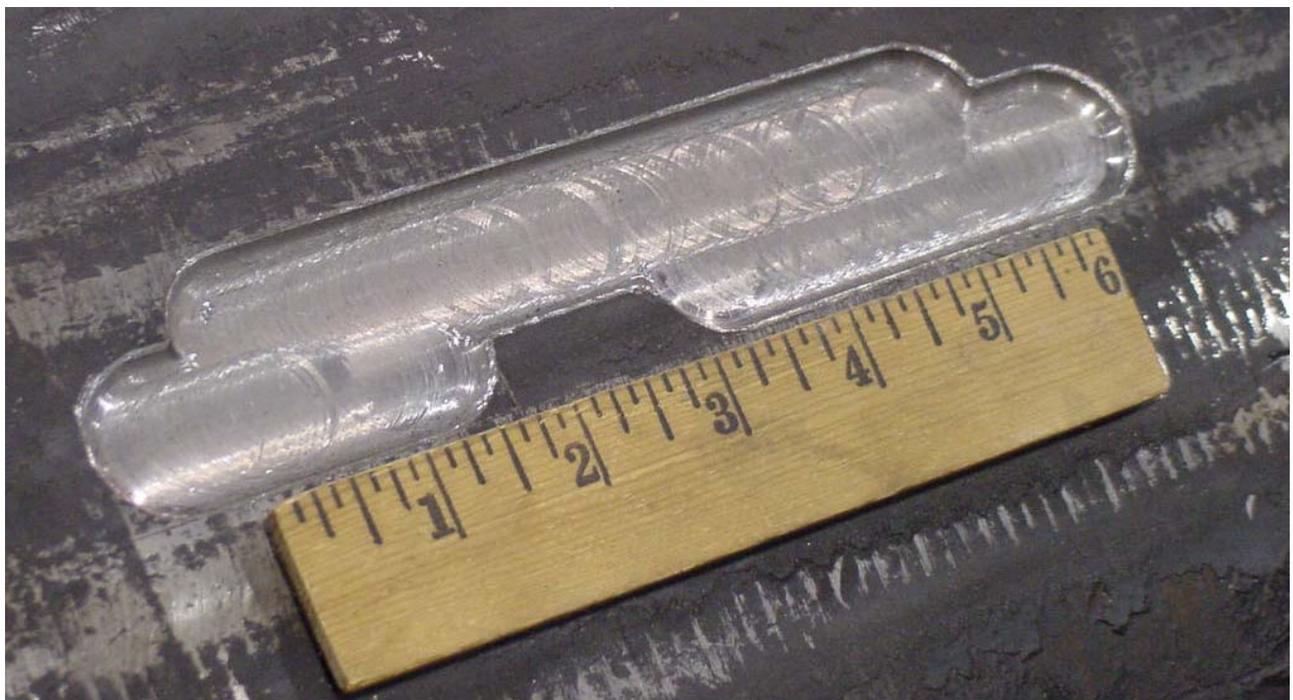
Figure 64 - Selected Configuration of Simulated Damage for 558.80 mm (22 in.) Diameter Pipe Sections

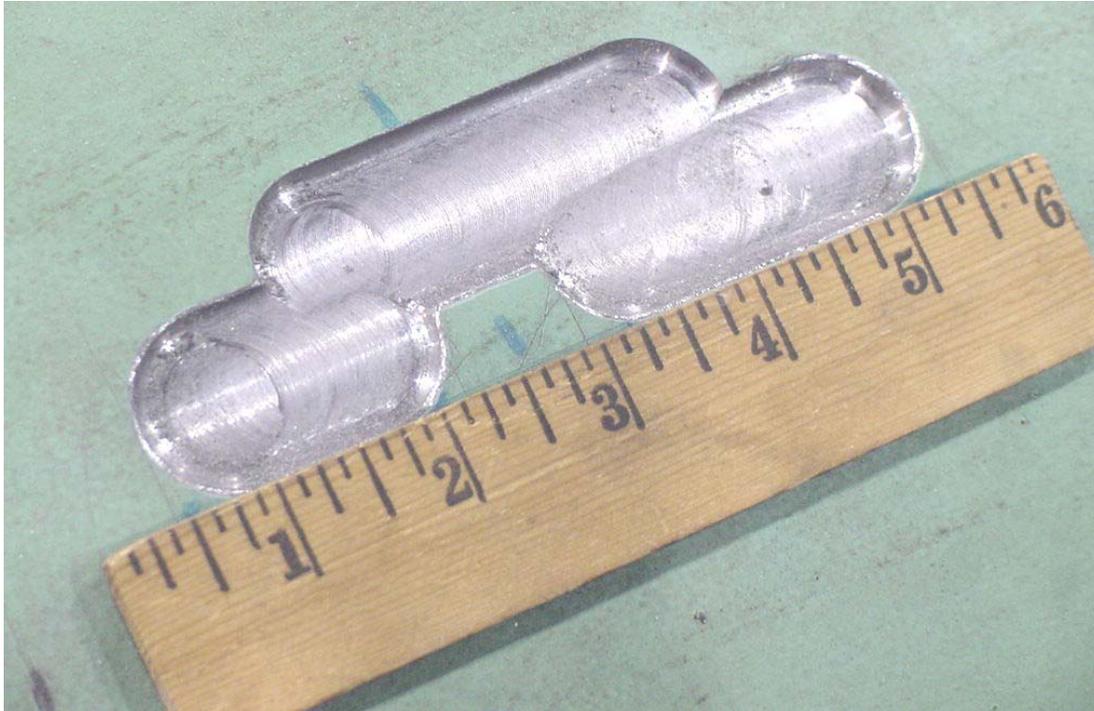
Figure 65 - Selected Configuration of Simulated Damage for 508 mm (20 in.) Diameter Pipe Sections

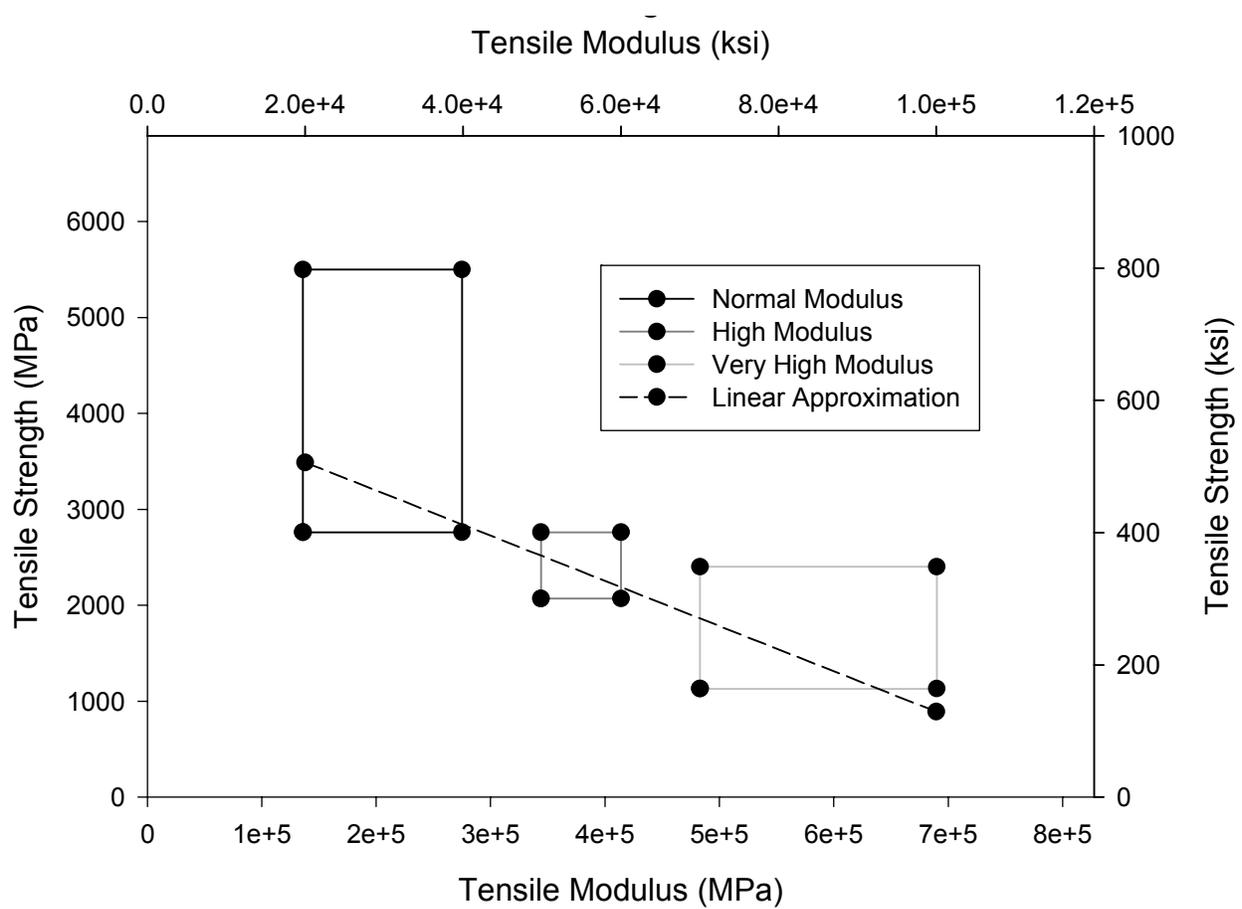
Figure 66 - Relationship Between Modulus and Strength for Carbon Fibers

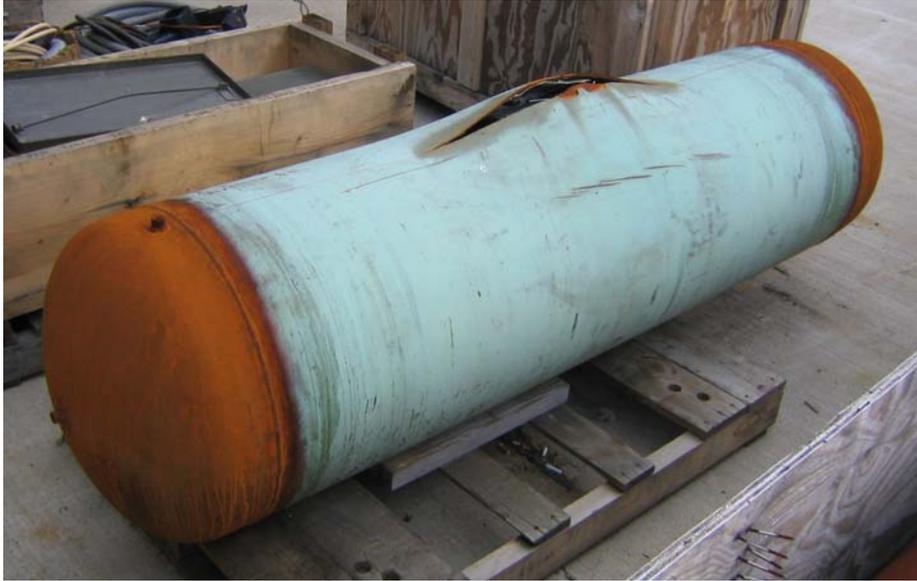
Figure 68 - Pipe With Carbon Fiber-Reinforced Liner Repair After Burst Test

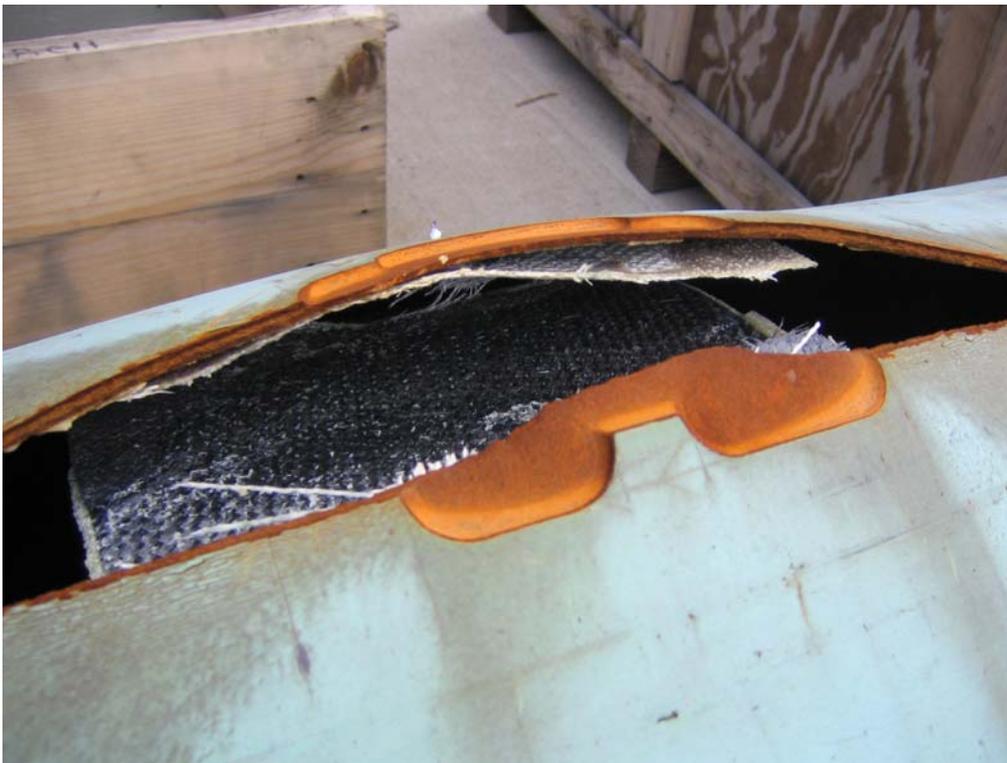
Figure 69 - Failure Initiation Site For Burst Tested Pipe With Carbon Fiber-Reinforced Liner Repair

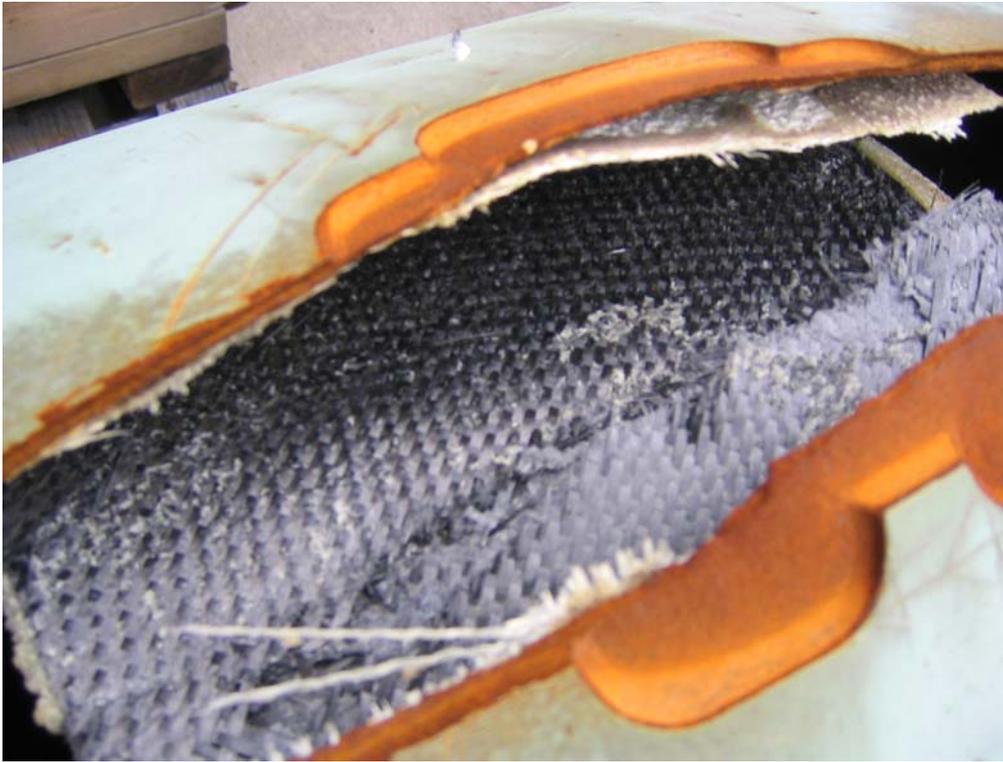
Figure 70 - Magnification of Carbon Fiber-Reinforced Patch After Burst Test
