REPORT

EWI Project No. 46211GTH
Electronic File Name: 41633R47.pdf

Internal Repair of Pipelines Review & Evaluation of Internal Pipeline Repair Trials Report

Report Issued: September 2004

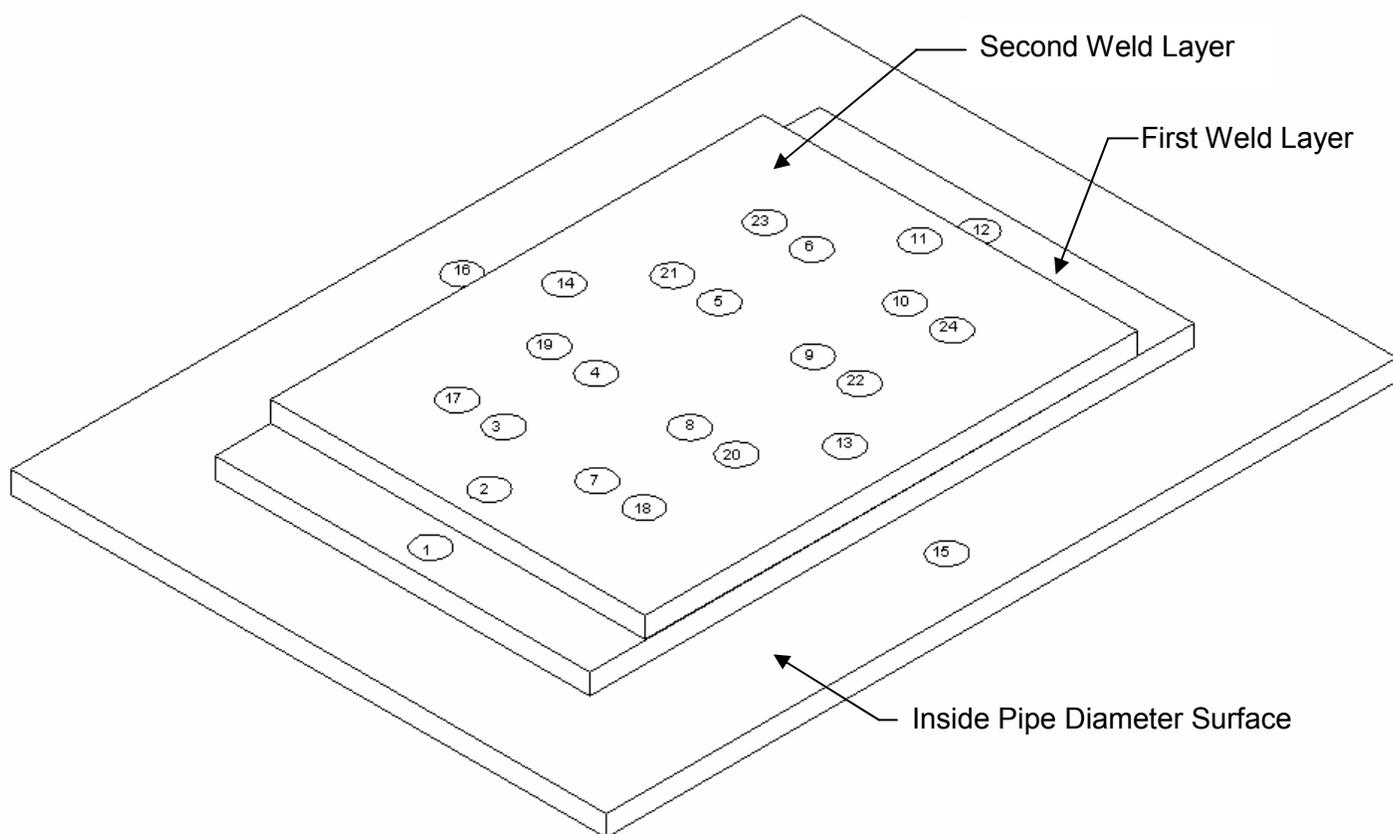
Figure 71 - Ultrasonic Thickness Measurement Locations on Weld Deposition Repair

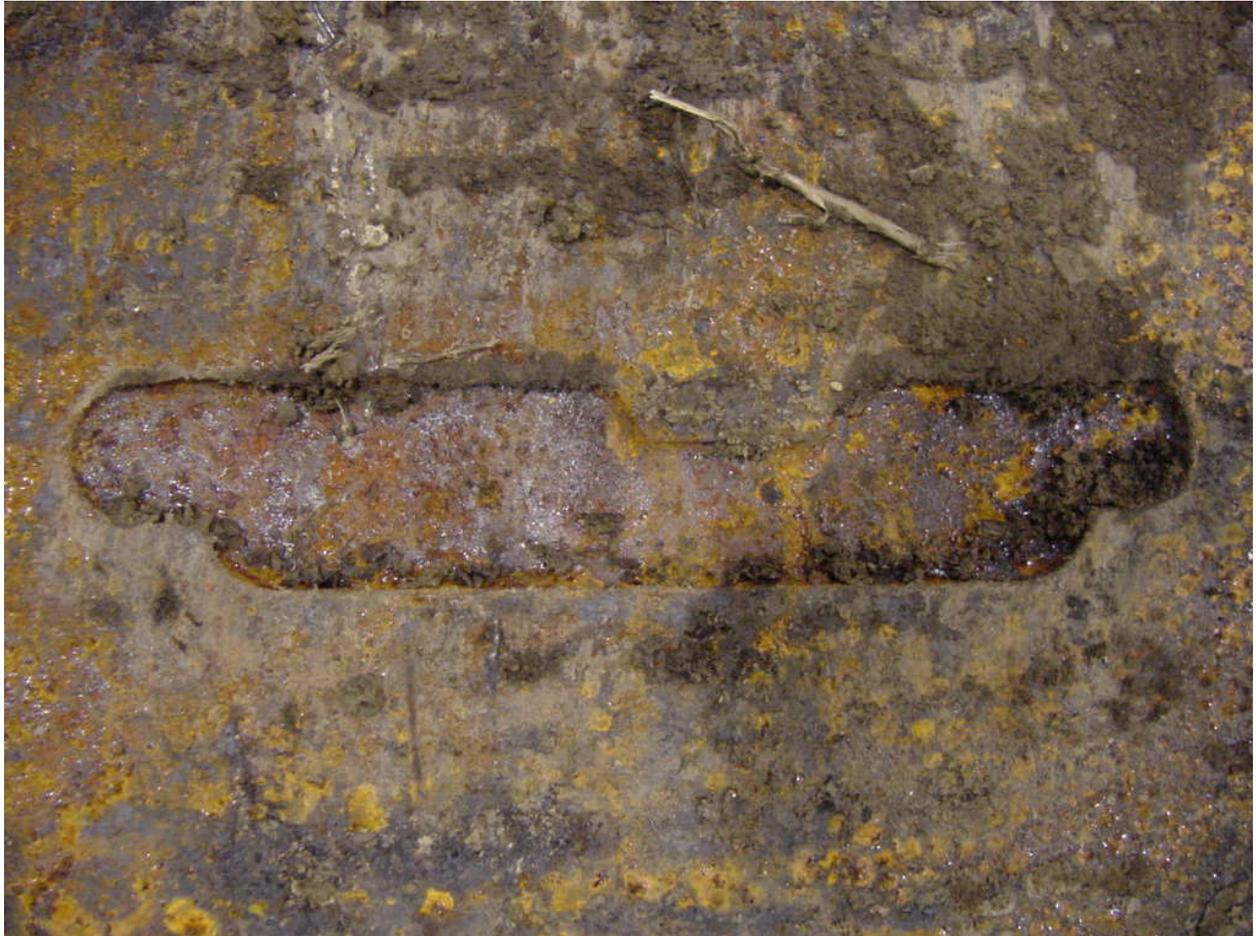
Figure 72 - Simulated Corrosion on Outside of Pipe After Internal Weld Deposition Repair

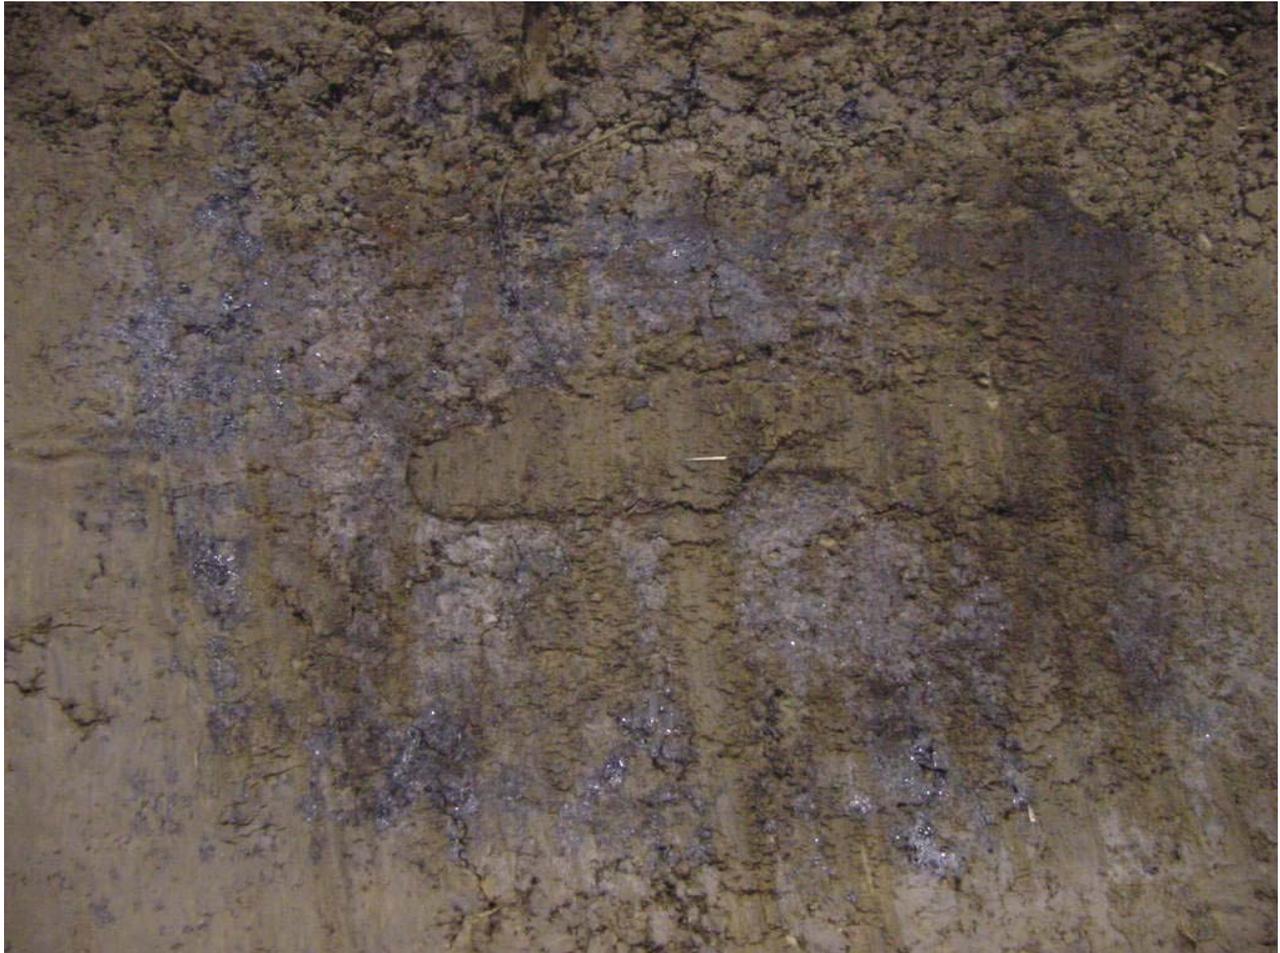
Figure 73 - Dirt That Was In Contact With Pipe During Internal Weld Deposition Repair

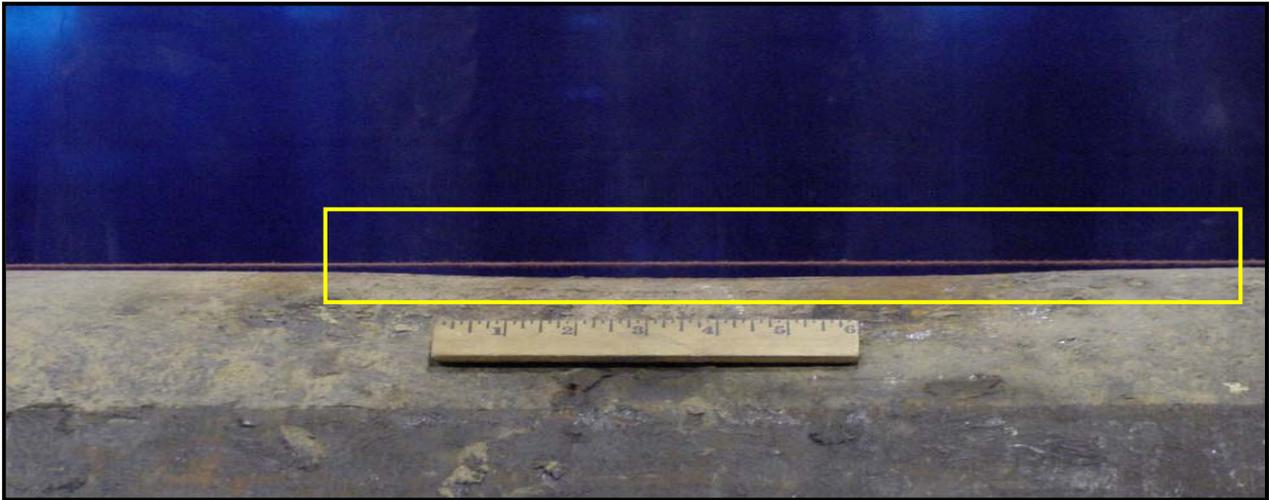
Figure 74 - Profile of Dent in Outside Pipe Surface After Internal Weld Deposition Repair

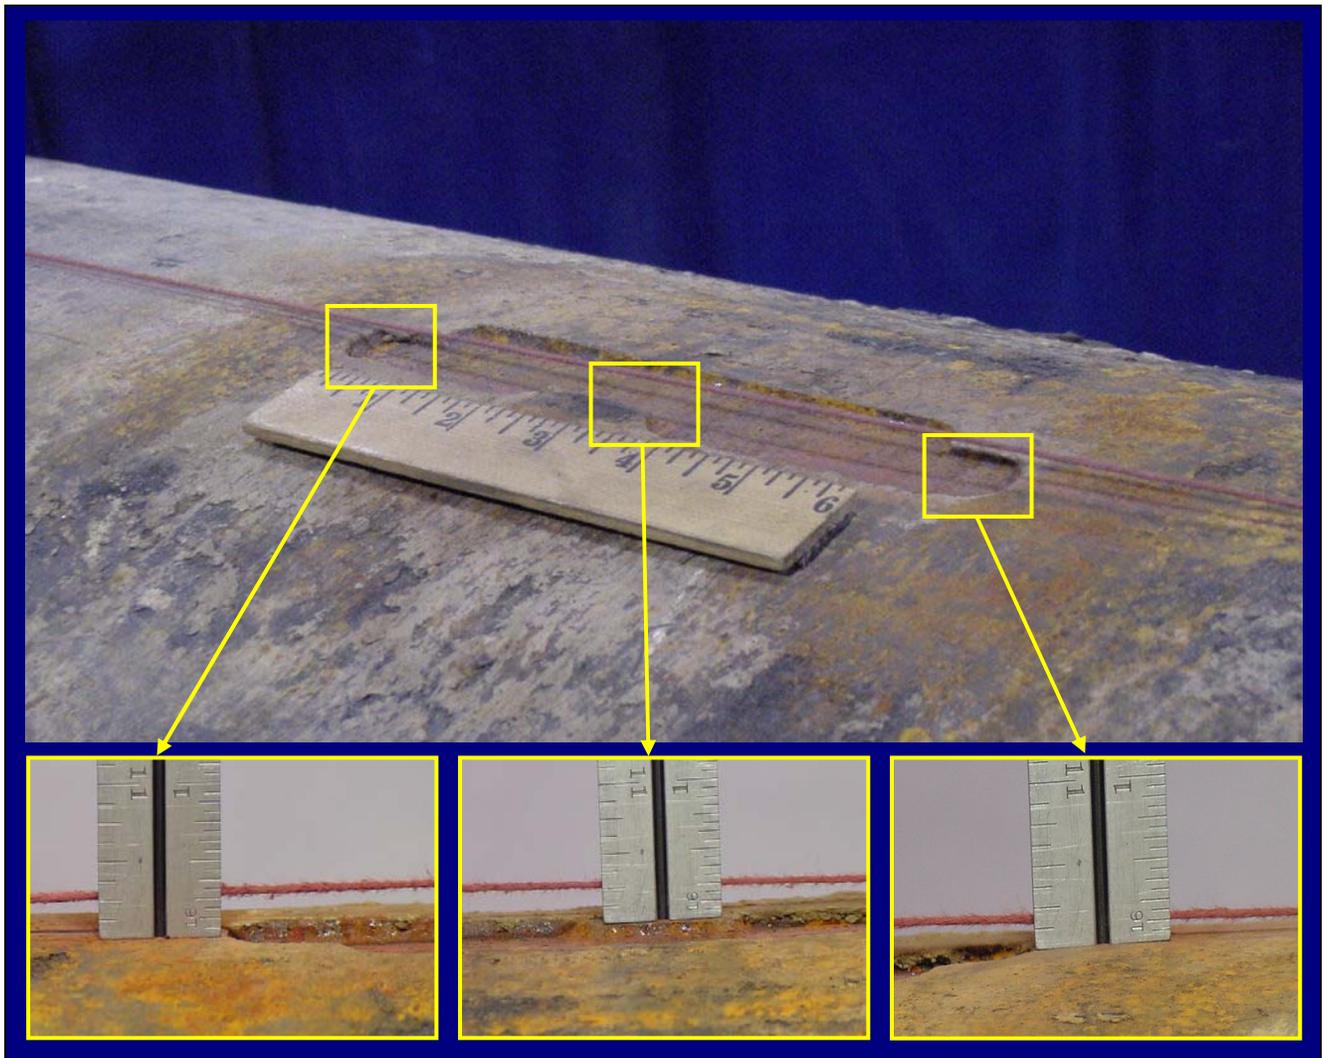
Figure 75 - Magnified Pictures of Dent at Ends and Middle of Simulated Damage

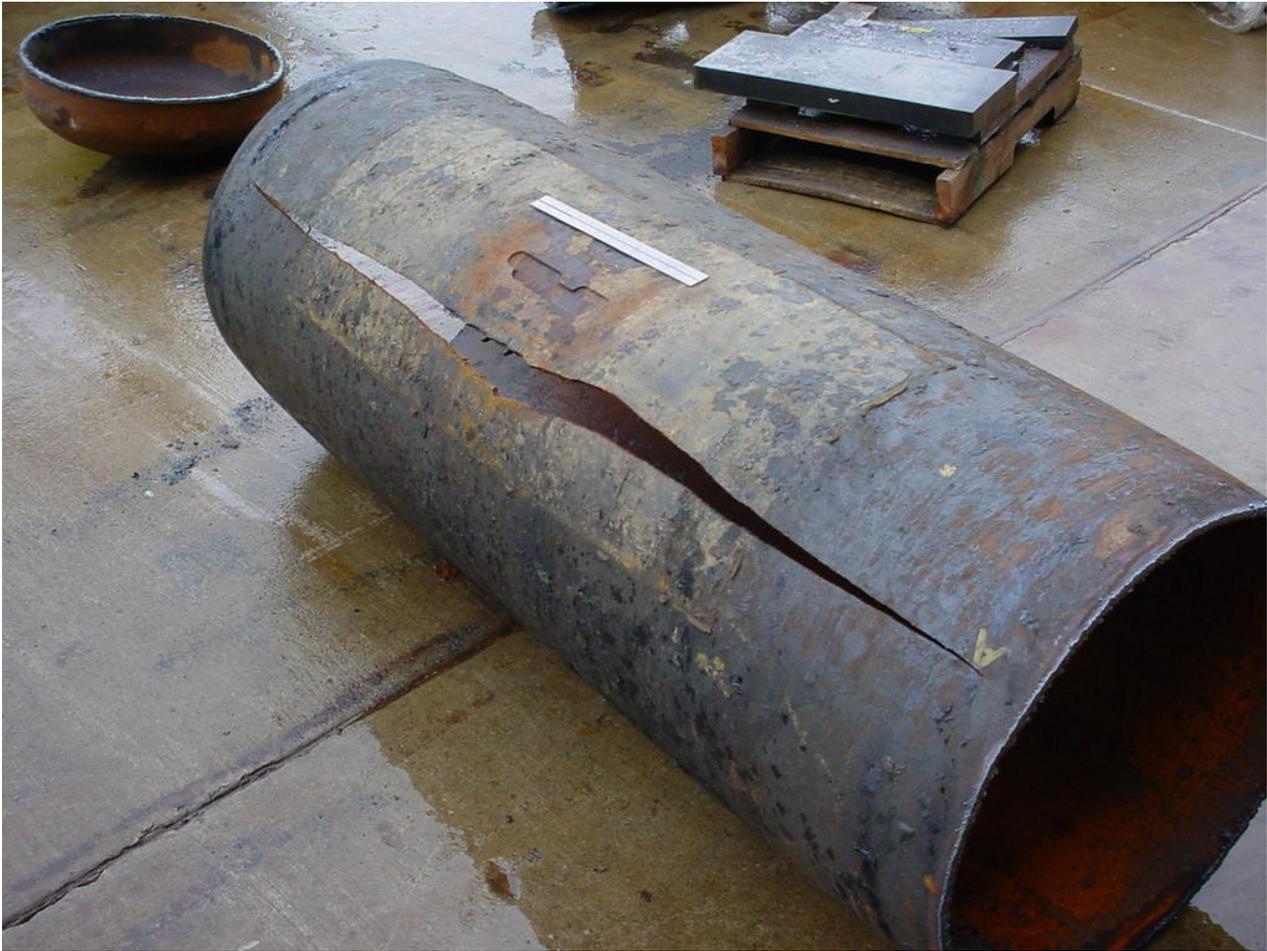
Figure 76 - Pipe Section with Internal Weld Deposition Repair After Hydrostatic Burst Test

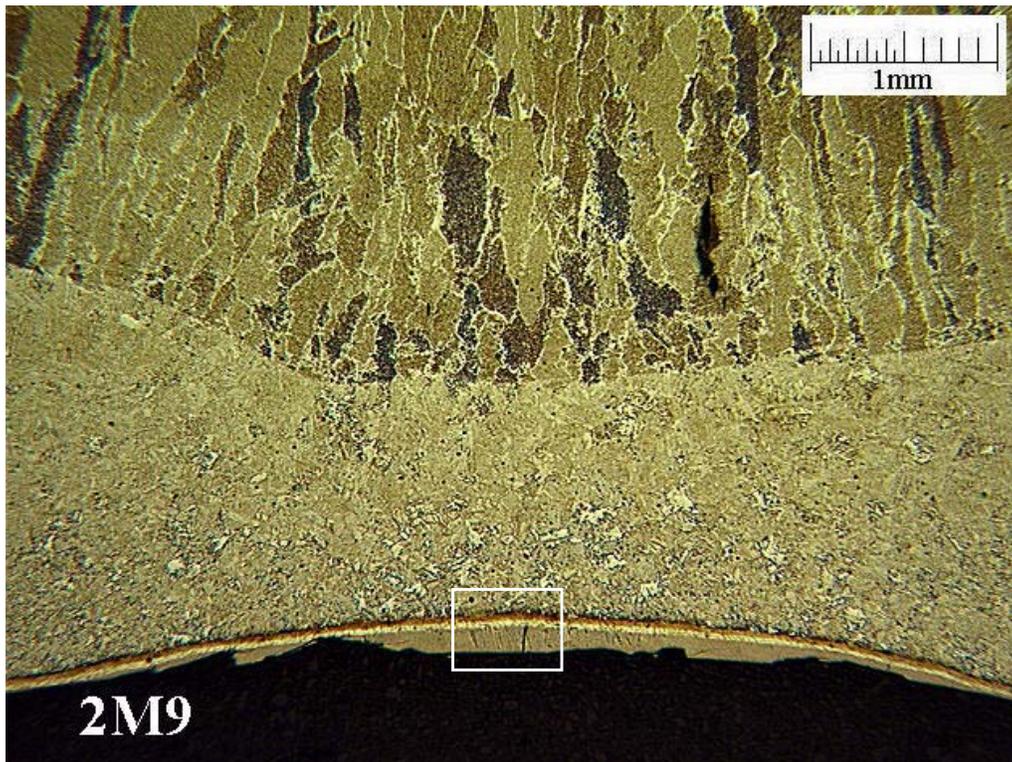
Figure 81 - Eutectic Iron Layer at Inside Surface of Metallographic Section through Weld 2M9

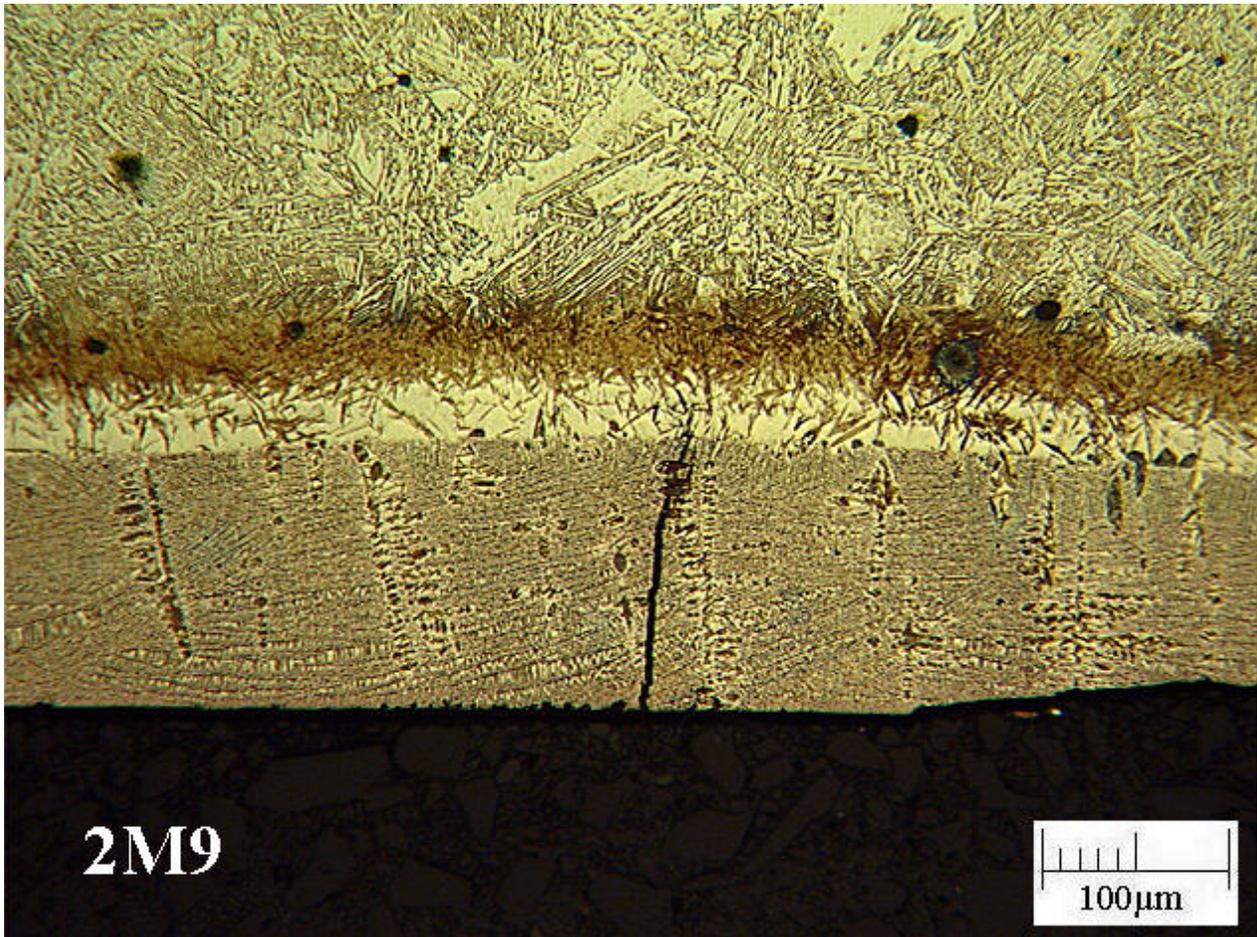
Figure 82 - Cracks in Eutectic Iron Layer of Metallographic Section Shown in Figure 81

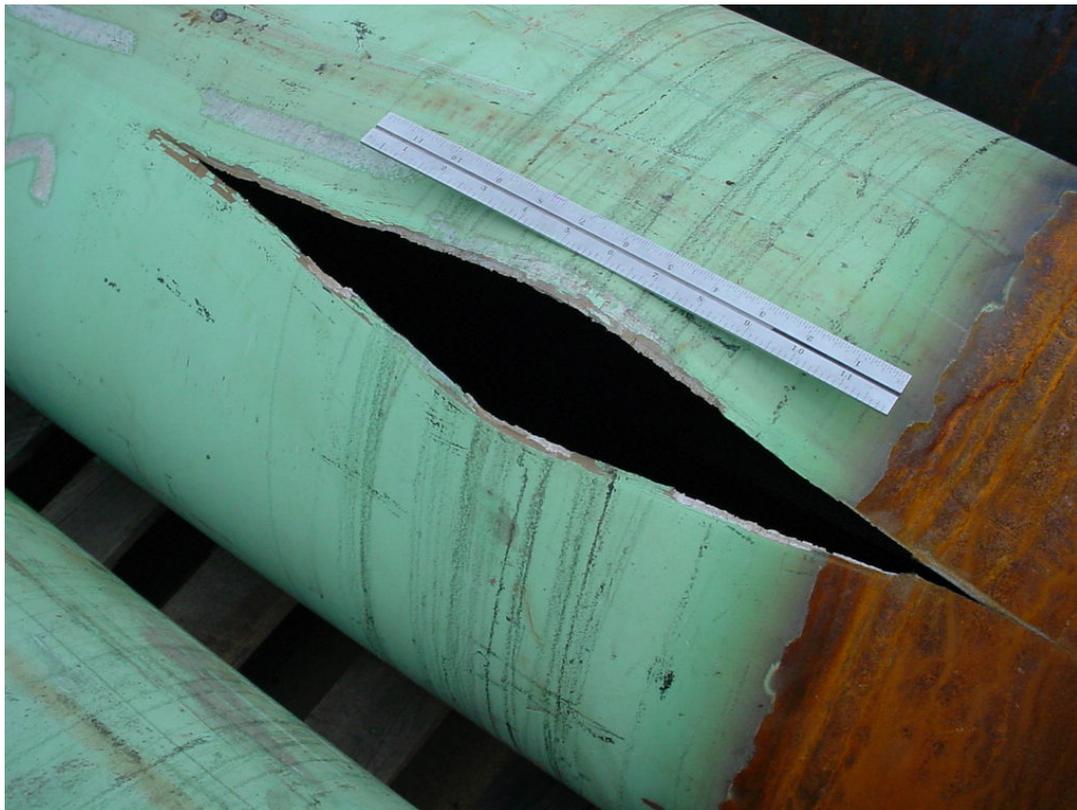
Figure 91 - Hydrostatic Burst Specimen of 508.0 mm (20 in.) in Virgin Pipe

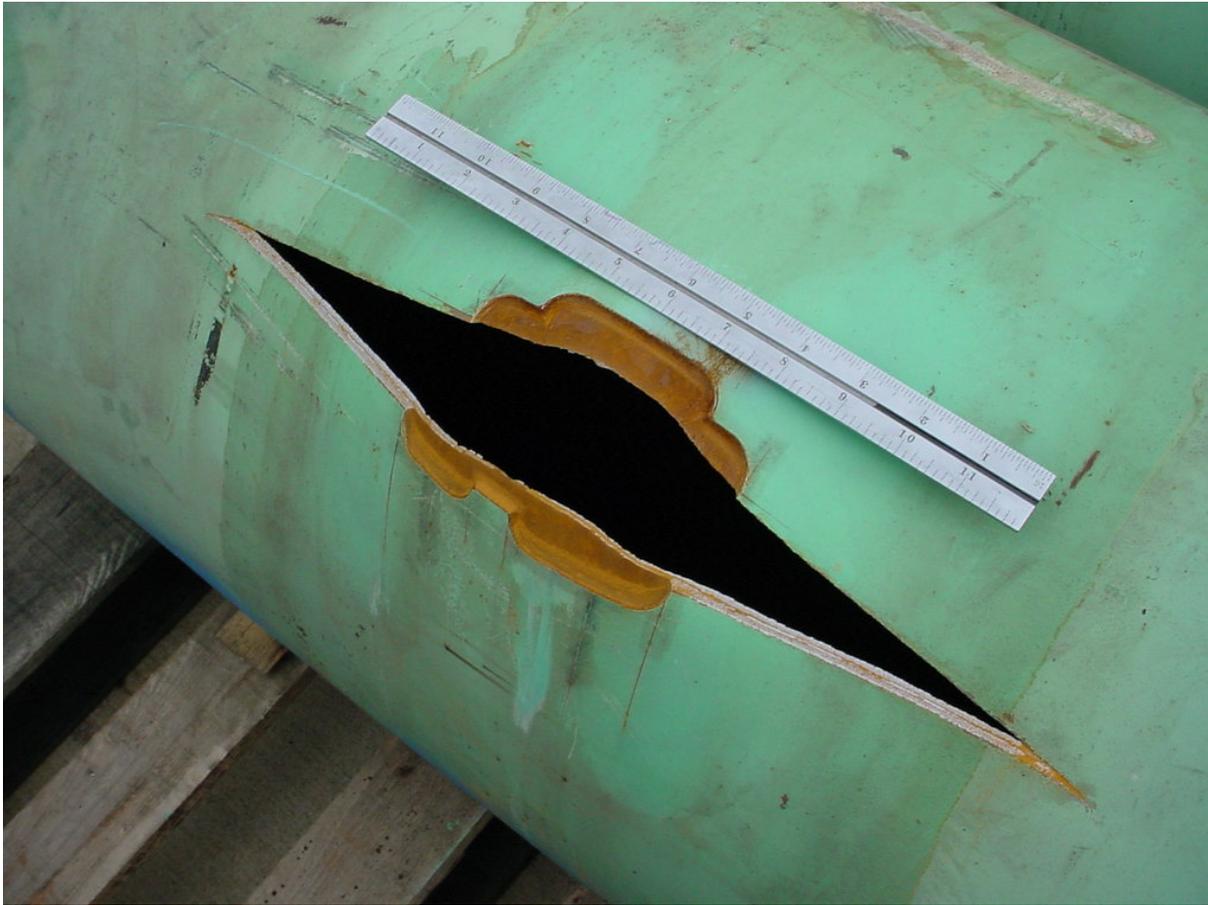
Figure 92 - Hydrostatic Burst Specimen of 508.0 mm (20 in.) with Un-Repaired Damage

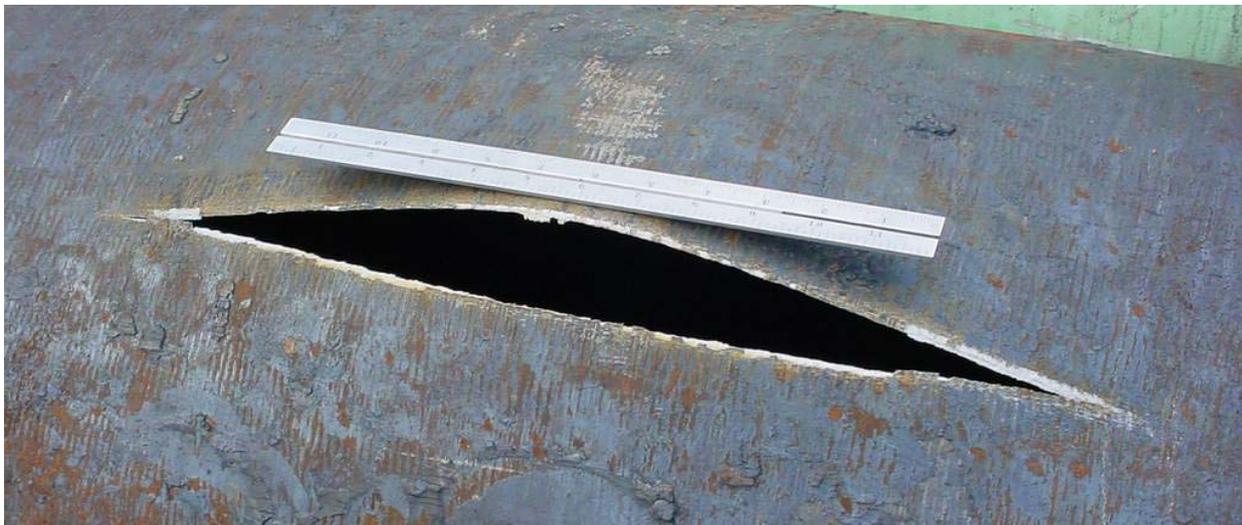
Figure 93 - Hydrostatic Burst Specimen of 558.8 mm (22 in.) Pipe in Virgin Pipe

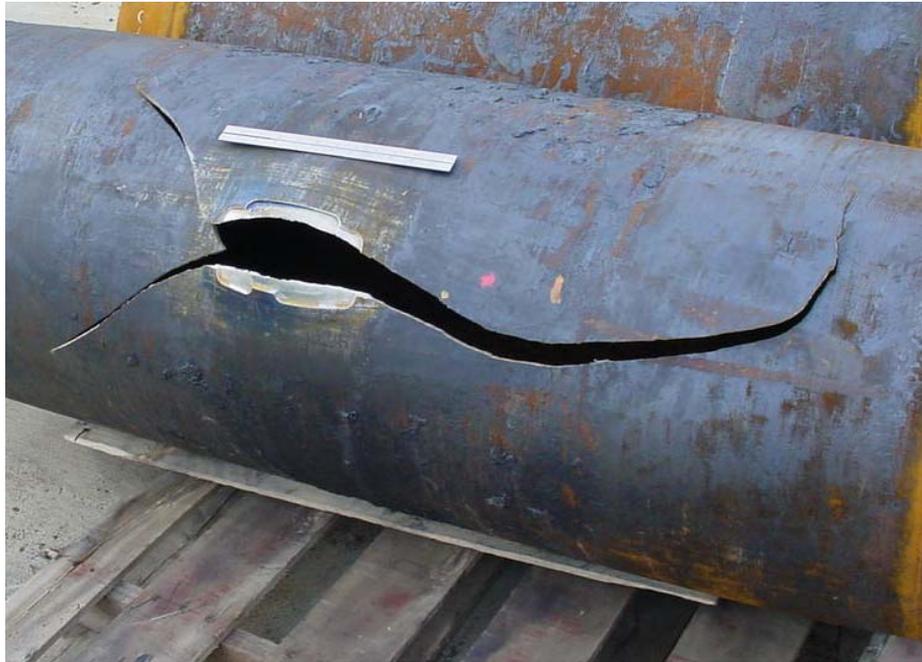
Figure 94 - Hydrostatic Burst Specimen of 558.8 mm (22 in.) With Un-Repaired Damage
