Ni-Based Alloys for Advanced Ultrasupercritical Steam Boilers

P.F. Tortorelli, K.A. Unocic, H. Wang
Oak Ridge National Laboratory

Fossil Energy Crosscutting Research Program Review

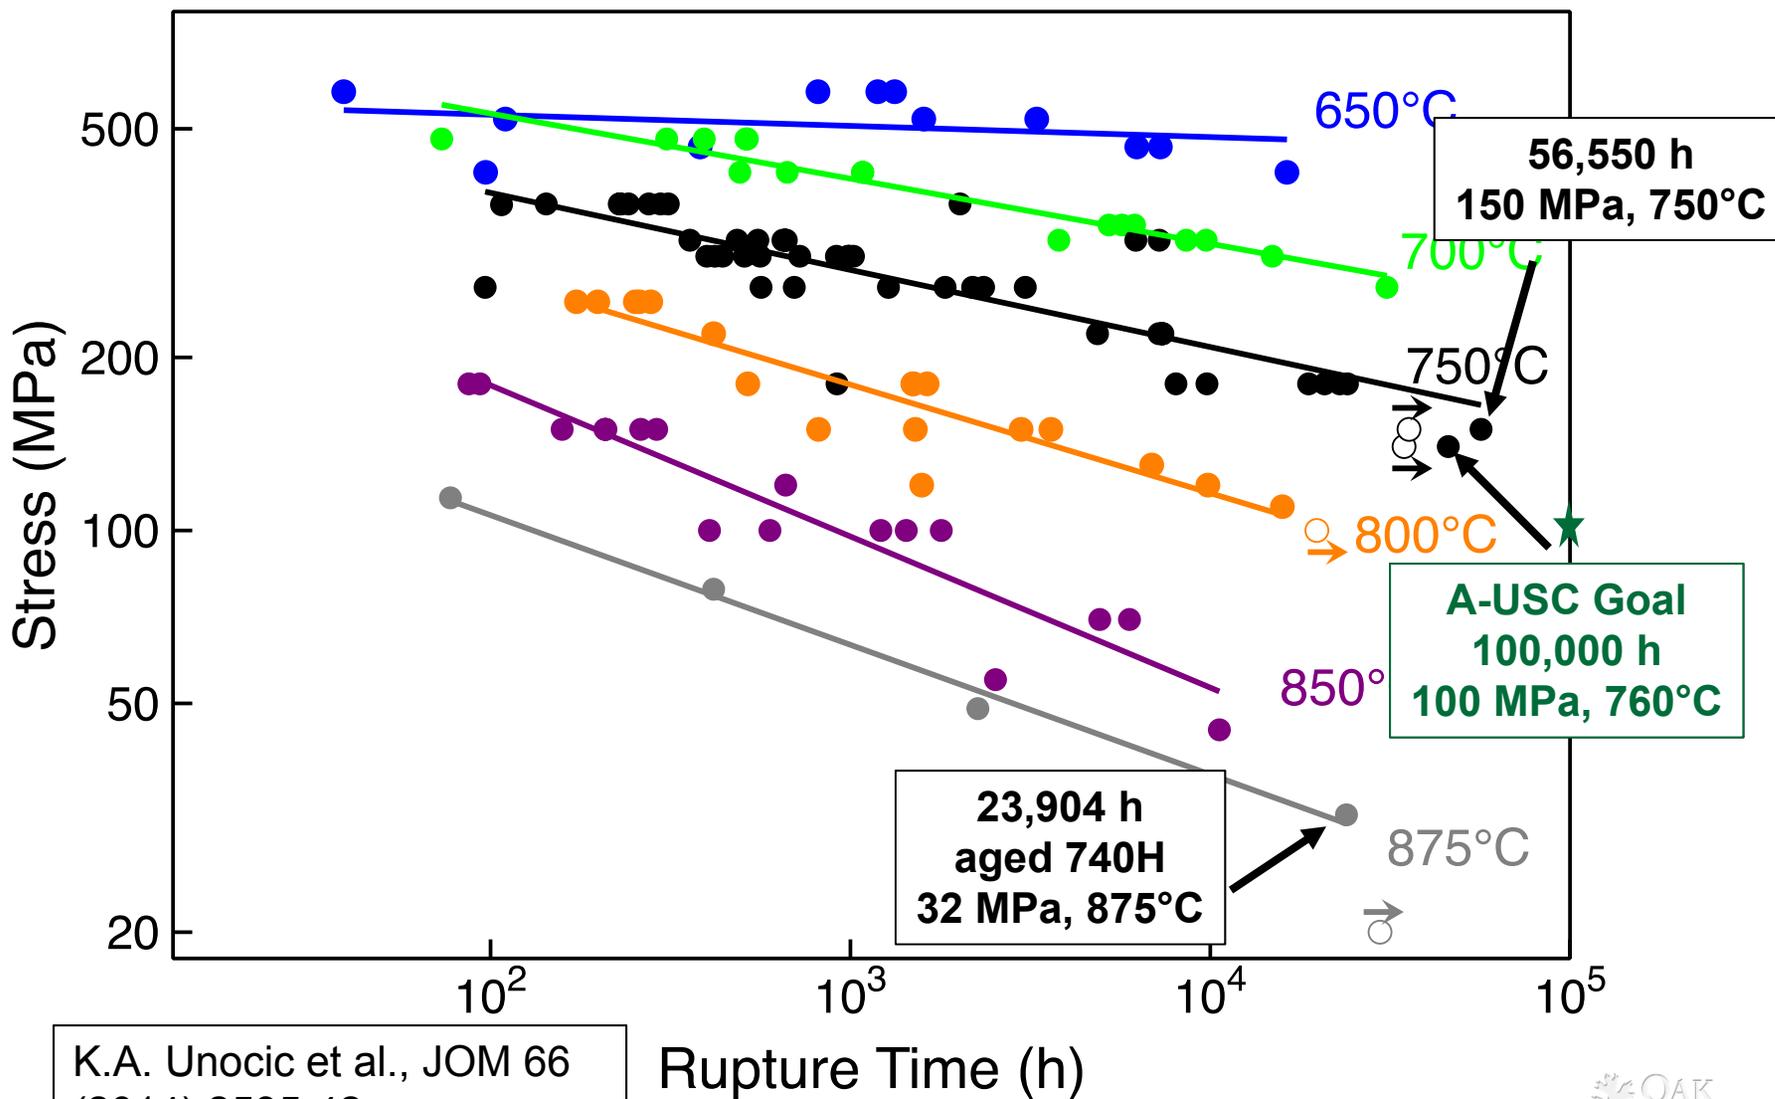
Long-Term Creep-Rupture Data for 740/740H Build Confidence in A-USC Boiler Use

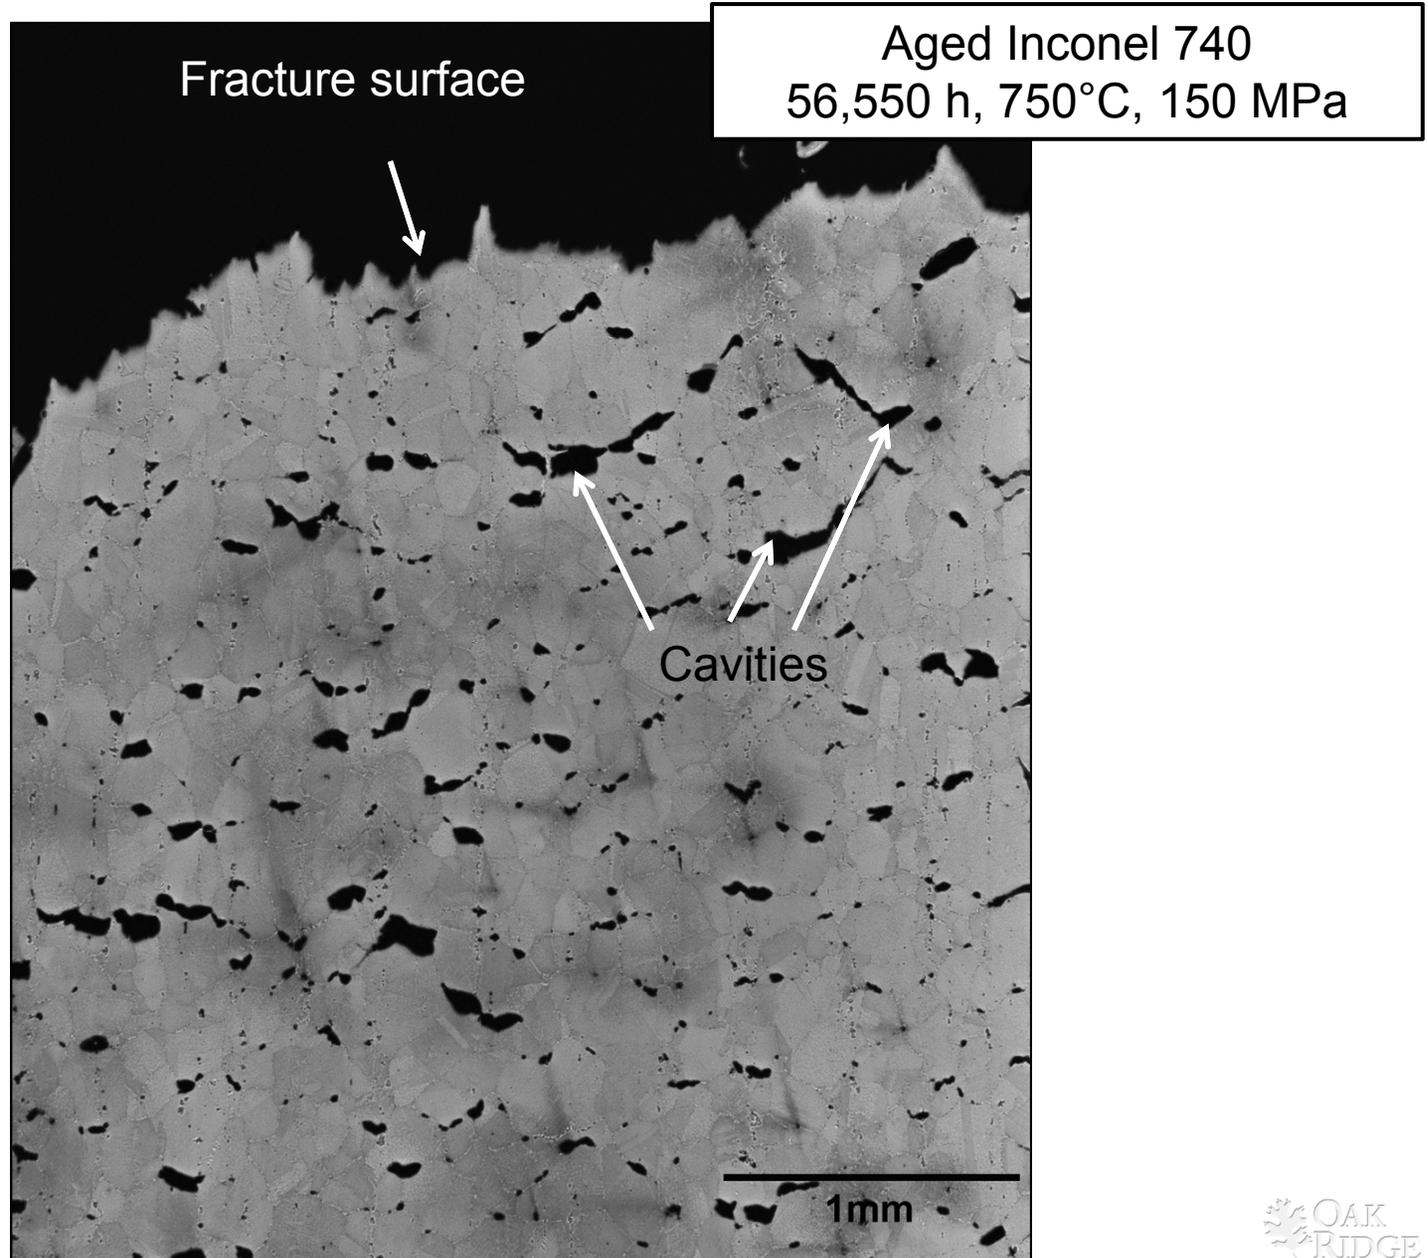
High Density of Cavities After 56,550 h

Grain Boundary Cavitation

Aged (8h/800°C) Inconel 740
56,550 h, 750°C, 150 MPa

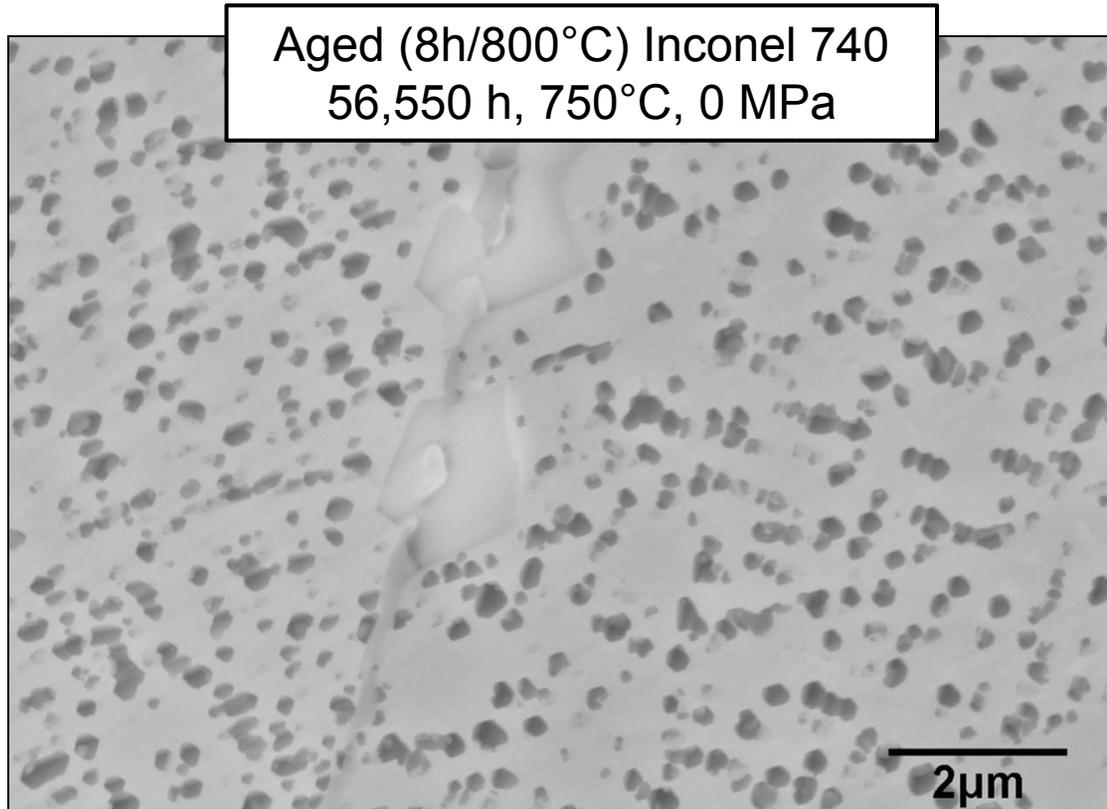
Little γ' Depletion Noted at GBs

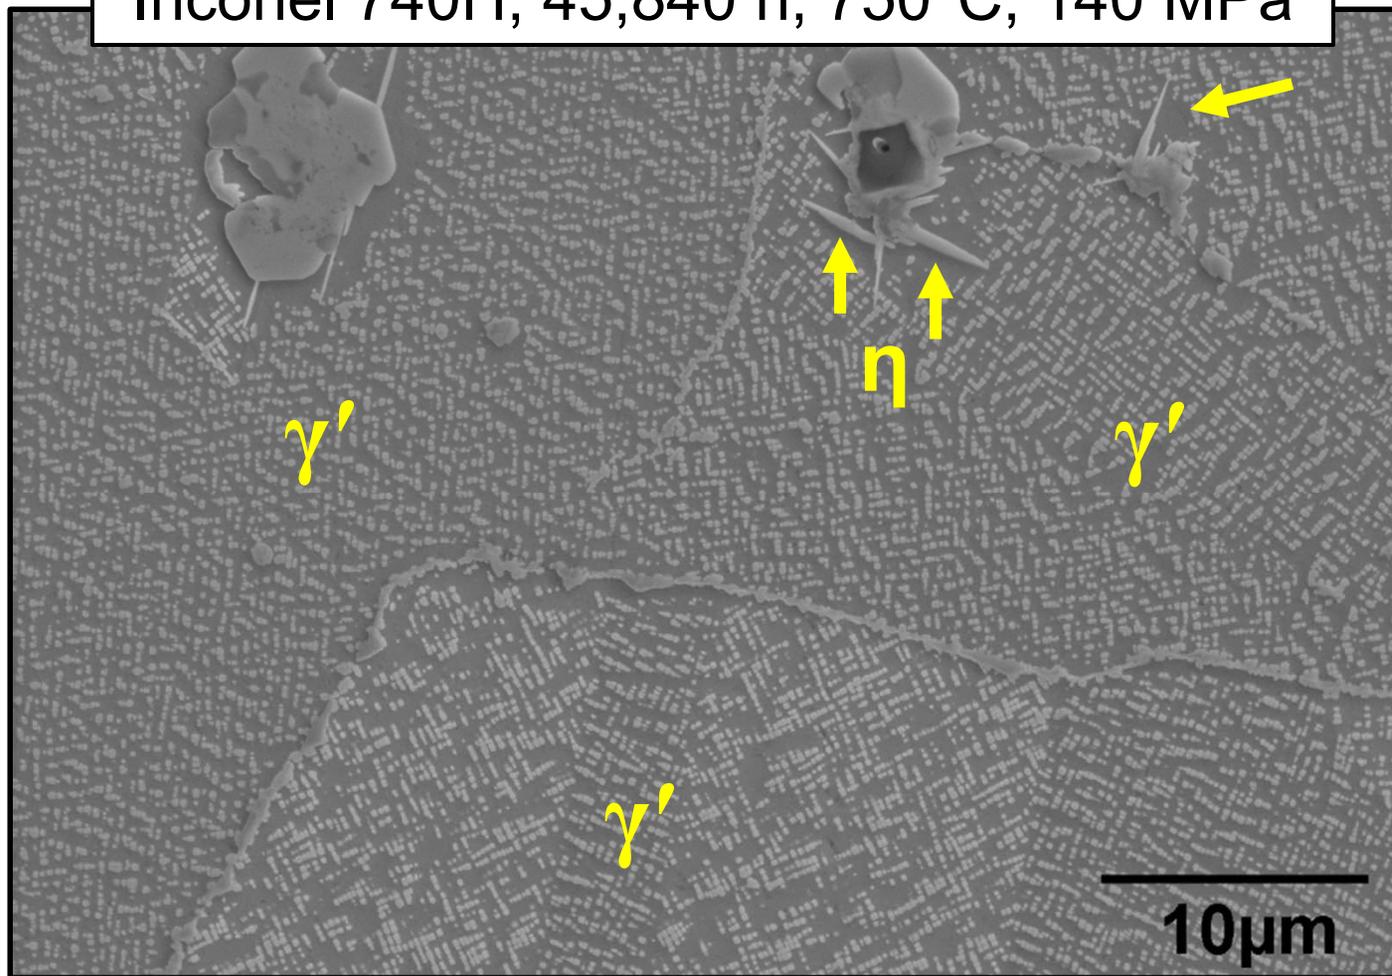
740H Long-Term Creep-Rupture Specimen Showed “Good” Microstructural Stability

Inconel 740H, 45,840 h, 750°C, 140 MPa

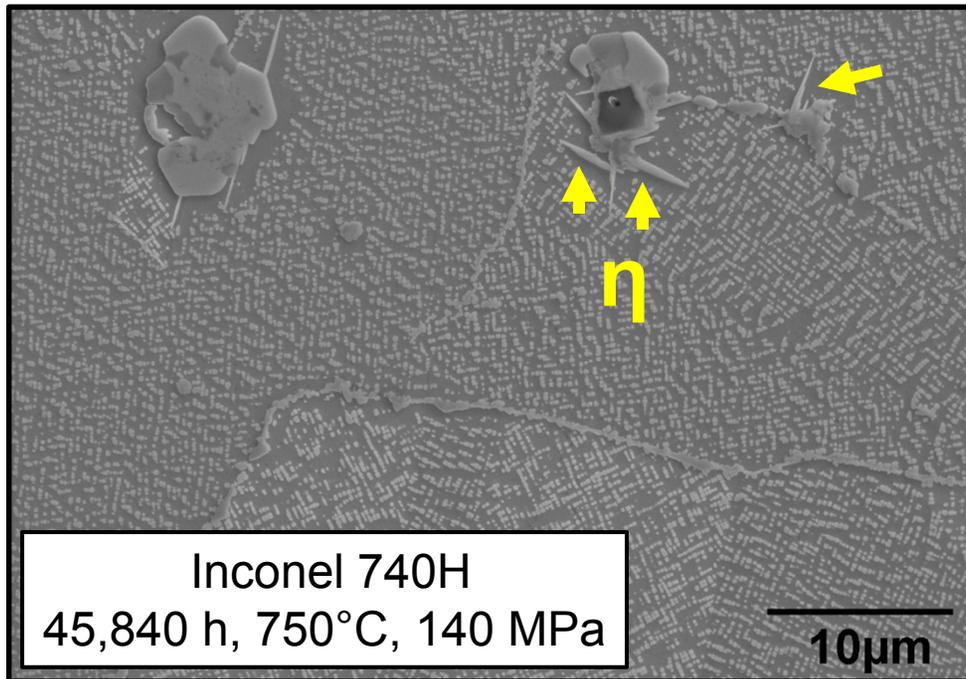
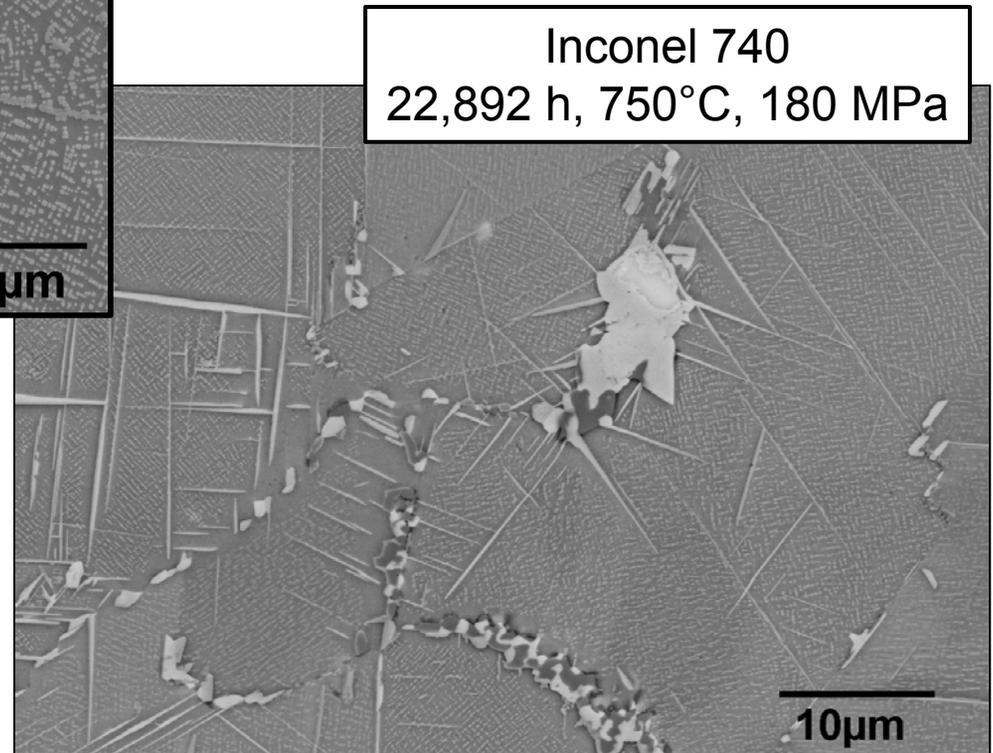
Despite ~46,000 h at 750°C under Load, Little Eta Phase Observed for Inconel 740H

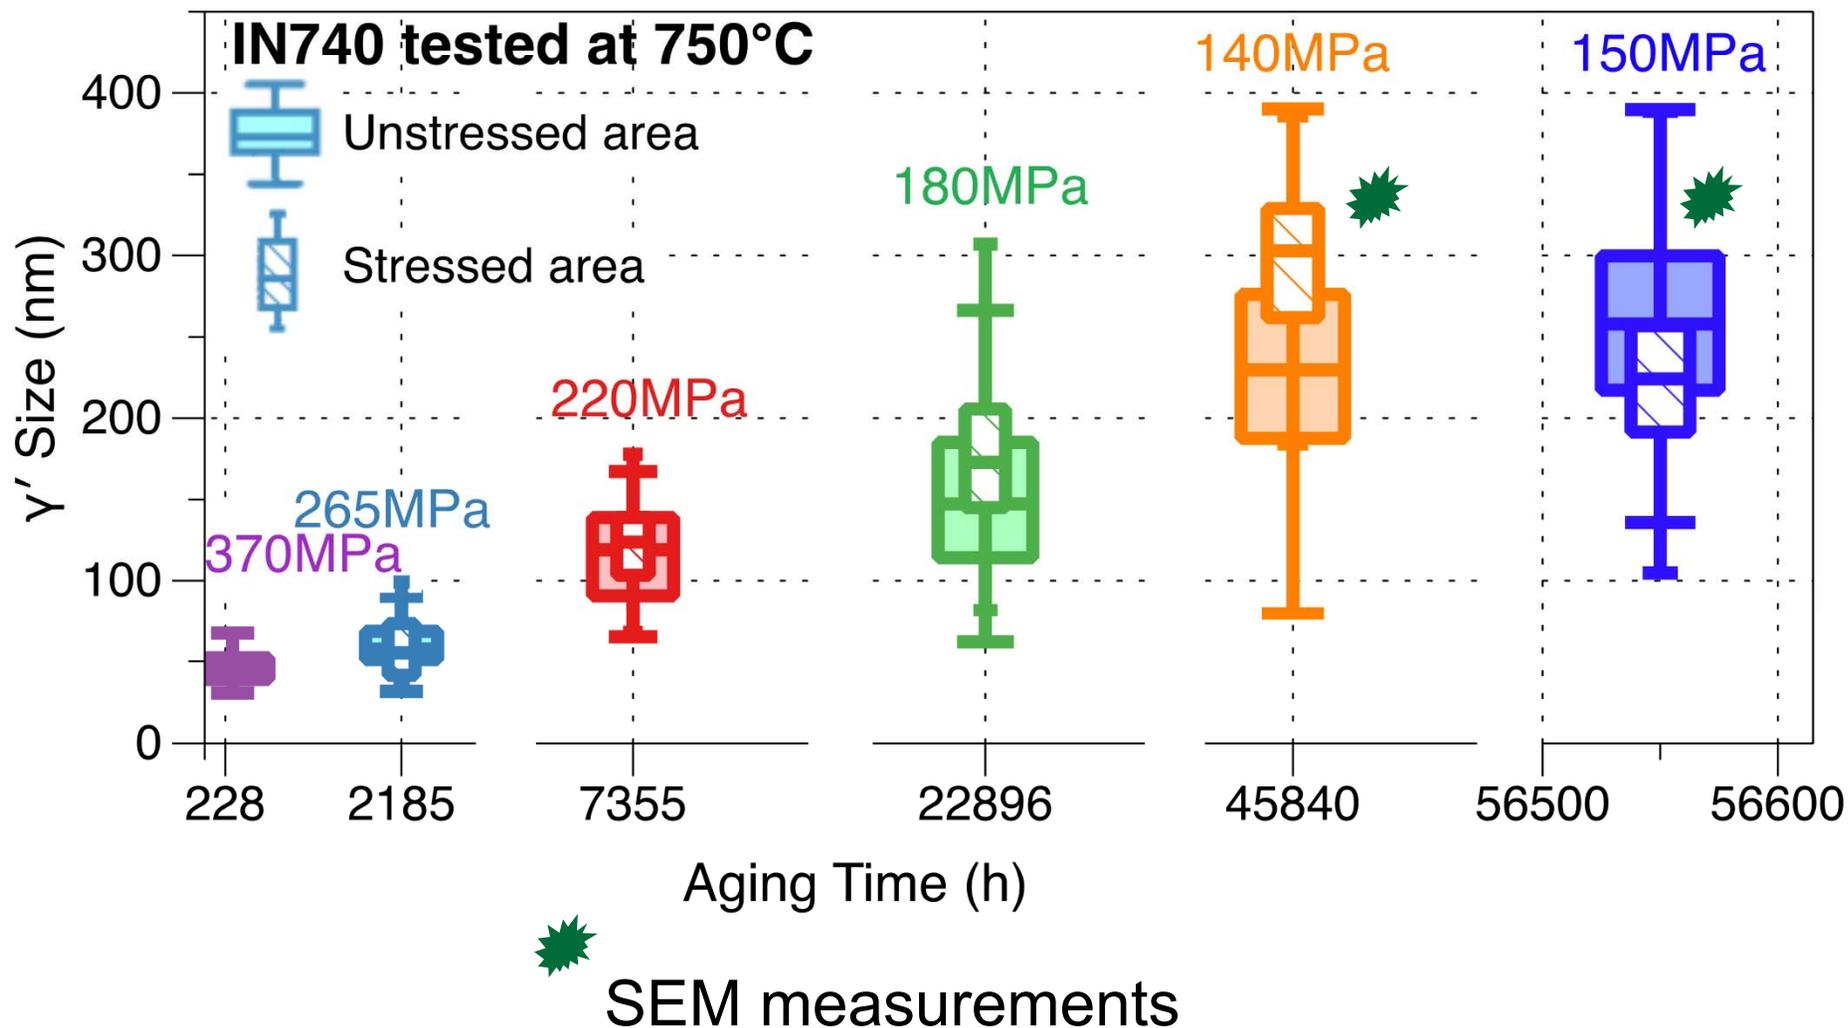
γ' Size Measurements Show Coarsening But Little Change in Later Stages

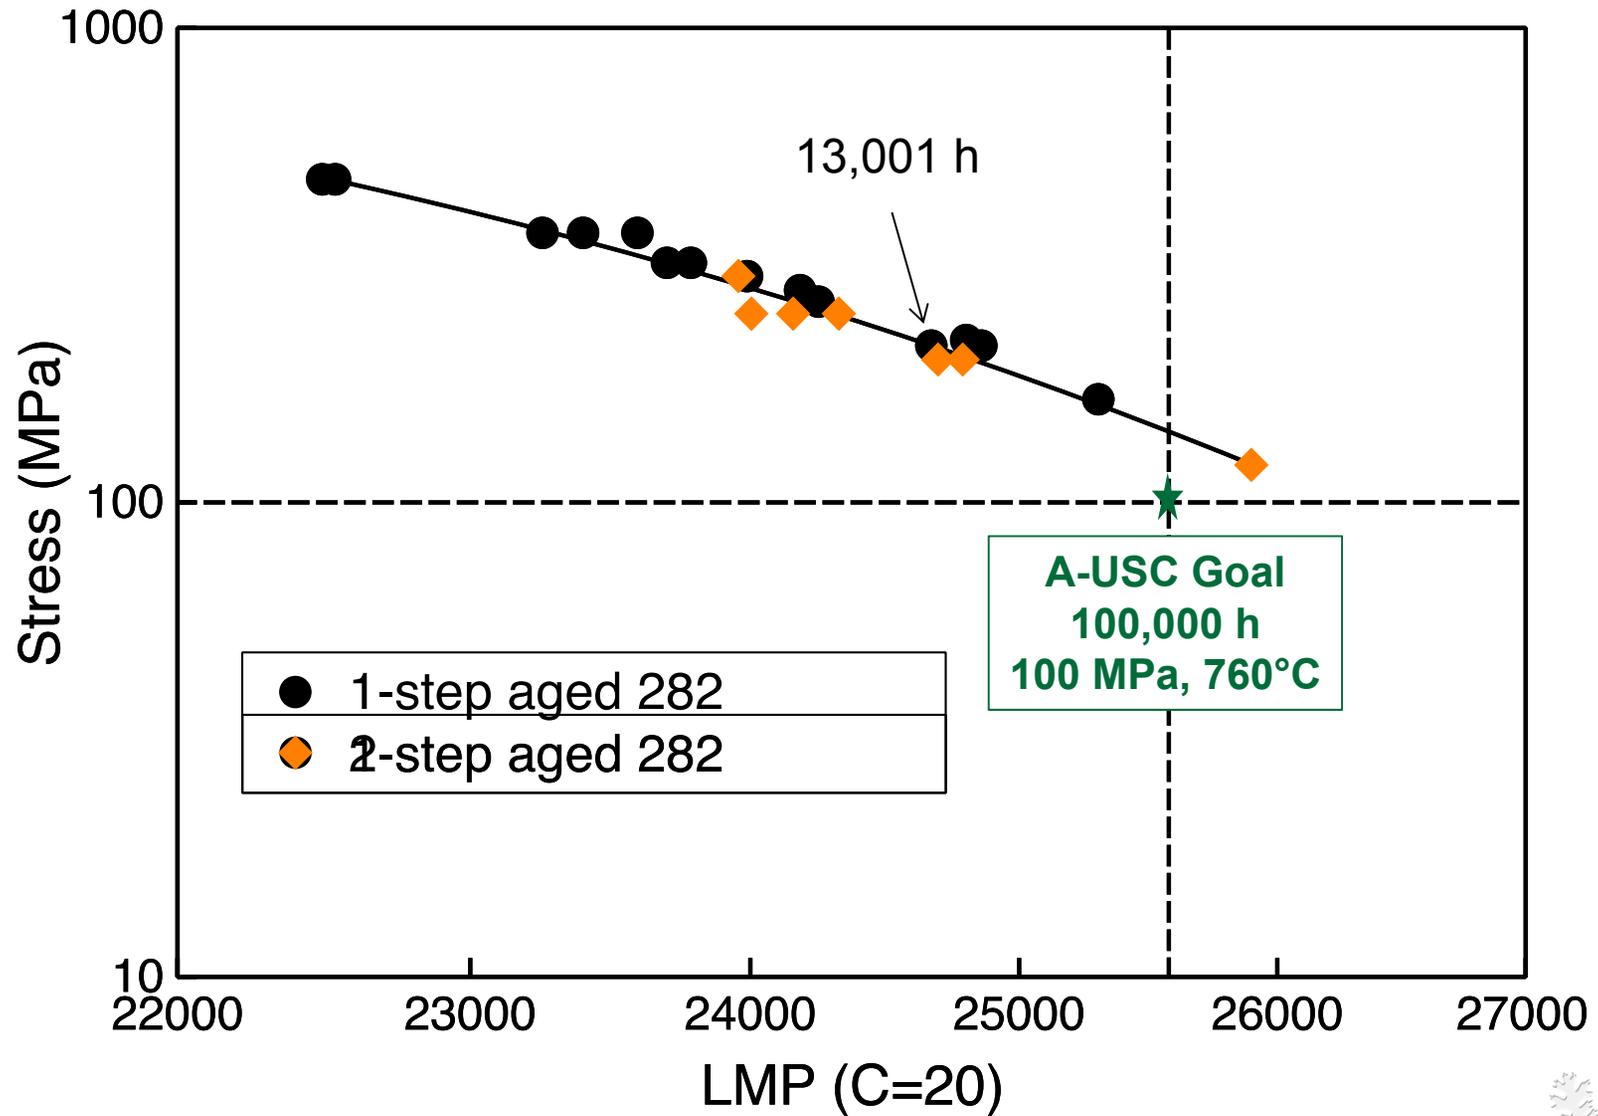
Little Difference in Creep-Rupture Lifetimes for the Two Aging Treatments

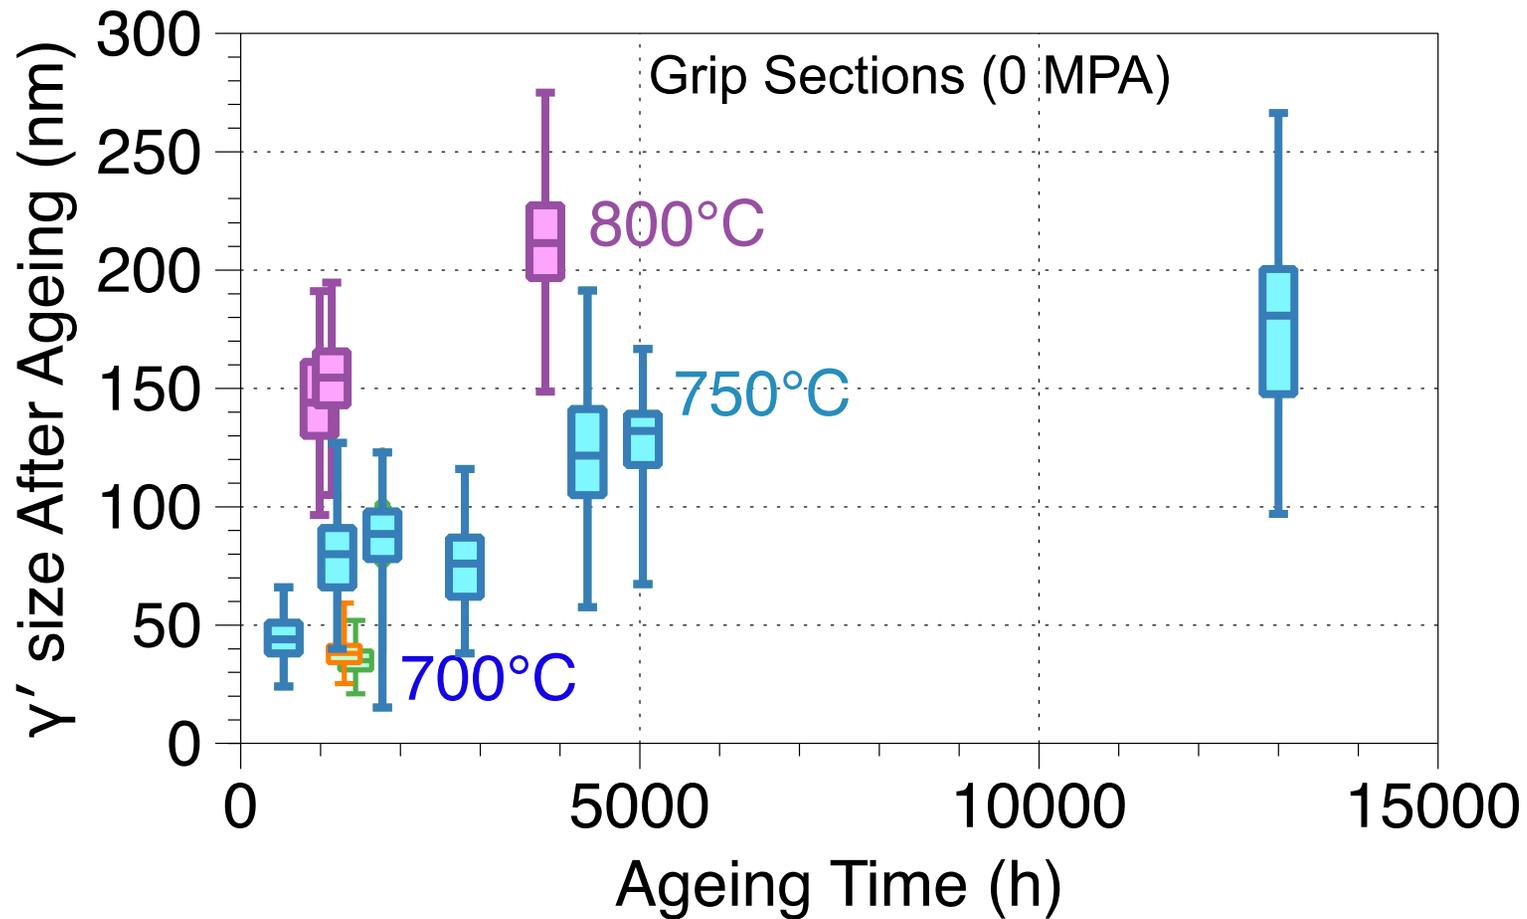
Significant γ' Coarsening Observed for Haynes 282 Creep Specimens

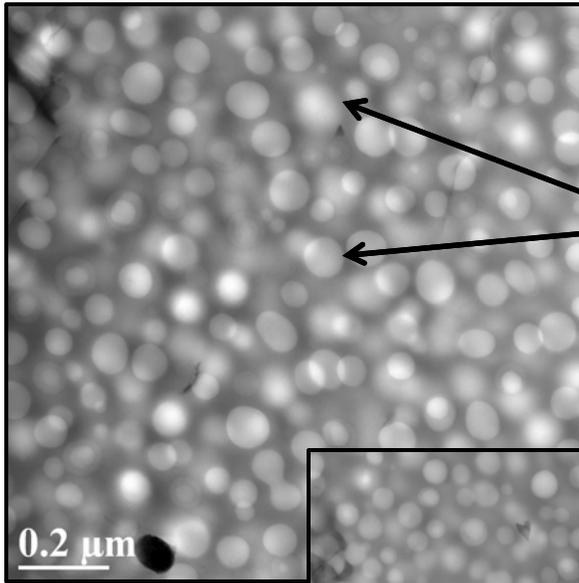
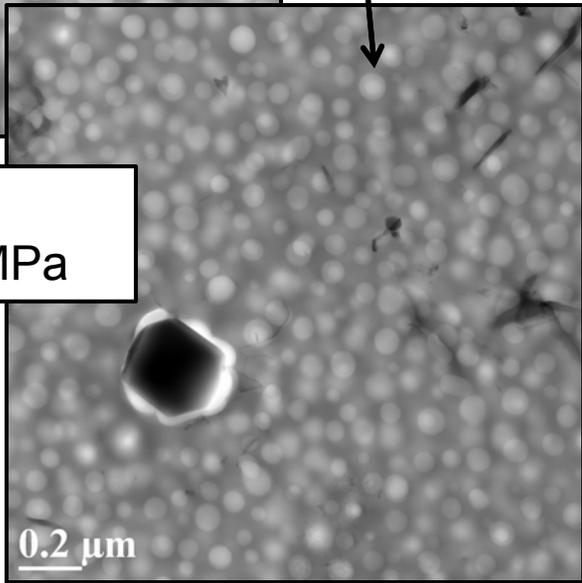
Spherical γ' in Haynes 282 Contrasts with Cuboidal γ' in Inconel 740

Haynes 282
2809 h, 750°C, 0 MPa

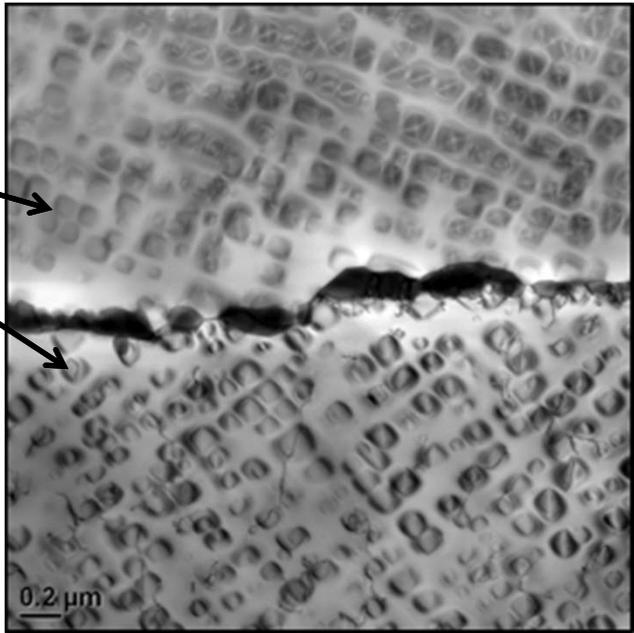
Inconel 740
4864 h, 750°C, 220 MPa

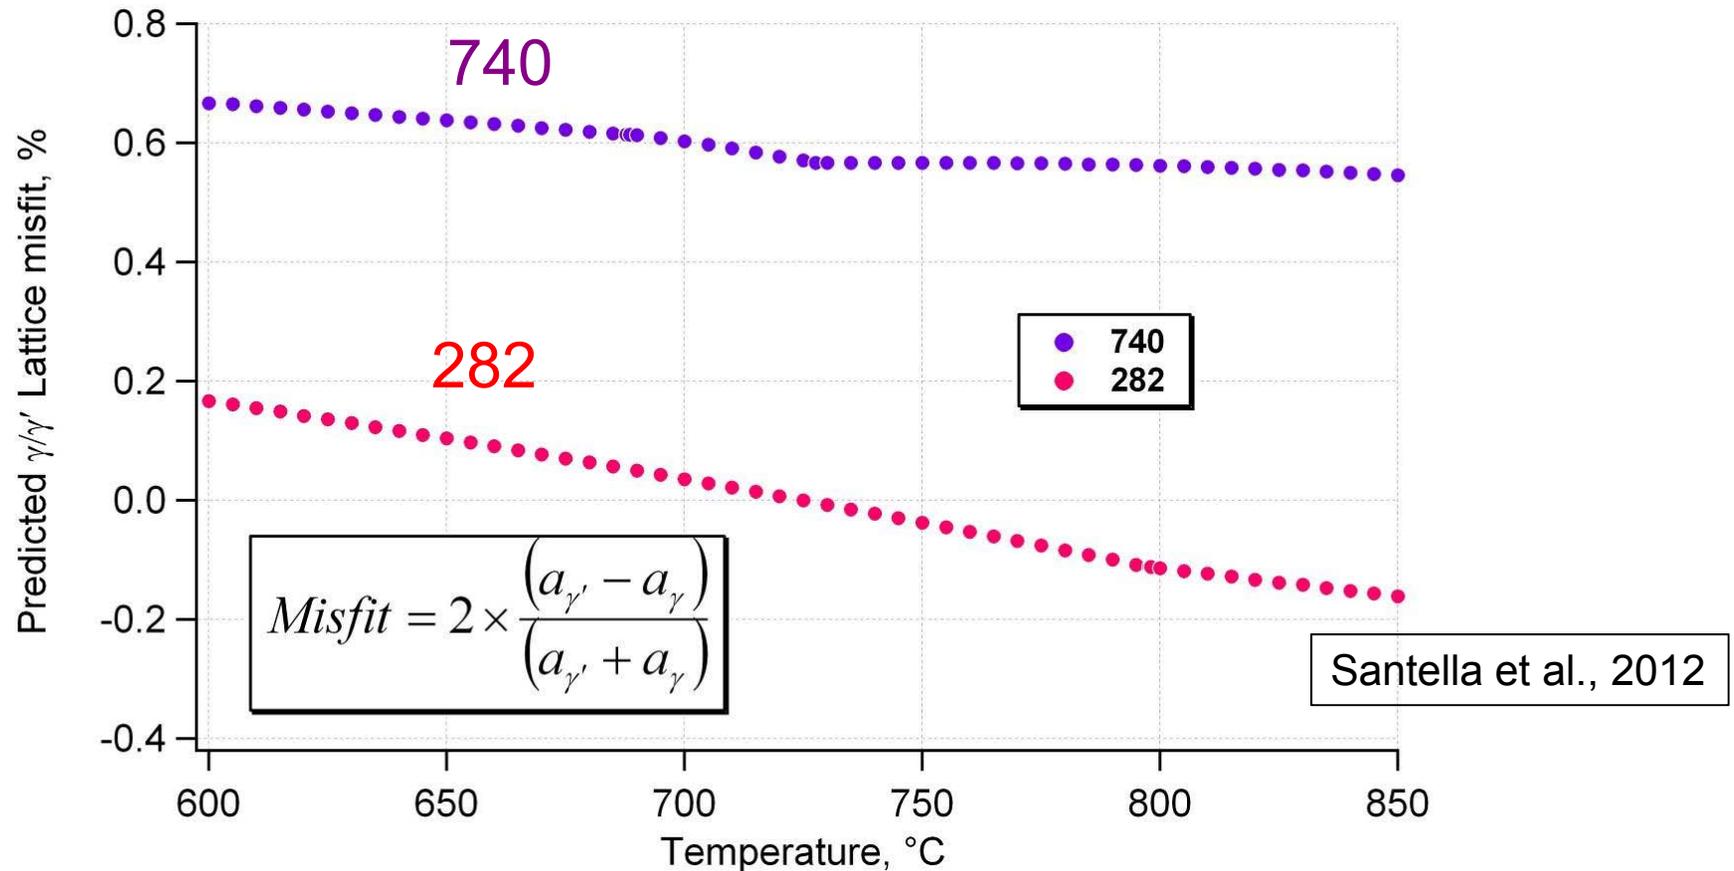
Differences in Shape Can Be Explained by Respective γ/γ' Lattice Mismatches

Larger misfit results in greater interfacial energy

- Cuboidal shape of precipitates
- Larger driving force for coarsening

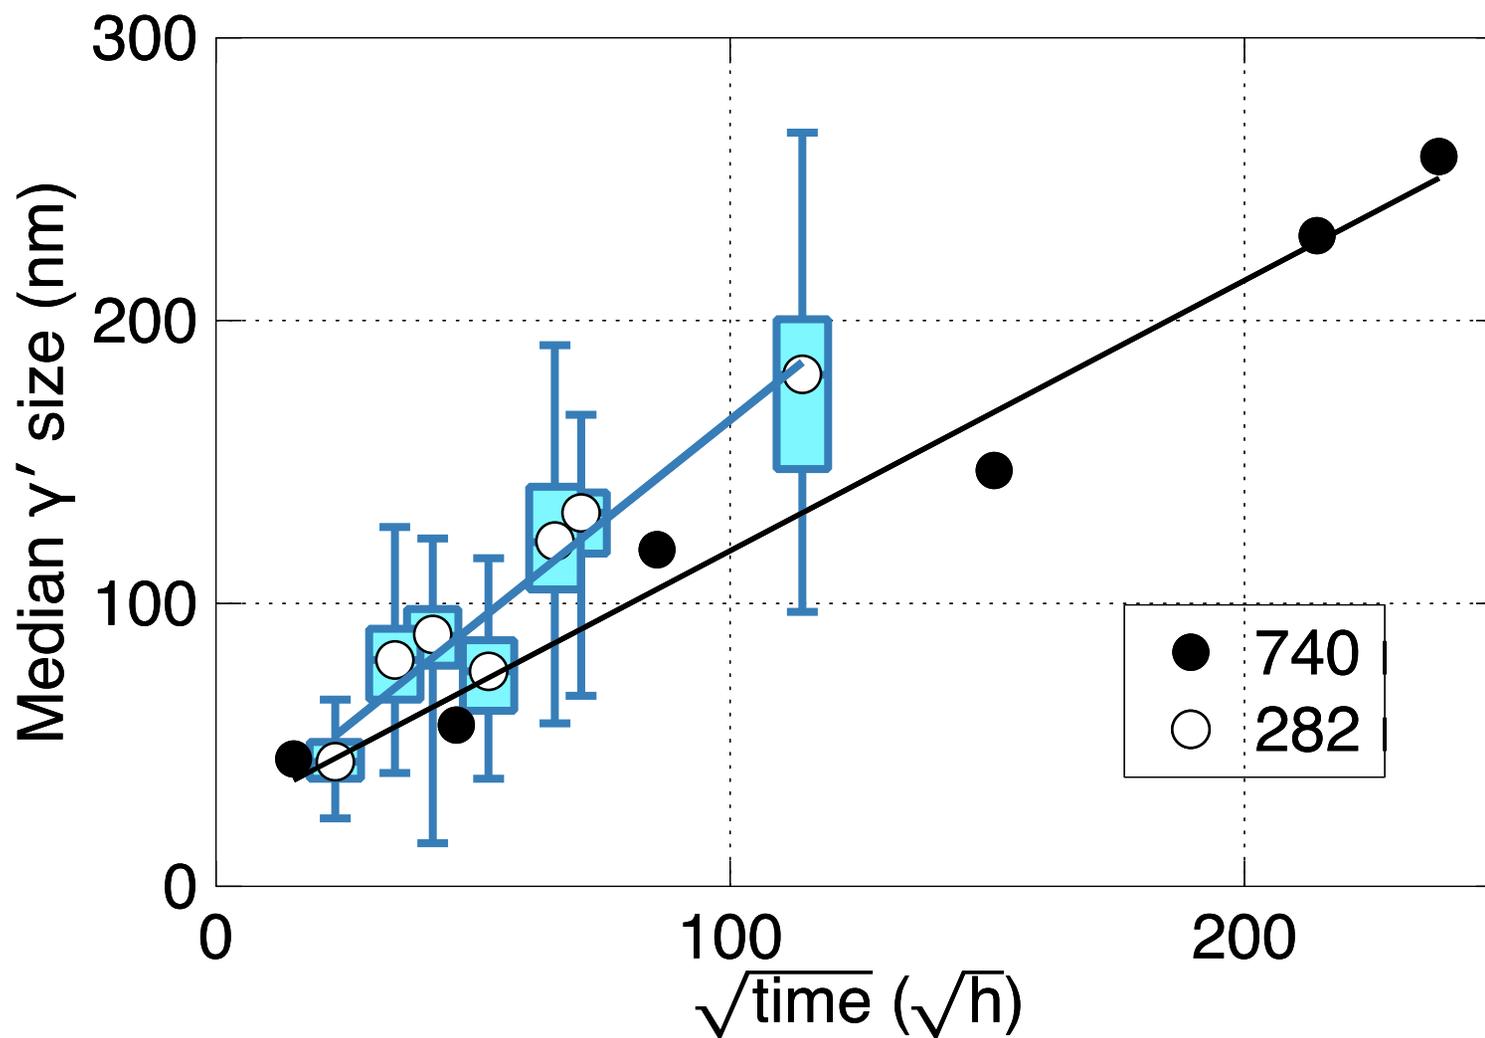
Median 282 γ' Size Falls Above that of 740 But within Scatter

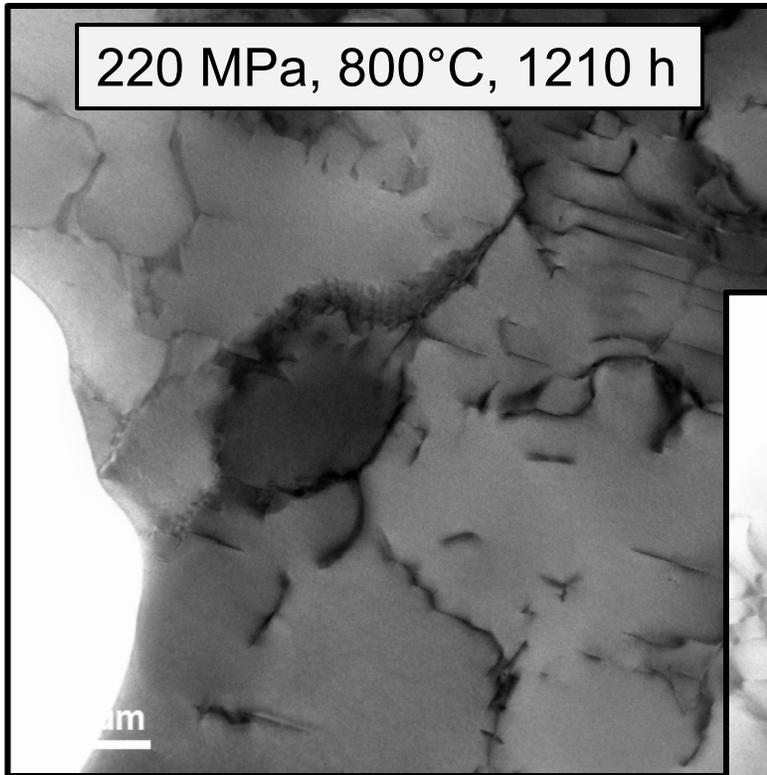
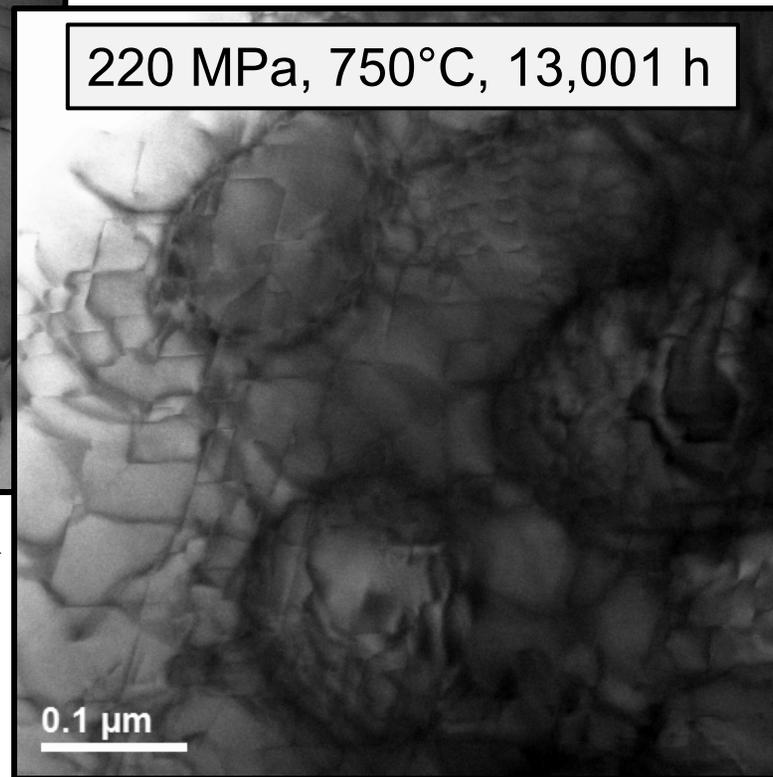
Particle Strengthening in Haynes 282

High density dislocation network in the matrix indicative of work hardening

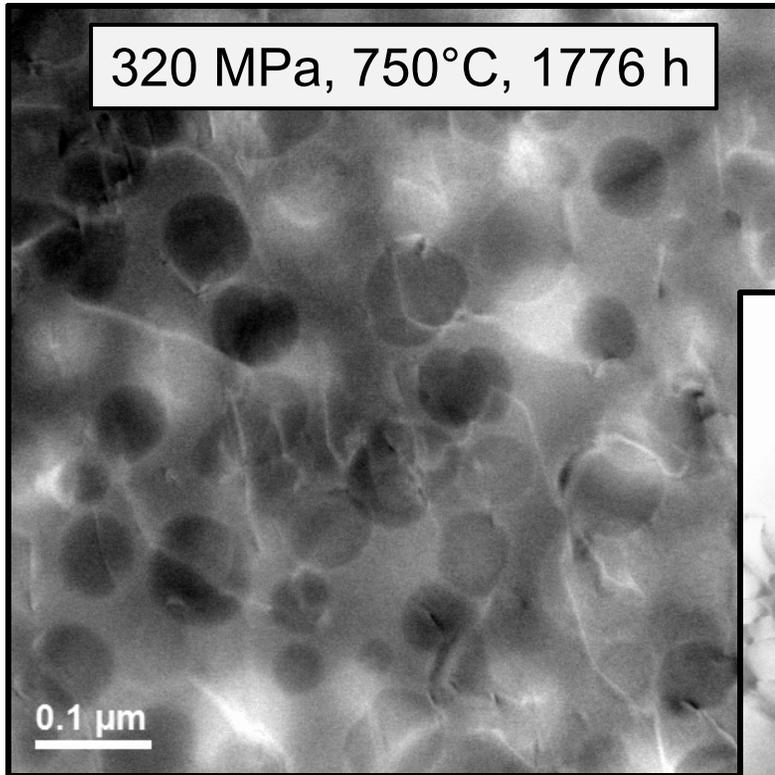
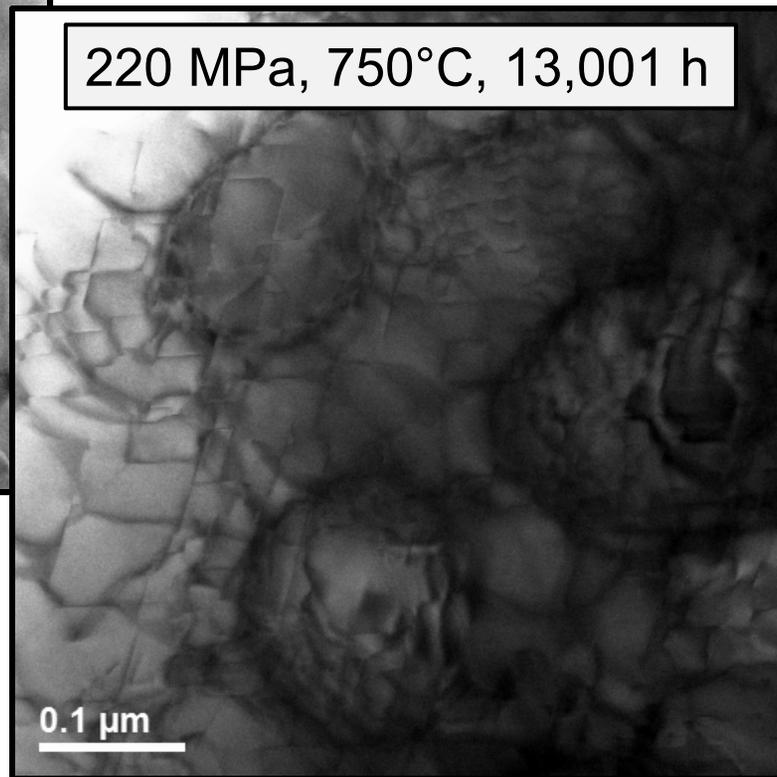
Similar Behavior as Load Varied

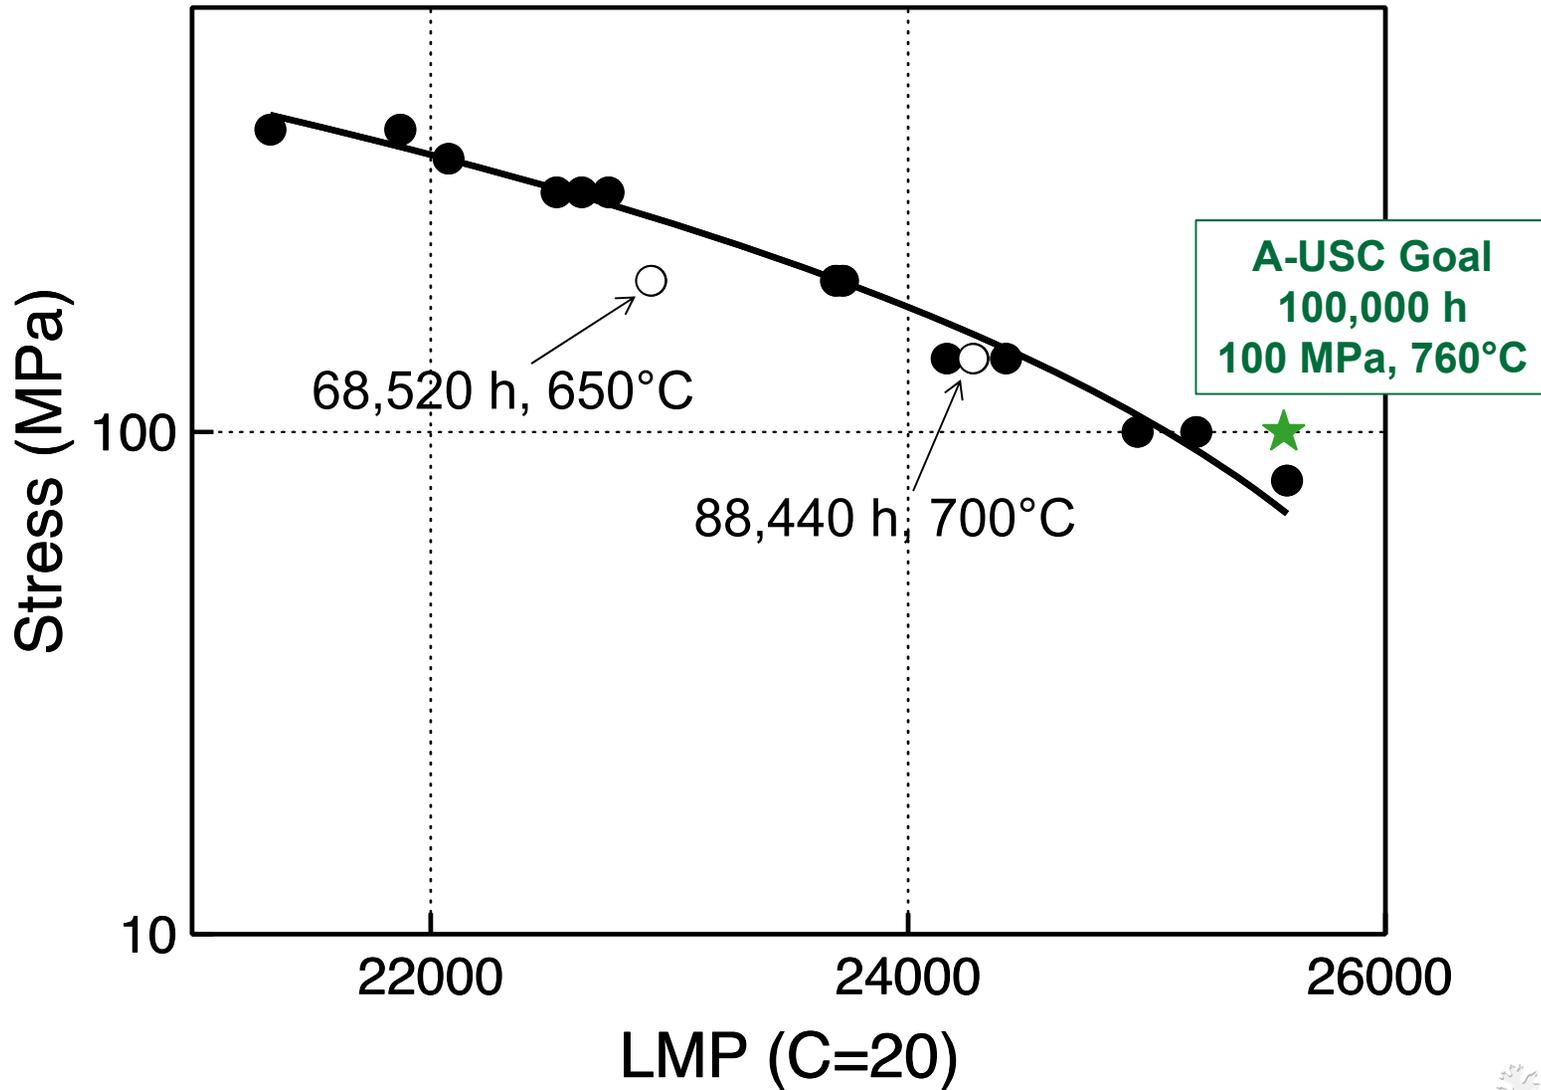
Creep-Rupture Testing of Alloy 617CCA Completed Earlier in Program

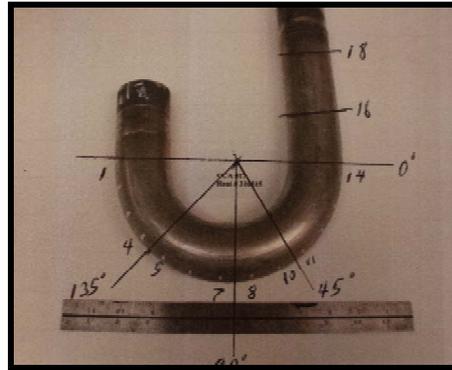
76.2 mm bend
33% OFS (outer
fiber strain)

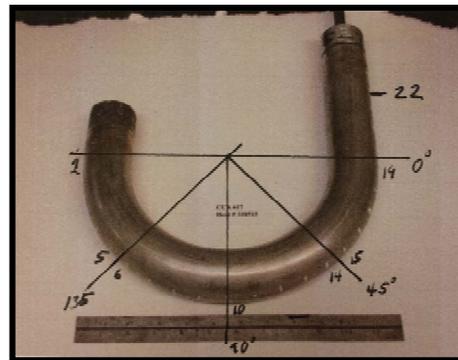
127.0 mm bend
20% OFS

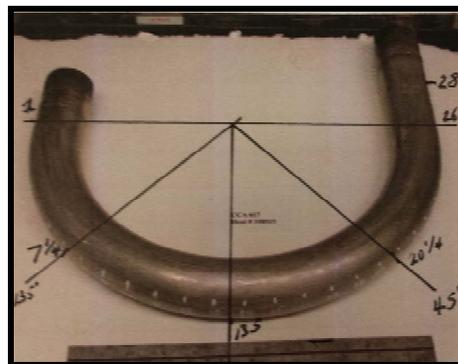
171.4 mm bend
15% OFS

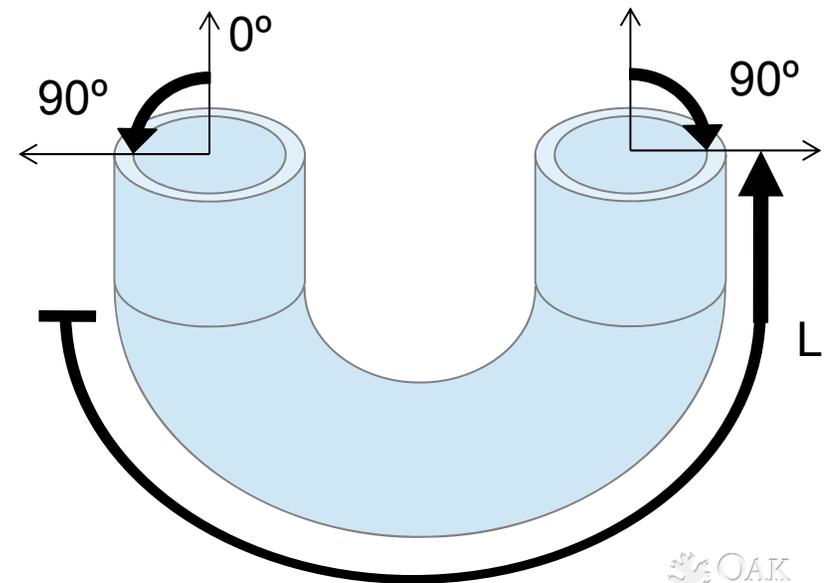
- 775° C, 38.6 MPa
- Strain Tracked by Diameter Increase With Time
- Outer Diameter measured at 0, 45, 90, 135° along tube length L

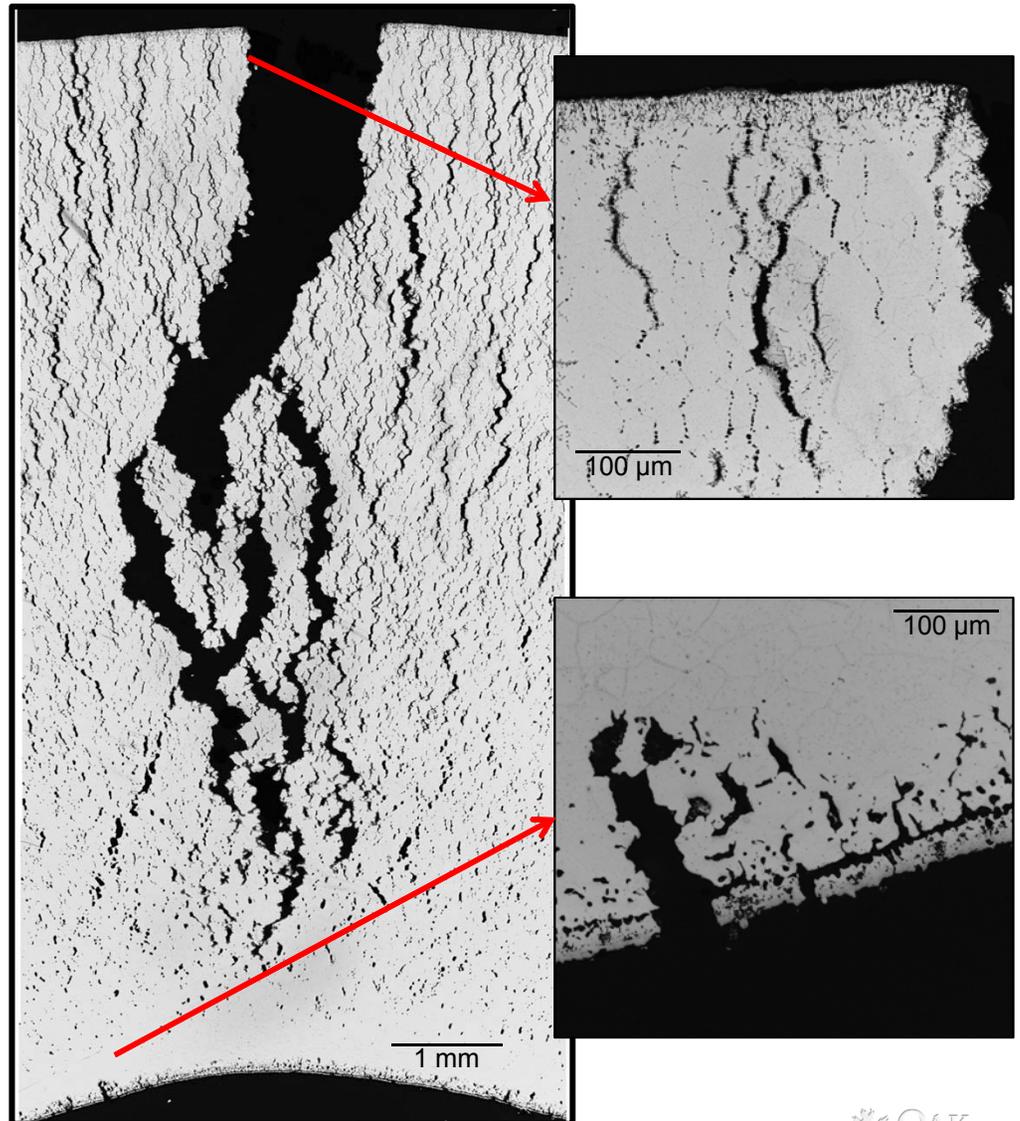
First alloy 617 Failure at ~32,800 h Recorded in Past Year

775°C, 38.6 MPa, 33% OFS
