Ni-Based Alloys for Advanced Ultrasupercritical Steam Boilers

P.F. Tortorelli, K.A. Unocic, H. Wang
Oak Ridge National Laboratory

Fossil Energy Crosscutting Research Program Review

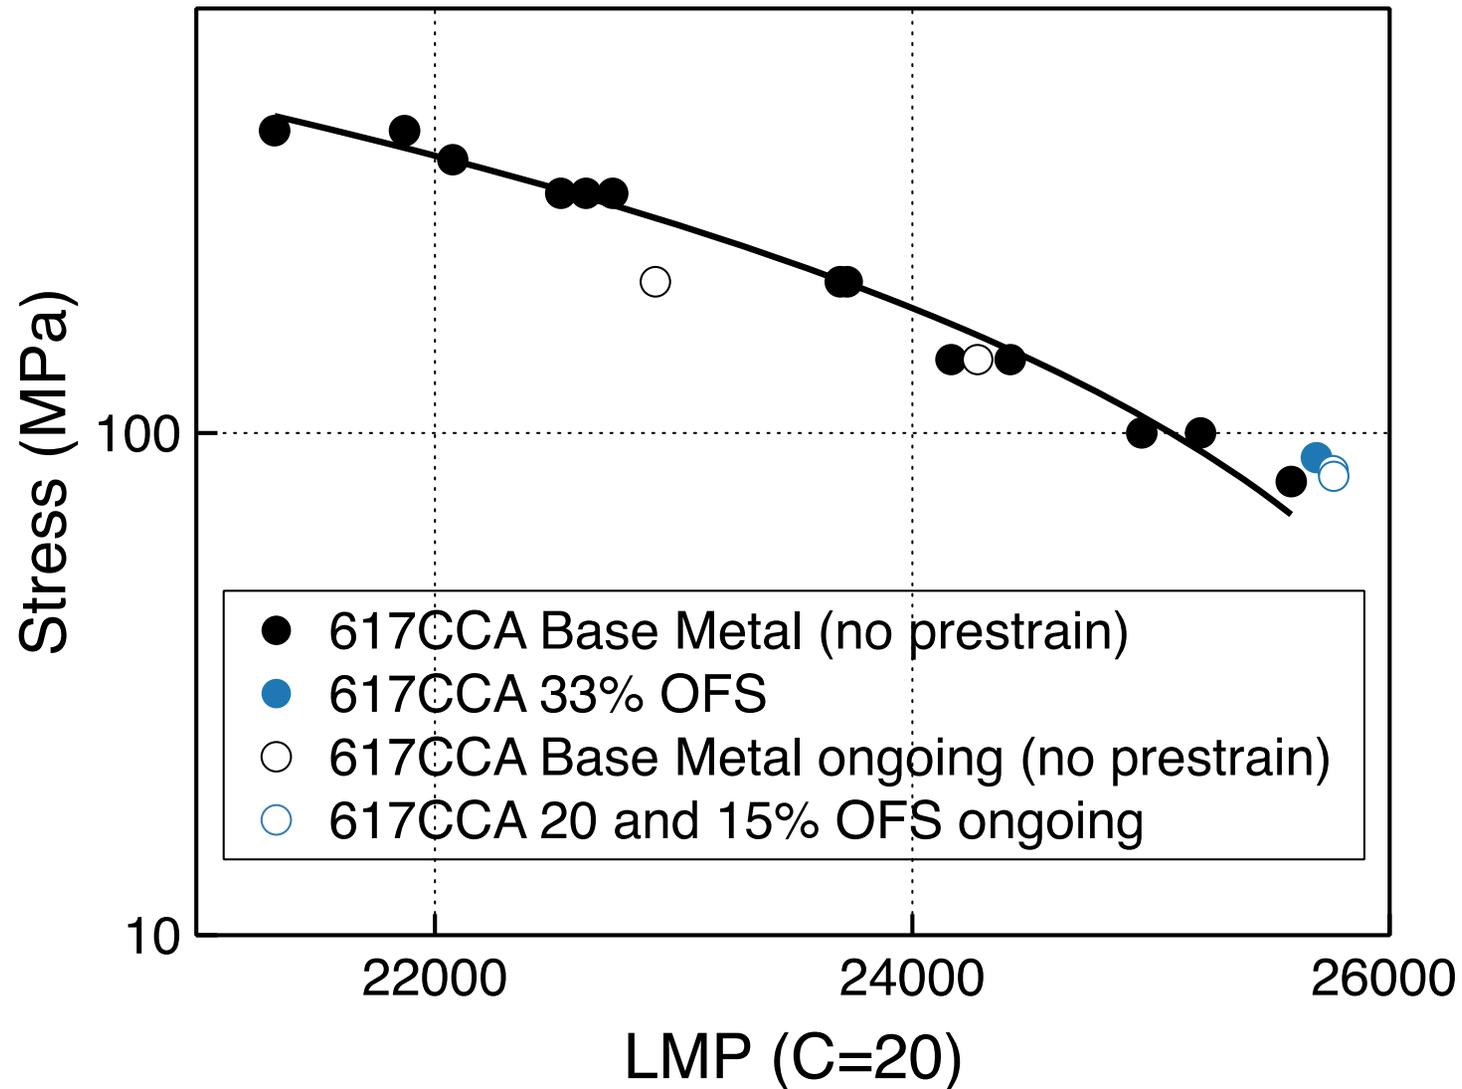
Cold Work by Tube Bending Had No Effect on Creep-Rupture Lifetime for 617CCA

Creep rupture of solid solution Ni-based alloys like 617CCA thought to be less susceptible to cold work effects than precipitation-strengthened alloys such as Inconel 740

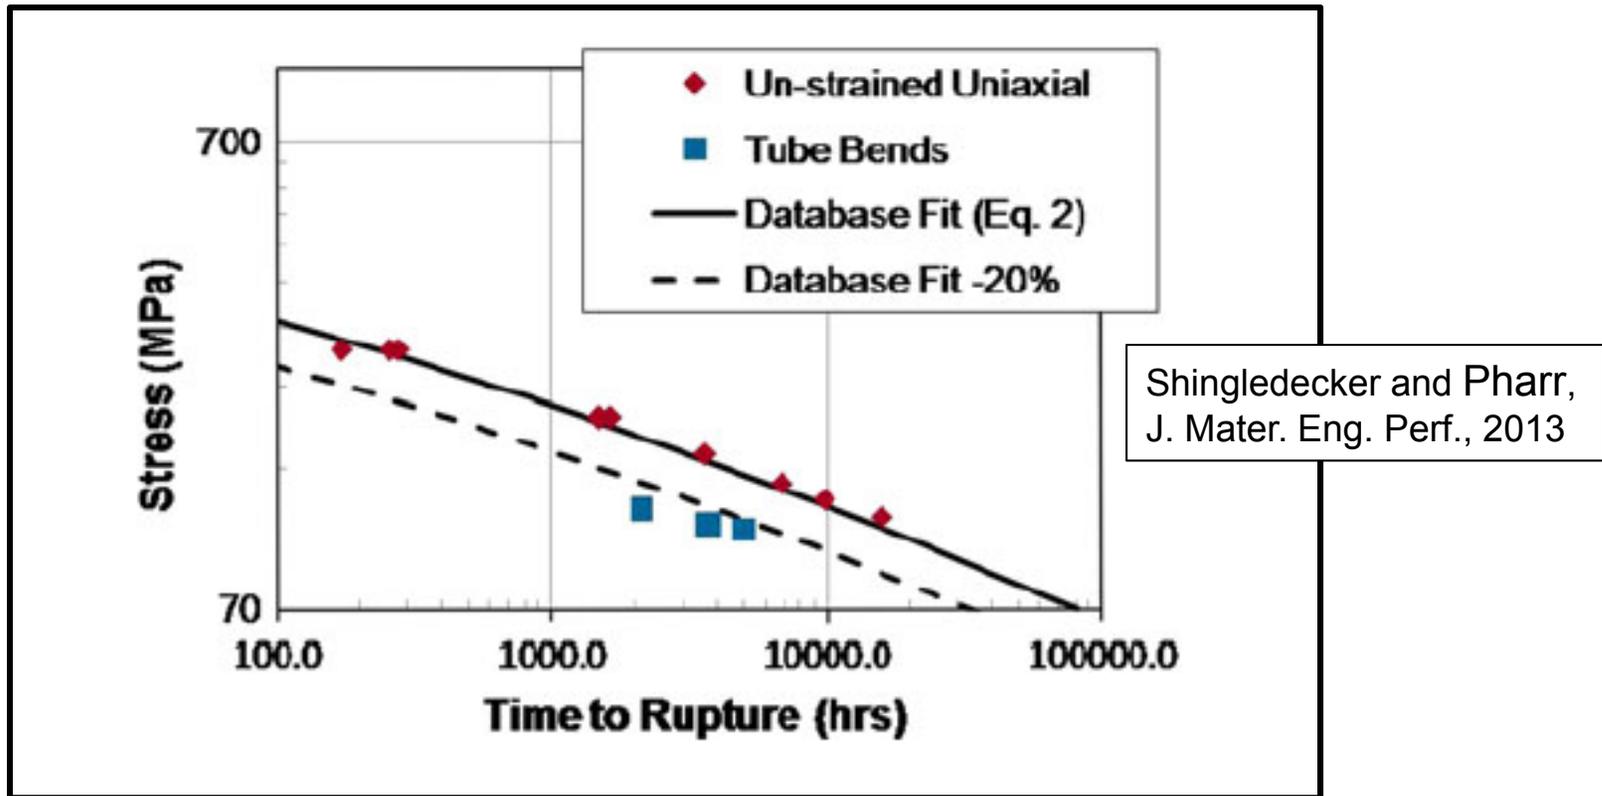
In Contrast, Inconel 740 Showed a Significant Debit due to Cold Work of Tube Bends

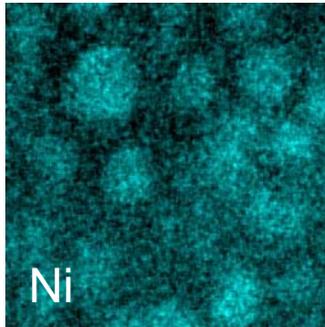
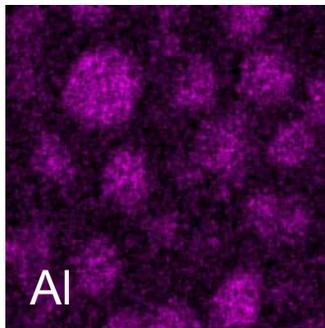
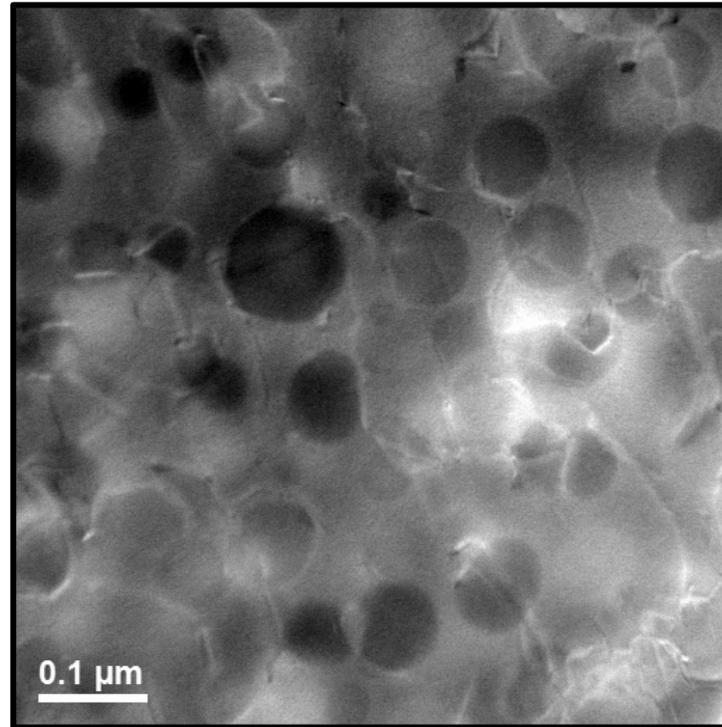
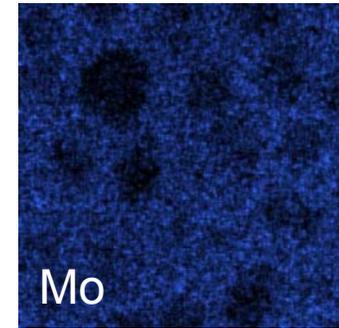
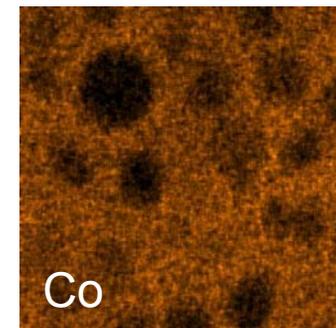
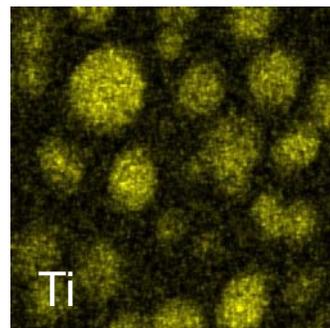
STEM Measurements Used For Aging Data

Haynes 282 – 750°C, 320MPa 1462h

DF-STEM

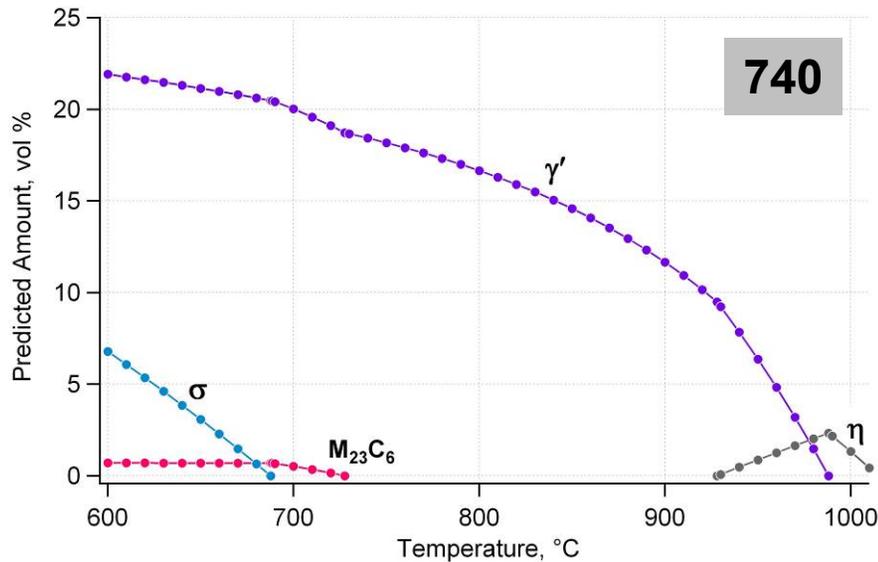
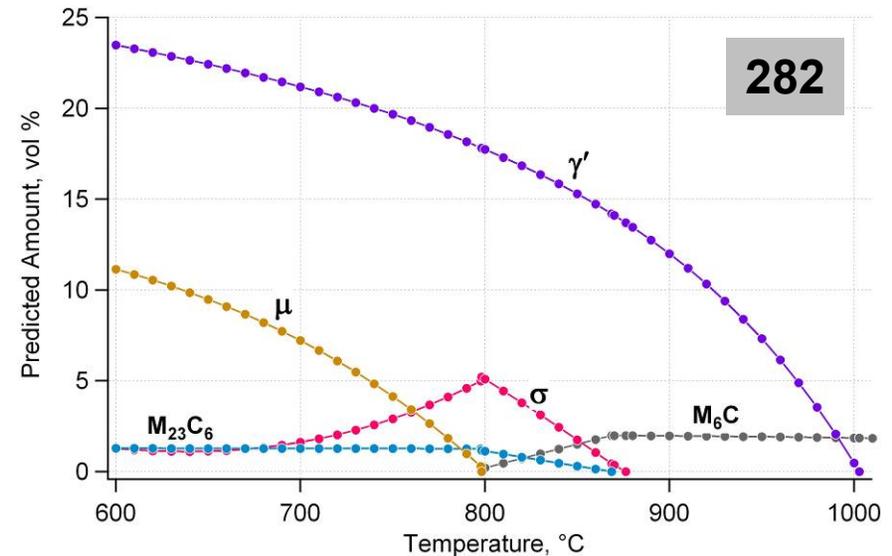
γ/γ' misfit reduces as Mo increases

- Mo promotes formation of TCP phases, μ & σ
- TCP phases can be linked to premature creep cavitation
