WIRELESS CONDITION BASED MONITORING OF GAS TURBINE ROTATING COMPONENTS

FINAL TECHNICAL REPORT

DE-FE0005666

Siemens Energy, Inc.

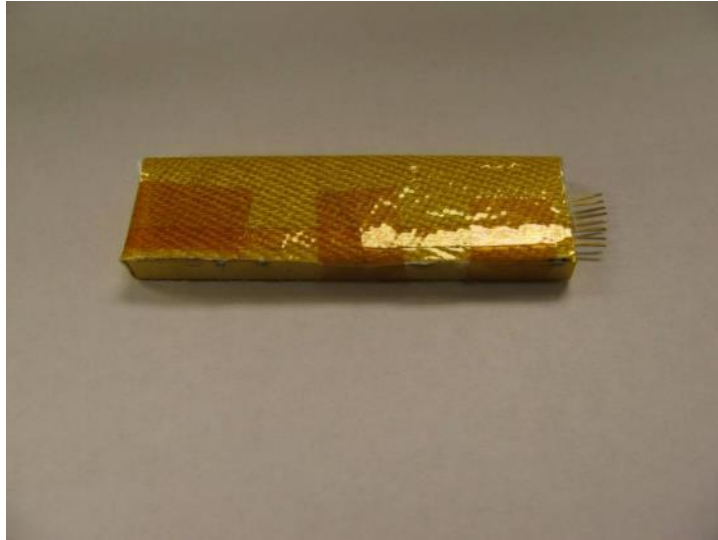
Figure 15: Electronics Board Wrapped in Alumina Mesh and Tape

In order to simulate the high g-loads the board is expected to see in an engine, spin rig tests were performed on the electronics boards. These spin tests were accomplished at the Aerodyn spin rig in Indianapolis, Indiana. The electronics boards were installed into their metallic packages and tested over temperature. Then these packages were wrapped in alumina fiber mesh for vibration protection, and wrapped in high temperature tape in order to keep the fiber mesh in place (see Figure 15). This was then inserted into the custom seal plate. This seal plate has a mechanical interface with the electronics board which is identical to the engine installation. The wrapped board is covered with a metallic lid which is bolted in place.

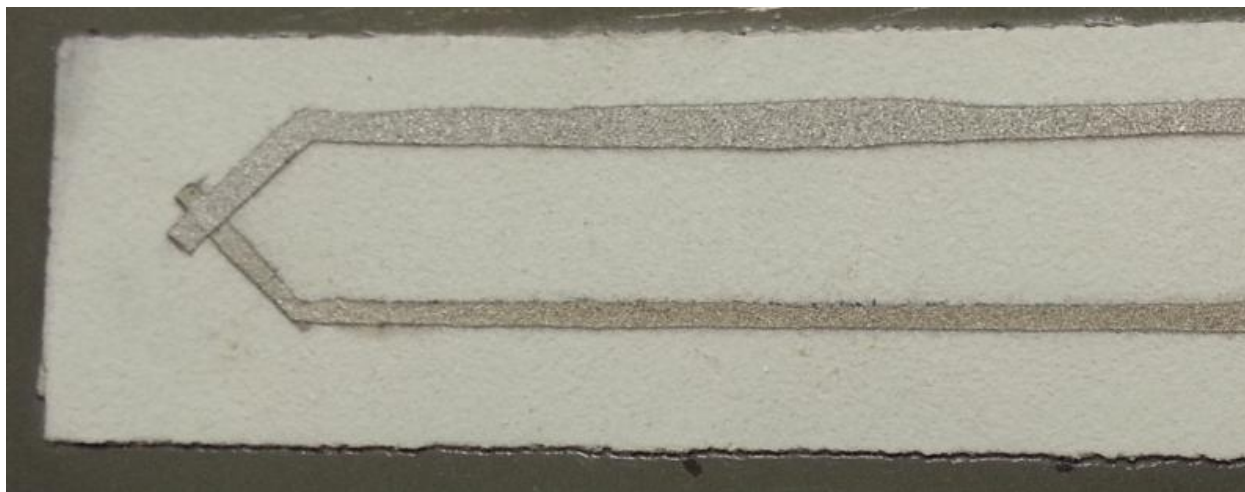
Figure 30: Close-up of Spray-On Thermocouple Applied to H-Class Blade

Task 2 performs scale up of thermal spray sensors and manufacturing blades with sensors for H-Class engine testing. At the base of the blade, the imprinted sensor is connected to more conventional wire. This wire is routed to the wireless telemetry board mounted at the root of the blade. Siemens spray-on thermocouple technology offers a less accurate but more durable alternative to traditional thermocouples, and represents the only sensor-based method for directly measuring temperatures on blades for extended periods (greater than 100 hours). Figure 30 shows a close-up of spray-on thermocouple active region as installed on an H-class engine blade.

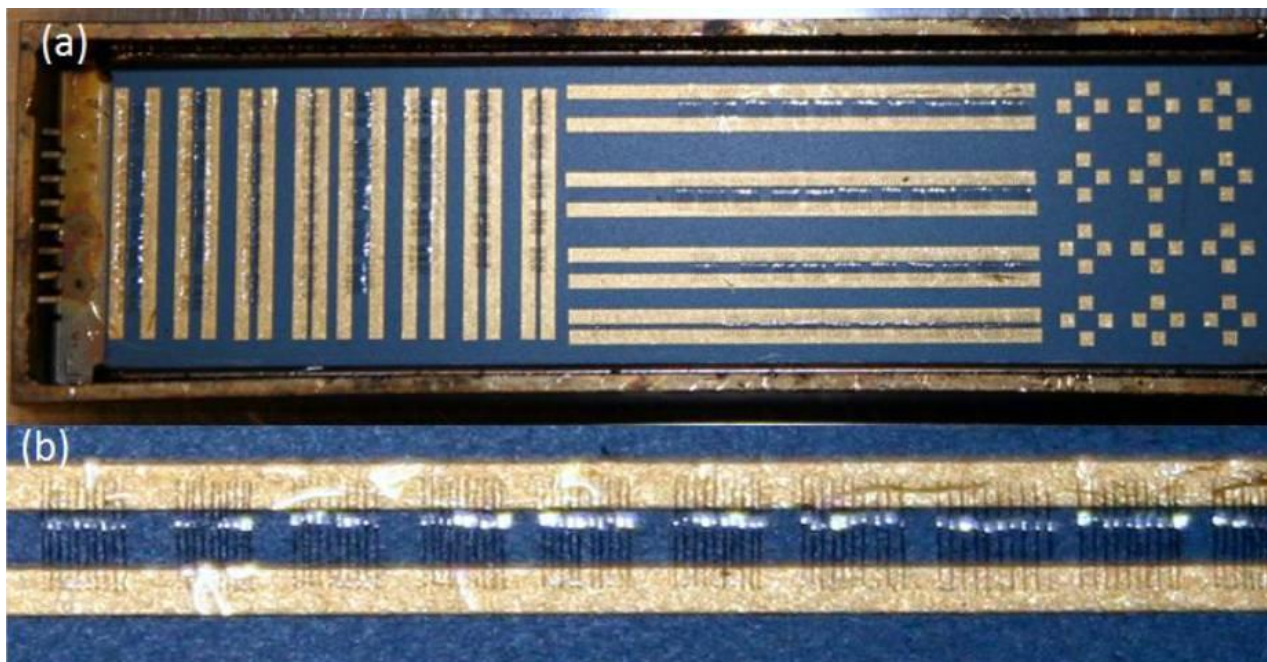
Figure 37: Completed Bond Test Board (a) and a Close-up View of the Bonds (b)

The solution chosen to mitigate this failure mode is coating the wire bonded boards with a thin coat of high temperature polymer in order to mechanically stabilize the wire bonds. In order to test this approach, four wire bond boards were created, each with 1,000 wire bonds, for a total of 4,000 wire bonds. Of these, 10% were tested for wire bond pull strength before polymer coating. These were initially coated with differing layers of this material: 2 μ m, 12 μ m, 25 μ m, and 50 μ m. One of the bond test boards (after coating) is shown in Figure 37.

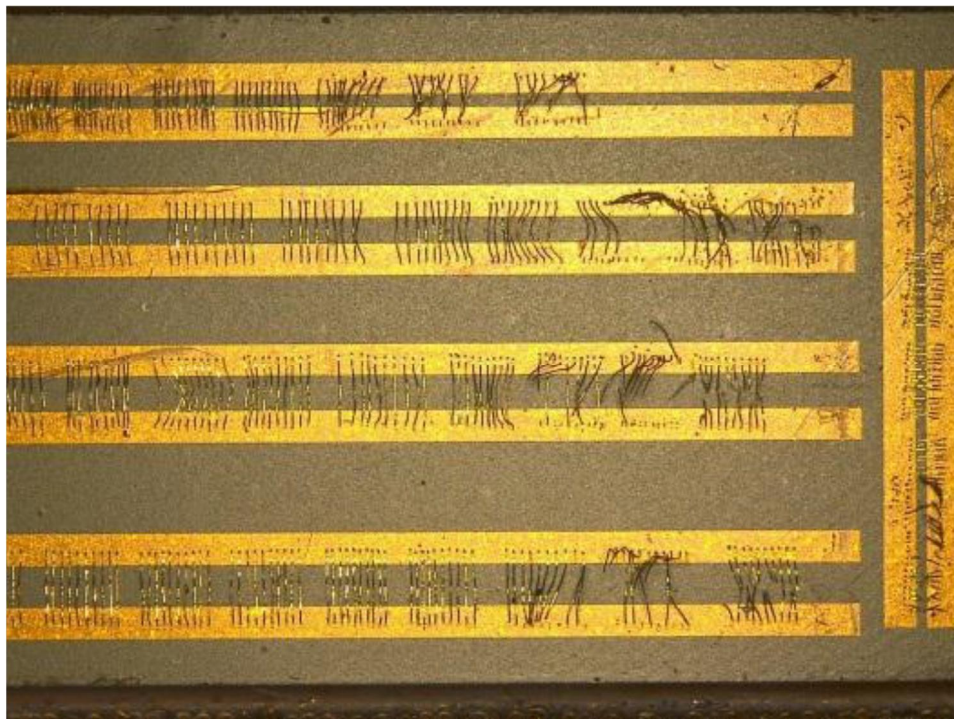
Figure 39: Board 3 after 20 Thermal Cycles at 450°C

Another issue caused NPD situations with Board 3 and exposed larger issues that will affect future test plans. It appears that the softening of the coating at higher temperatures causes it to weigh down the wire bonds and make them sag. This made it impossible to get the hook under the wire bonds for pull testing. This is especially problematic for g-loading applications. The sagging indicates that at high temperatures coating is no longer mechanically supporting the wire bond. In fact, the extra loading from the coating would likely cause the wire bonds to fail during centrifugal g-loading.

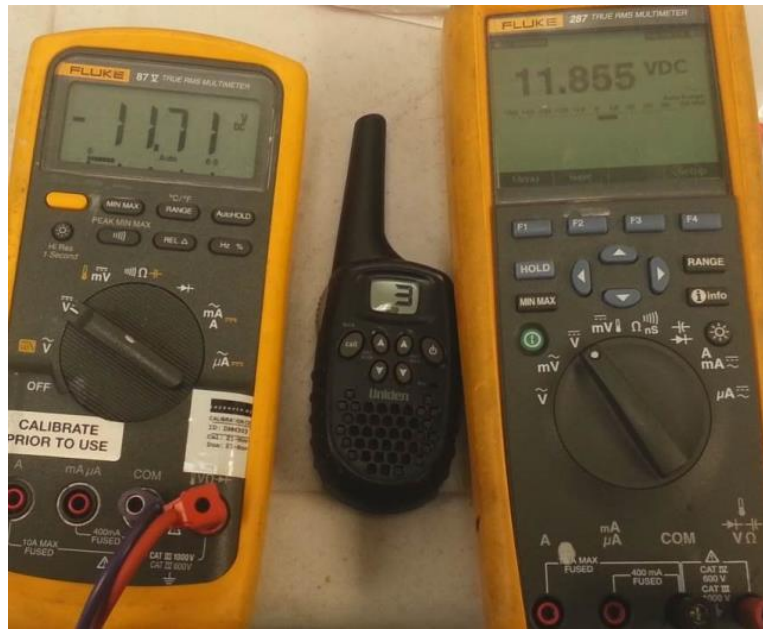
Figure 59: Monitoring of Rectified Voltage on Spinning Electronics Board

The electronics boards receive alternating current (AC) power from the inductive power supply. In order to be utilized by the chips on the board, this power must be rectified, or converted, from alternating current to direct current (DC) power. At this point in the circuitry, this DC power is sampled to external pins on the board. These external pins allow the user to check the DC voltage levels being made available to the remainder of the board. In the spin rig test, these DC voltage pins are relayed out of the spin rig via a slip ring to the control room, where they are monitored (see Figure 59). When the spin rig was at 350°C and 1500g, this voltage went from >15VDC to less than 0.5VDC. At the same time, the RF carrier signal from the strain gage board was lost. It is, therefore, assumed that the rectifier circuit malfunctioned.

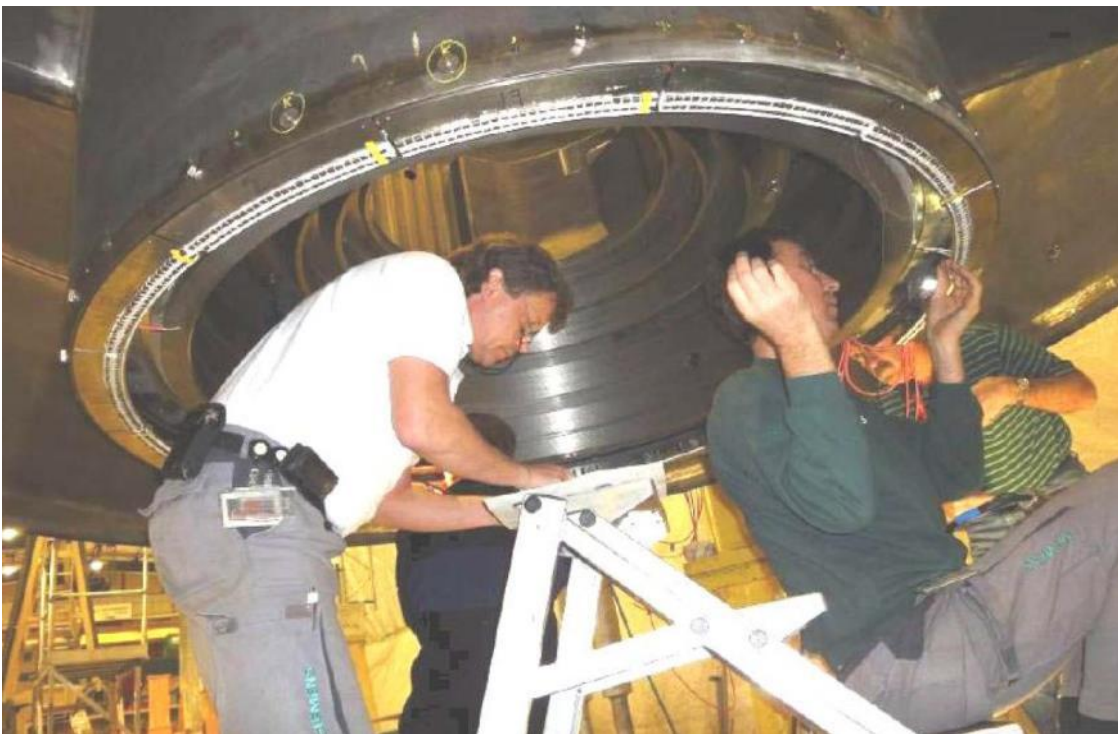
Figure 69: Stator Ring Installation in H-Class Engine

The power inducing stators are powered by an external power supply which sits outside the engine. Through wires connecting it to the stators, the external power supply sends alternating current (AC) electrical power to segments of the power inducing stators. A varying magnetic field is produced along the entire ring of stators. Figure 69 shows the scale of the stator ring in the H-class engine, and the Figure 70 shows a section of the stator ring (showing three of the sixteen segments) installed in the H-class engine.

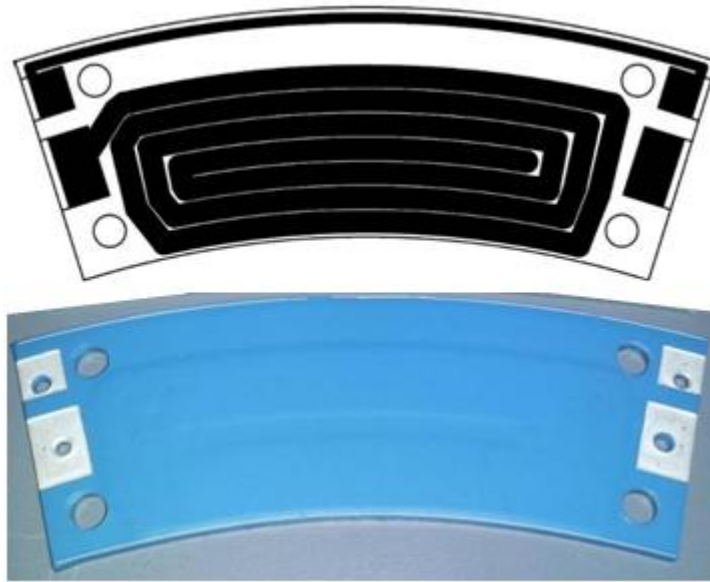
Figure 76: Internal Diagram and Photo of LTCC Magnetic Coil Arc

The stack is compressed together and held in place by bolts threaded through four different holes in each of the arc pieces. These holes go through all layers and into threaded holes in the metal plate. Spring washers are compressed under the bolt head to maintain compression on the stack over temperature, because the bolt grows with temperature more than the stack does.

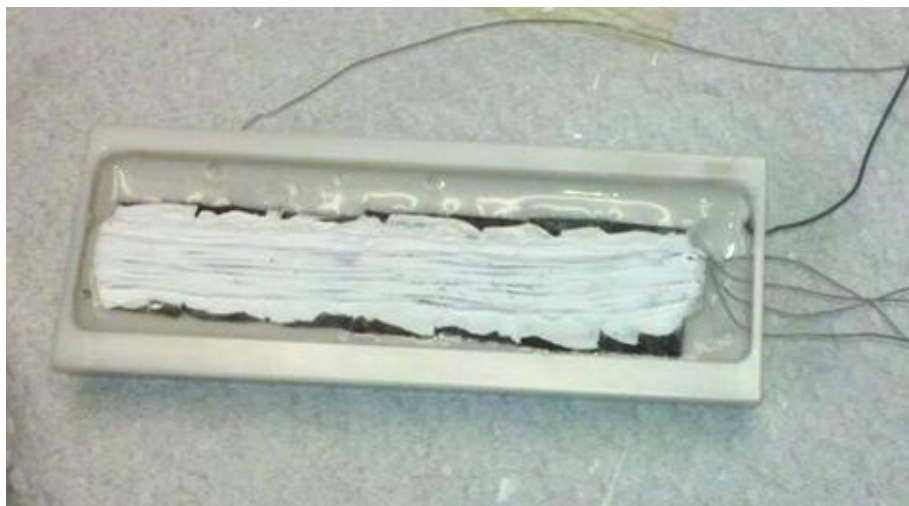
Figure 80: Wound Core Assembly Potted into the Ceramic Box

The initial design of the rotating antenna was developed by Rove technology. The rotating antenna is composed of seven custom-designed magnetic cores wound with small diameter ceramic insulated high temperature wire (the red lines in Figure 79). This wire is wrapped in a bifilar method, meaning that pairs of the wire are wound simultaneously. There are two layers of 8 wire pair windings each, for a total of 32 windings. This core assembly is then placed inside a custom-designed ceramic box, and potted into place using specialized ceramic cement shown in Figure 80. During this potting process, a length of wire is also laid in the box, not touching the core assembly. This length of wire extends out of the ceramic box and serves as the RF telemetry antenna, which allows the wireless telemetry board to communicate the RF modulated sensor data across the air gap to the RF antenna embedded in the stators.

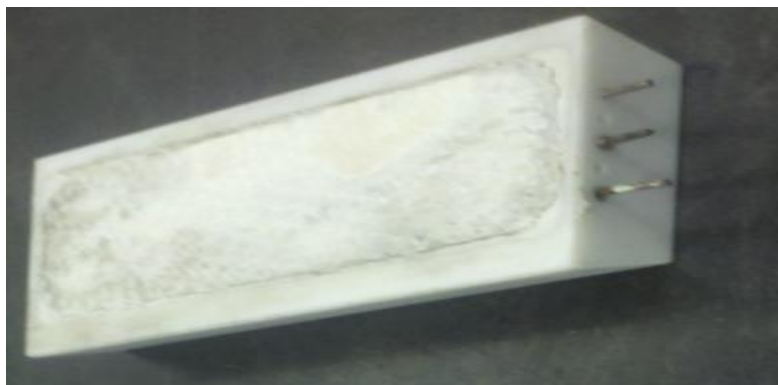
Figure 81: Redesigned Power Receiving Antenna

Because of these issues, Siemens redesigned the rotating power receiving antenna as shown in Figure 81. This redesign will be referred to as Generation 1.5. Design improvements included:

- Providing a method for strain relief and insulation within the wire windings
- Changes in the potting material to increase electrical isolation
- Magnetic core geometry changes to increase mechanical stability
- Improved manufacturing process for mechanical stability
- Improvements pin design to improve mechanical stability
- Improvements in winding coating to increase high temperature electrical isolation

When these improvements were implemented, the results were dramatic. The rotating antenna now transduces power with little variation at temperatures above 500°C (see Figure 82). The variation in power induced improved to approximately 20%, instead of the 50-100% seen with previous antennas.

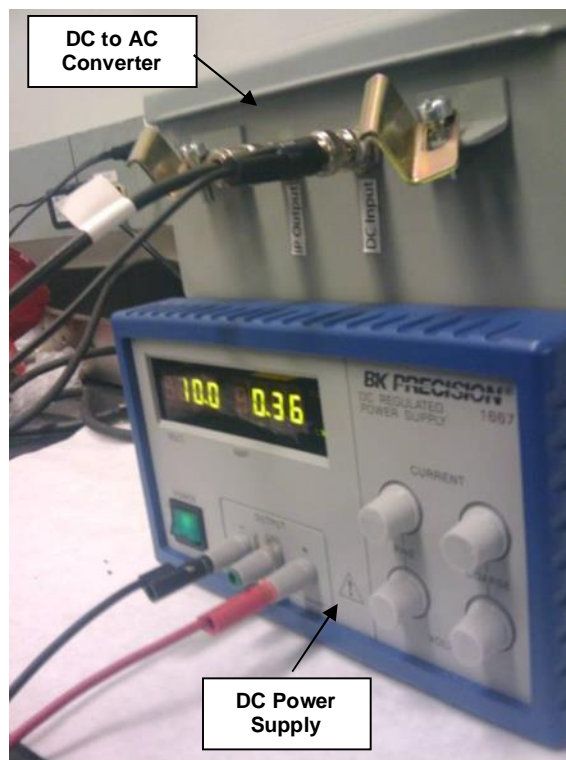
Figure 83: External Power Supply

As stated above, the power inducing stators are energized by an external power supply. This external power supply was originally comprised of two devices (see Figure 83 below). The first is an off-the-shelf DC power supply which can be plugged into facility power, and will output voltage-regulated DC power. The second is a 30-50W, 250 kHz DC-to-AC converter which was custom designed and built for this wireless system. This device was designed and built before the current project period by Rove Technical Services; however, beginning in late 2011, a significant redesign commenced. This AC-to-DC converter redesign provides significant external power supply improvements. These improvements included a lower-resistance transformer, the flexibility to change the AC frequency, and the ability to induce a variety of different waveform shapes.

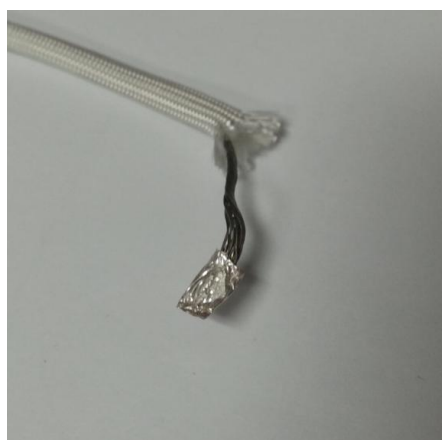
Figure 102: New External Line Contact

These wires were replaced with stranded wires of a non-oxide-forming element, thereby increasing surface area and eliminating the oxide contact issues. Figure 102 shows an example of the new contact.

With the new contacts there was a major improvement in the circuit both at high and low temperatures. Table 12 shows the differences in the DC and RF resistances of the power coils and RF antenna.

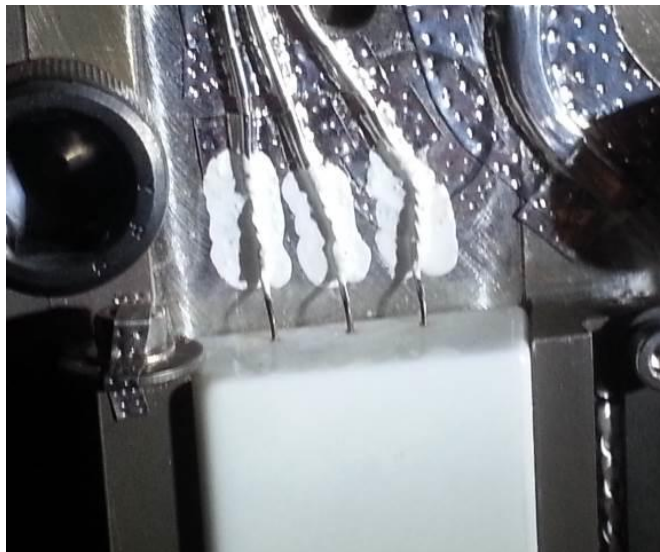
Figure 112: Rotating Antenna Pins before Spin Test

The rotating antennas performed nominally throughout the spin test. Electrical tests before and after the spin test showed no degradation in the resistance or inductance of the rotating antennas. The ceramic boxes which enclose the antennas showed no cracking, chipping, or other mechanical issues. The external pins showed excellent durability and minimal bending. Electrical connections were maintained throughout the test. These rotating antennas, which see the highest temperatures and g-loads in the spin rig and engine, are functionally and mechanically fully operational. Figures 112-115 show the pins before and after the spin test, along with pictures of the spin disk assembly. No pin breaks or elongations occurred. No bending of the pins occurred. This is a first time these pins have survived without significant bending, which is remarkable given that this portion of the spin disk experienced over 14,500g at 350°C for well over an hour. As can be seen in the after spin test pictures, the light application of the white cement (used for electrical insulation) did experience some chipping and cracking. No short circuits to the underlying metal occurred.

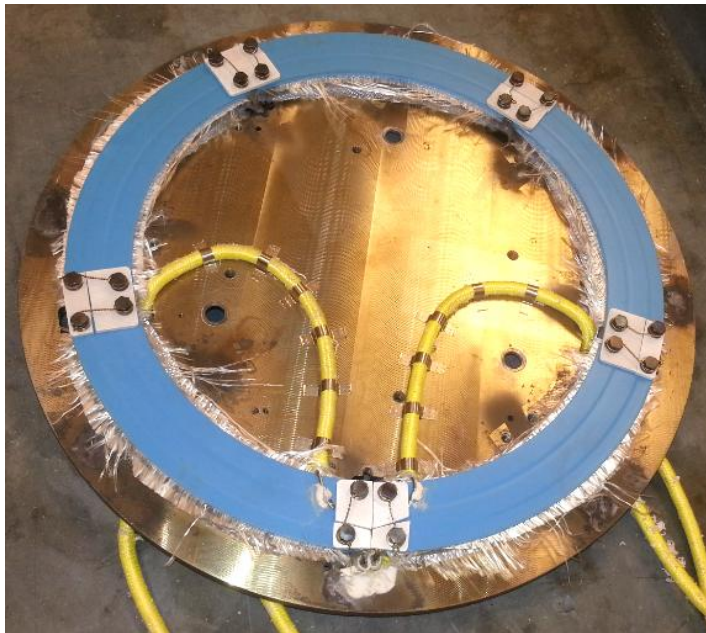
Figure 116: Inductive Power Ring after Spin Test

The stationary inductive power ring, shown in Figure 116, provided power sufficient to power the electronics boards over the full temperature range of the test. This ring of ceramic-embedded coils also received the RF carrier signal and sent the signal outside the rig on specialized high temperature cables.

Three functional issues occurred with the inductive power ring during the spin test:

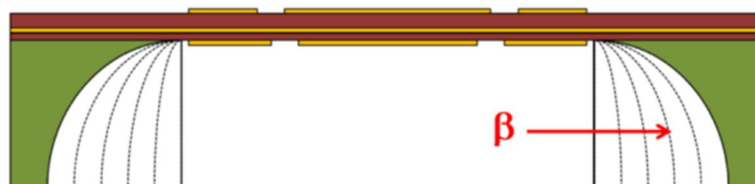
Figure 124: Sidewall Etching Angles Under a SiC Pressure Transducer

A significant discovery was made by the University of California at Berkeley that may increase the power scavenging by several fold. By etching the sidewalls of the cavities at an angle less than 90° (see Figure 124), lower resonant frequencies, higher vibration quality factors, and higher stress thresholds can be realized. Figure 125 shows the estimated power enhancement factor, which looks to be a factor of seven at reasonable etching dimensions.

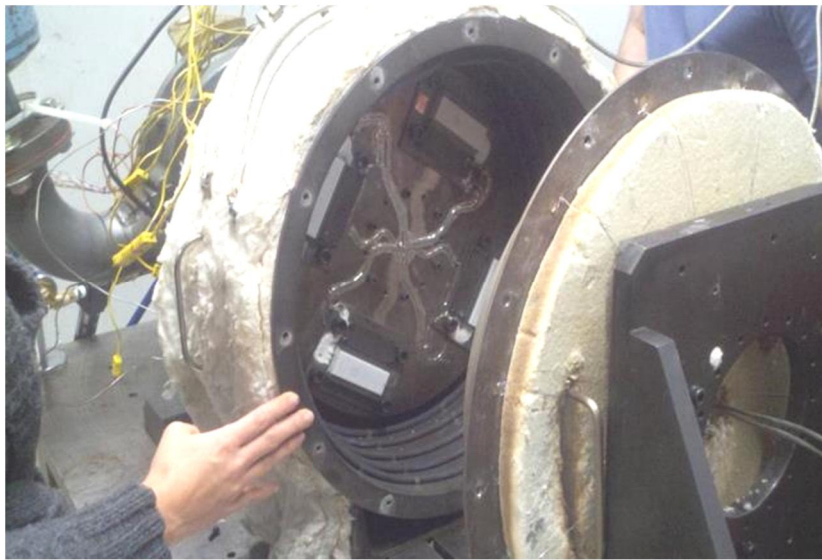
Figure 129: Aerodyn Spin Rig

In order to perform high temperature, high g-load spin testing, Siemens contracted the services and facilities of Aerodyn, Inc. They have the capability to subject test articles to g-loads exceeding 20,000G while simultaneously exposing them to temperatures above 450°C (Figures 129 and 130). This test rig simulates well the 14,500g, 450°C engine environment.
