Quarterly Research Performance Progress Report (Period Ending 12/31/2015)

Deepwater Methane Hydrate Characterization and Scientific Assessment

GOM² PRESSURE CORING TOOL WITH BALL VALVE (PCTB) LAND TEST INITIAL REPORT

GOM² MARINE BASED TEST GEOTECHNICAL SOW

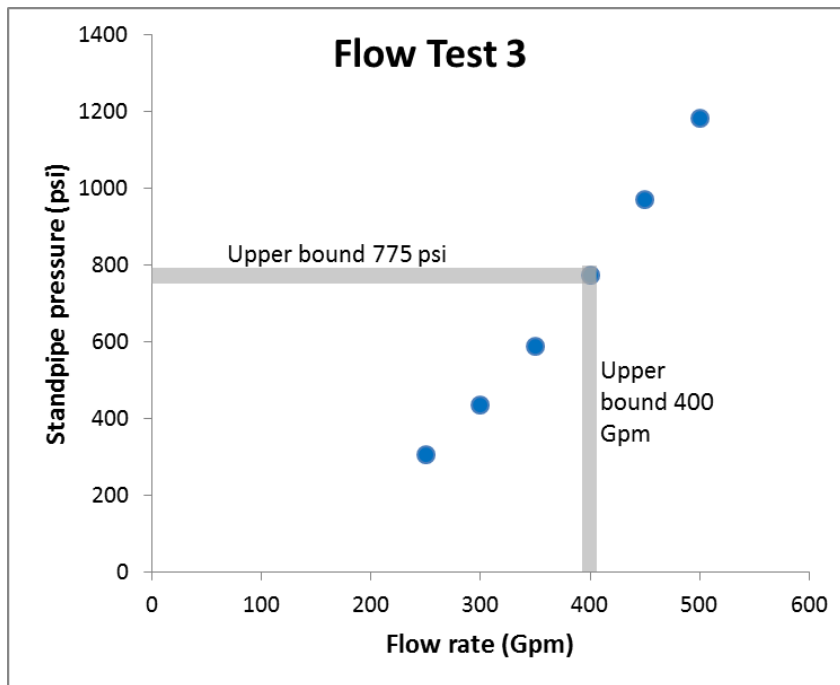
Figure 3: The results of Flow Test 3 suggest 400 Gpm is an upper bound for the PCTB cutting-shoe configuration.

Flow Test 3 (liner collapse test) suggests that a significantly larger standpipe pressure can be applied without collapsing the liner. In this example, during the Field Dynamic Flow Test, no liner deformation was observed up to a flow rate of 400 GPM or a standpipe pressure of 770 PSI. This is perhaps an upper bound for the standpipe pressure that the tool can withstand without collapsing the core liner. At a flow rate of 500 GPM with a corresponding standpipe pressure of 1184 PSI, the liner was found to have collapsed. Upon recovery we noted that only part of the core liner had collapsed (Fig. 4), the area from the ball-valve up about 3 feet. In this section of the tool, the liner is not supported by the inner-tube when in the coring position, which allows for the pressure differential to establish between the liner and the inner-tube. This test indicates that a flow rate of 400 GPM with a corresponding stand pipe pressure of 770 psi is perhaps a true upper bound for operating the PCTB without collapsing the liner (Fig. 3).

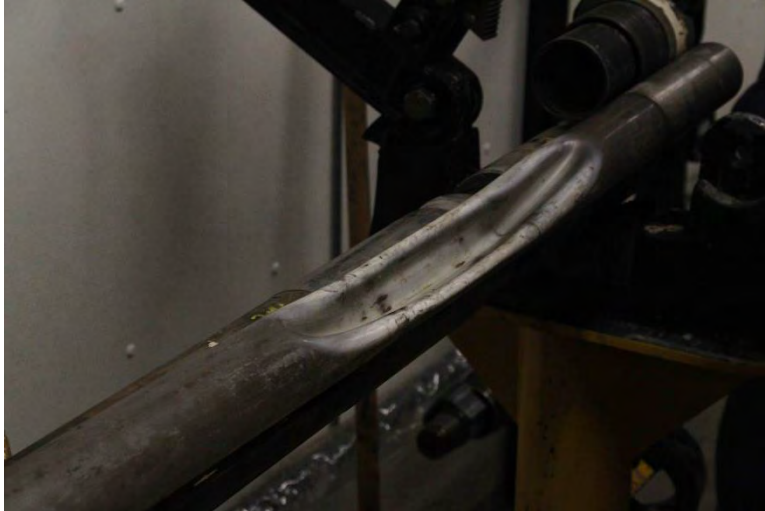
Figure 4: Collapsed liner after Flow Test 3.

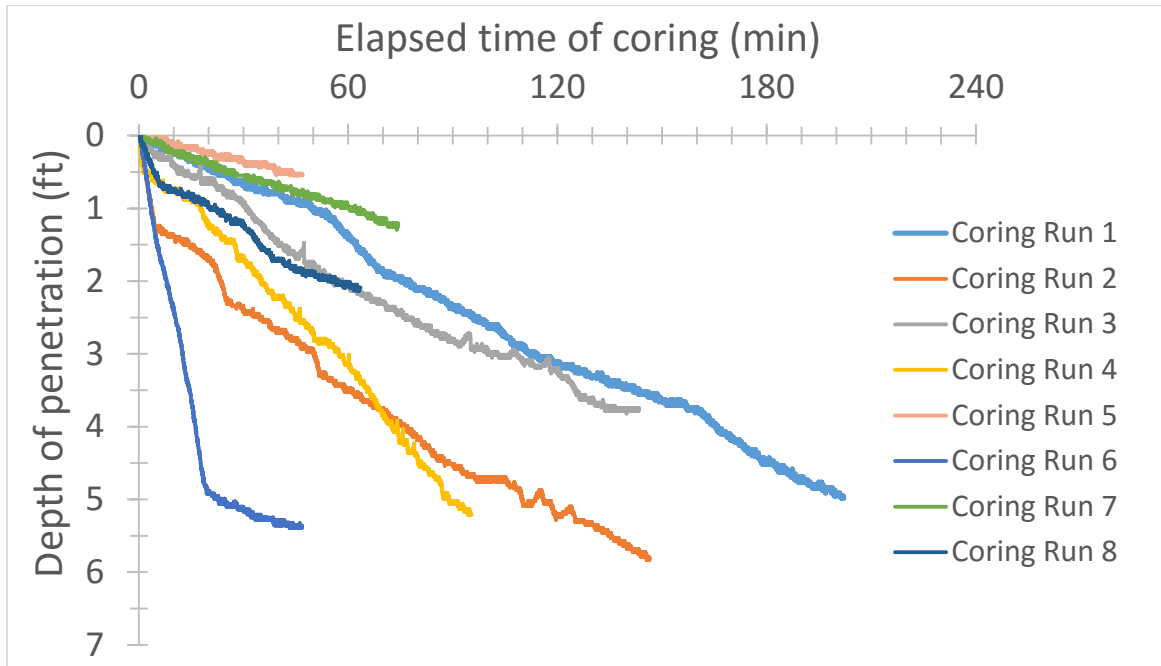
Figure 8: Depth versus penetration for all coring tests.

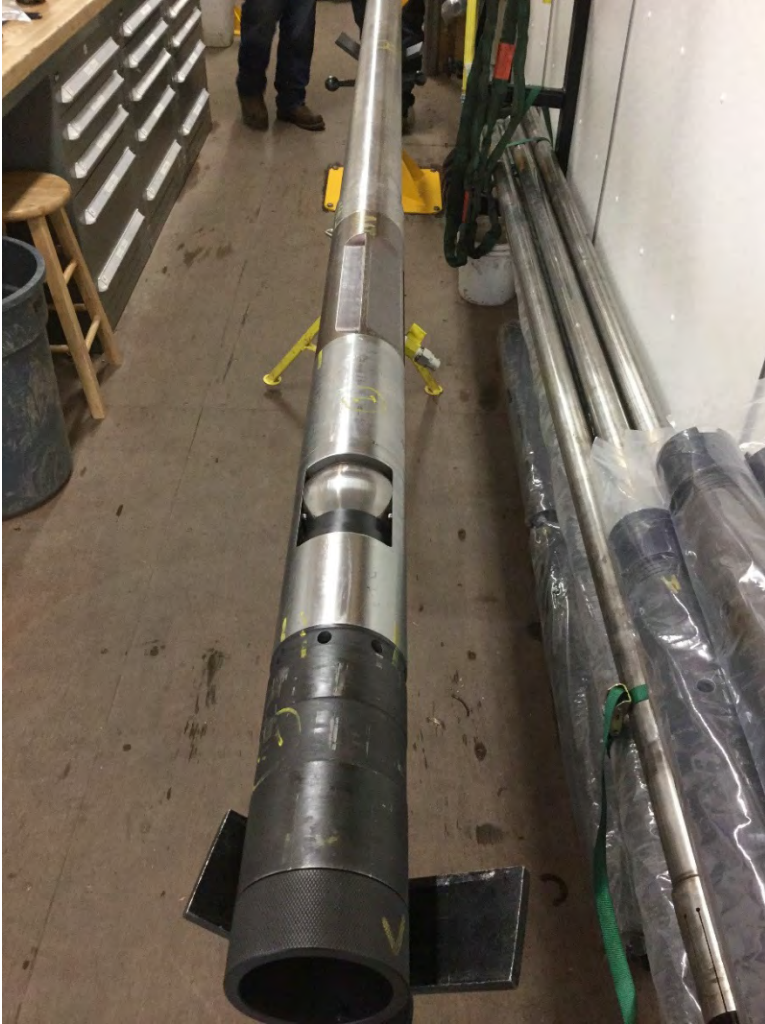
Figure 1: PCTB (Pressure Coring Tool with Ball)

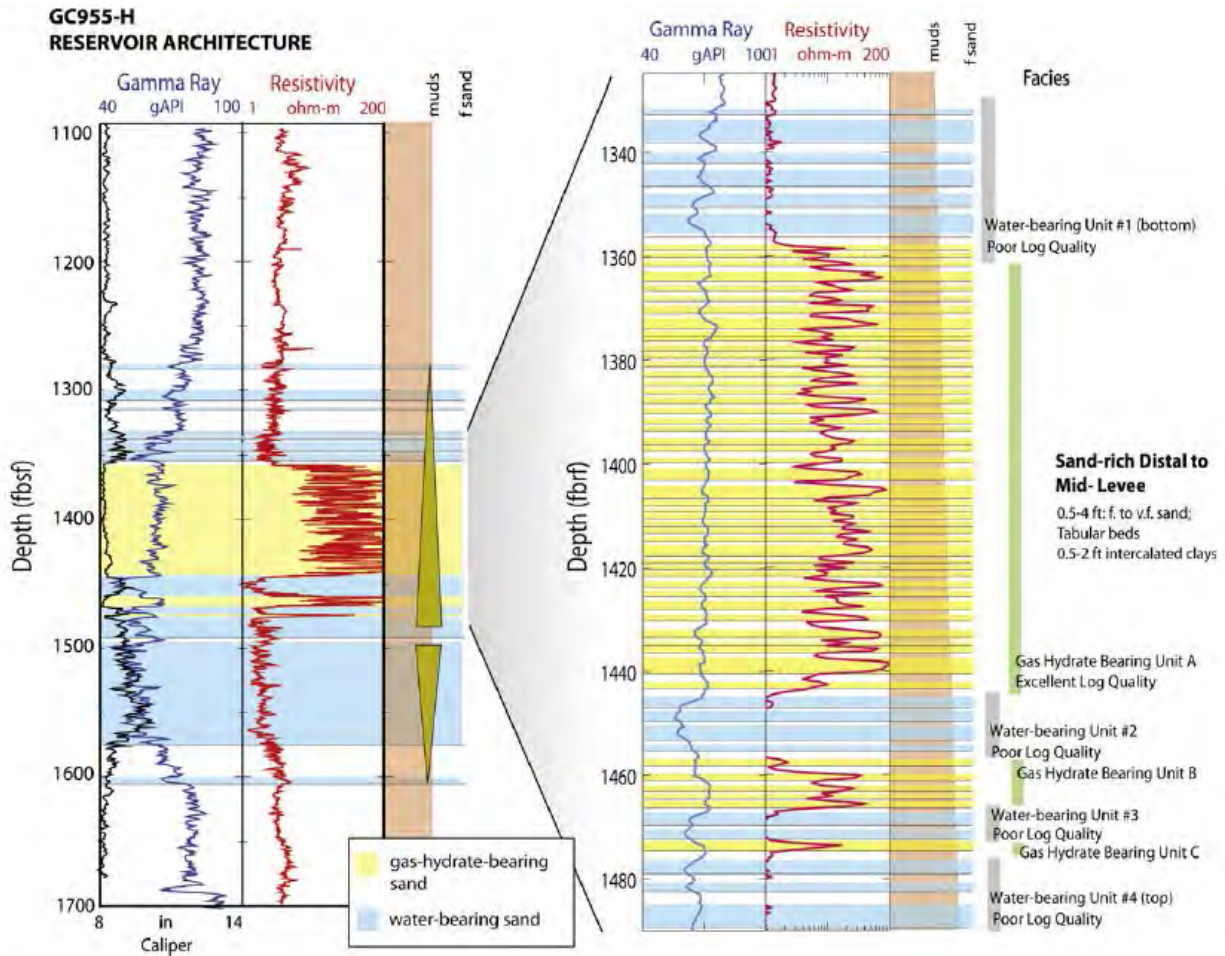
Figure 6: LWD data from the reservoir sands in the GC955-H well showing the thinly-interbedded nature of the gas-hydrate-bearing sands, as well as the areas of poor LWD data quality in the bounding water-saturated sand-rich units. Lithology as inferred primarily from the GR log to right (yellow $\frac{1}{4}$ fine sand; beige $\frac{1}{4}$ silts and silty muds). Intervals of graded bedding (fining-upwards and coarsening upwards) indicated by brown triangles. For more information on the LWD data used in Leg II, please see Collett et al., (2012).
