## **Inspection of Fusion Joints in Plastic Pipe**

**National Energy Technology Laboratory**

## **Final Technical Report**

DOE Award No: DE-FC26-03NT41882

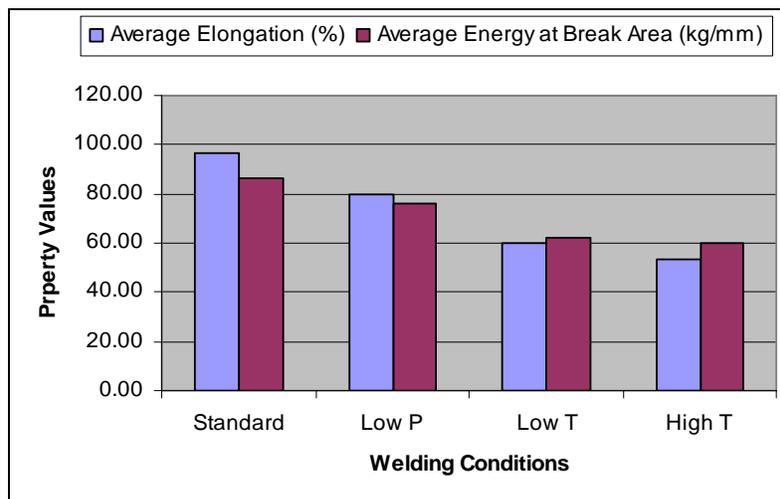
**Figure 3. Driscoplex 6800, PE 3408, 152-mm (6-in.) Yellowstripe SDR11 STDT Results Graph**

Based on STDT results, as shown in Figures 3 through 14, the WZIM accurately detected all welds with reduced strength. A graph of the STDT results for each pipe material type versus the fusing parameters are in Figures 3, 5, 7, 9, 11, and 13. Each graph shows the value of the STDT result of *average elongation of the material (%)* and the *energy at the break area (kg/mm)*. Also for each pipe material type, is a table of the actual data values of the STDT, compared with the NDE result and WZIM prediction (Figures 4, 6, 8, 10, 12, and 14). Several joints made under substandard conditions were detected by the WZIM, which did not show a reduced strength during the STDT. It appears that the WZIM inspection is more sensitive in distinguishing joints made under substandard conditions than STDT. This can be explained by the fact that STDT, while providing an initial indication of the weld quality, is not sensitive enough to be used as a final means for evaluating the effect of flaws in plastic welds, including those resulted from substandard welding conditions. Also, STDT may not directly correlate with long-term strength of the joint under static and fatigue loading.

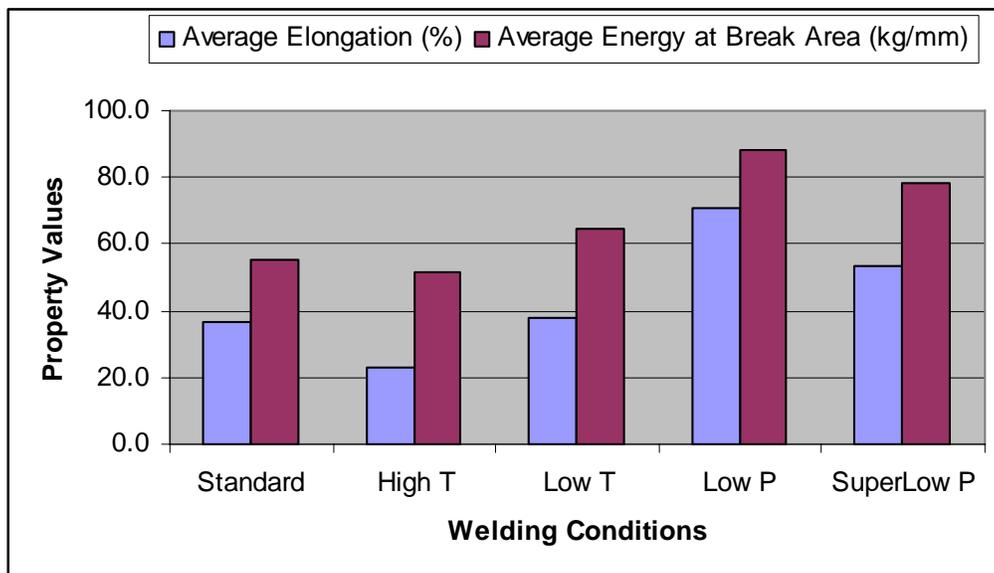
Figure 5. 8100 Driscopipe, PE 3408, 203-mm (8-in.) SDR11 STDT Results Graph

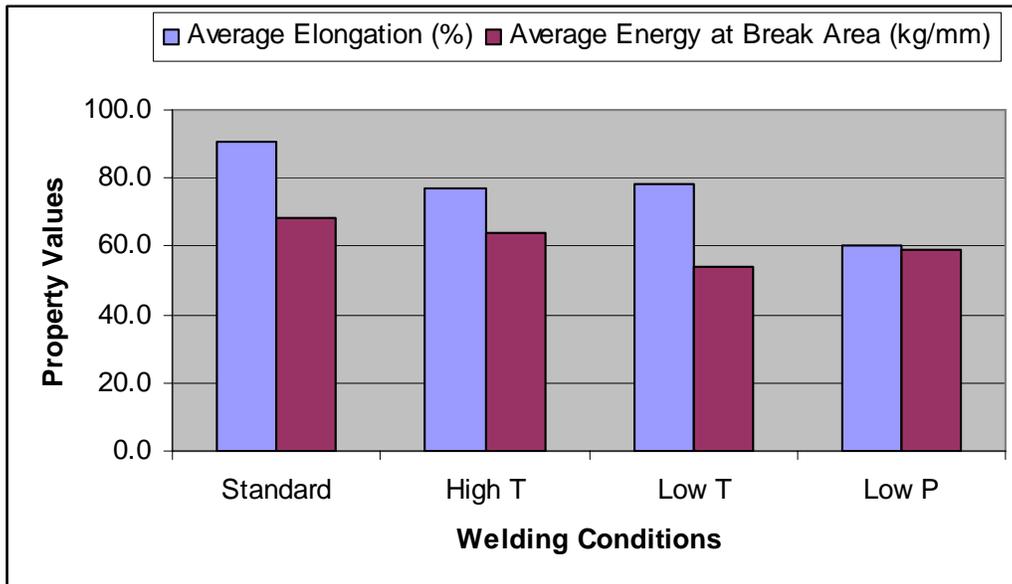
Figure 7. Driscoplex 6800, PE 3408, 101-mm (4-in.) SDR11 STDT Results Graph

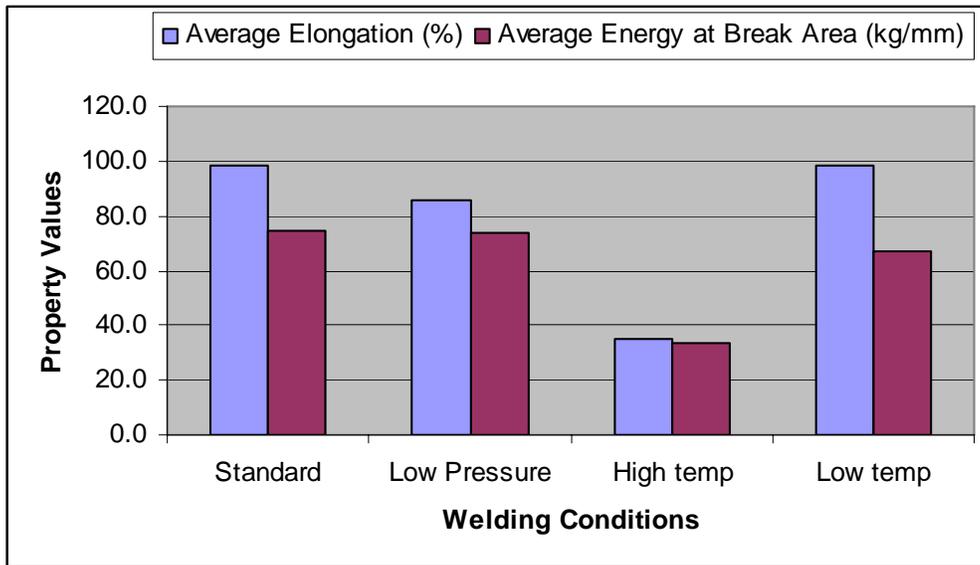
Figure 9. Driscoplex 6500, PE 2406, 203-mm (8-in.) SDR13.5 STDT Results Graph

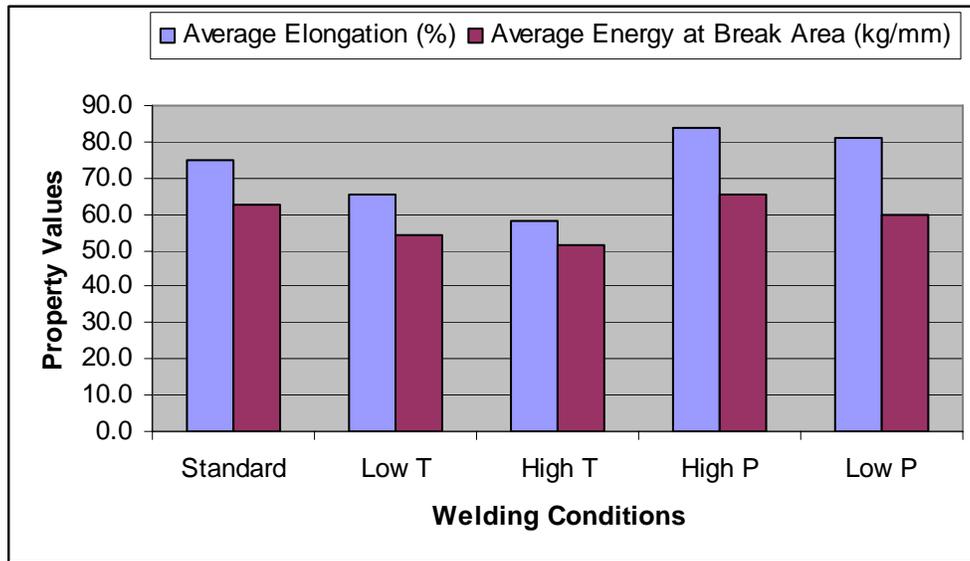
Figure 11. Driscoplex 6500, PE 2406, 152-mm (6-in.) SDR13.5 STDT Results Graph

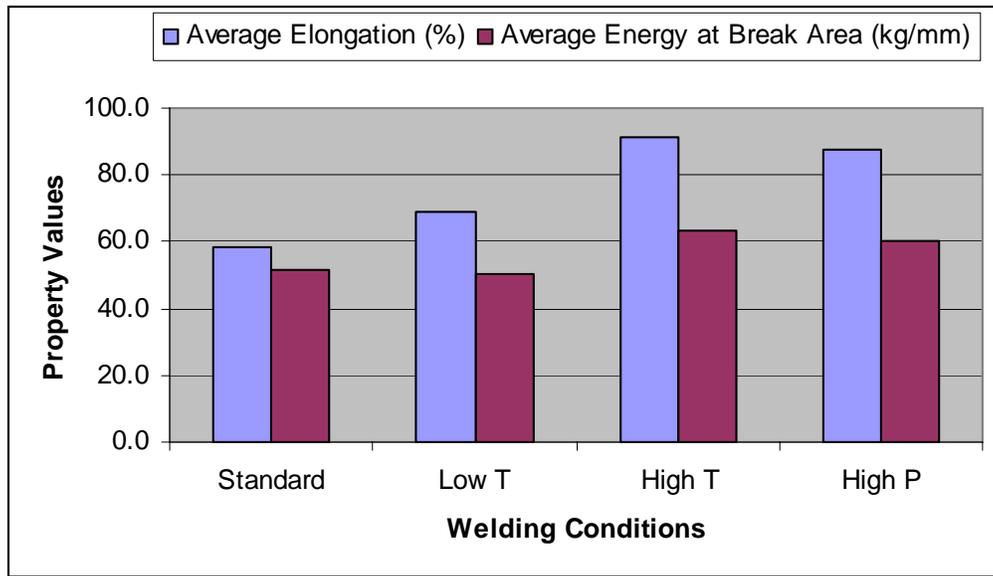
**Figure 13. Driscoplex 6500, PE 2406, 101-mm (4-in.) SDR11.5 STDT Results Graph**

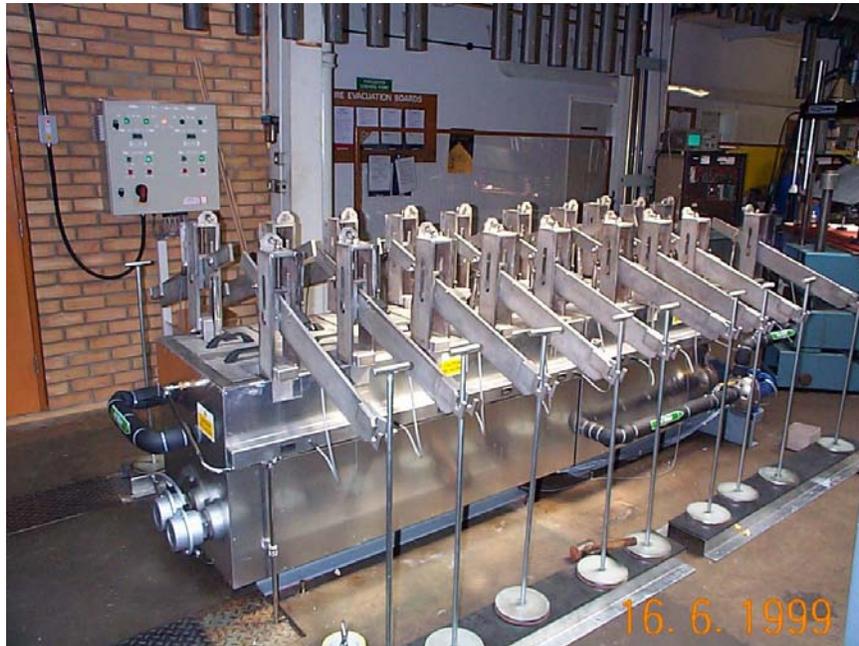
The equipment needed to perform the creep rupture tests was located at TWI. This equipment, shown in Figure 15, consists of two hot water baths, each containing 10 test stations. Each bath contains two heaters, and water is constantly circulated throughout the bath to maintain an even temperature. Each test specimen is fit onto a hanger that applies a load force onto the specimen while it is submerged in 80°C water. The amount of load applied to the specimen is determined by the size of the specimen and prior experience of TWI using PE100 material. A timer is set from the moment the load is applied and the specimen submerged, and continues to count until the specimen fractures, indicating time to failure. After failure, the specimen is tested to make certain it failed with at least 30% brittle surface. BS EN 12814-3<sup>(5)</sup> specifies that at least 30% of the fracture surface must be “brittle” for the test to be considered valid. If the failed specimen does not have the brittle characteristic, the results from the creep rupture test will not

**Figure 15. Photograph of Tensile Creep Rupture Test Rig**

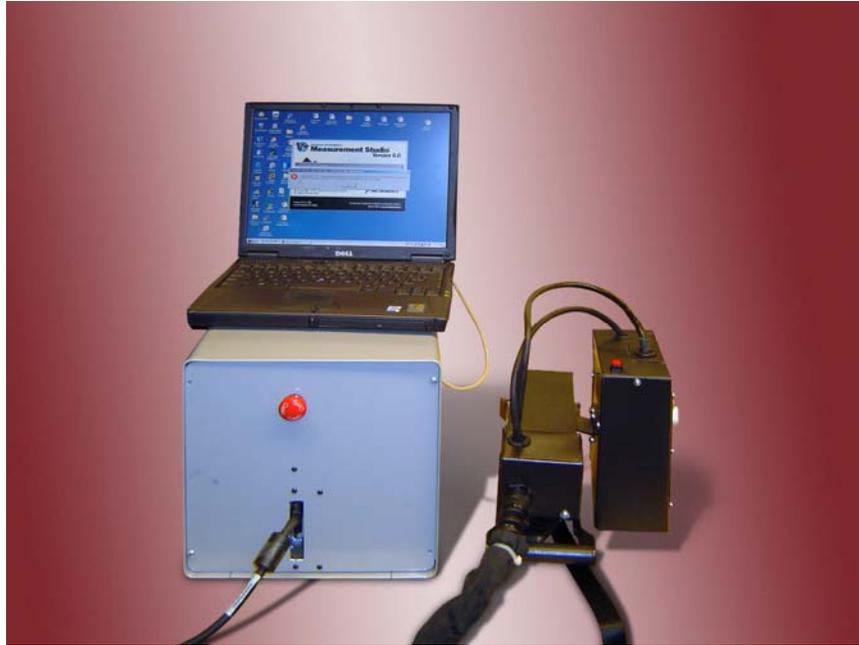
tool (Figure 16) is a portable device to be used in-situ, and this prototype system was designed, developed, and demonstrated throughout the course of this project.

**Figure 16. WZIM Inspection Tool**

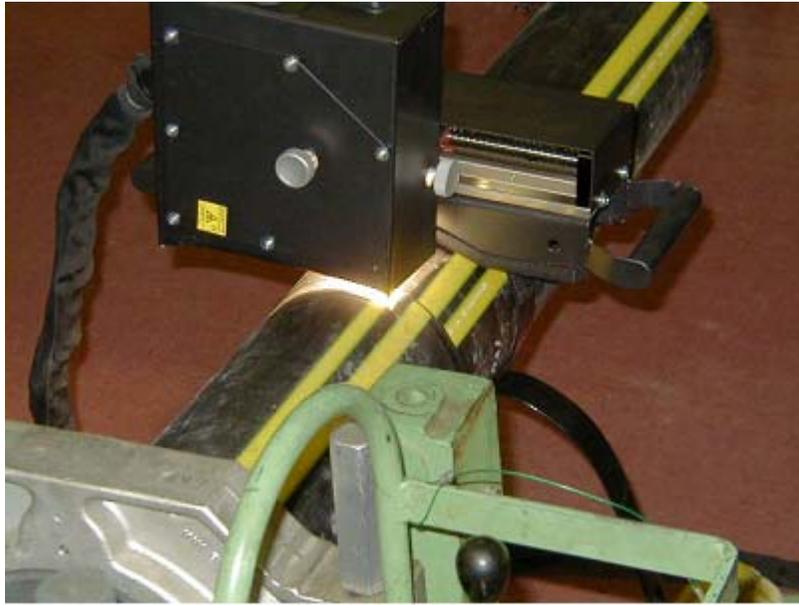
**Figure 23. WZIM Inspection Tool Performing Local Reheating**

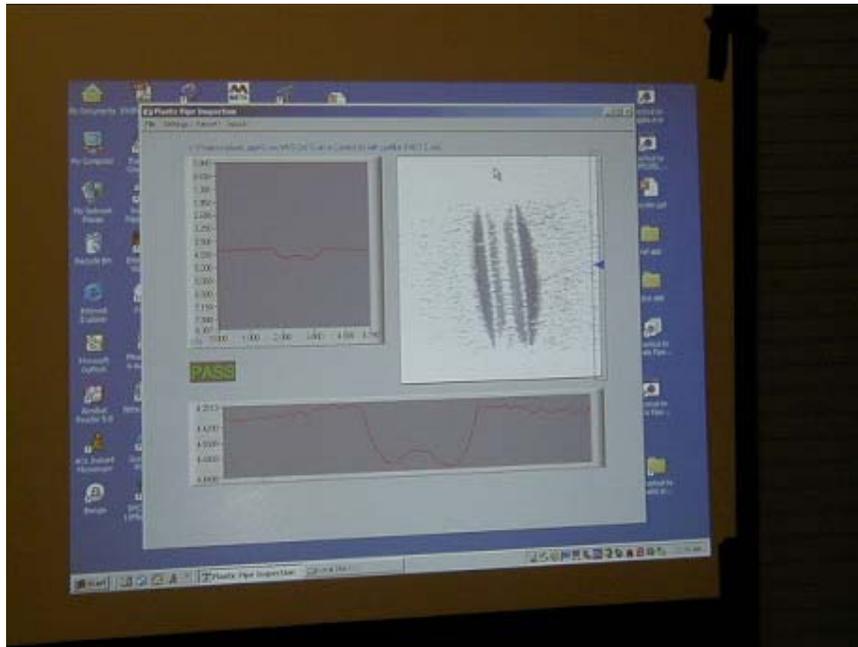
Figure 25. Result of Pass shown on Laptop Software Screen on the WZIM Inspection Tool

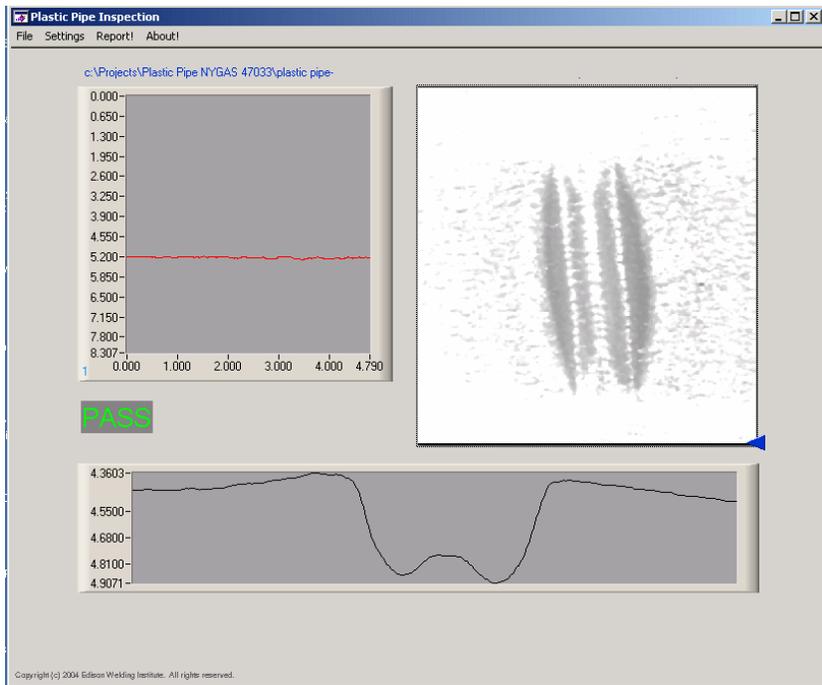
Figure 27. Typical Pass Result on UIR Screen for MDPE Pipe

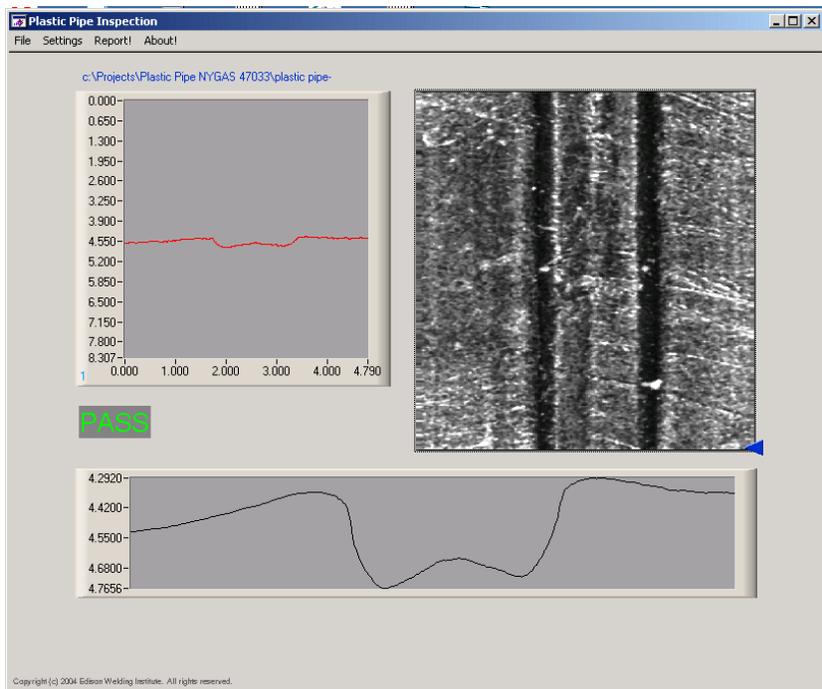
Figure 28. Typical Pass Result on UIR Screen for HDPE Pipe

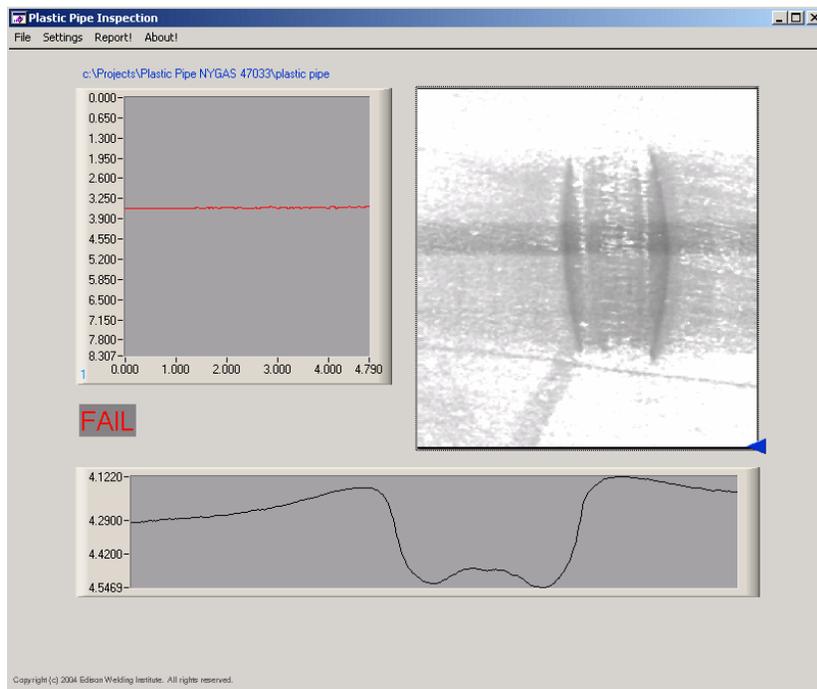
**Figure 29. Typical Fail Result on UIR Screen for MDPE Pipe**

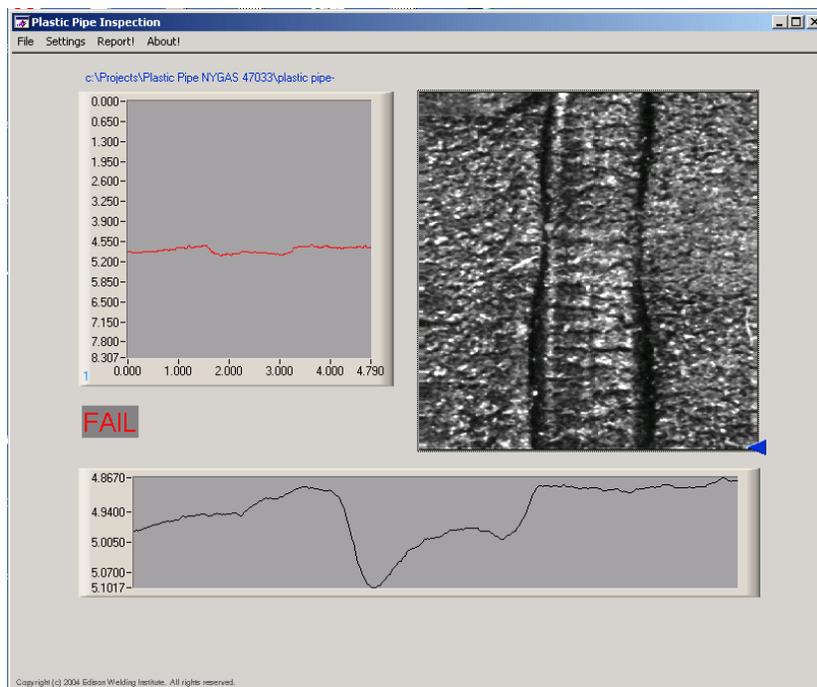
**Figure 30. Typical Fail Result on UIR Screen for HDPE Pipe**

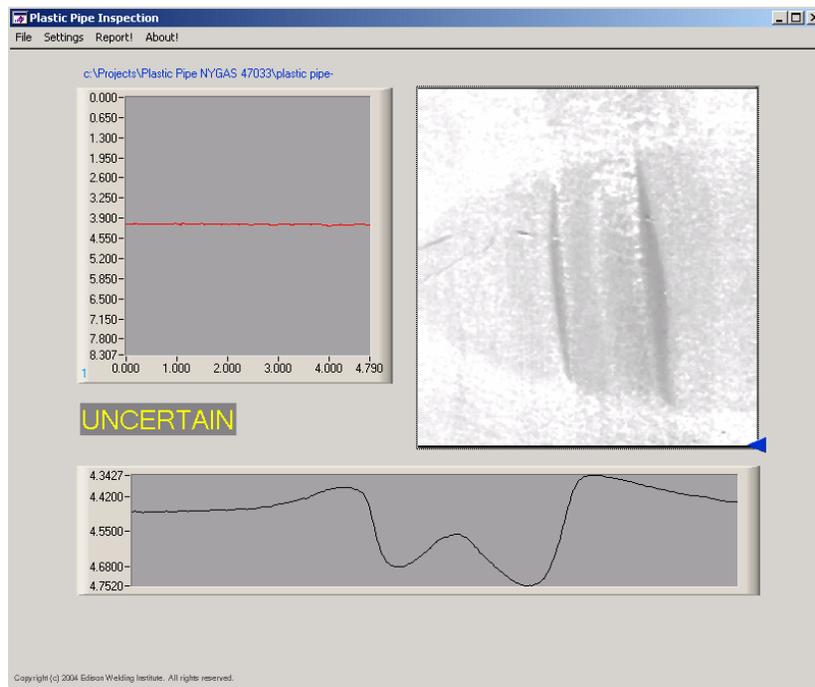
**Figure 31. Typical Uncertain Result on UIR Screen for MDPE Pipe**

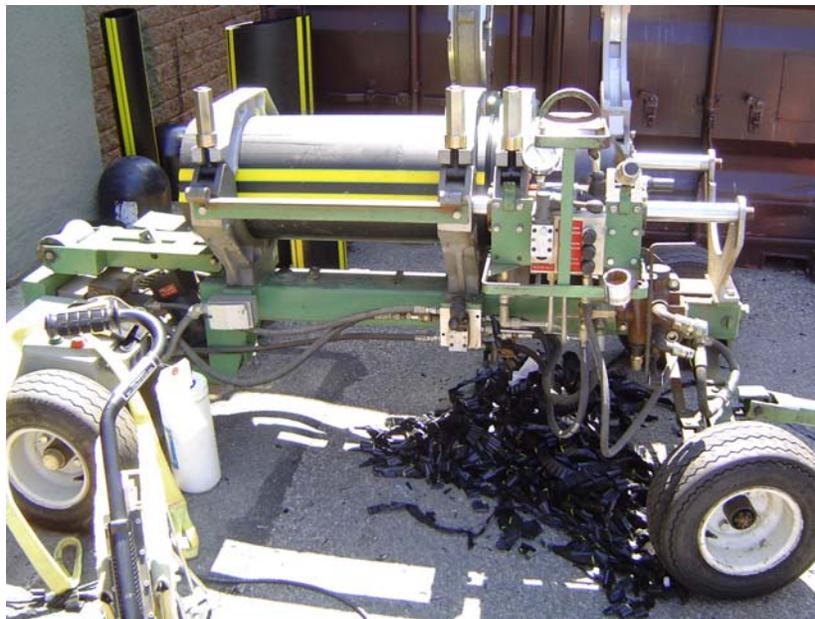
**Figure 32. HDPE Pipe in Fusing Machine at ConEdison Facility**

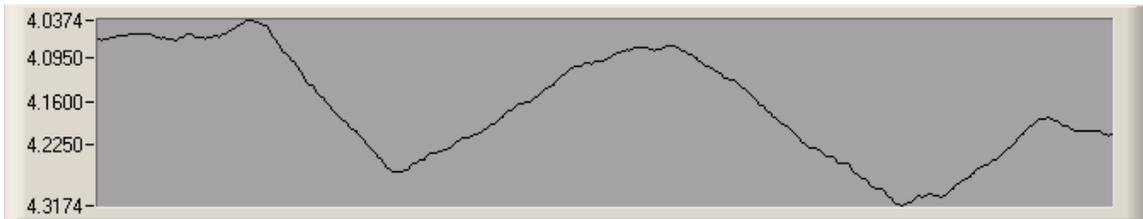
Pipe 1 was produced under standard welding conditions (Table 5) for a 4-in., HDPE pipe. Tests from Pipe 1 were completed at 180 degrees from one another on the bond line. Figures 36 and 37 show the image of the laser-scanned surface of the pipe, after the local reheating has occurred.

**Figure 37. ConEdison Pipe 1 Position 1 Surface Profile**

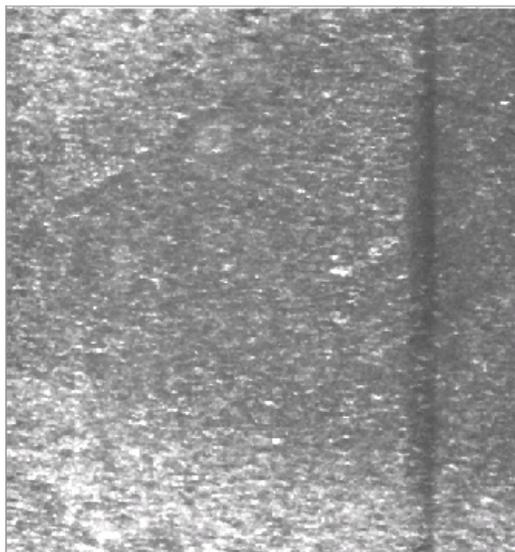
Samples from Pipe 6 were created with a low-pressure condition (Table 15). This generally causes the weld fusion area to be larger than expected. In these cases, the fusion zone was larger than the window of the laser sensor so an accurate measurement cannot be made. This is clear in the image of the scanned pipe in Figure 72 and in the single profile across the joint in Figure 73. The system produced a result and classified the joints, but the confidence in the classification of both tests performed on this pipe is low due to the weld zone size being larger than the field of view of the WZIM system. Two tests were performed on Pipe 6. Figures 74 and 75 also indicate the joint area was outside of the laser window field of view.

**Figure 72. KeySpan Pipe 6 Position 1 Scanned Image**

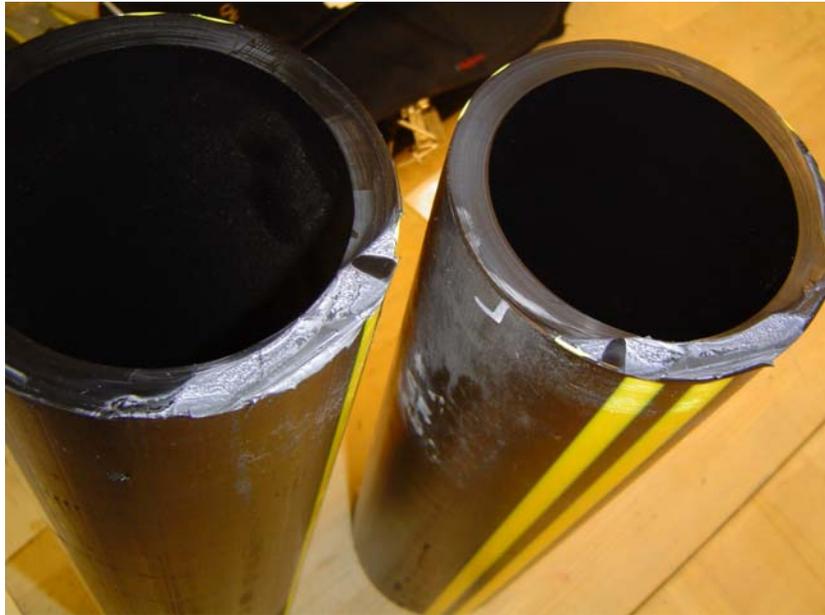
PE pipe can produce a good butt fusion joint with a wide set of parameters. Because of this, it was hard to create a bad weld containing a “LOF” defect. In order to create such a defect, some joints were made at conditions so far out of specification that either they would not be expected in the field or the weld joint was so noticeably deformed that a WZIM test would not be necessary to determine the integrity of the joint.

**Figure 84. Cold Weld Defect on Small Section of Joint Interface** (Notice that the cold weld defect does not exist over the entire joint.)

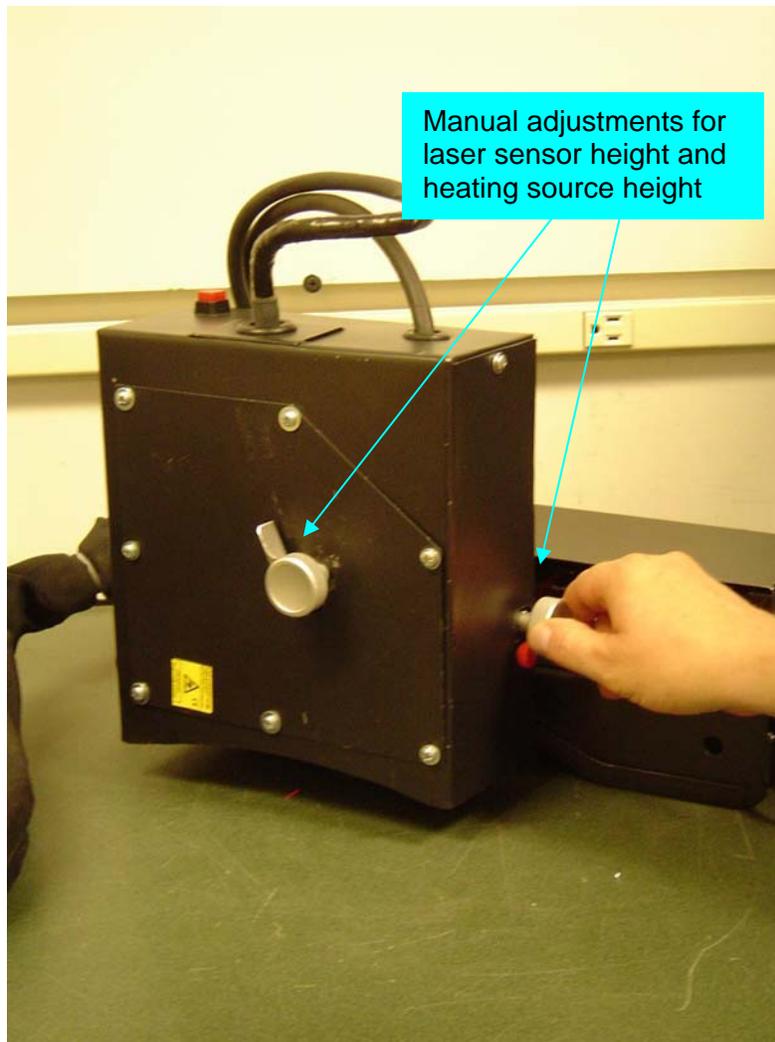
**Figure 85. Operator Manually Adjusting Heating Source Height on WZIM Inspection Unit**

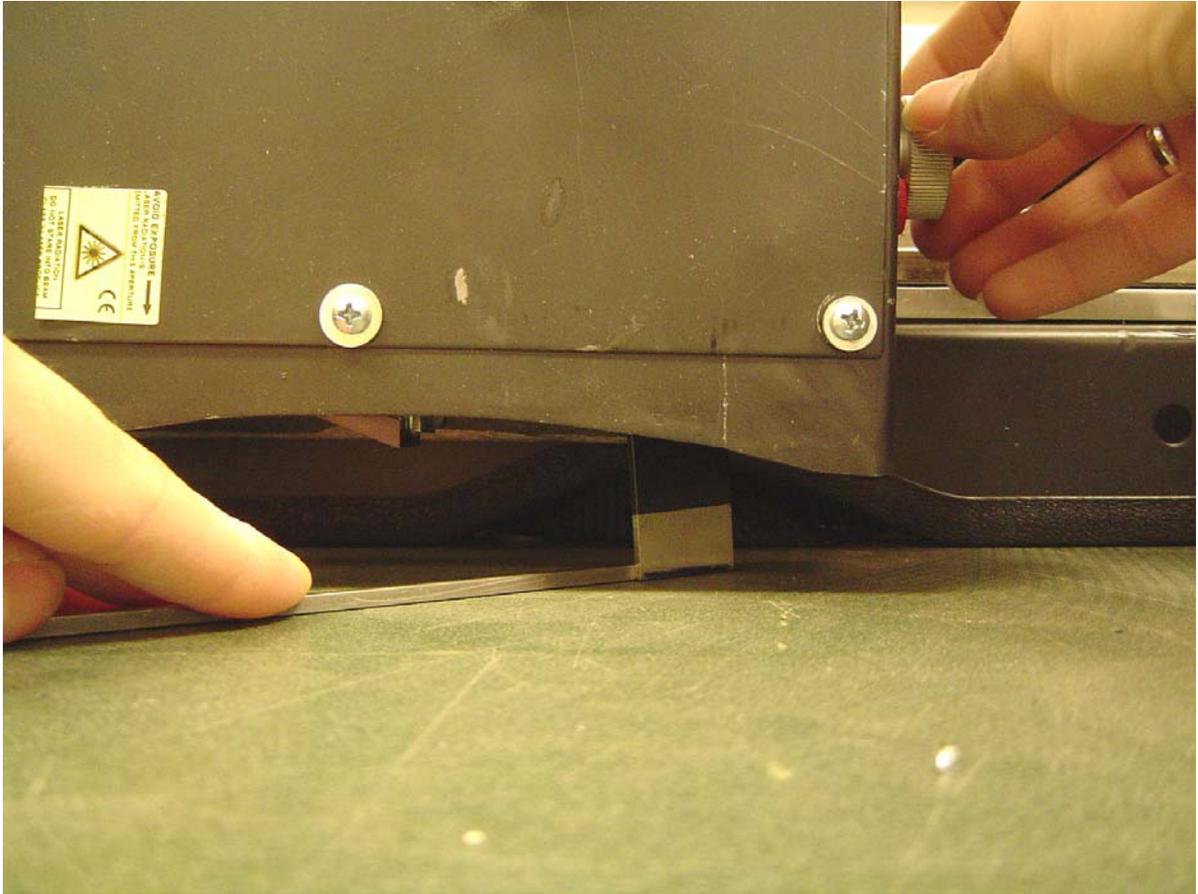
- **Set height of heating element**

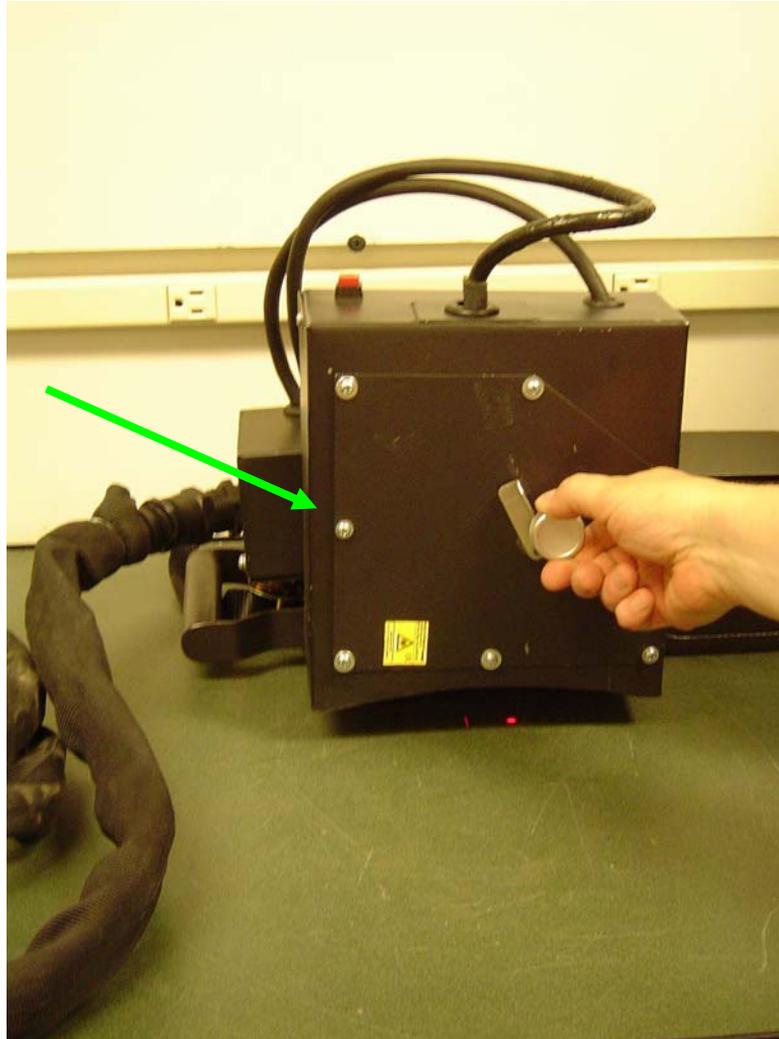
- **Manually adjust laser height during calibration**

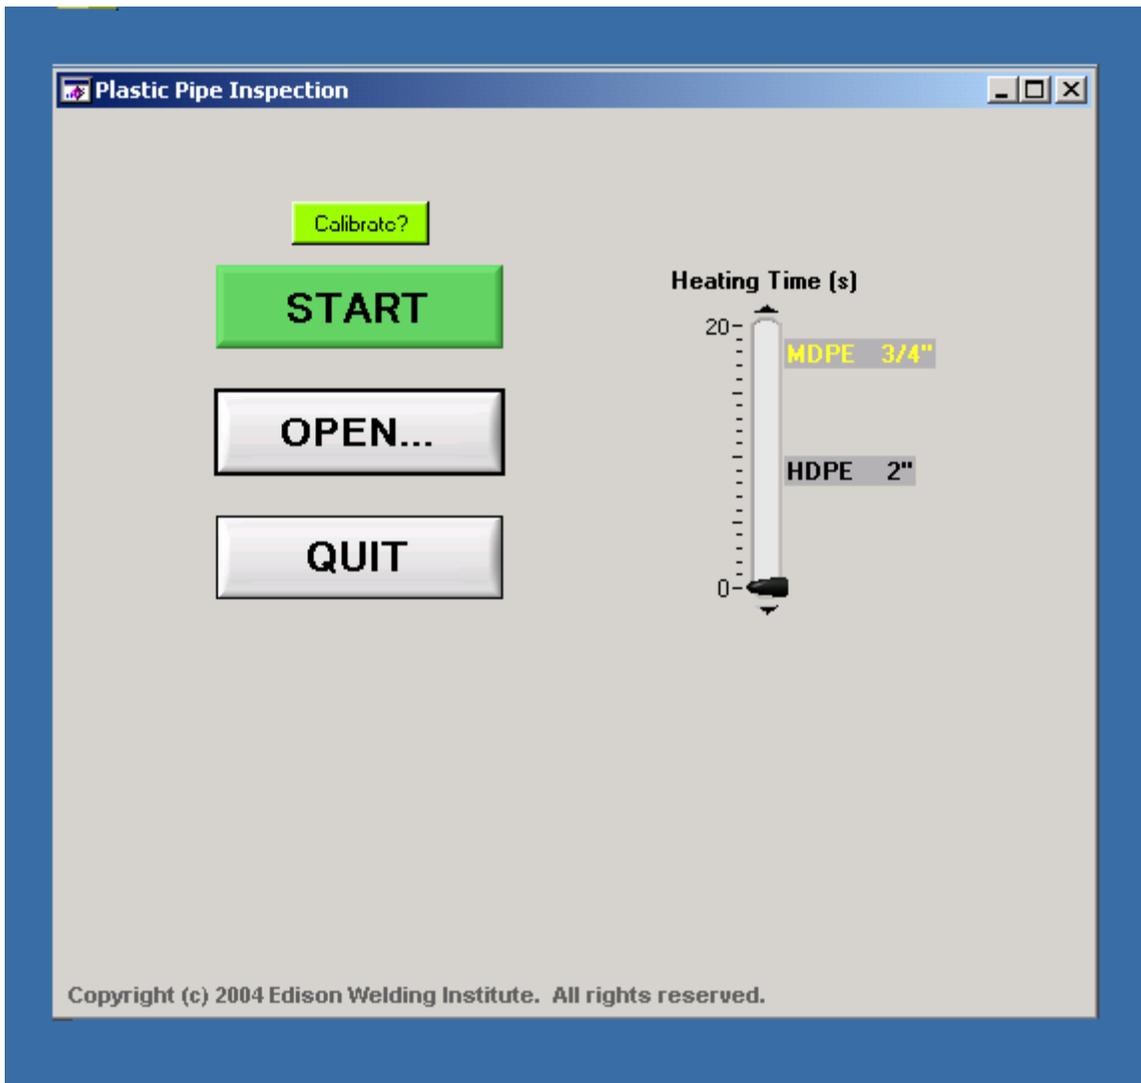
- **MAIN UIR Screen**
  - Calibrate Button
  - Heating Time Button
  - Start Button
  - Open... Button
  - Quit Button
