# *Advanced SOFC Development at Redox Power Systems*

*2019 Hydrogen and Fuel Cells AMR – Crystal City, VA*

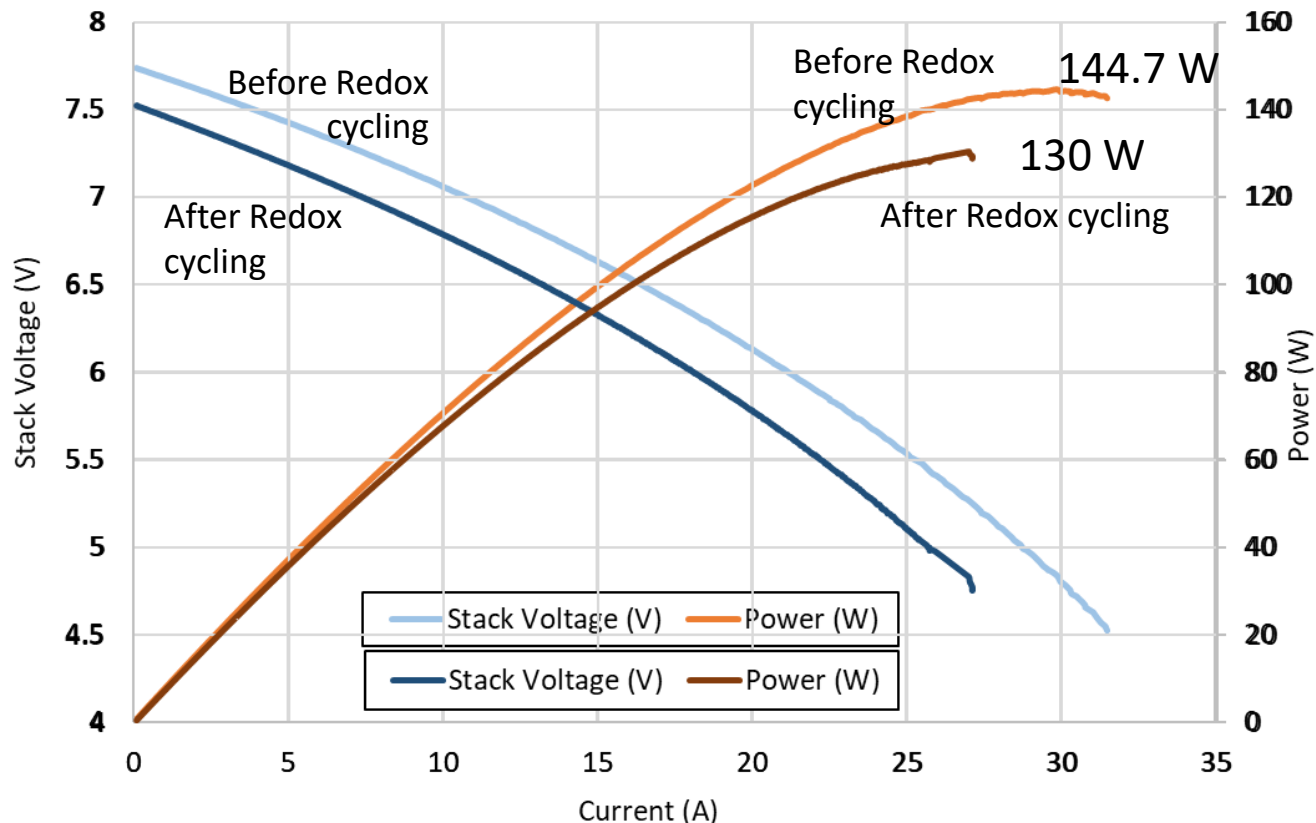
10 cm x 10 cm stack - cycling between hydrogen and nitrogen at 600 °C

- Some degradation in performance after red-ox cycling
- Previous 5 cm x 5 cm tests showed 3 red-ox cycles with minimal ASR, OCV, and seal degradation, but more cycles led to degradation
- Future work includes continued anode structure modification

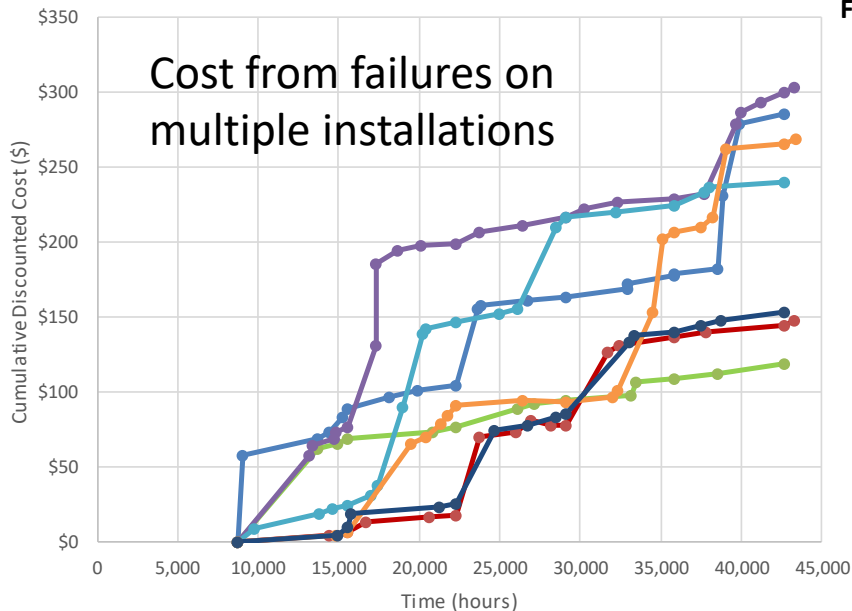
## Model output

Cost from failures on multiple installations

- *Initial deployment and stack replacements largest cost components in initial model*
- *Stack replacements include failure due to “critical events”*
- *Future work includes improving estimates of MTTFs, costs, and model utility*

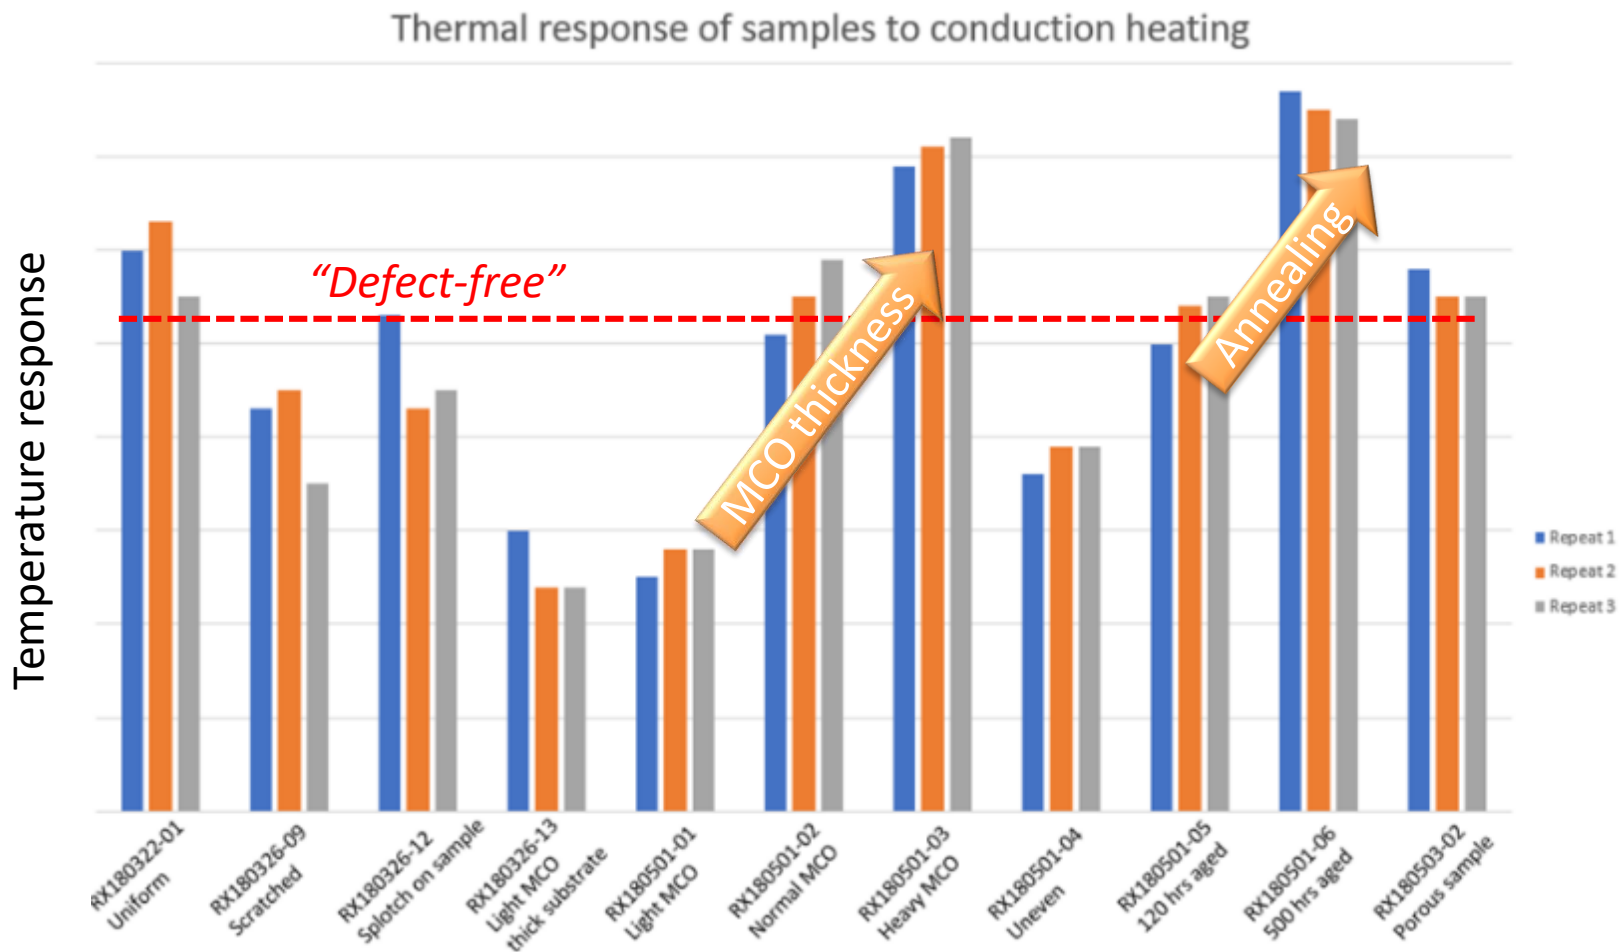
# Trends observed in thermal responses

Redox currently performing microstructural and compositional analysis on NREL evaluated samples for feedback on thermography response origin and modeling

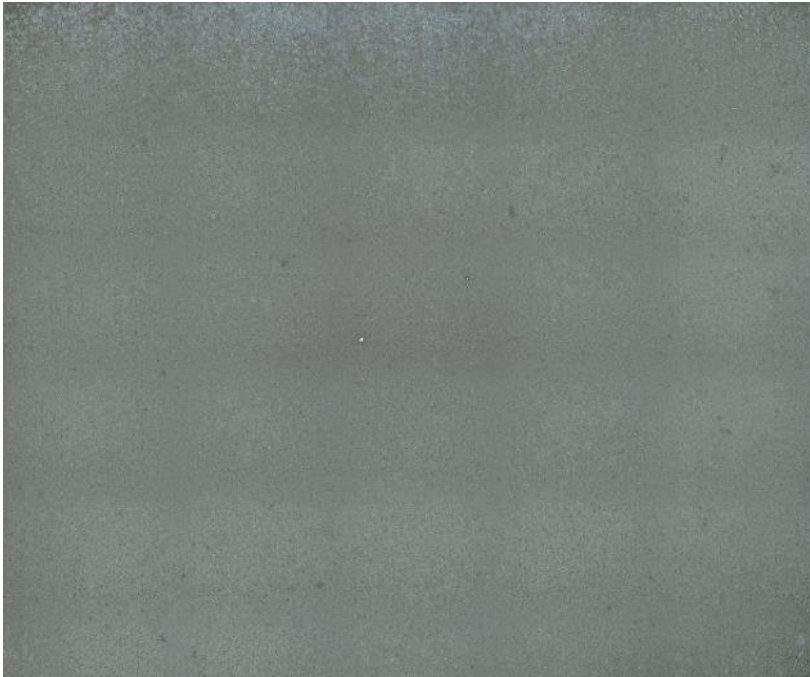
MCO coated sample (with lots of bump defects)

*Optical Image as taken with macroscope*

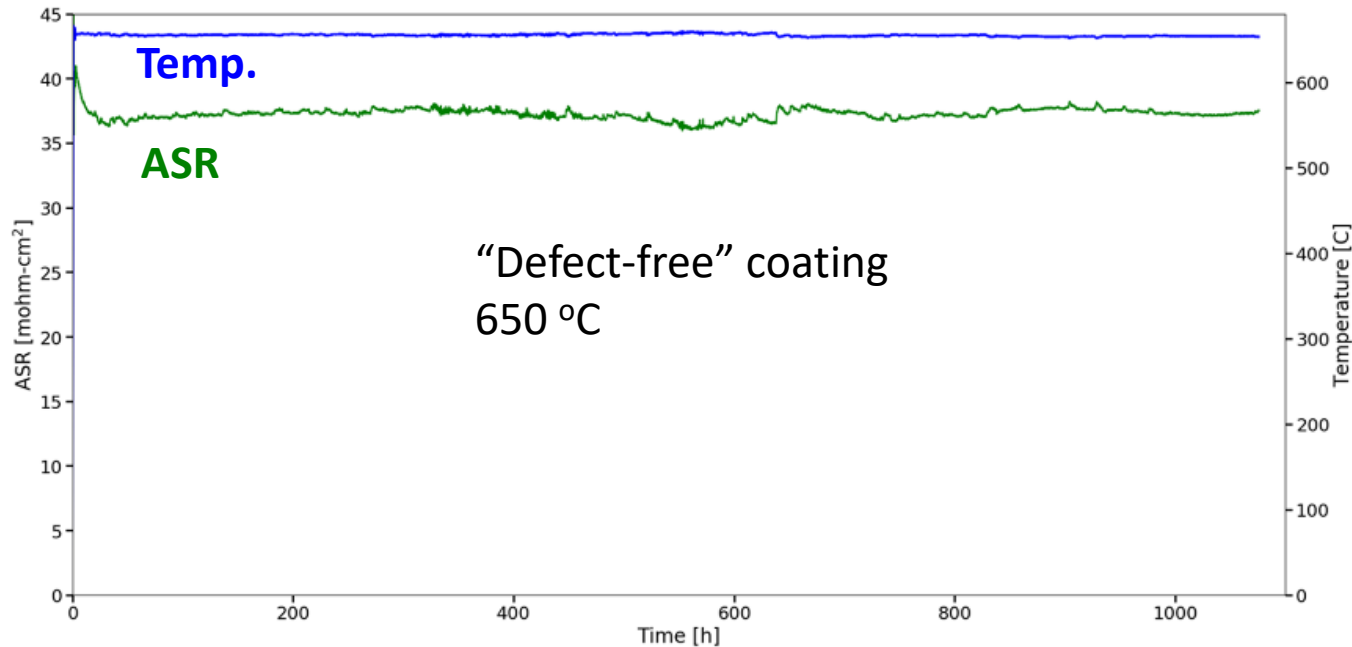
# Long-term ASR of “defect-free” coating exhibits reasonable performance

- ASR at  $\sim 0.037 \Omega\text{cm}^2$  for 1000 h (a 2<sup>nd</sup> measurement resulted in ASR  $\sim 0.048 \Omega\text{cm}^2$  for 350 h)
- Achieved M2.2 ( $< 0.05 \Omega\text{cm}^2$  for 1000 h at 650 °C)

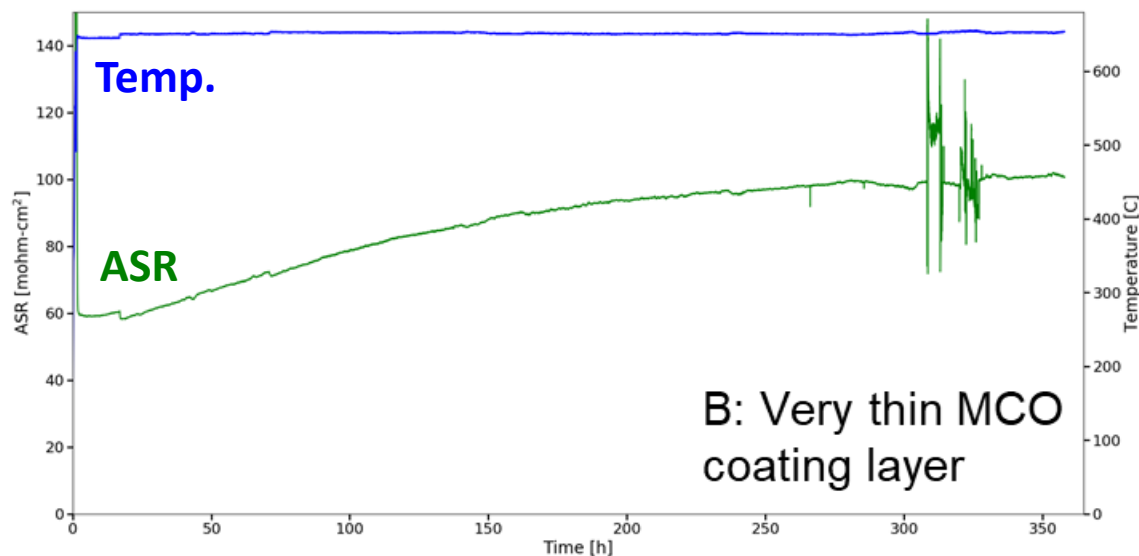
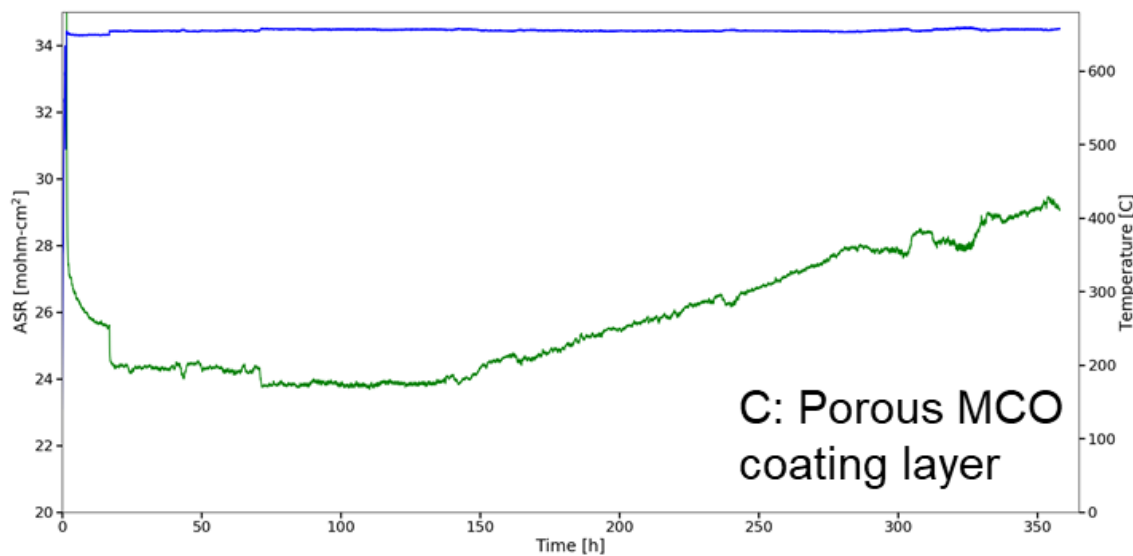
- Thin coating exhibits high ASR that increases from  $0.06 \Omega\text{cm}^2$  to  $0.1 \Omega\text{cm}^2$  (66%) with time
- Porous coating has low ASR, which also increases with time from  $0.024 \Omega\text{cm}^2$  to  $0.029 \Omega\text{cm}^2$  (21%)
- Porous coating exhibits a promising initial ASR, though high porosity may lead to more Cr volatilization
