Please fill in the name of the event you are preparing this manuscript for.	SPE Improved Oil Recovery Conference
Please fill in your 6-digit SPE manuscript number.	SPE-200463-MS
Please fill in your manuscript title.	Experimental Investigation of Polymer Induced Fouling of Heater Tubes in the First-ever Polymer Flood Pilot on Alaska North Slope

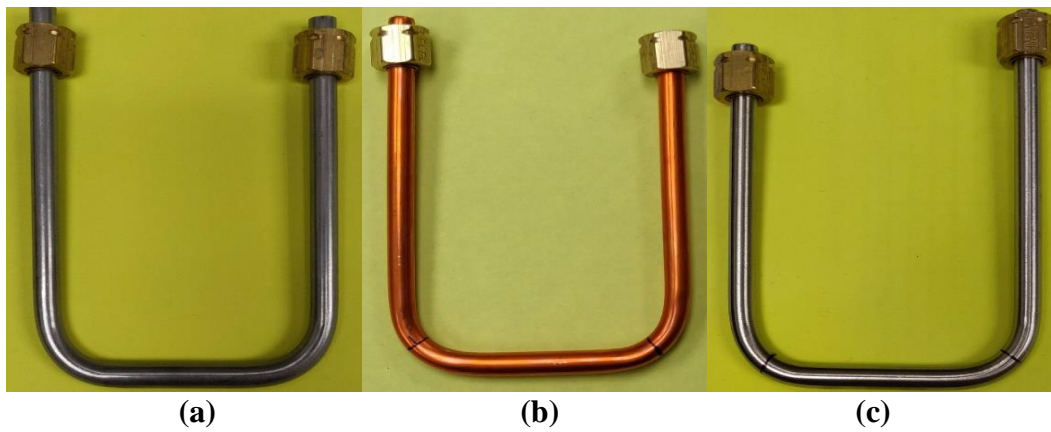
**Figure 1. Heating tubes (a) Carbon steel (b) Copper (c) Stainless steel**

The polymer used is Flopaam 3630s, which is a linear copolymer comprised of acrylamide and acrylic acid, hydrolyzed to 30%, and with a tight molecular weight range of 18-20 Million Dalton, and it is provided by SNF FLOPAAM™ Inc. The tested heating tubes are made from copper, carbon steel, stainless steel, respectively, and all have ¼ inch OD, as shown in **Figure 1**.

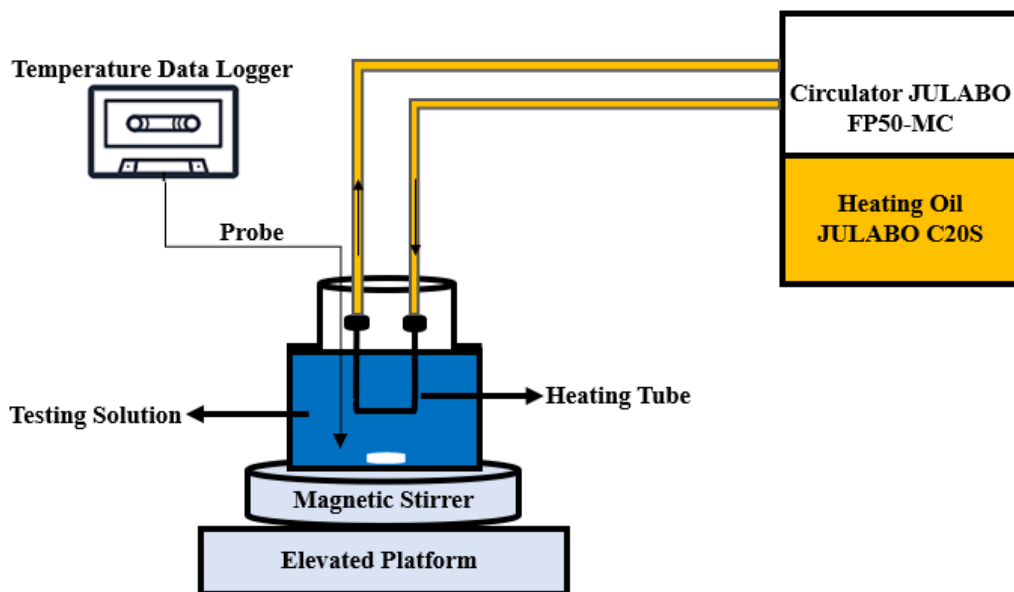
**Figure 2. Schematic of fouling test setup**

Experimental setup and equipment. A new experimental device has been specially designed and built in-house to simulate the heating process of the heat exchanger at Milne Point, which can operate under extremely high skin temperature conditions. **Figures 2** and **3** show the schematic and the picture of the actually built experimental setup.

The Julabo FP50-MC heating circulator, which is filled with thermal bath fluid (C20S), with a heating range of 32 °F to 428 °F, is used to heat the tubes to desired skin temperatures. The U-shaped heating tube is used to heat the prepared solution in the glass container directly. The magnetic stirrer is used to continuously stir the solution during the heating process to keep uniform heating. A temperature probe associated with a data logger is used to monitor and record the solution temperature change. An analytical balance with 0.01 mg accuracy is used to measure the mass of the heating tube before and after each test to calculate the amount of fouling. Additionally, Environmental Scanning Electron Microscopy (ESEM) and XRD facilities are employed to analyze the morphology and composition of the fouling deposits accumulated on the U-shape heating tube surface, respectively.

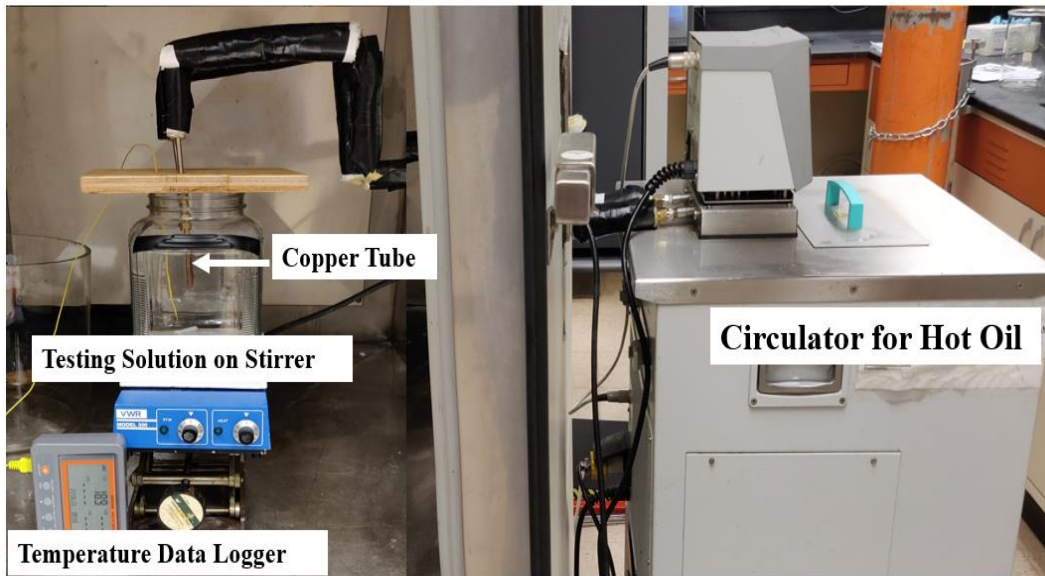
Figure 3. Actual experimental setup for fouling test

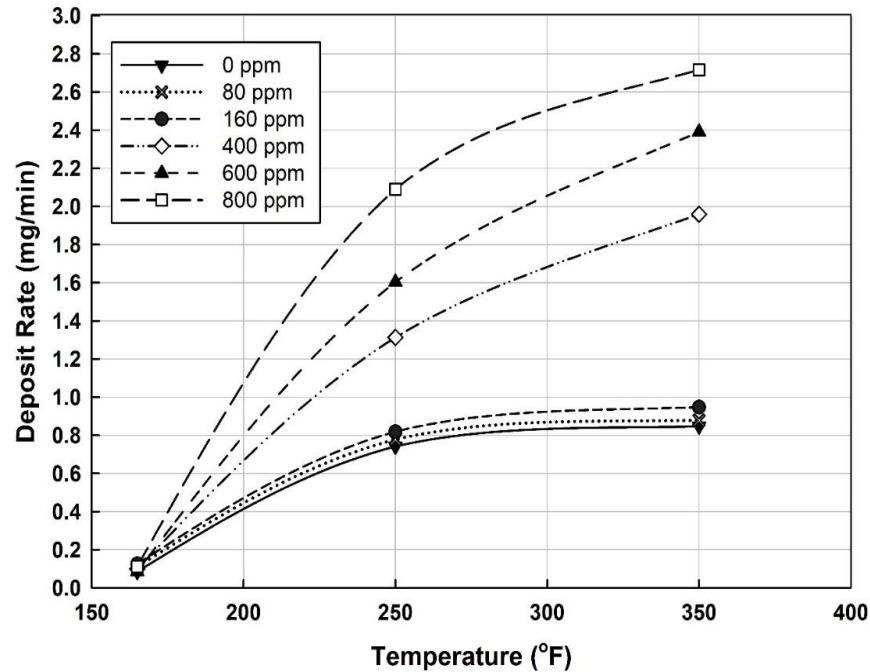
Figure 4. Deposit rate on copper tube vs. the tested skin temperatures at various polymer concentrations

The influence of heating tube skin temperature on the deposit rate at various polymer concentrations is shown in **Figures 4** and **5** respectively, where the deposit rate is defined by the following equation,

As can be seen from Figures 4 and 5, at the same polymer concentration, the deposit rate generally increases with the skin temperature but is much more pronounced between 165°F and 250°F (i.e., the curve slope between 165°F and 250°F) than between 250°F and 350°F. This phenomenon confirms that skin temperature is one of the critical factors affecting the fouling tendency on the heating tube surface, which is consistent with previous studies (Shupe 1981, Ramsden and McKay 1986, Moradi and Doe 1987, Seright and Skjevraak 2015, Xiong et al., 2018). That is because the temperature can significantly affect the degree of hydrolysis of polyacrylamide in the solution. In general, if the degree of hydrolysis of polyacrylamide is lower than the desired value (generally 30%), the hydrolyzed polyacrylamides (HPAM)

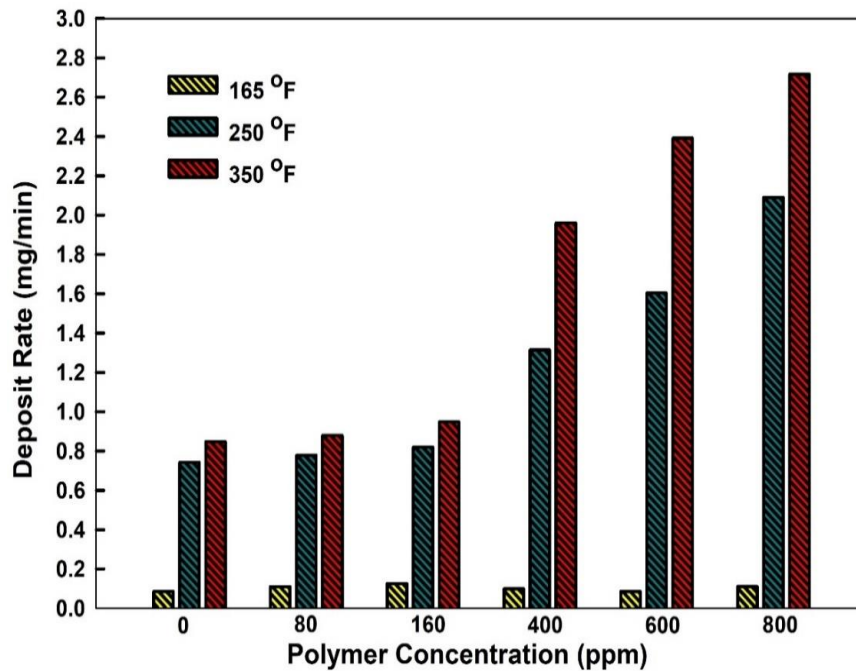
Figure 5. Deposit rate on copper tube vs. various polymer concentrations at the tested skin temperatures

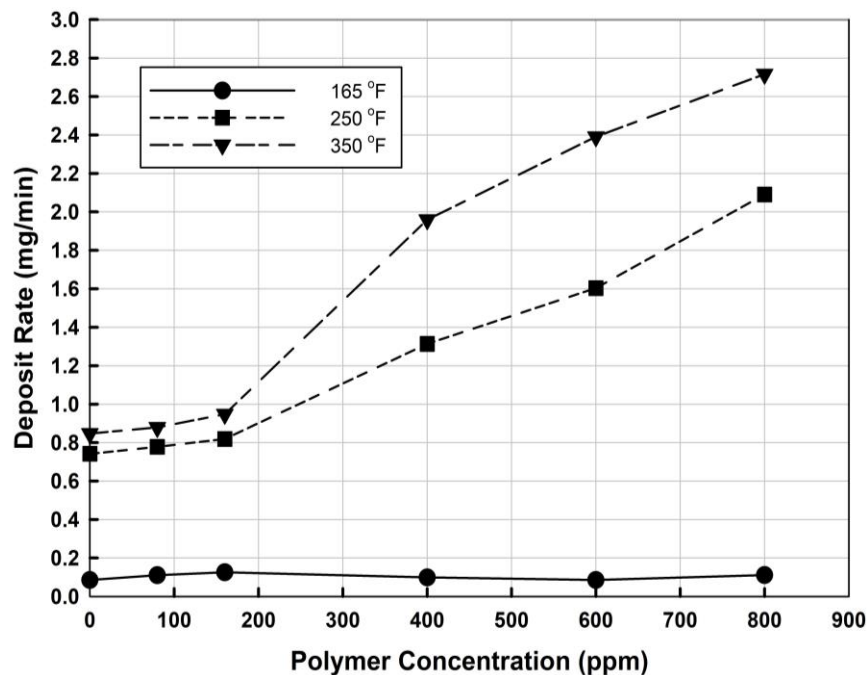
Figure 6. Effect of polymer concentration on deposit rate on copper tube

The influence of polymer concentration on the deposit rate at different skin temperatures has been described in **Figure 6**. As can be seen, at a lower skin temperature of 165°F, the deposit rates at different polymer concentrations are almost the same with and without polymer; however, at higher skin temperatures of 250°F and 350°F, the deposit rates increase steadily with the increase of polymer concentration.

Note that the scale deposited on the tube surface at 0 ppm concentration of polymer should be pure mineral scale. The test results showed that, at 165°F, the deposit rates are nearly the same as that of pure mineral scale regardless of the polymer concentration. This finding implies that, at 165°F, it does not matter what the polymer concentration is, only mineral scaling might occur on the heating tube surface. It is believed that is because the lower skin temperature of 165°F in this study would not cause excessive hydrolysis or decompose the HAPM directly, the HPAM could stably exist in the solution and will not precipitate, and the fouling issues will not be aggravated. Therefore, the skin temperature of 165°F, which is the current operating temperature of the heat exchanger on the pilot site at Milne Point, should be safe to treat the produced fluids associated with various polymer concentrations. However, at higher tested skin temperatures of 250°F and 350°F, the deposit rates increased with polymer concentrations and were

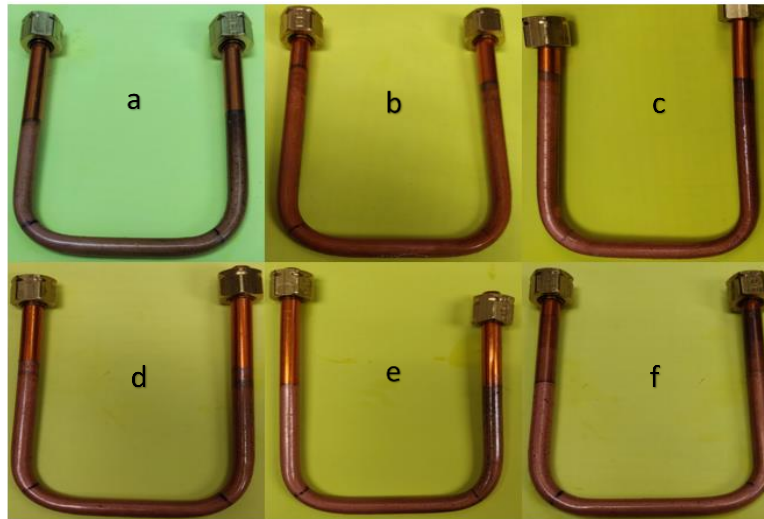
Figure 7. Accumulated fouling on tube surface at 165°F at polymer concentration of: (a) 0ppm, (b) 80ppm, (c) 160ppm, (d) 400ppm, (e) 600ppm, (f) 800ppm

Figures 7 to 9 visually depict the accumulated fouling after 5 runs on the tube surface associated with respective skin temperatures of 165°F, 250°F, and 350°F at different polymer concentrations.

As can be seen obviously from Figure 7, compared with Figure 7 (a) which shows the pure mineral scale, no aggravated fouling issues were identified from Figure 7(b) to 7(f) due to the existence of different concentrations of polymer at 165°F. However, from the comparison of Figure 8(a) and Figure 9(a) with Figure 8(b) to 8(f) and Figure 9(b) to 9(f), respectively, it is clear that adding polymer into the solution would significantly aggravate the fouling issues at higher temperatures, and the higher the polymer concentration, the more severe the fouling. Therefore, Figures 7 to 9 qualitatively confirm our quantitative findings drawn from Figure 6. Additionally, when we scraped the fouling materials from the tube surface for ESEM and XRD analysis, we found the pure mineral scale was brittle and easily scraped off, but the aggravated fouling material with polymer was tougher and much more difficult to scrape off. This finding indicates that if the heat exchanger were not operated properly, once polymer-induced fouling occurred on the tube surface, it would be much more difficult to remove using the common mechanical methods.

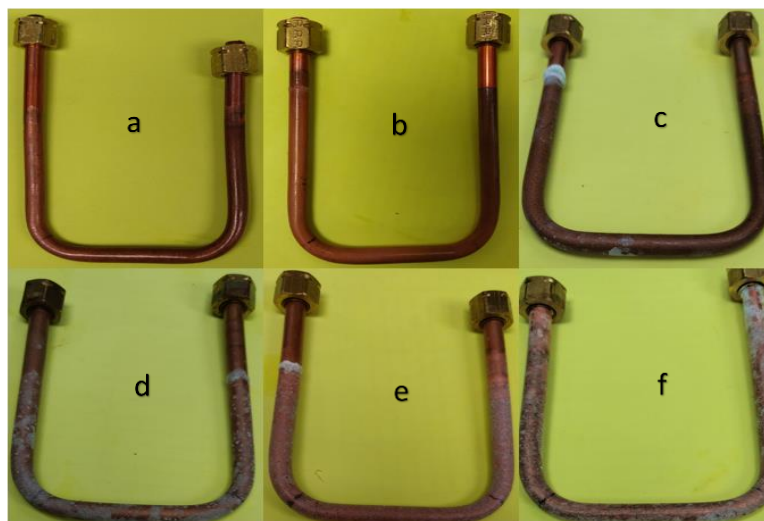
Figure 8. Accumulated fouling on tube surface at 250°F at polymer concentration of: (a) 0ppm, (b) 80ppm, (c) 160ppm, (d) 400ppm, (e) 600ppm, (f) 800ppm

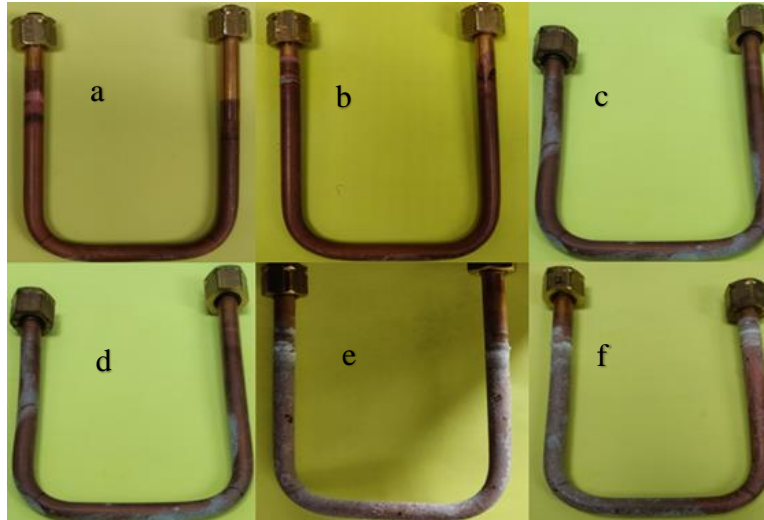
Figure 9. Accumulated fouling on tube surface at 350°F at polymer concentration of: (a) 0ppm, (b) 80ppm, (c) 160ppm, (d) 400ppm, (e) 600ppm, (f) 800ppm

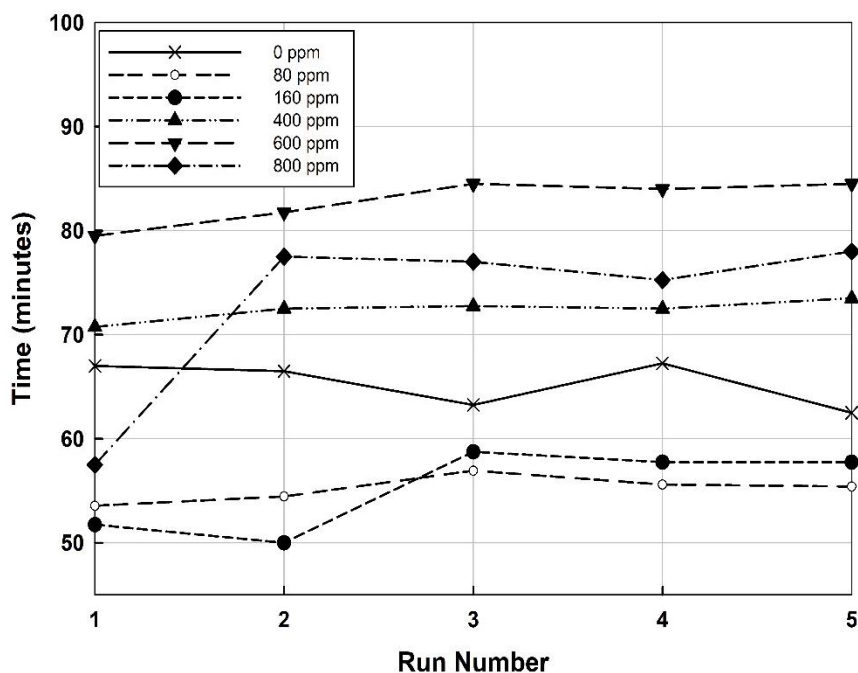
Figure 10. Effect of fouling on heating time of each test at 165°F

Figures 10-12 show the time needed to heat testing solutions with different polymer concentrations from 77°F to 122°F at the skin temperatures of 165°F, 250°F, and 350°F, respectively. The common trend is that the heating time increases successively in each subsequent test. This trend is more obvious at higher tested skin temperatures, as shown in Figures 11 and 12, but there are some small fluctuations on the trend at lower test skin temperature, as shown in Figure 10.

The common trend of increased heating time can be attributed to the fact that deposition takes place on the tube surface, so the heating tube is coated. This means that the tested solution would not be able to make effective contact with the tube surface directly but instead comes in contact with the thin coating which may have a lower thermal conductivity than the metal tube itself. Thus, the fouling coating on the tube surface reduced its heating efficiency, and more time was required to heat the test solution in each subsequent test. The small fluctuations associated with the heating time trend described in Figure 10 may result from the weak adhesiveness of mineral scale on the tube surface. As mentioned previously (Figures 6 to 9), only the mineral scale would be produced and deposited on the tube surface at the lower skin temperature of 165°F, which was easily scraped off. Thus, the mineral scale may alternatively deposit on the tube surface and then be washed off, which may cause an alternate change in the heating efficiency of the tube.

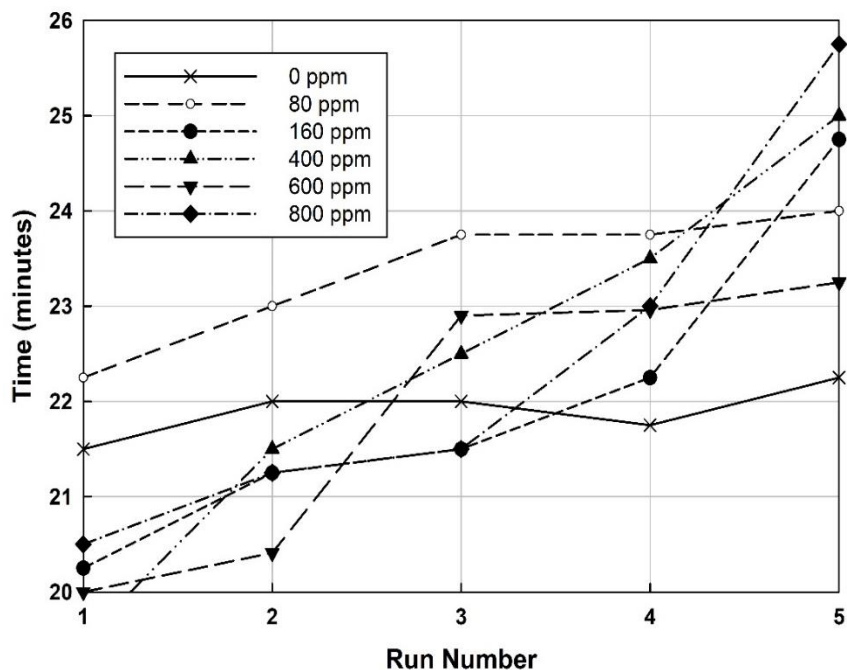
Figure 11. Effect of fouling on heating time of each test at 250°F

Accordingly, the heating time in different runs has fluctuated. However, at higher skin temperatures of 250°F and 350°F, polymer-induced fouling would be generated and deposited on the tube surface, and they generally could not be washed off. Thus, the accumulation of polymer-induced fouling would continuously reduce the heating efficiency of the heating tube, and thereby more time was required to heat the test solution in the subsequent runs, which explains the consistent increase in heating time of each test in Figures 11 and 12.

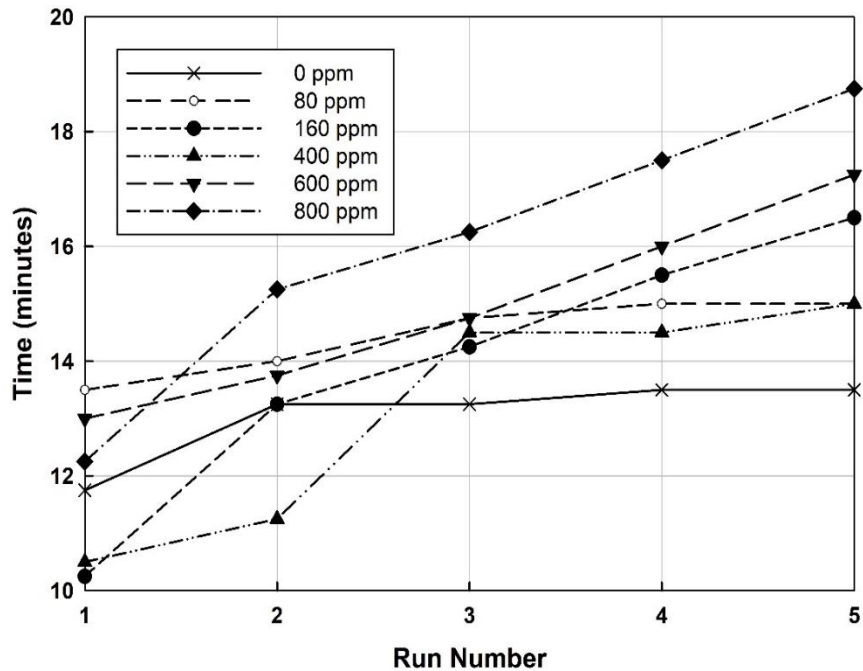
Figure 12. Effect of fouling on heating time of each test at 350°F

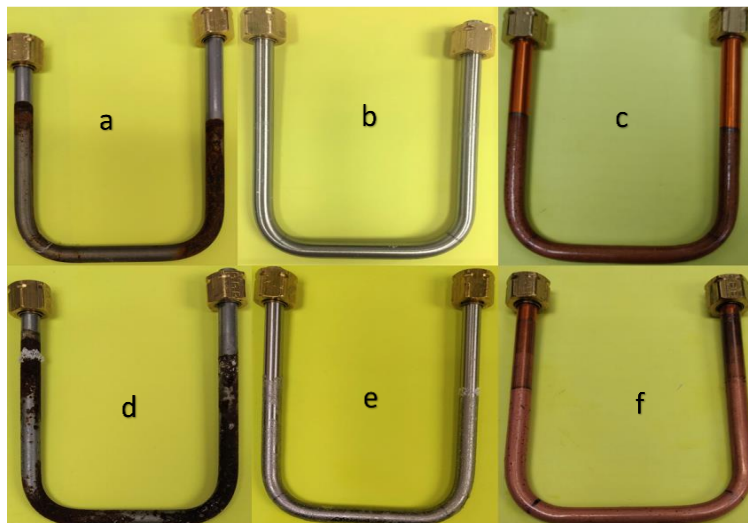
Figure 13. Accumulated fouling on tube surface at 165°F: (a) Carbon steel, 0ppm (b) Stainless steel, 0ppm (c) Copper, 0ppm (d) Carbon steel, 800ppm (e) Stainless steel, 800ppm (f) Copper, 800ppm

As can be seen from Figure 13, compared with stainless steel and copper, there was obviously much more iron oxide deposits on the surface of the carbon steel tube, which can explain why the deposit rates on the carbon steel tube surface were higher than those on the stainless steel and copper surface at either polymer concentrations as shown in Figure 14. In addition, compared to Figure 13(a), with 800 ppm polymer in the test solution, we could observe more iron oxide deposits and some additional white deposits which were believed to be polymer-induced fouling on the surface, as shown in Figure 13(d). This observation indicates that the redox reactions on the carbon steel surface may be intensified with the existence of polymer in the solution. Since previous tests have confirmed that lower skin temperature of 165°F cannot directly cause polymer fouling issues on the surface, the observed polymer fouling material in Figure 13(d) may result from the redox reactions and their products. This finding tells us that the existence of polymer in the solution would aggravate the fouling issues on the carbon steel surface even at a lower skin temperature, which can be further confirmed by the fact that the deposit rate on carbon steel surface at 800 ppm polymer concentration was higher than that without polymer (i.e., 0 ppm) in the solution, as shown in Figure 14.

As can be seen from Figure 13(b), the stainless steel surface was still clean after all tests if there was no polymer in the solution. However, the stainless steel surface would be coated with a white fouling layer which was also believed to be polymer-induced fouling if 800 ppm polymer existed in the solution. That is why the calculated deposit rate on the stainless steel surface at 800 ppm polymer concentration was significantly higher than that at 0 ppm polymer concentration, as shown in Figure 14. Thus, we can confirm that the existence of polymer in the solution can aggravate the fouling issues on the stainless steel surface even at lower skin temperature. Besides, as can be seen from Figure 14, at 800 ppm of polymer concentration, the calculated deposit rate on copper tube surface was much lower than those on both carbon steel and stainless steel surfaces. Without the polymer, the deposit rates on the copper tube and stainless tube surface were much lower than that on the carbon steel surface. These calculated higher deposit rates at either polymer concentrations all result from the aggravated polymer-induced fouling issues, which has been explained. However, without the polymer, the calculated deposit rate on the copper tube surface was a little bit higher than that on the stainless steel surface. As mentioned previously, only the mineral scale deposited on the surfaces without polymer in the solution. Under the same test conditions, we found that the heating time needed for stainless steel tube was much longer than that for the copper

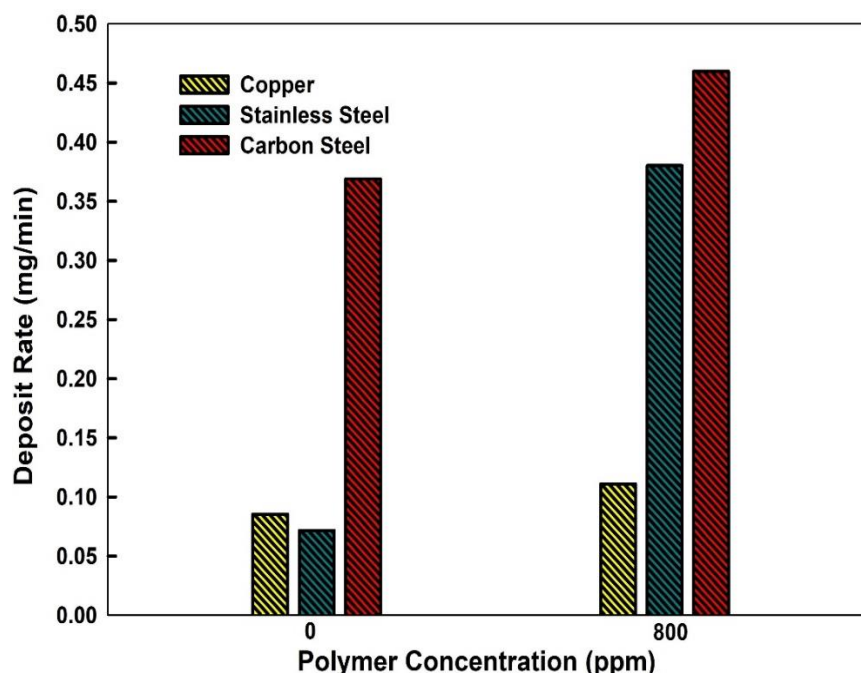
Figure 14. Deposit rates of different heating tube material

The influence of heating tube material including copper, carbon steel, and stainless steel on fouling tendency also has been investigated. For each heating tube material, the fouling tendency was evaluated without the polymer (0 ppm) and at 800 ppm polymer concentration. Note that all the tests were conducted at the skin temperature of 165°F since the carbon steel and stainless steel tubes could not be heated to the stable higher skin temperatures of 250°F and 350°F (see Table 2). **Figure 13** shows the accumulated fouling or deposit after 5 runs on the tube surface, and **Figure 14** illustrates the calculated deposit rates for each tube material at 0 ppm and 800 ppm polymer concentrations, respectively. Our interpretation of previous tests (Figures 4 – 9) has confirmed that the existence of polymer in the solution would not aggravate the fouling issues on the copper tube surface at a lower skin temperature of 165°F.

tube due to the lower heating efficiency of stainless steel tube. According to Equation (1), that is why the calculated deposit rate on the copper tube surface was higher than that on the stainless steel surface. All of these findings indicate that copper tube would be the best choice for heat exchanger (without considering the cost) to treat the produced fluids, especially when polymer exists in the produced fluids.

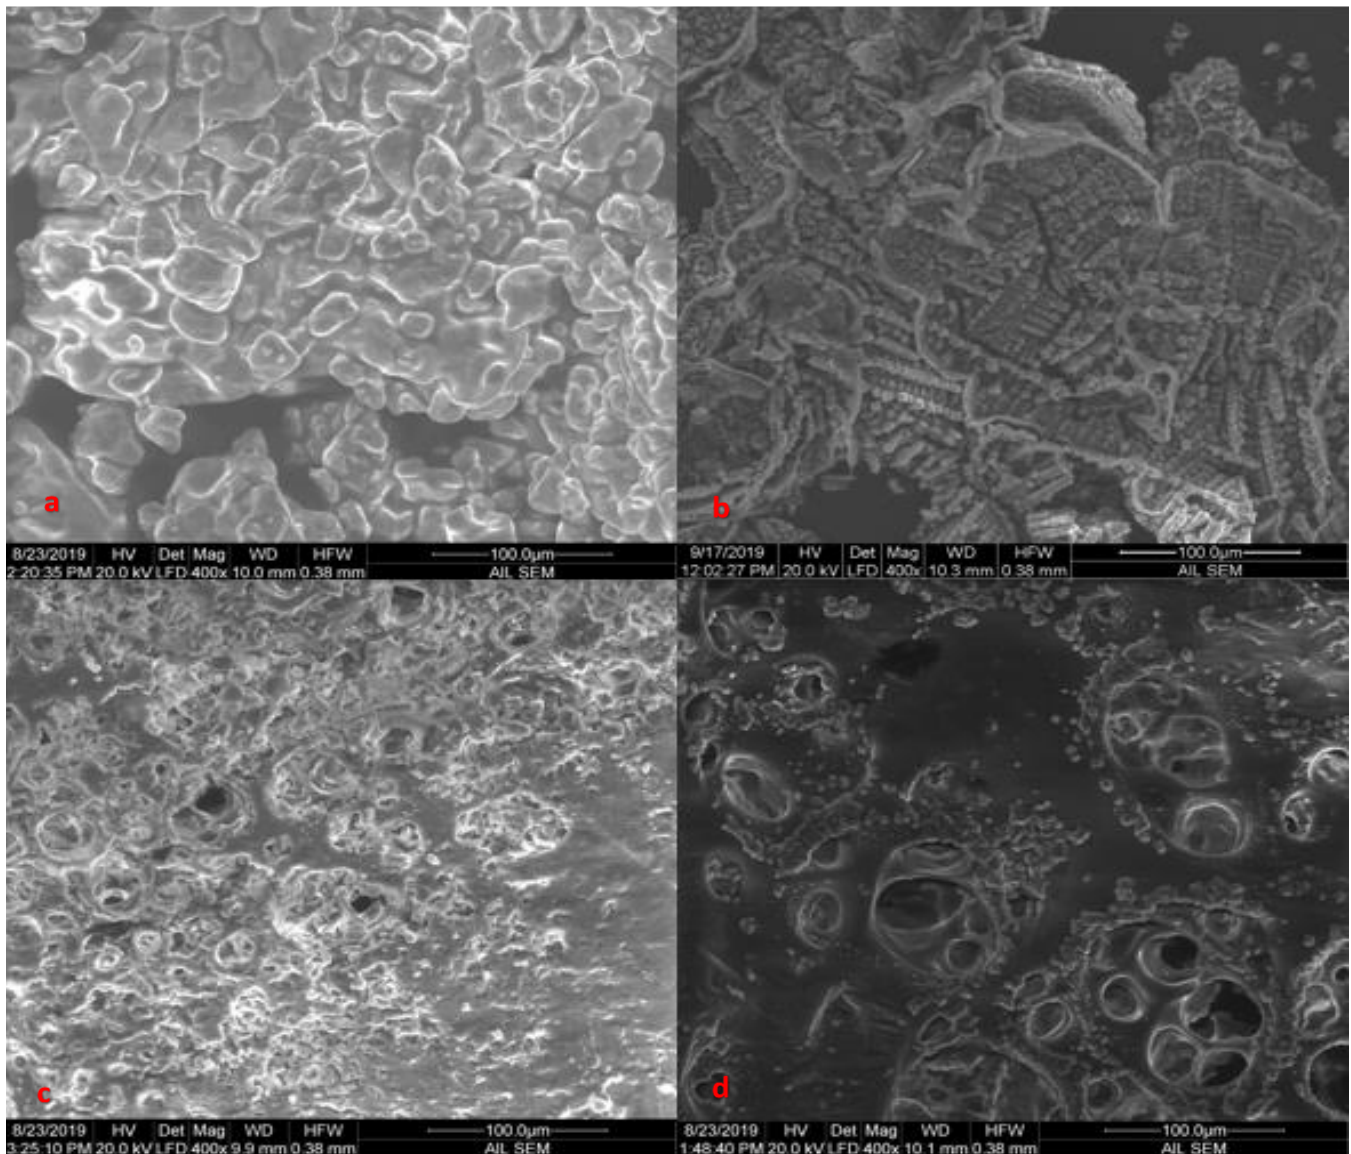
Figure 15. ESEM pictures of fouling generated at the polymer concentrations of (a) 0 ppm (b) 160 ppm (c) 400 ppm (d) 800 ppm on the copper tube at a skin temperature of 350°F

The impacts of polymer on the morphology and composition of the fouling deposit on the heating tube surface can also be reflected in the ESEM and XRD analyses. In this study, only the fouling deposit on the copper tube surface generated at the skin temperature of 350°F, as shown in Figure 9, was characterized by ESEM. The ESEM pictures of fouling deposits at respective polymer concentrations of 0 ppm, 160 ppm, 400 ppm, and 800 ppm are shown in **Figure 15**.

Figure 15(a) shows the morphology of the pure mineral scale since the polymer concentration was 0 ppm (i.e., there was no polymer in the solution). As can be seen, the mineral crystals are irregular and naturally compact together, so the bonding between the mineral crystals is weak and the mineral crystals

generally have less adhesion on the tube surface, which can explain why the pure mineral scale is brittle and easily scraped off as mentioned previously. Compared to Figure 15(a), Figures 15 (b), (c), and (d) illustrate that morphology of the polymer-induced fouling is different from that of pure mineral scale. As can be seen, once the polymer precipitated and deposited on the tube surface, it would be bonded to the mineral scale crystals forming a three-dimensional network structure, becoming denser with the increase of polymer concentration. In general, this kind of network structure of polymer-induced fouling is stronger than the simple compaction of the pure mineral scale, and it also has more adhesion to the tube surface. That is why, as mentioned previously, the polymer-induced fouling was tougher and more challenging to be scraped off.

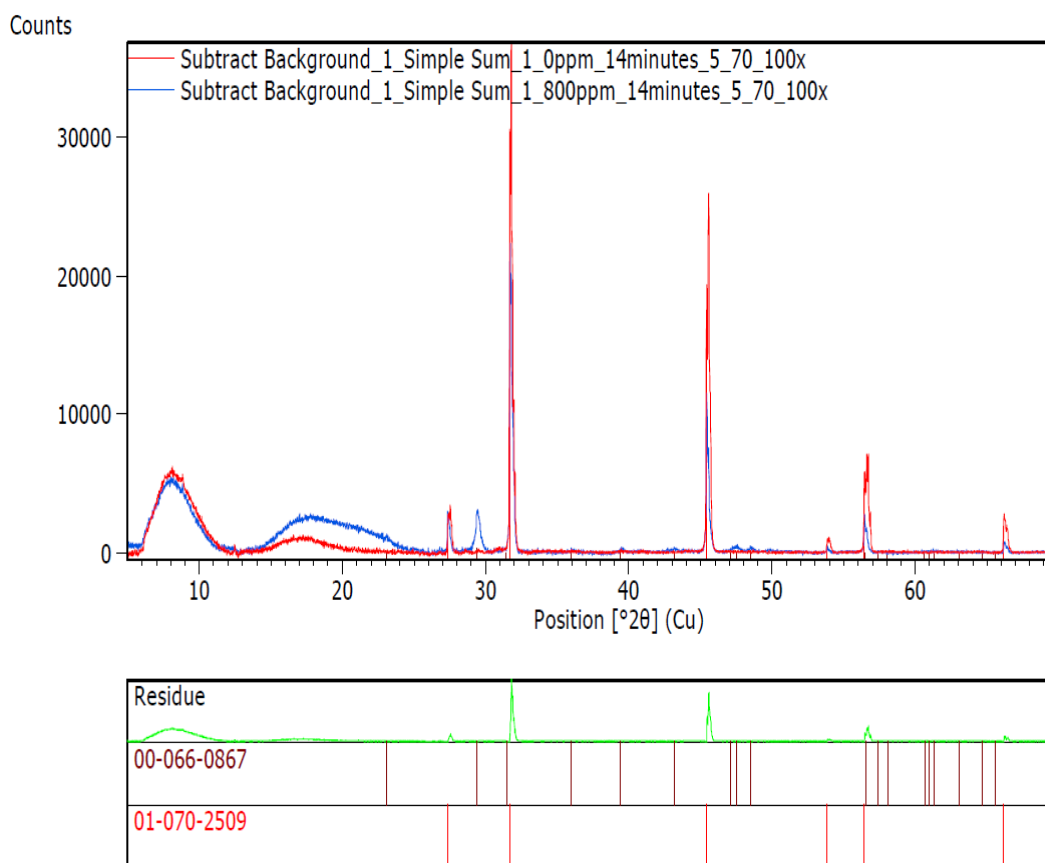
Figure 16. XRD analysis of fouling generated at the polymer concentrations of 0 ppm and 800 ppm on copper tube at a skin temperature of 350°F

Among the deposit samples characterized in Figure 15, two of them were analyzed by XRD to compare their composition difference. The results of XRD analysis have been depicted in **Figure 16**, where the blue color represents the XRD pattern of deposit generated using 800 ppm polymer solution while the red color represents the XRD pattern of deposit generated using 0 ppm polymer solution (i.e., without polymer in the solution). The compound codes below the pattern represent sodium chloride - Halite (01-070-2509) and calcium carbonate - Calcite (00-066-0867). It is necessary to point out that XRD analysis is only able to identify mineral salts of sodium and calcium in the deposit, but polymer fouling cannot be identified as diffraction peaks in the XRD pattern, since X-Rays cannot detect elements below sodium and polymer is only composed of carbon, hydrogen, oxygen, and nitrogen. Furthermore, the compositional analysis for the two deposit samples was also conducted by HighScore Plus software based on the obtained XRD patterns, as shown in **Figure 17**.

As can be seen from Figure 16, the most significant difference in the two patterns occurs at the angle of approximately $2\theta = 29$ which represents calcite (CaCO_3) peak. The peak at $2\theta = 29$ was obtained in the blue pattern (with polymer) but it was absent in the red pattern (without polymer). This difference indicates that, compared to the solution without polymer, the presence of polymer in the solution may cause one more type of calcite mineral scale. Besides, noticeable background noise can be observed in the two patterns between the angles of $2\theta = 15$ and $2\theta = 24$, which may represent some byproducts resulting from the interaction between polymer and mineral salts. Since X-Rays cannot detect C, H, O, and N, these byproducts cannot be detected as a peak in the pattern. Figure 17 describes the compositional quantification of mineral scale in both deposit samples. As for the mineral scale in the deposited sample generated from the solution without polymer, as shown in Figure 17(a), 98% of the mineral scale is Halite and the remaining 2% is Calcite. Figure 17(b) shows that the presence of polymer in the solution decreased the Halite composition in the mineral scale to 80% and increased the calcite composition to 20%. Therefore, this finding further confirms the previous conclusion that the presence of polymer in the produced fluids can enhance the mineral scale propensity.

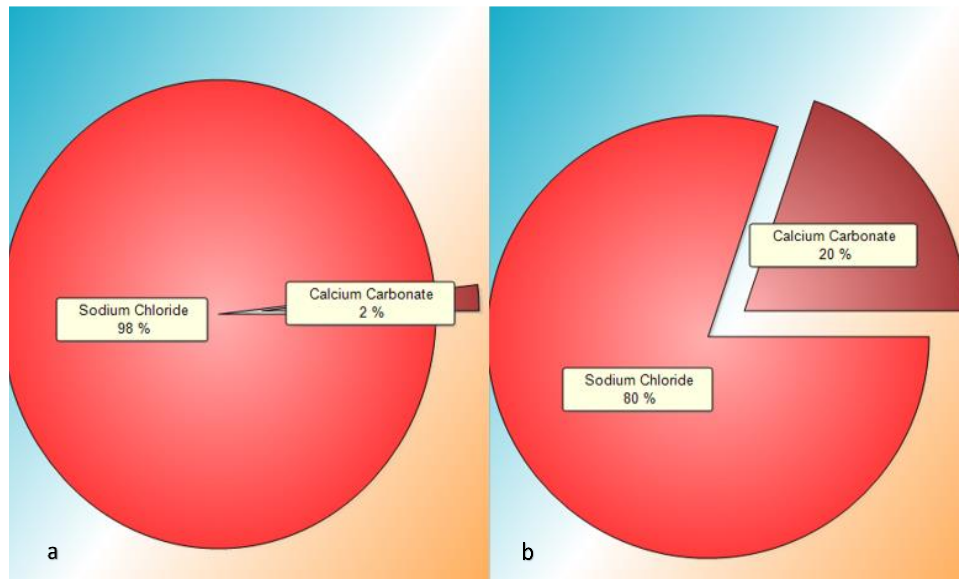
Figure 17. Compositional analysis of deposit samples, (a) without polymer in solution and (b) with 800 ppm polymer in solution, using HighScore Plus
