## **HV-BPL Phase 2 Field Test Report**

DOE/NETL-2009/1388

## **August 2008 to October 2008**

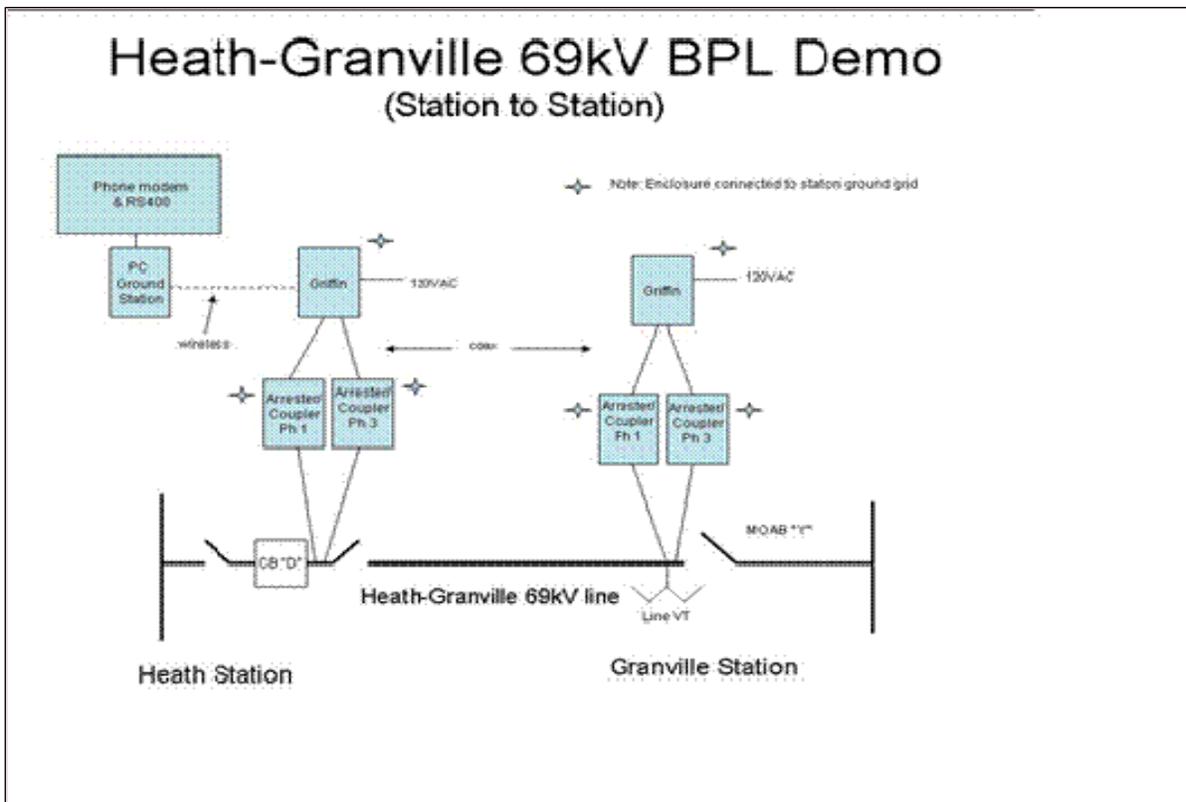
Figure 1: Phase 1 Heath-Granville HV-BPL Demo Configuration

Figure 1, shows the configuration installed during Phase 1 of the trial. The system works by overlaying a high frequency, wideband OFDM signal on the 60Hz transmission power lines between the substations. The Griffin communications node in the Heath station uses its master modem and the Griffin node in the Granville station uses its slave modem for point to point BPL communications. Each HV-BPL coupler uses 69 kV station class utility arresters to couple the RF signal onto the HV transmission line. The arresters are used as a capacitive coupler and not as a lightning protection device. However, the arresters do provide additional lightning protection, a desirable by-product of this coupling method. The coupler's electrical circuit has a secondary mechanism for lightning protection of the Griffin in case the primary arrester is discharged. The coupler uses an impedance matching circuit to optimize the system's impedance with the HV line impedance. The coupler was carefully designed to minimize attenuation and enhance RF signal performance. In order to reduce signal loss through the ground, ferrite beads were added in the ground path. These beads saturate instantly whenever an arrester discharges, hence they do not diminish the ground's primary role. The ferrite beads were tested at AEP for proper saturation performance.

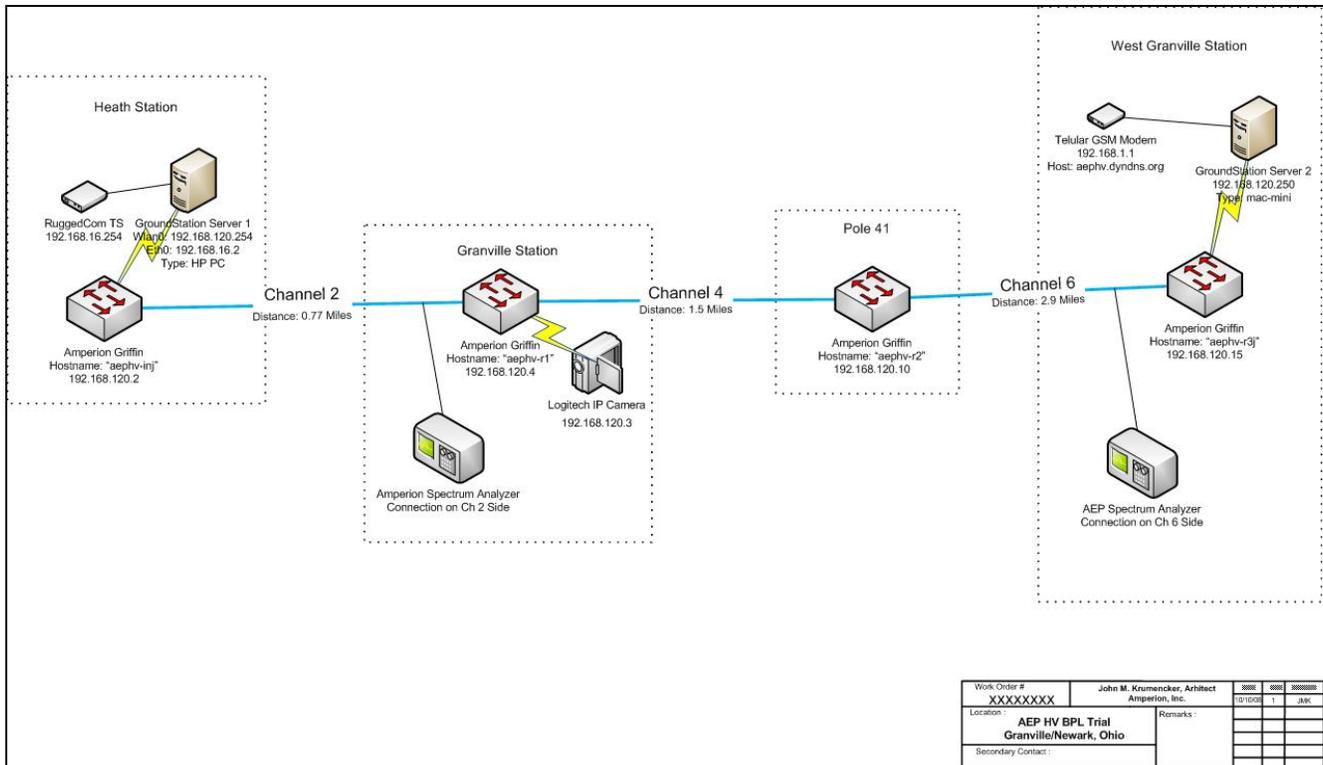
**Figure 2: Final Phase 2B Network Configuration**

Phase 2B was implemented in Oct 6-10, 2008. The work involved installing four new In-Line HV-BPL couplers and three Amperion Griffin systems. AEP crew installed the four new in-line, couplers at Pole 41, which is located 1.8 miles from Granville station. Amperion crew installed the Griffin units at Granville, Pole 41 and West Granville. The team also upgraded the Amperion NMS systems (one at Heath and one at West Granville Stations) and established remote connectivity from each NMS to Amperion's office in MA. The remote connection to Heath is a less than 56 kbps dial-up connection, while West Granville is operating with a cell-based wireless connection at about 300 kbps. Performance with 6 different operational frequencies was tested and verified. The team spent time searching for noise sources referred to as Electromagnetic Interference or EMI. EMI is defined here as intentional or unintentional noise created by a utility, a customer of the utility or a by third party (e.g. in the form of a radio station), that contributes to diminishing the Signal to Noise ratio (SNR) of the 69 kV transmission line. EMI sources near the Granville station and along the Granville to West Granville transmission line were found and mitigated.

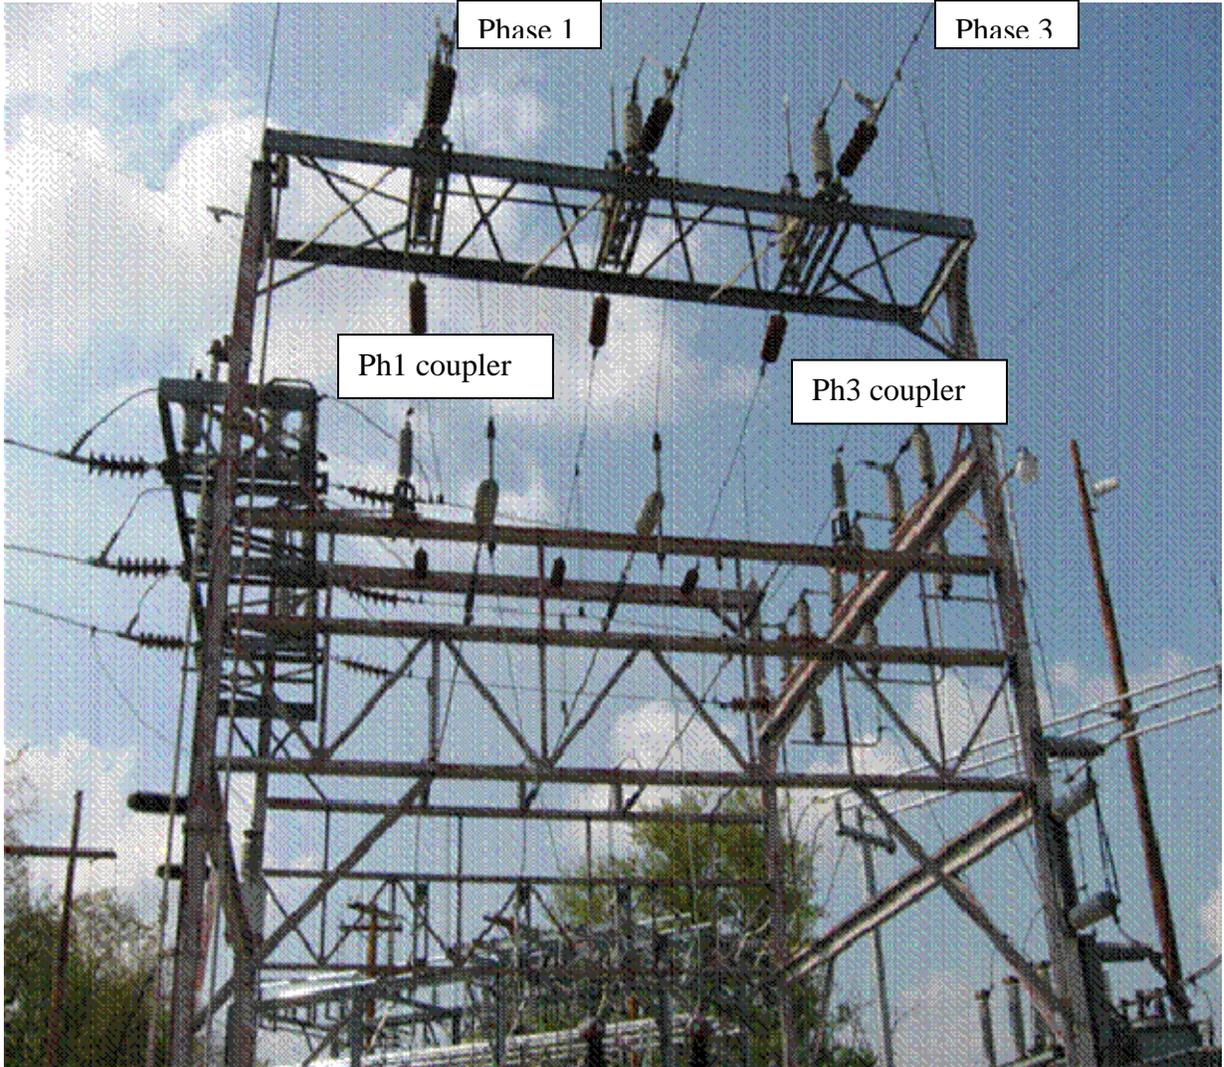
**Figure 4: HV couplers installed at Granville on electric phases 1 and 3**

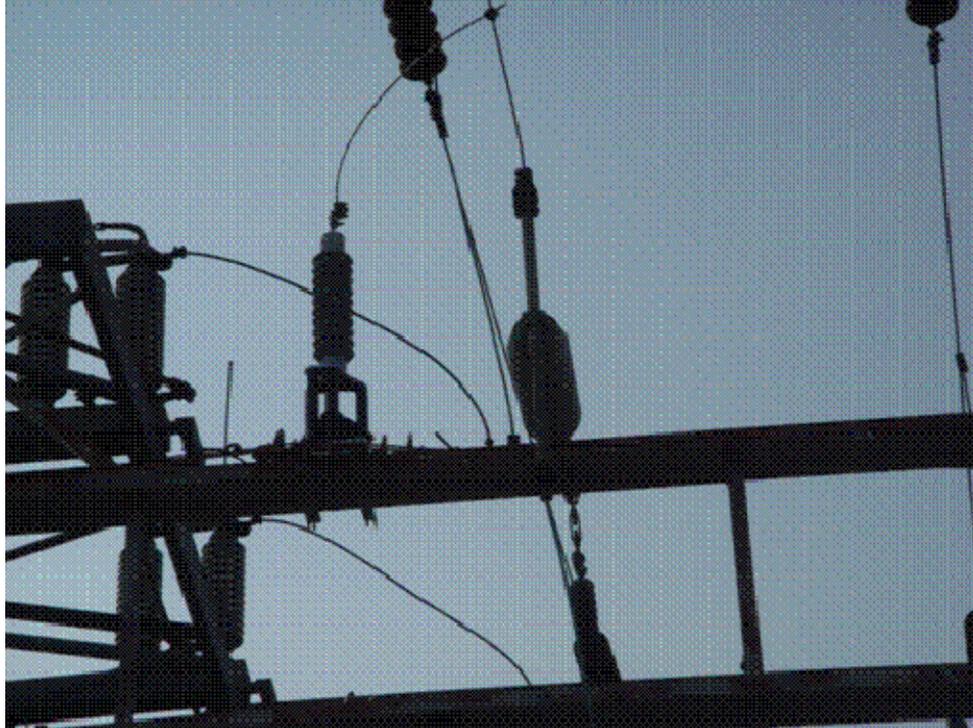
**Figure 6: Granville Station, HV-BPL Coupler**

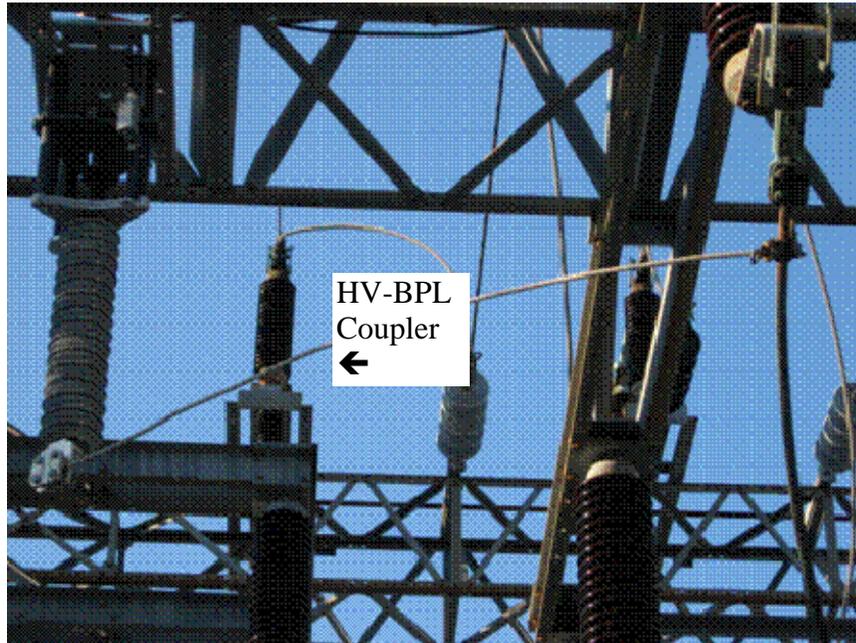
**Figure 8: HV-BPL Coupler West Granville Station**

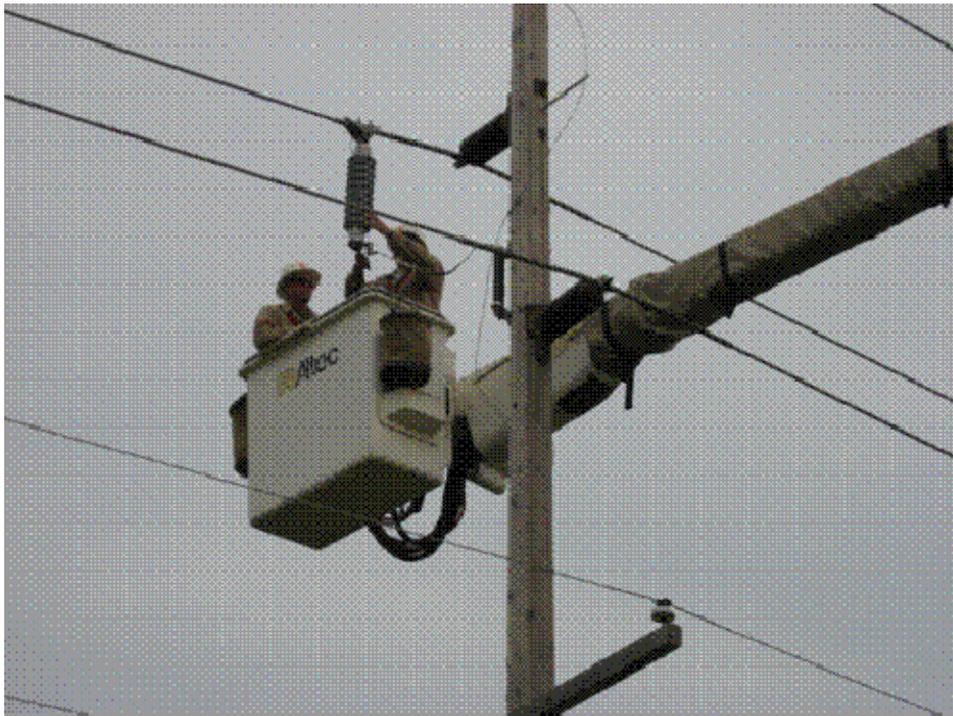
**Figure 10: Installing T-Line RF Coupler at Pole 41**

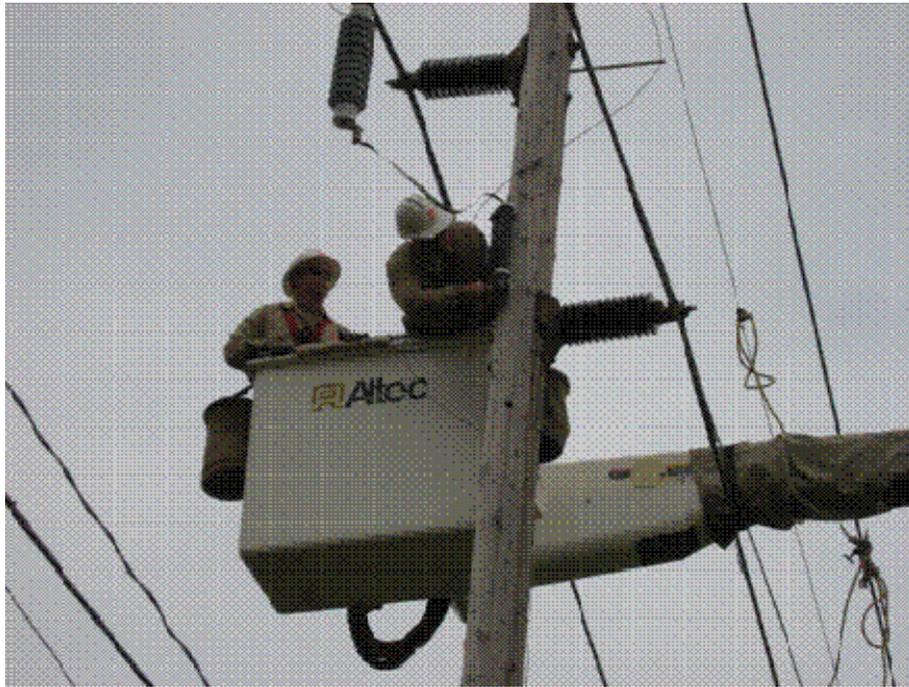
**Figure 11: Installing T-Line RF Coupler at Pole 41**

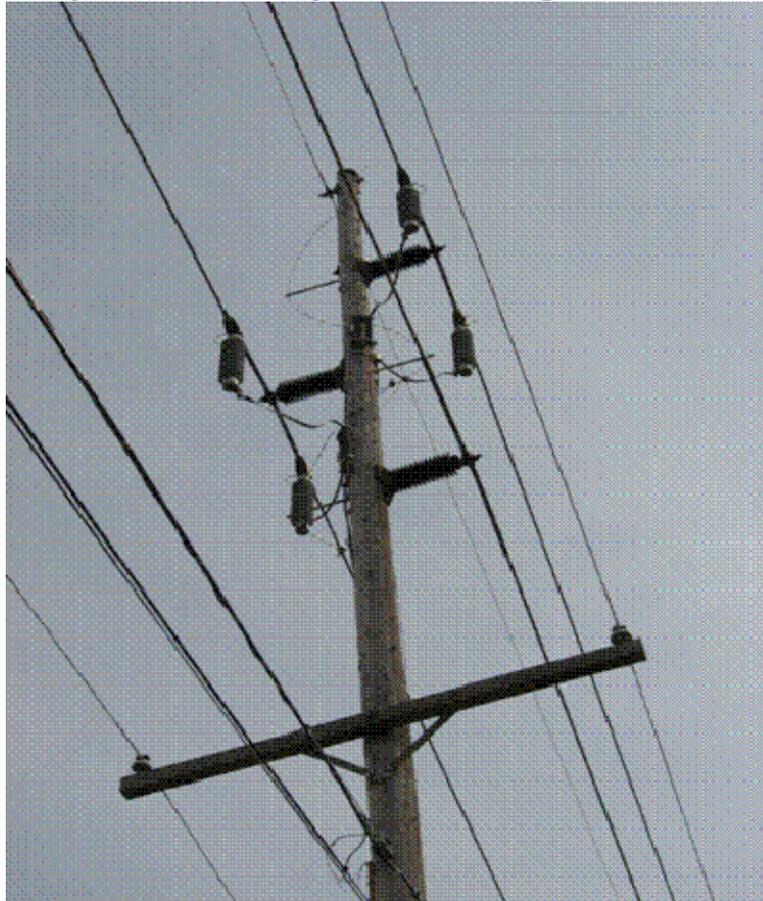
**Figure 12: (4) T-Line Coupler Installed at Pole 41**

A transmission line crew from AEP installed four couplers at pole 41. After the coupler installation was completed, the HV-BPL repeating node was installed at Pole 41 and the BPL system was fired-up on the de-energized line. The FDM repeating approach operated the BPL system between Granville and Pole 41 on one 5 MHz frequency band and between Pole 41 to West Granville on another 5 MHz frequency band. Testing was conducted with three operating modes (frequency combinations) with the 69 kV line de energized and a safety ground in place. When the testing was completed, the 69 kV line was brought back into service. The BPL system went online between Granville and West Granville; as expected the data rate was lower than in the less noisy de-energized state.

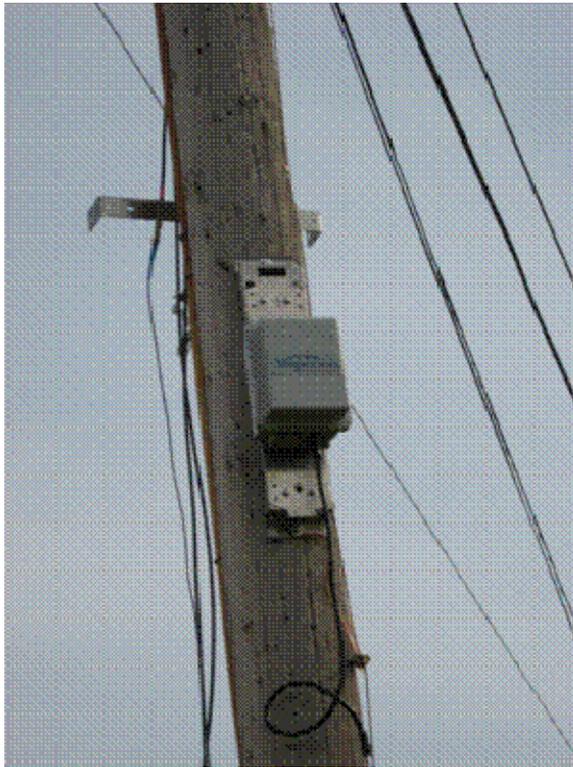
**Figure 13: BBU Battery Backup System**

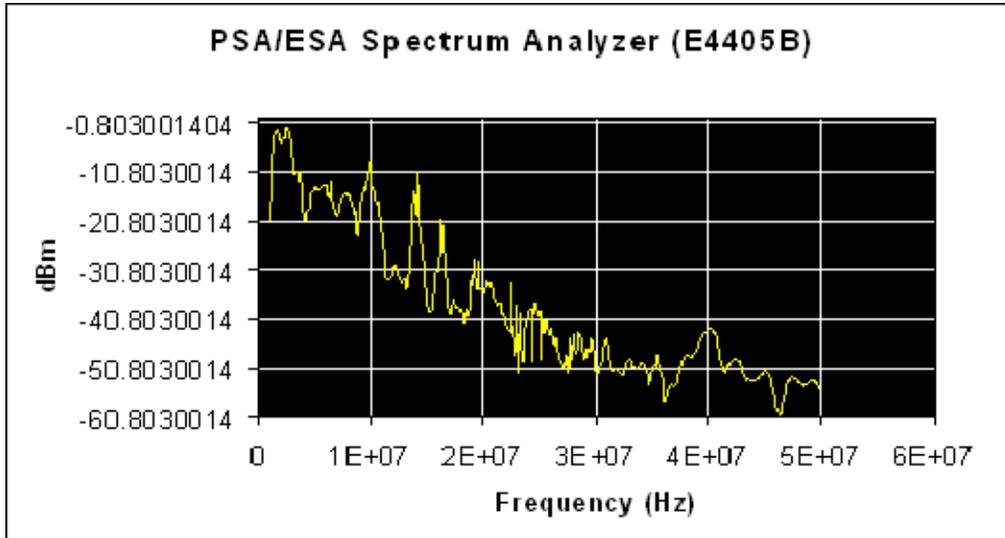
Figure 14 is a picture of a low frequency EMI source observed on August 18 from Granville station.

**Figure 14: Granville Station Aug 18, 2008 15:36:10**

Removing two noise sources near Granville station had a significant impact on the noise floor observed in Figures 14-16. The BPL connection is also influenced by changes in the noise floor. A higher noise floor reduced the carrying capacity of data on the BPL link. The Heath to Granville link was operating for months in the presence of this strong EMI source before it was located. Going forward it should be possible to use internal metrics from the BPL chipset (e.g. the PHY and BPC rate) to identify the number, duration, intensity and directionality of local noise events.

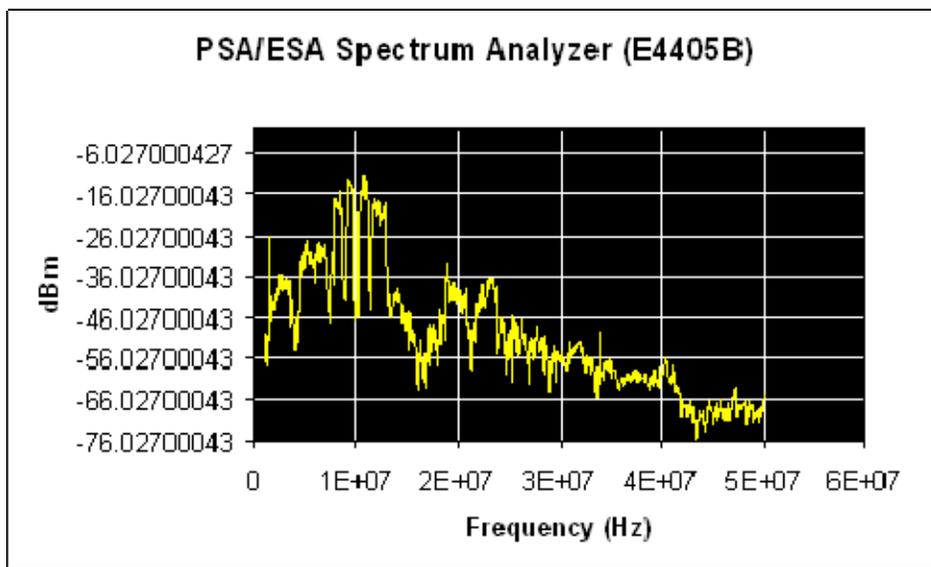
Figure 15 shows the noise source observed in the morning of Oct 10<sup>th</sup> 2008. At 2 MHz the noise floor is 30-35 dB lower then it was on Aug 18<sup>th</sup> 2008.

**Figure 15: Sample from Oct 10, 2008 9:29AM**

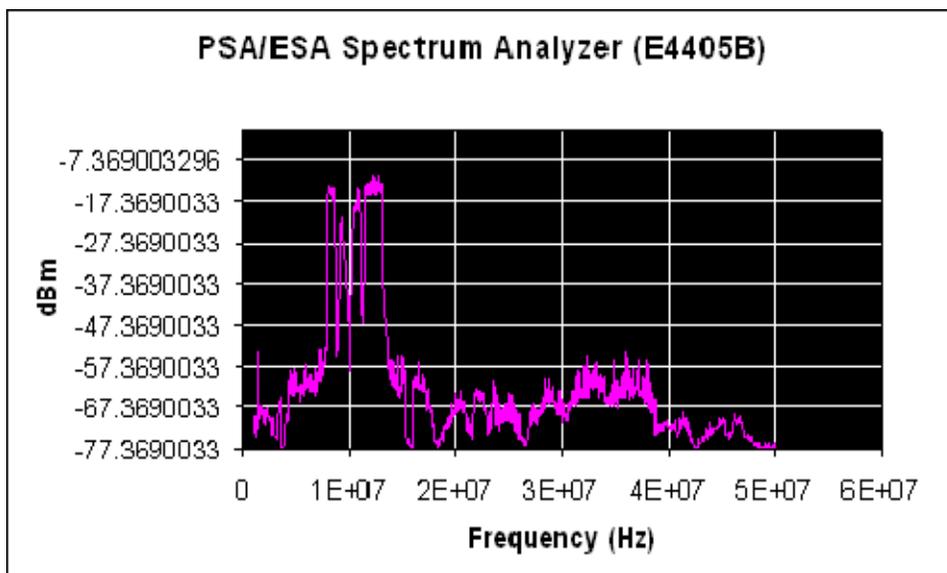
Figure 16 shows the noise floor seen at Granville Station after finding and removing the EMI source along the Granville to West Granville line. Figure 16 below is typical of the samples since noon on Oct 10, 2008. Notice that the noise floor at 2MHz has since dropped by 70dB when compared with figure 14. (The BPL signal can be clearly seen in Figures 15-16 in the region of 10 MHz)

**Figure 16: Sample from Oct 10, 2008 16:41 PM**

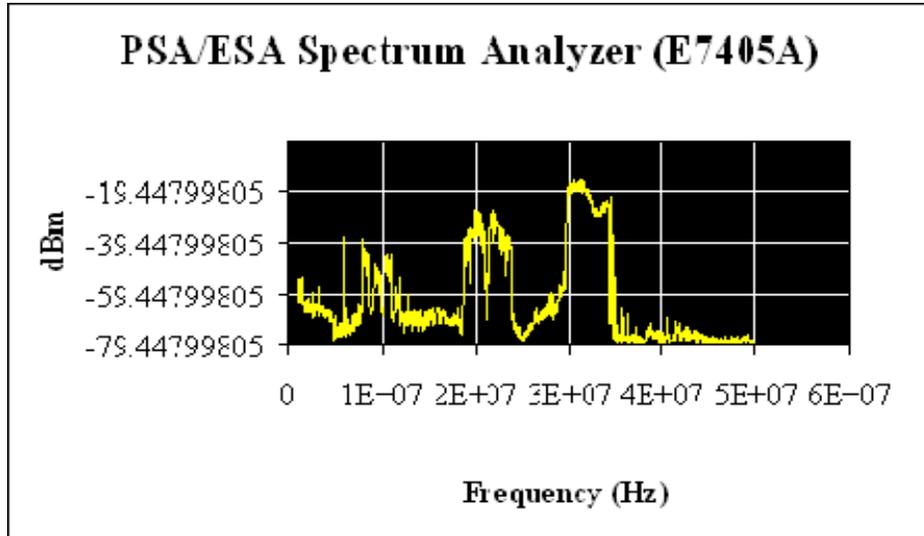
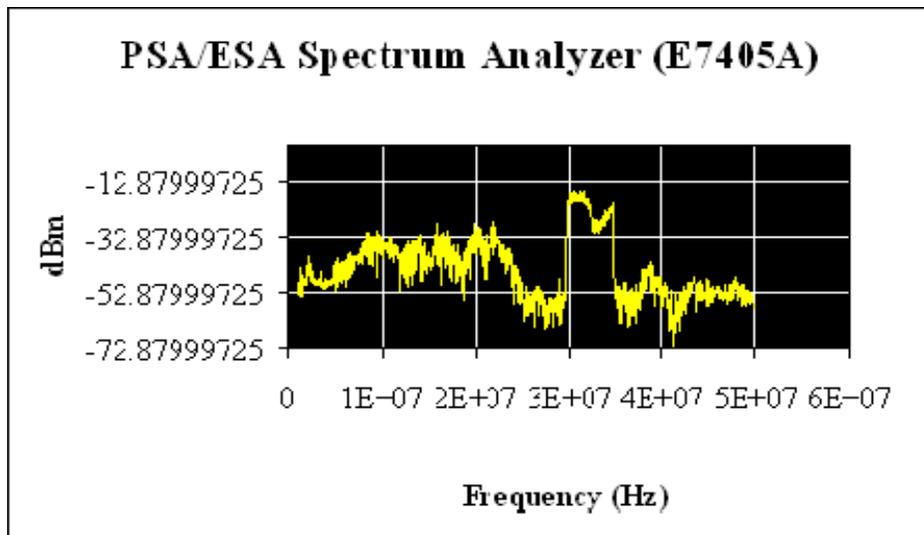
The two snapshots below compare noise floor signatures at West Granville station, with (on Oct. 10) and without (on Oct. 11) a noise source present. Notice a 30 db shift in the noise floor at the West Granville station when the EMI event was active. The spectrum analyzer at Granville station (Figure 17) does not show the same activity, indicating that this noise source was located near West Granville.

Figure 17: Normal signal and noise levels at W. Granville Oct 11, 2008 0:41:41

Figure 18: Higher noise floor W. Granville Station Oct 10, 2008 18:31:41

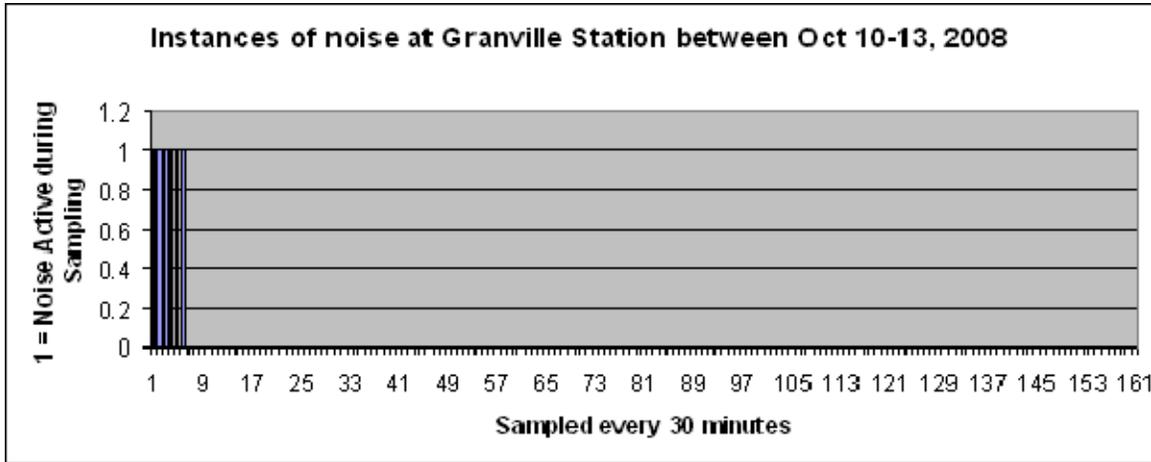
This data indicates that these EMI events occurred more frequently before eliminating the EMI sources along the Granville – West Granville line. This analysis considers the noise event as either present or not. The graph below shows the distribution of wideband noise events detected over an 80+ hour sample period. At Granville, the noise source was active in the first six samples or 3.7% of the time.

The spectrum analyzer was set to sample (50 seconds sweep) twice per hour. During this testing period 161 samples were collected. Since noon on Oct 10, 2008 an elevated EMI level at Granville station has not been seen.

**Figure 19: Detection of elevated low frequency EMI events over time**

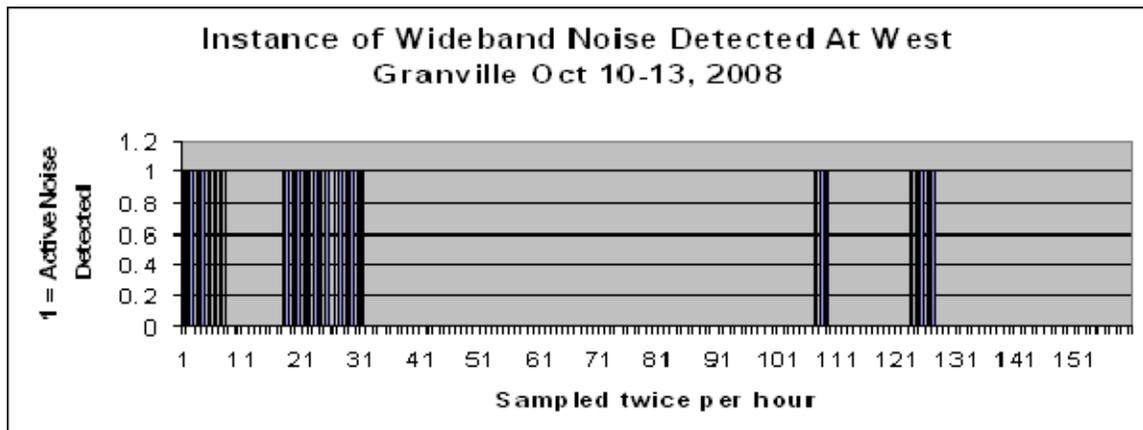
Spectrum analyzer data from the West Granville location still shows a significant number of samples with an elevated noise floor. The noise events occurred in four clusters with duration lasting for 1 to 6 1/2 hours. The noise event was present in 30 of 160 samples or about 19% of the time. Twenty two of the events recorded occurred after mitigating EMI sources along the Granville – West Granville link.

**Figure 20: Detection of elevated low frequency EMI events over time**

At least one noise source still exist near the West Granville station.

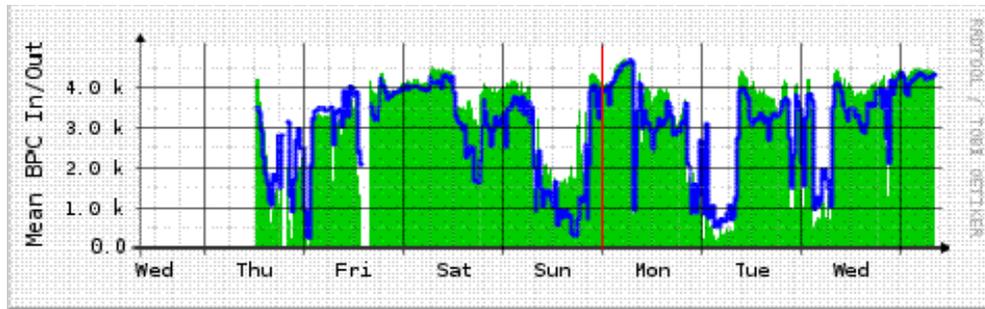
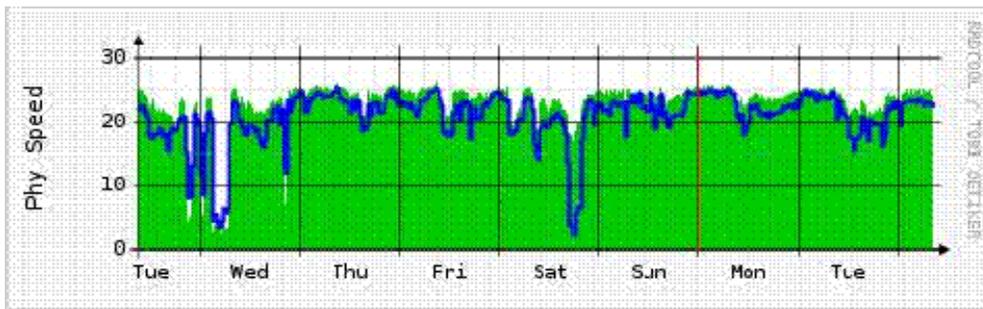
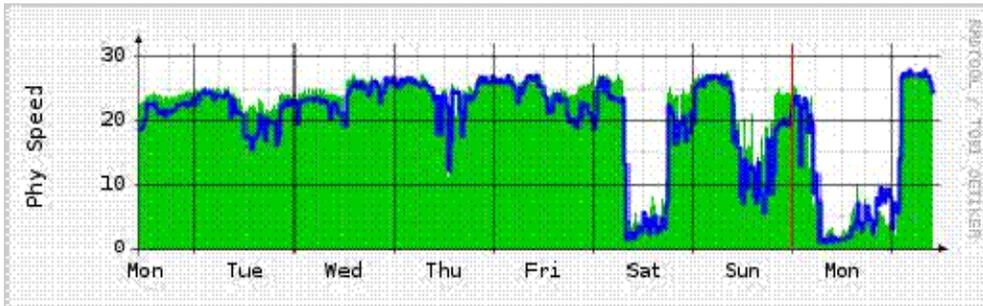
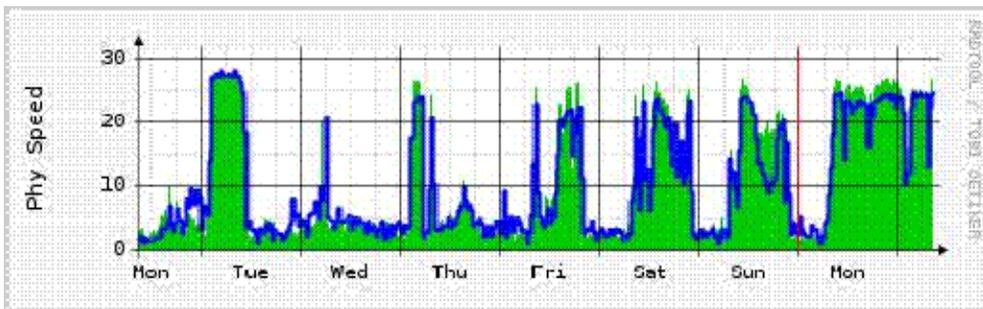
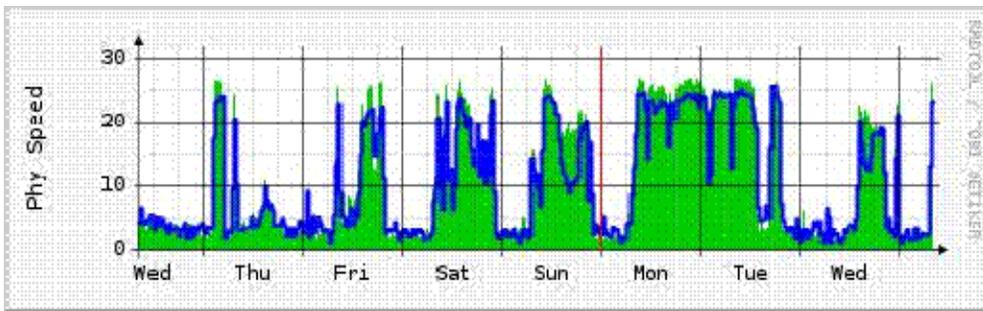
At times the data rate has fallen for multiple hours due to very strong external EMI events. **Yet the HV-BPL link has always remained operational at 100% availability with data rates of at least single Mbps. The reboot counters on the BPL system indicate that it has remained operational since installation.** The performance graph below gives an indication of the effect this noise has on the BPL system. The data was recorded for the PHY and BPC value which are internal metrics. The BPC is the “bit per carrier” which represents the capacity of the operational carriers. The PHY rate is the raw capacity of the link before the transport overhead. The blue line indicates BPC and PHY data coming into the station (RX) and the green area indicates data going out (TX) from the station. A higher line has a higher BPC level or Mbps reading and therefore is an indication of a stronger BPL signal. A lower reading indicates that the noise floor is high and is affecting the BPL signal. Figures 21-25 show performance of the Heath to Granville link over the month of May, 2008. Figure 21 shows the BPC graph for May 1- May 7, 2008. Figures 22-25 show the PHY rate from May 8, 2008 thru May 28 2008.

**Figure 21: May 1 – May 7 MRTG graph**

**Figure 22: May 6 – May 13 MRTG graph**

**Figure 23: May 12 – May 19 MRTG graph**

**Figure 24: May 19-May 26 MRTG graph**

**Figure 25: May 21- May 28 MRTG graph**

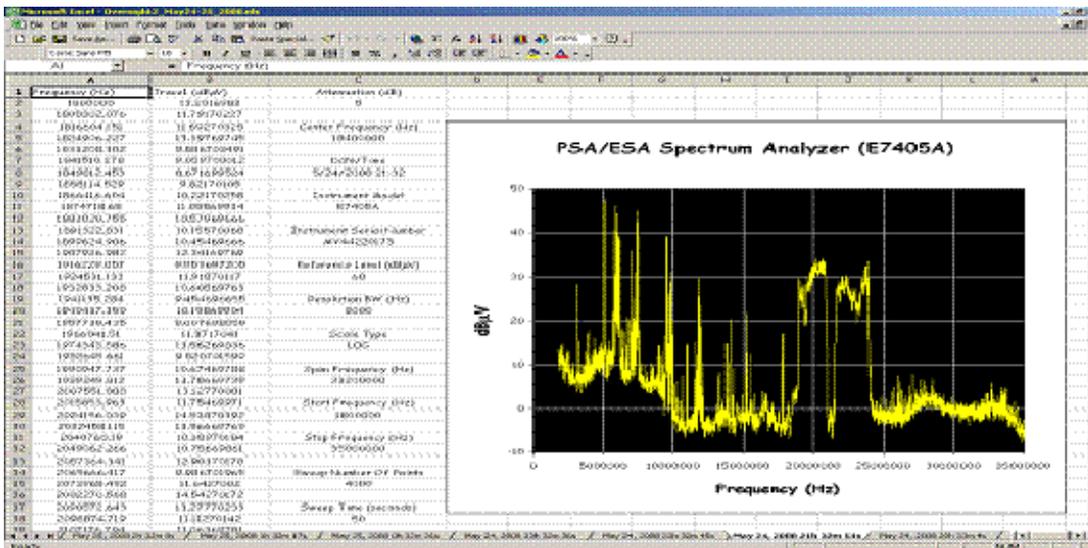
A spectrum analyzer connected to an antenna was used to capture the local EMI conditions. Figures 26 and 27 show the ambient EMI condition recorded from the Heath station. The BPL signal can be seen in the region of 20 to 25 MHz in figures 26 and 27. Figure 27 was captured while a noise source was active.

**Figure 26: BPL Operating in Normal SNR Conditions**

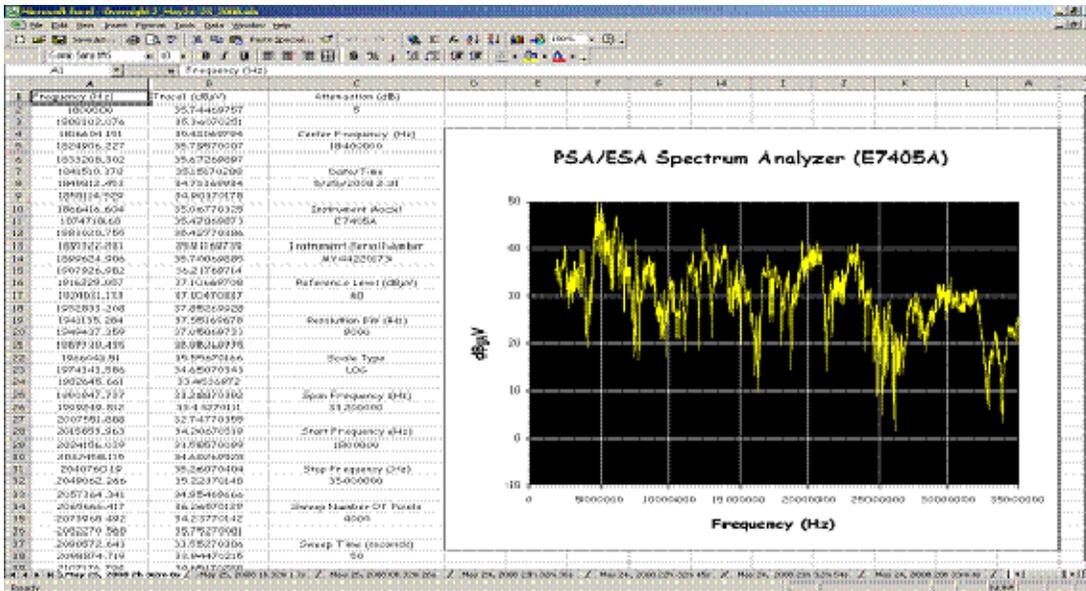
**Figure 27: BPL Operating in presence of a 30-40dB Noise Source**

The Heath to Granville link remained in service in the presence of this intermittent noise source shown figure 28. The noise source spawned the creation of an automated system with onsite test equipment to understand the EMI patterns and locate its source.

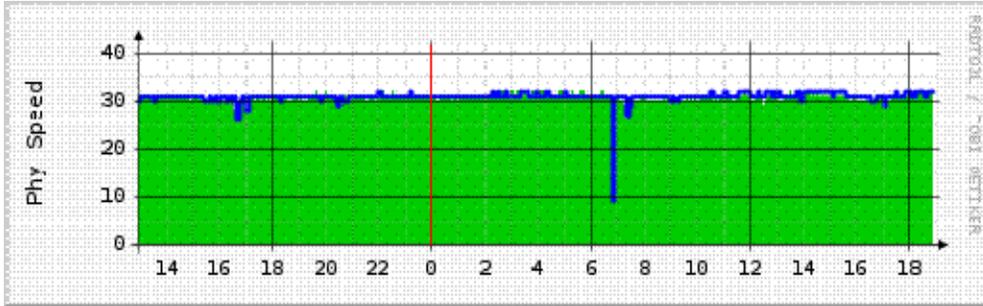
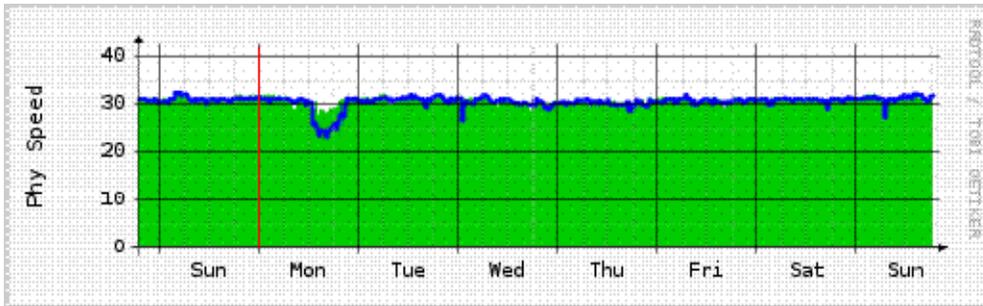
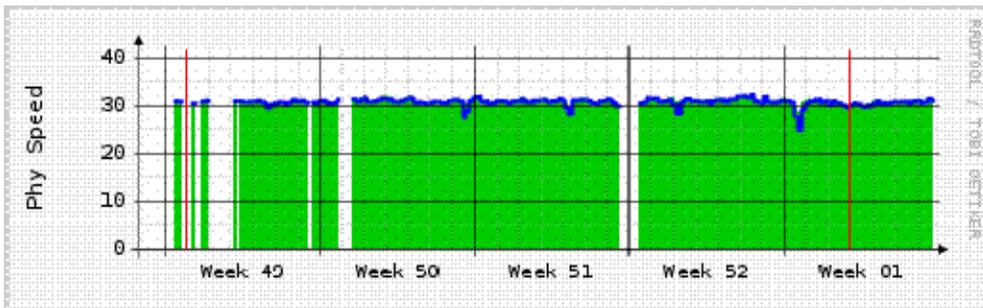
**Figure 28: Heath to Granville: 'Daily' Graph (5 Minute Average)**

**Figure 29: Heath to Granville: 'Weekly' Graph (30 Minute Average)**

**Figure 30: Heath to Granville: 'Monthly' Graph (2 Hour Average)**

Since eliminating two noise sources near Granville station in Oct 2008, the Heath – Granville link has been very reliable. Figures 28-30 show the performance of the Heath to Granville link after the removal of the two noise sources. This data can be directly compared to Figures 21-25 captured during in May 2008 that show system performance in the presence of the EMI sources.

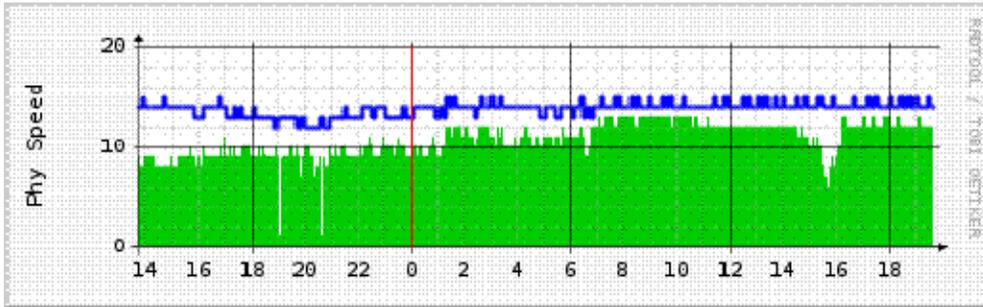
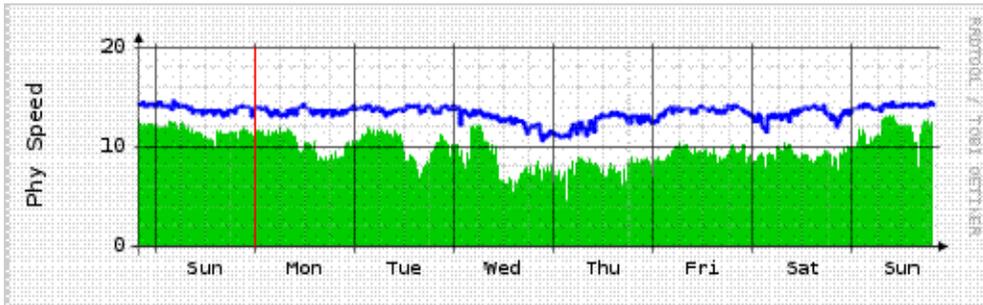
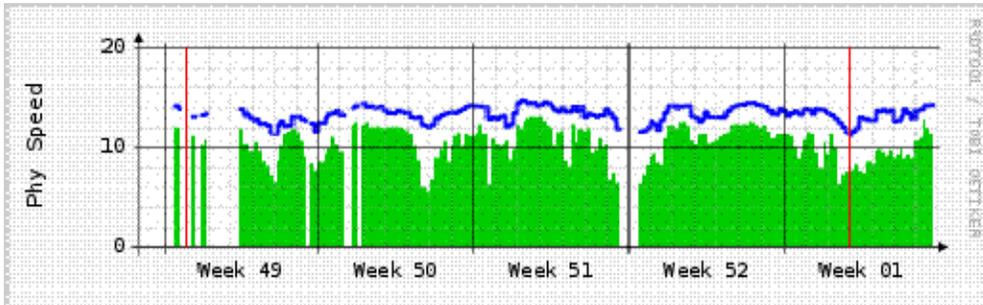
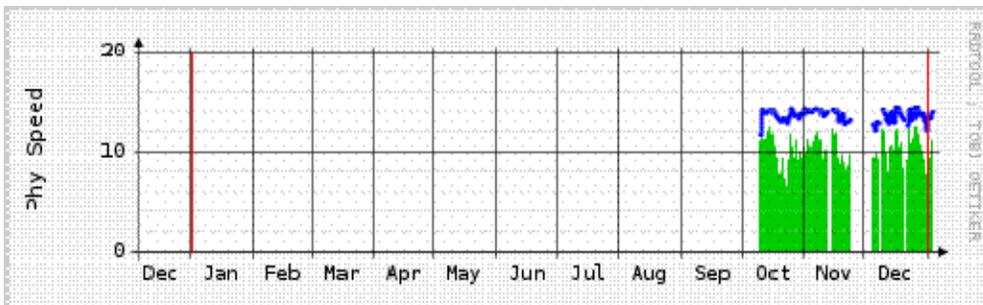
**Figure 31: Granville – Pole 41: 'Daily' Graph (5 Minute Average)**

**Figure 32: Granville – Pole 41: 'Weekly' Graph (30 Minute Average)**

**Figure 33: Granville – Pole 41: 'Monthly' Graph (2 Hour Average)**

**Figure 34: Granville – Pole 41: 'Yearly' Graph (1 Day Average)**

The Granville to Pole 41 link, a 1.8 mile segment, has been very reliable since going on line on Oct 10, 2008. All graphs in section 5.3.x show stripping caused by a dropout of the wireless backhaul between the NMS and Griffin at West Granville station. The stripping

seen in figures 33 and 34 is a result of viewing the data collected by the West Granville NMS. With the wireless failure mentioned previously, the NMS was unable to collect data from all three links. The BPL connection for the Heath to Granville and Granville – Pole 41 link was in fact up.

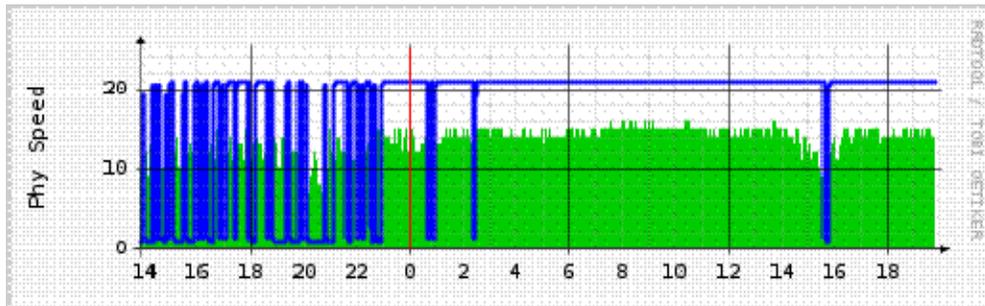
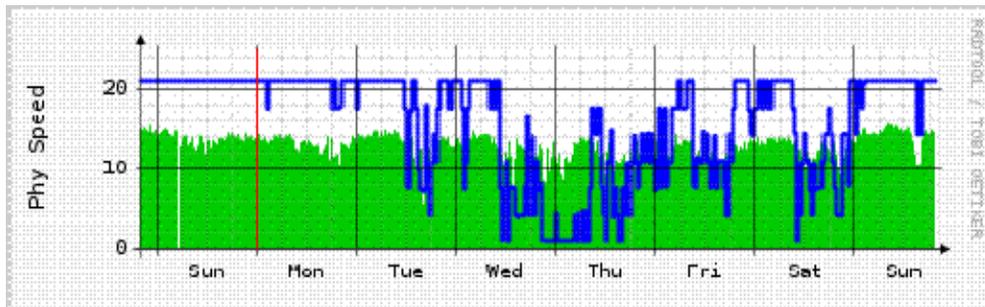
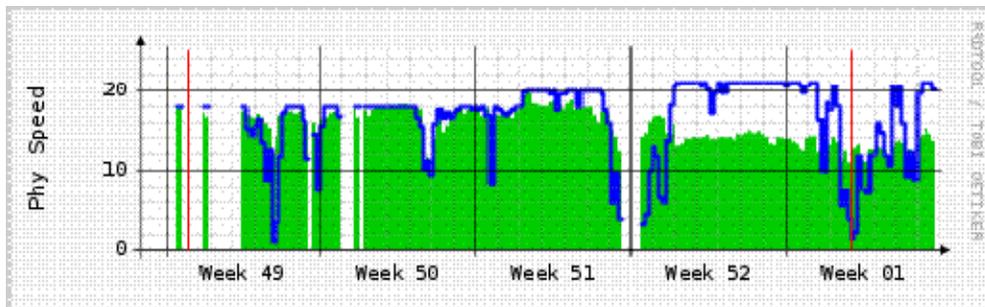
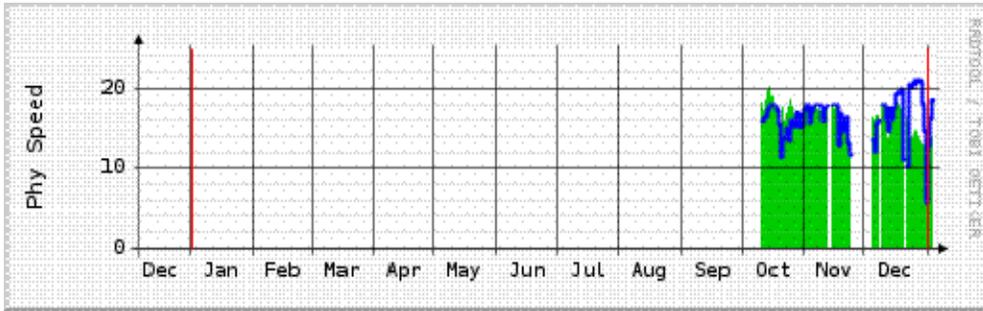
**Figure 35: Pole 41 – West Granville: 'Daily' Graph (5 Minute Average)**

**Figure 36: Pole 41 – West Granville: 'Weekly' Graph (30 Minute Average)**

**Figure 37: Granville – Pole 41: 'Monthly' Graph (2 Hour Average)**

**Figure 38: Pole 41 – West Granville: 'Yearly' Graph (1 Day Average)**

Data collection on the Pole 41 to West Granville link has been impacted by three events.

- The wireless connection was intermittent between the Griffin located in the yard and the NMS located in the building.
- The power supply feeding the NMS was disrupted.
- The BPL signal strength over 2.6 mile path was accompanied by an intermittent noise source.

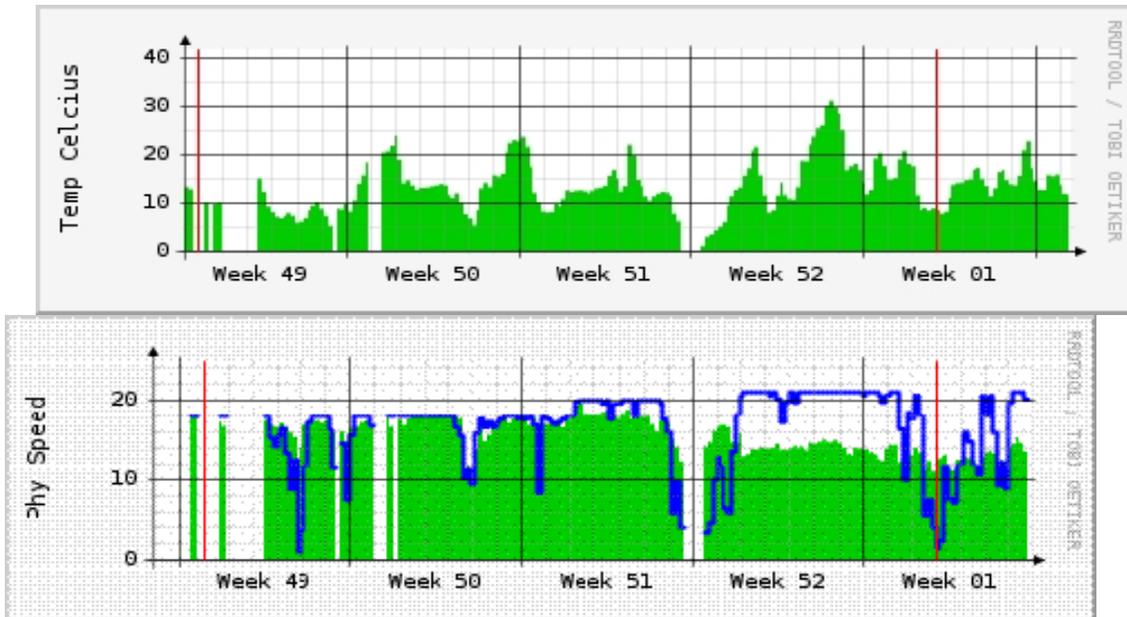
**Figure 39 & 40: WG Griffin Temperature vs Uptime on BPL PHY Transport Layer**

An analysis of West Granville Network Management System data shows conclusively that down time was due mainly to a failure of the wireless system between the NMS and first Griffin. Temperature graphs from the West Granville Griffin show the same stripping pattern indicating a loss of communication over the wireless connection between the NMS and the first Griffin. Local temperature readings do not traverse the BPL path.

Figures 39 and 40 have been aligned in time to show a correlation in the up time recorded by the NMS. The temperature graph (on top) line up in time with most of the outage events. This strongly suggests that the wireless connection was responsible for most of the down time in figure 41. We believe the BPL connection was up during these wireless outages.

As a corrective action an uninterruptable power supply was installed for the NMS. The wireless connection was replaced by a wired Ethernet connection between the NMS and the Griffin unit. Since Jan 2009 these problems have been resolved and the entire 4.4 mile span is operating reliably without a repeater.
