23rd Annual Conference on Fossil Energy Materials
Pittsburgh, PA May 12-14, 2009

IMPROVED TEMPERATURE SENSING IN SLAGGING GASIFIERS

James P. Bennett Rick Krabbe
Jasper Kwong Hugh Thomas

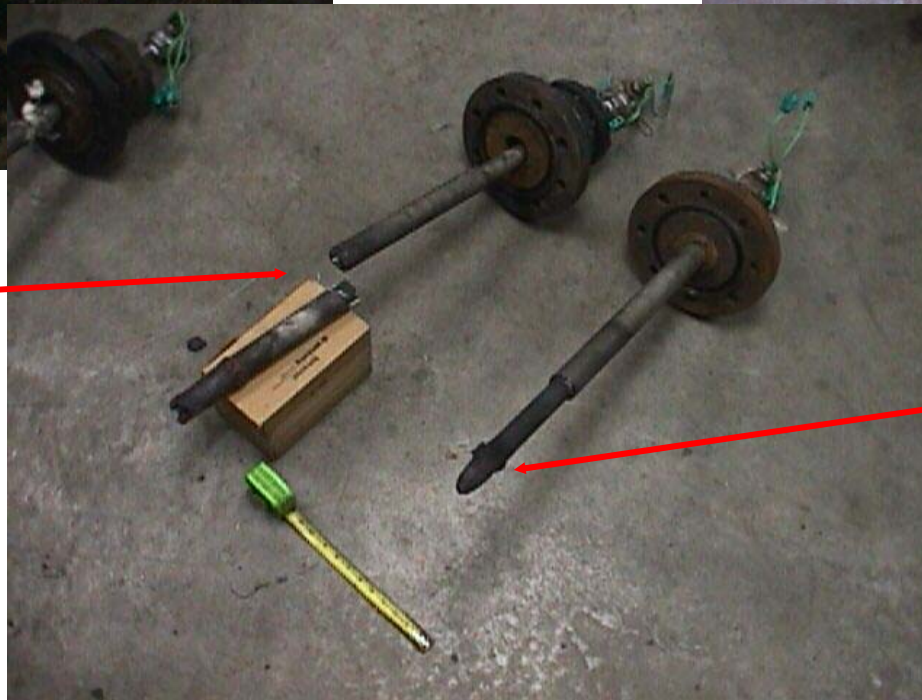
Corrosion
(refractory block
and
thermocouple)

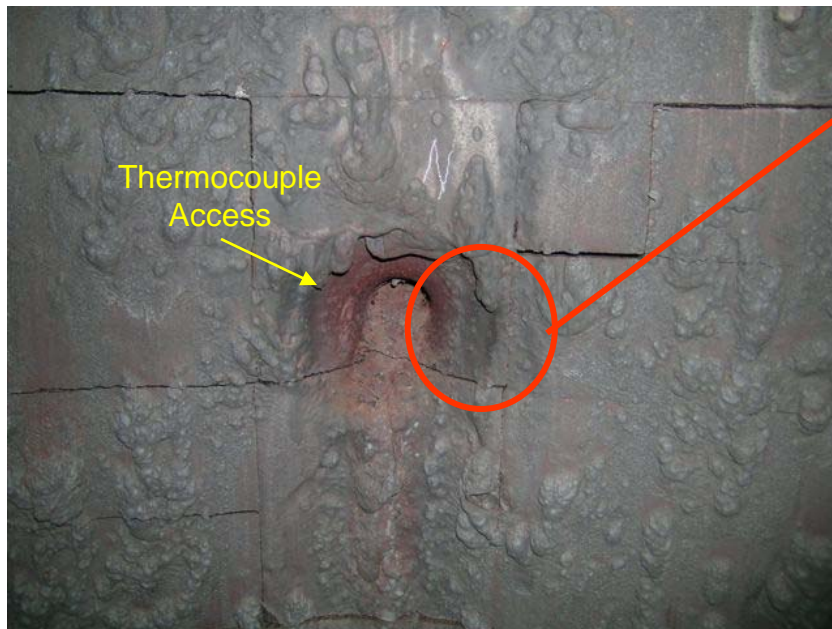
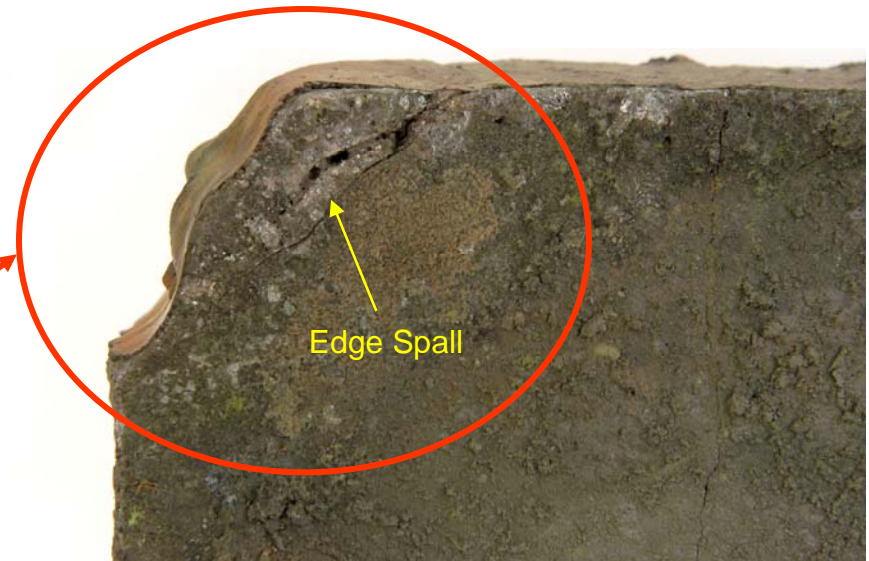
Edge Spalling/Corrosion of Refractory Where the Thermocouple Enters the Gasifier

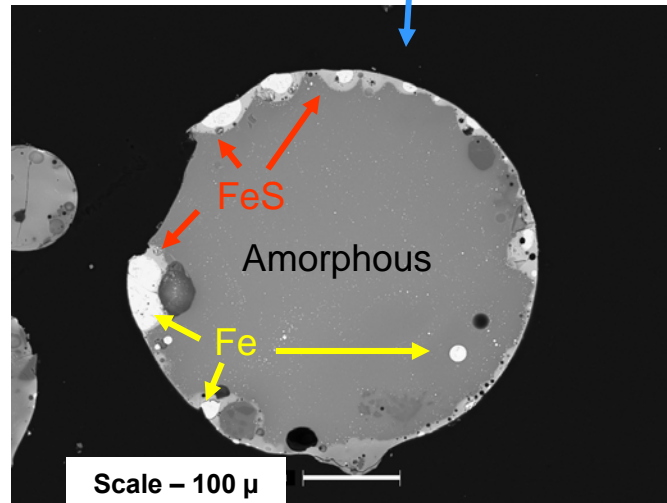
SEM
Micrograph
Showing FeS
and Fe in
Slag Particle

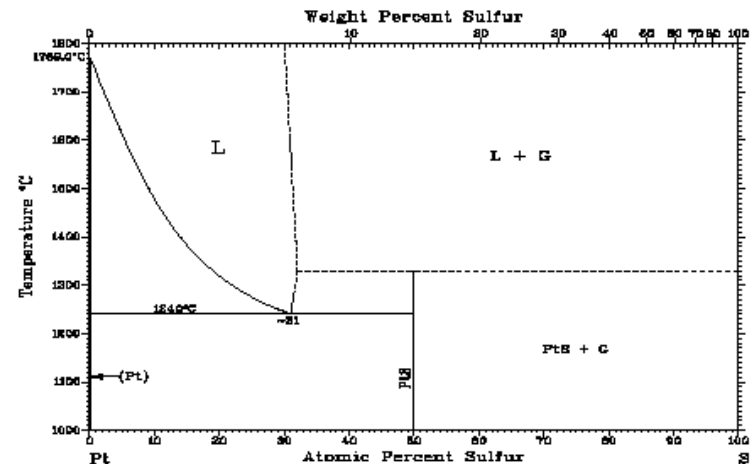
Pt - S Phase Diagram

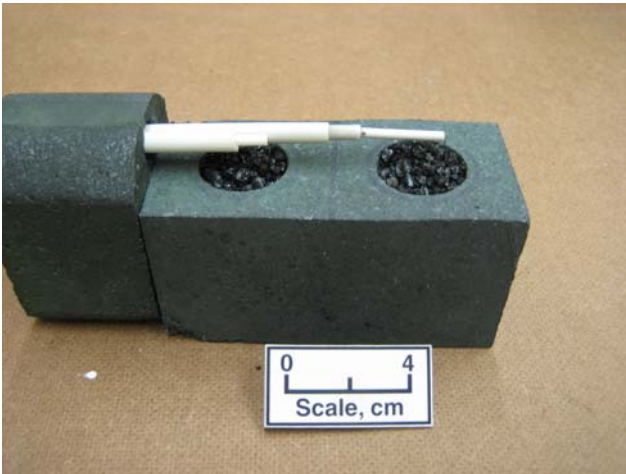
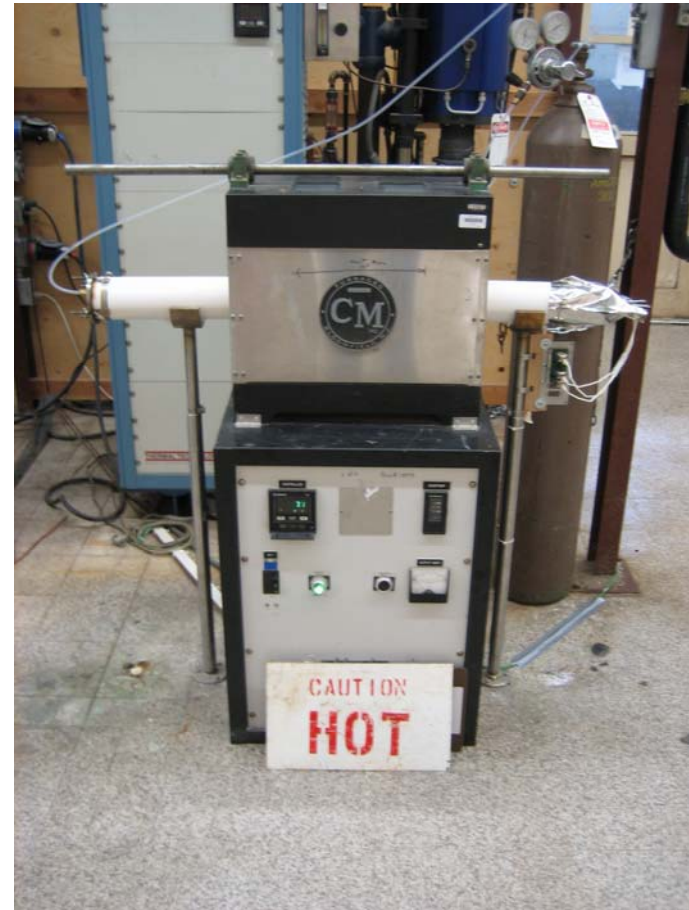
Test Assembly – Type “S” Thermocouple, 1500°C (goal), Ar

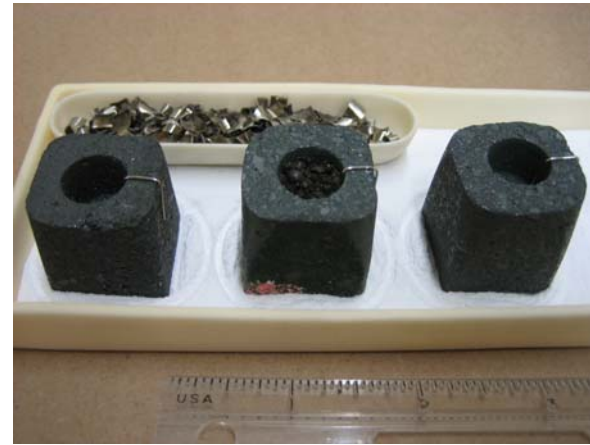
Thermocouple Wire Sample Exposure Test Conditions

- 1450°C, 8 Hours hold at temperature
- 100 % Pt wire
- Ultra high purity Ar with C and Ti metal getters
- Samples covered with high purity alumina crucible caps and set on high purity alumina setter powder
- Test Slag: Coal ash
- Test Samples:
 - 99 % Al_2O_3
 - 90 % Cr_2O_3 - A
 - 90 % Cr_2O_3 - B

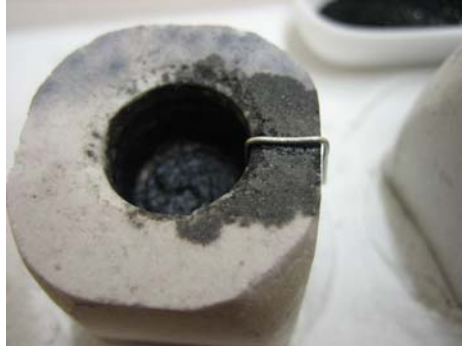
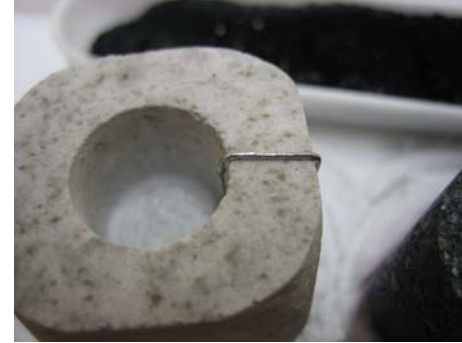
Al_2O_3

Cup – Top View, After Exposure

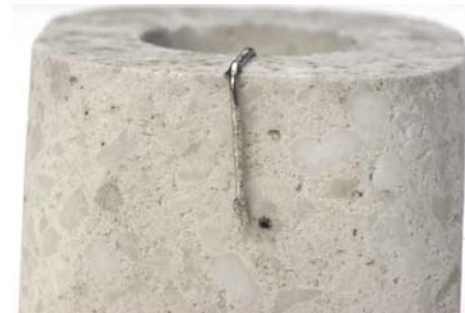
Al_2O_3

Cup – Side View, After Exposure
