Wellbore Seal Repair Using Nanocomposite Materials

Project Number DE-FE0009562

U.S. Department of Energy
National Energy Technology Laboratory
Carbon Storage R&D Project Review Meeting
August 18-20, 2015

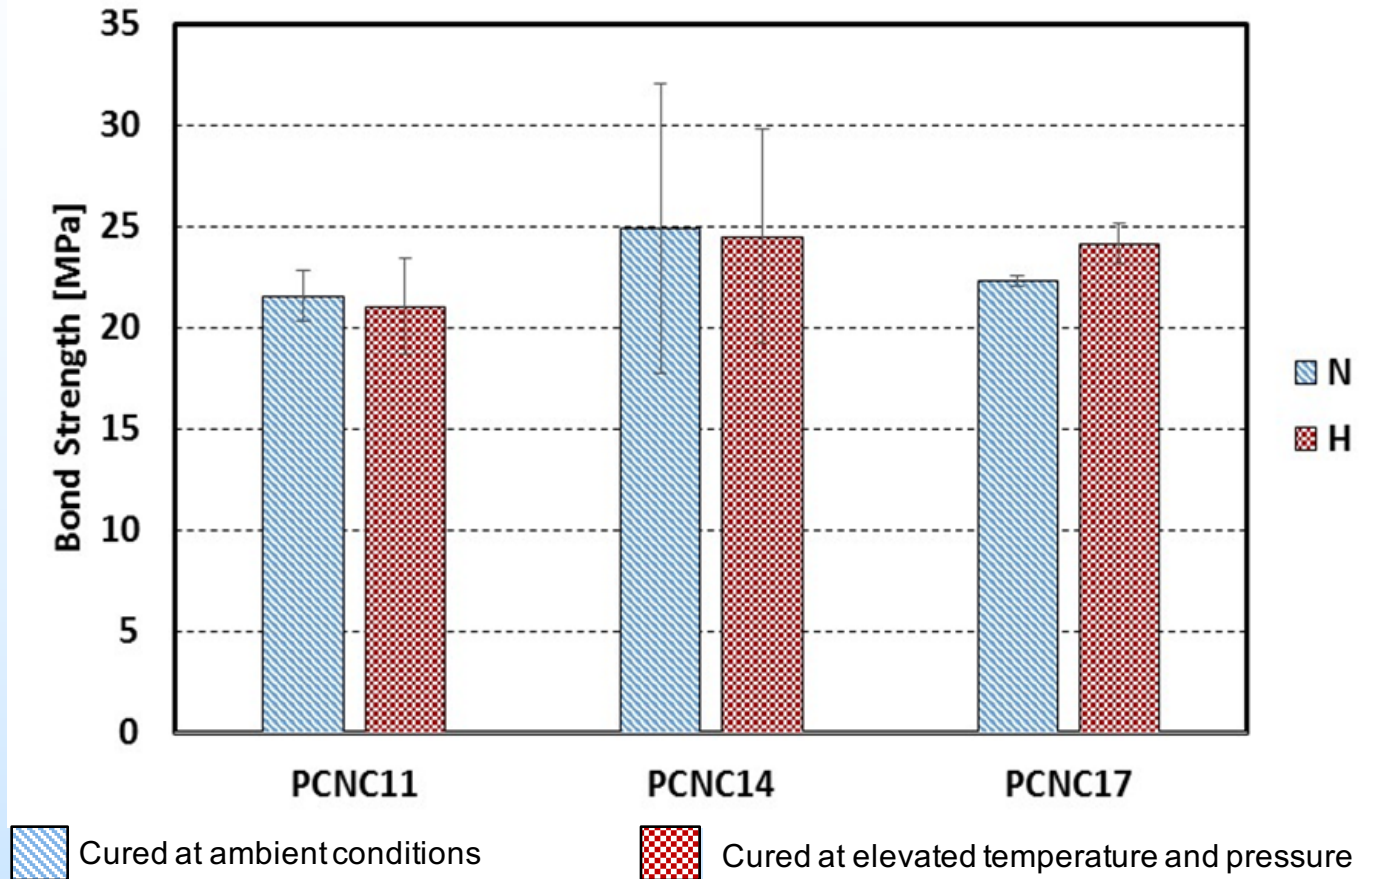
Temp: 80 °C, Pressure 10 MPa

No effect of elevated temperature and pressure on performance of PCNC

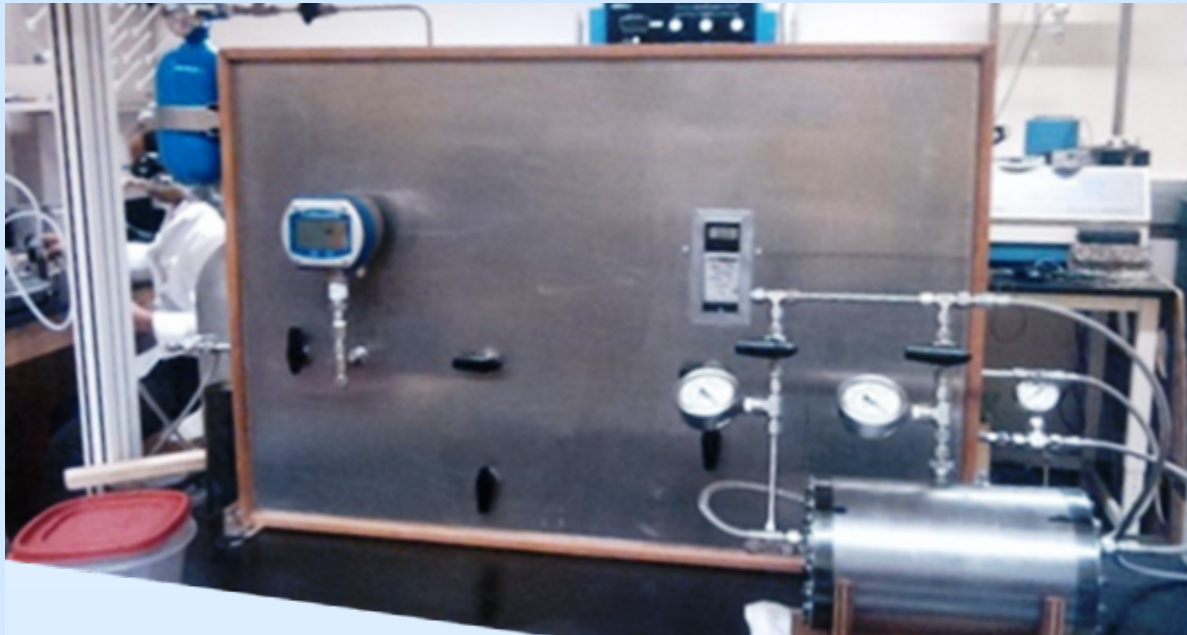
Gas Permeameter

Gas pressures to 14 MPa.

Permeability range $>10^{-12}$ to $<10^{-21}$ m²

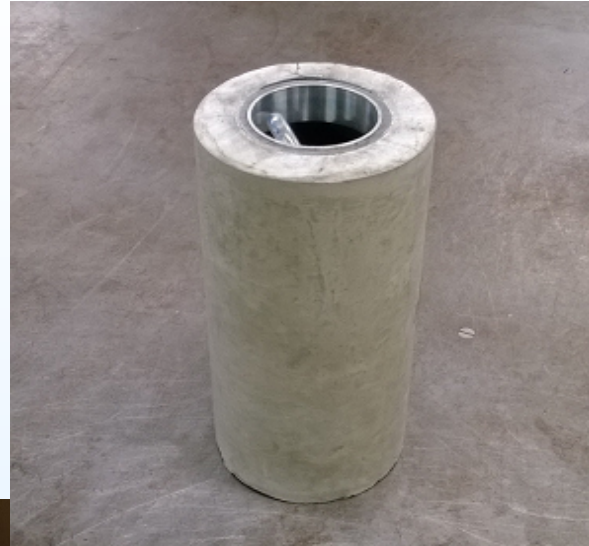
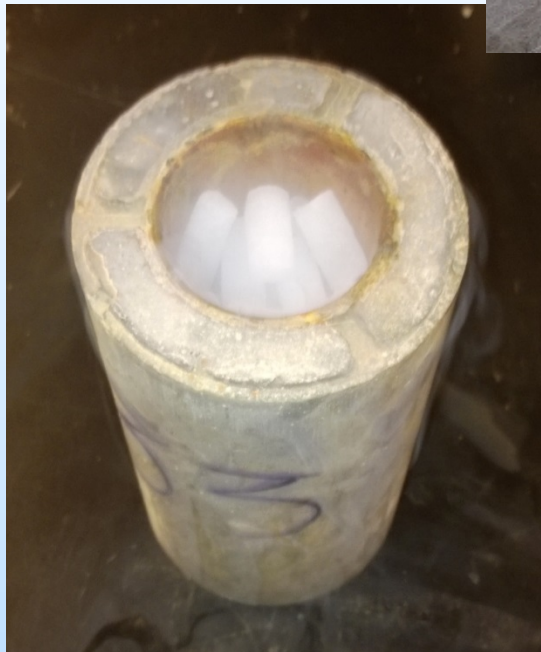
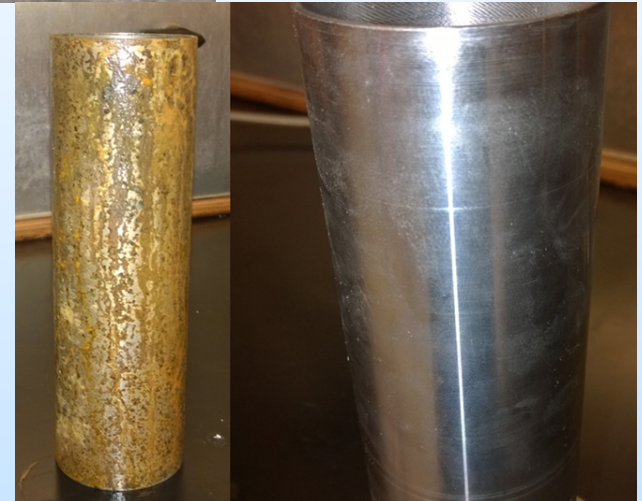
Specimen preparation

- Microannulus
 - Large
 - Small
- Cement fracture

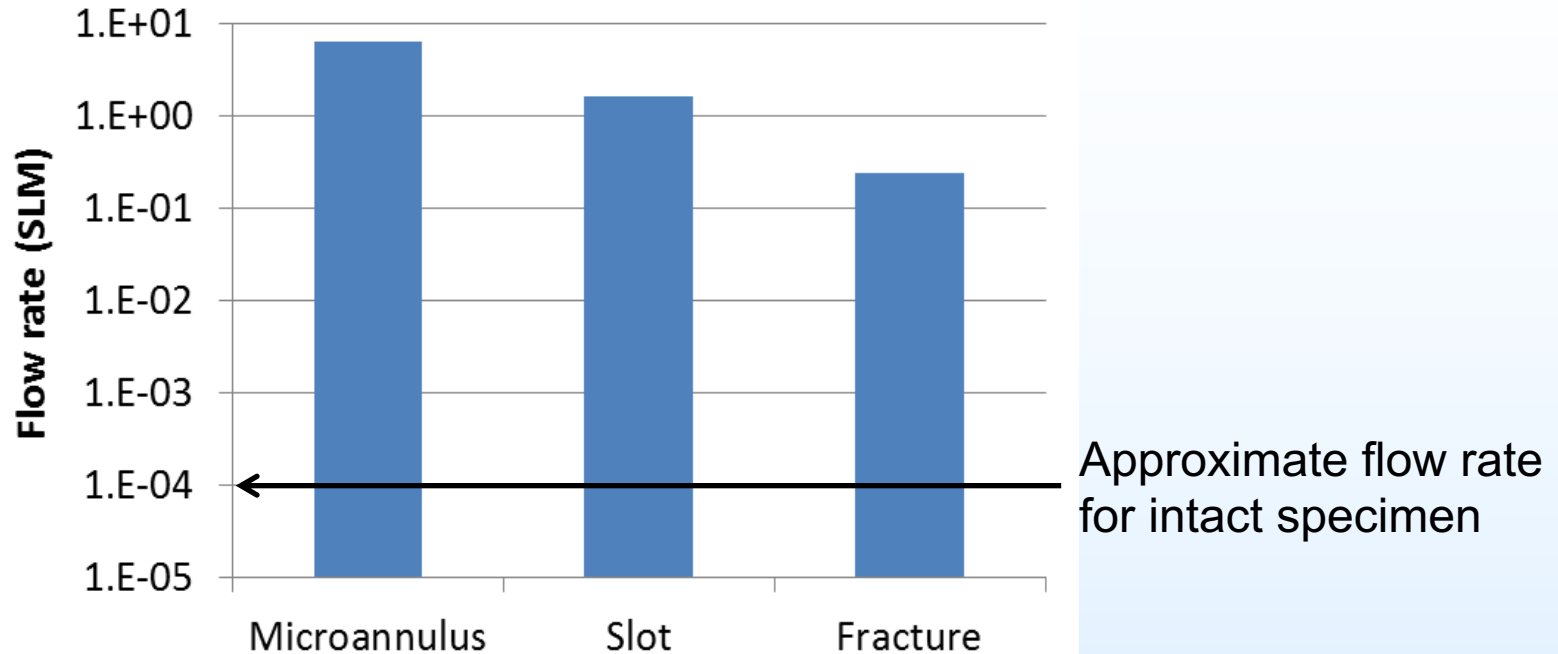
Flow dominated by flaws

Cubic law for hydraulic aperture

$$h^3 = \frac{12 k A}{w}$$

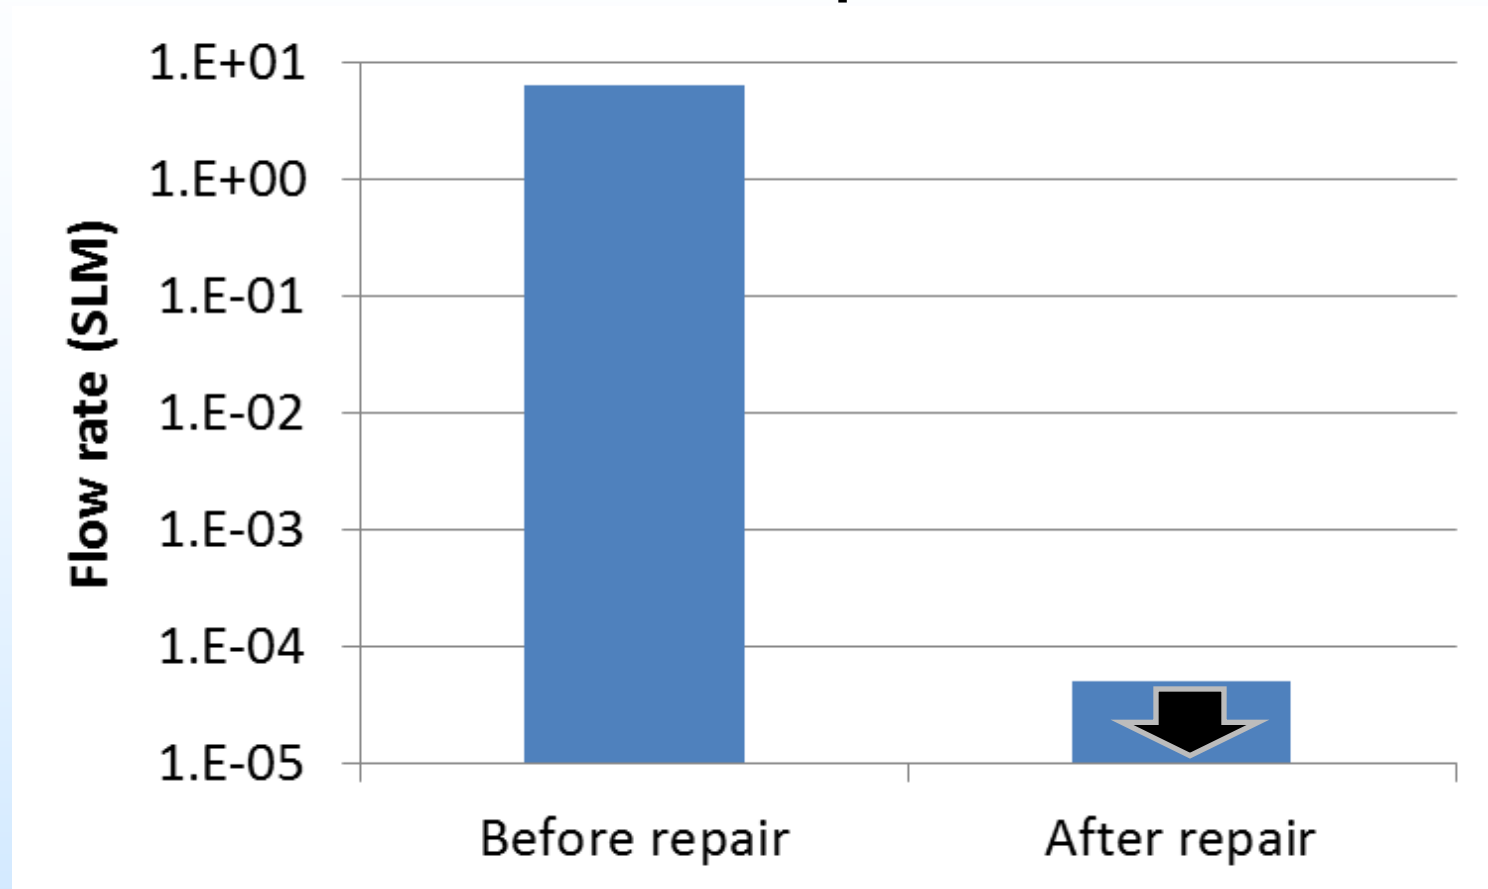
Microannulus repair using nanocomposite

Confining pressure = 200 psig
 Internal pressure = 200 psig
 Pore pressure = 100 psig
