Extreme Environment Materials

DOE FE0031562

Michael Gagliano
Electric Power Research Institute

DOE Crosscutting Research Program Portfolio
Review Meeting

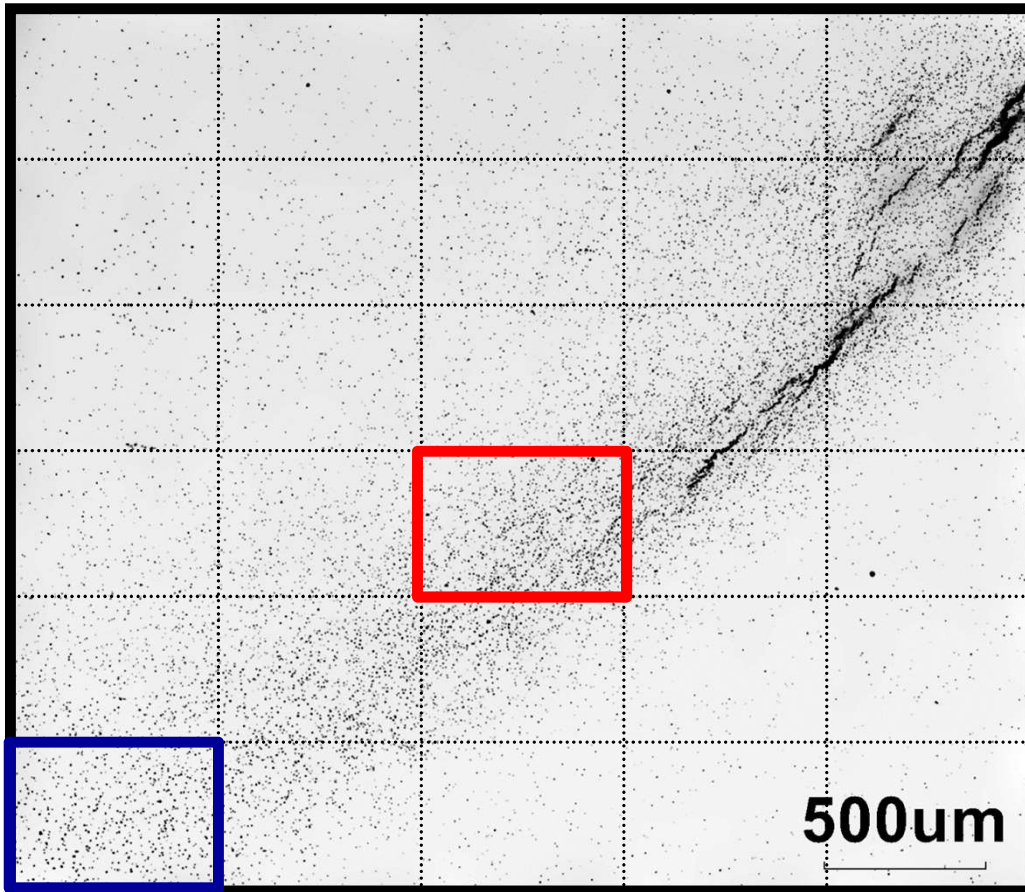
Evaluation of Damage (Stub to Header Weld - Rugeley Heat 1)

Compiled from 30 - 20X images

4,320 voids/mm²

2,528 voids/mm²

Observed damage is almost twice as extensive relative to typical behavior in 9%Cr steel uniaxial samples; e.g. this heat of Gr. 91 steel is particularly prone to damage when subject to triaxial stresses

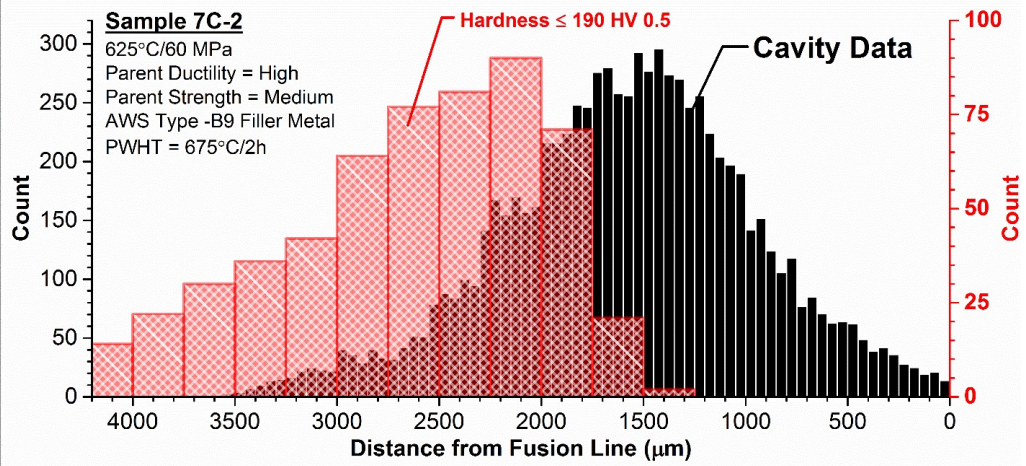
Combining Microhardness and Damage Distribution Plots

Distribution of hardness at welded joints

Combining hardness and damage distribution data to understand association of damage to hardness

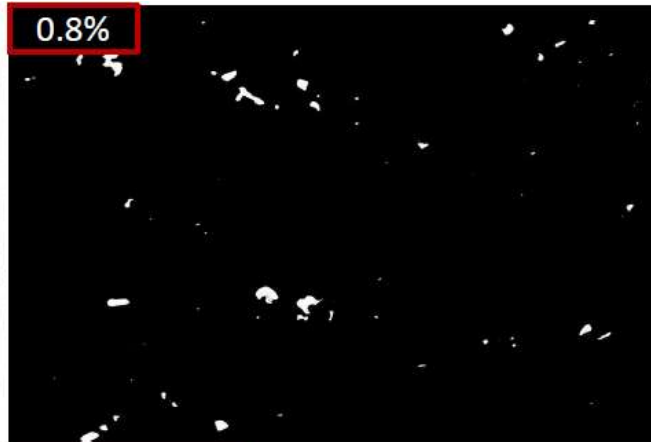
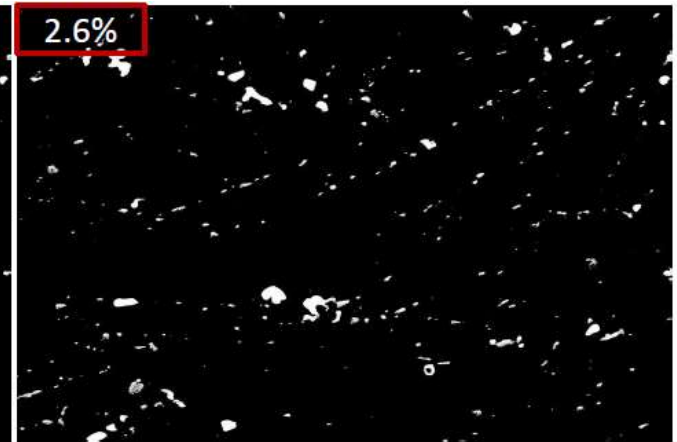
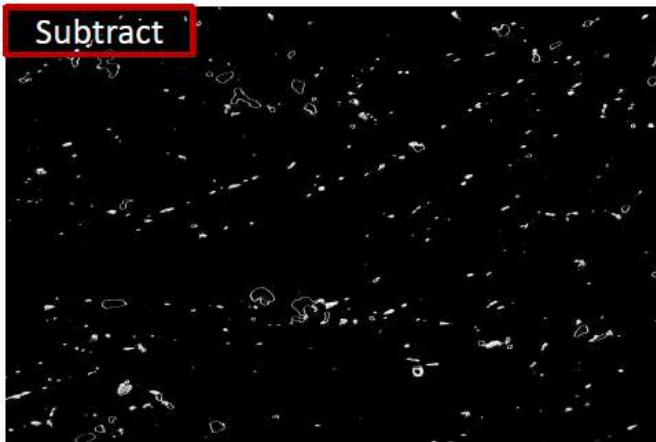
Quantification using Image J Analysis

Precipitates	Count	Total Area	%Area	Feret (um)
0.8	Laves	67	2.187	0.757	0.225±0.213
Subtract	M ₂₃ C ₆	328	2.607	0.903	0.135±0.095
