# Tidd Hot Gas Clean Up Program

## Final Report

October 1995

By  
Ohio Power Company  
Columbus, Ohio

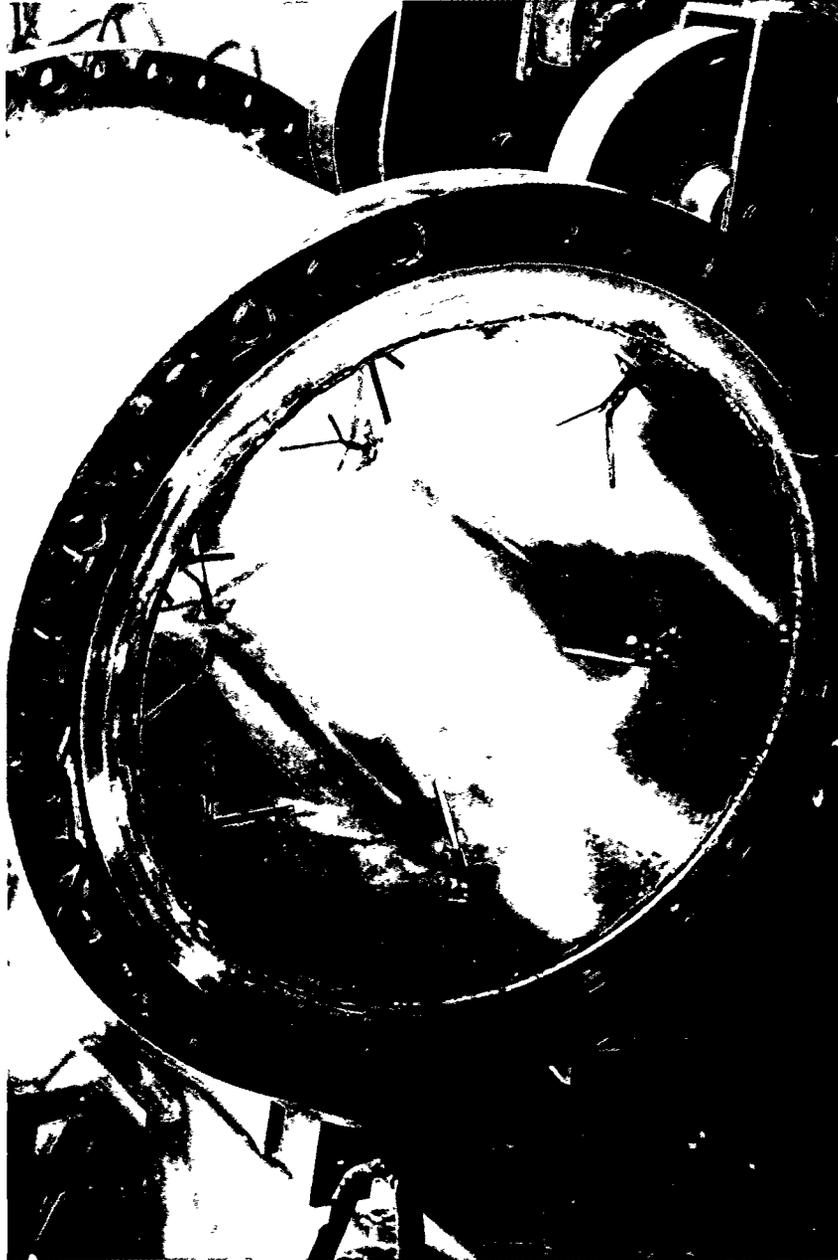
Figure 4.2.1 - Photograph of Hastelloy Liner in Hot Gas Pipe Spool

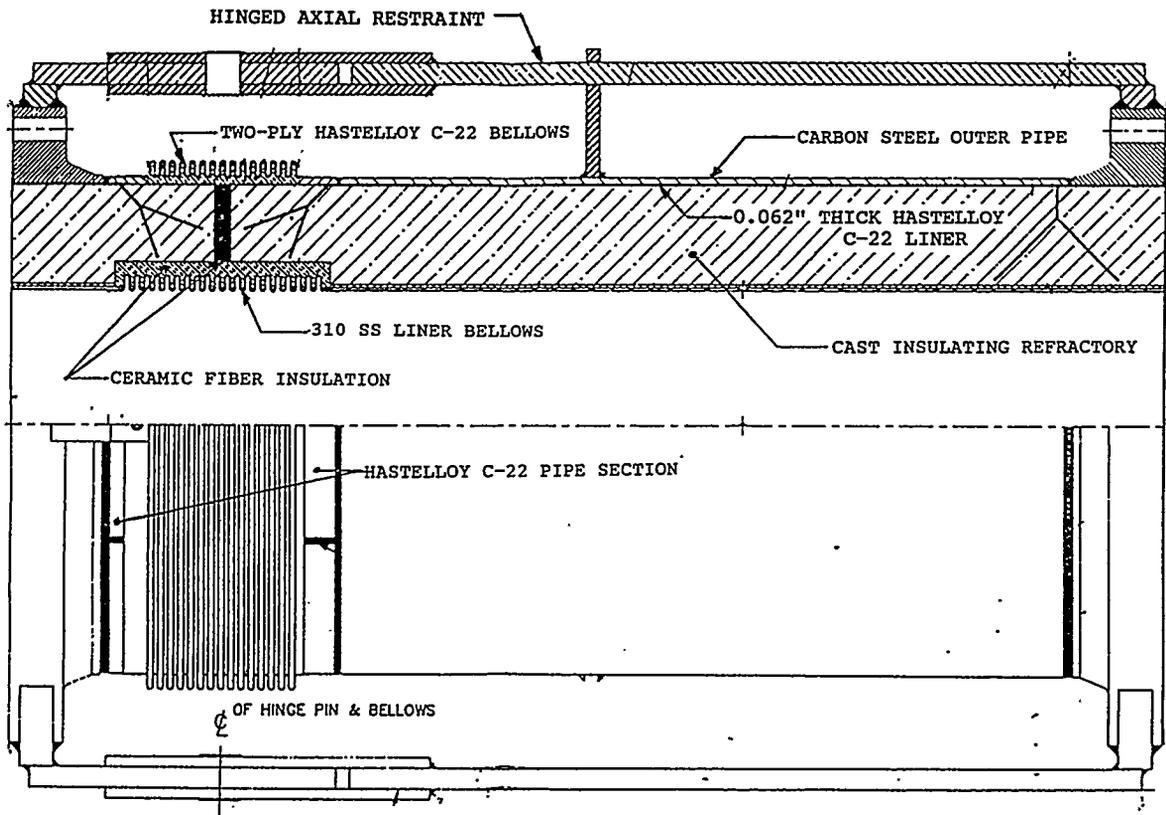
Figure 4.2.2 - Typical Expansion Joint After Modifications

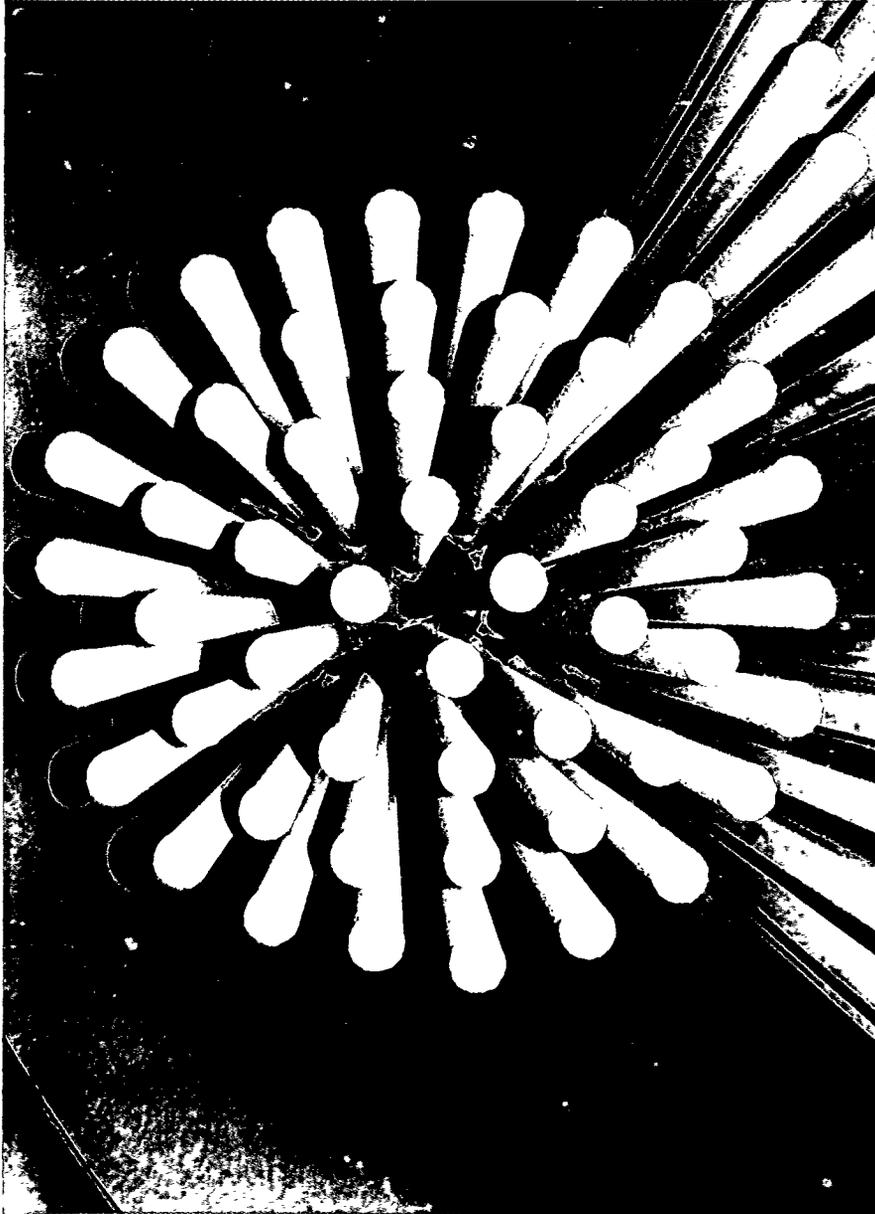
Figure 4.3.1 - Photograph of Bottom Filter Candles Following Test Run 1

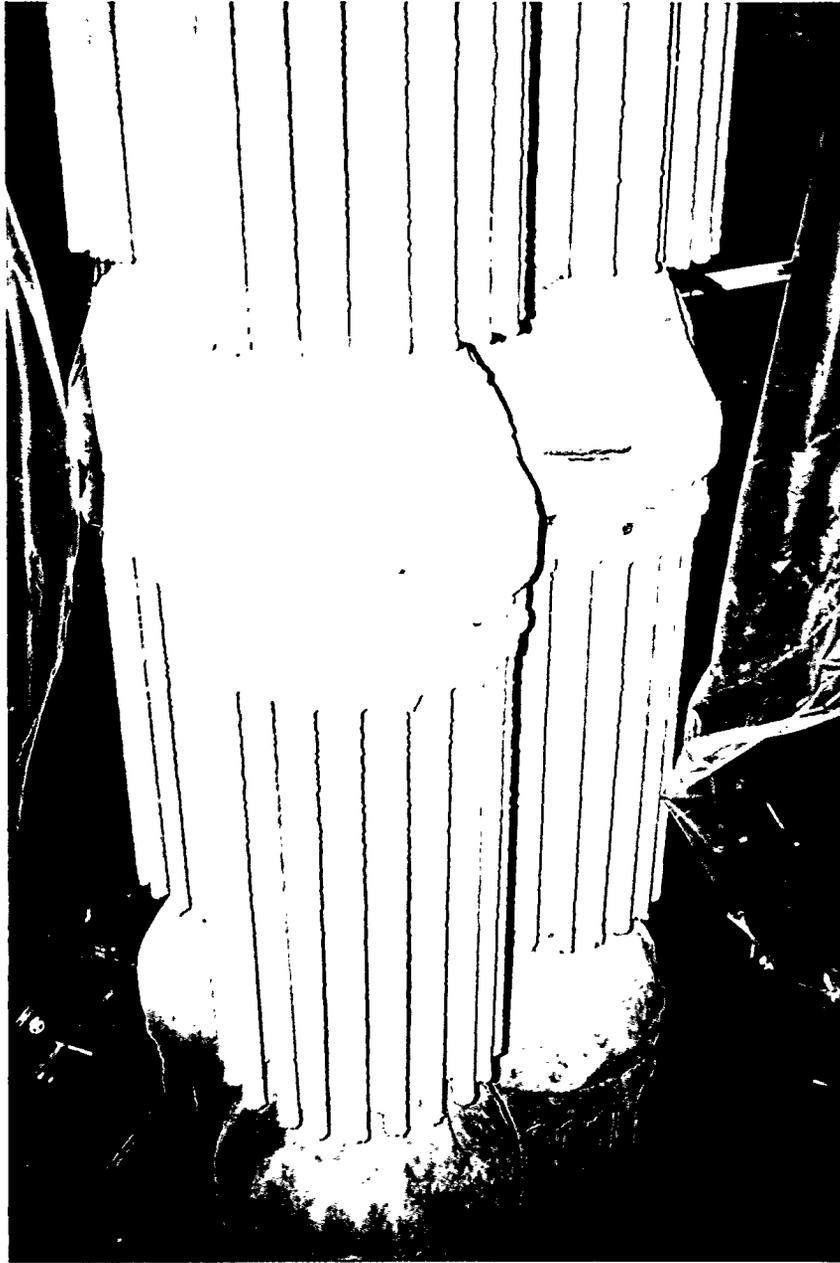
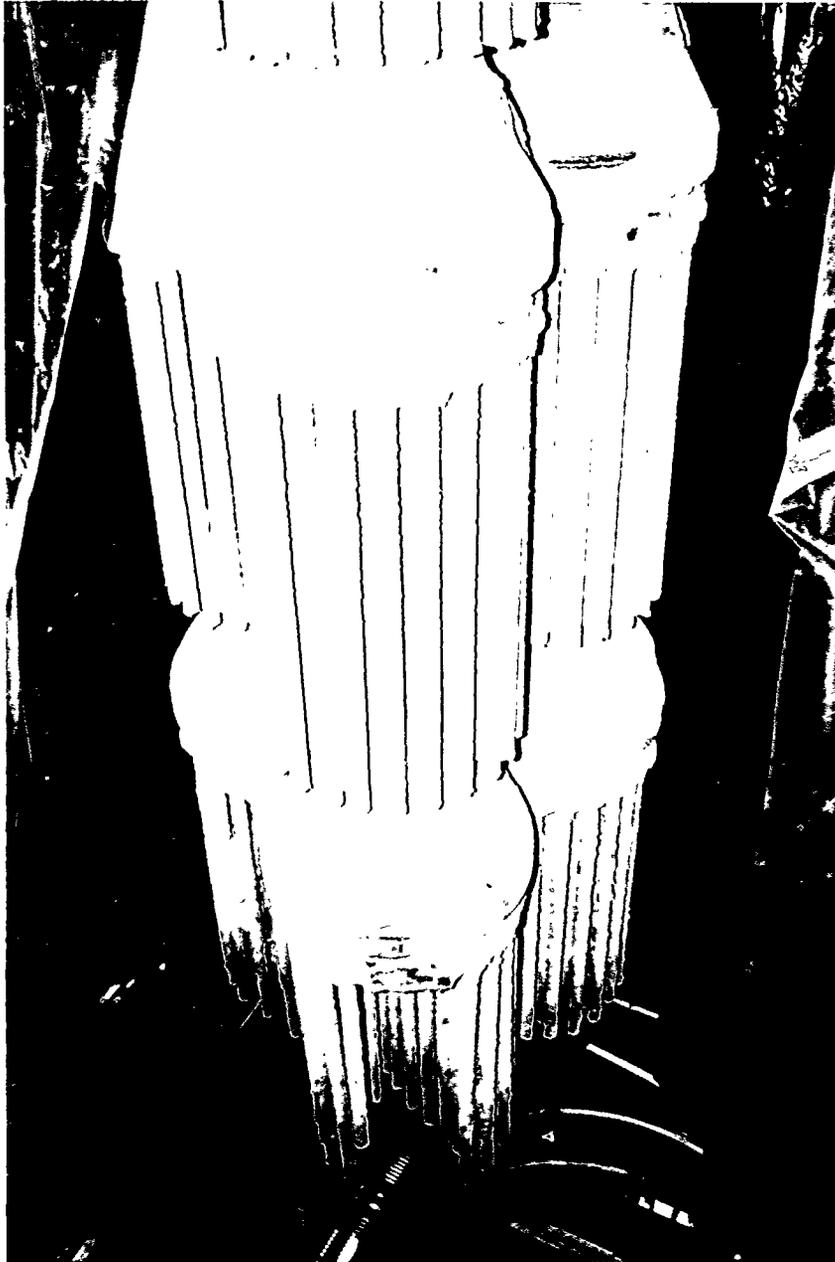
**Figure 4.3.2 - Photograph of Filter Internals Following Test Run 4**

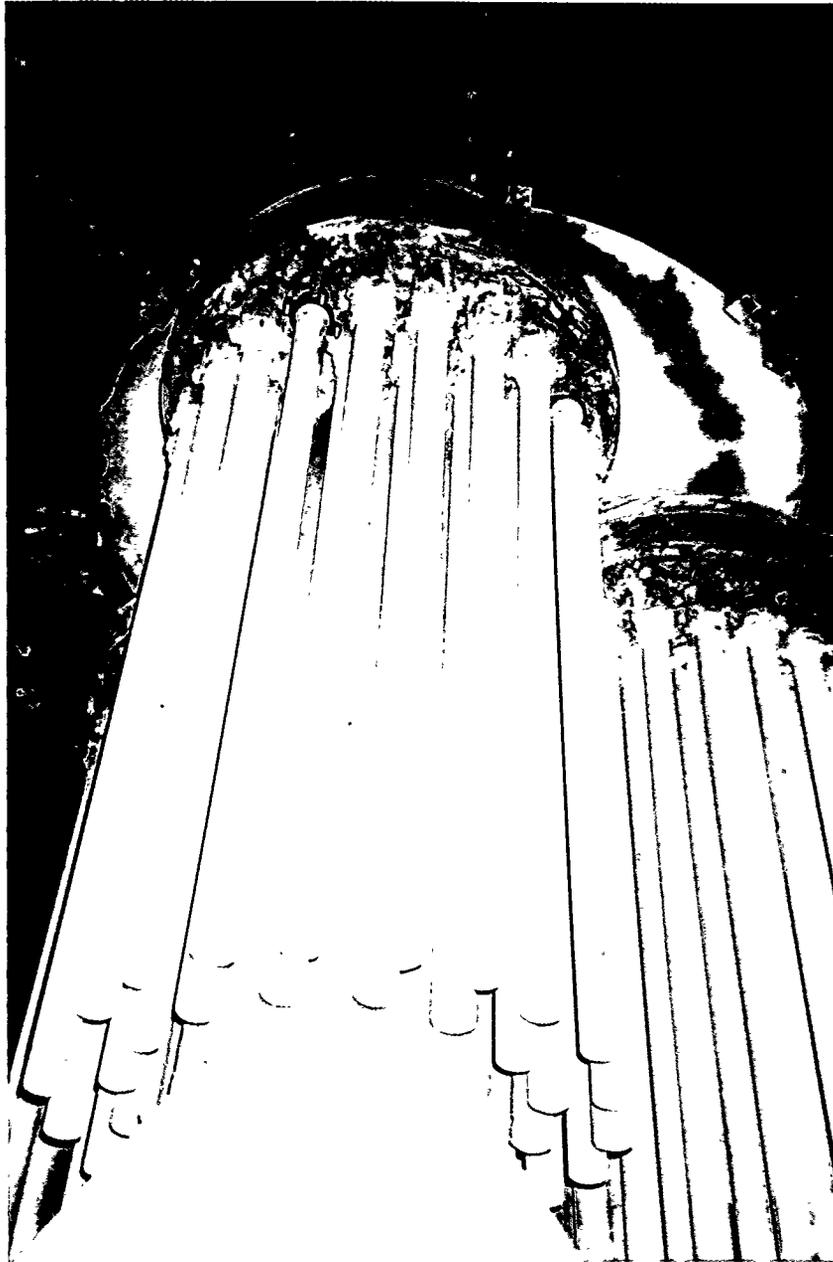
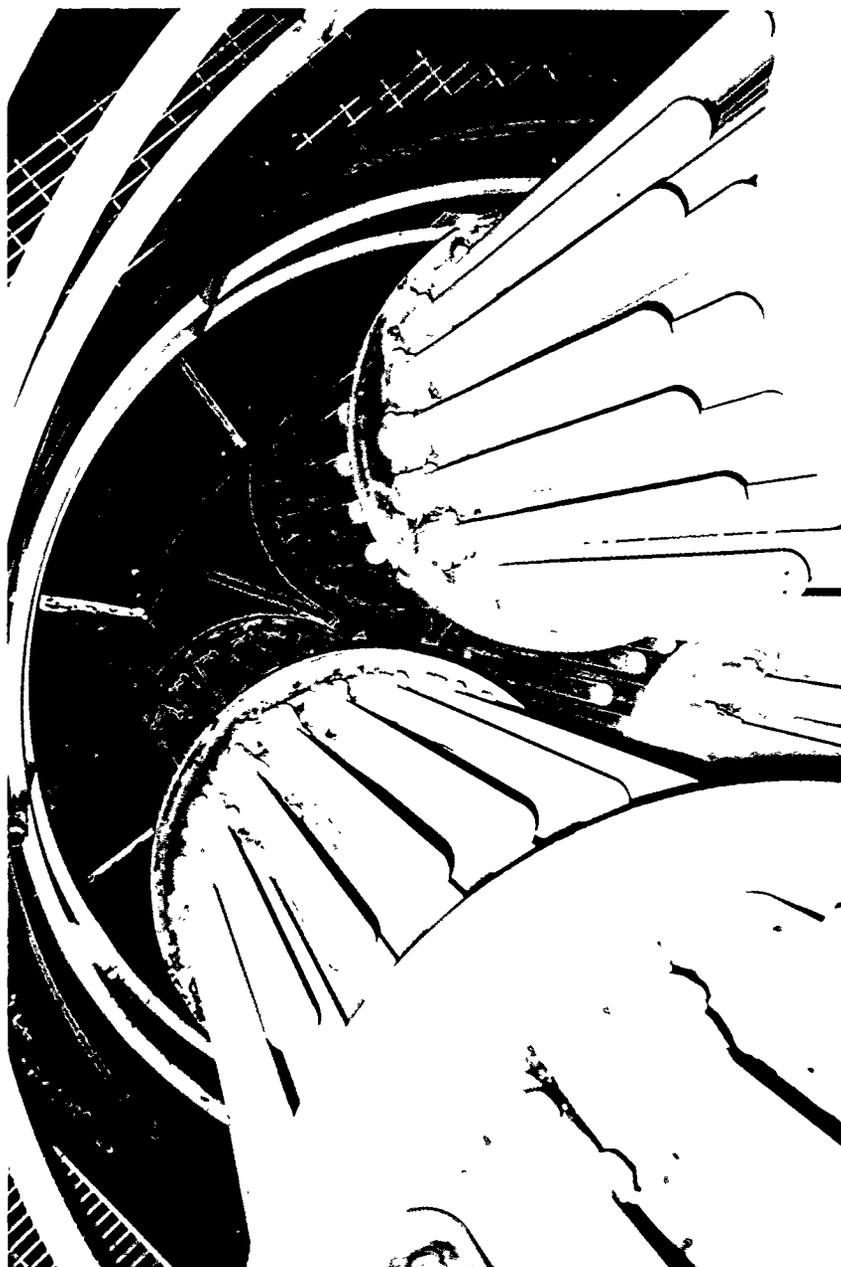
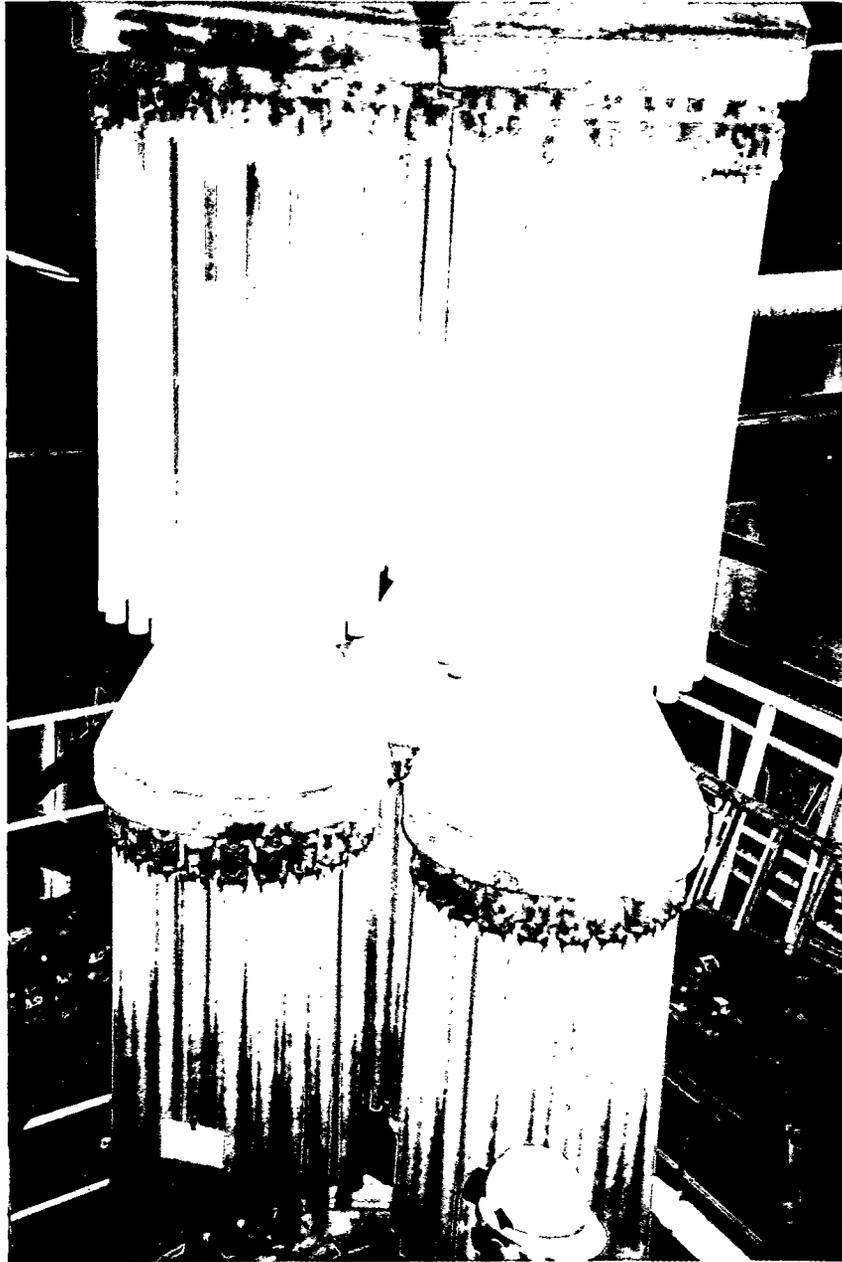
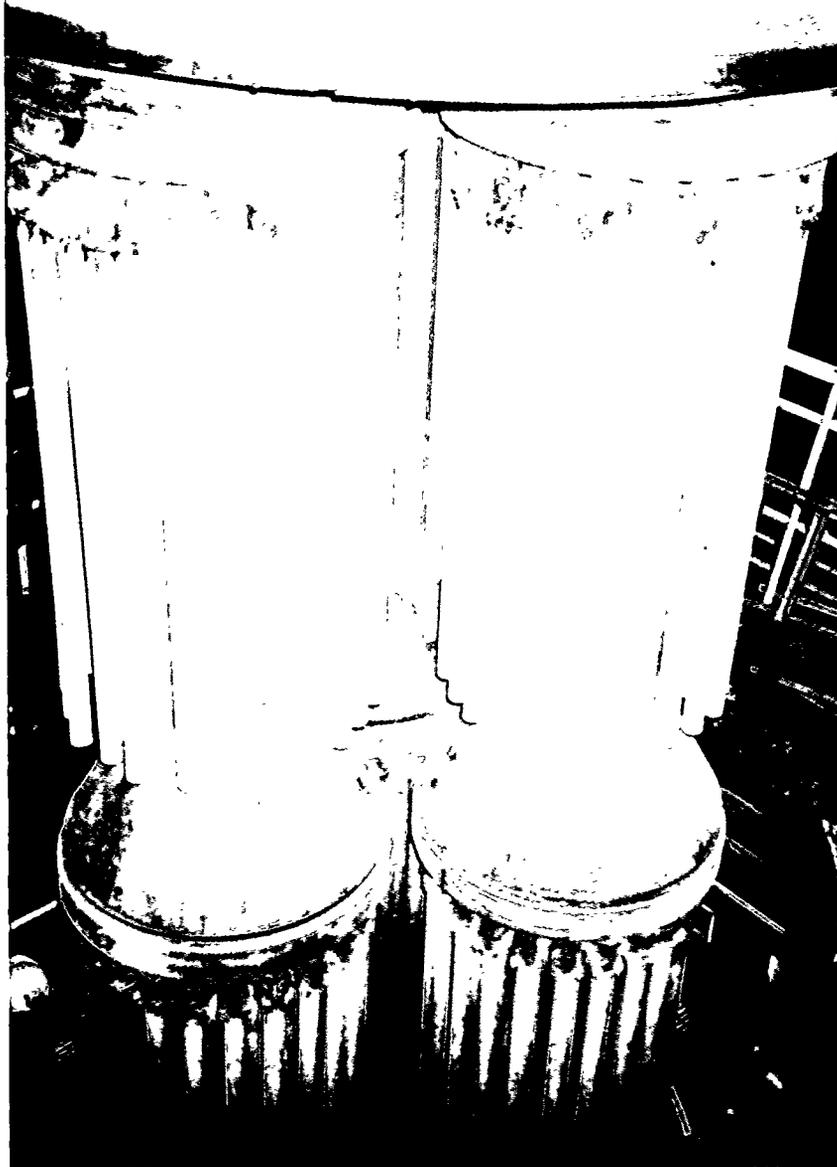
**Figure 4.3.12 - Photograph of Filter Internals Before Test Period II**

Prior to the resumption of testing, all of the filter candles in the bottom plenums were replaced and all of the ash accumulation on the filter candles and metal surfaces in the upper and middle plenums was removed, as shown in Figures 4.3.12 through 4.3.15.

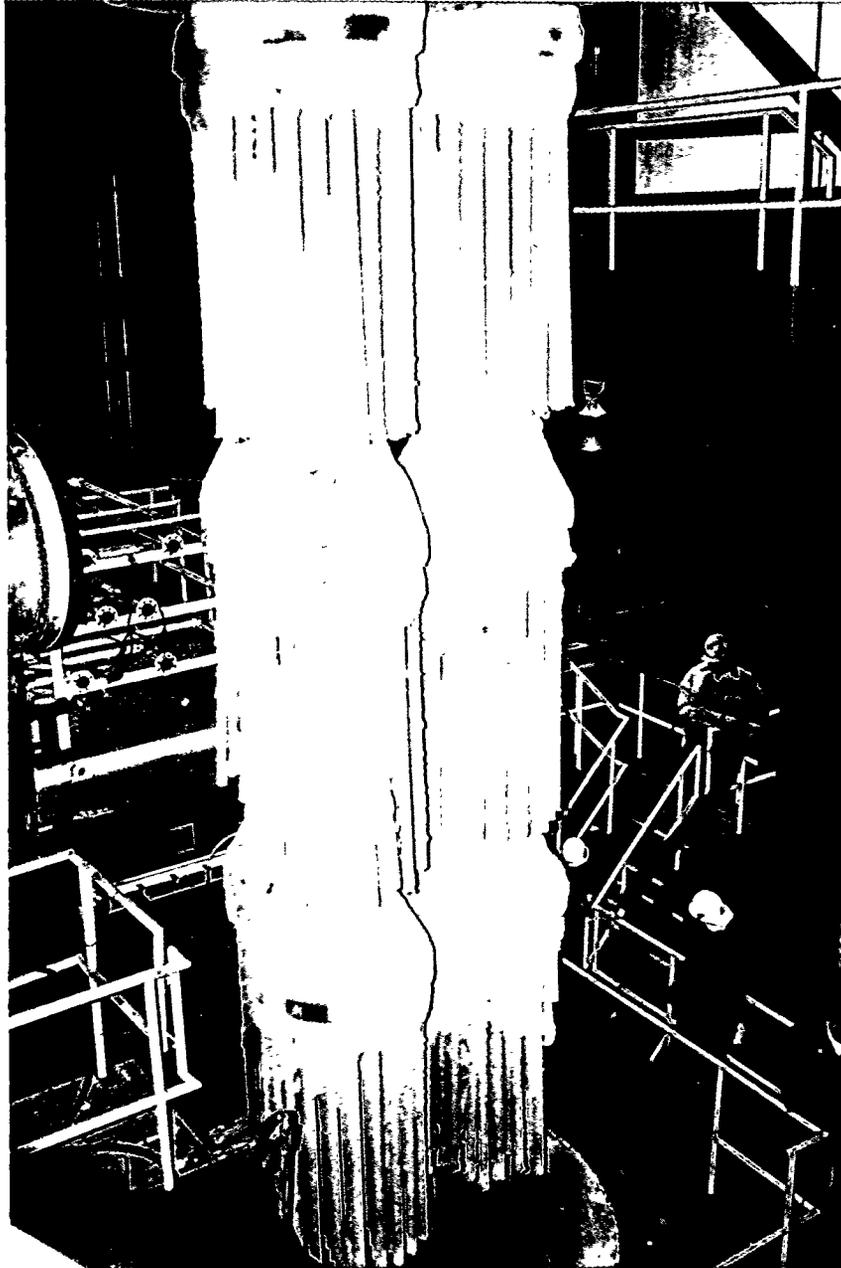
**Figure 4.4.6 - Photograph of Filter Internals Following Test Run 11**

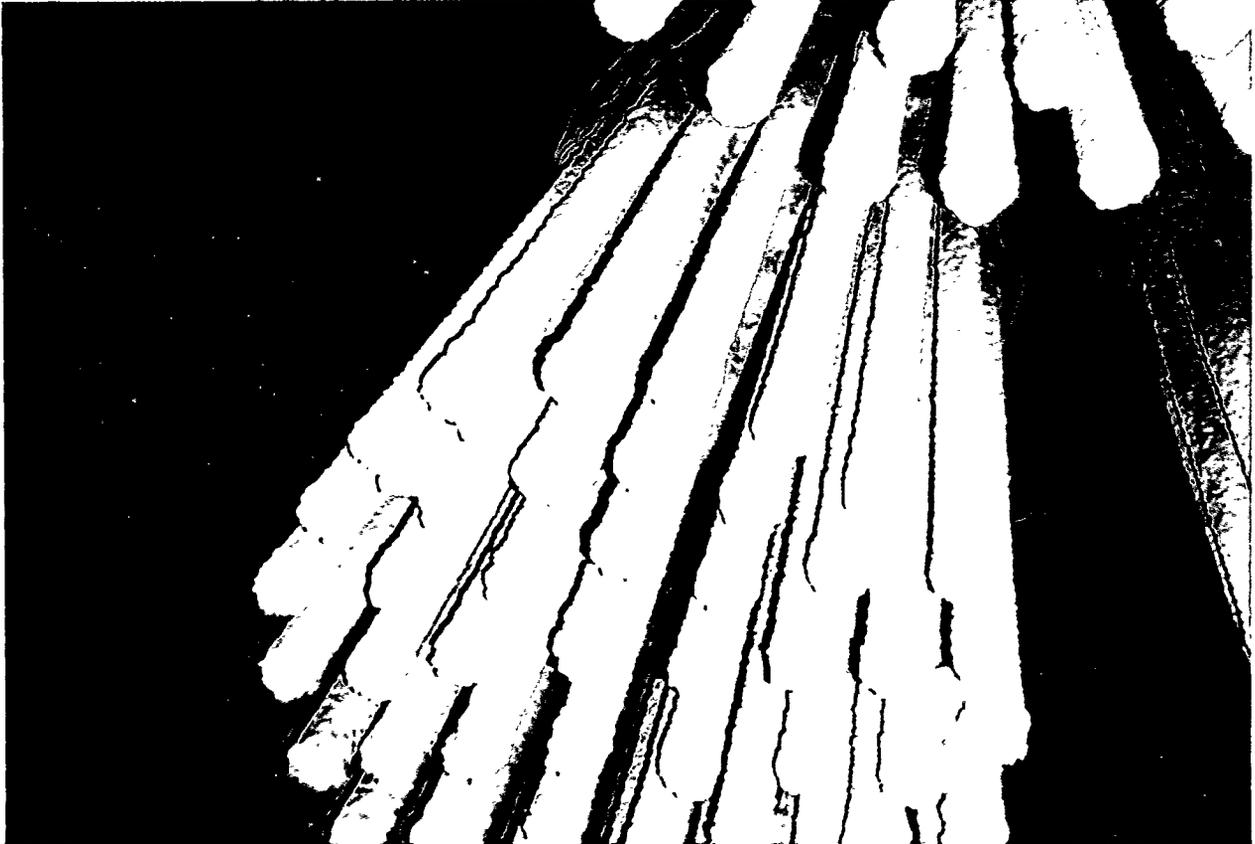
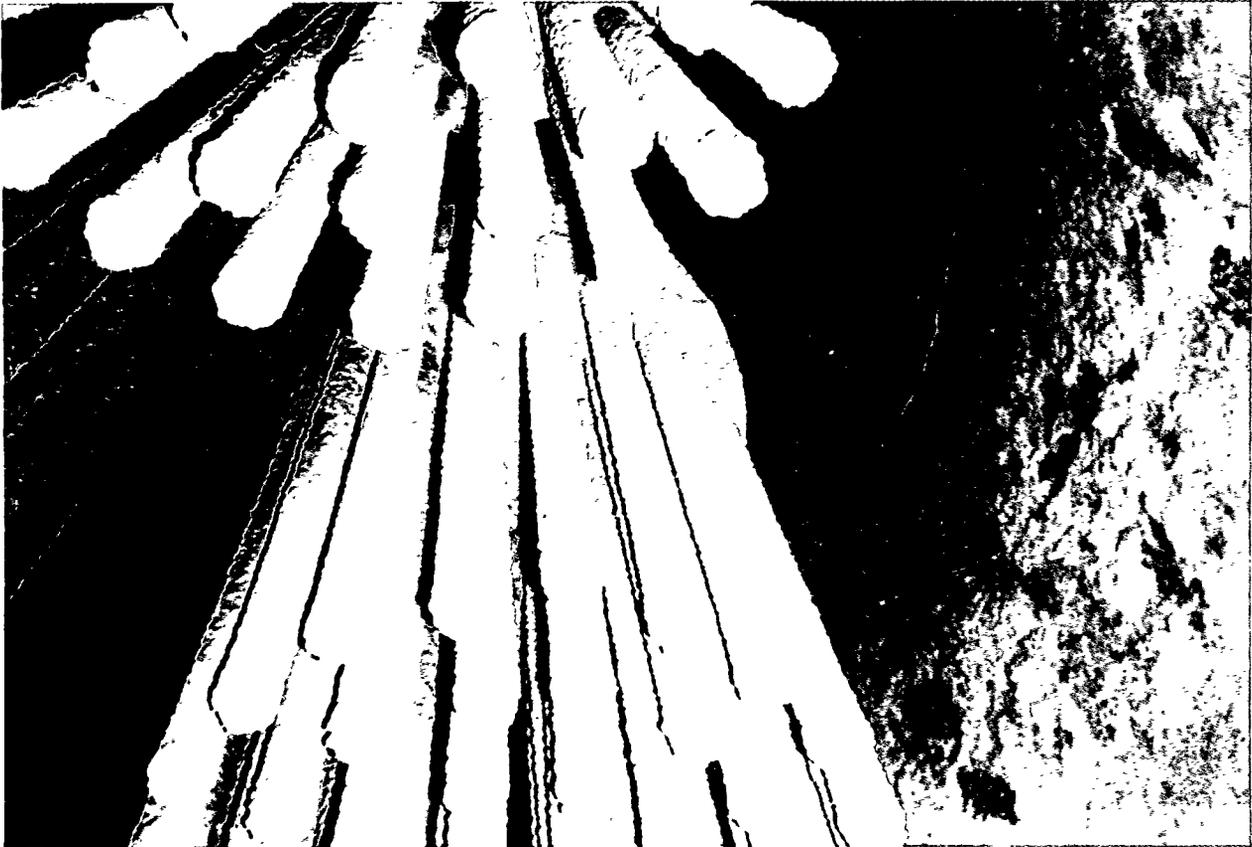
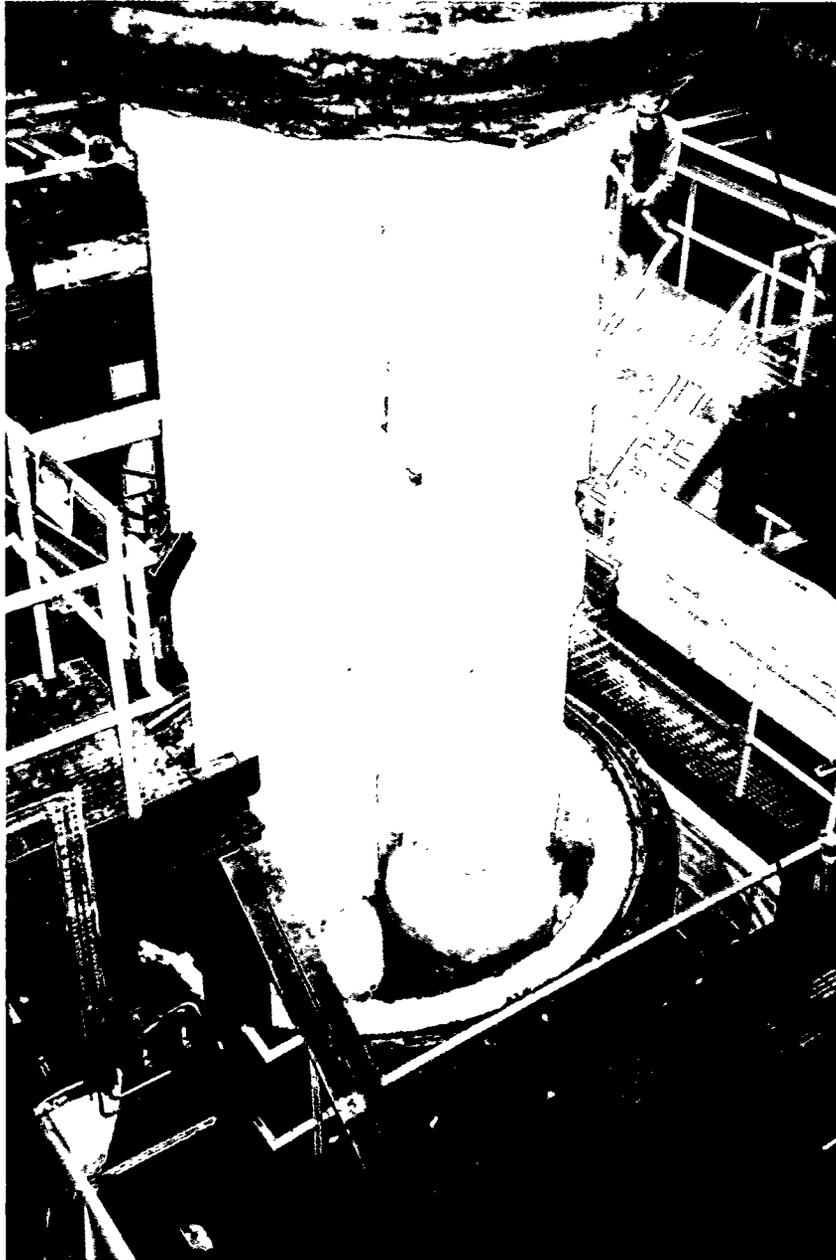
The APF internals were inspected via the instrument ports after this run. The filter candles had a thin layer (about 1/8") of residual ash, however broken candles were observed during this inspection. The filter internals were removed from the APF vessel on 5/5/94 and a more detailed inspection was performed. A total of 28 broken candles were found at the following locations:

The two breaks in the bottom plenum are believed to have occurred during removal of the filter internals from the filter housing. Very heavy ash bridging was observed between the inner rows of candles and the support pipe on the top and middle plenums. Figures 4.5.10 through 4.5.18 are photographs of the candle clusters following Test Period III. The ash build-up extended over the entire length of the inner candles. In some cases the ash bridging extended into the outer rows of candles. Many of the inner candles were bowed outward and in some cases almost contacted the candles in the outer row. All of the candle breaks except one appeared to be fresh breaks judging from the clean fracture surfaces. All of the breaks occurred at the top of the candle just below the candle holder. The breaks appeared to result from bending forces from ash bridging from the inner candles to the outer candles. Only one break was in an inner row; the remainder were in outer rows.

The outlet side of the filter was very clean with virtually no ash deposits. This is further indication that the failures occurred during or after plant shutdown, and that the filter was not leaking ash to the clean side during operation.

**Figure 4.5.10 - Photograph of Filter Internals Following Test Run 18**

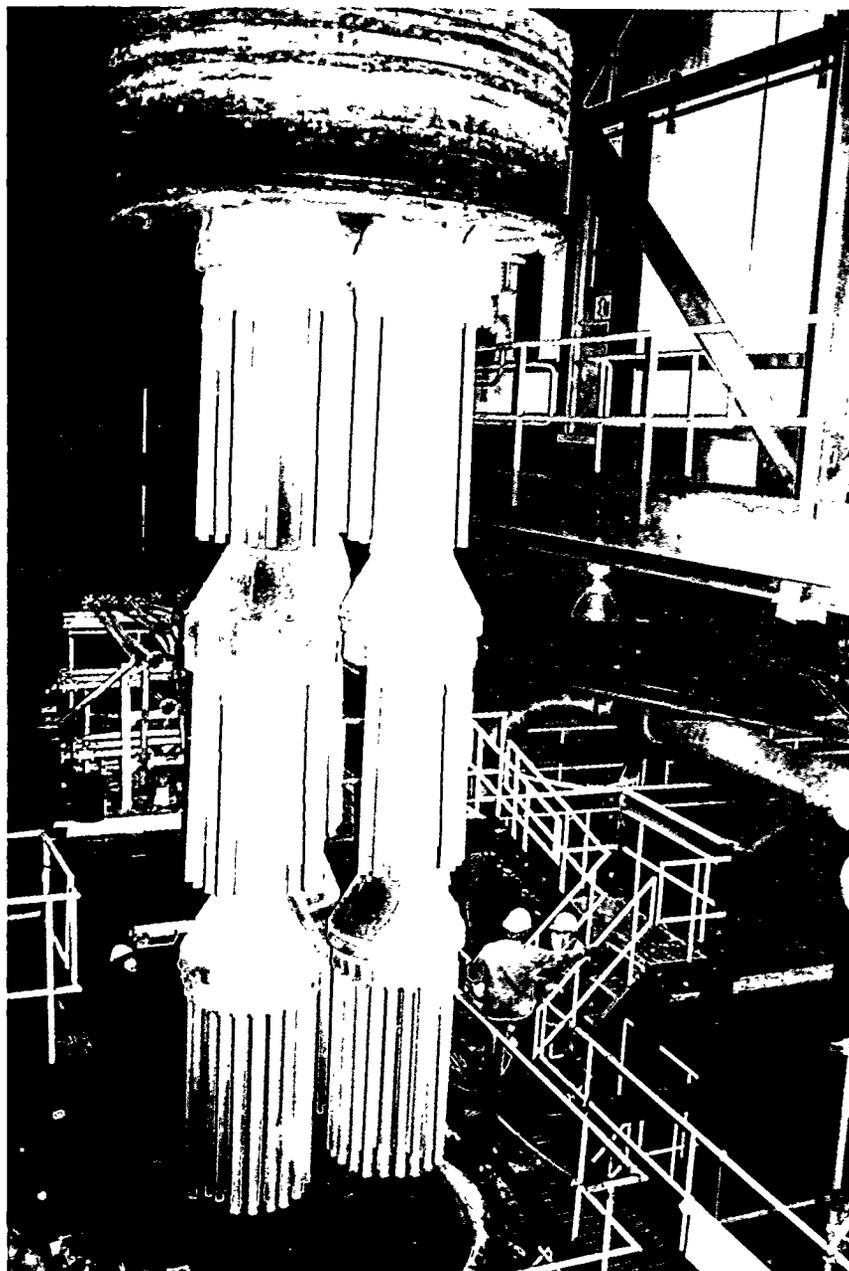
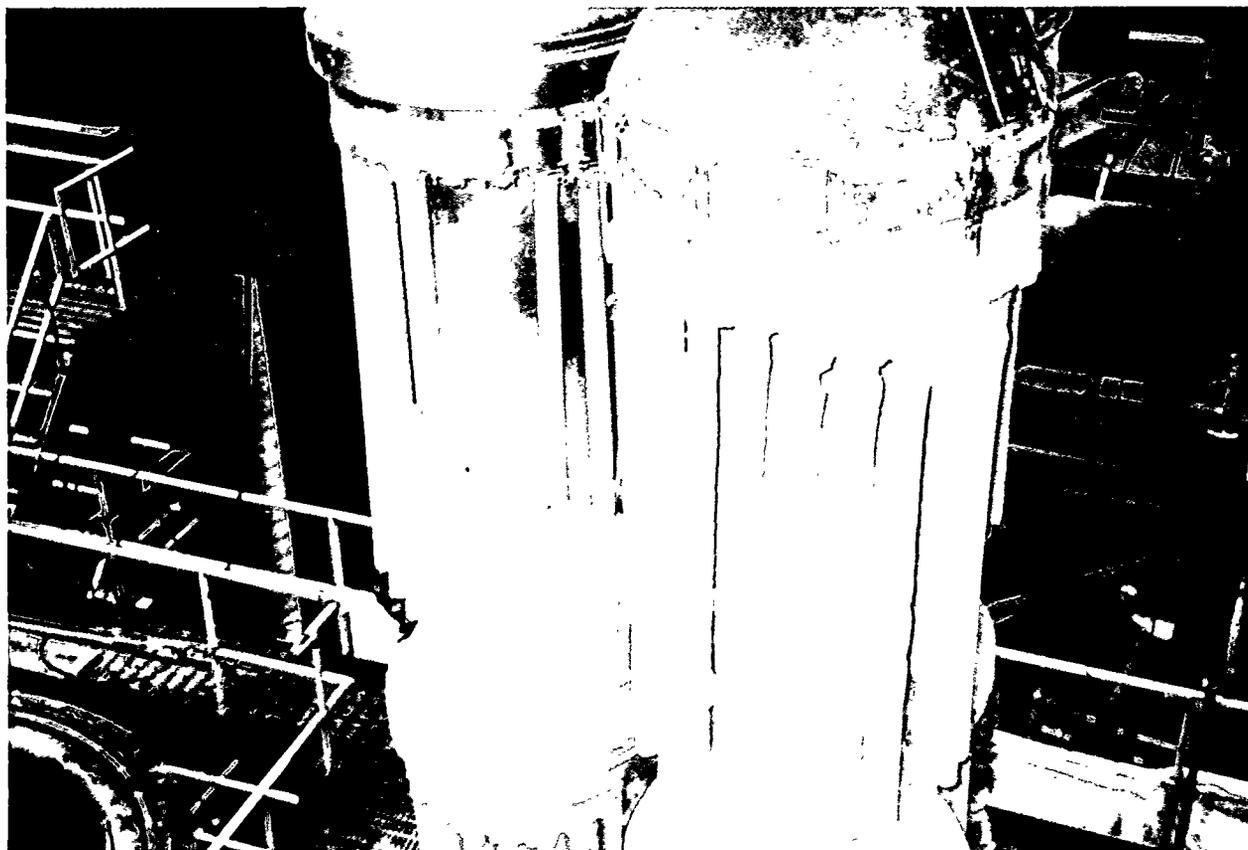
On 10/27/94 the APF internals were removed from the vessel for inspection and candle replacement. A total of 30 candles were observed to be broken, as listed below.

Ten of the 30 breaks had clean fracture surfaces indicating that the breaks occurred after shutdown or during removal from the vessel. Heavy ash bridging was apparent near the bottoms of candles in clusters B Top and B Middle, while light to moderate ash bridging was seen in clusters C Top, A Bottom, and B Bottom. Figure 4.6.8 through 4.6.16 are photos of the candle clusters following Test Period IV. It was evident that the ash accumulation that occurred during the first 600 hours of this run was not removed during the last 90 hours of operation with the cyclone spoiled.

**Figure 4.6.8 - Photograph of Filter Internals Following Test Run 24**

All of the filter candles in the APF were replaced between Test Periods IV and V. In order to broaden the base of candle filter material testing, the filter was fitted with a combination of silicon carbide, alumina mullite, and two other second generation materials, namely, Dupont PRD66 and 3M CVI-SiC. Figure 4.6.18 shows the location of the various candle materials as installed for the last test period. The inner rows of candles in the upper and middle plenums were left out, the same as in the prior test series. Figures 4.6.19 and 4.6.20 are photos of the candle clusters showing the different candle materials installed prior to the start of Test Period V.

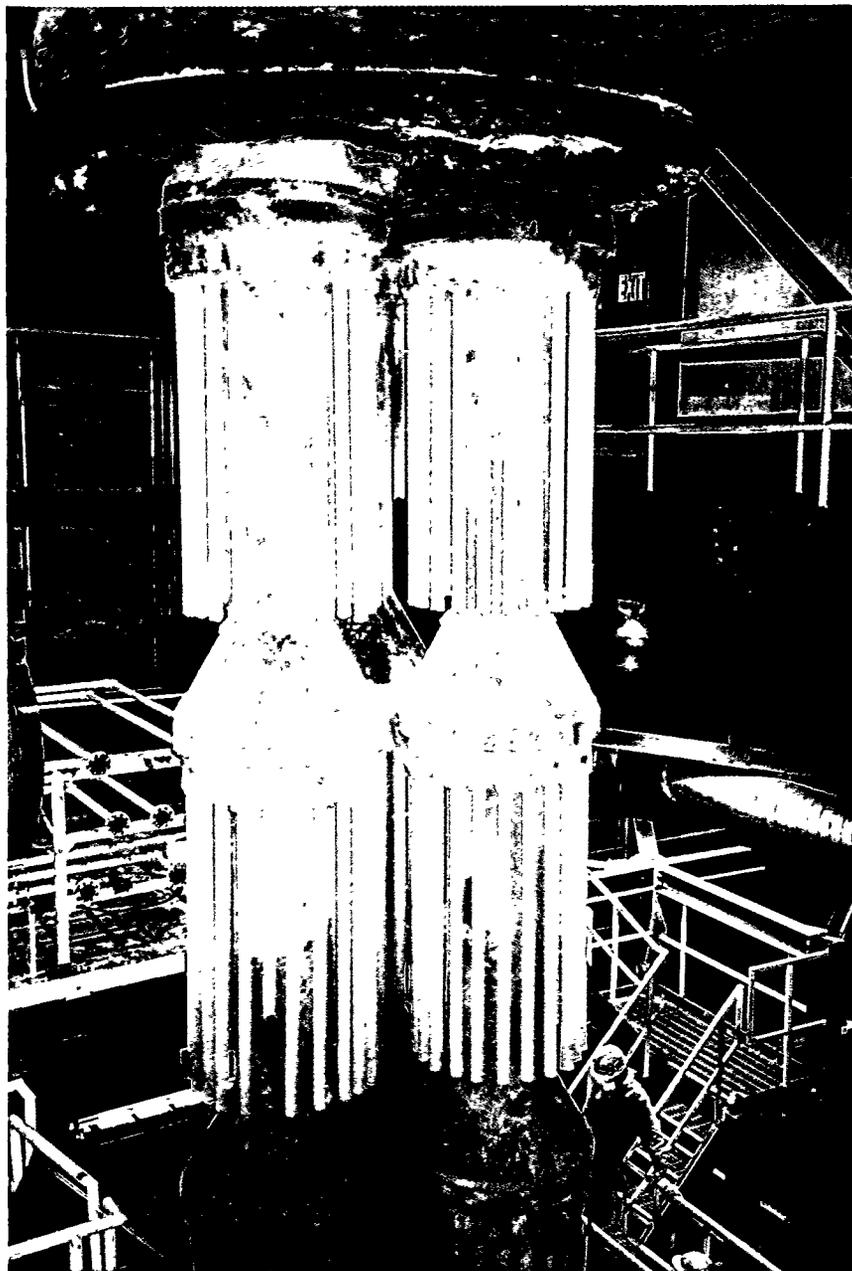
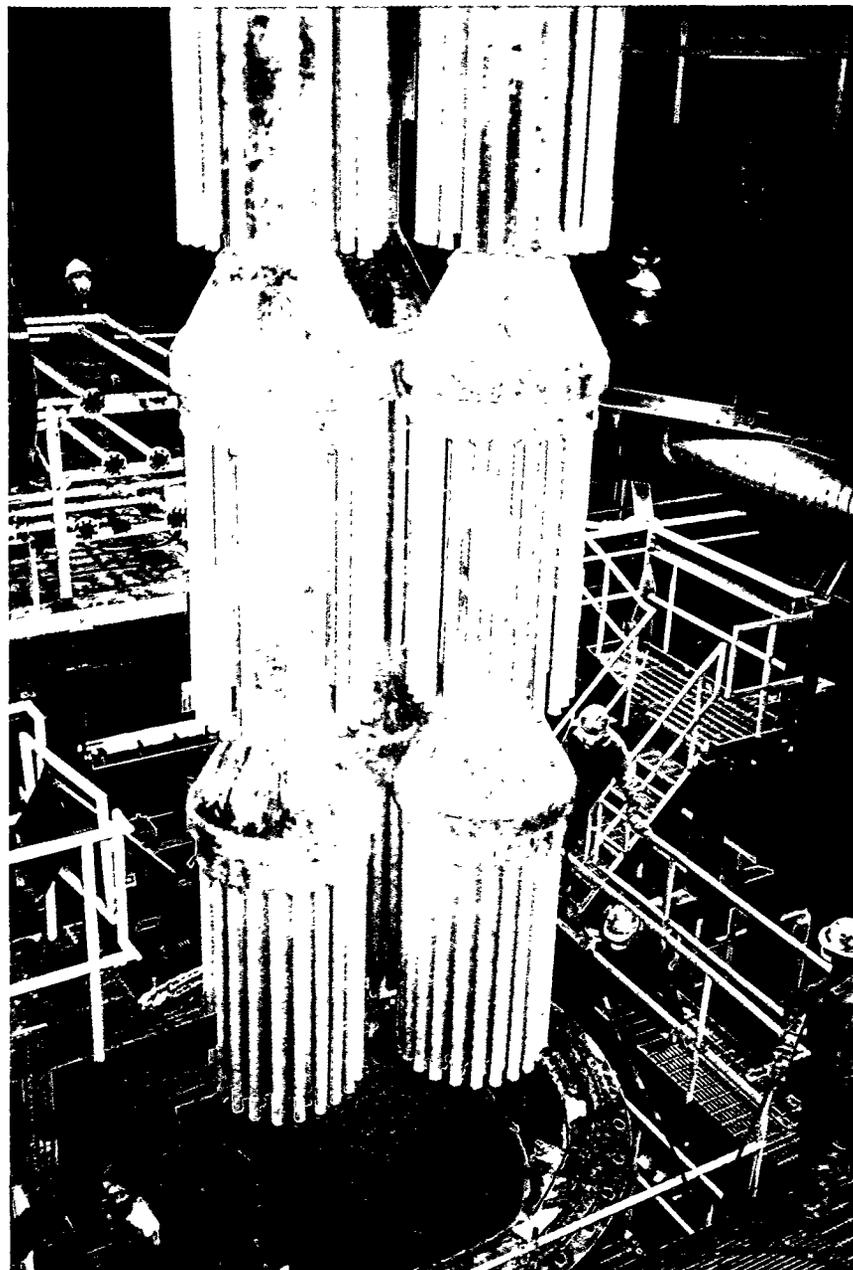
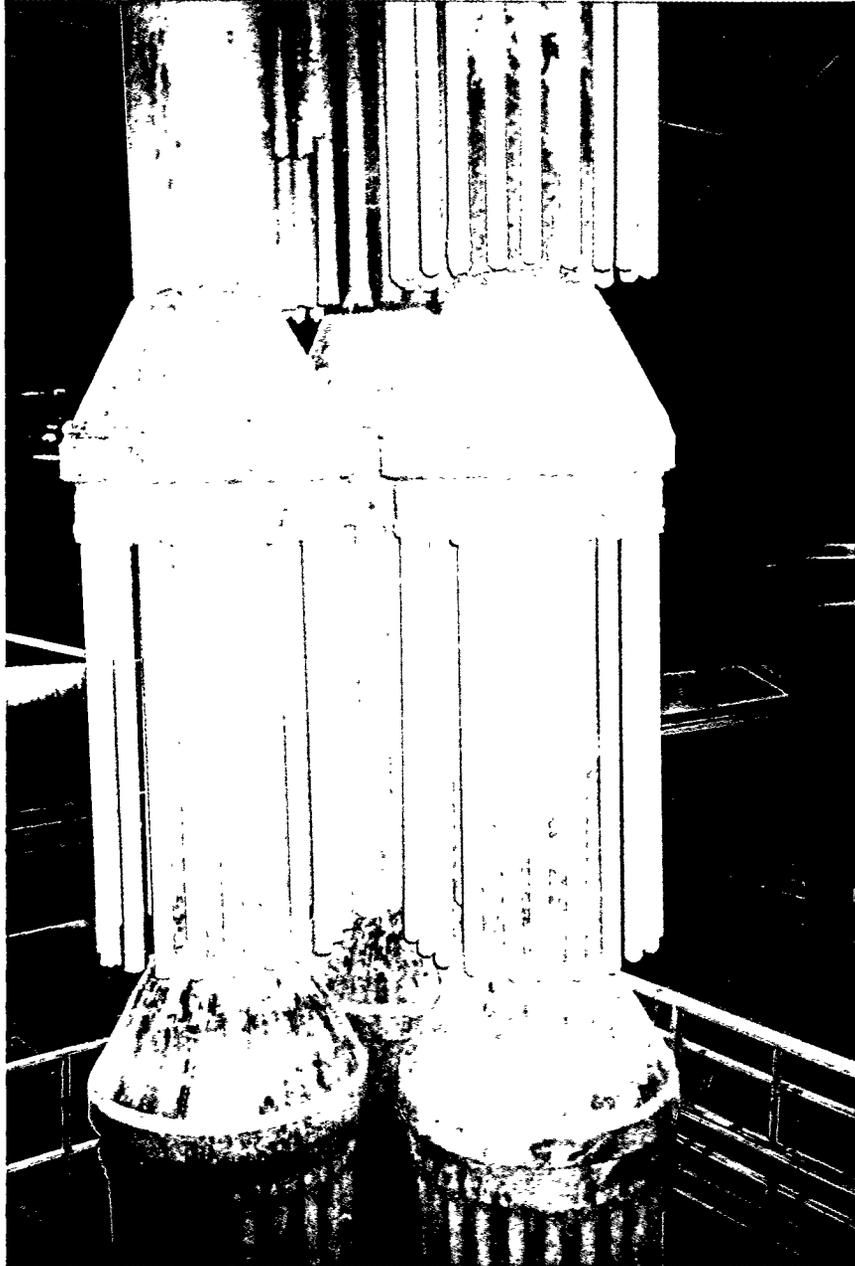
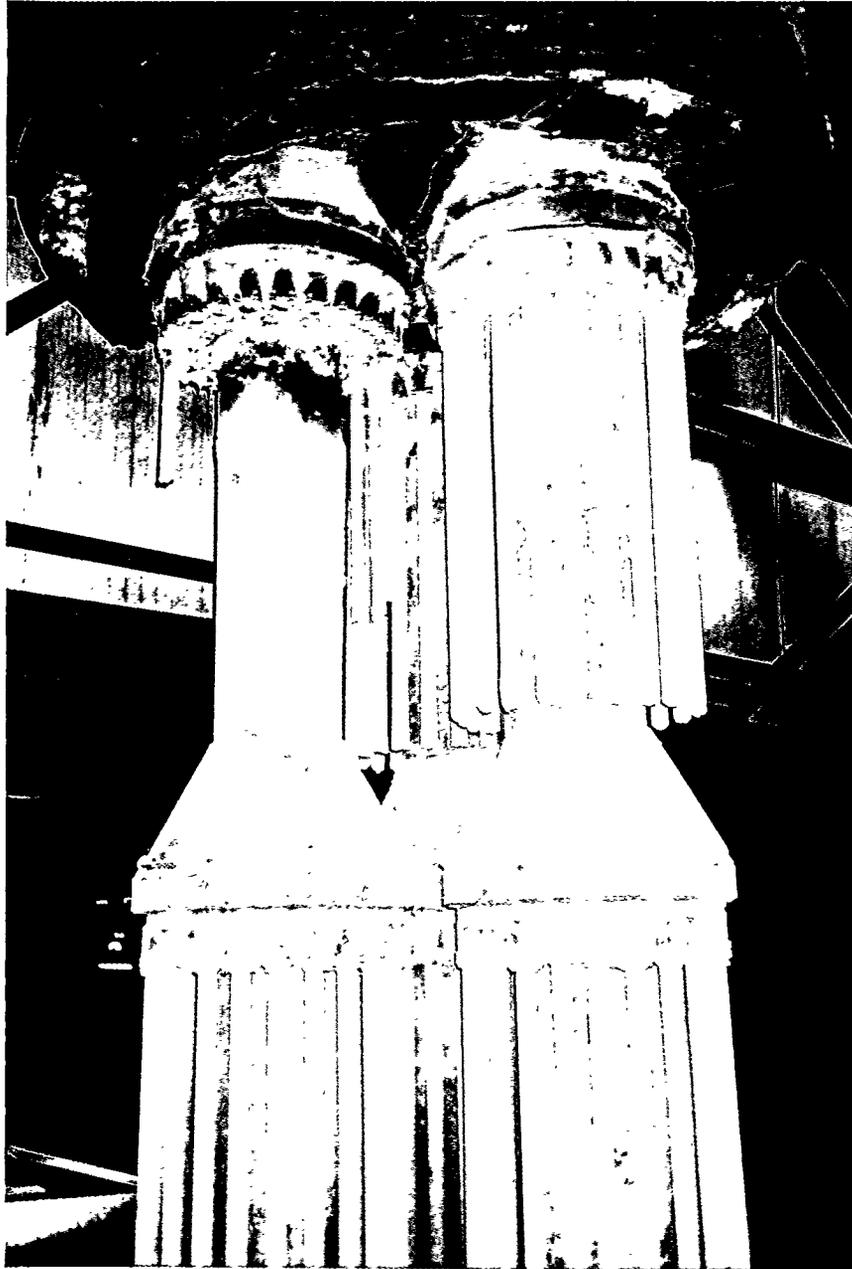
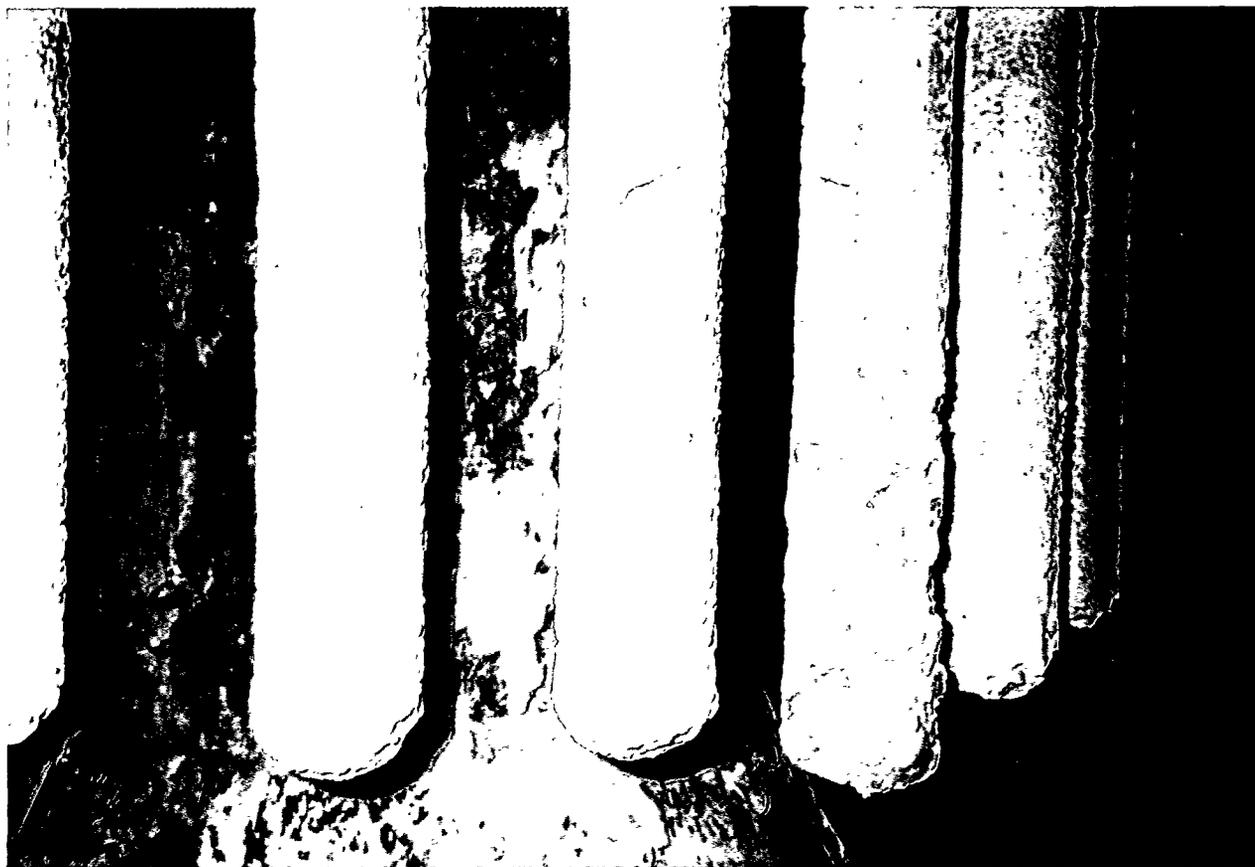
On 5/11 the APF internals were removed from the filter vessel. Figures 4.7.10 through 4.7.18 are photographs of the filter internals after removal. As observed by the boroscopic inspection, 20 of 22 of the Dupont PRD66 candles were broken, all in plenum B Top. In addition, two Coors alumina-mullite candles were broken (rather than one), one near the top in plenum A Top and the other about 2/3 down from the top in plenum A Middle. No ash bridging was seen. The residual ash cake layer thickness on the candles ranged from about 1/8" on the Coors alumina-mullite candles to about 3/8" on the Vitropore silicon carbide candles. During removal, cracks were seen in two candles (Figure 4.7.18), one alumina-mullite the other an original Schumacher silicon carbide surveillance candle. Both candles broke during removal and handling. Hard ash deposits were found in the bottom 6 to 12 inches of these cracked candles. In addition, a 3M candle was found to be cracked near the bottom after it was removed. No indication of an ash leak path was seen at the gasket area of any of these candles, but it appeared that ash accumulated in the bottom portion of these candles which resulted in cracking of the candles.

**Figure 4.7.10 - Photograph of Filter Internals Following Test Run 34**
