# Tidd Hot Gas Clean Up Program

## Final Report

October 1995

By  
Ohio Power Company  
Columbus, Ohio

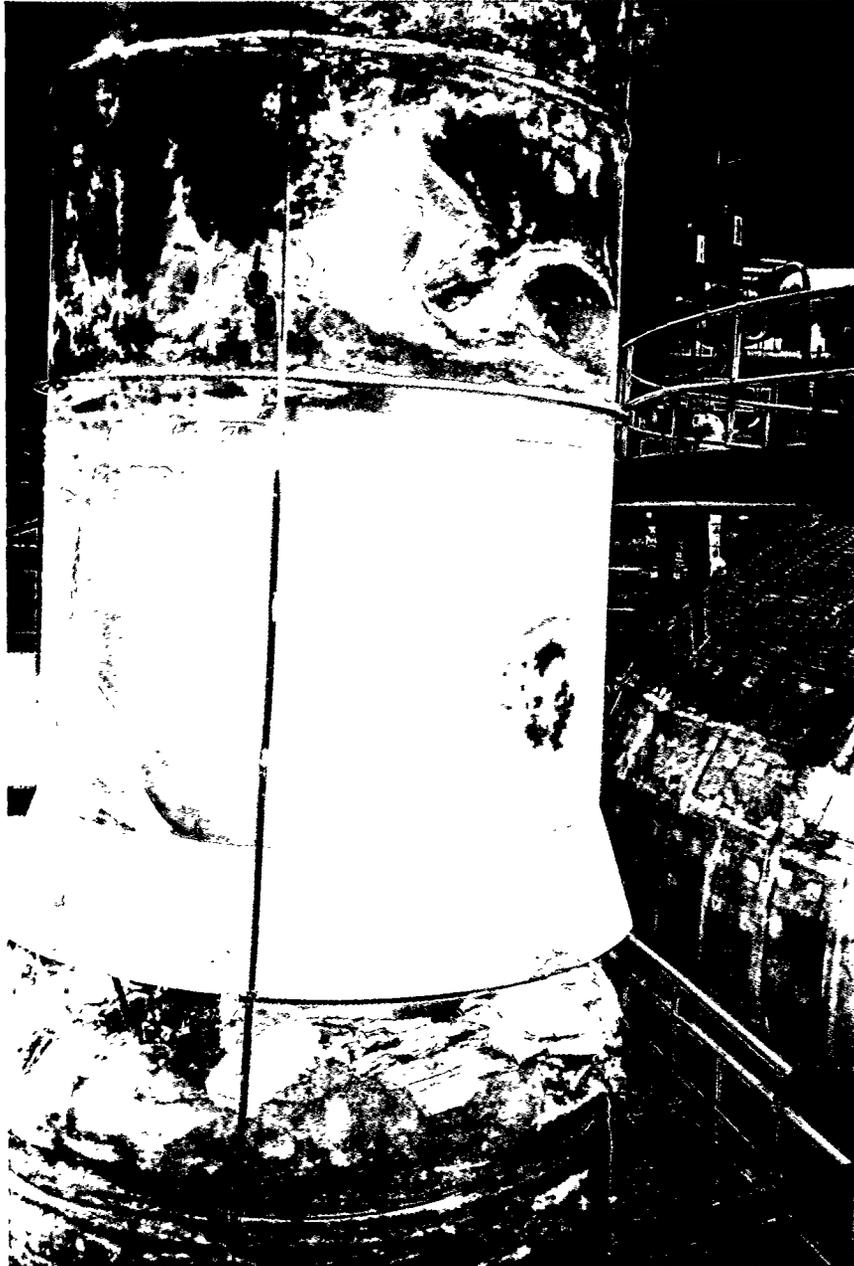
The shroud was removed from the vessel for inspection. It appeared to be in generally good condition as shown in Figure 4.8.2. No erosion was seen on the impingement plate opposite the inlet nozzle. This was of concern after the ash loading and particle size were increased during the last test period. The ash tended to form a deposit and flake off on the impingement plate as shown in Figure 4.8.3. One problem was noted with the shroud. The four support brackets were bent upward due to deformation of the shroud. This occurred even after the shroud material thickness was increased to 1/4 inch and a stiffening ring was added at the top of the shroud to mitigate this problem prior to the last test period. It was apparent that the shroud thickness was still insufficient to prevent distortion.

**Figure 4.8.2 - Photograph of APF Shroud During Final Removal**

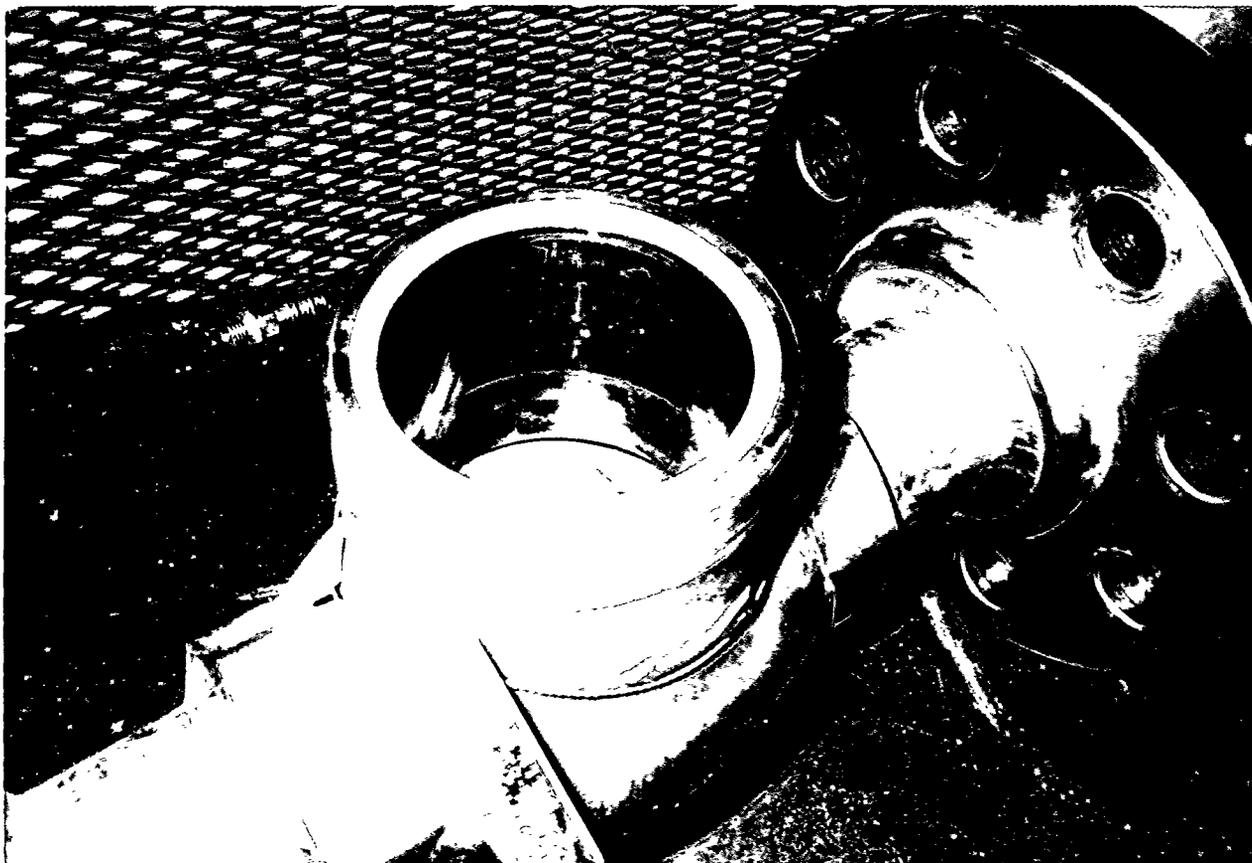
Two of the Atkomatic solenoid valves and the COAX valve (used in the last test period) were disassembled for inspection. The COAX valve did not show any signs of degradation. The two Atkomatic valves appeared to be in excellent condition. Some very minor surface scratches were seen in localized areas on the pistons indicating that the Stellite coating held up very well. The valve body bores showed very minor surface pitting, but felt very smooth. Figures 4.8.7 and 4.8.8 are photographs of the valve internals.

**Figure 4.8.7 - Photograph of Backpulse Valve Internals**

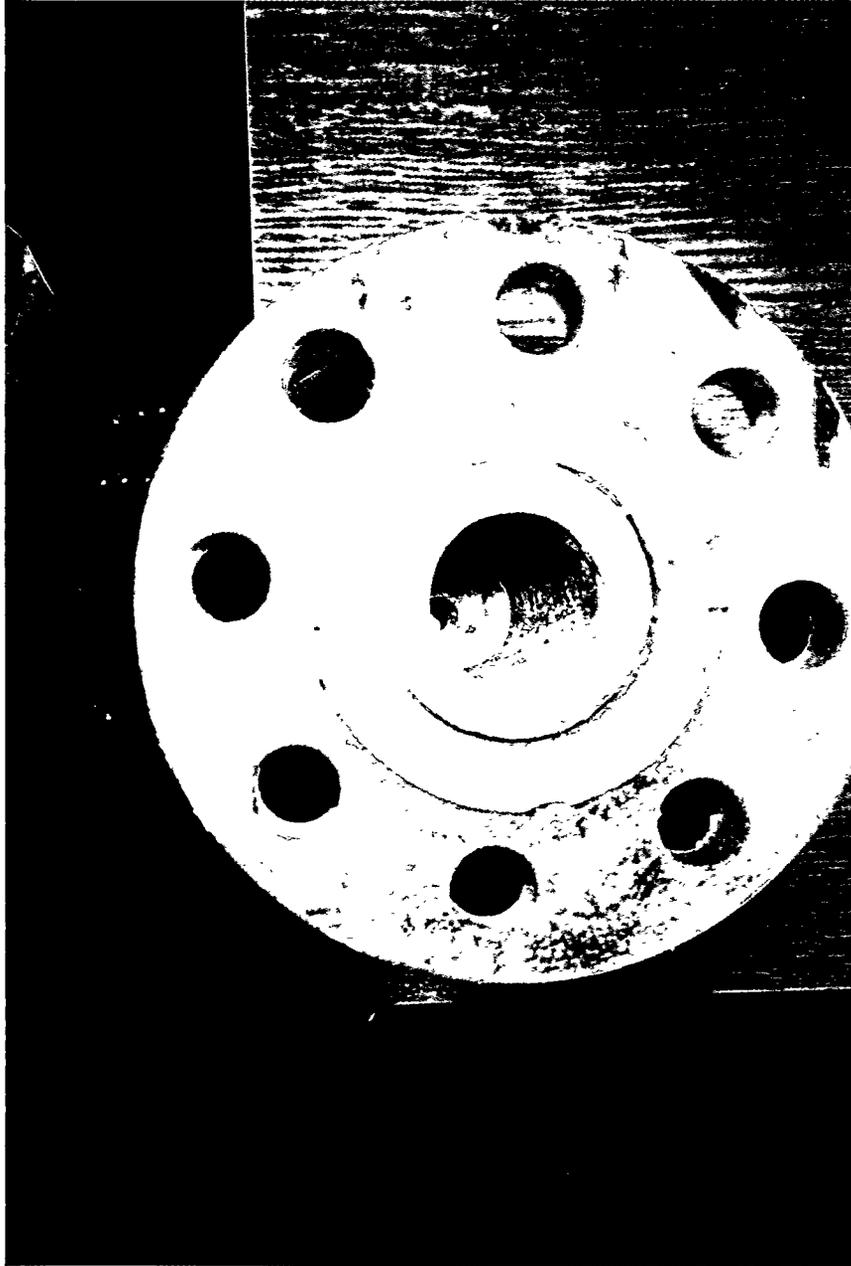
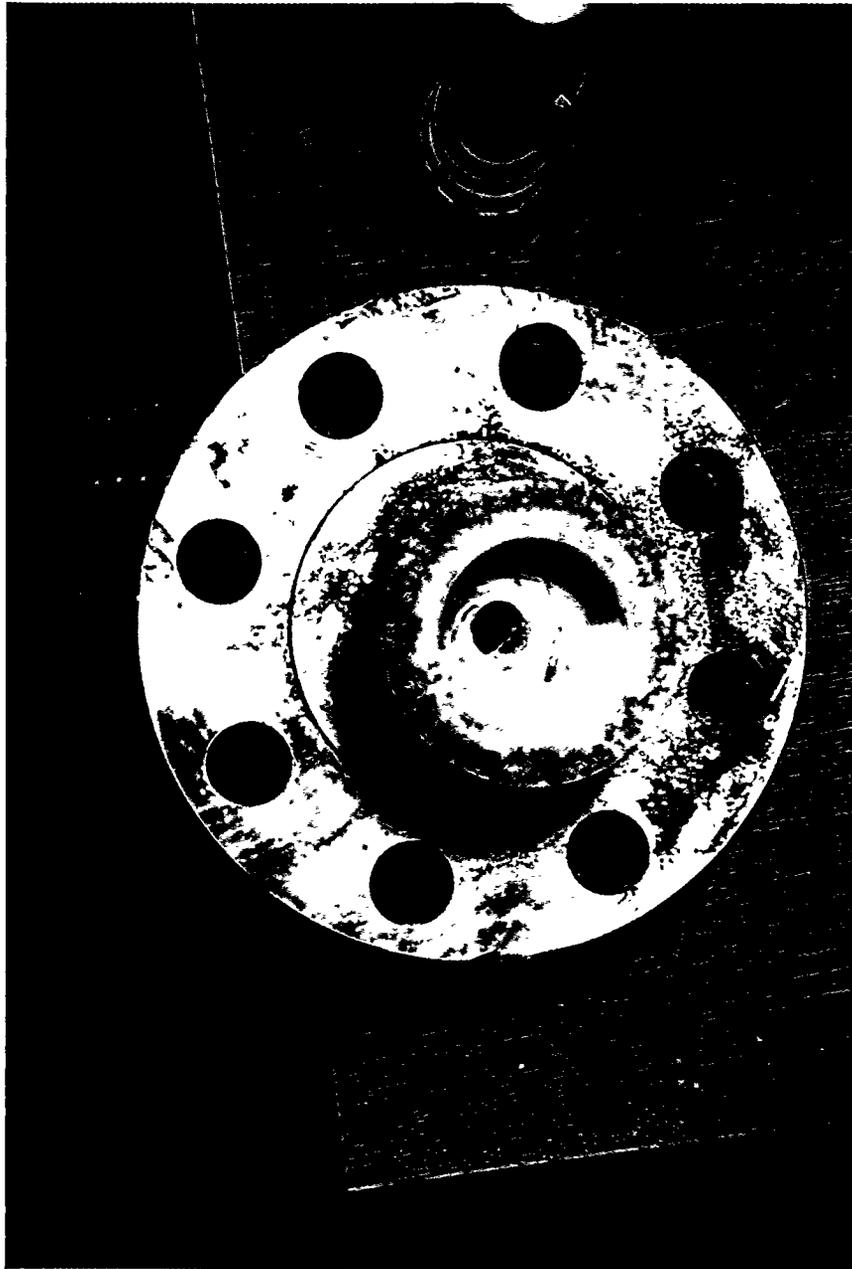
A section of the alternate ash line was removed and sectioned to determine if it had experienced erosion. No erosion was noted. This indicated that ash conveying lines can be properly sized to handle heavy ash loading with coarse particles without experiencing erosion. The restrictive orifice in the alternate ash line was removed and inspected. The orifice, which was a tungsten carbide nozzle, appeared in excellent condition, as shown in Figures 4.8.13 and 4.8.14. Also, the tee downstream of the orifice was inspected and it also was undamaged.

**Figure 4.8.13 - Photograph of Alternate Ash Line Restrictive Orifice**

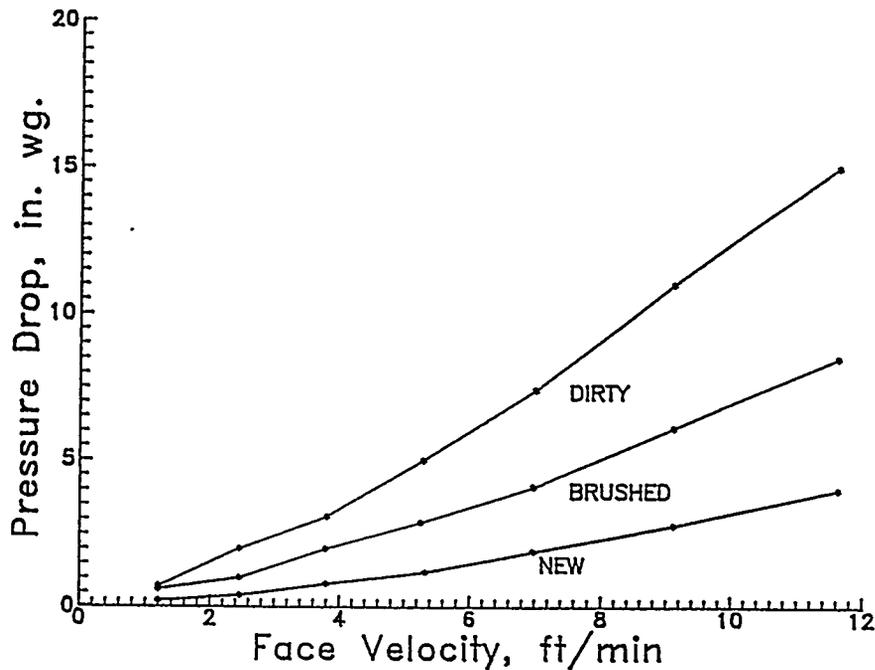
As shown in Figure 4.9.11, the pressure drop or gas flow resistance through the filter element increased as fines collected and remained along the outer surface of the filter elements. Following normal operating conditions, the as-manufactured gas flow resistance was regenerated by simply washing the elements with water and drying. In the event that candles failed and process operation continued, fines released into the clean gas stream were pulsed back into the inner wall of the remaining intact filter elements. Posttest washing of these elements generally did not permit regeneration of the as-manufactured gas flow resistance, since the fines typically blinded the inner wall of the coarse support matrix. Since the ID fines generally could not be removed, the elements were eliminated for continued use.

Figure 4.9.11 - Room Temperature Gas Flow Resistance Measurements Across As-Manufactured Clay Bonded Silicon Carbide Filter Elements. Measurements Were Repeated After Operation at Tidd.

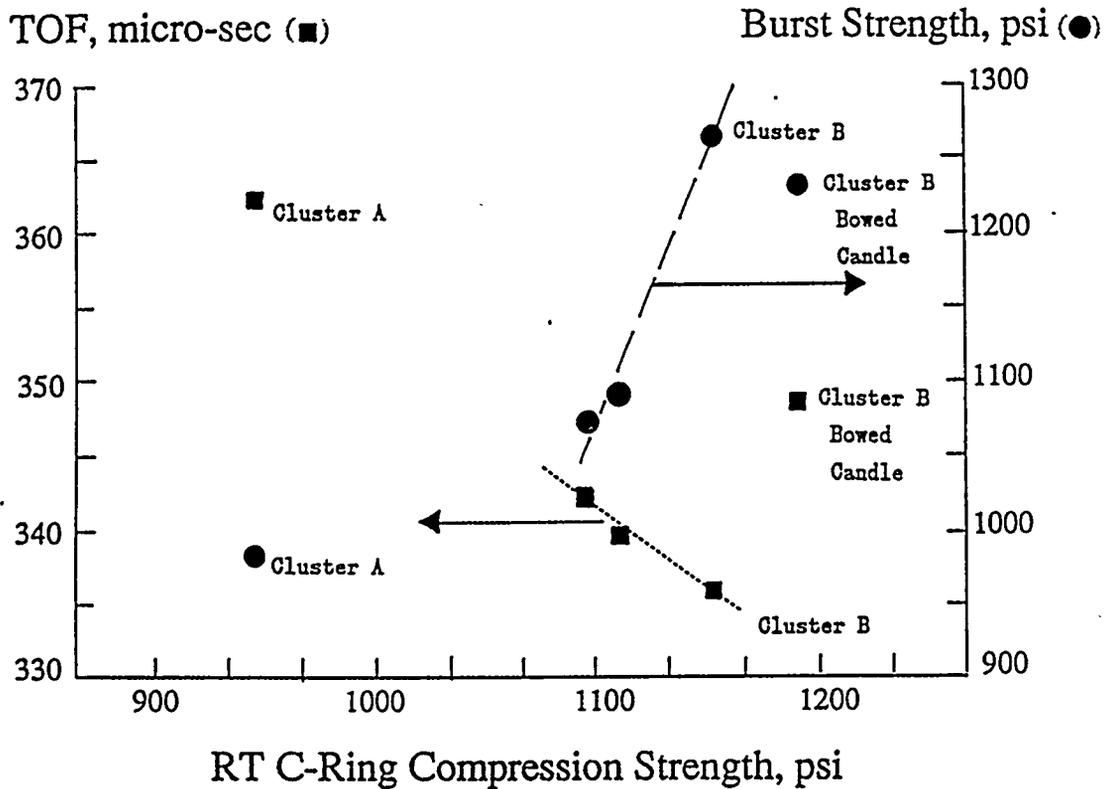
As shown in Figure 4.9.12, a direct correlation between room temperature C-ring compressive and burst strength of the 464 hr PFBC-exposed clay bonded silicon carbide filter matrix resulted particularly for candles that were located in a common cluster or location within the system. As the TOF value for a given filter element increased, the room temperature C-ring compressive strength of the clay bonded silicon carbide filter matrix decreased, again for candle filters that were located in a common cluster. Cluster A candles and the bowed Cluster B candles tended to deviate from the TOF/C-ring compressive and burst strength/C-ring compressive relationship.

Figure 4.9.12 - Correlation of Time-of-Flight and Burst Strength with Room Temperature C-Ring Compressive Strength for Candle Filters Exposed for 464 Hours of PFBC Operating Conditions in Test Period I.

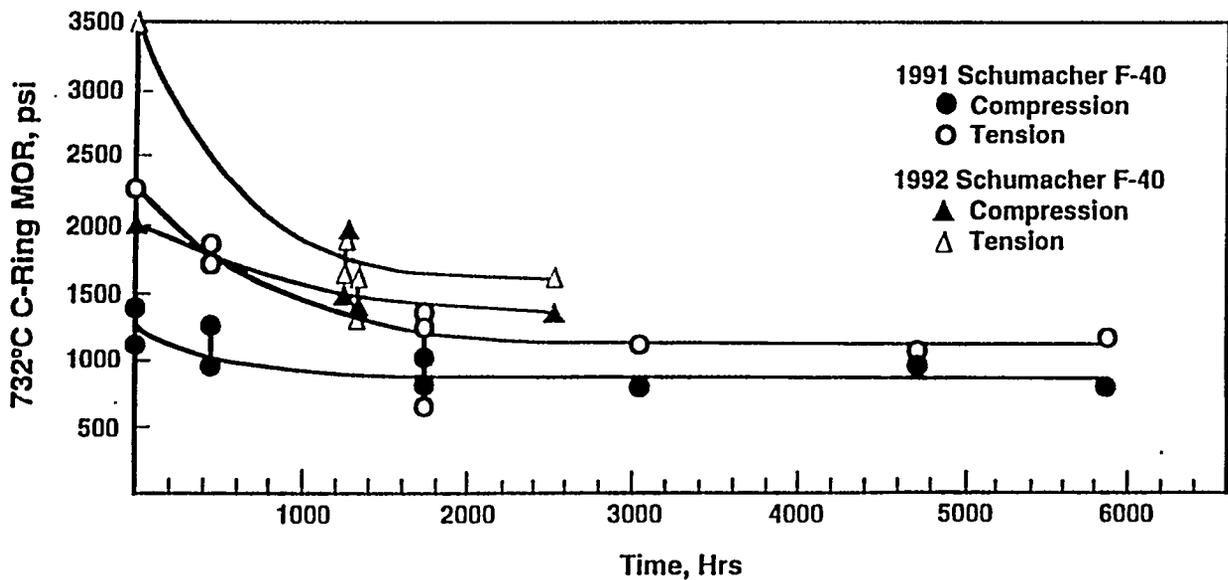
Within the entire candle filter assembly, generally 5-16% of the Schumacher Dia Schumalith F40 filter elements failed during operation in Test Periods I through IV, primarily as a result of ash bridging. After removal of the primary cyclone from service in Period V, ash bridging, as well as candle failure were mitigated. Schumacher Dia Schumalith F40 surveillance candles, however, successfully achieved 5854 hours of operation. The residual bulk strength of the Schumacher Dia Schumalith F40 matrix was determined via room temperature and process temperature C-ring compressive and tensile testing. As shown in Figure 4.9.13, the process temperature bulk strength of the Schumacher Dia Schumalith F40 matrix decreased during the initial 1000-2000 hours of PFBC operation. With continued operation, however, the bulk strength of the Schumacher Dia Schumalith F40 matrix remained constant. The residual or "conditioned" strength was considered to result from the complete or nearly complete crystallization of the binder phase that encapsulated the silicon carbide grains, as well as the bond posts or ligament surfaces as shown in the photo micrograph in Figure 4.9.14.

Figure 4.9.13 - Schumacher Strength Profile

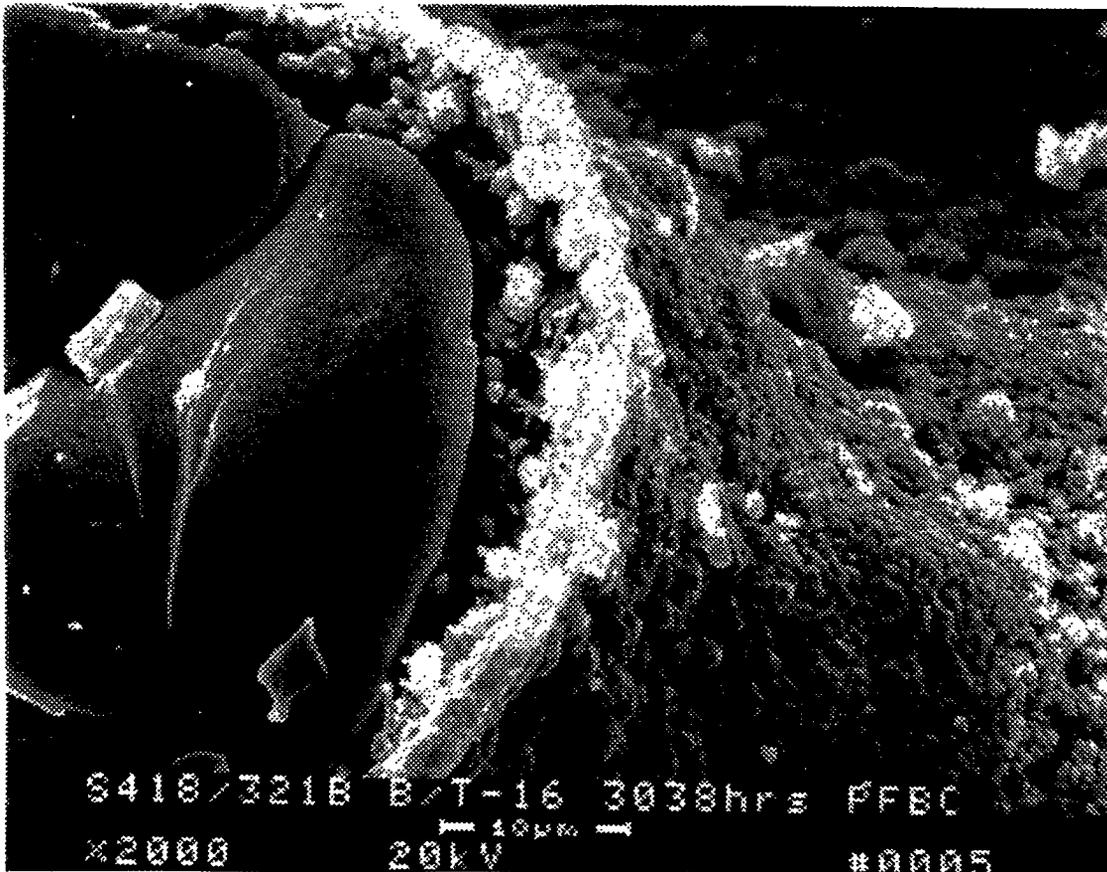
**Figure 4.9.14 - Photo Micrograph Showing Crystallization of the Schumacher Dia Schumalith F40 Filter Matrix**

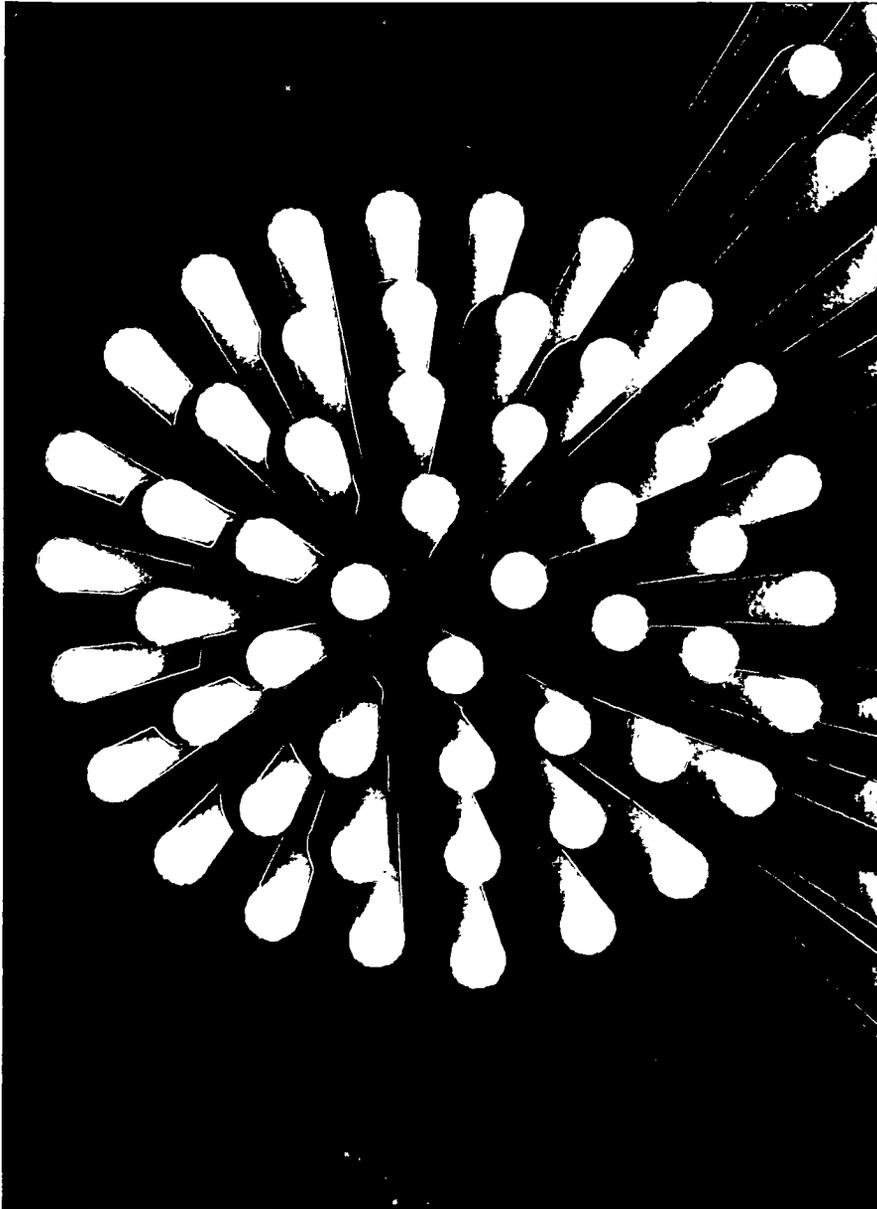
**Figure 4.3.1 - Photograph of Bottom Filter Candles Following Test Run 1**

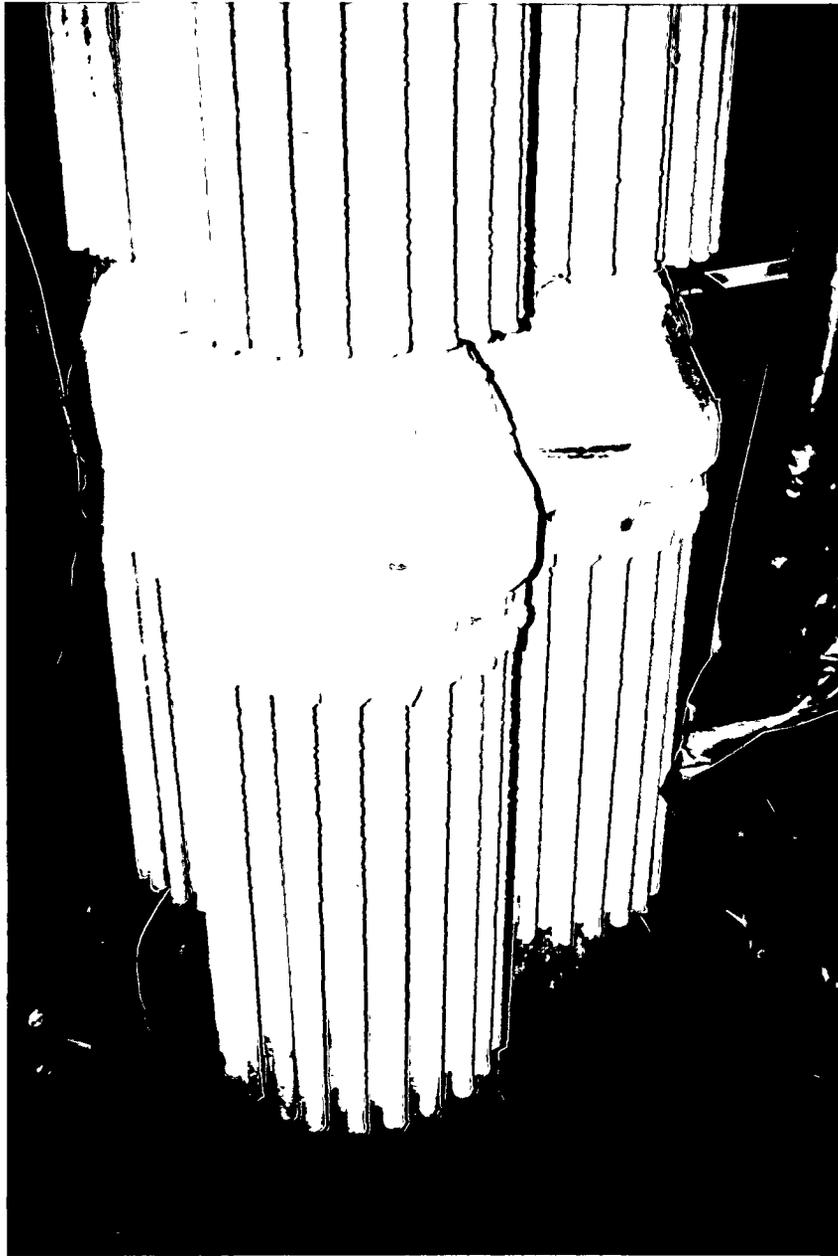
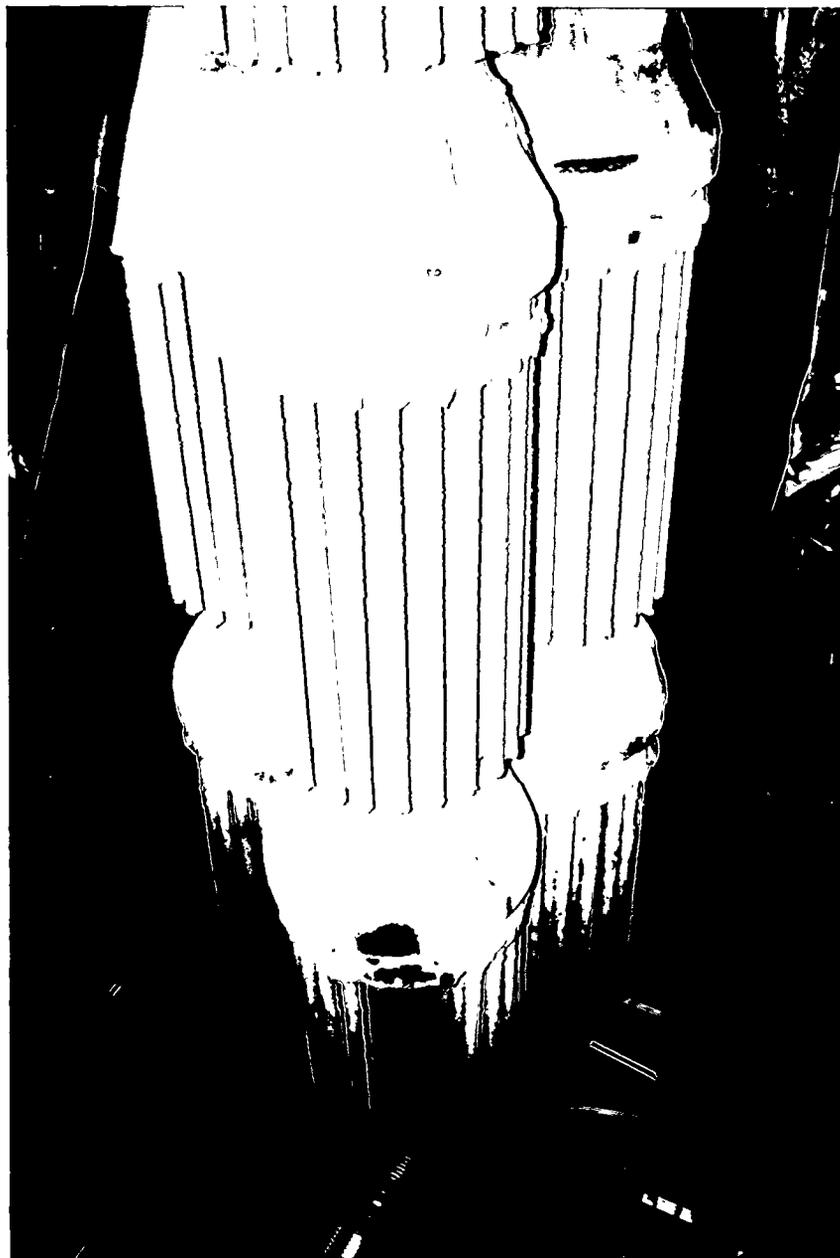
**Figure 4.3.2 - Photograph of Filter Internals Following Test Run 4**

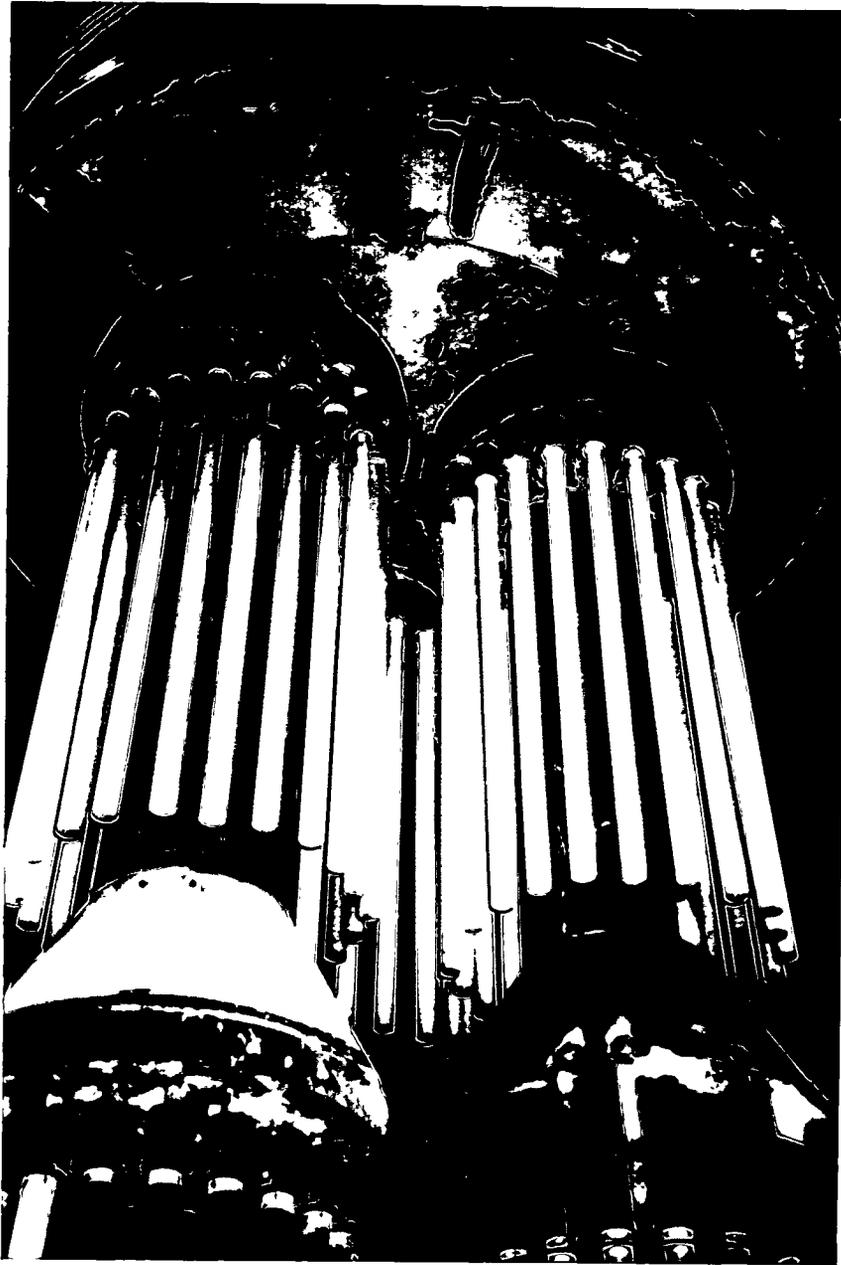
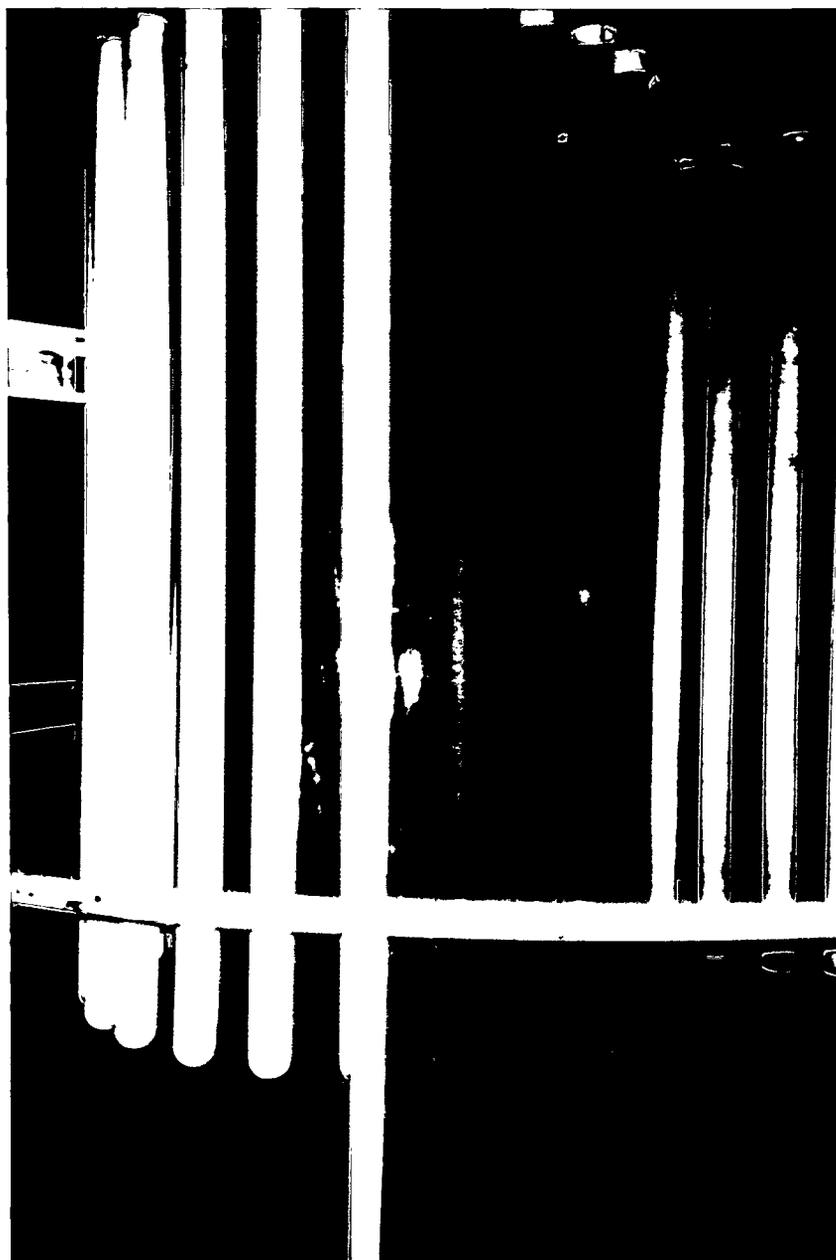
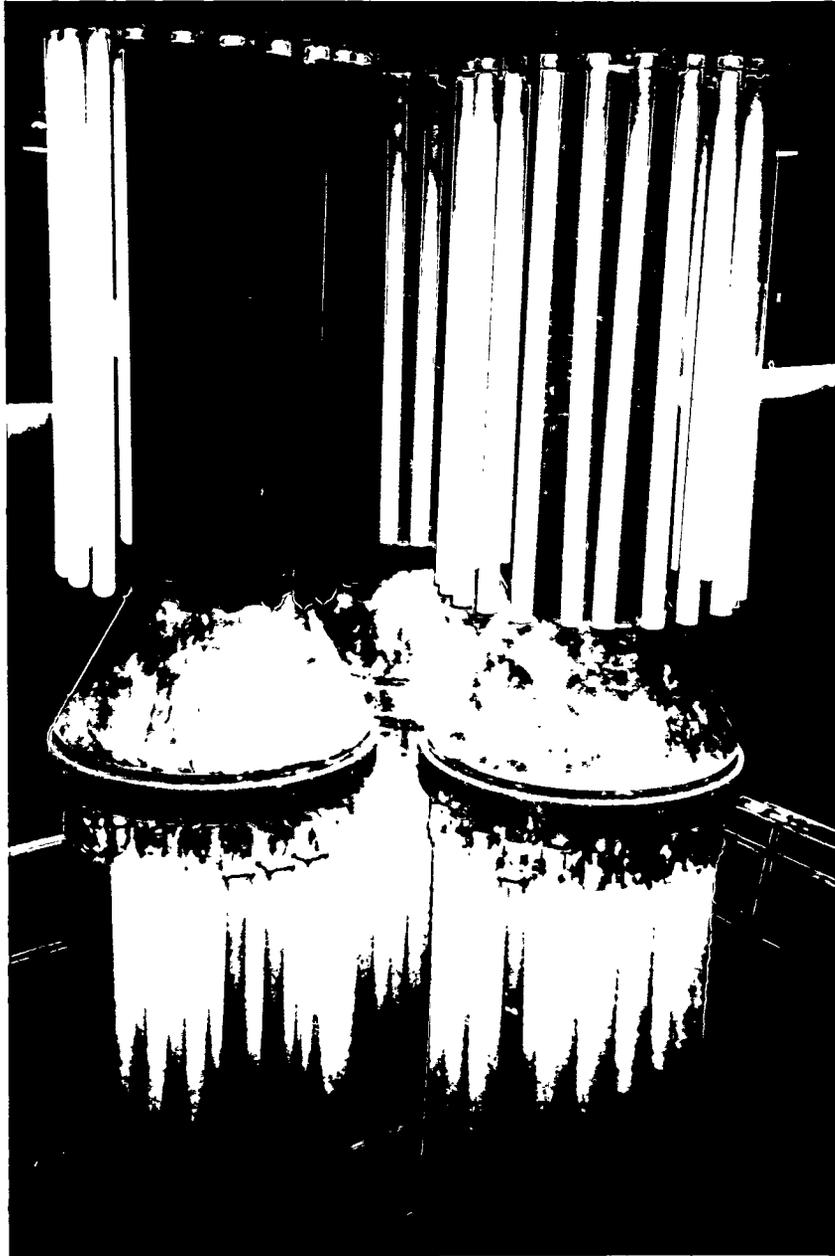
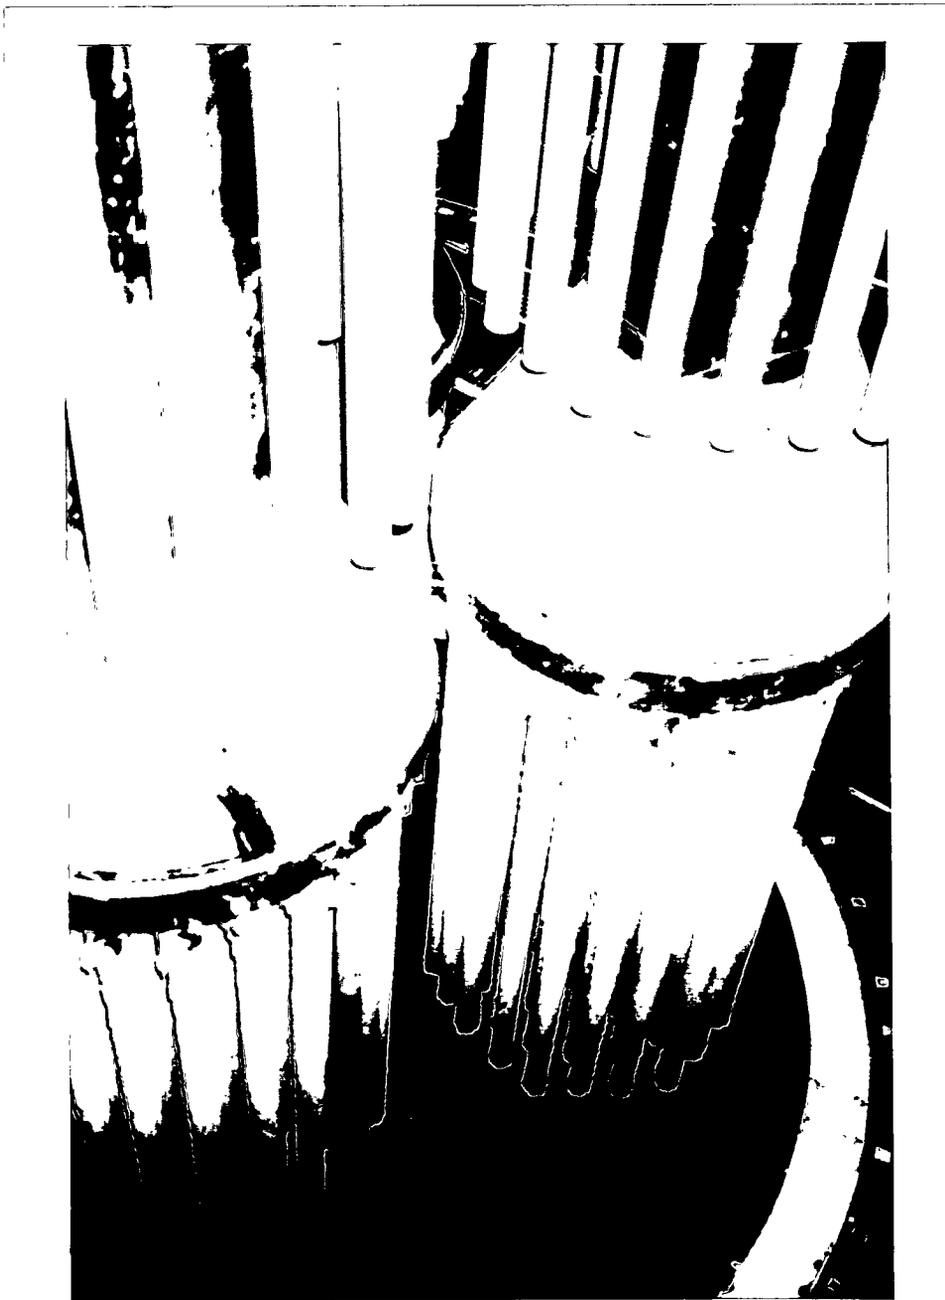
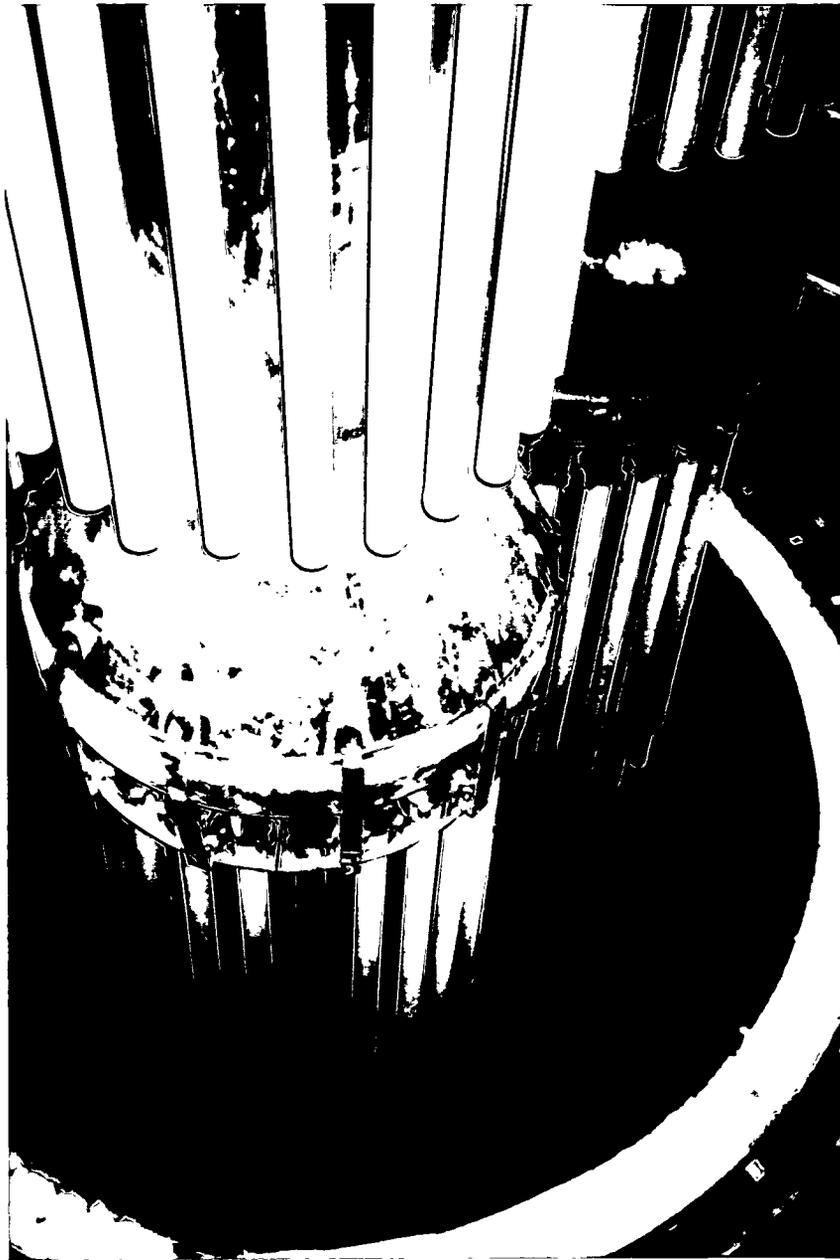
**Figure 4.5.19 - Photograph of Filter Internals Before Test Period IV**

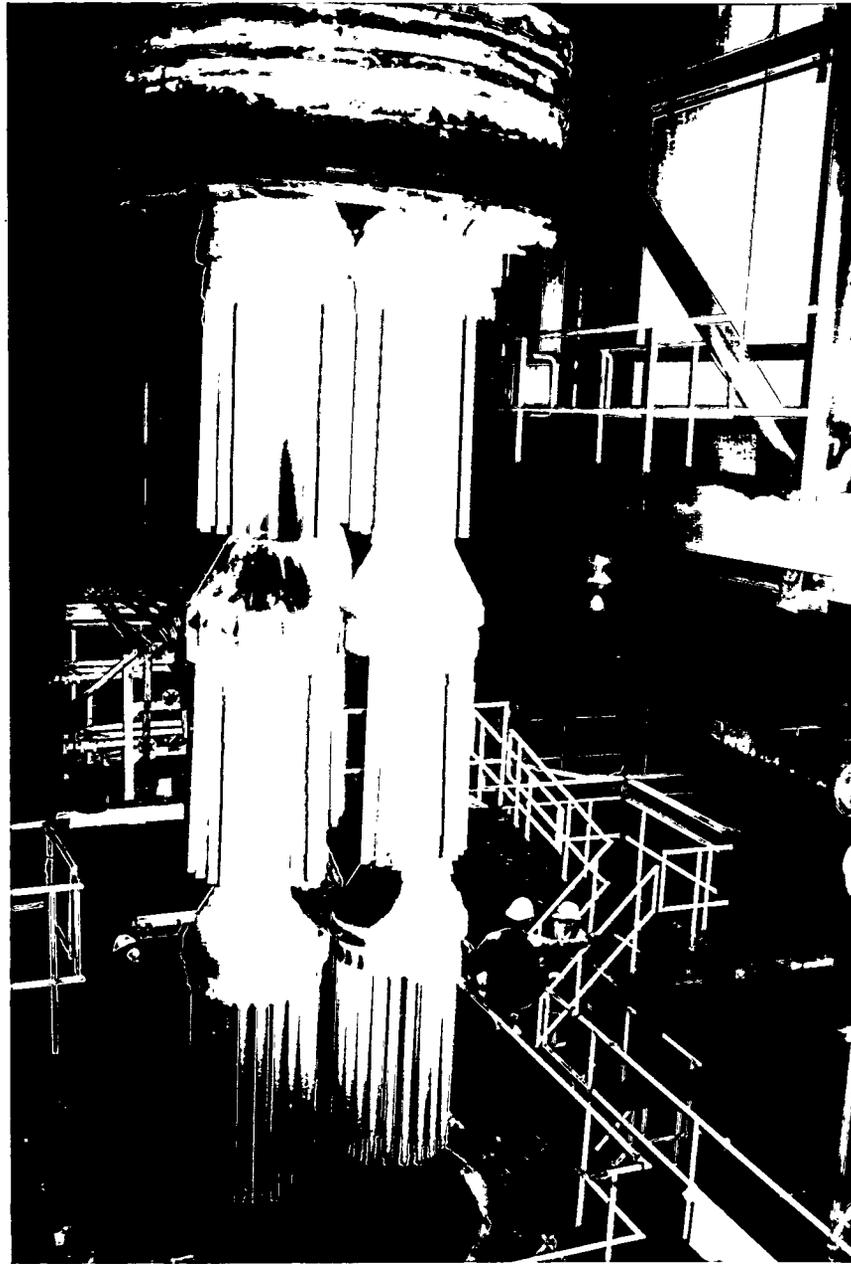
**Figure 4.6.8 - Photograph of Filter Internals Following Test Run 24**
