# Tidd Hot Gas Clean Up Program

## Final Report

October 1995

By  
Ohio Power Company  
Columbus, Ohio

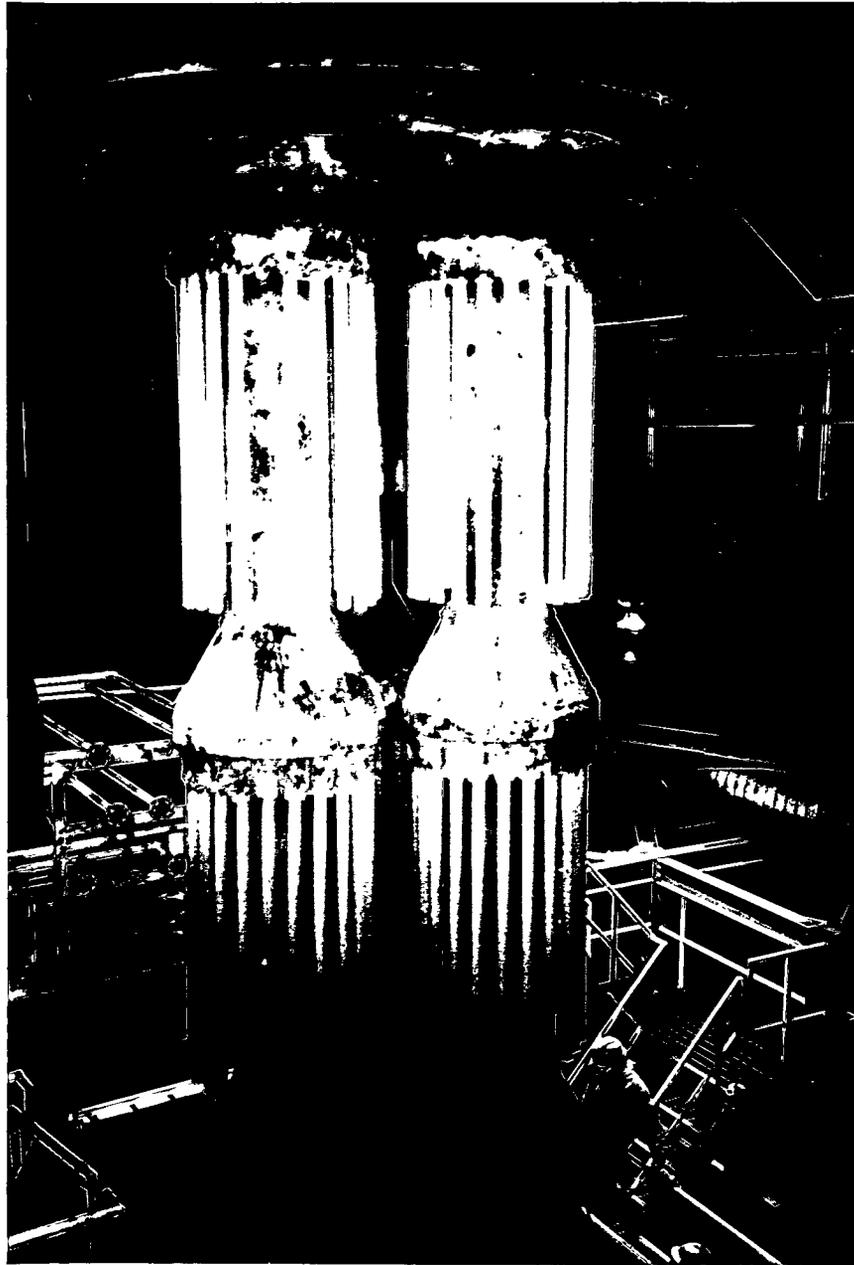
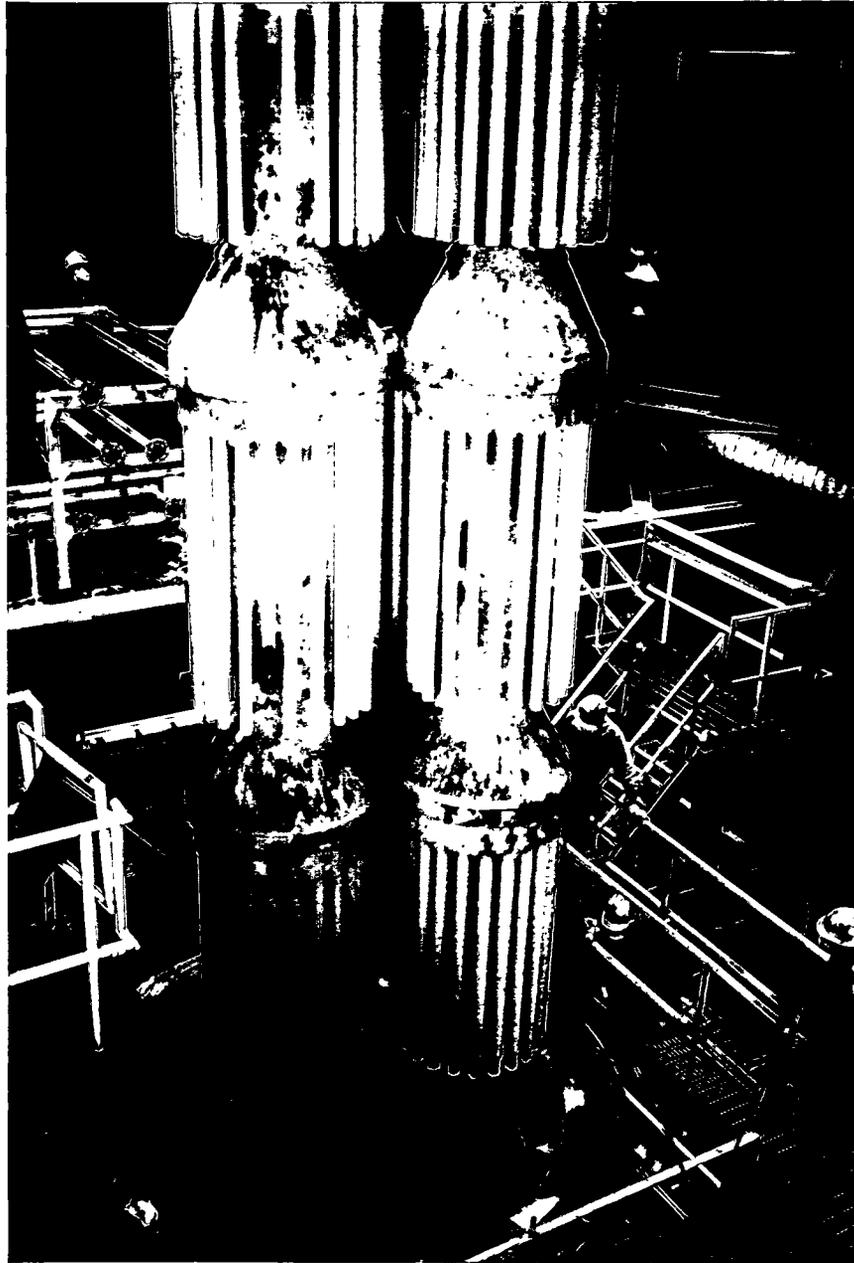
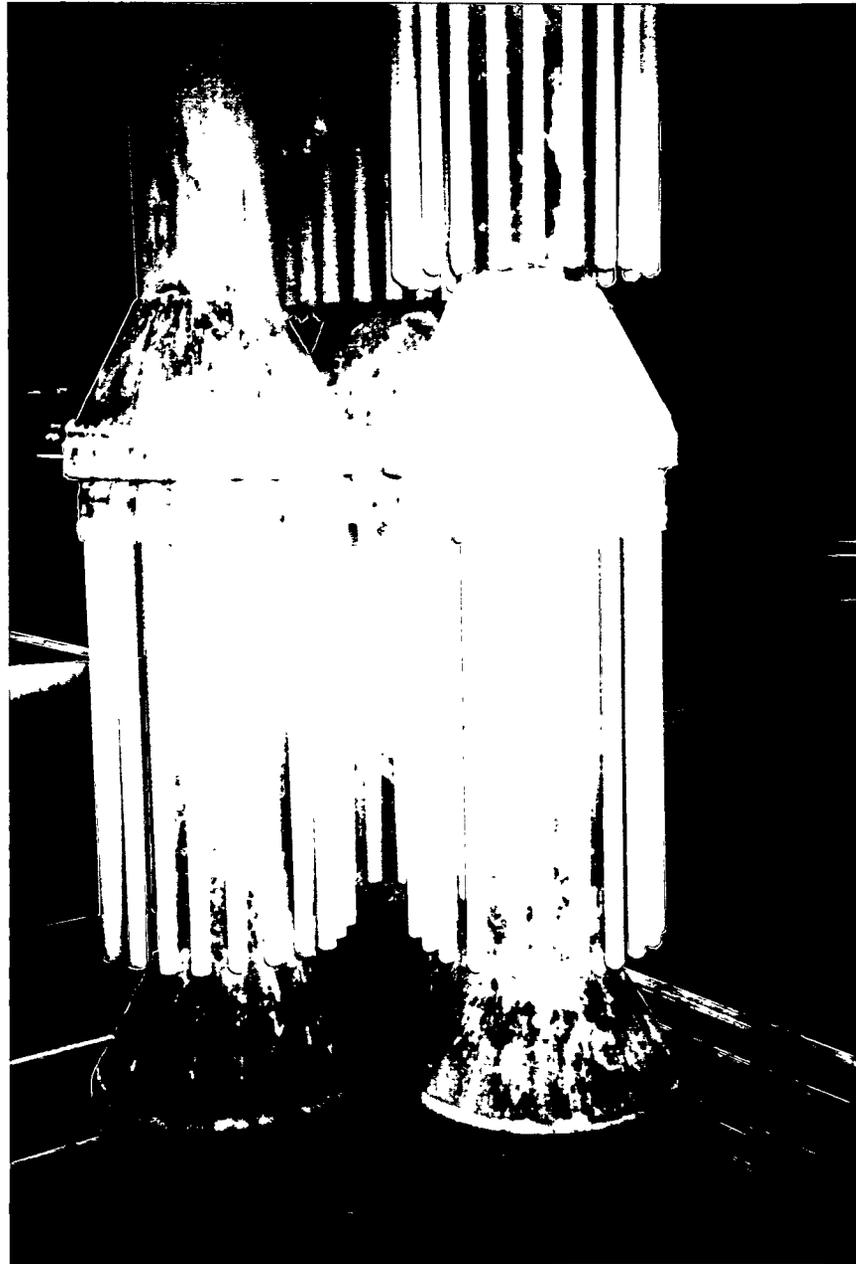
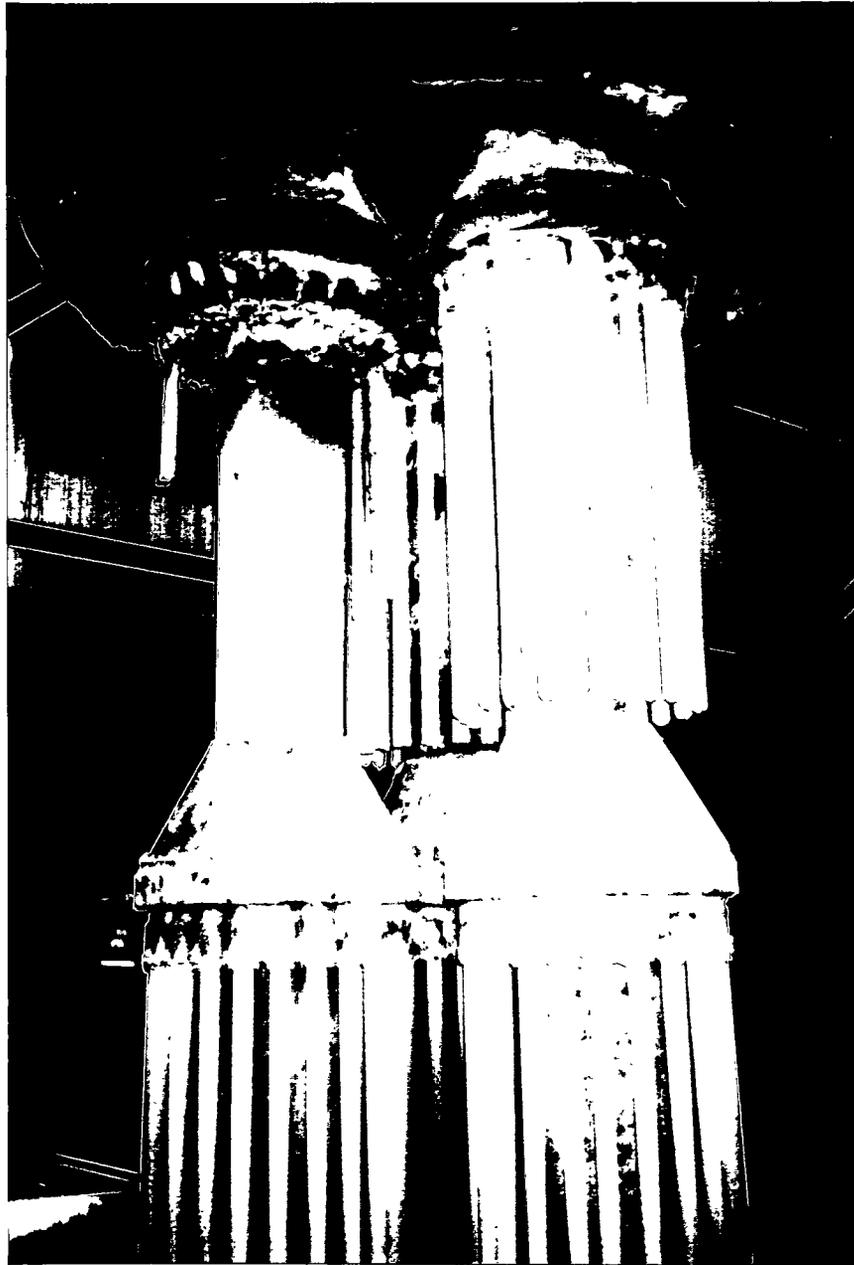
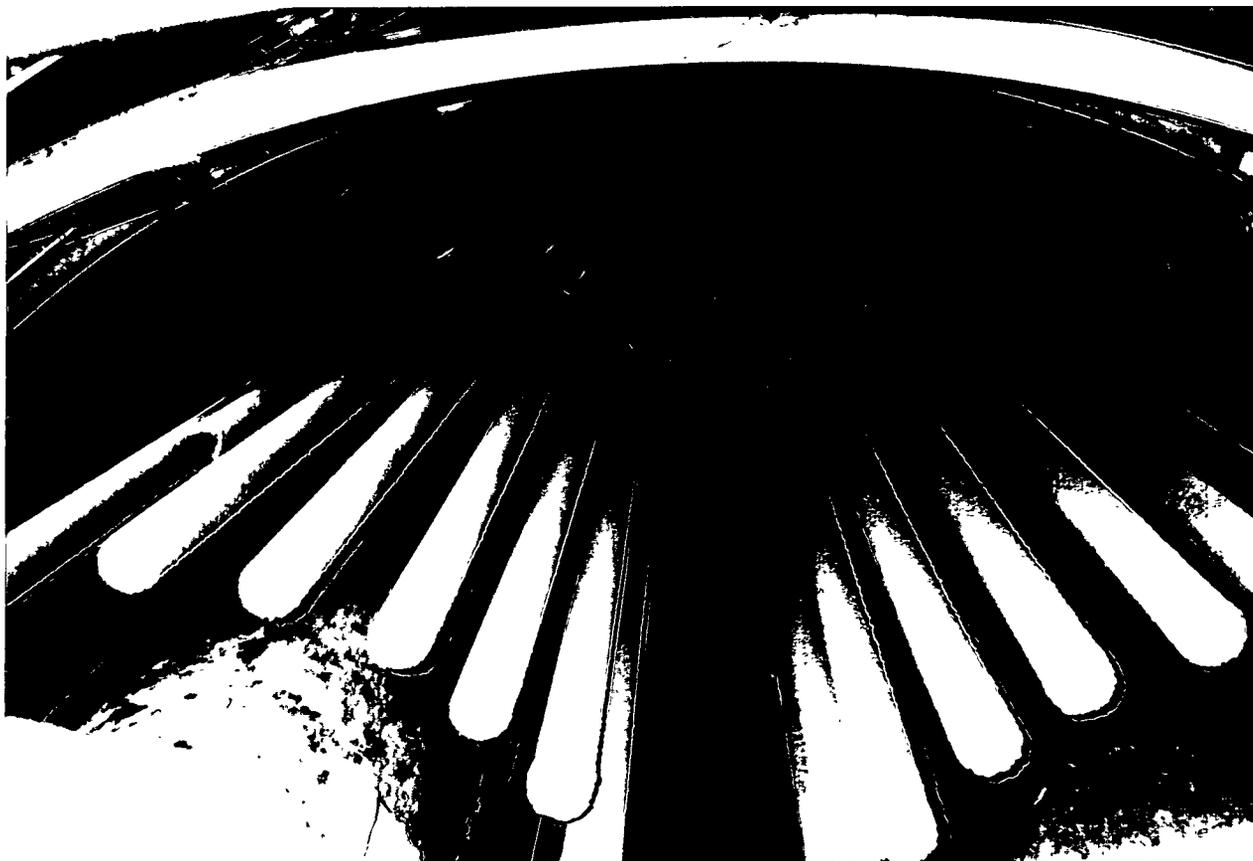
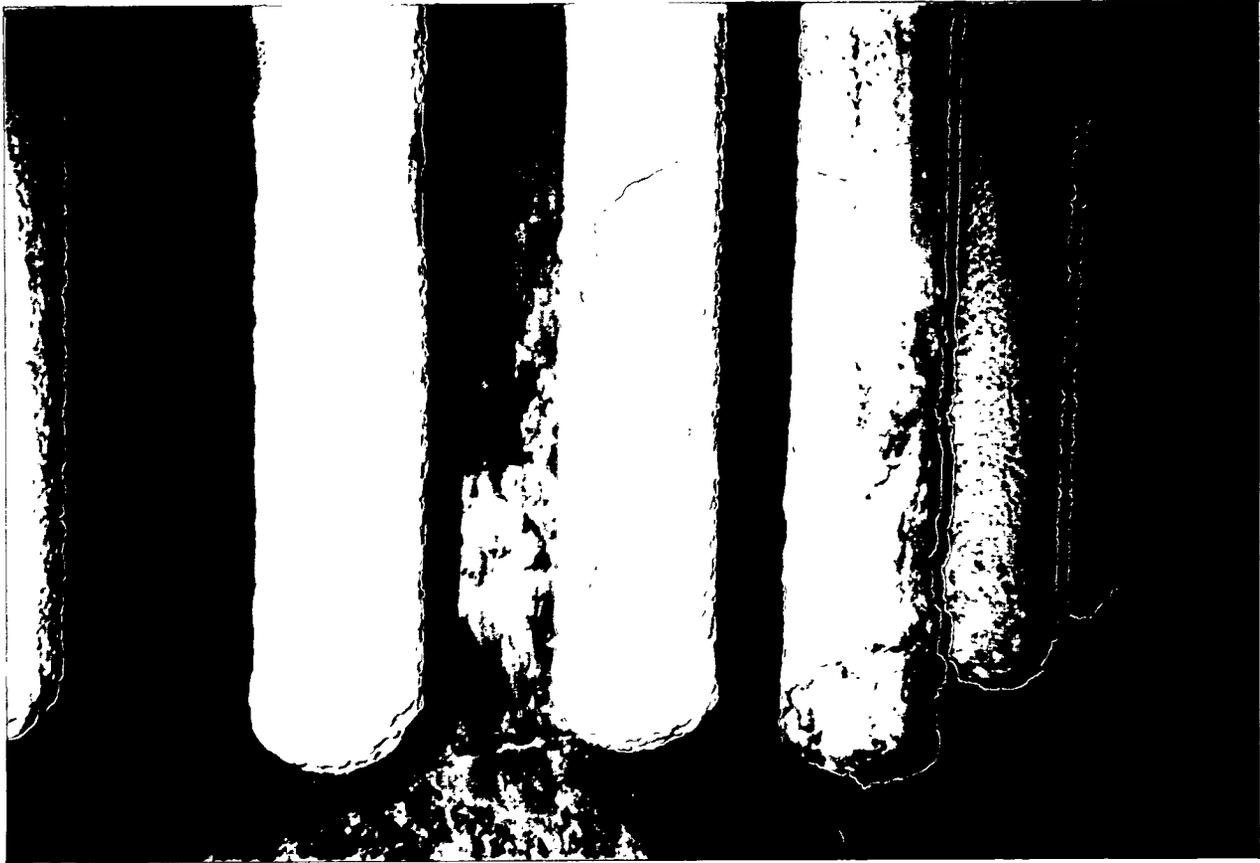
On 4/26 the internals of the APF were inspected with a boroscope. The internals were very clean with no ash bridges observed. All but two of the 22 Dupont PRD66 experimental filter candles appeared to be missing or were partially broken off. In addition, one Coors alumina-mullite candle was observed partially broken off. The remaining candles appeared in good condition.

On 5/11 the APF internals were removed from the filter vessel. Figures 4.7.10 through 4.7.18 are photographs of the filter internals after removal. As observed by the boroscopic inspection, 20 of 22 of the Dupont PRD66 candles were broken, all in plenum B Top. In addition, two Coors alumina-mullite candles were broken (rather than one), one near the top in plenum A Top and the other about 2/3 down from the top in plenum A Middle. No ash bridging was seen. The residual ash cake layer thickness on the candles ranged from about 1/8" on the Coors alumina-mullite candles to about 3/8" on the Vitropore silicon carbide candles. During removal, cracks were seen in two candles (Figure 4.7.18), one alumina-mullite the other an original Schumacher silicon carbide surveillance candle. Both candles broke during removal and handling. Hard ash deposits were found in the bottom 6 to 12 inches of these cracked candles. In addition, a 3M candle was found to be cracked near the bottom after it was removed. No indication of an ash leak path was seen at the gasket area of any of these candles, but it appeared that ash accumulated in the bottom portion of these candles which resulted in cracking of the candles.

**Figure 4.7.10 - Photograph of Filter Internals Following Test Run 34**

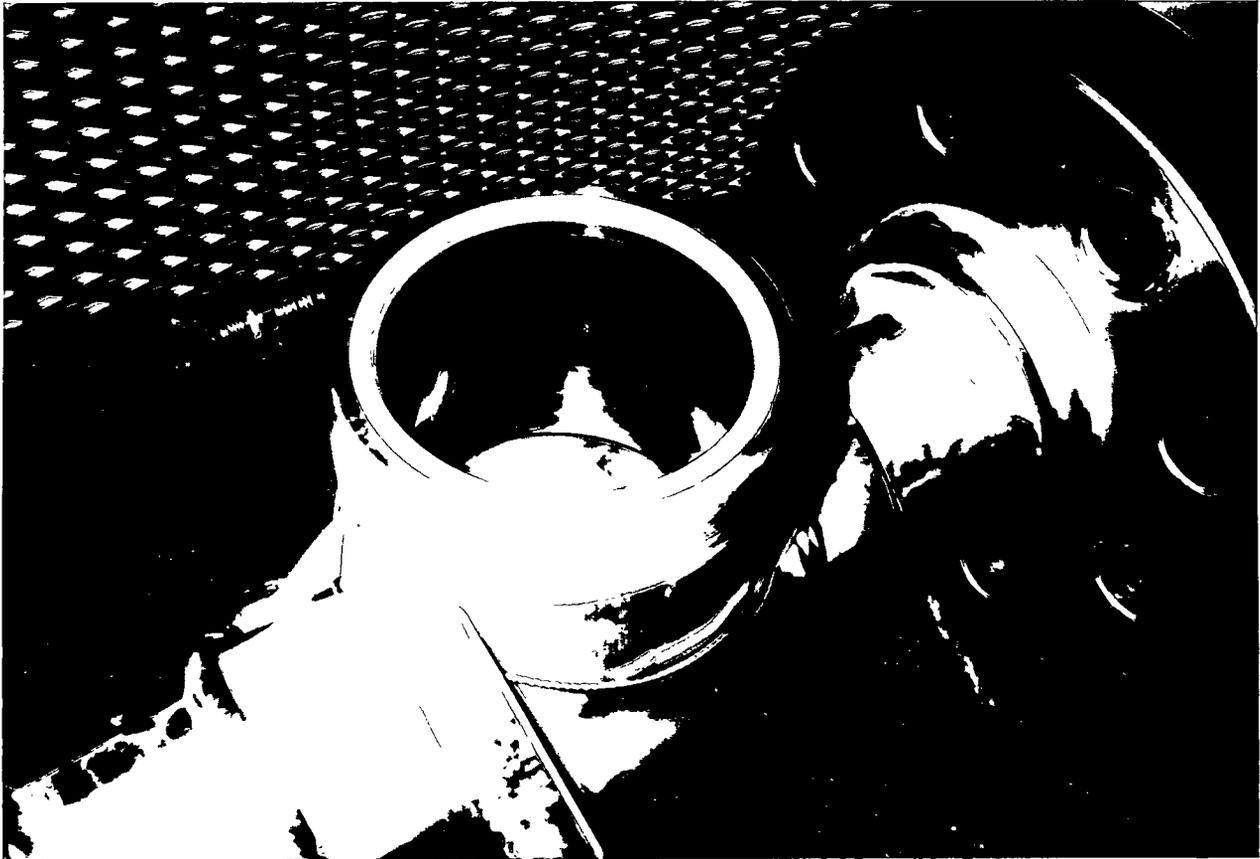
Two of the Atkomatic solenoid valves and the COAX valve (used in the last test period) were disassembled for inspection. The COAX valve did not show any signs of degradation. The two Atkomatic valves appeared to be in excellent condition. Some very minor surface scratches were seen in localized areas on the pistons indicating that the Stellite coating held up very well. The valve body bores showed very minor surface pitting, but felt very smooth. Figures 4.8.7 and 4.8.8 are photographs of the valve internals.

**Figure 4.8.7 - Photograph of Backpulse Valve Internals**

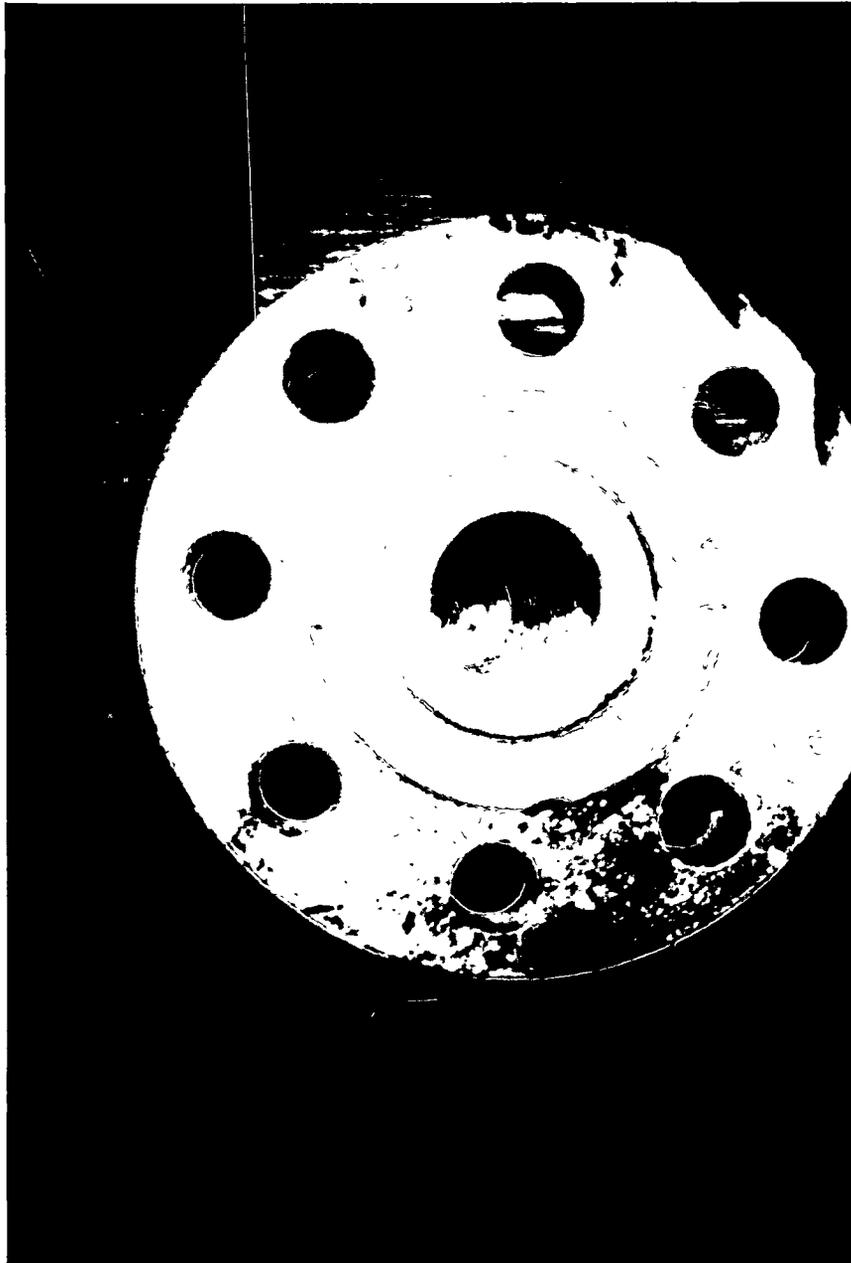
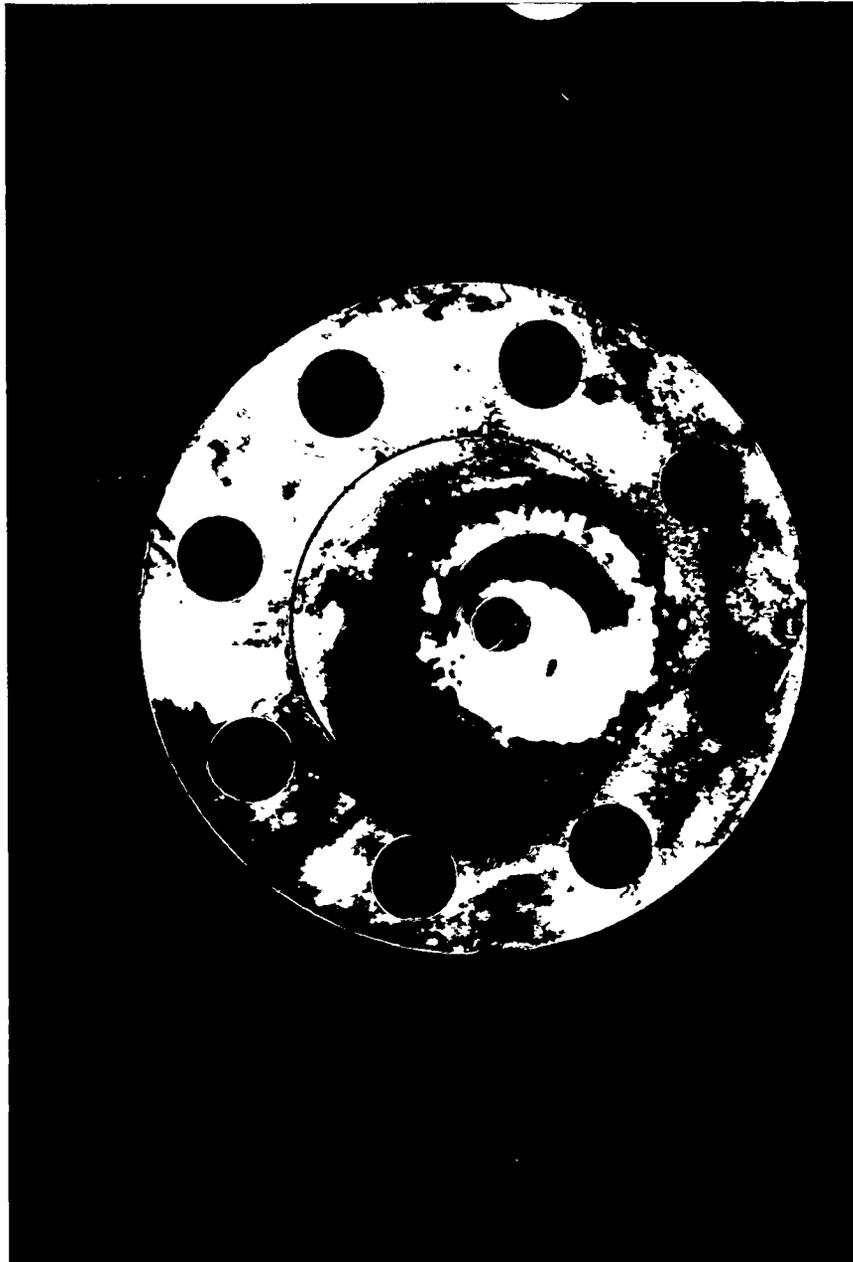
A section of the alternate ash line was removed and sectioned to determine if it had experienced erosion. No erosion was noted. This indicated that ash conveying lines can be properly sized to handle heavy ash loading with coarse particles without experiencing erosion. The restrictive orifice in the alternate ash line was removed and inspected. The orifice, which was a tungsten carbide nozzle, appeared in excellent condition, as shown in Figures 4.8.13 and 4.8.14. Also, the tee downstream of the orifice was inspected and it also was undamaged.

**Figure 4.8.13 - Photograph of Alternate Ash Line Restrictive Orifice**

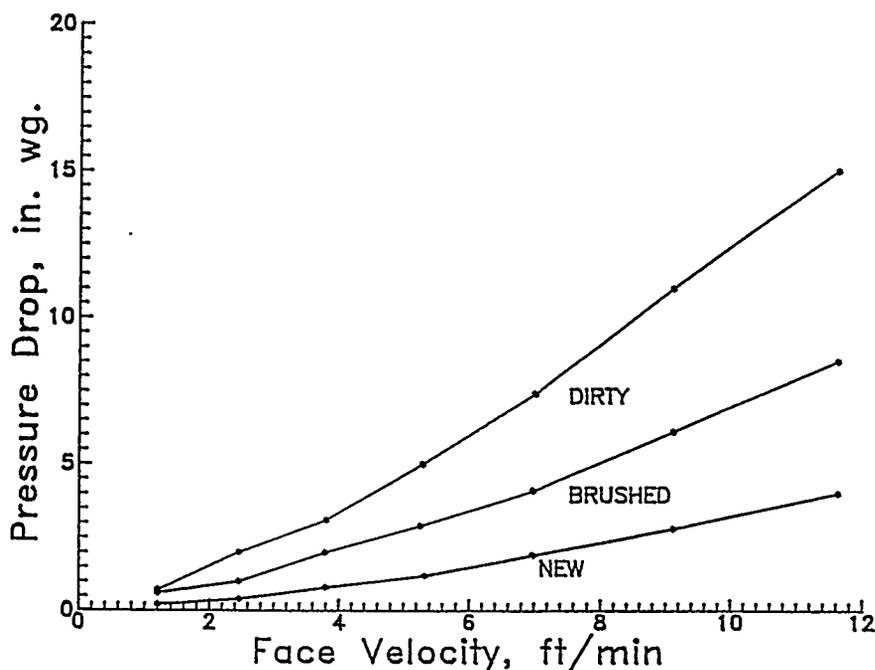
As shown in Figure 4.9.11, the pressure drop or gas flow resistance through the filter element increased as fines collected and remained along the outer surface of the filter elements. Following normal operating conditions, the as-manufactured gas flow resistance was regenerated by simply washing the elements with water and drying. In the event that candles failed and process operation continued, fines released into the clean gas stream were pulsed back into the inner wall of the remaining intact filter elements. Posttest washing of these elements generally did not permit regeneration of the as-manufactured gas flow resistance, since the fines typically blinded the inner wall of the coarse support matrix. Since the ID fines generally could not be removed, the elements were eliminated for continued use.

Figure 4.9.11 - Room Temperature Gas Flow Resistance Measurements Across As-Manufactured Clay Bonded Silicon Carbide Filter Elements. Measurements Were Repeated After Operation at Tidd.

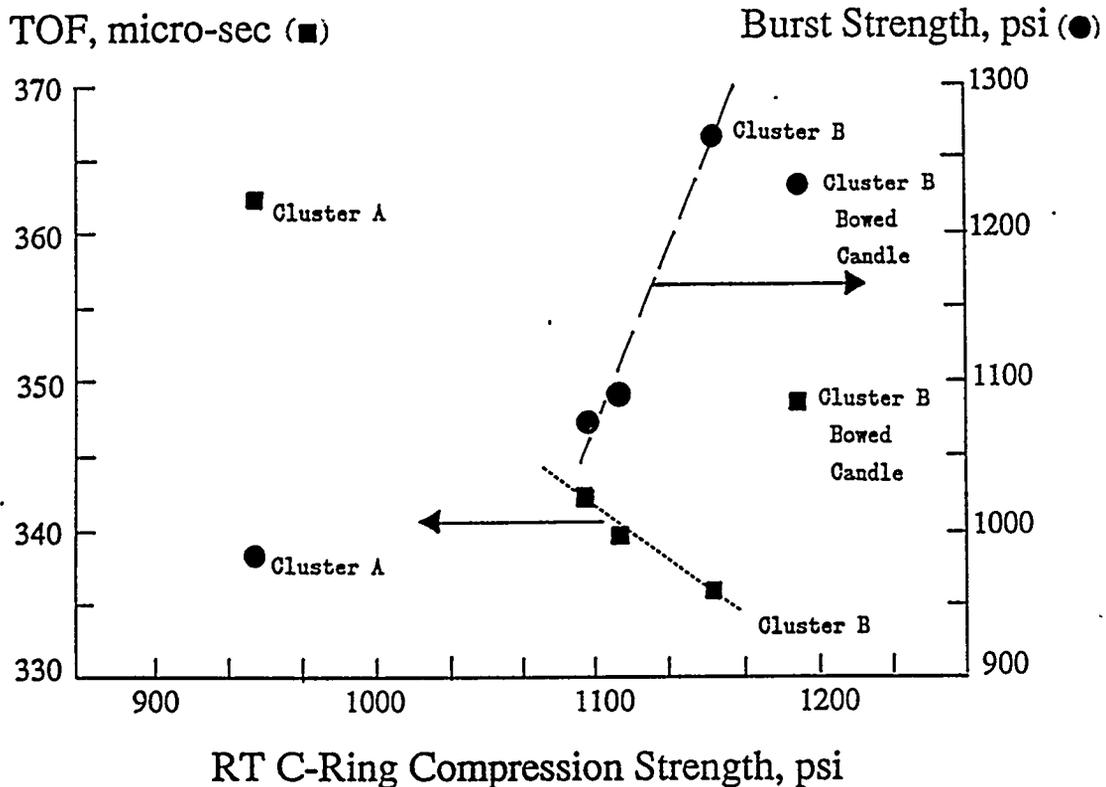
As shown in Figure 4.9.12, a direct correlation between room temperature C-ring compressive and burst strength of the 464 hr PFBC-exposed clay bonded silicon carbide filter matrix resulted particularly for candles that were located in a common cluster or location within the system. As the TOF value for a given filter element increased, the room temperature C-ring compressive strength of the clay bonded silicon carbide filter matrix decreased, again for candle filters that were located in a common cluster. Cluster A candles and the bowed Cluster B candles tended to deviate from the TOF/C-ring compressive and burst strength/C-ring compressive relationship.

Figure 4.9.12 - Correlation of Time-of-Flight and Burst Strength with Room Temperature C-Ring Compressive Strength for Candle Filters Exposed for 464 Hours of PFBC Operating Conditions in Test Period I.

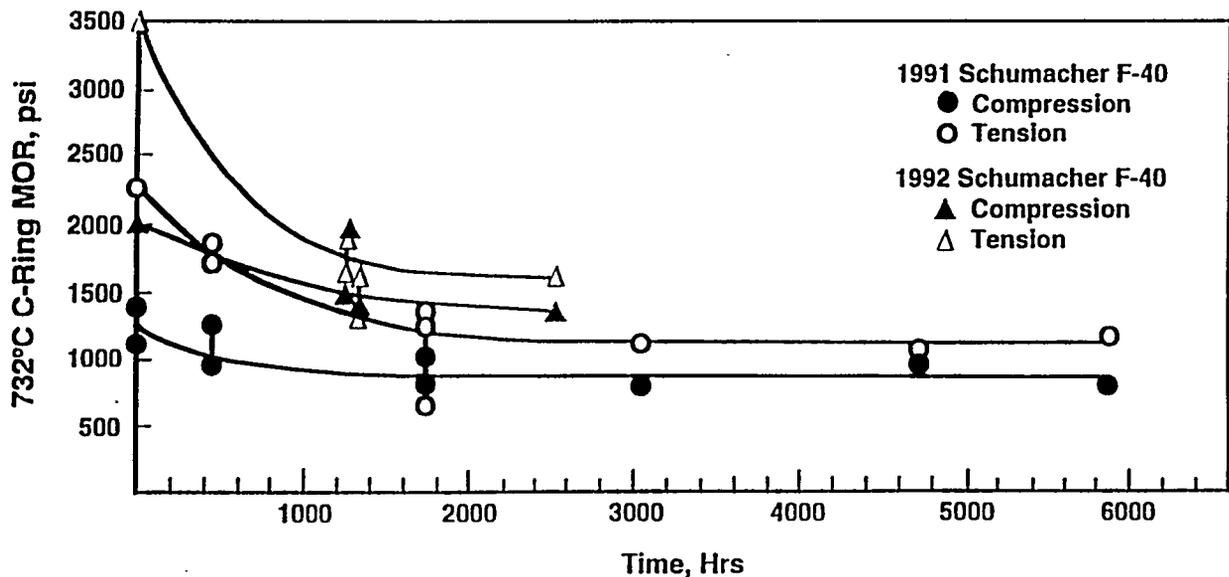
Within the entire candle filter assembly, generally 5-16% of the Schumacher Dia Schumalith F40 filter elements failed during operation in Test Periods I through IV, primarily as a result of ash bridging. After removal of the primary cyclone from service in Period V, ash bridging, as well as candle failure were mitigated. Schumacher Dia Schumalith F40 surveillance candles, however, successfully achieved 5854 hours of operation. The residual bulk strength of the Schumacher Dia Schumalith F40 matrix was determined via room temperature and process temperature C-ring compressive and tensile testing. As shown in Figure 4.9.13, the process temperature bulk strength of the Schumacher Dia Schumalith F40 matrix decreased during the initial 1000-2000 hours of PFBC operation. With continued operation, however, the bulk strength of the Schumacher Dia Schumalith F40 matrix remained constant. The residual or "conditioned" strength was considered to result from the complete or nearly complete crystallization of the binder phase that encapsulated the silicon carbide grains, as well as the bond posts or ligament surfaces as shown in the photo micrograph in Figure 4.9.14.

Figure 4.9.13 - Schumacher Strength Profile

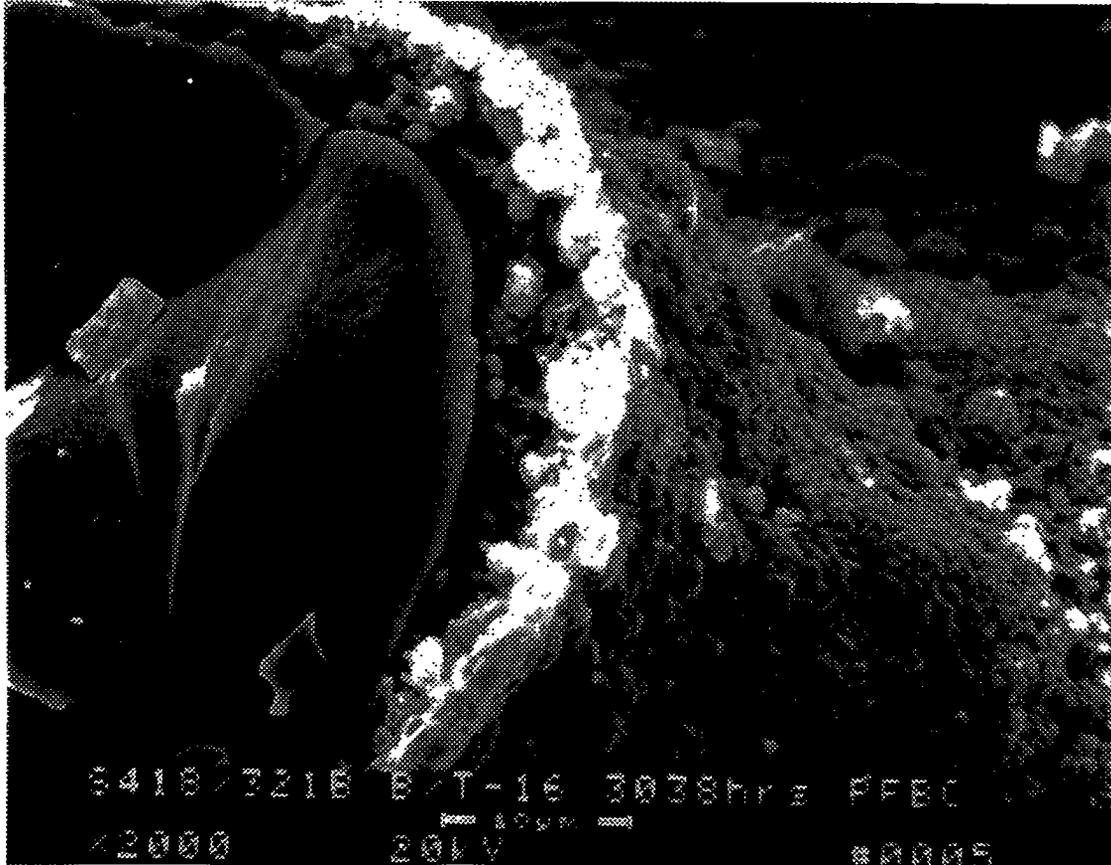
**Figure 4.9.14 - Photo Micrograph Showing Crystallization of the Schumacher Dia Schumalith F40 Filter Matrix**
