POLK POWER STATION - 6TH COMMERCIAL YEAR OF OPERATION

John E. McDaniel - Senior Engineering Fellow (Speaker)

Mark Hornick - General Manager, Polk Power Station

2002 GASIFICATION TECHNOLOGIES CONFERENCE

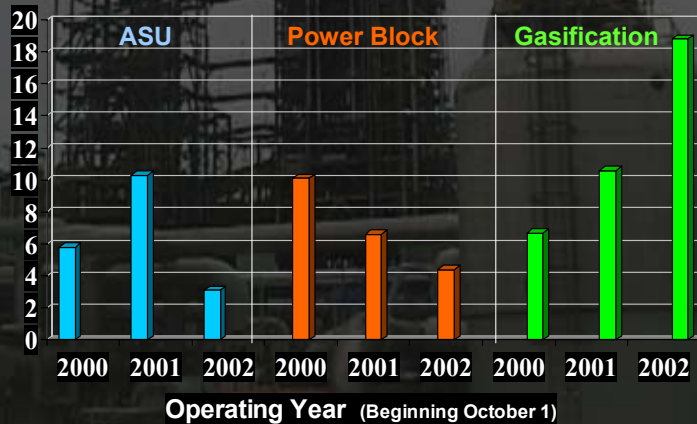
Unplanned Outage Rate

The trends of unplanned outage rates of the three main subsystems over the last three years are probably the most revealing of the statistics.

The ASU experienced a serious column leak in 2000 (Year 4) and a main air compressor failure in 2001 (Year 5), unique problems. Its performance in Year 6 at only a 3% unplanned outage rate is more typical of this technology.

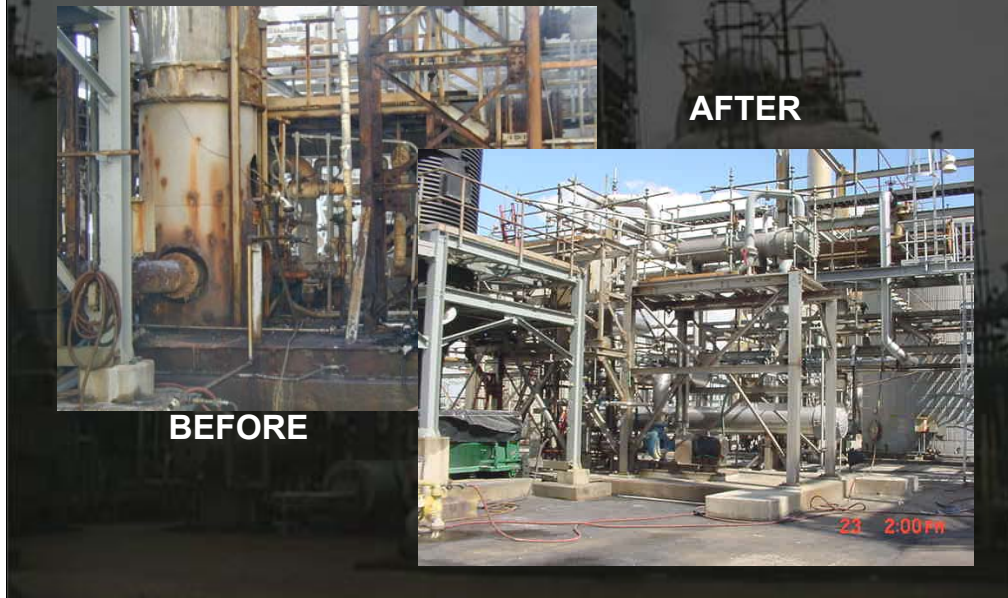
BRINE CONCENTRATION NEW BACK-END

Polk is a zero process water discharge facility. Without the ability to discharge process water, there must be some way to handle chlorides in the fuel which would otherwise build up in the process water. Polk's brine concentration system serves that purpose in a two step process: a front end vapor compression cycle to efficiently evaporate most of the water in a small blowdown stream, and a back-end direct heating and crystallization step which produces a solid ammonium chloride salt. Improvements to the front-end vapor compression cycle were discussed at previous years' conferences. While that work was in progress, the back end continued to function, but its condition had deteriorated significantly. The back-end was recently replaced with a system incorporating all the lessons learned over the last 6 years, including appropriate materials of construction which will survive the extremely corrosive conditions..

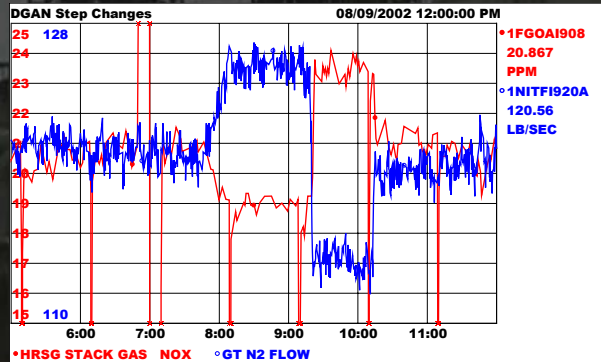
NO_x REDUCTION

In May 2003, Polk will be required to reduce NO_x emissions from the current permit level of 25 ppmv (dry basis @ 15% O₂) to 15 ppmv (same basis) which is equivalent to approximately 20 ppmv as measured in the stack. We plan to meet this requirement by converting an existing column to serve as a saturator which will add water vapor to the syngas as additional diluent. A key question is, “How much water vapor will be required?” We used two approaches in an attempt to answer the question, statistical analysis of thousands of plant data points and parametric testing were we systematically varied the amount of diluent nitrogen (DGAN), nitrogen injected directly into the syngas, and CO₂ in the syngas by adjusting conditions in the MDEA acid gas removal system. The results of varying the DGAN flow are shown in the graph.
