# Development of Permanent Mechanical Repair Sleeve for Plastic Pipe

## **Semi-Annual Report**

D.O.E. Contract No. 03-NT41880

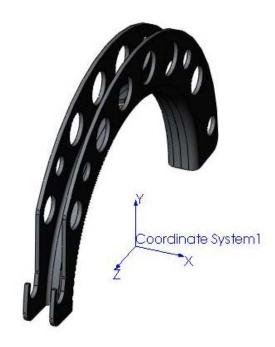
Figure 4: Small clamping structure

The entire clamp structure was made of 316 CRES (Stainless Steel). Each collar clamp half was made in two pieces by piercing and blanking the outline of the collar channel and then forming the perpendicular surface. For the prototype, the blanks were laser cut in their flat form to represent a part that would be produced on a pierce and blank die. Two simple tools, one (1) for the small collar clamp and one (1) for the large collar clamp, were built that could be loaded in a hydraulic press brake for forming the perpendicular radial surface. Two (2) blanks were loaded in the forming tool where one (1) cycle of the tool would produce a left and a right version of the part. Laser cutting the blank allowed for easily changing and optimizing the shape of the blank to produce a formed part needing only minimal cleanup before the welding process. The formed left and right parts were then placed into a welding fixture where a stitched seam weld was placed on the inside of the channel making the two pieces into one half (½) of the collar clamp as shown in Figure 4.

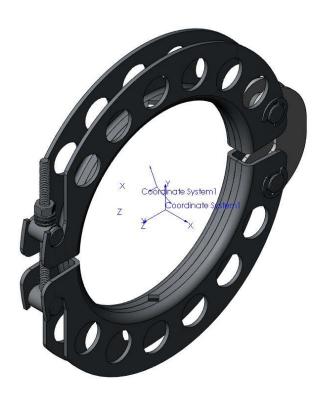
Figure 5: Assembled small clamping structure

Link plates for the clamp hinge were also laser cut for the prototypes where they will be pierced and blanked from a die in production. The threaded Swing Pin and Threaded Stud were welded together to form the tee bolt for the Small Collar Clamp. Two Small Collar Clamps halves were assembled together with the Link Plates, Link Pins and E-Rings. The tee bolt was crimped in to the saddle on one of the collar halves to capture the bolt and allow it to pivot. This with the Nylock nut completed the Small Collar Clamp assembly as shown in Figure 5.

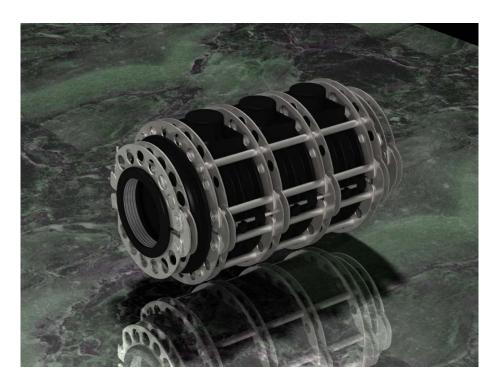
Figure 9: Final prototype

Because the mechanical repair fitting is intended to cope with the entire range of damage that can occur in service under typical line pressure of up to 60 psig, the principal design challenge is not only ensuring the repair of a "blowing" failure; i.e., a through wall opening in the pipe wall through which pressurized gas escapes, but also ensuring a leak tight seal and ability to withstand the internal pressures. To that end, based on a series of FEA analysis and the prototype build, as shown in Figure 9, it has been shown that the objectives of this program can be successfully achieved.
