MONITORING TECHNOLOGY FOR EARLY DETECTION OF INTERNAL CORROSION FOR PIPELINE INTEGRITY

Final Report March 25, 2002 – September 24, 2003

Glenn M. Light, Sang Y. Kim, Robert L. Spinks, and Hegeon Kwun Southwest Research Institute[®] San Antonio, TX

DOE Award Number DE-FC26-02NT41319 SwRI[®] Project 14.05529

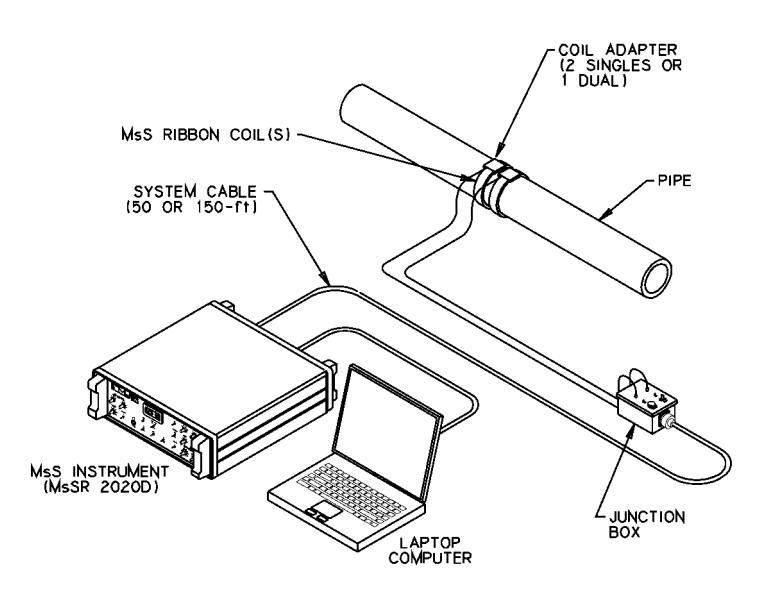
Figure 1. A schematic diagram of the MsS and associated instruments

pipe-wall and propagate along the pipe. When guided waves are reflected from welds or defects in the pipe arrive at the sensor location, the waves generate electric voltage signals in the coil. The generation and detection of the guided waves are achieved electromagnetically via a physical phenomenon called "magnetostrictive" and its inverse effects. Figure 1 illustrates the MsS system as applied to pipe.

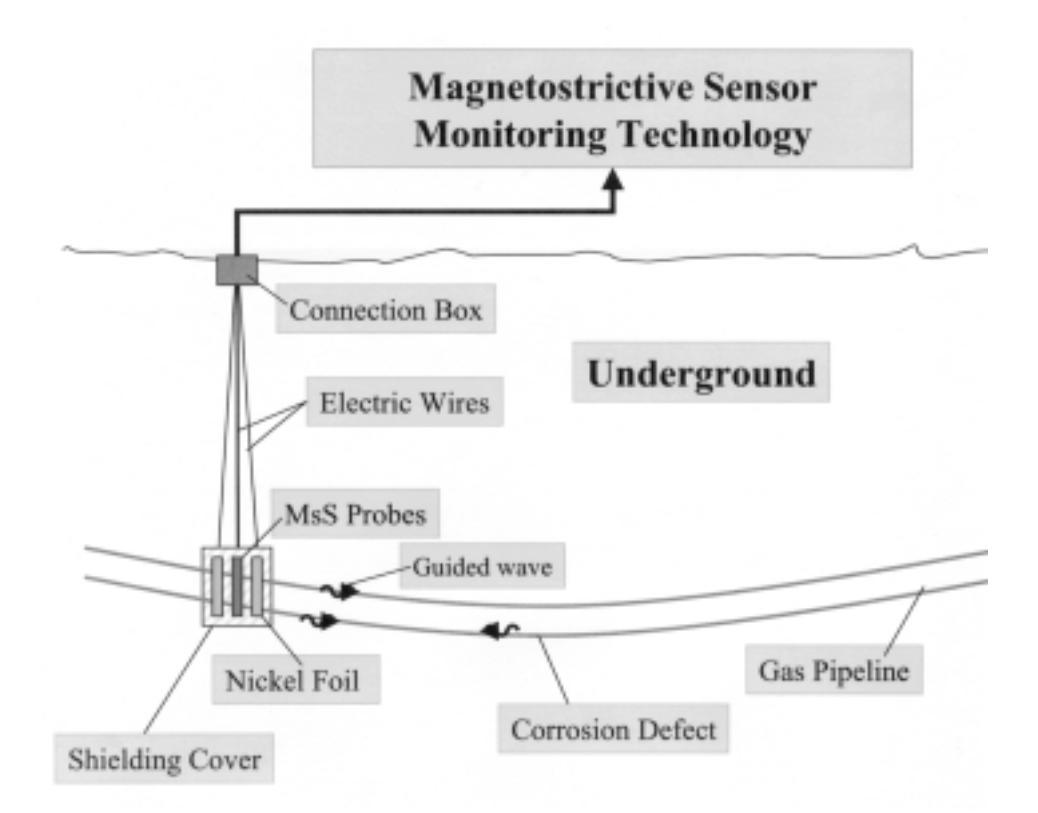
Figure 2. Illustration of MsS torsional wave technology applied to pipeline in monitoring scenario

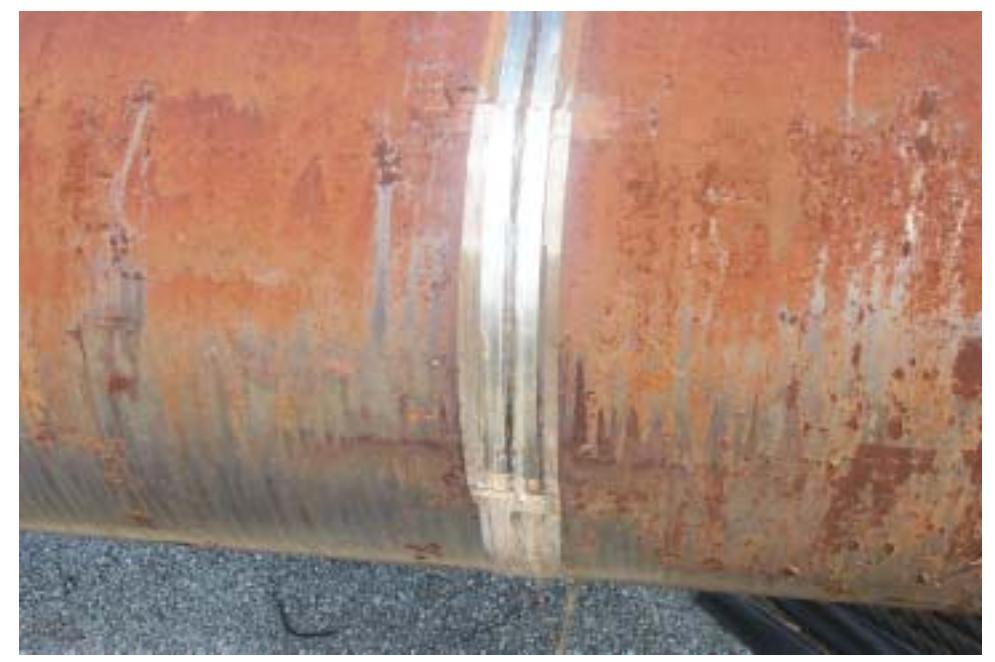
Figure 3. Photograph showing nickel strip bonded to the 610-mm (24-inch)-diameter pipe. The two strips are used to provide directionality in the transmitted signal.

A T-wave MsS, consisting of a 0.25-mm (0.01-inch)-thick nickel foil epoxied to the pipe (shown in Figure 3) and a coil consisting of 20 windings wrapped around the nickel foil (shown in Figure 4), was used to collect 32-kHz MsS data from the 610-mm (24-inch)-OD, 9.5-mm (0.375)-inch-thick wall pipe. Data were collected from the pipe prior to and after placing various types of artificial simulated corrosion pits. These simulated corrosion pits ranged in size from approximately 5 mm (0.2 inch) deep by 40.6 mm (1.6 inches) in diameter to 9.5mm (0.375 inch) deep by 57.2 mm (2.25 inches) in diameter (or 0.33% to 1% of the total pipe wall cross section). These defects were placed on the outside and inside surfaces of the test pipe. MsS data were collected from 0.33% defects, 0.66% defects, and 1% defects. Locations of defects along the pipe axis are shown in Figure 5 and schematically represented in Figure 6 (with the depths and diameters of the various percentage defects). A photograph and replica of the 1% defect are shown in Figure 7.

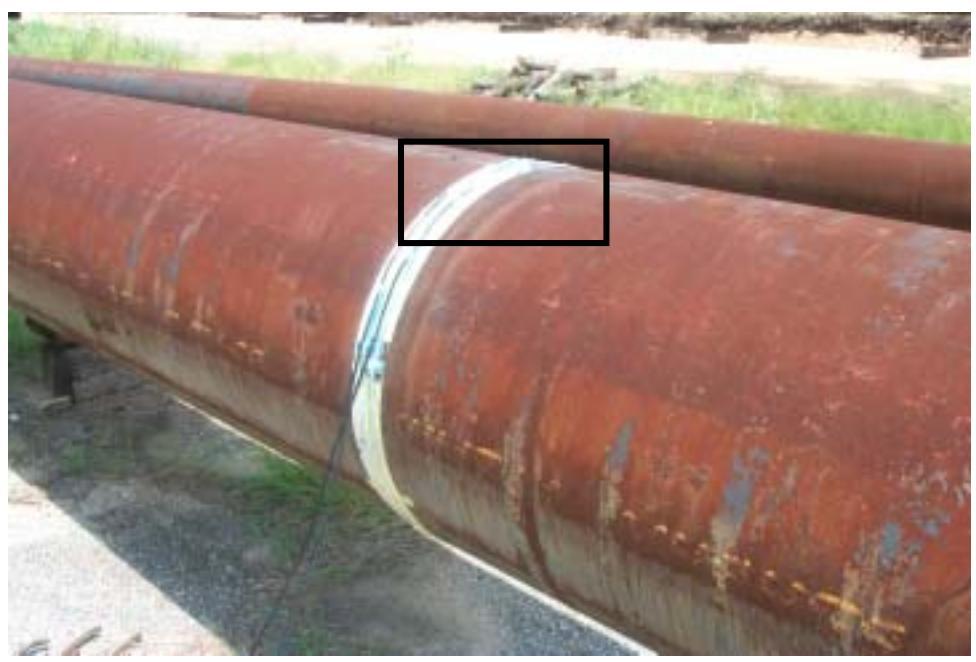
Figure 4. Photograph of the nickel strip and coil bonded to the test pipe showing the low height profile of the MsS

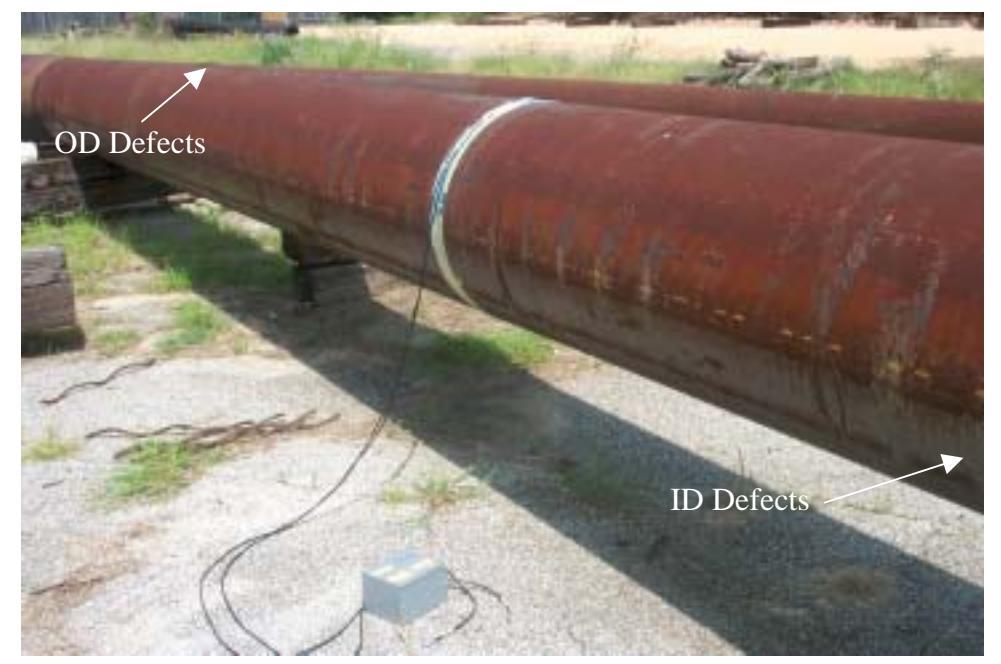
Figure 5. Photograph of the 610-mm (24-inch)-diameter pipe showing the location of the MsS and the OD and ID defects along the pipe axis

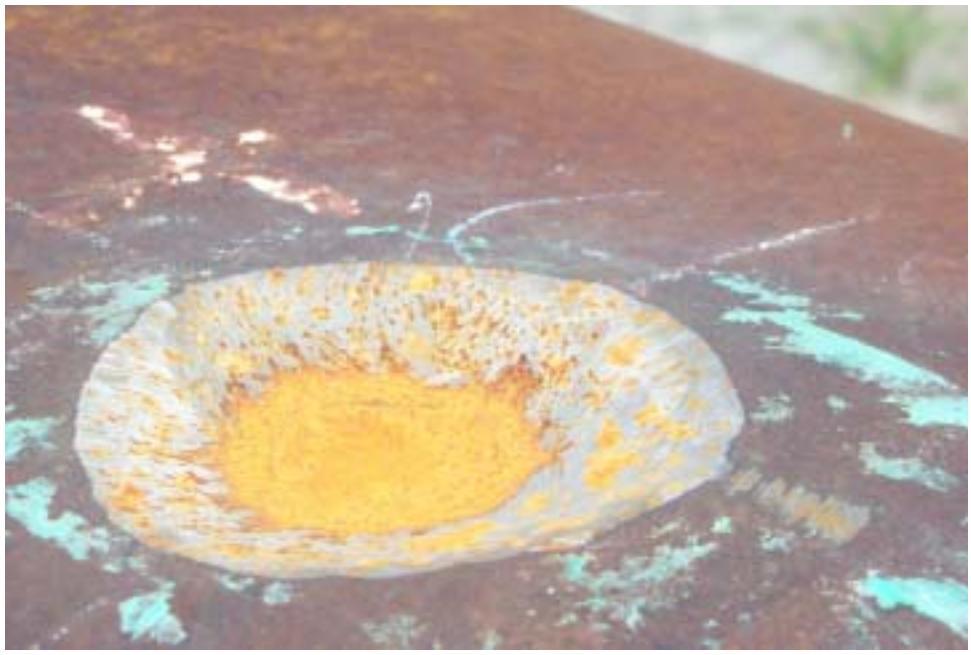
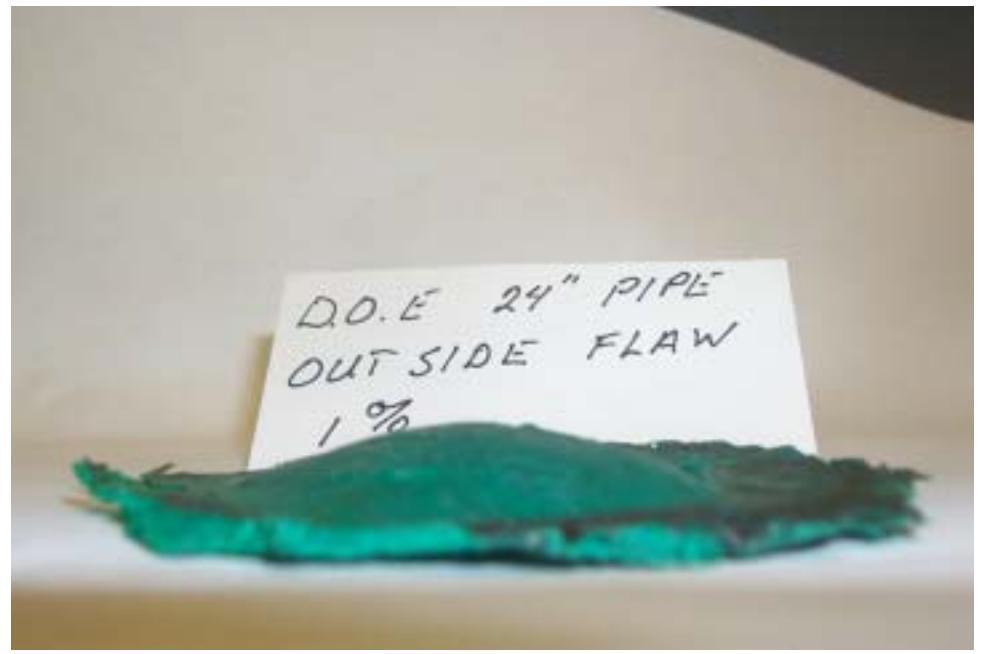
Figure 7. Photograph showing (a) the topography and (b) replica of the intentionally placed 1% cross-sectional defects

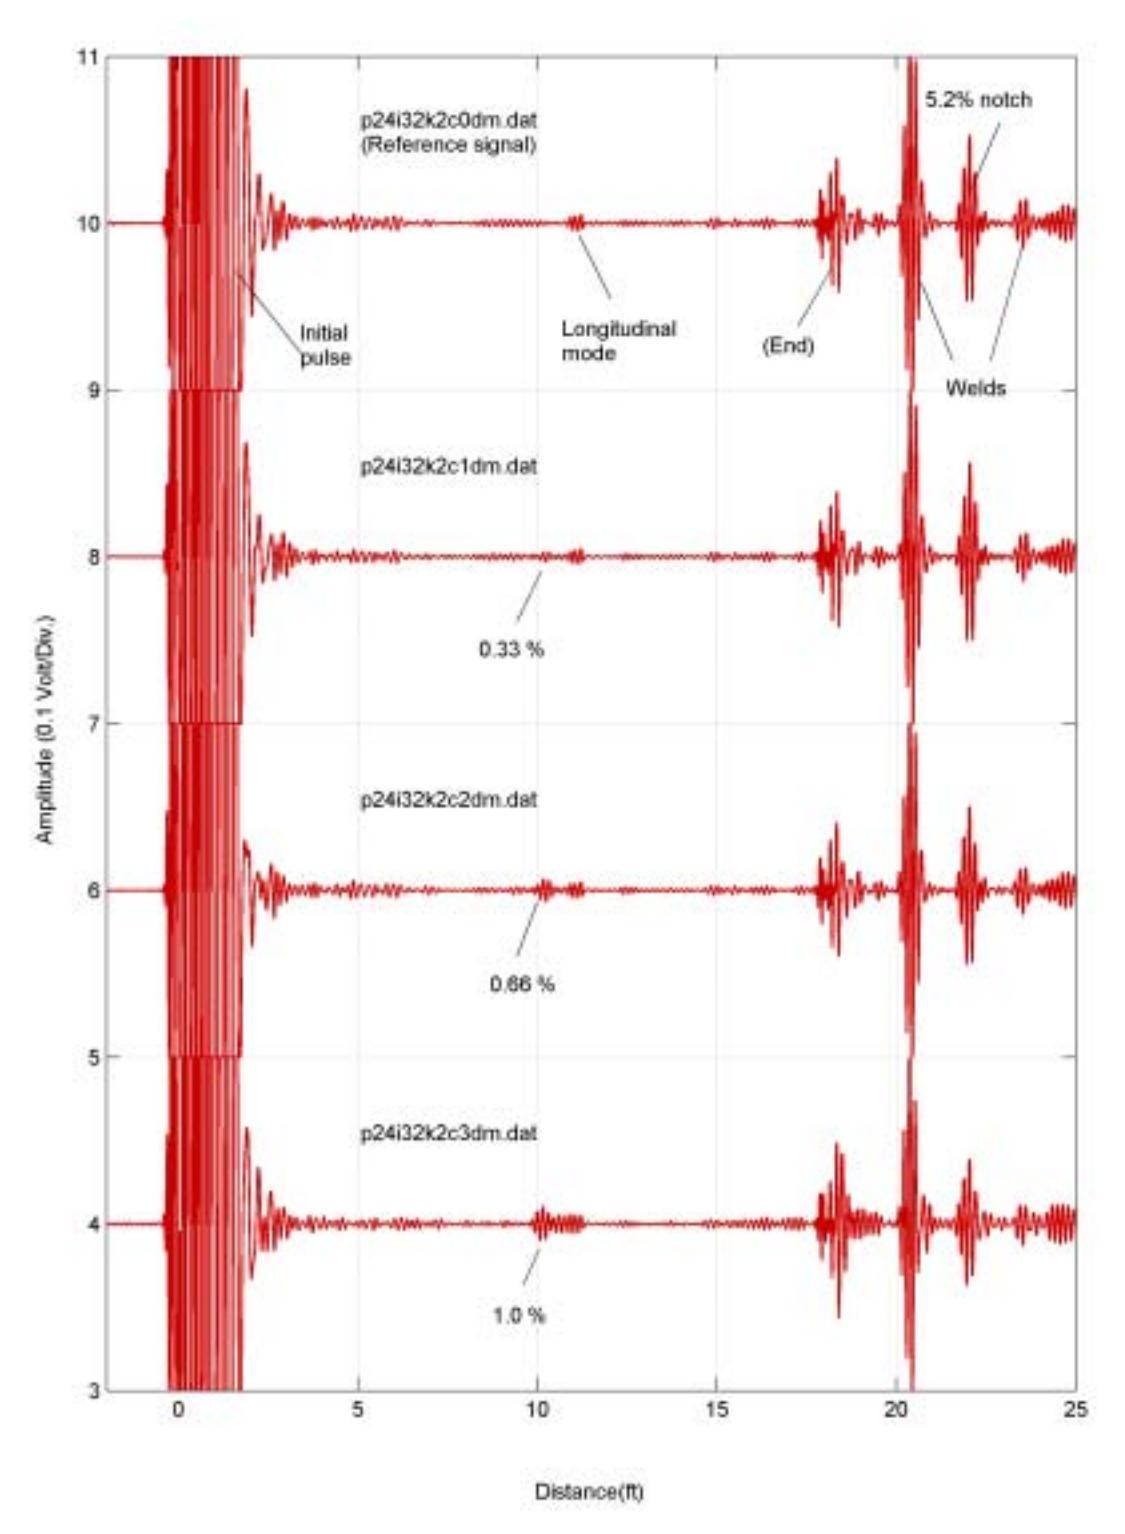
Figure 8. MsS inspection data obtained from the region of the pipe where the OD flaw is located. The top waveform shows no defect. The remaining waveforms are from a 0.33% defect placed in the pipe, and the defect size is increased to 0.66% and 1% of the pipe wall cross section.

MsS data were collected from the intentionally placed ID and OD defects. The OD defects were on one side of the MsS sensor and the ID defects were on the other side. Figure 8 shows the actual inspection data collected from the pipe with no OD defect, with an OD defect that is approximately 0.33% of the pipe wall cross section, with the OD defect increased to 0.66% of the pipe wall cross section, and finally with the OD defect increased to 1% of the pipe wall cross section. This defect is approximately 3 m (10 feet) from the MsS. The 0.33% defect is difficult to see in Figure 8, but the 0.66% and 1% defects can clearly be detected. The preliminary monitoring data are shown in Figure 9 where the MsS inspection data collected prior to placing defects in the pipe are used as the reference waveform. These data clearly show that defects as small as 0.33% can be detected in the monitoring mode. The signals on the right side of the last waveform in Figure 9 are caused by slight changes in temperature and the slight offset in subtracting two large signals. In addition, when the amplitude of the signal that would normally travel to the weld and the 5.2% notch is decreased because the signal is scattered by the 0.33%, 0.66%, and 1% defects, then the difference waveform between the reference where there is no defect and the cases where the defect at 3 m (10 feet) increases from 0.33% to 1% would yield a larger and larger difference in the signals observed after the defect at 3 m (10 feet). This behavior is clearly seen in the difference data for the 0.33% and 1% defects. It is unclear why it appears to be minimal in the 0.66% data difference waveform. Similar data are shown in Figure 10 with the video signals.

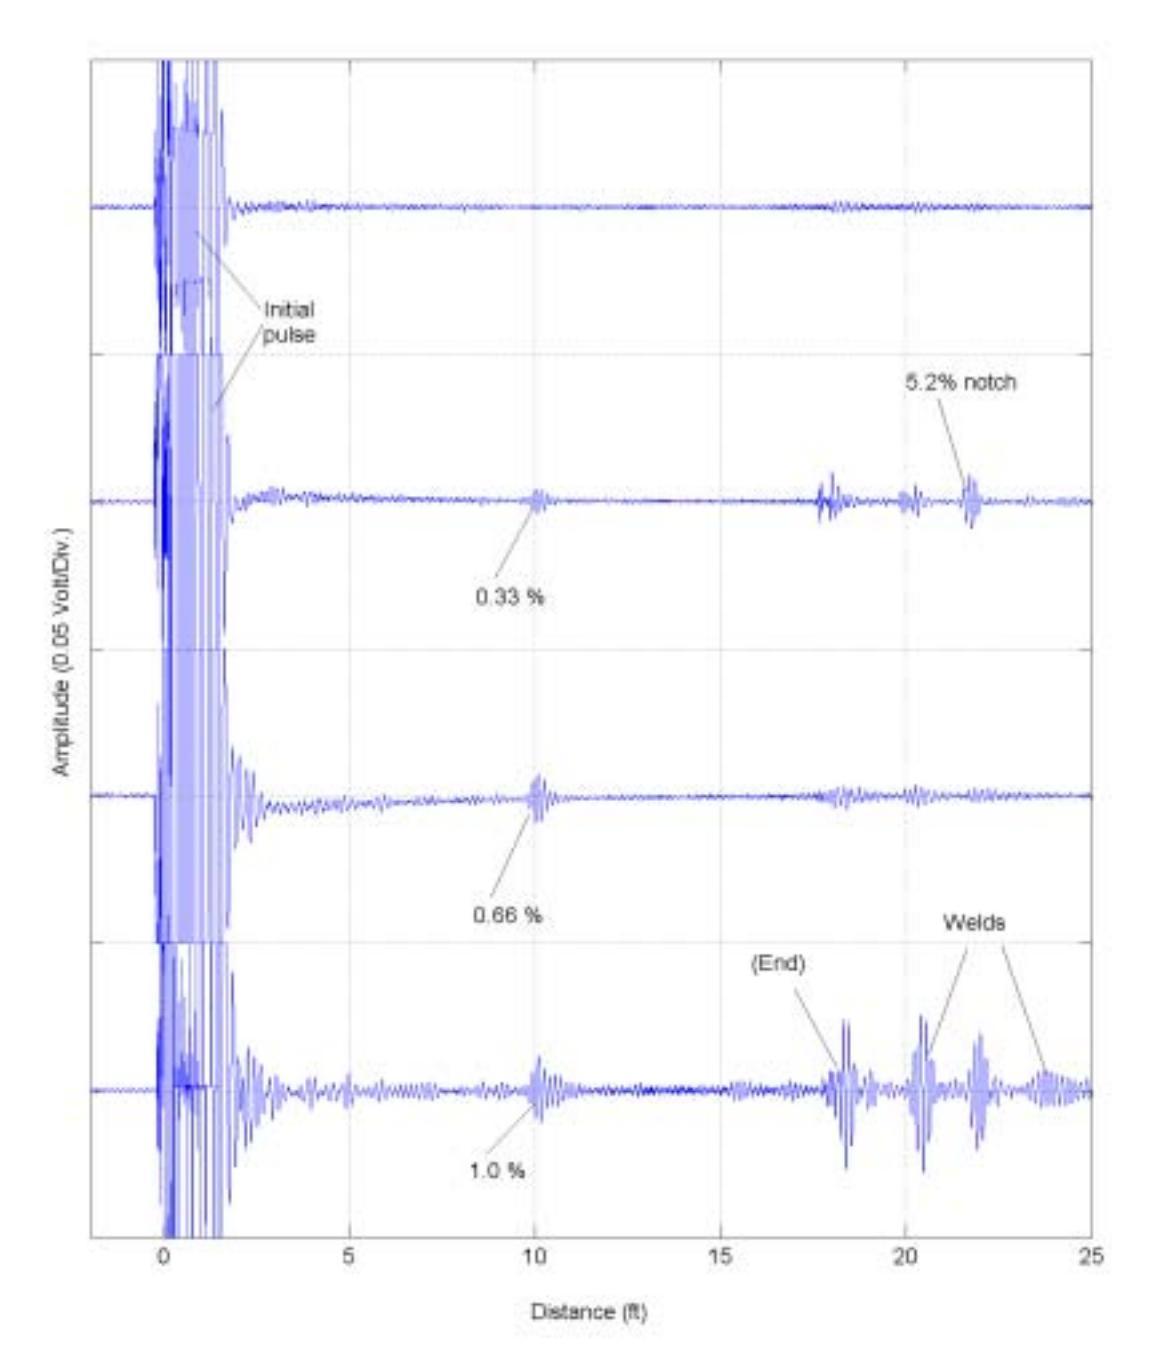
Figure 9. Monitoring data (subtracted from the reference) obtained from the region of the pipe where the OD flaw is located. The top waveform is the result of subtracting two waveforms from the pipe where there is no defect. The remaining waveforms are the difference waveforms between the reference waveform and the waveform with a 0.33% defect placed in the pipe, and the defect size is increased to 0.66% and 1% of the pipe wall cross section.

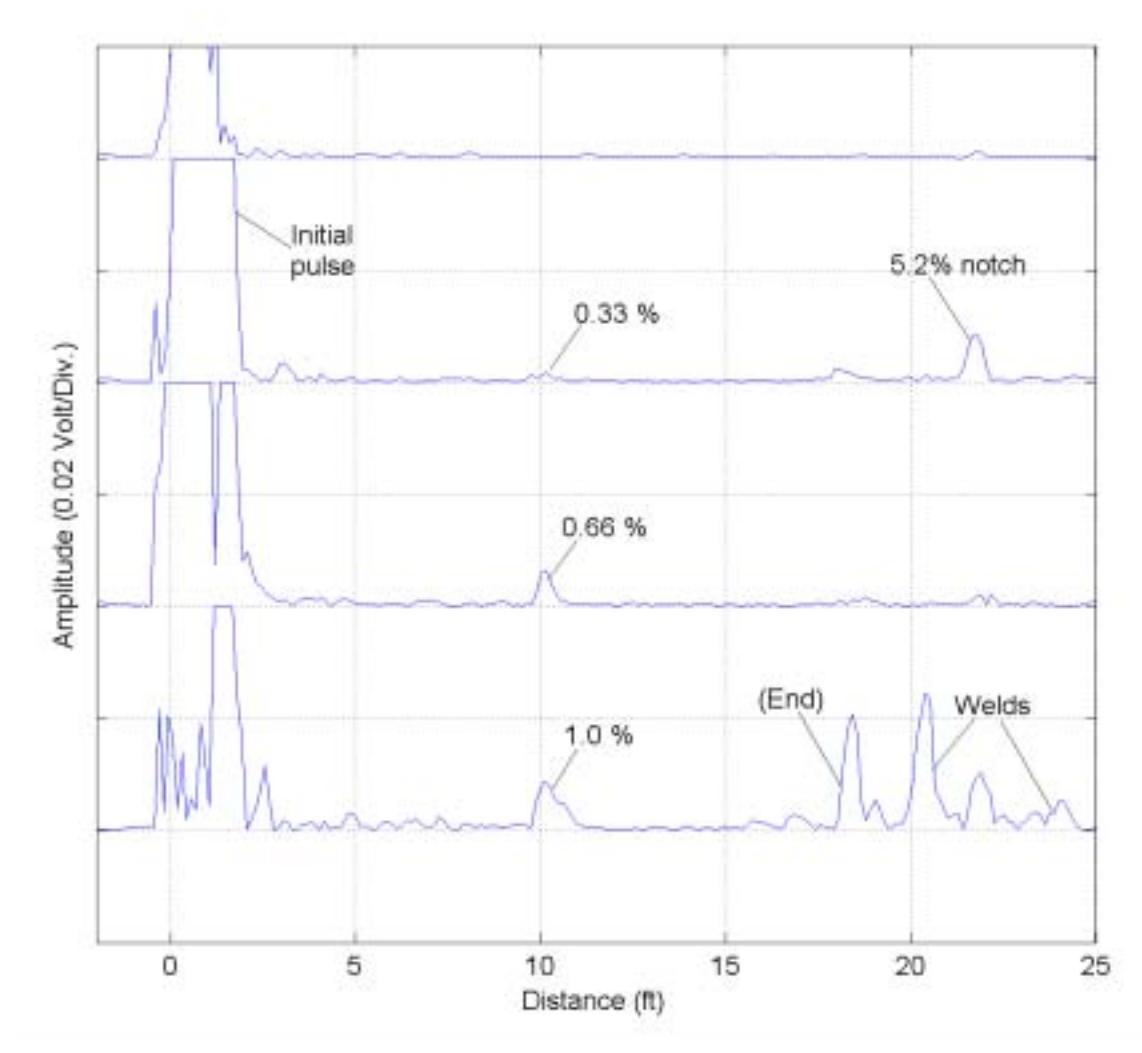
Figure 10. MsS monitoring data (video) obtained from the region of the pipe where the OD flaw is located. The top waveform is the result of subtracting two waveforms from the pipe where there is no defect. The remaining waveforms are the difference waveforms between the reference waveform and the waveform with a 0.33% defect placed in the pipe, and the defect size is increased to 0.66% and 1% of the pipe wall cross section.

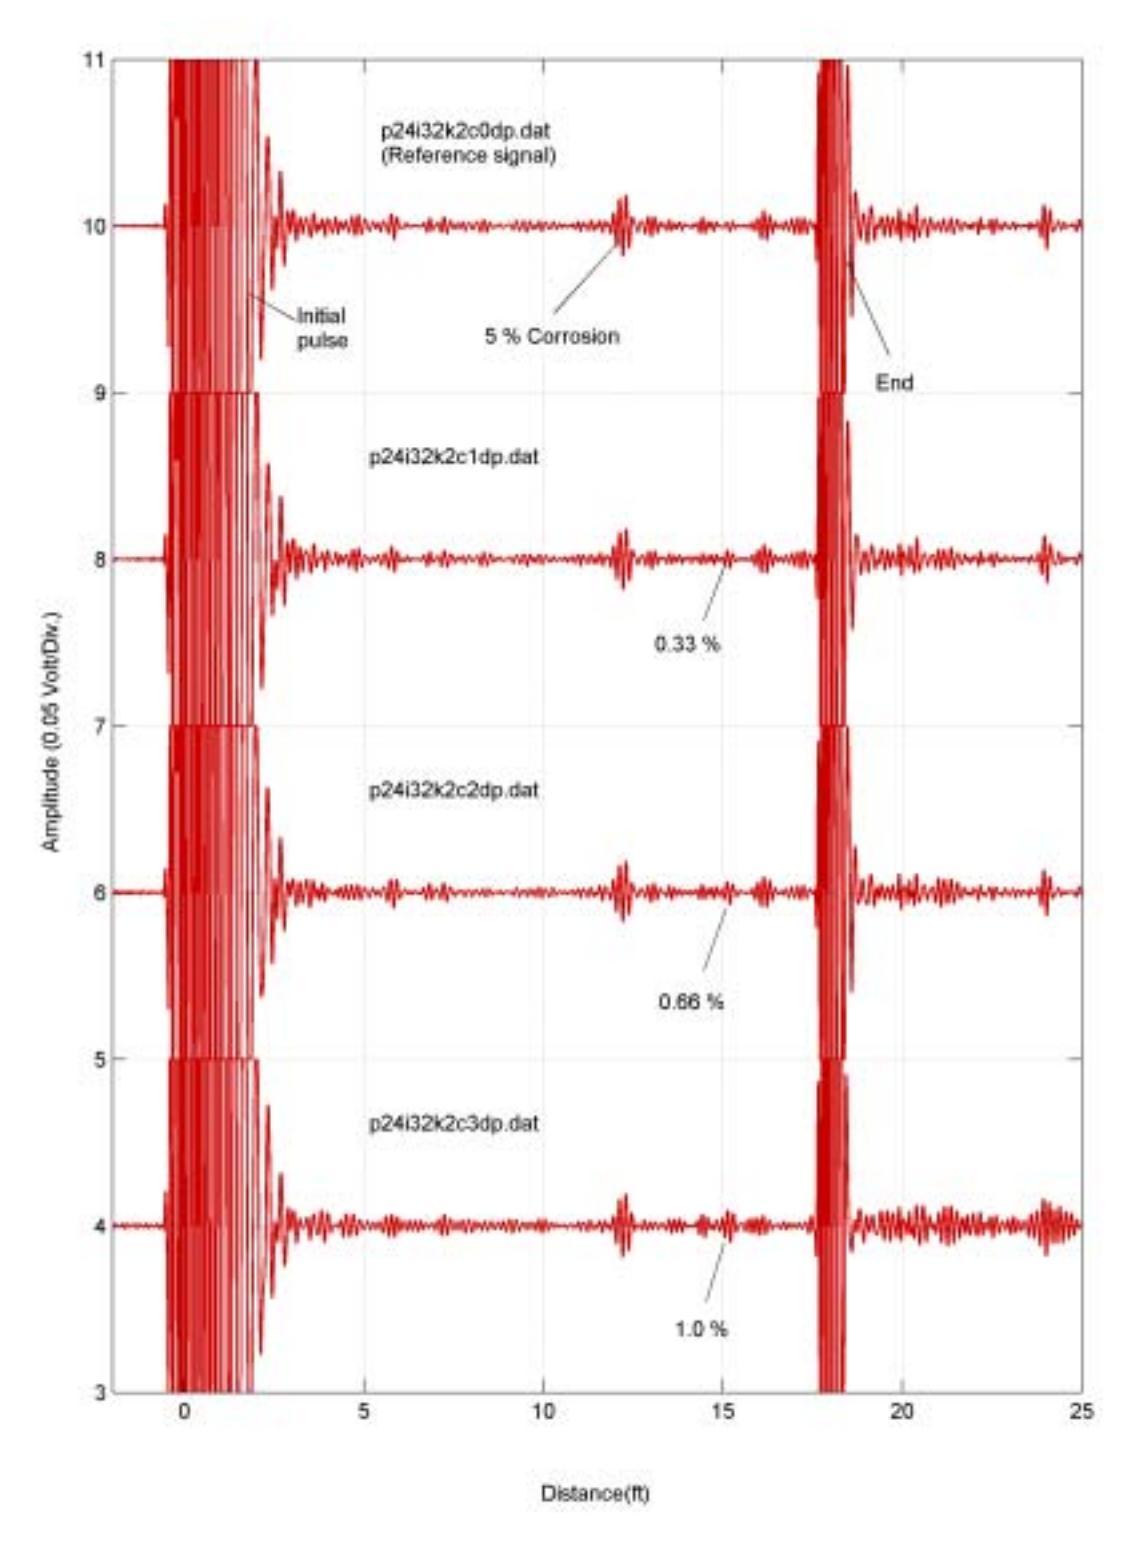
Figure 11. MsS inspection data obtained from the region of the pipe where the ID flaw is located. The top waveform shows no defect. The remaining waveforms are from a 0.33% defect placed in the pipe, and the defect size is increased to 0.66% and 1% of the pipe wall cross section.

Similar results were obtained for the ID defects. The inspection data waveforms are shown in Figure 11 and the monitoring (subtracted) waveform data are shown in Figure 12 and Figure 13.

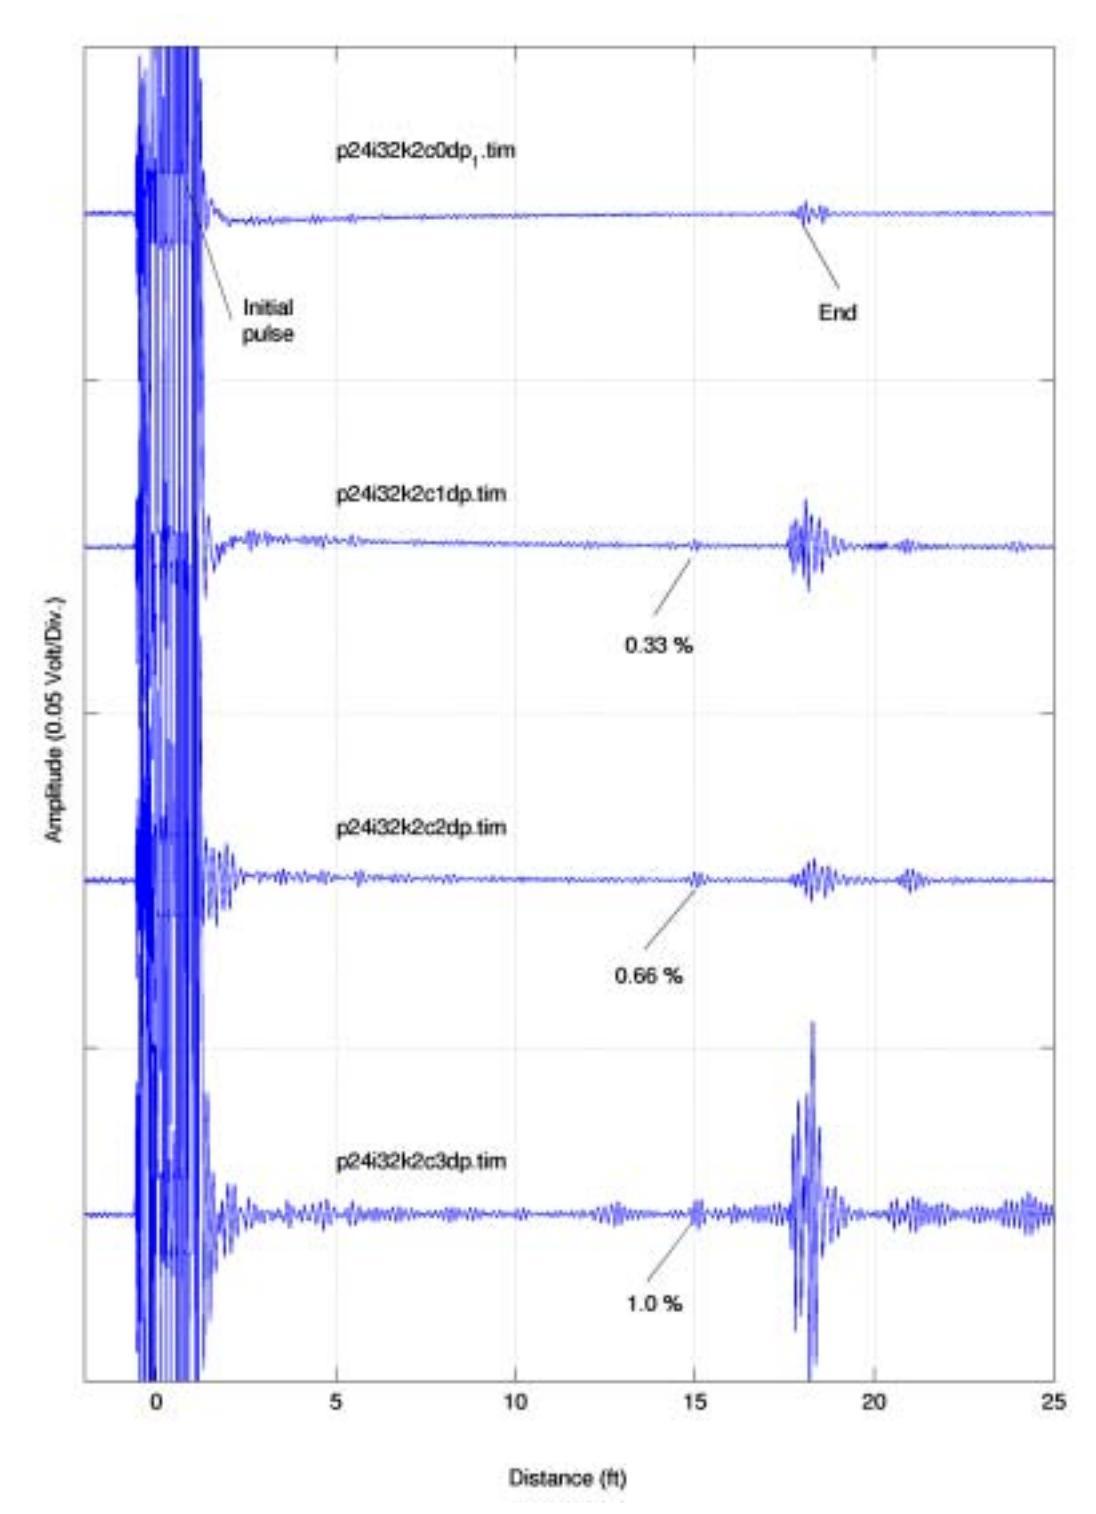
Figure 12. MsS monitoring data (subtracted from the reference) obtained from the region of the pipe where the ID flaw is located. The top waveform is the result of subtracting two waveforms from the pipe where there is no defect. The remaining waveforms are the difference waveforms between the reference waveform and the waveform with a 0.33% defect placed in the pipe, and the defect size is increased to 0.66% and 1% of the pipe wall cross section.

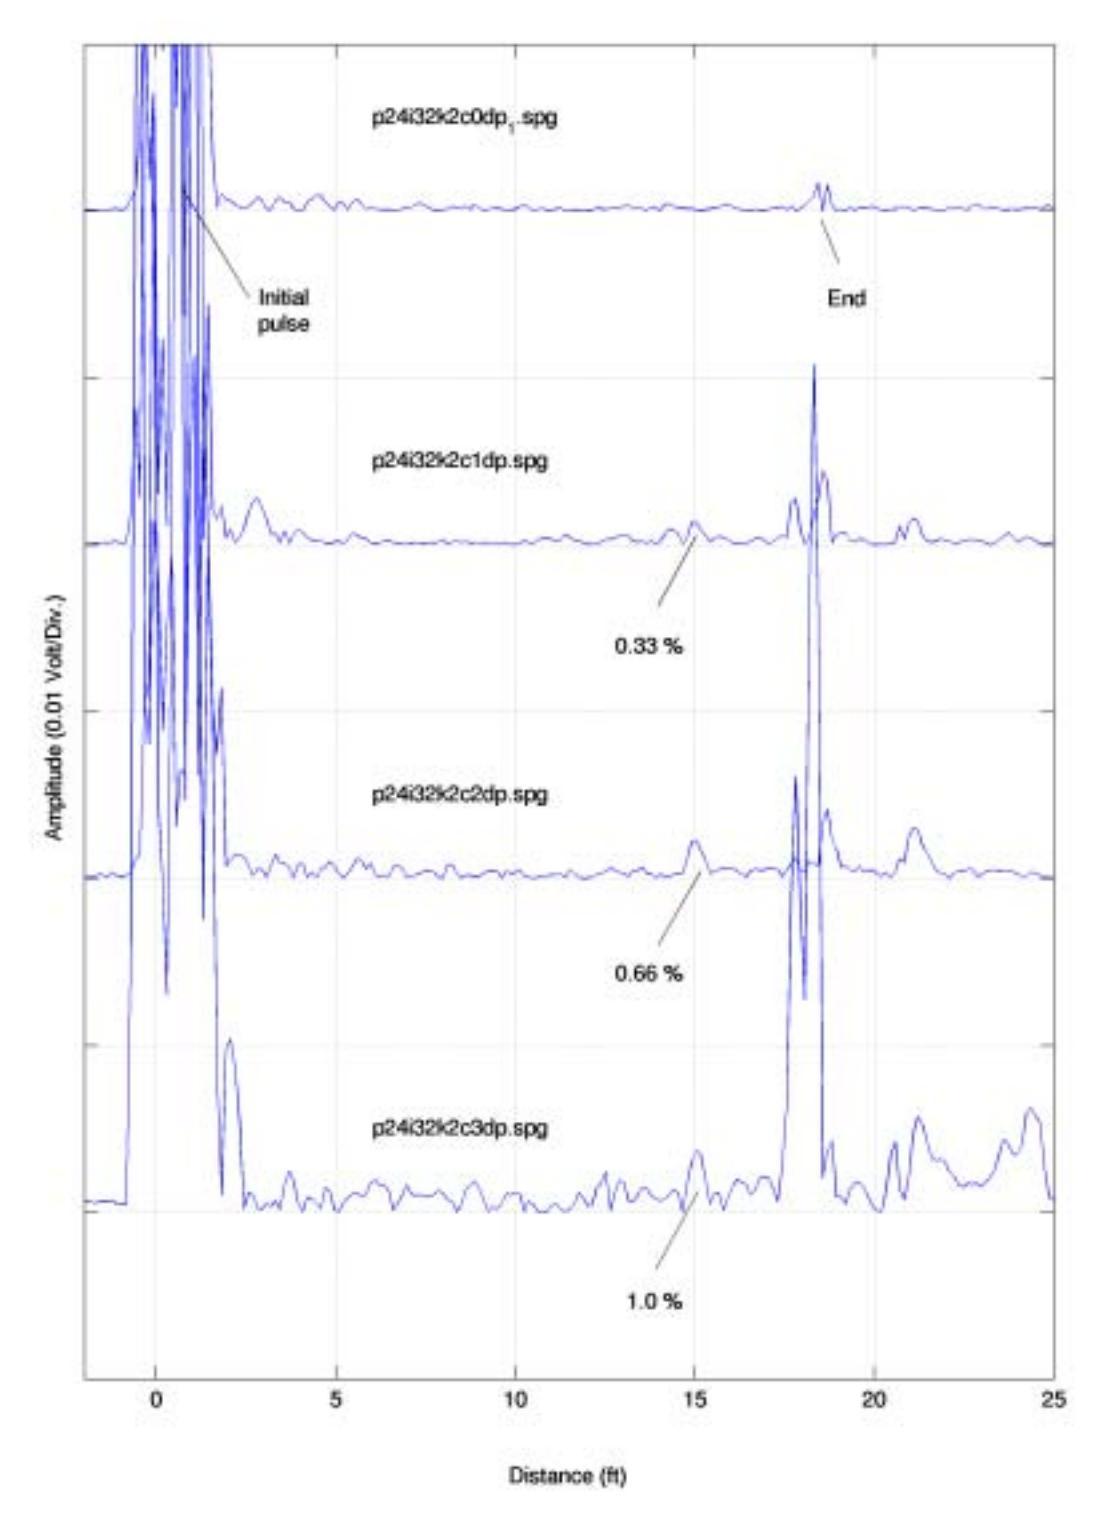
Figure 13. MsS monitoring data (video) obtained from the region of the pipe where the ID flaw is located. The top waveform is the result of subtracting two waveforms from the pipe where there is no defect. The remaining waveforms are the difference waveforms between the reference waveform and the waveform with a 0.33% defect placed in the pipe, and the defect size is increased to 0.66% and 1% of the pipe wall cross section.

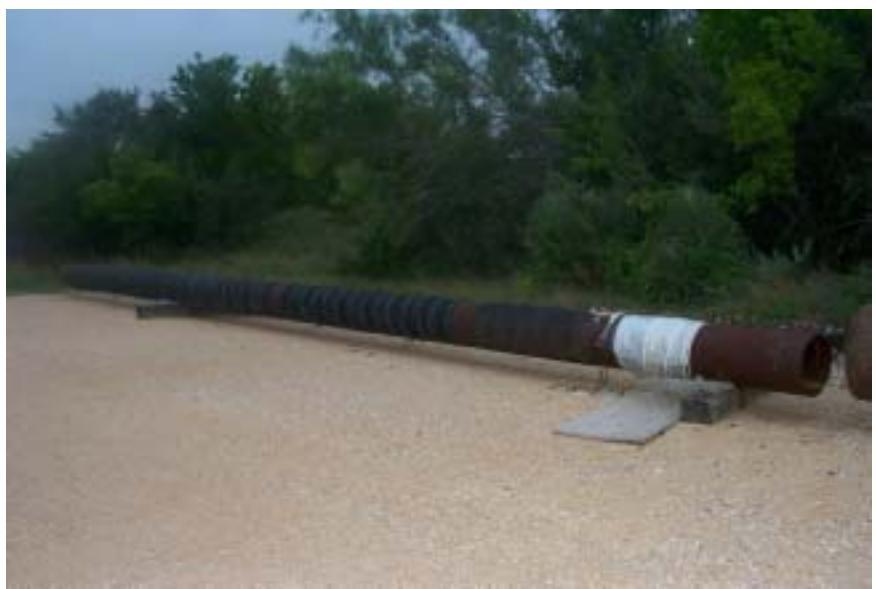
Figure 14. Photograph of the bitumen coated, 16-inch-diameter pipe

To address the bitumen effect, a nickel strip was epoxied onto 406-mm (16-inch)-OD, bitumen-coated pipeline as shown in Figure 14 that had a number of 1% defects at various axial locations. Data were collected at 10 and 20 kHz guided wave frequencies. No data were collected at higher frequencies because previous work [1] has shown that bitumen-coated pipe would not effectively propagate 32-kHz waves. The experiments showed that 20-kHz guided waves were not effectively transmitted. However, 10-kHz guided waves did appear to be effectively propagated. Data were collected on this 406-mm (16-inch)-OD pipe after a 1% defect was paced in the pipe approximately 3 m (10 feet) from the MsS. The data obtained show that a 1% defect could not be detected using the 10-kHz nickel foil probe at a distance of 3 m (10 feet as shown in Figure 15. This indicates that bitumen-coated pipe is very difficult to inspect and monitor using the present state of the art of the MsS technology.

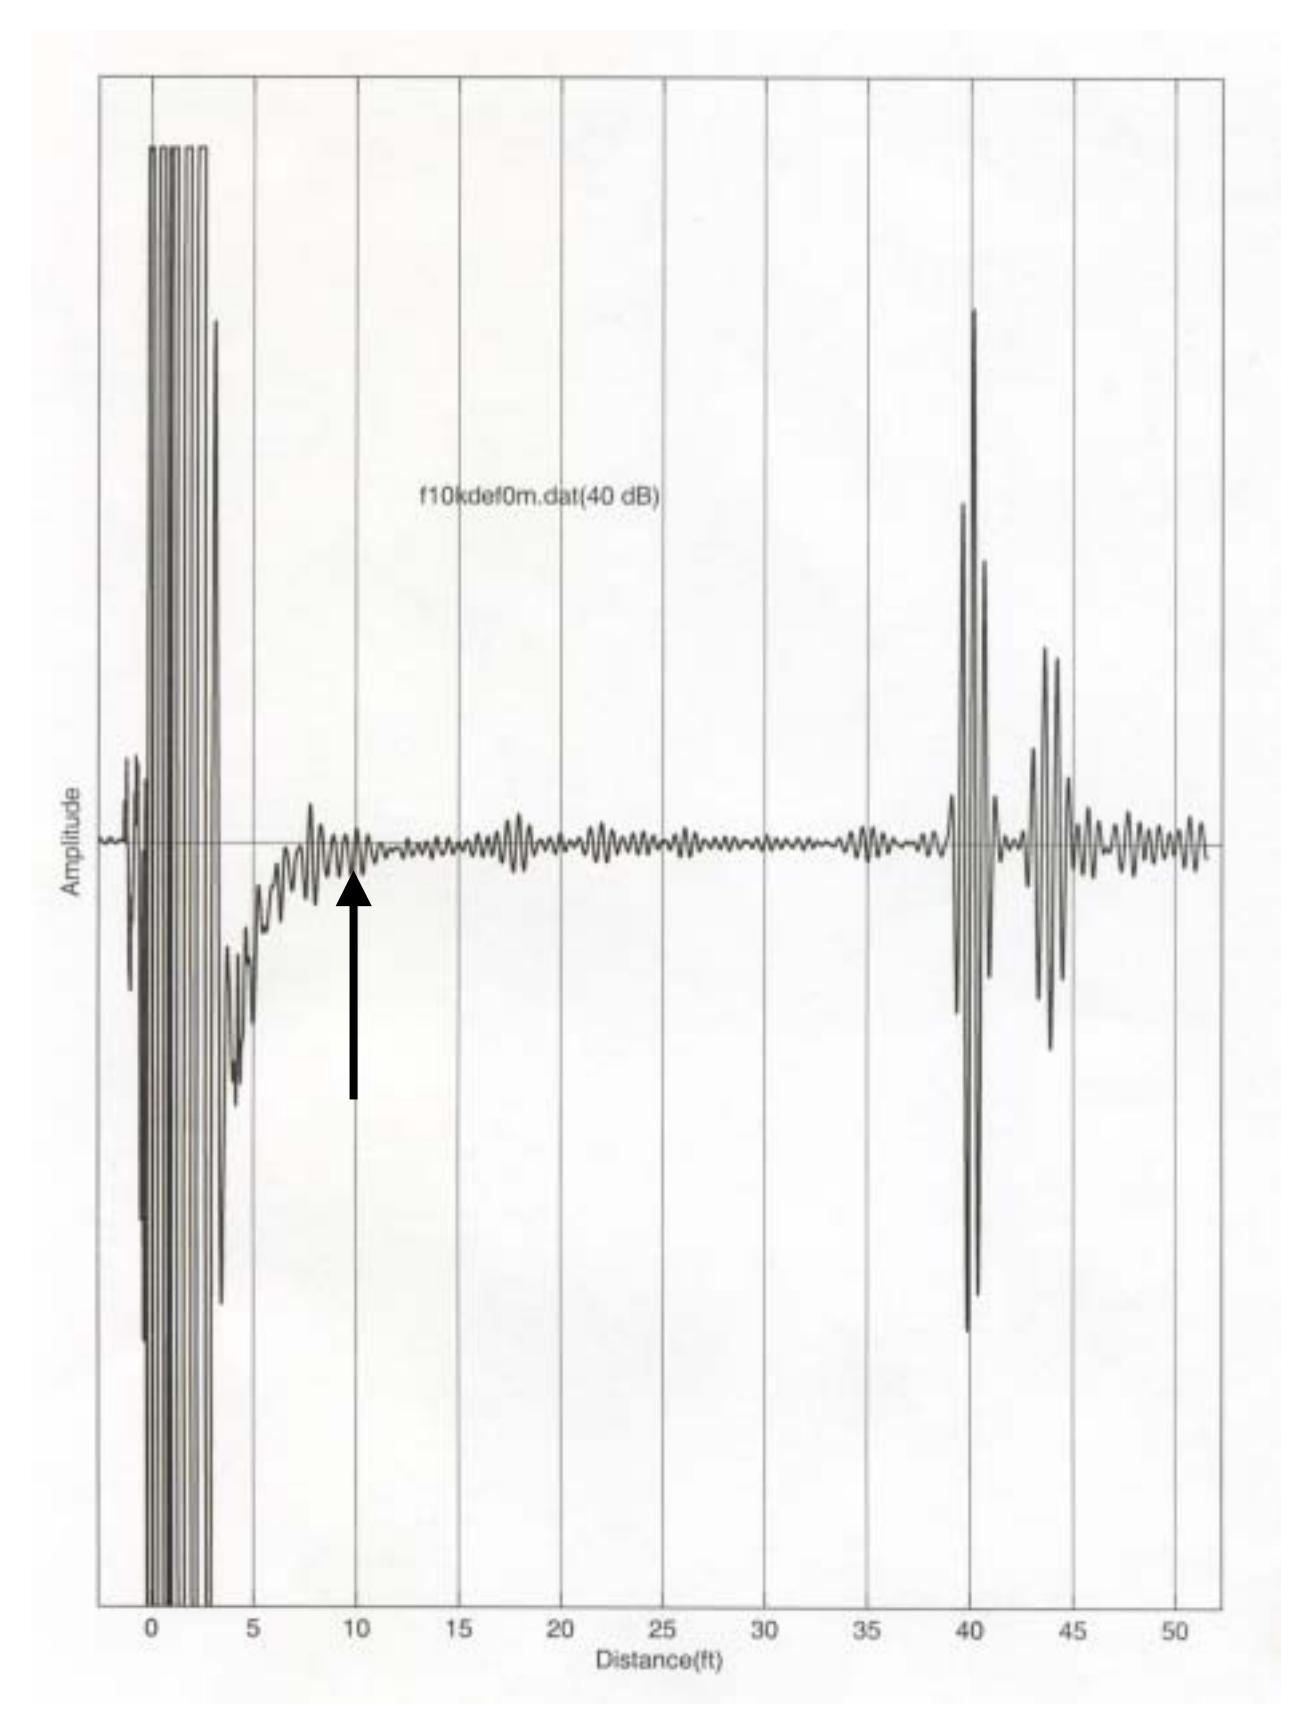
Figure 15. Data showing that a 1% defect could not be detected using the 10-kHz nickel foil probe at a distance of 10 feet flaw distance

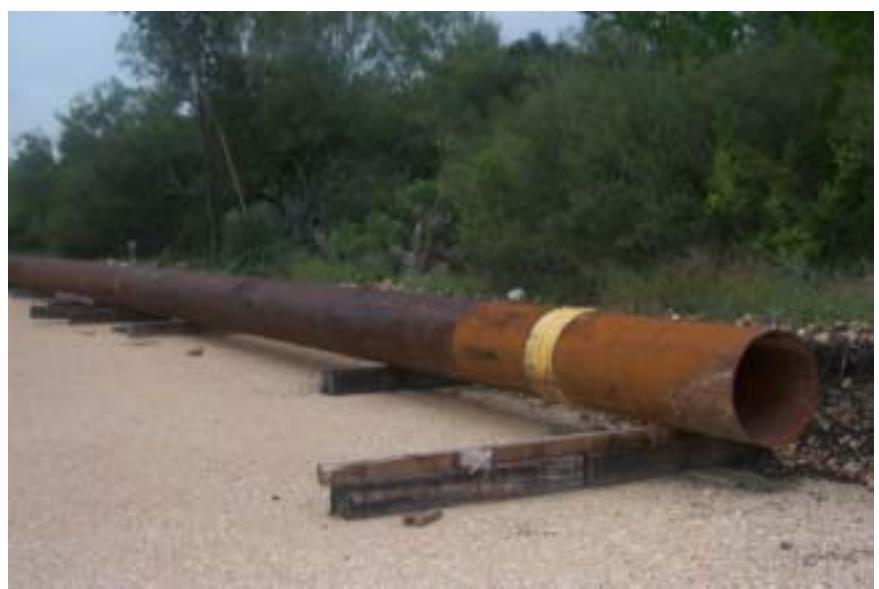
Figure 16. Photograph of two 40-foot-long sections of 24-inch-diameter pipe welded together

To address the effects of the MsS signal on buried pipe, a long pipe was constructed from two 12.2-mm (40-foot)-long sections of 610-mm (24-inch)-diameter pipe obtained from El Paso Corporation and welded together as shown in Figure 16.

SwRI placed several MsSs on buried pipe section to evaluate the effects of the MsS being buried. The 610-mm (24-inch)-OD, 24.4-m (80-foot)-long pipe (shown in Figure 16 prior to burying and in Figure 17 after burying) was buried on the grounds at SwRI so that both ends of the pipe were accessible. The MsSs were buried with the wire leads accessible aboveground (as shown in Figure 18). The location of the MsS with respect to the welds and defects is illustrated in Figure 19. MsS data using 20 kHz were collected from this pipe after it was buried. MsS reference data were collected using the buried sensor before simulated corrosion was placed in the pipe. These data are shown in Figures 20 through 23. It is important to note that the data shown in the two top waveforms in Figures 20 through 23 represent reference data taken within a few minutes of each other. The respective difference waveforms should show very little difference and indeed the difference waveforms are almost a straight line showing no difference (except at the 0 point in the waveform). The amplitude differences of digitized saturated signals do not accurately subtract.

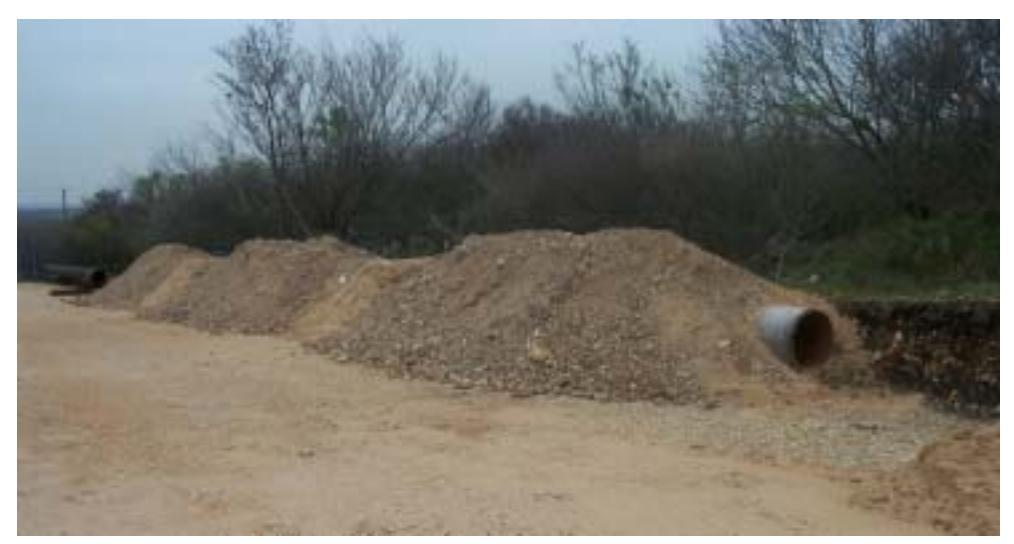
Figure 17. Photograph of the 24.4 m (80-foot)-long, 610-mm (24-inch)-diameter pipe buried under approximately 0.6 m (2 feet) of soil

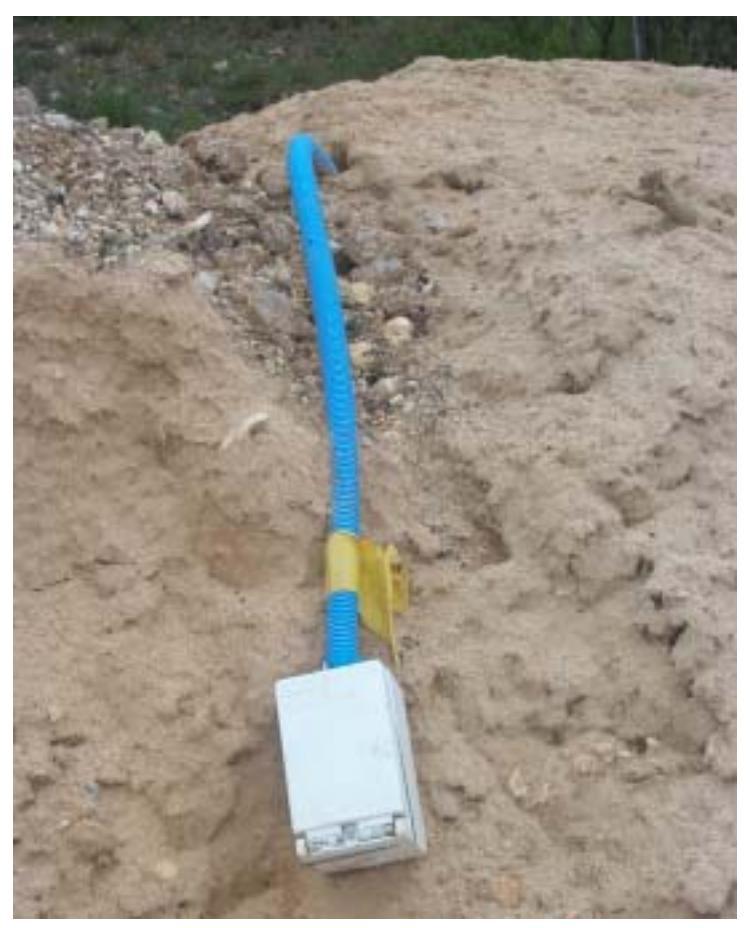
Figure 18. Photograph of one of the locations of an MsS bonded to the buried 610-mm (24-inch)-diameter pipe

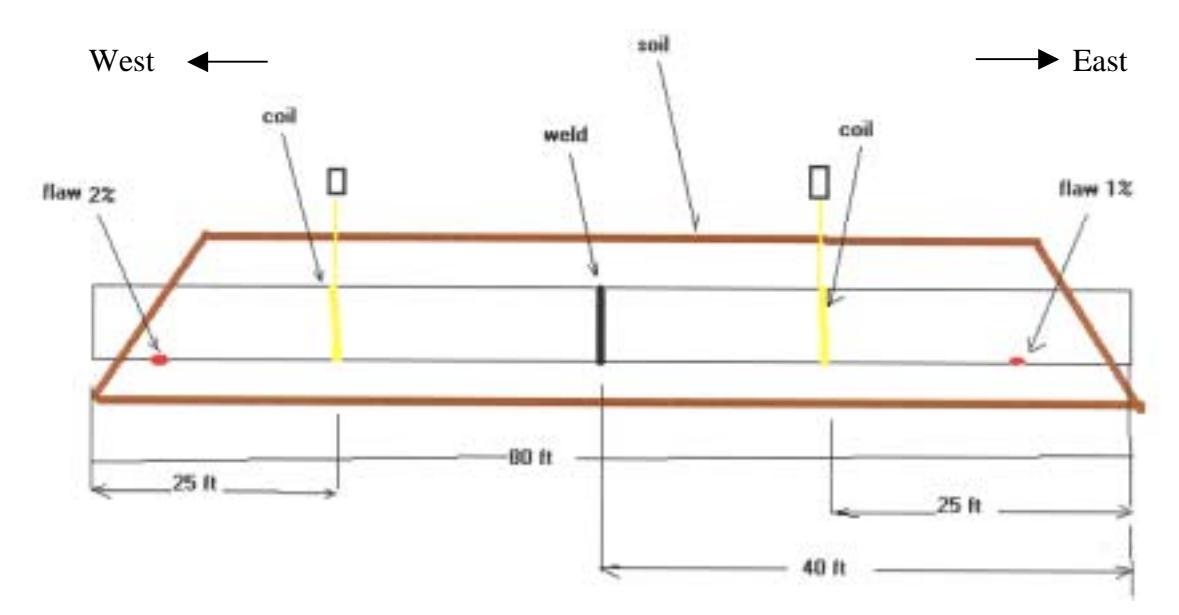
Figure 19. Illustration of the buried 610-mm (24-inch)-diameter pipe showing the locations of the MsS probes, the weld, and the intentionally placed simulated defects
