MONITORING TECHNOLOGY FOR EARLY DETECTION OF INTERNAL CORROSION FOR PIPELINE INTEGRITY

Final Report March 25, 2002 – September 24, 2003

Glenn M. Light, Sang Y. Kim, Robert L. Spinks, and Hegeon Kwun Southwest Research Institute[®] San Antonio, TX

DOE Award Number DE-FC26-02NT41319 SwRI[®] Project 14.05529

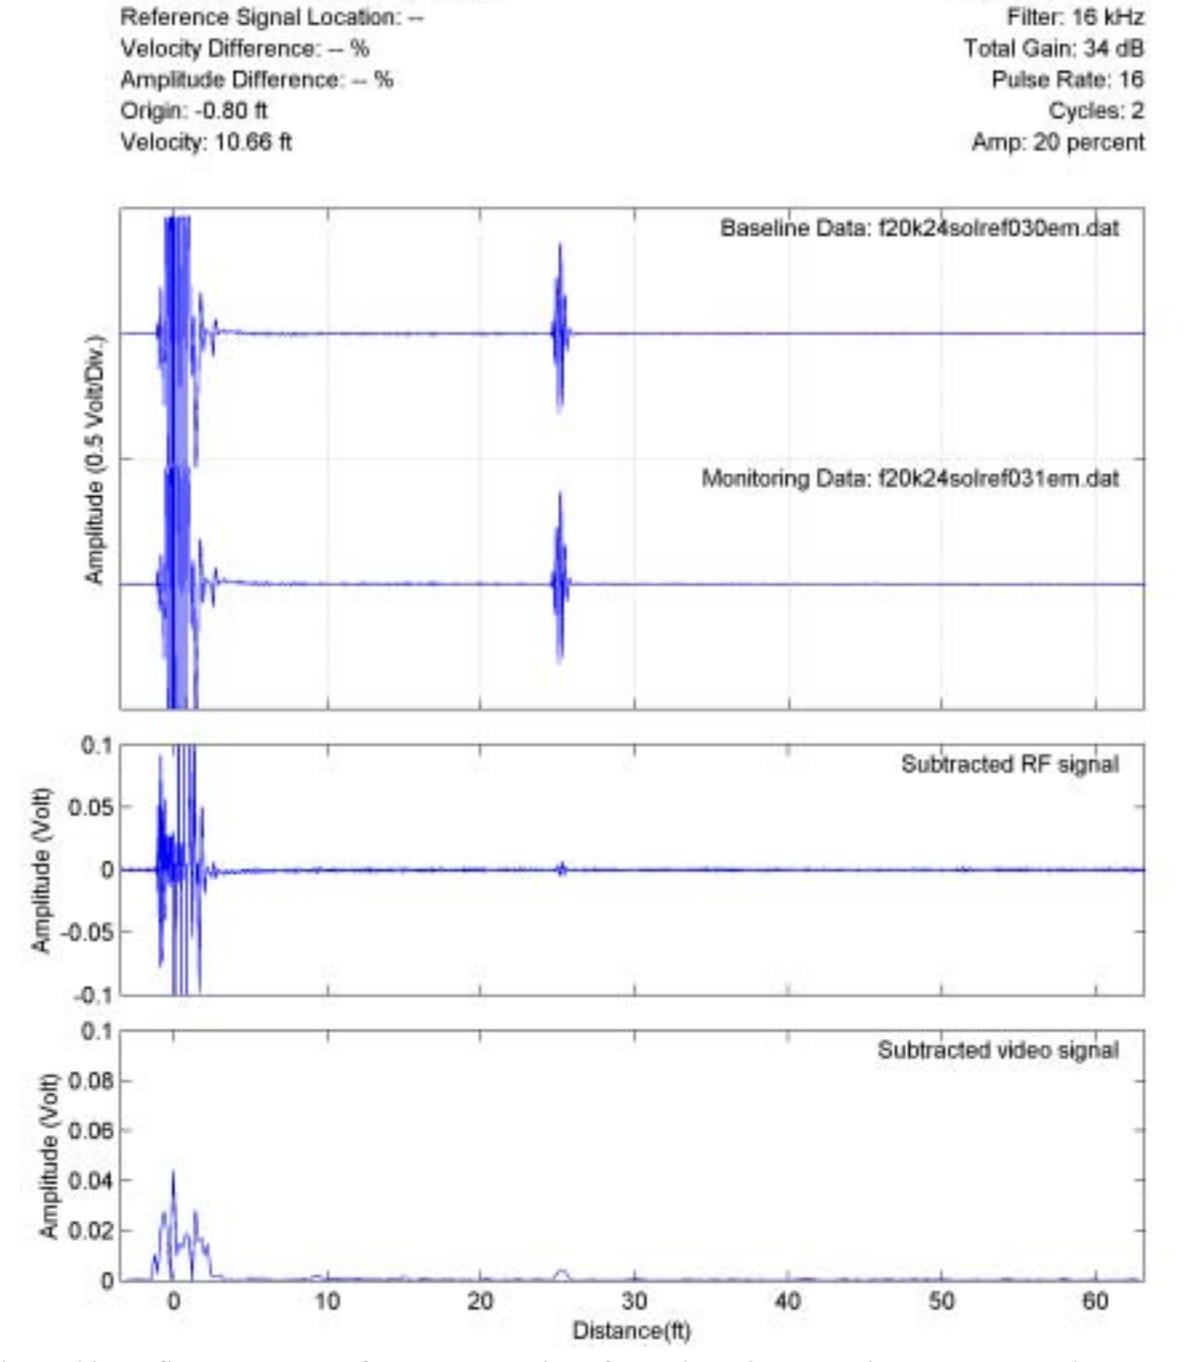
Figure 20. MsS data collected from the east side of the pipe with the guided wave traveling toward the end of the pipe (shown in Figure 18). No intentionally placed defects were present in the pipe.

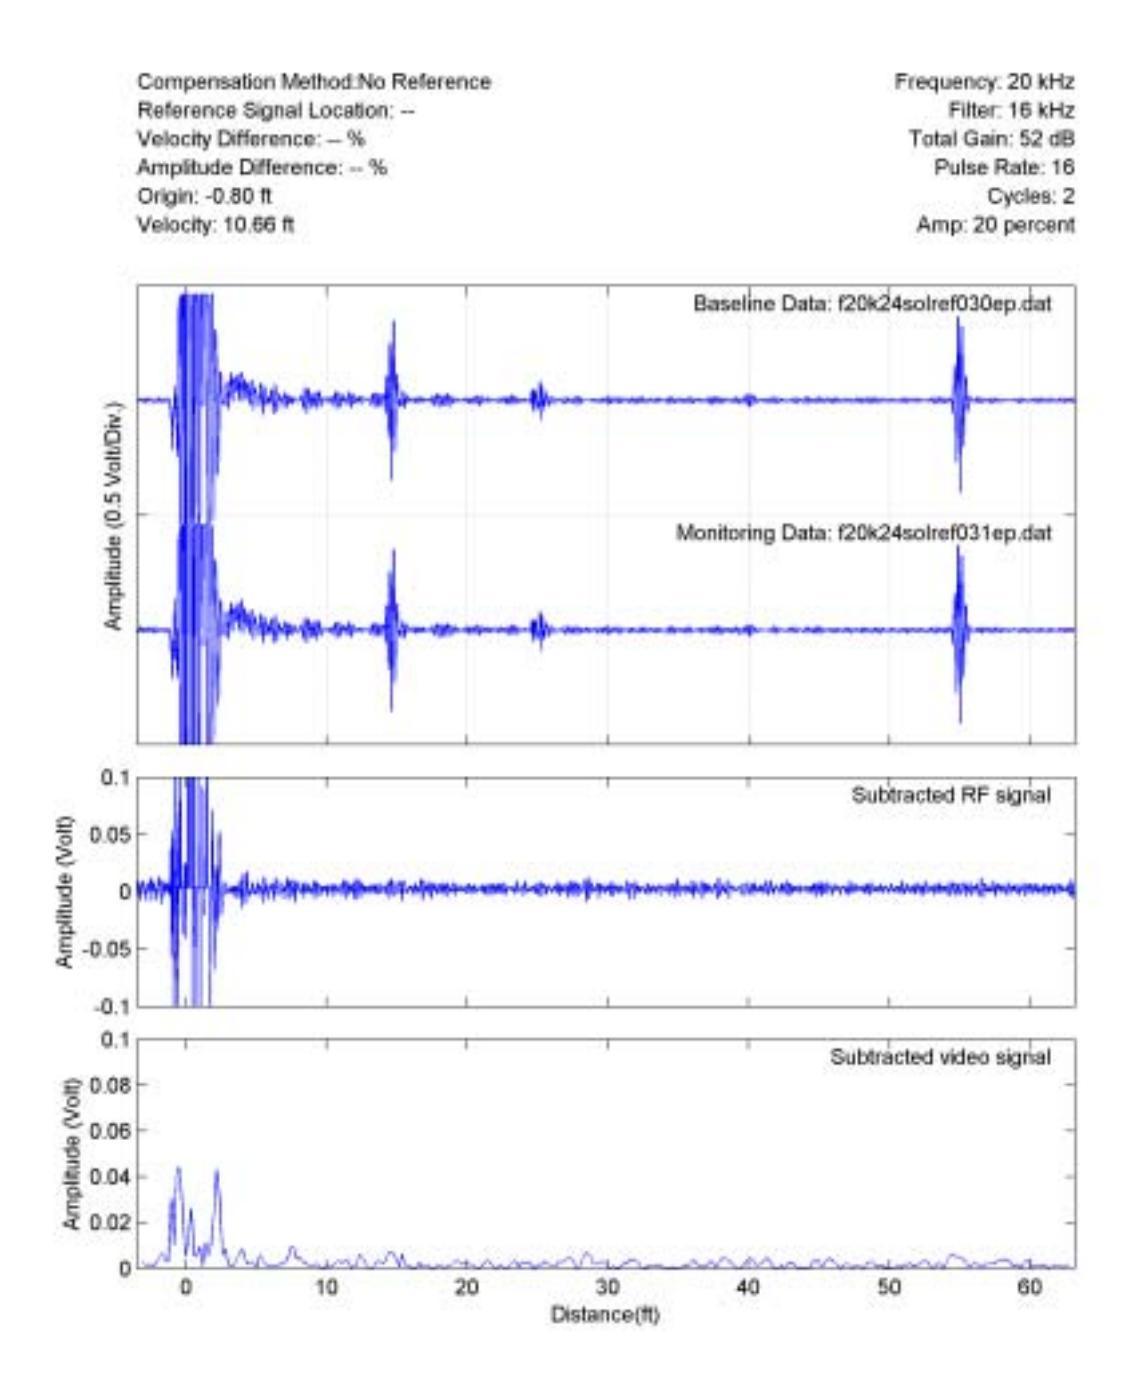
Figure 21. MsS data collected from the east side of the pipe with the guided wave traveling toward the weld in the pipe (shown in Figure 18). No intentionally placed defects were present in the pipe.

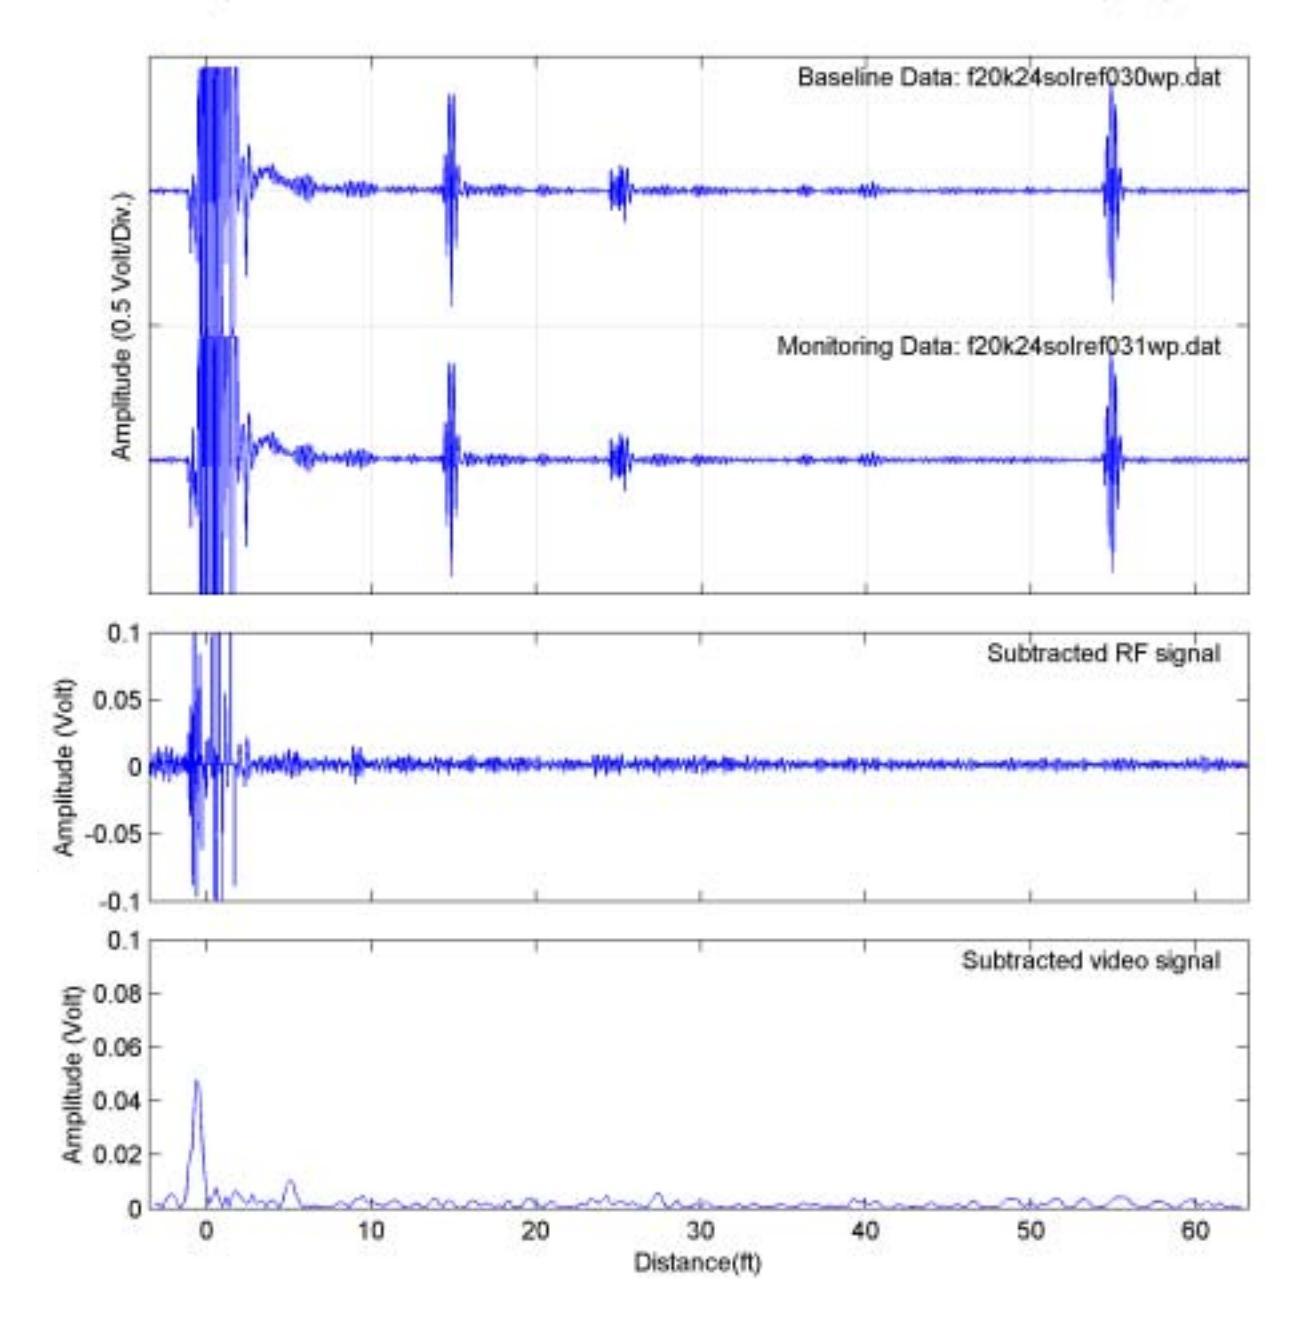
Figure 22. MsS data collected from the west side of the pipe with the guided wave traveling toward the weld in the pipe (shown in Figure 18). No intentionally placed defects were present in the pipe.

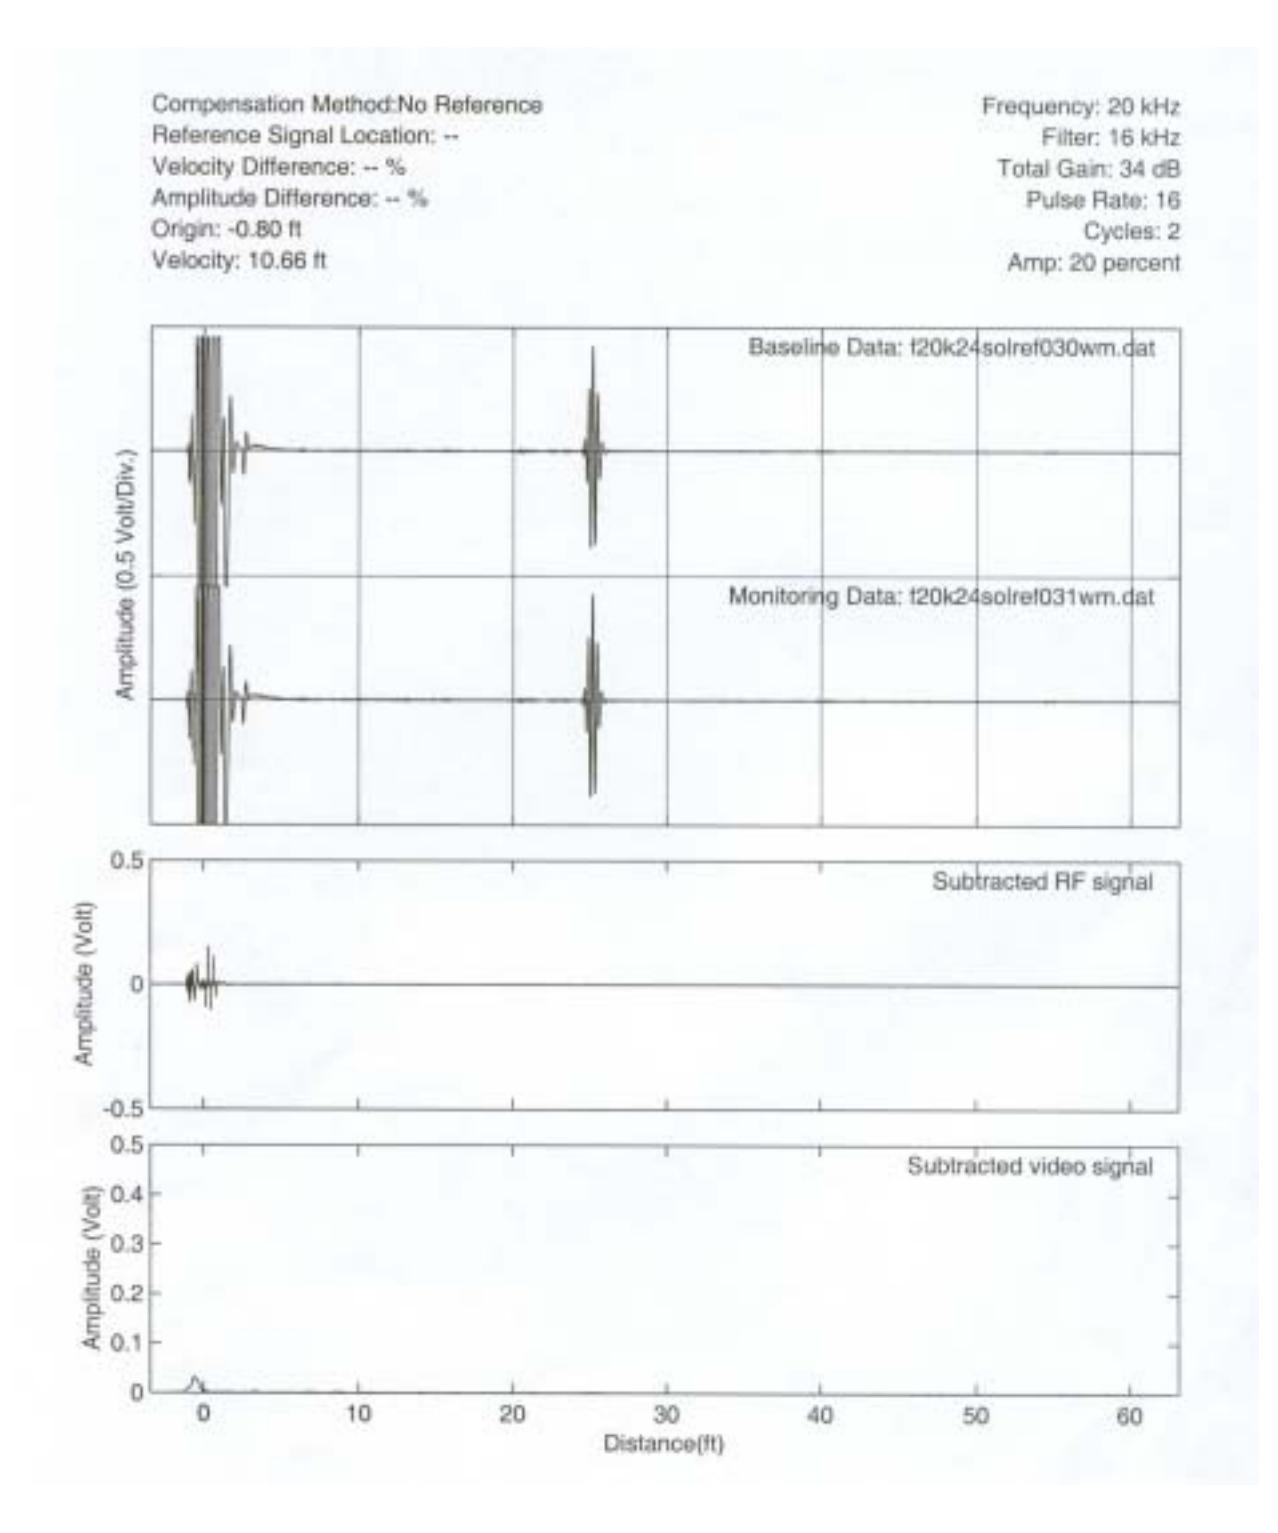
Figure 23. MsS data collected from the west side of the pipe with the guided wave traveling toward the end of the pipe (shown in Figure 18). No intentionally placed defects were present in the pipe.

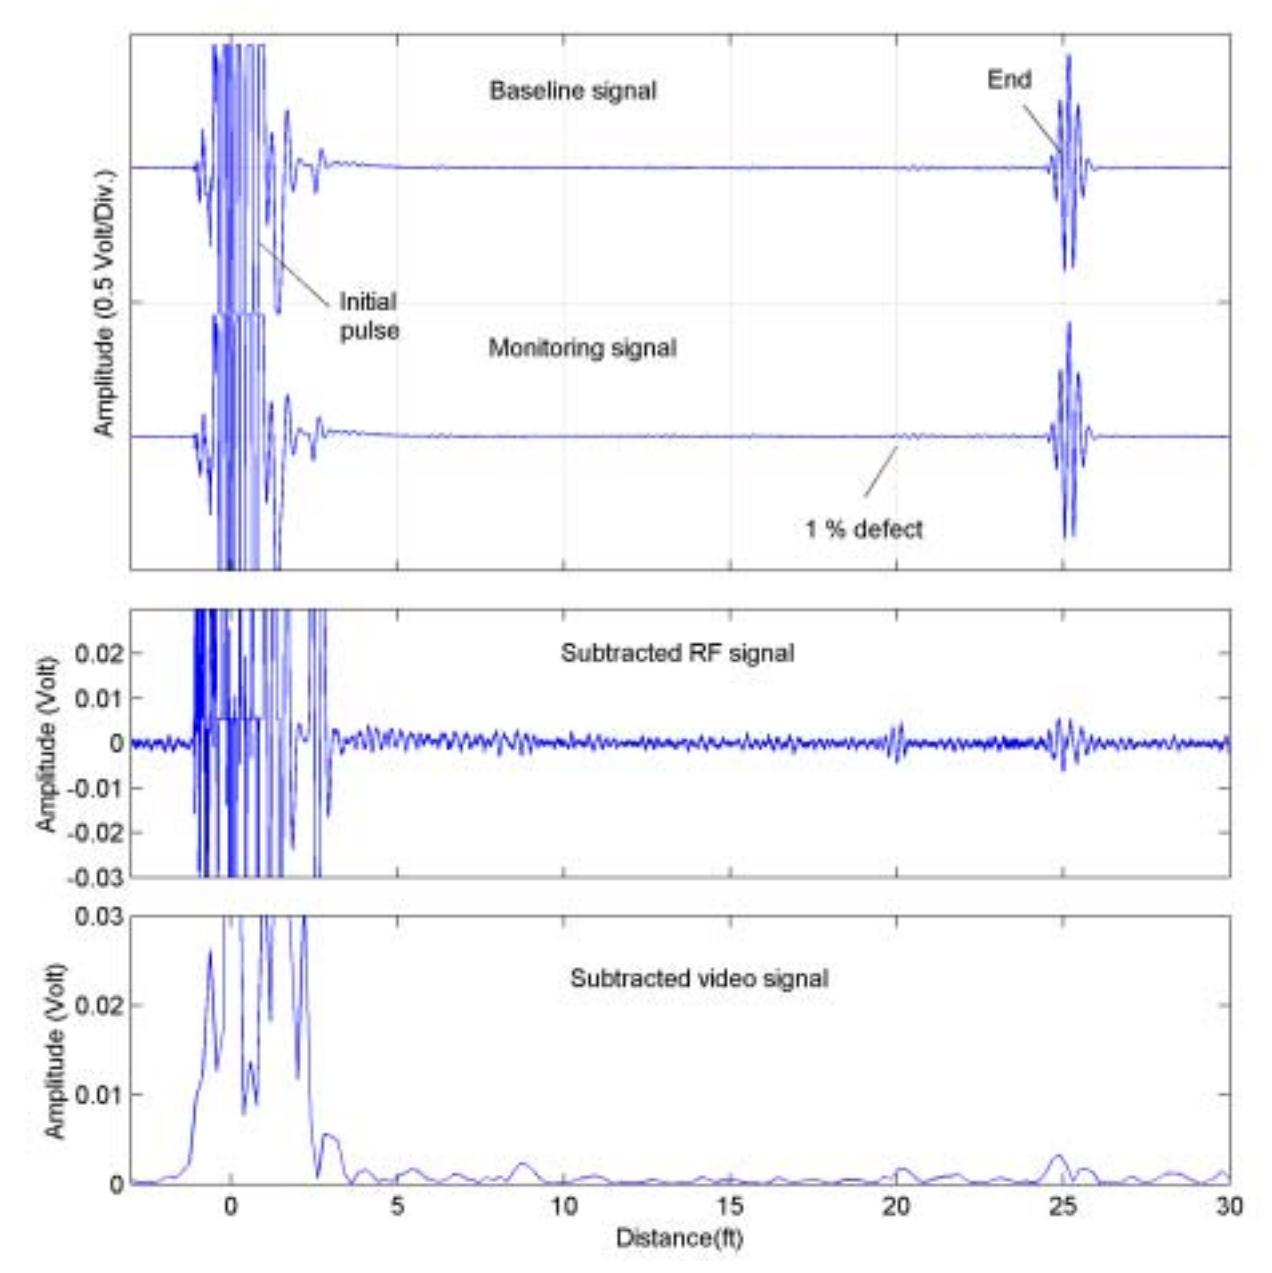
Figure 24. MsS data collected from the pipe with 1 percent of the total pipewall cross-section defect at 6 m (20 feet). It is difficult to visually detect any difference between the reference inspection data and the inspection data obtained from the pipe with the 1-percent defect. However, the difference (subtracted data) clearly shows a signal at 6 m (20 feet).

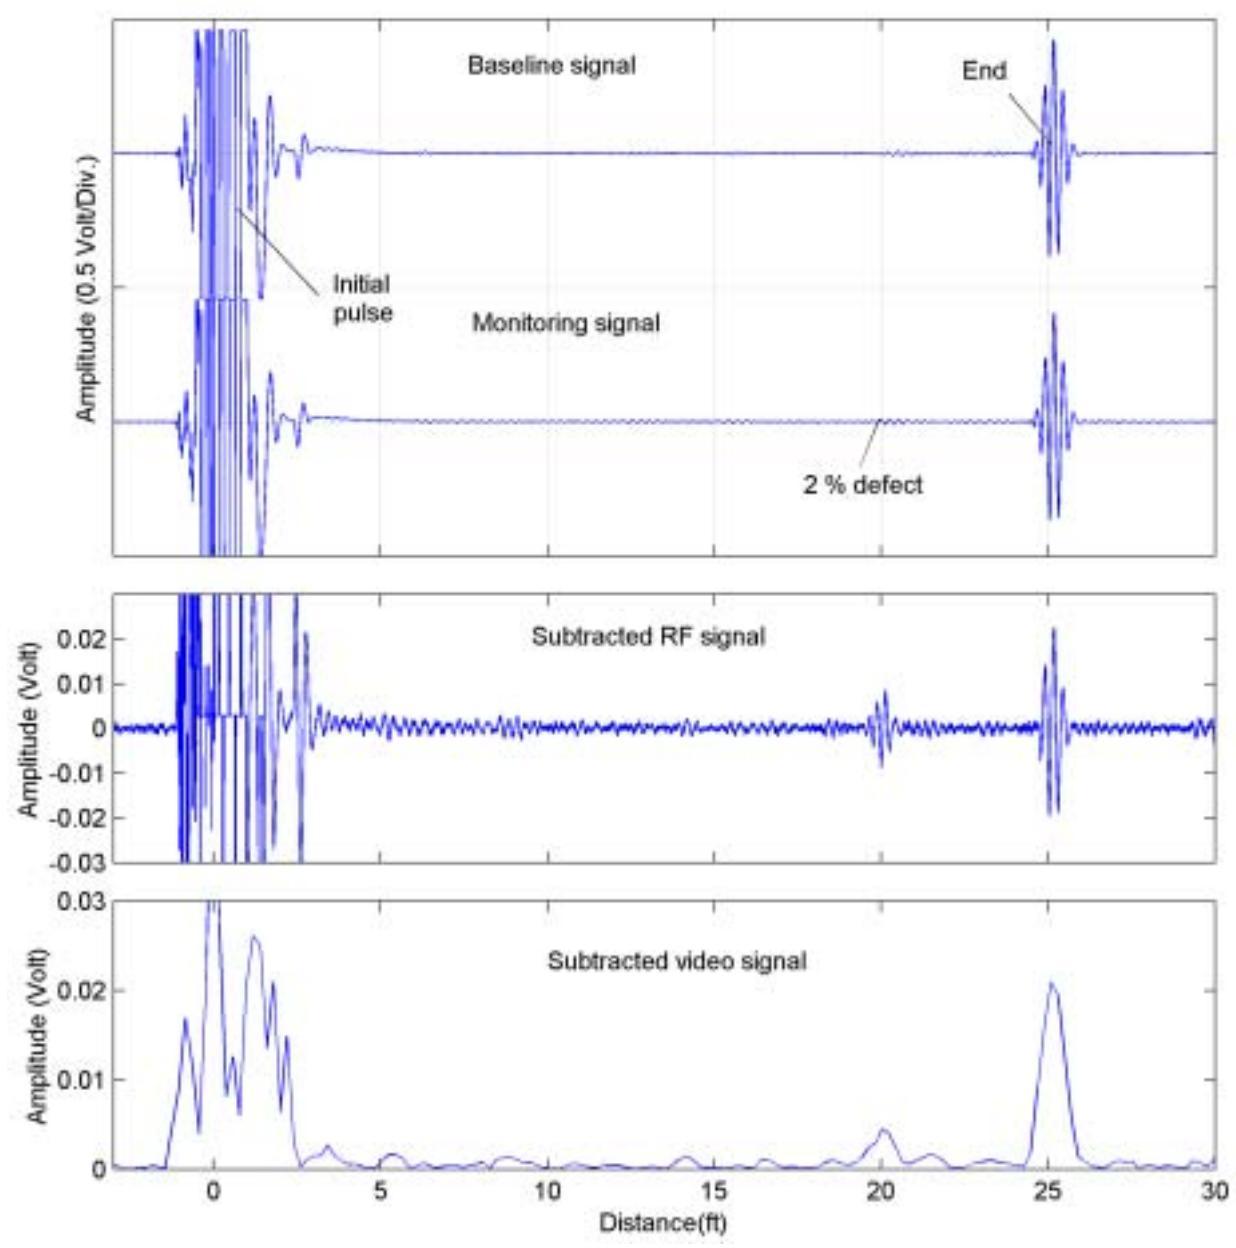
Figure 25. MsS data collected from the pipe with 2 percent of the total pipewall cross-section defect at 6 m (20 feet). It is difficult to visually detect any difference between the reference inspection data and the inspection data obtained from the pipe with the 2-percent defect. However, the difference (subtracted data) clearly shows a signal at 6 m (20 feet).

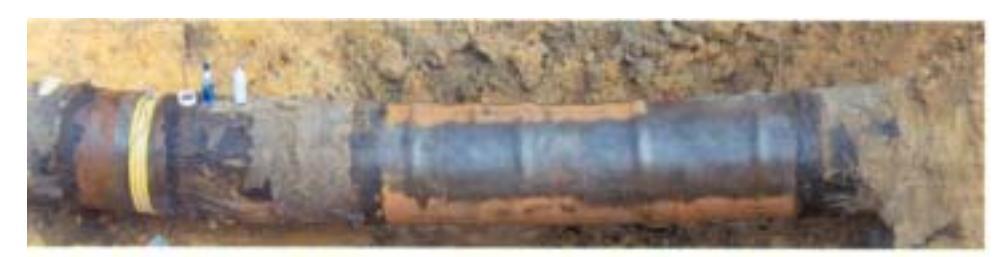
Figure 26. Photograph of the pipe excavated at the Cleveland site showing the location of the MsS coil and bend rings

A section of the pipe approximately 7.6 m (25 feet) long was excavated (as shown in Figure 26). The weld was located by the El Paso crew and marked as a landmark. The corrosion defect was approximately 16 feet from the weld. A 2.1-m (7-foot)-long section of wax-based coating was removed for X-ray and UT thickness measurement testing (as illustrated in Figure 27). The topside of the pipe was wrinkled at approximately 0.6 m (2 feet) increments. The wrinkles were the result of the technique used for many years to bend the pipe in the field; however, this practice is no longer used. There was some concern about the effect the wrinkles might have on the MsS results. A 0.3-m (1-foot)-long section of bitumen coating was removed and the pipe was sandblasted so that the MsS probe could be installed.

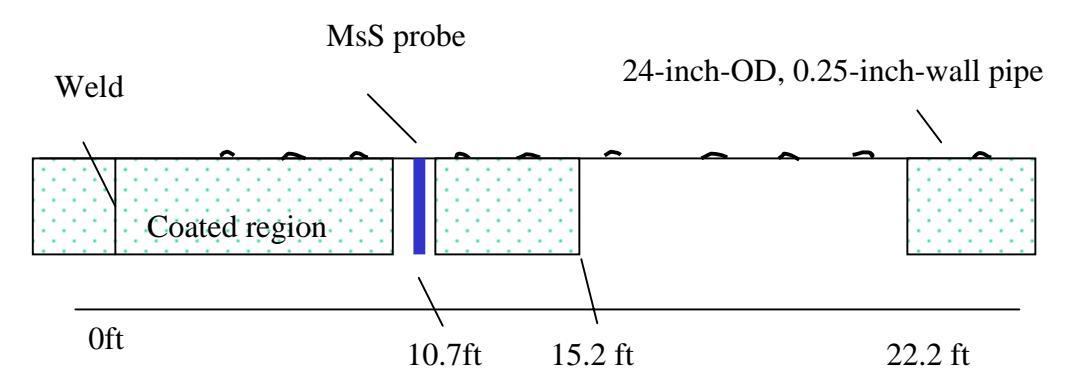
Figure 27. Photograph and diagram showing the MsS ribbon coil and pipe

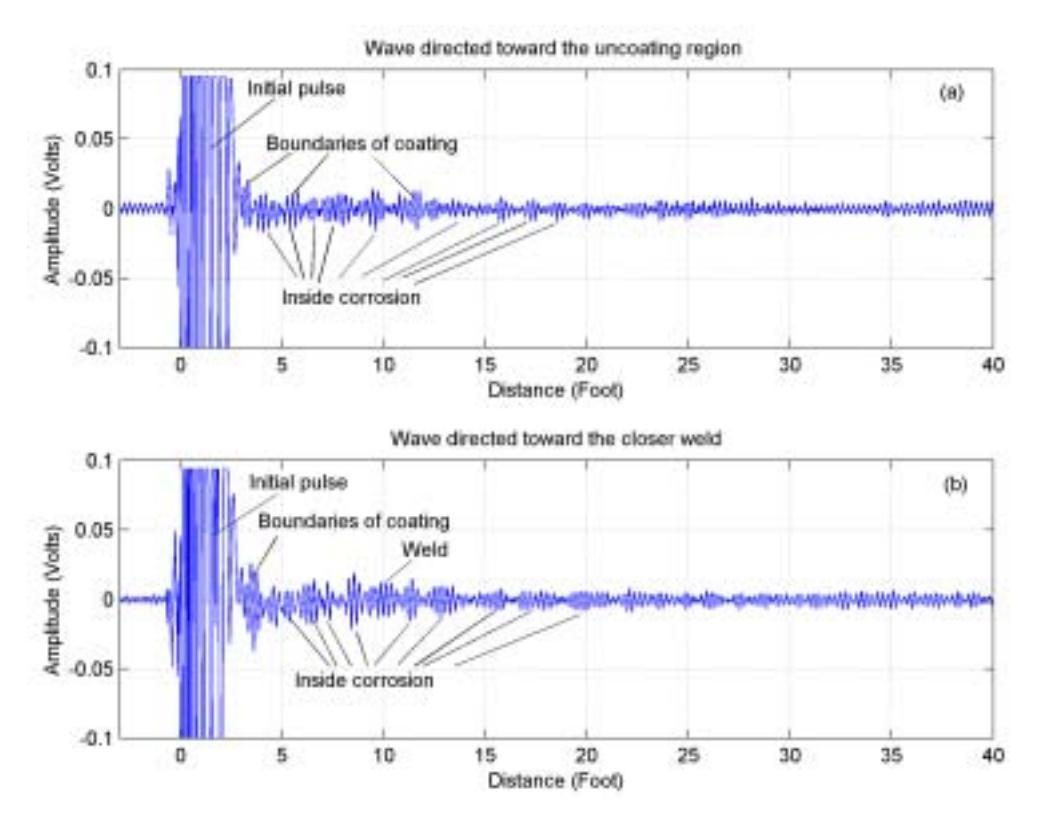
Figure 28. 20-kHz MsS data acquired from excavated bitumen-coated pipeline: (a) with wave directed toward the uncoated region; (b) with wave directed toward the closer weld

MsS data were taken the following morning. Figure 28 (a) and (b) show the 20-kHz MsS data taken by directing the T-waves toward the uncoated region (toward the defect) and the weld, respectively, from the MsS probe positioned approximately 3.3 m (10.75 feet) from the weld. Signals from the weld and boundaries of coating in the sample were indicated. A randomly distributed noise-like signal appeared after the initial pulse in both directions, indicating the inside of the pipe had a high level of generalized internal corrosion on both sides of the MsS. Similar MsS data were obtained from a pipe that was heavily corroded on the outside [1]. Figure 29 is a photograph of the heavily surface-corroded section and the location of the MsS probe. The MsS data in Figure 30 clearly show the signal difference between the good surface between W5 and W4 and the heavily corroded section between W4 and W2.

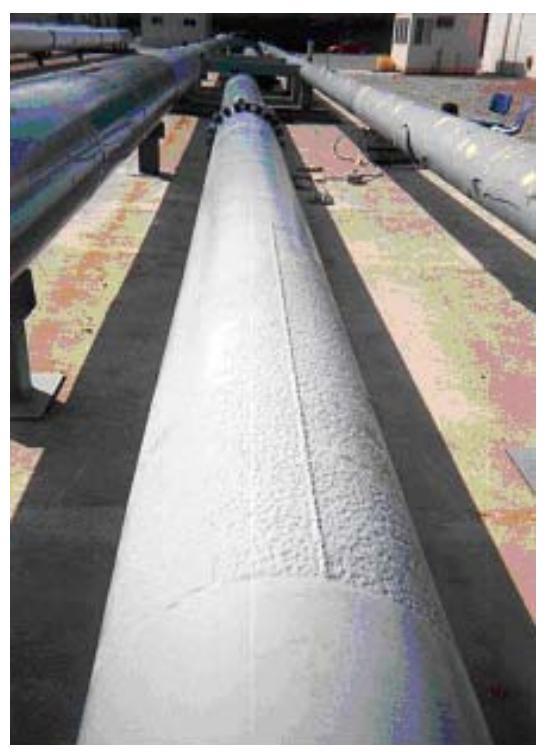
Figure 29. Photograph showing MsS probe installed on pipe having a heavily corroded section

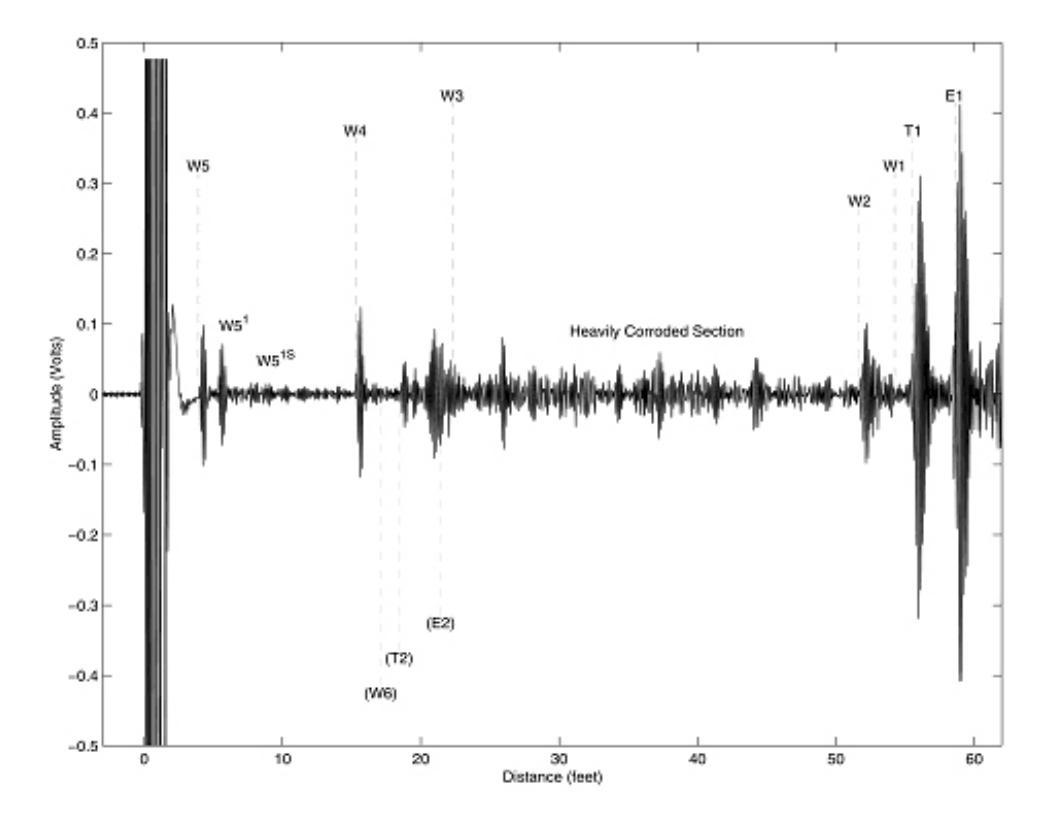
Figure 30. MsS guided wave data acquired from a natural corrosion pipe sample

Since the guided wave propagates uniformly with the same wave front through the pipe wall cross-sectional area, generalized corrosion on either the outside or inside surface of the pipe highly attenuates the propagating T-wave by reflecting and scattering randomly distributed noise-like signals. If the MsS had been buried with the pipeline, the initiation and growth of generalized corrosion could have been monitored by observing the appearance and increase of randomly distributed noise-like signals. However, based upon the results of the X-ray and UT thickness measurements and the preliminary results obtained with the MsS, the decision was made to remove this section of pipe. Therefore, this test site was no longer acceptable for evaluating the MsS technique for pipeline monitoring. However, the condition of the pipe did show the need for a monitoring technique such as the MsS. If the MsS could have been put in place and the pipeline had an acceptable corrosion level, then the MsS could be used to monitor the corrosion growth without having to expose the pipe.

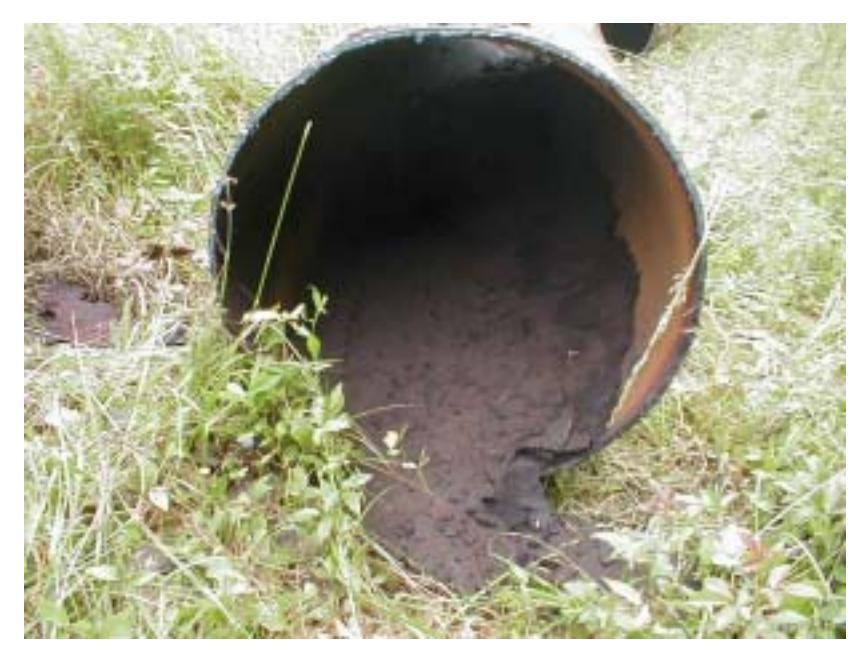
Figure 31. Inside surface of pipeline showing major internal corrosion

The corroded pipe section was cut out of the line and photographs were taken of the opening. These photographs are shown in Figures 31 through 34.

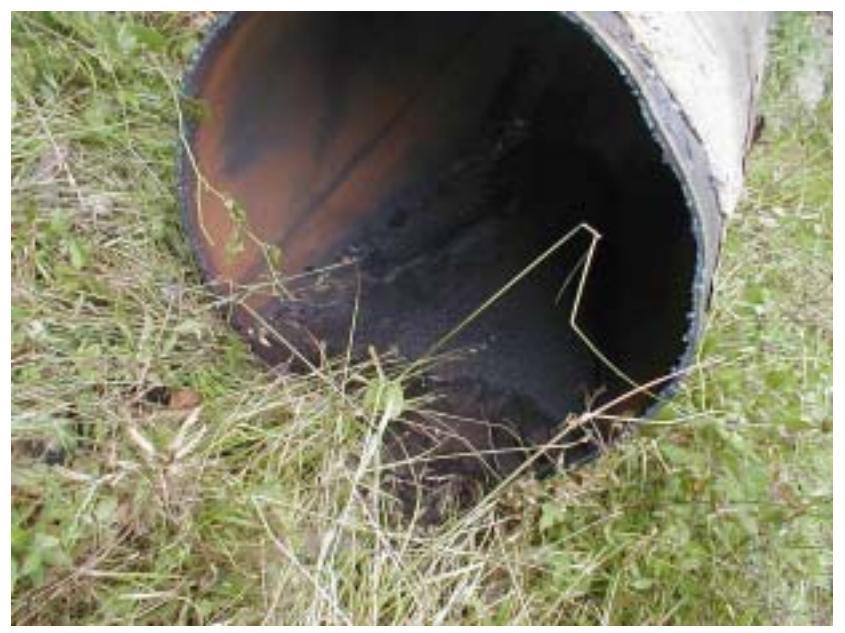
Figure 32. Another view of the inside surface of the pipeline showing major internal corrosion

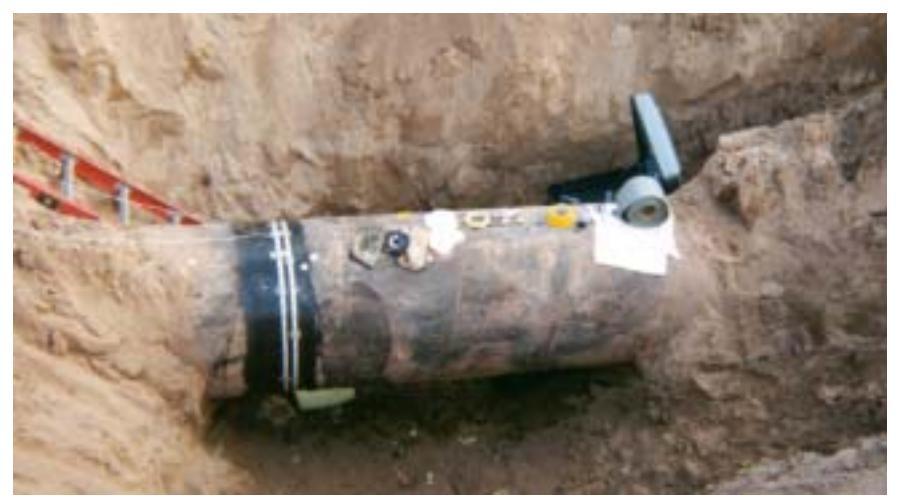
Figure 35. MsS installed on the 762-mm (30-inch)-OD gas transmission pipeline

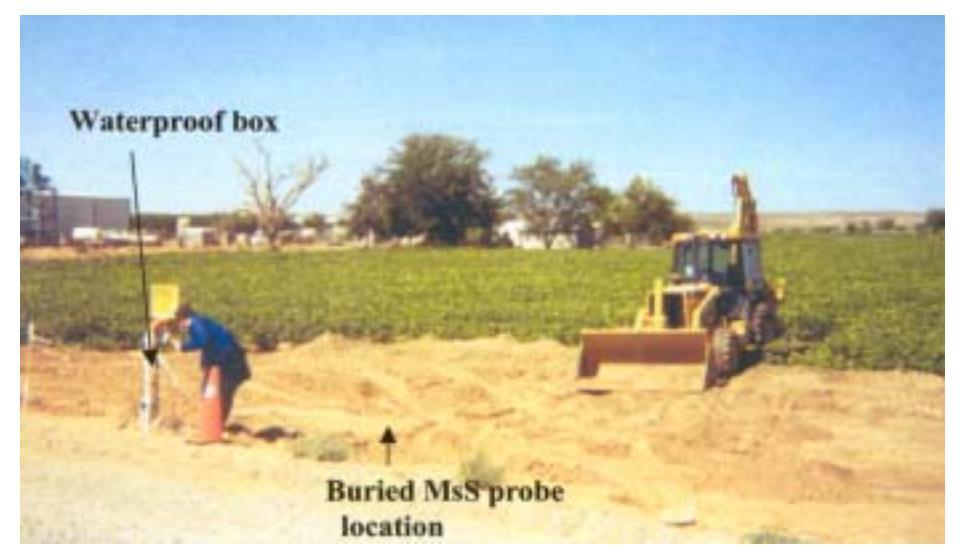
Figure 36. Photograph showing a waterproof box after the site was restored

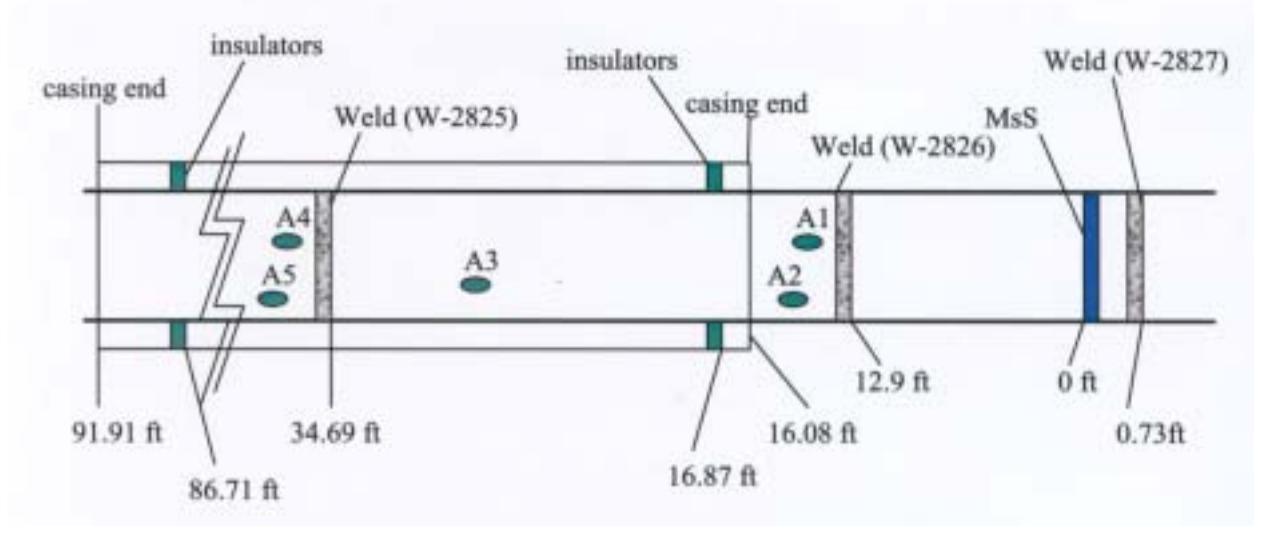
Figure 37. Configuration of the pipeline at the road crossing. The locations of the MsS and distances to the known geometric features in the line are indicated.

To identify the locations of the MsSs, the configuration of the pipeline at the road crossing is schematically illustrated in Figure 37, including the locations of known geometric features and known defects found from the ILI results. The distance between the center of two MsSs and the nearest weld (No. 2827) was 0.22 m (0.73 feet). The corrosion defects found from the ILI results are indicated as A1 through A5 and their characteristics are summarized in Table 3. It should be noted that the detection sensitivity determined during laboratory tests on buried pipe was on the order of 1.5 to 2% of the pipe wall cross section. The defects listed in Table 3 were much smaller. These small defects can be detected by pigs, but monitoring could detect defects that are larger but still acceptable for continued pipeline operation, then the monitoring technology would provide an inexpensive alternative to pigging (if it is possible at all).

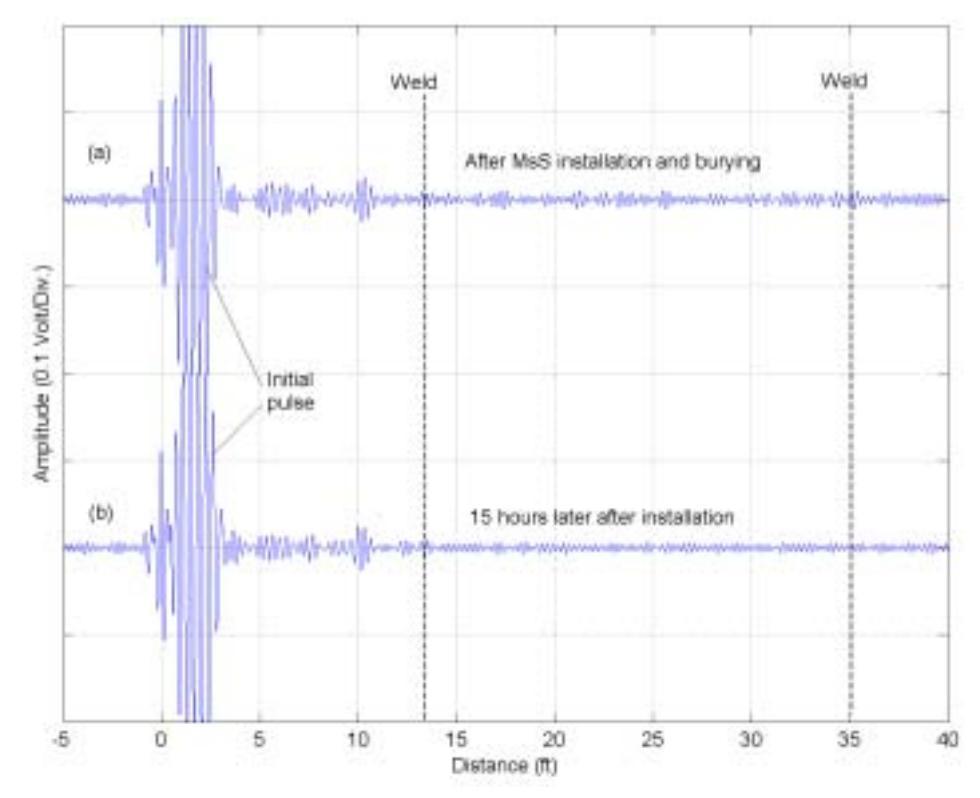
Figure 38. 20-kHz MsS data acquired from the 762-mm (30-inch)-OD gas transmission line: (a) after restoration of the line and (b) 15 hours after restoration of the line

Figure 38 (a) and (b) shows the data acquired on August 18 and 19, respectively. The locations of welds (Nos. 2825 and 2826) are indicated in the figure as the vertical dotted lines. As shown, the two sets of data were approximately identical, indicating that the installed MsSs were stable and repeatable.

Because of the high attenuation in the bitumen-coated and buried lines, no detectable signal was detected from weld No. 2826 at approximately 3.9-m (12.9-feet) distance from the MsS. Also, signals from the known corrosion defects were not observable in the data since they were too far away from the sensor location to be detectable.

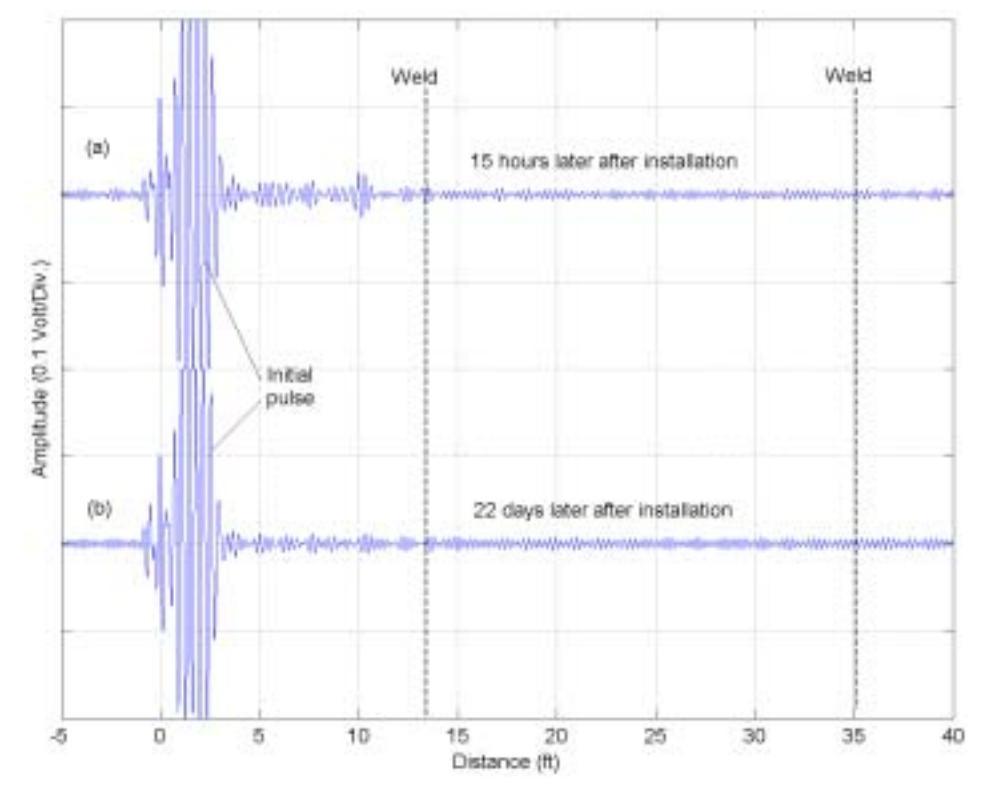
Figure 39. 20-kHz MsS data acquired from the 762-mm (30-inch)-OD gas transmission line: (a) 15 hours later after restoration of the line and (b) 22 days later after restoration of the line

At high amplifications such as those used in this test, detectable signals are produced from the MsS system after the excitation of the initial pulse. The signals over 3-m (10-feet) distance in Figure 37 are, therefore, most likely to be those produced from the MsS system and not from any actual anomalies in the pipeline itself. This interpretation would indicate that the signals seen past 3 m (10 feet) were from electronic noise, not defects. This interpretation is consistent with Tuboscope's test results that showed no defect indications in the pipe section between welds 2826 and 2827 on which the MsS was installed. A second data collection was conducted on September 9, 2003. The comparison of the initial data and the most recent data is shown in Figure 39. As expected, no significant difference in signal was detected. It is believed that perhaps changes will occur within a year, and the setup was left in place so that data could be collected again in approximately 1 year.

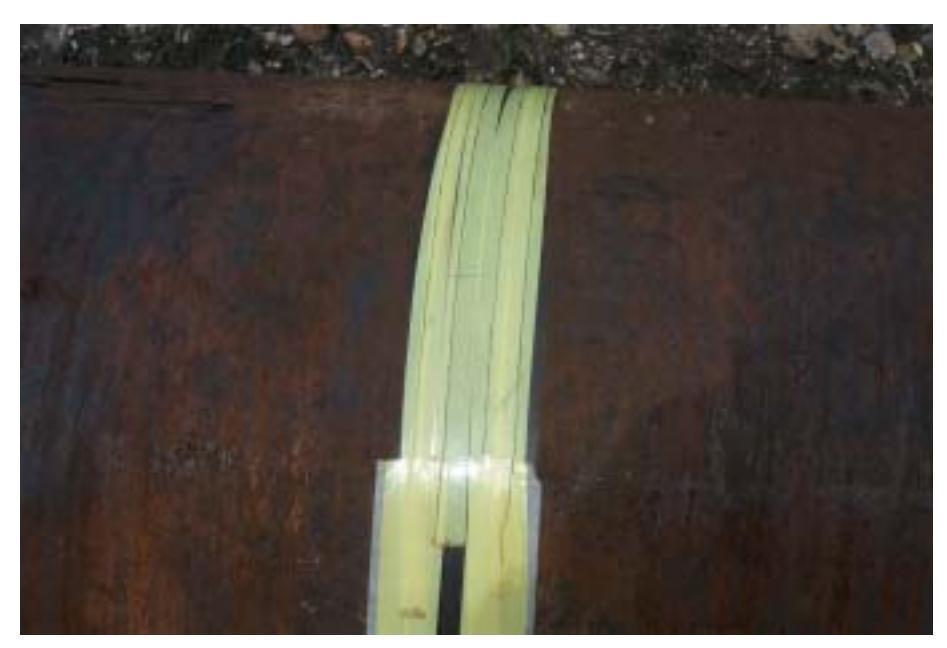
Figure 1. Photograph showing tape wrapped around the two-nickel strips with their outline marked with a pen

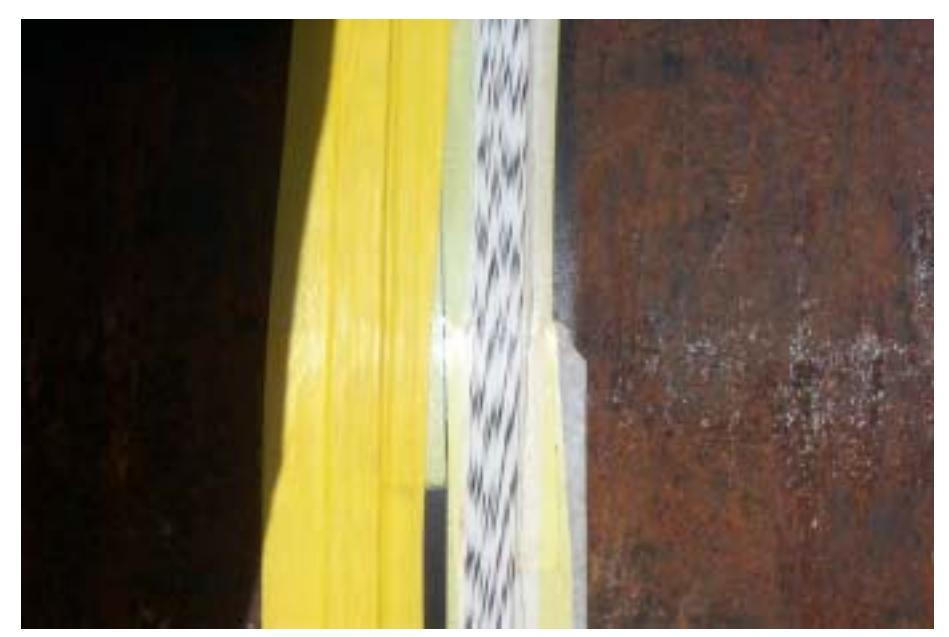
Figure 2. Photograph of the coils wound on the pipe showing yellow vinyl duct tape used to cover the windings of one coil while the second coil is held down with double-sided tape

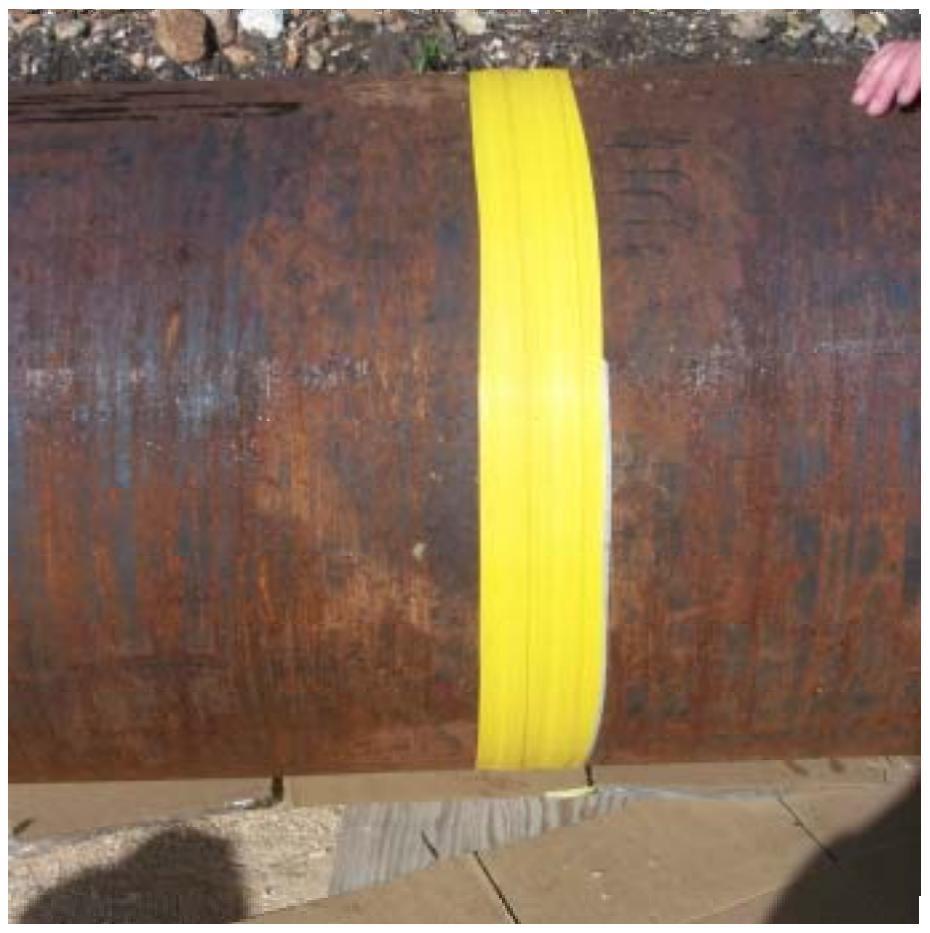
Figure 3. Protective tape coating over nickel strip and electrical coil

9. *Remove* the temporary coils and place double-sided tape over the nickel foil once good guided wave results have been observed and recorded. The reason for marking the edge of the nickel with a pen is to aid in the placement of the tape directly over the nickel foil. Using #22 awg insulated wire, carefully wrap a coil of 16 turns around the pipe. Double-sided tape placed over the nickel foil is used to hold the wire in place while the 16 turns are being made. Mark one end of the wire with tape prior to beginning the wire wrapping process. Leave enough wire free at both the beginning and the end of the coil to extend out of the excavation to the eventual test box. It is good practice to use different colored wires for the two coils so that the two coils can be properly identified when connected into the test box. (NOTE: Always wind the coils in the same detection. A mix-up here could mean you are looking in the wrong direction later.) Once the two coils have been wound around the pipe, twist the ends of the coil wires together so that coming out of the excavation are two twisted pairs of wires of different colors with a tape tag indicating the first turn wire. Figure 2 is a photograph of the coils wound on the pipe showing a yellow vinyl duct tape used to cover the windings of one coil while the second coil is held down with double-sided tape. Then, the layer of protective tape is placed over the nickel strip and electrical coil (Figure 3).

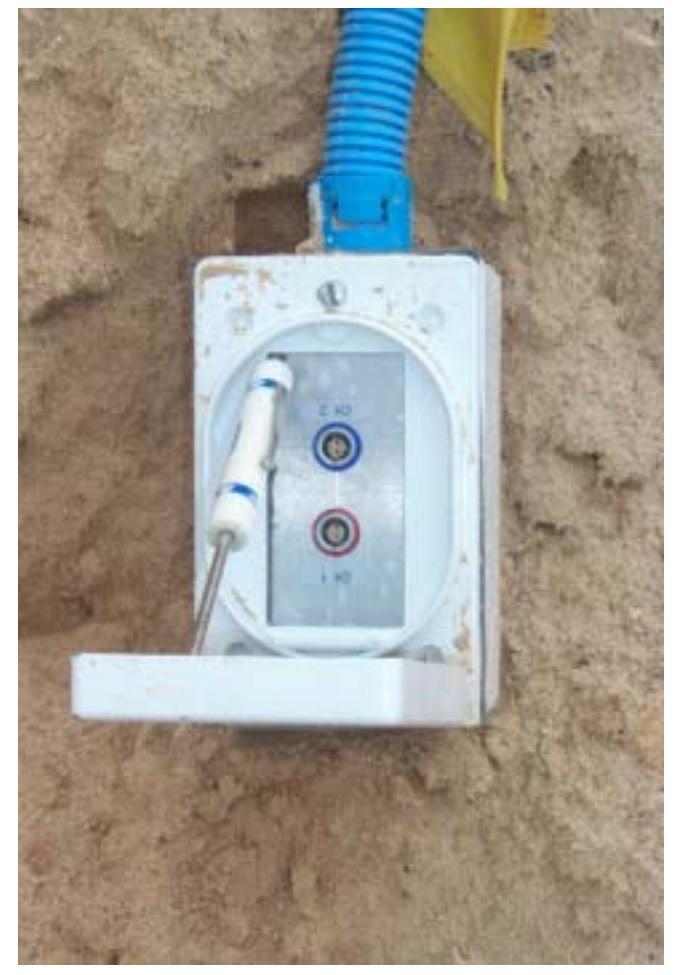
Figure 4. Photograph of the junction box showing the connectors that are connected to the MsS instrument for collecting MsS data
