Oil & Natural Gas Technology

Quarterly Research Performance Progress Report (Period Ending 09/30/2016)

Deepwater Methane Hydrate Characterization and Scientific Assessment

HYBRID PRESSURE CORING TOOL WITH BALL VALVE MARK III (PCTB III) 2016 PRE-SEA TRIAL TESTS

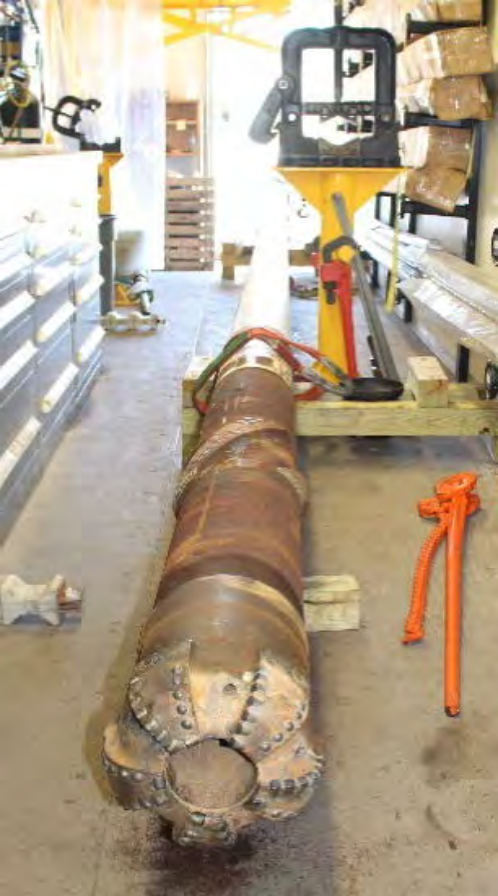
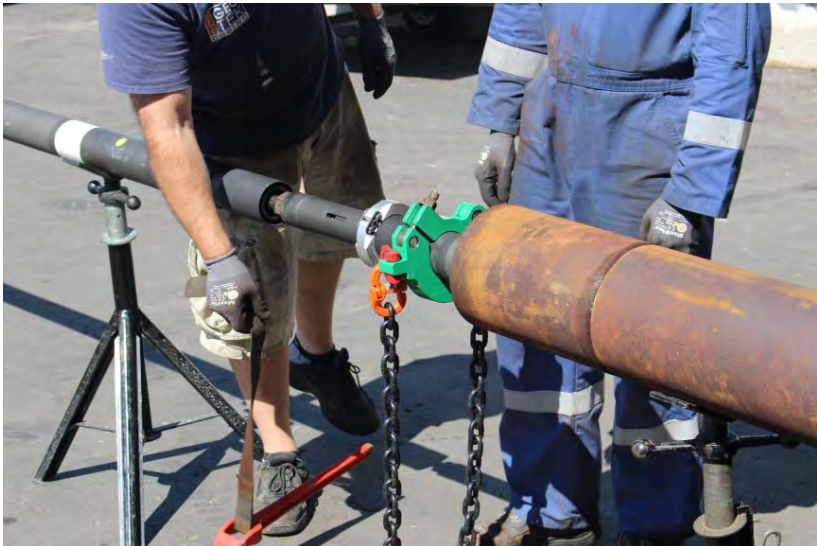
Figure 1.1: Pre-Sea Trial Horizontal Space out Test

Figure 1.2: Pre-Sea Trial Horizontal Space out Test

PCTB in cutting shoe configuration successfully latched and unlatched properly after two attempts in the bottom hole assembly (drill bit, bit sub, OCBA, landing sub, top sub, head sub). Spacing observed to be correct; latching confirmed by inability to move PCTB by bumping cutting shoe with sledgehammer. Some resistance in horizontal orientation due to friction between PCTB and BHA.

Pulling tool used with forklift to pull out PCTB; PCTB released and ball valve closed in correct sequence.

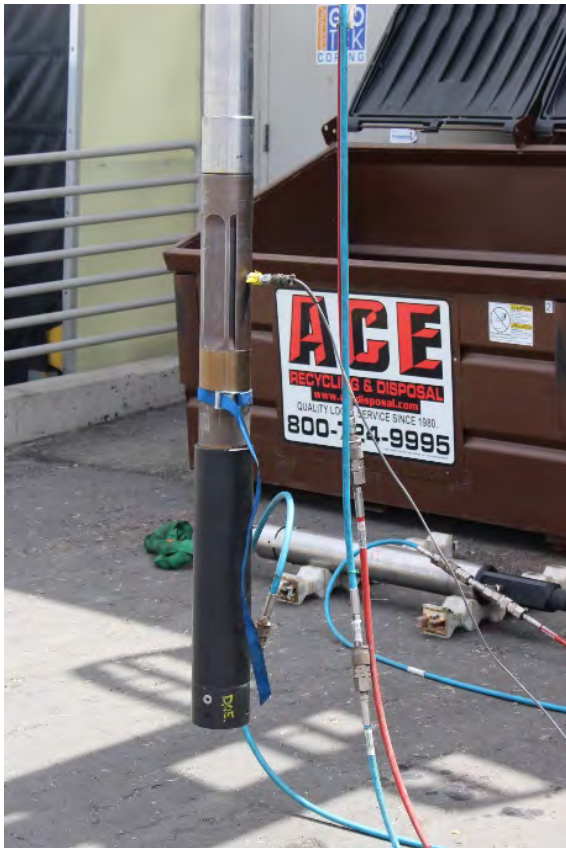
Figure 1.3: Lower end of PCTB with ball valve capped and annulus filled with water and pressurized

- Pressure increased in annulus to ~1000 psi
- PCTB actuated with pressure boost to 1500 psi
- Pressure and temperatures within autoclave and annulus monitored with data storage tags (DST) aka “fish pills”
- Annulus depressurized slowly to simulate rise of PCTB through borehole

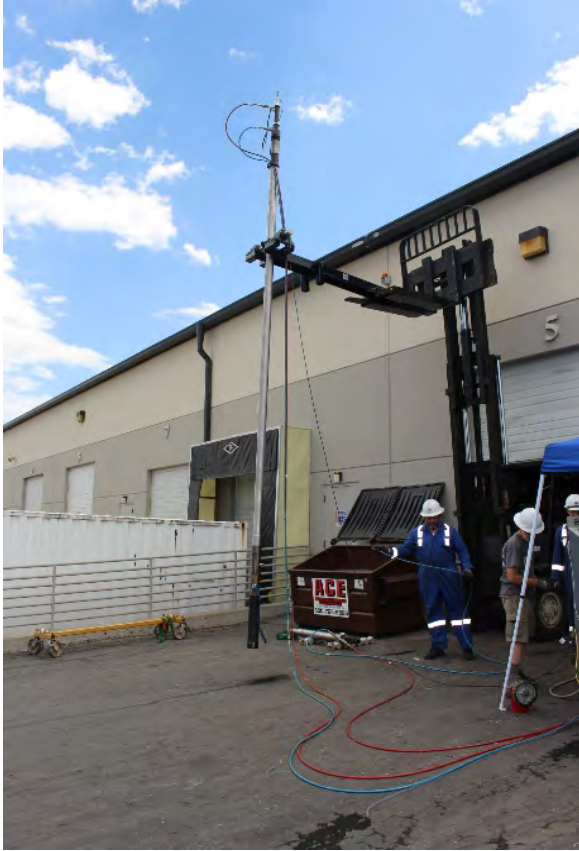
Figure 1.4: PCTB actuated hydraulically from top to simulate pull on wireline

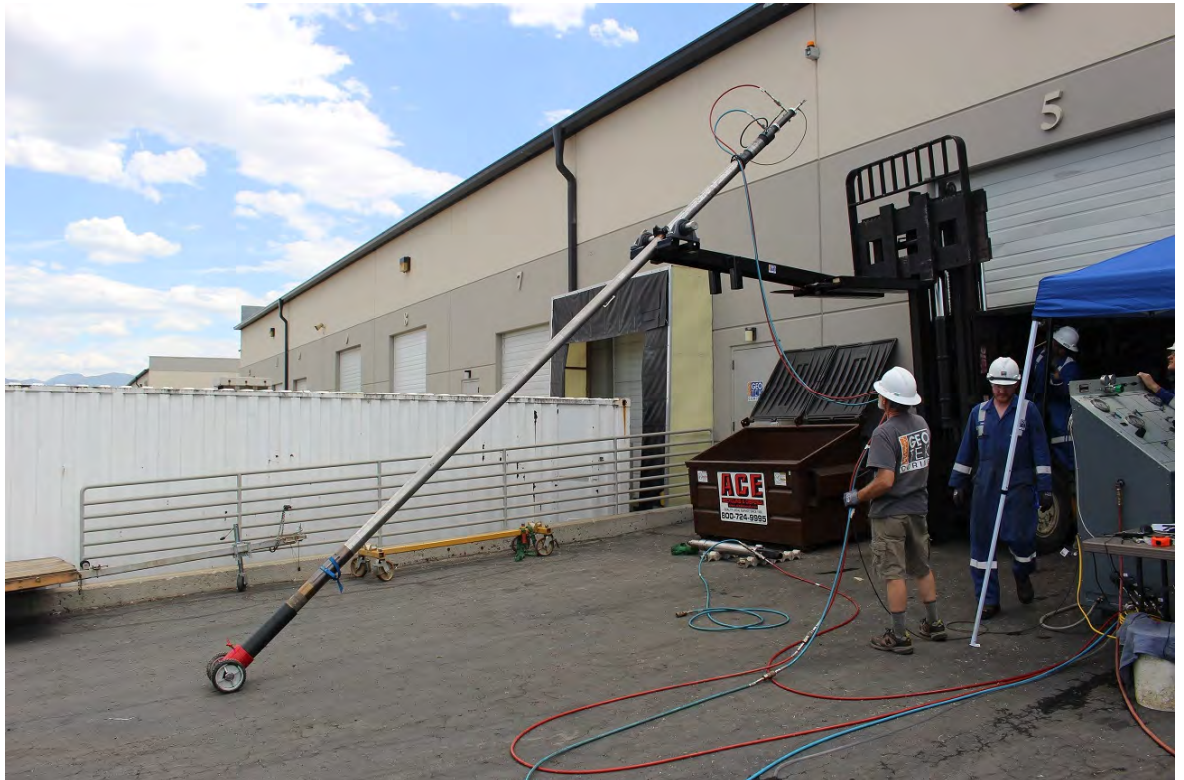
Figure 2, VFFPT Test Fixture being raised to vertical position for test.

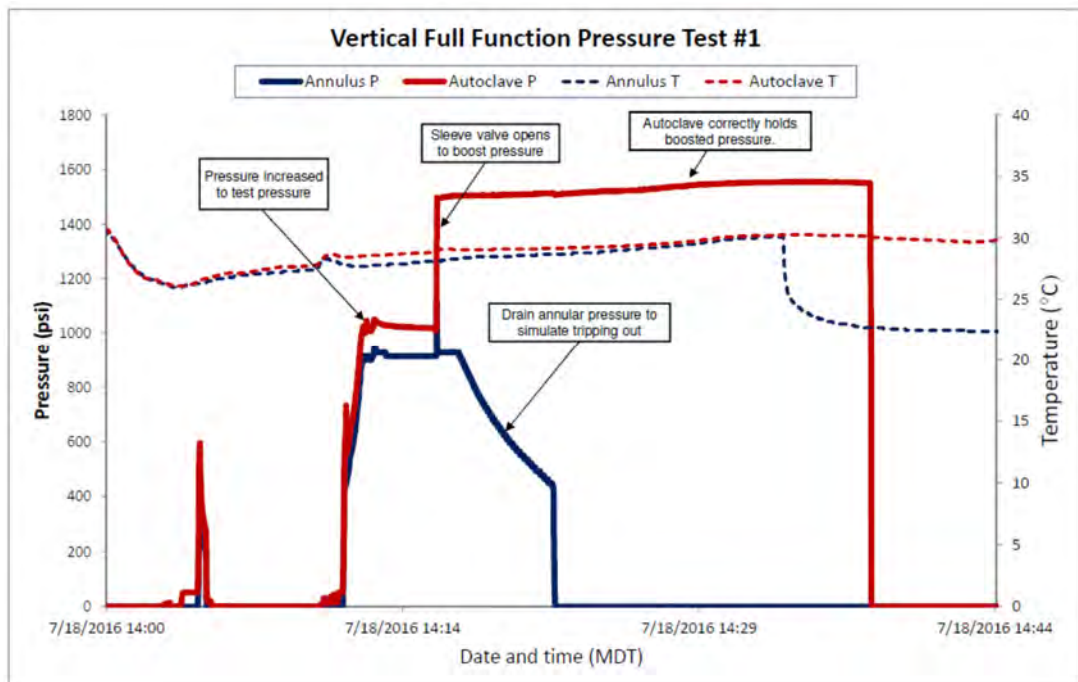
To conduct a VFFPT, the PCTB autoclave is assembled and hydraulically pressure tested as is normally done for an operation. The reservoir chamber in the pressure control section is filled with nitrogen and the regulator set to the desired boost pressure and function tested. The pressure control section is assembled to the autoclave. Then the upper balancing chamber and lower pressure test cap are installed. Hoses are used to connect the upper to lower chamber and to the new pressure test console and to an accumulator used to smooth out the pulses from the pump. The pressure transducer is attached to the port in the drive sub and the linear transducer is connected to its readout box. The PCTB is attached to the gimbaled lifting clamp and raised vertically using the forklift. The tool and the annulus are filled with water and pressure increased to the static test pressure (~1000 psi used for this series of tests) via the pump in the pressure test console. Pressure is applied to the actuator cylinder at the top of the assembly to simulate the pulling of the wireline to trigger ball valve closure and N₂ boost from the pressure control section. After the pressure boost is observed, the pressure in the annular chambers is slowly lowered to simulate coming out of the hole. An example DST pressure chart shows correct operation.

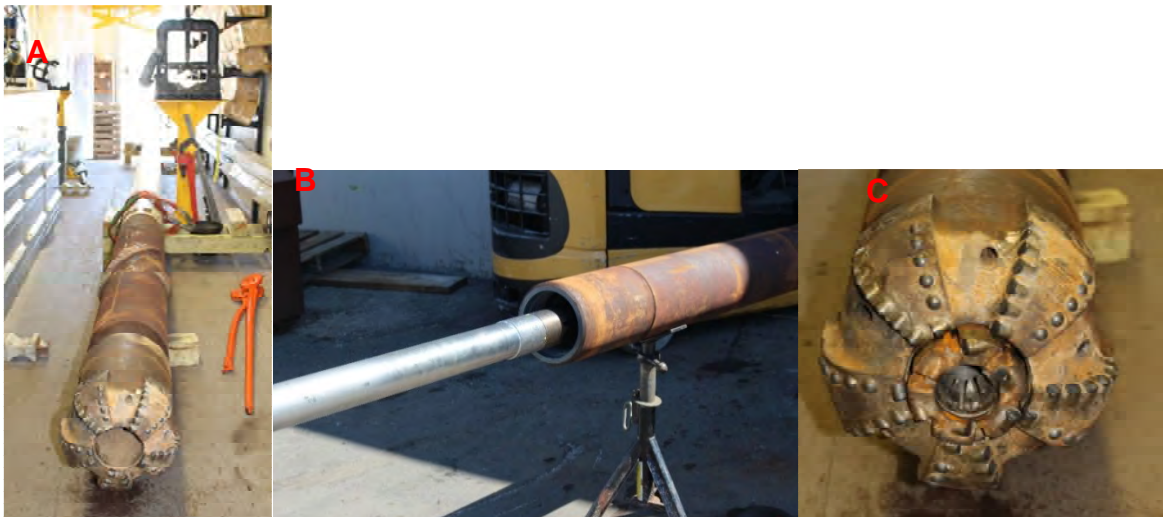
Figure 5: Horizontal space-out test. A) The bottom hole assembly viewed from the bottom. B) The PCTB inserted into the head and top sub. C) The face bit with cutting shoe fully inserted.

The PCTB stopped sliding about 12" above the landing point when the outer latch dogs contacted the head sub ID. Note, normally the outer latch dogs are retracted by the weight of the PCTB hanging on the running tool. The PCTB was pulled out of the OCB until the outer latch dogs were accessible. The running tool was installed in the PCTB to retract the outer latch dogs. A spare latch sleeve was slid over the outer latch dogs to keep them retracted. The running tool was manually released and removed. The PCTB was then slid back into the OCB as far as it would go while removing the spare latch sleeve once the outer latch dogs had entered the head sub ID.

It appeared that the PCTB was within 1/4" - 1/2" of latching but had not latched. To confirm that the PCTB was not latched, a sledge hammer was used to bump the PCTB out of the OCB by hammering on the cutting shoe. The PCTB continued to slide out of the OCB confirming that it was not latched.

The failure of the PCTB to latch on the first attempt was due to friction caused by performing the test horizontally. When the head sub was made up the second time, the latch sleeve was able to push against the outer latch dogs more evenly and with the power screw effect of the thread the PCTB was seated properly. This type of failure to latch is not likely to occur in the field where everything is done vertically.

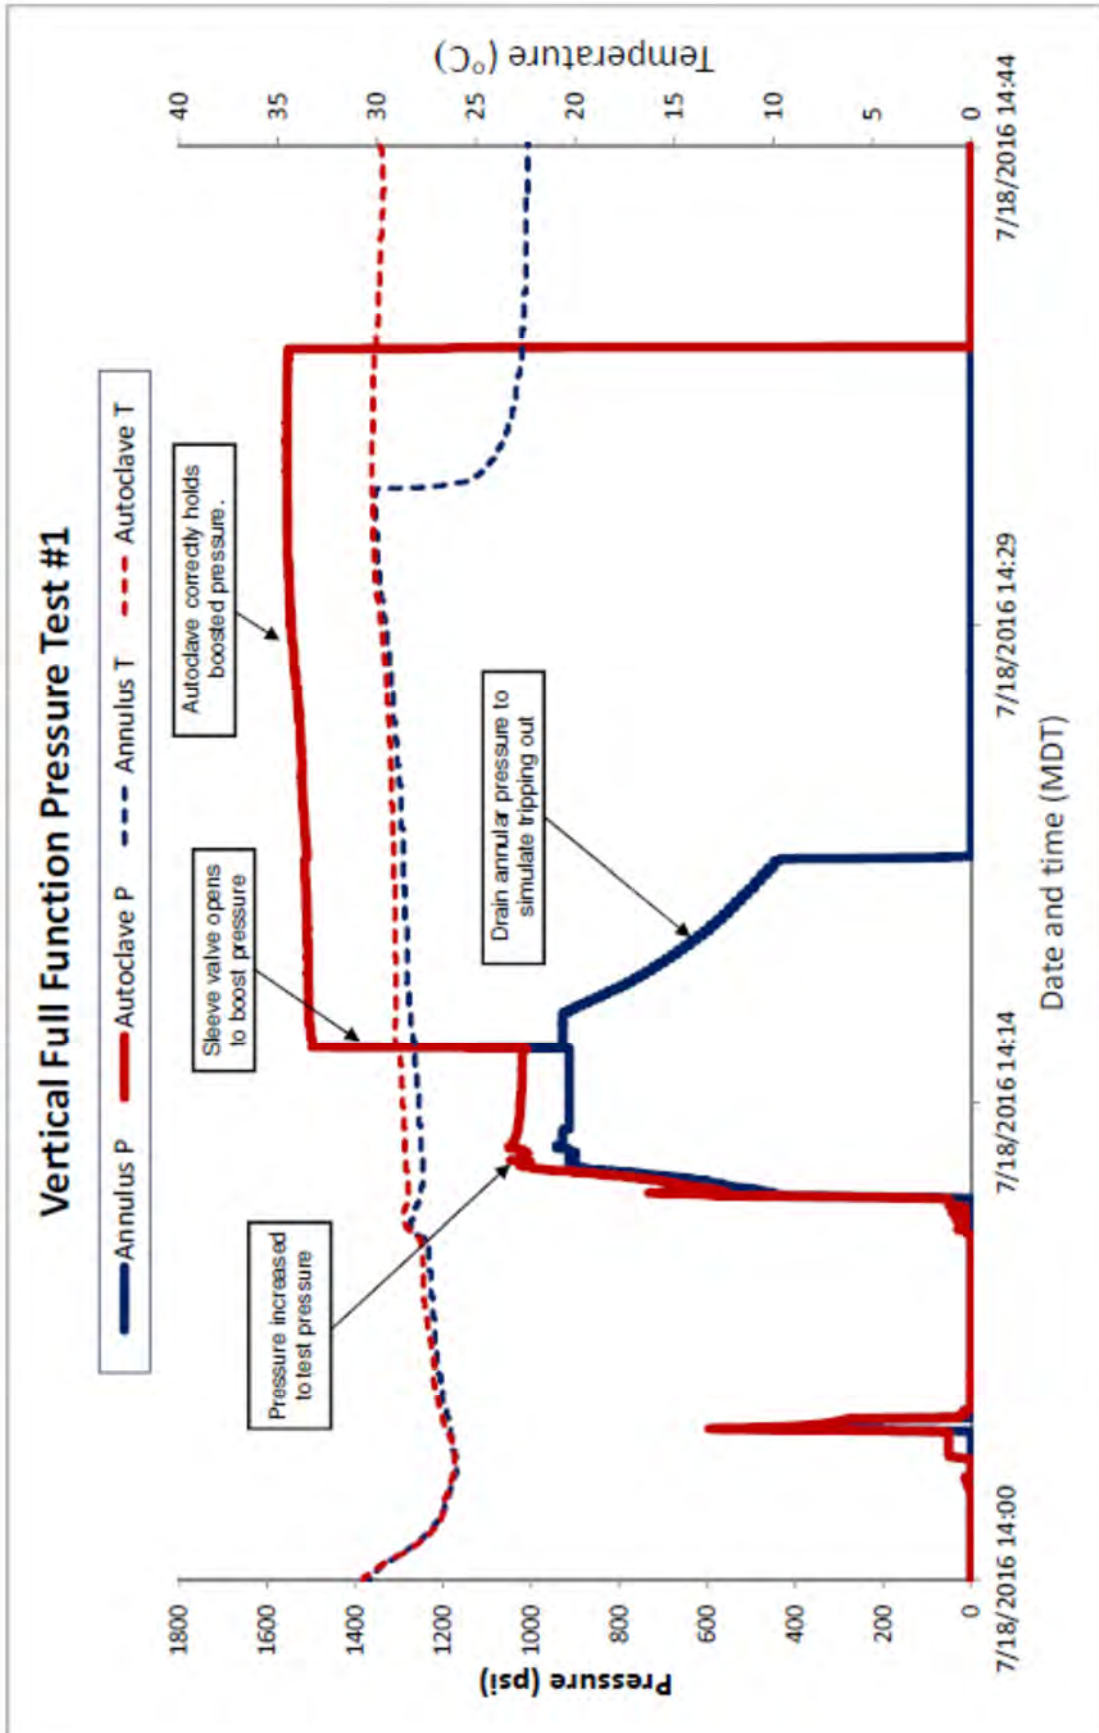
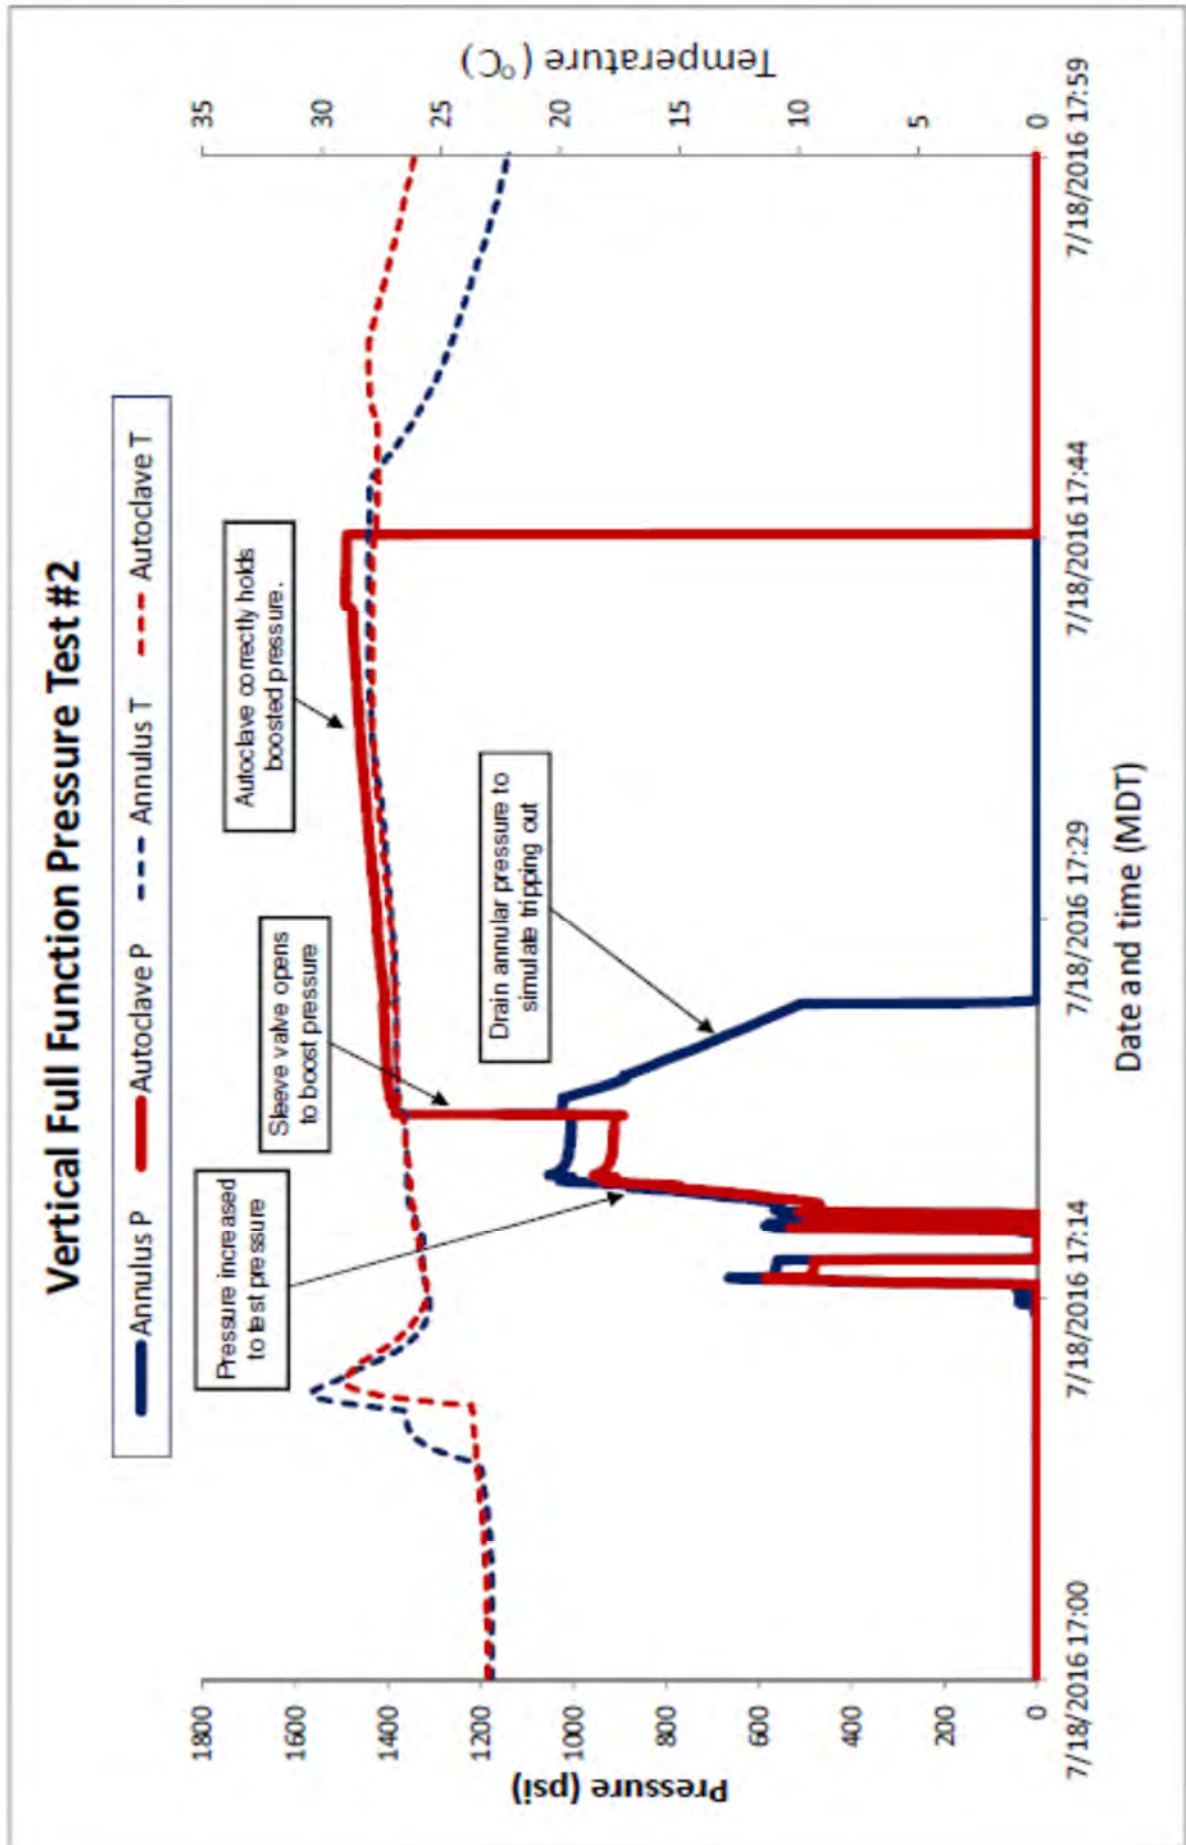
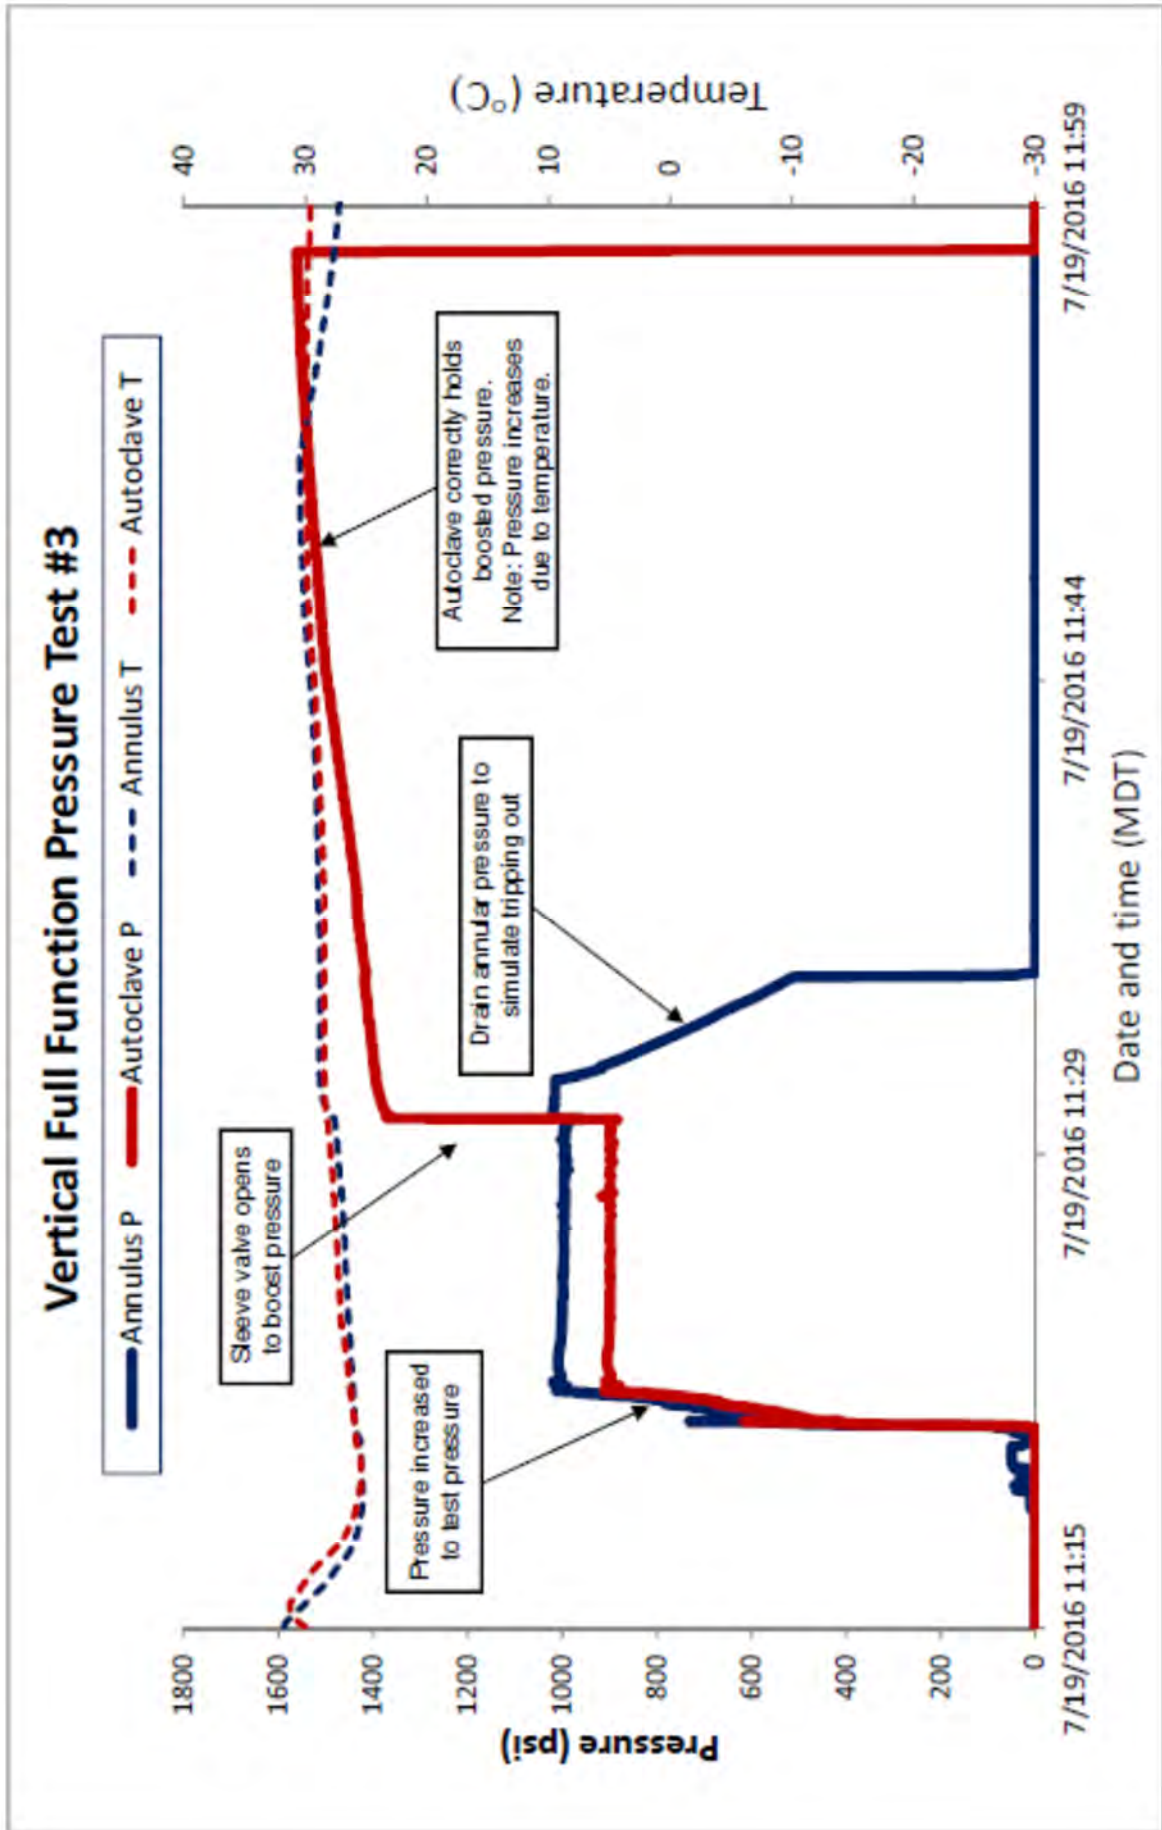
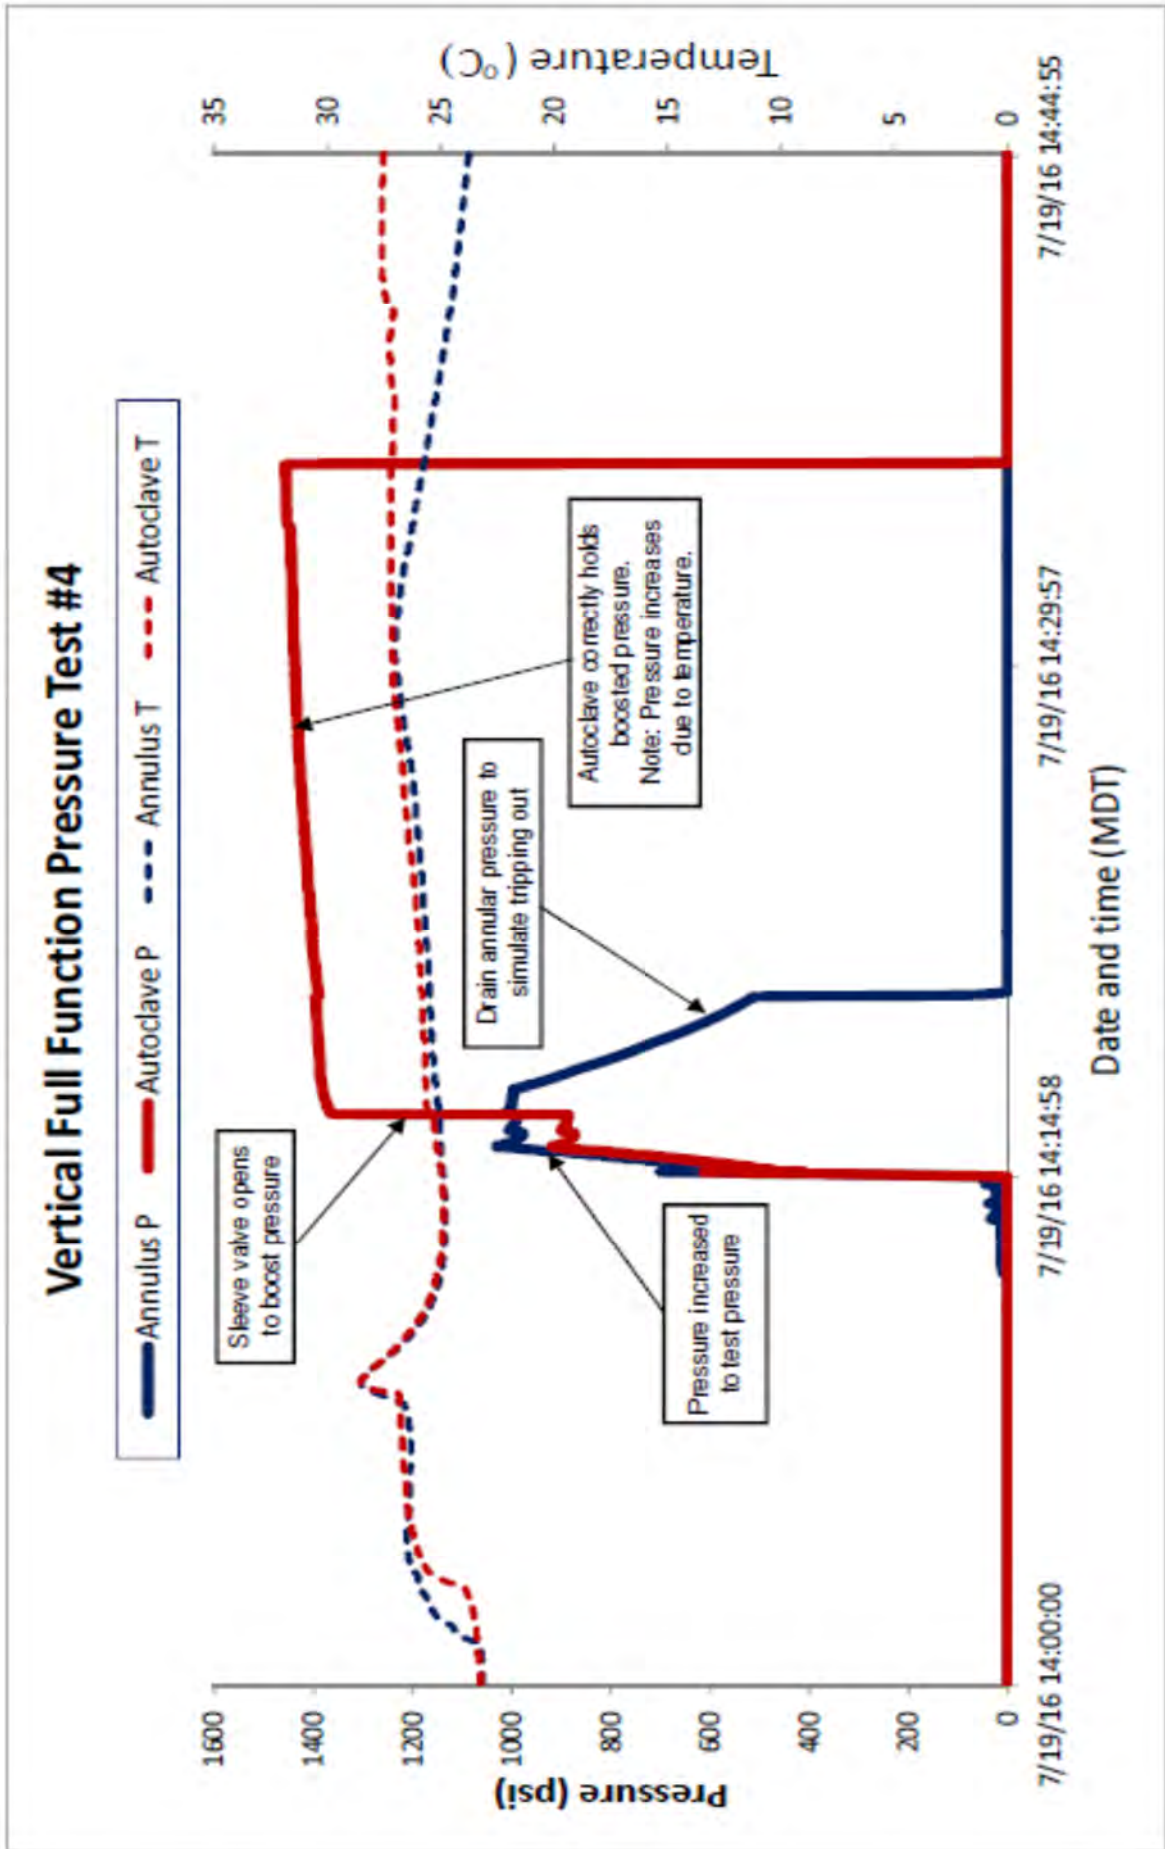
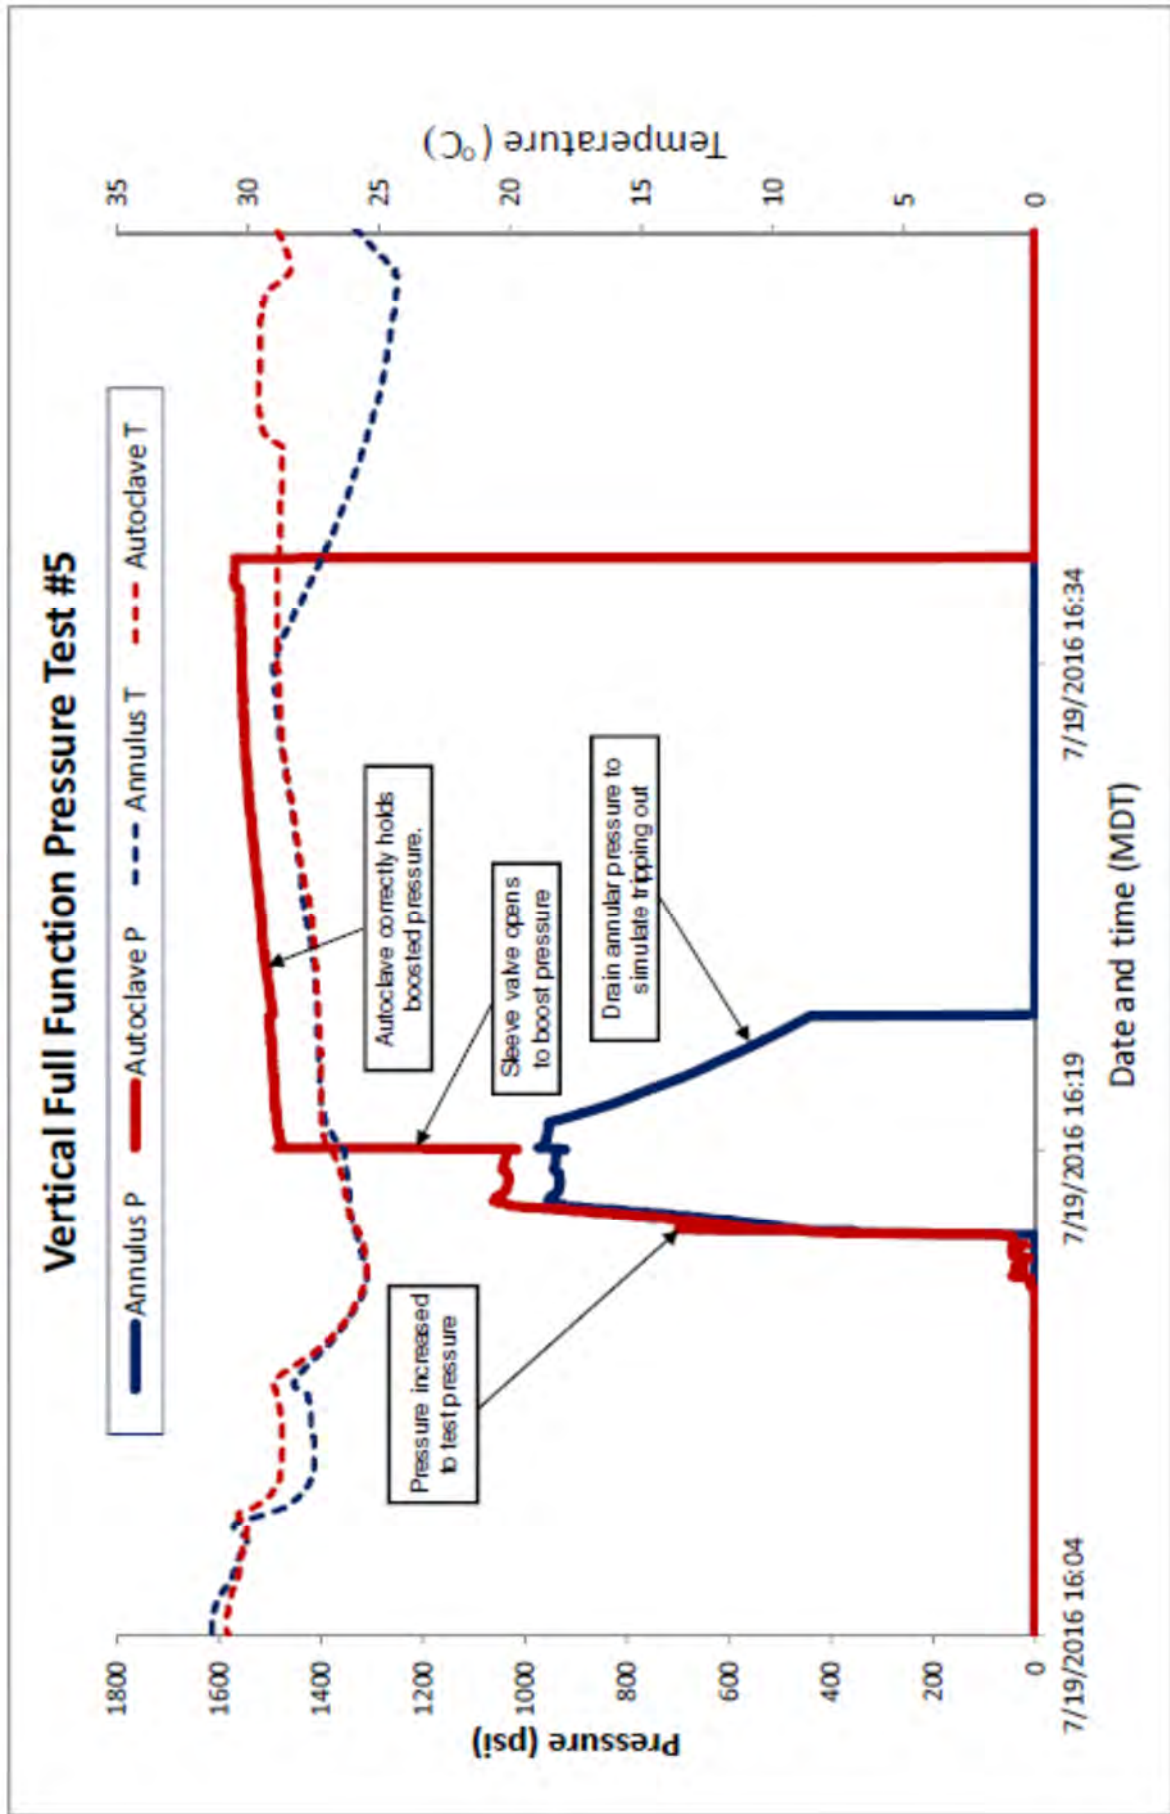
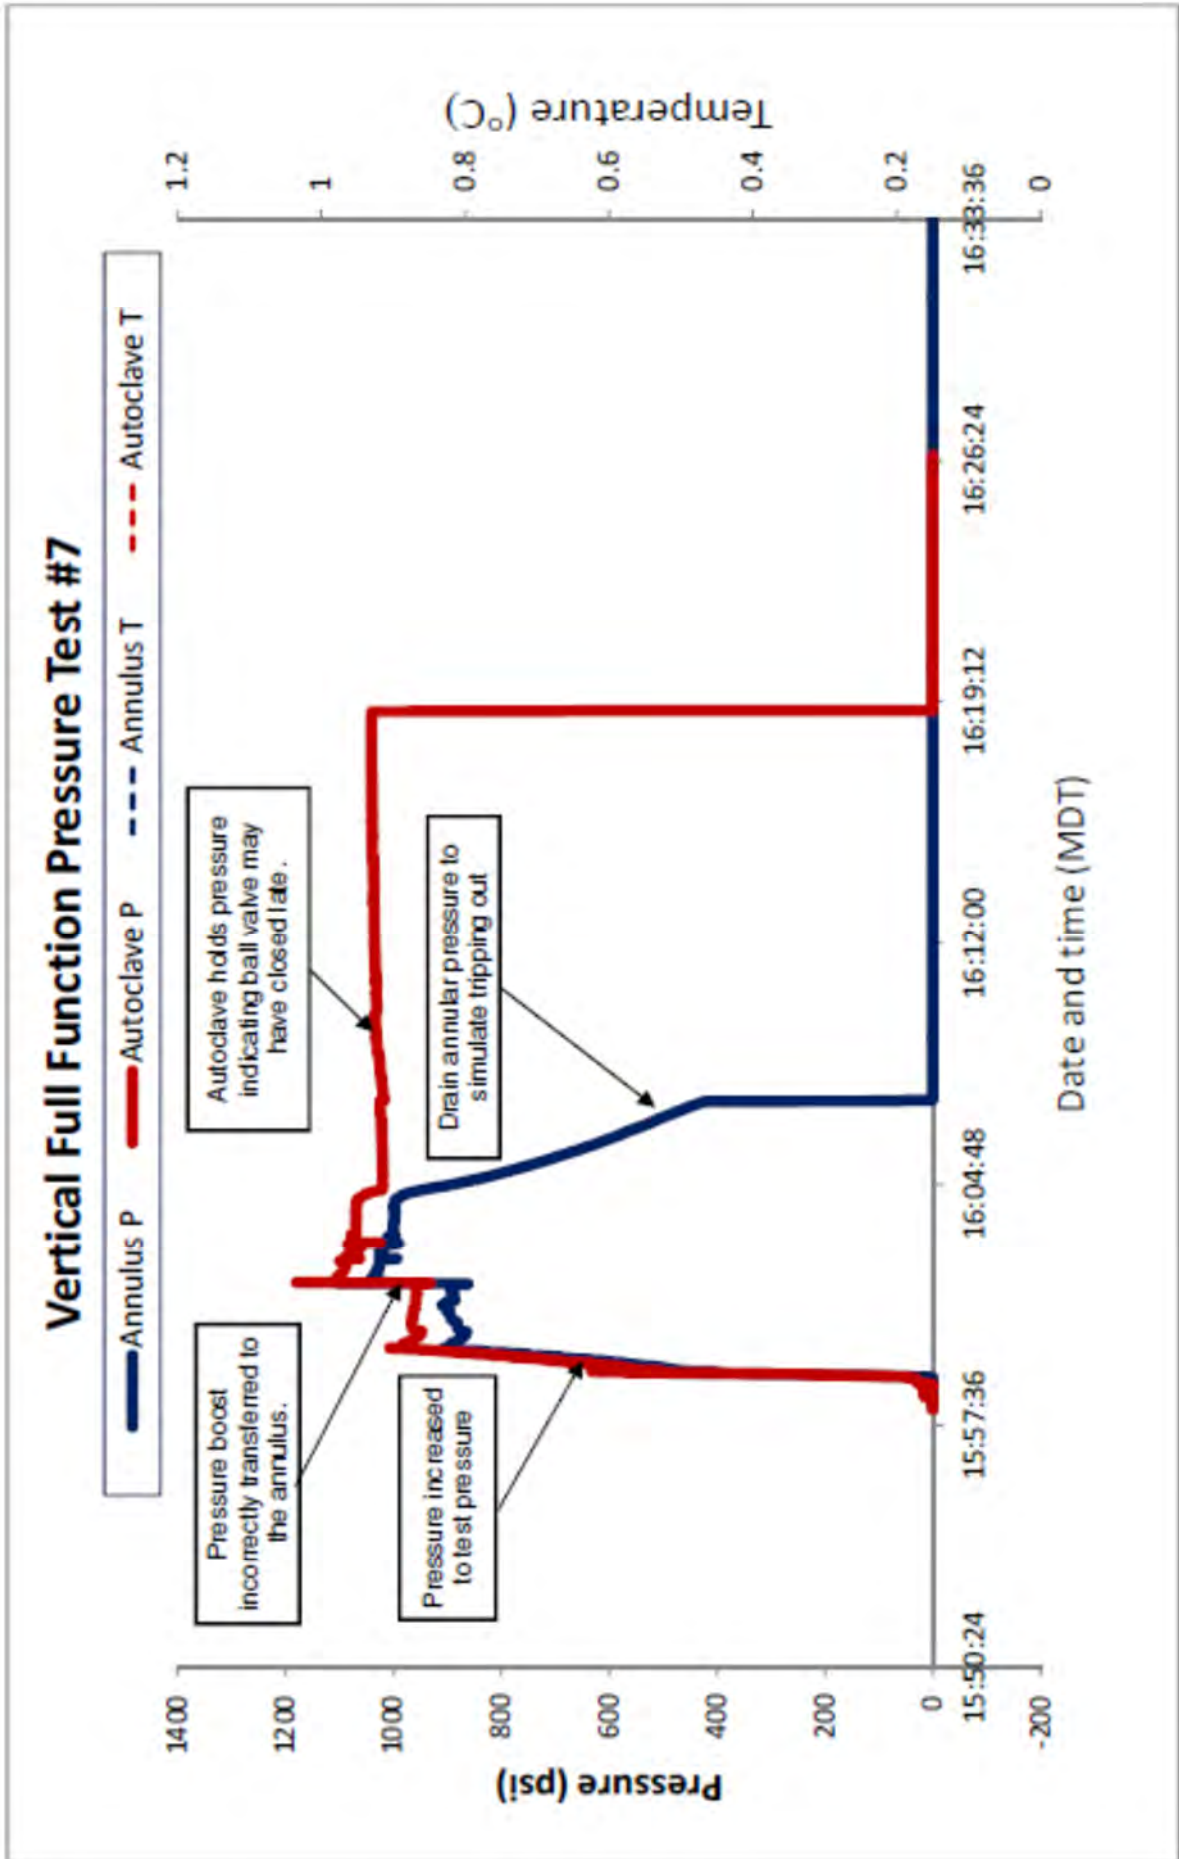
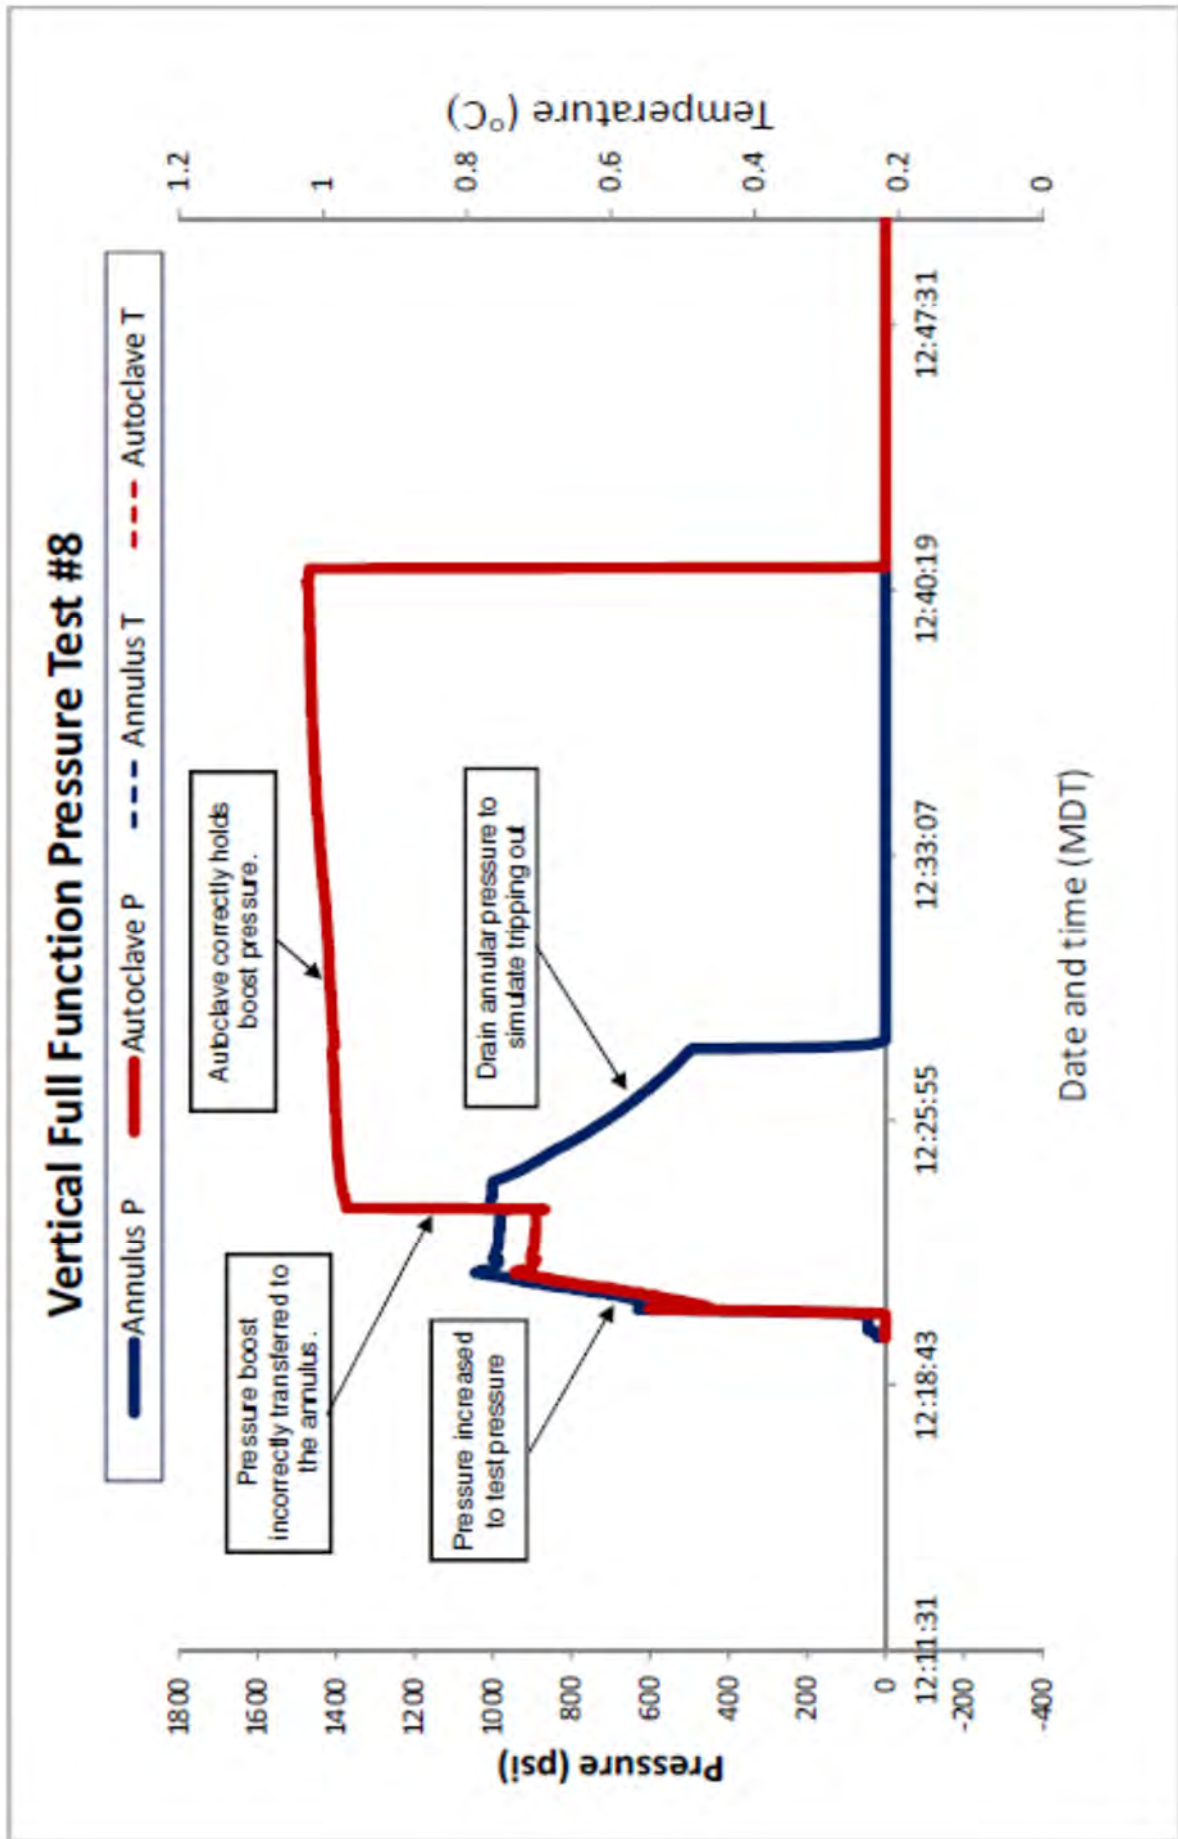
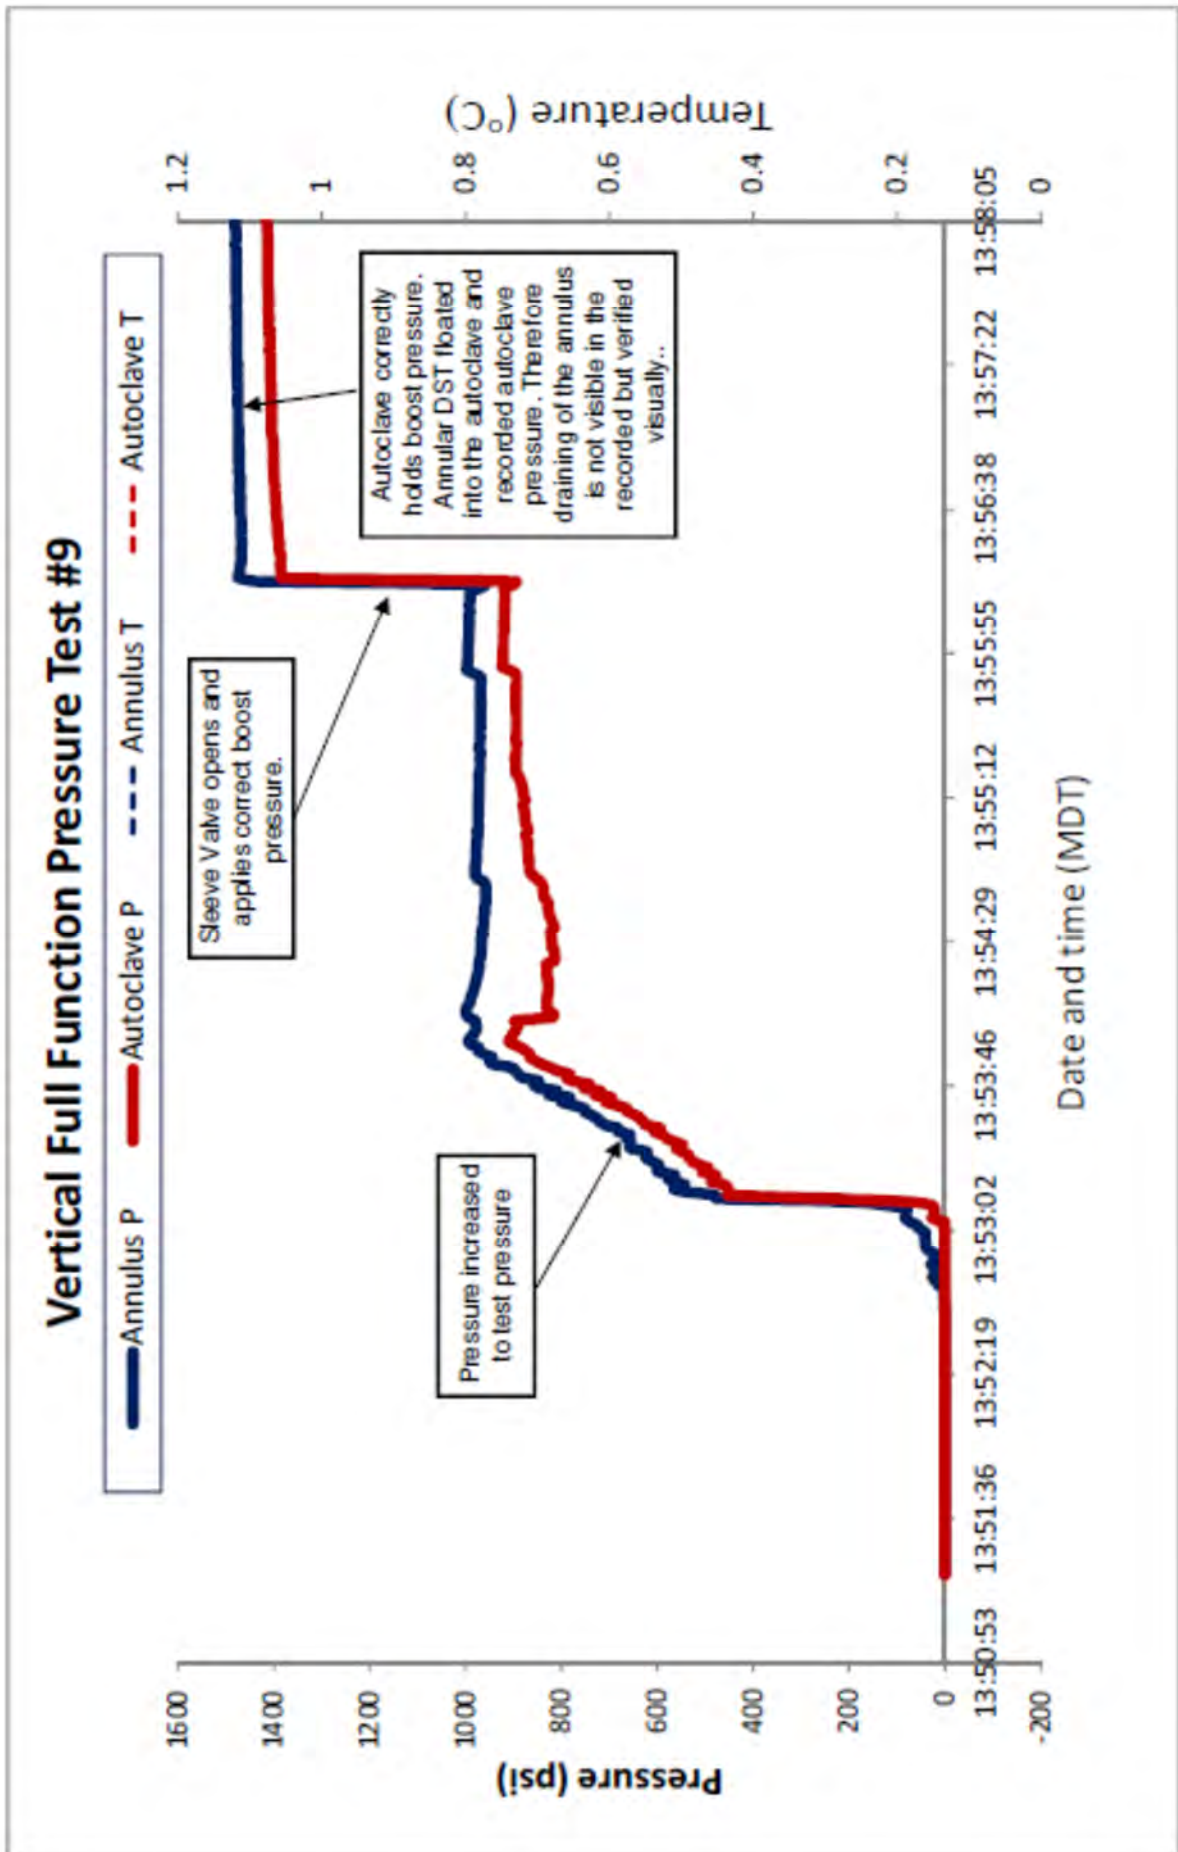
Appendix C, Vertical Full Function Pressure Test Pressure Charts

7		7/20/2016	R	29C7068	27C7066	3010	1510	1000	1125	1125	1070	0.46	Boost occurred before the ball valve was completely closed. This pressured up the annulus as well during the pressure boost. However, the ball valve sealed during depressurization indicating it has closed late. Burrs were discovered on the ball valve housing causing the seal carrier to hang up delaying ball valve closure.
8		7/21/2016	R	28C7066	30C7068	3005	1501	990	1010	1375	1410	0.46	Good test.
9		7/21/2016	R	28C7066	30C7068	3004	1512	990		1470	1490		Good test. However, the annulus DST migrated from the annulus chamber below the ball into the autoclave and also recorded the autoclave pressure. As a result, no annular pressures were recorded.

Test 3 – The tool failed to fully stroke initially but finally fully stroked after several attempts to pull it using the actuation cylinder. The autoclave contained the fully boosted pressure and was ultimately successful. The maximum force applied by the actuator to the release rod was ~2,000 lbs. This force is well within the capabilities of a wireline unit in the field. Since the modified parts now prevent the PCTB from releasing from the BHA until it is fully stroked internally, should this particular hang up occurred in the field, the wireline operator would be able to work the wireline up and down and achieve the same results. In the event the PCTB fails to stroke in the field, it would be necessary to shear release pin in the pulling tool and pull it out of the hole. Then the emergency pulling tool, which engages only the PCTB upper latch, would have to be run in the hole to recover the PCTB. In this case the ball valve would likely remain open.

Test 7 – During this test the actuator was actuated and the PCTB only partially stroked. The actuator was worked up and down several times when both the annulus pressure and the autoclave pressure were observed to increase to ~1,125 psi and the PCTB could not be stroked further. The annular pressure was slowly bled off to zero as usual, simulating coming out of the hole on wireline. The autoclave held pressure but the pressure dropped from ~1,125 to ~1,070 psi and then remained there. The PCTB was rigged down for autopsy.
