Wabash River Coal Gasification Repowering Project

Final Technical Report

August 2000

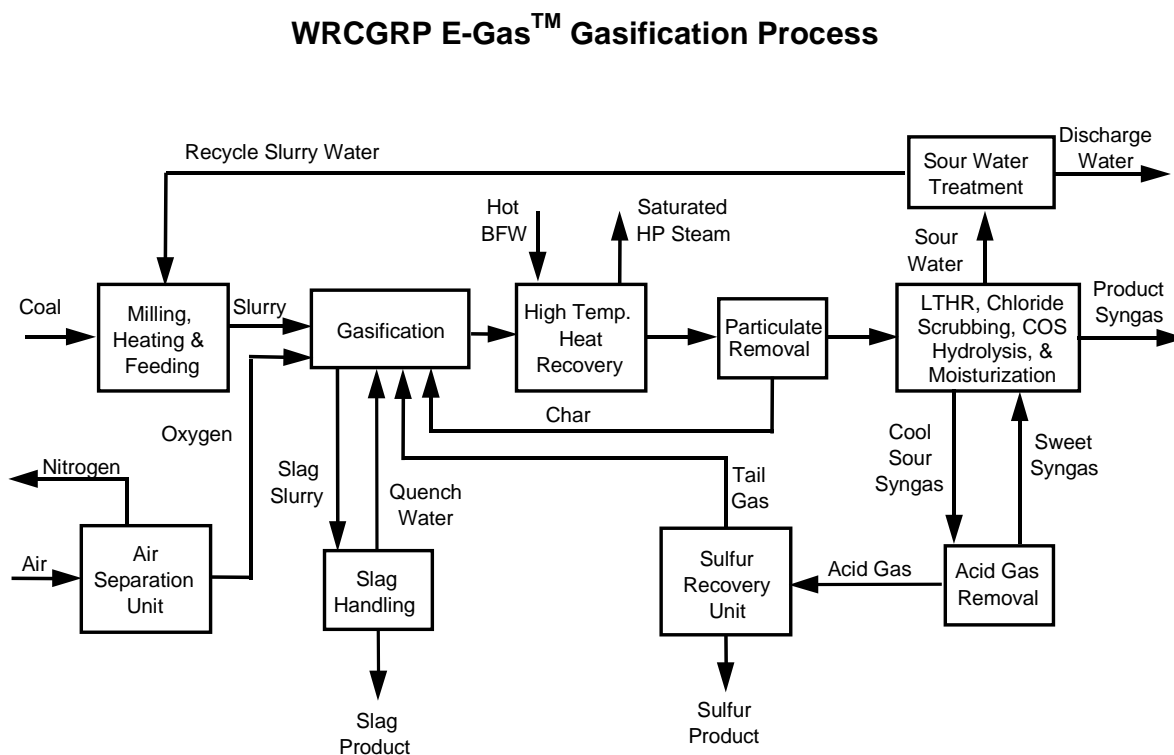
Figure ES-1: Gasification Process Simplified Block Flow Diagram

vitreous slag. The syngas flows to the second stage, where additional coal slurry is injected. This coal is pyrolyzed by the hot syngas to enhance the syngas heating value and to improve overall efficiency. Syngas leaving the gasifier flows to the high temperature heat recovery unit (HTHRU), also referred to as the boiler, to produce high-pressure saturated steam. After cooling in the HTHRU, particulates in the syngas are removed in a hot/dry filter and recycled to the gasifier where the carbon in the particulates is converted into more syngas.

Following the particulate removal system, the syngas is further cooled in the low temperature heat recovery (LTHR) area, water-scrubbed to remove chloride, and passed through a catalyst that hydrolyzes carbonyl sulfide (COS) to hydrogen sulfide (H₂S). H₂S is removed using methyldiethanolamine (MDEA) based absorber/stripper columns. The “sweet” syngas is then moisturized, preheated, and piped over to the power block, where it is combusted in a General Electric 7FA high-temperature combustion turbine/generator to produce 192 MW electricity. The heat recovery steam generator (HRSG) configuration is optimized to utilize both the gas turbine exhaust energy and the heat energy made available in the gasification process. Steam

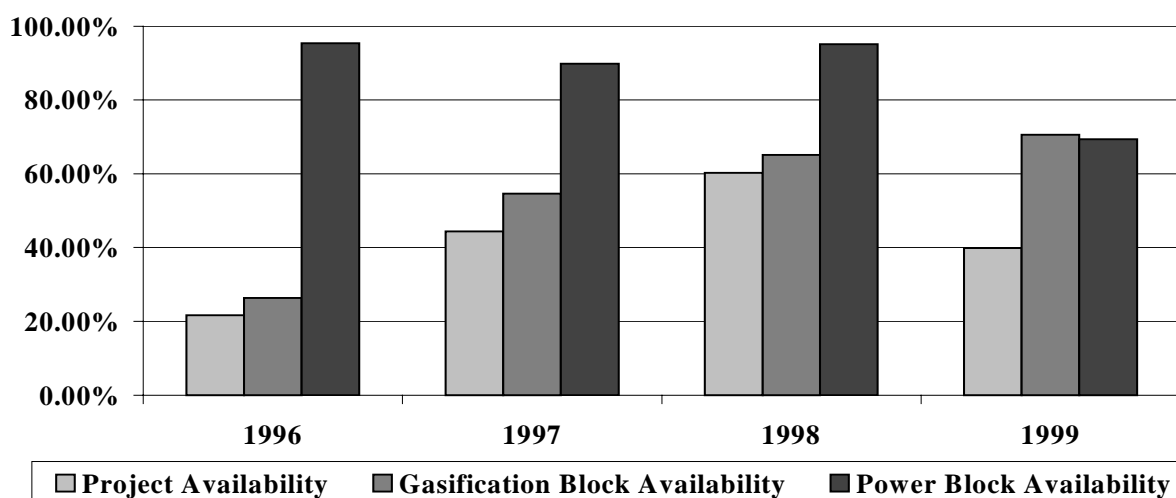
Figure ES-2: Project Syngas Block and Power Block Availability

In 1998 and 1999 a high percentage of coal interruptions and downtime were caused by the air separation unit (ASU). Ten coal interruptions in 1998 alone were due to the ASU. In 1999, failure of a blade in the compressor section of the combustion turbine required a complete rotor rebuild that idled the Project for 100 days. Run-time in 1999 was also impacted by a syngas leak in the piping system of the particulate removal system, a main exchanger leak in the air separation unit, another plugged taphole, and a failure of a ceramic test filter in the particulate removal system. Consequently, the availability factor for the Project in 1999 dropped to 40%.

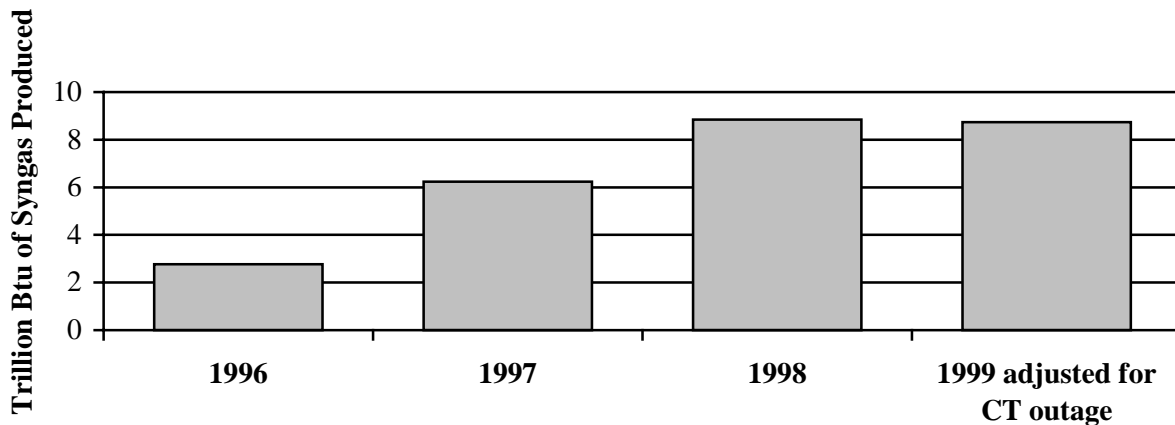
Figure ES-3: Syngas Production by Year

Early identification of availability-limiting process problems led to aggressive implementation of improvement projects which resulted in 224% more syngas produced during the second year than in year one. The syngas produced during the third year exceeded the second year's production by an additional 42%. Assuming the availability factor during the combustion turbine outage was the same as in 1998, the facility production in 1999 would have favorably matched 1998's output. Figure ES-3 depicts this continuous improvement trend over the last four years as measured by total syngas production.

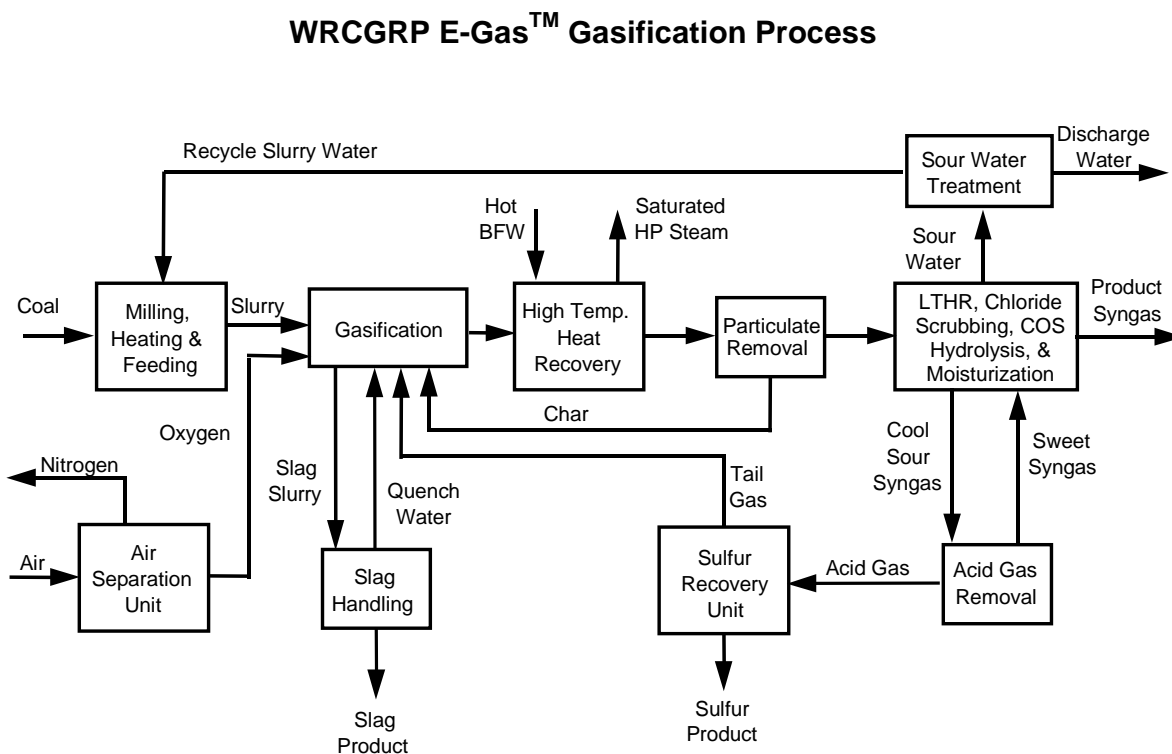
Figure 2.0A: Gasification Process Simplified Block Flow Diagram

The E-GasTM (Destec) Gasification Process features an oxygen-blown, continuous-slugging, two-stage, entrained-flow gasifier (Figure 2.0A). Coal or coke is milled with water in a rod mill to form a slurry. The slurry is combined with oxygen in mixer nozzles and injected into the first stage of the gasifier, which operates at 2600°F and 400 psig. A turnkey 2,060-ton/day low-pressure cryogenic distillation facility that WREL owns and operates supplies 95% pure oxygen.

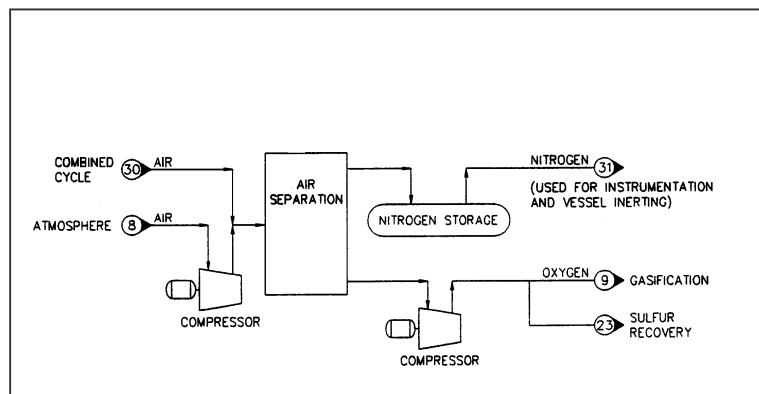
3.1 Air Separation Unit

The Air Separation Unit (ASU), or oxygen plant, contains an air compression system, an air separation cold box, an oxygen compression system and a nitrogen compression system.

Atmospheric air compressed by a multi-stage centrifugal compressor is cooled to approximately 40°F (5°C) and directed to the molecular sieve adsorbers where moisture, carbon dioxide and contaminants are removed to prevent them from freezing in the colder sections of the plant. The dry, carbon dioxide-free air is filtered before being separated into oxygen, nitrogen and waste gas in the cryogenic distillation system (cold box). An oxygen stream containing 95% oxygen is discharged from the cold box and compressed in another multi-stage centrifugal compressor, then fed to the gasifier.

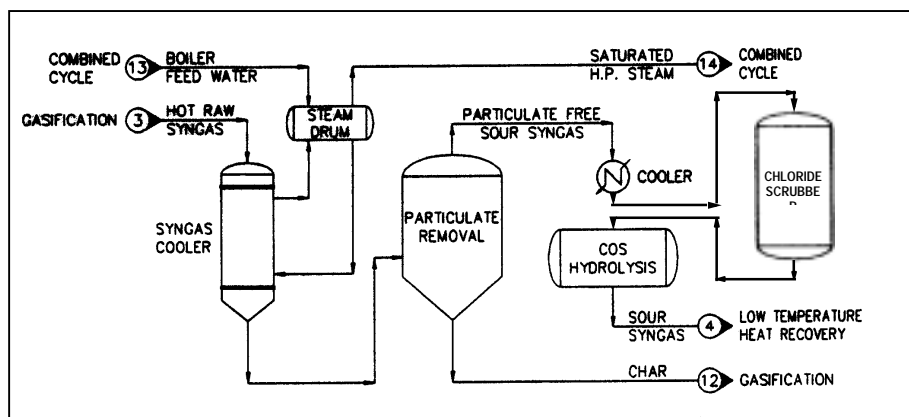
3.3.2 Syngas Cooling, Particulate Removal

The next two steps in the E-Gas™ process are to cool the syngas and then remove the particulate for recycle to the gasifier. Because of the high temperature of the

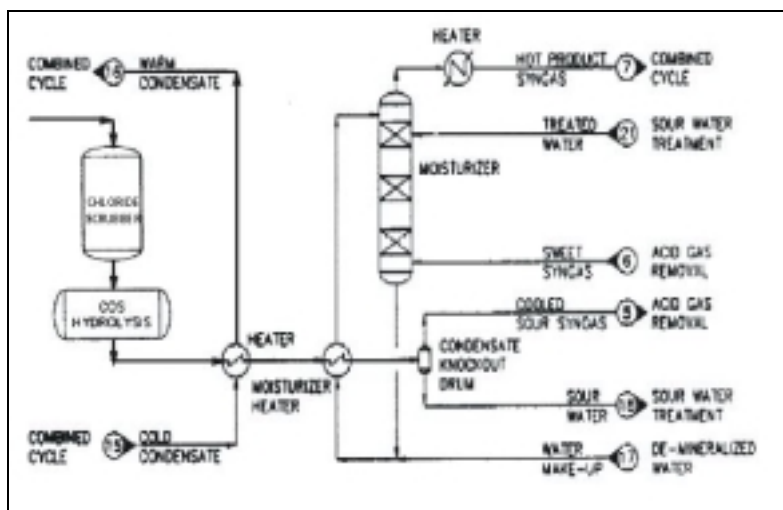
3.3.3 Low Temperature Heat Recovery, Chloride Scrubbing, and Syngas Moisturization

With particulates removed from the syngas, additional gas cleanup and cooling steps can be more easily performed. The syngas is scrubbed to remove troublesome chlorides and trace metals. These components are removed to reduce the potential of corrosion within the piping and vessels as well as reduce the formation of

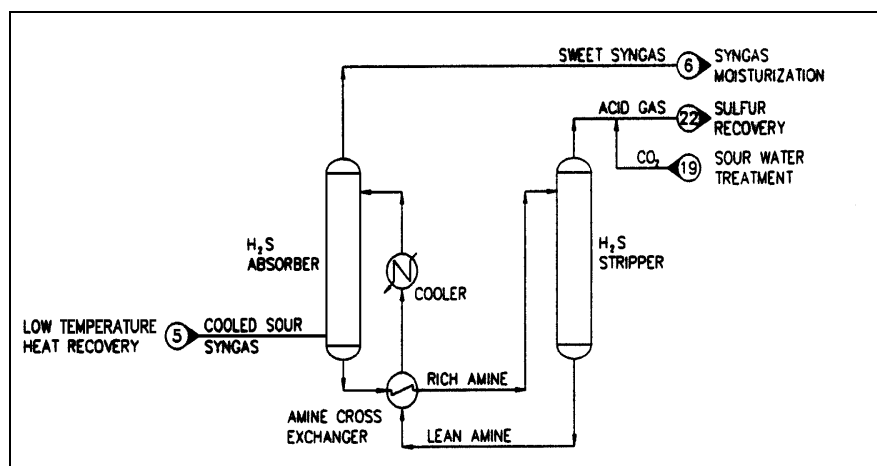
3.3.4 Acid Gas Removal

After the syngas has been sufficiently cooled, the sulfur is removed via the acid gas removal system. The principle acid gas removed at this point is hydrogen sulfide. This process contacts the cool sour syngas with a solvent

For selective and efficient sulfur removal from the syngas, an AGR system was chosen based on methyldiethanolamine (MDEA), which chemically bonds with H_2S , yet the bond can be easily broken with low-level heat to effect a regeneration of the absorbent. The H_2S is absorbed from the syngas by contacting the gas with MDEA at a system pressure of about 375 psia (25.9 bar) within the H_2S absorber column. A portion of the carbon dioxide is absorbed as well. The H_2S -rich MDEA from the bottom of the absorber flows under pressure to a cross exchanger to recover heat from the hot, lean MDEA coming from the stripper. The heated, rich MDEA is then directed to the H_2S stripper where the H_2S and CO_2 are steam-stripped in a reboiled column at near atmospheric pressure. A concentrated stream of H_2S in CO_2 exits the top of the stripper and flows to the SRU. The lean MDEA is pumped from the bottom of the stripper to the cross exchanger. The lean amine is further cooled to about 100°F (35°C) to remove residual heat before being stored and then circulated back to the absorber. The AGR system does not produce any emissions to the atmosphere.

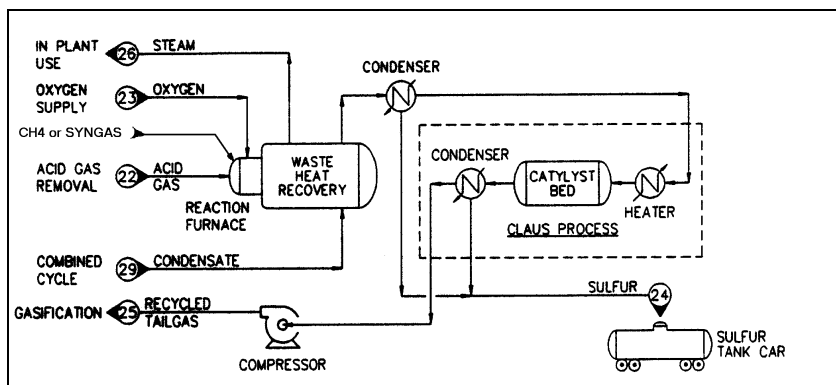
3.3.5 Sulfur Recovery

The H_2S leaving in the acid gas from the AGR system is converted to elemental sulfur in the sulfur recovery unit (SRU). This technology is based on the Claus process involving the partial oxidation

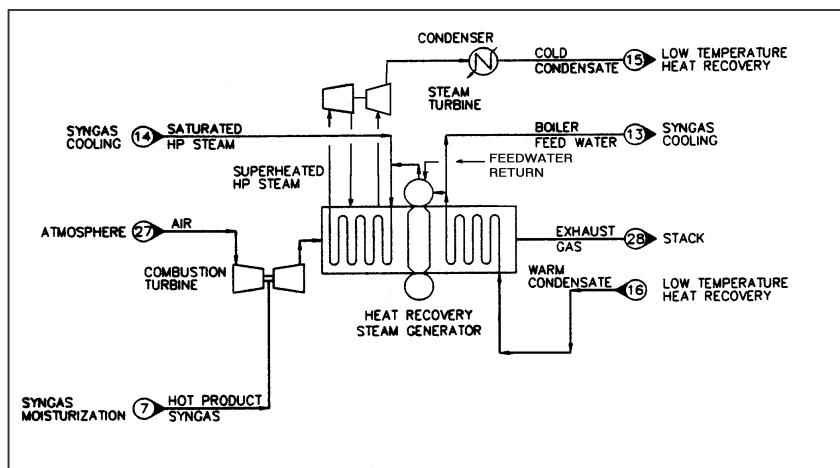
3.4 Power Block

The combined-cycle system consists of a combustion turbine generator, heat recovery steam generator, reheat steam turbine generator, condenser, flash drums, condensate pumps and boiler feedwater pumps.

Preheated, moisturized syngas and compressed air are supplied to the combustor. The hot gas exiting the combustor flows to the turbine, which drives the generator and air compressor section of the combustion turbine. Hot exhaust gas from the expander is ducted to the heat recovery steam generator (HRSG).

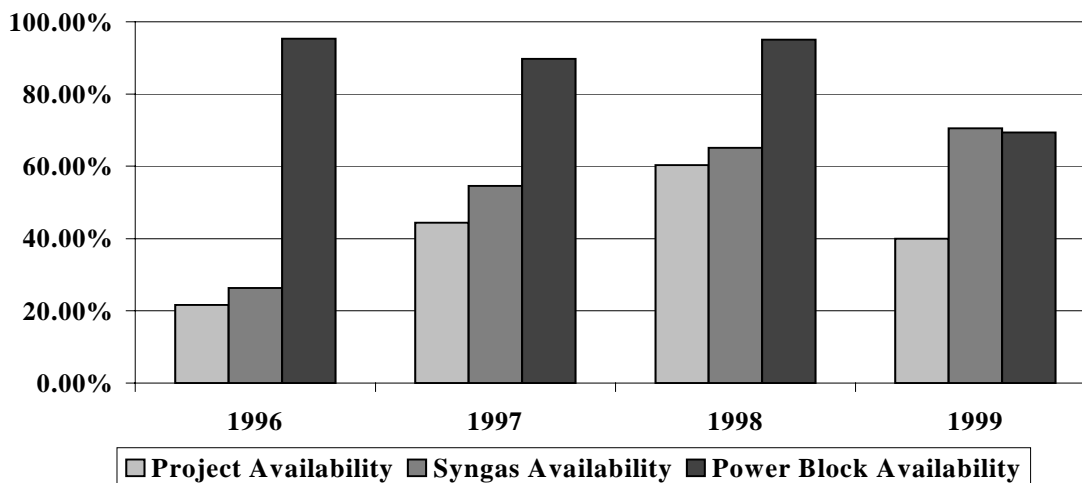
Figure 4.1A: Project, Syngas Block and Power Block Availability

In 1998 and 1999 a high percentage of coal interruptions and downtime were caused by the air separation unit (ASU). Ten coal interruptions in 1998 alone were due to the ASU. In 1999, failure of a blade in the compressor section of the combustion turbine required a complete rotor rebuild that idled the Project for 100 days. Run-time in 1999 was also impacted by a syngas leak in the piping system of the particulate removal system, a main exchanger leak in the air separation unit, another plugged taphole, and a failure of a ceramic test filter in the particulate

removal system. Consequently, the availability factor for the facility in 1999 dropped to 40%. However, 1999 clearly marked significant advances in the application of commercial IGCC as

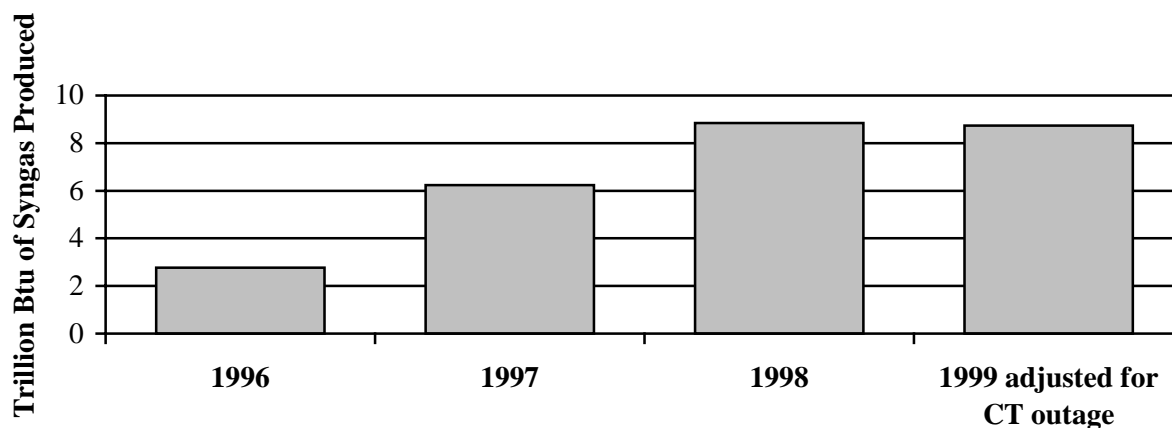
**Figure 4.1B: Syngas Production by Year**

Early identification of availability-limiting process problems led to aggressive implementation of improvement projects which resulted in 224% more syngas produced during the second year than in year one. The syngas produced during the third year exceeded the second year's production by an additional 42%. Assuming that the availability factor during the combustion turbine outage was the same as in 1998, the facility production in 1999 would have matched 1998's output. Figure 4.1B illustrates this continuous improvement trend over the last four years as measured by total syngas production.

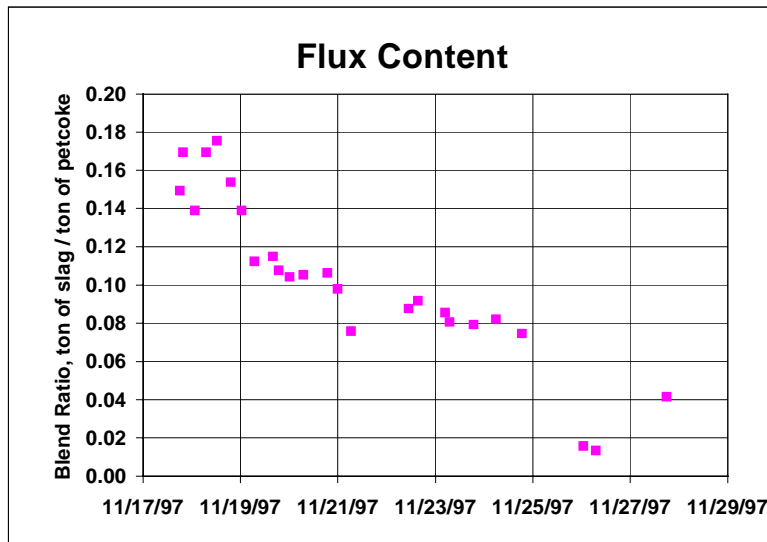
Figure 4.2.2C: Petroleum Coke Test Flux Content

Flux Addition and Slag Flow: Based on laboratory ash fusion and high temperature slag viscosity tests, a range of flux addition of 5 to 10 tons of slag per 100 tons of petroleum coke was targeted for the test. However, problems with the blending equipment resulted in the test starting at a ratio of about 20 tons/100 tons, or about 20% flux. This was corrected to the target ratio by the third day of testing. Near the end of the test, the flux ratio was purposely reduced to about 2 tons/100 tons (Figure 4.2.2C). No slag-tapping problems were encountered during the test.

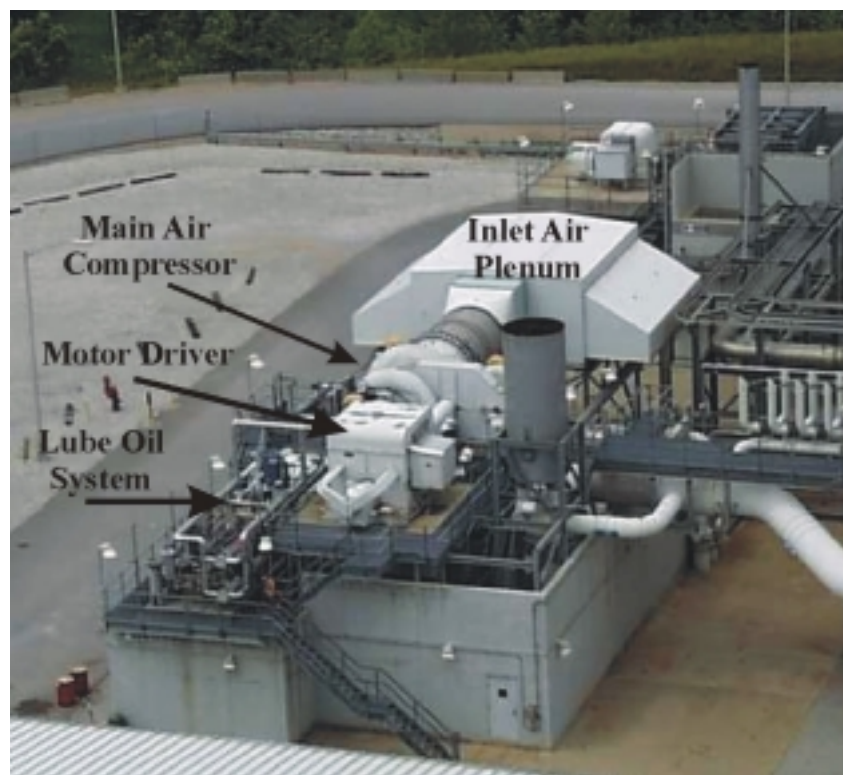
Figure 5.1.1A: Main Air Compressor

The flow of air through the compressor is controlled via modulation of guide vanes on each of the three compressor stages. The machine is protected from surge via automatic vent valves on the discharge.

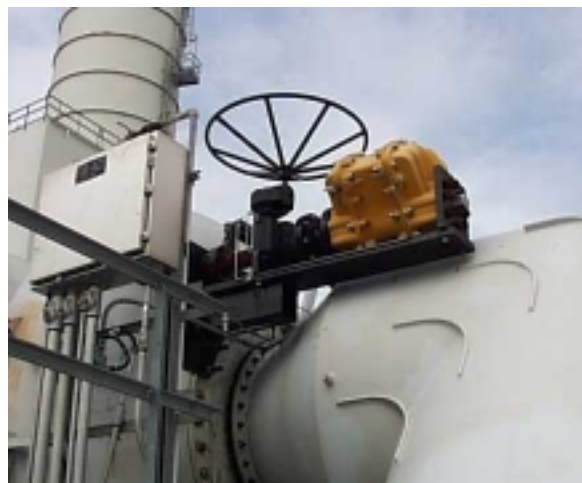
Figure 5.1.1B: Close-up of a Newly Installed Guide Vane Actuator

The actuators on the inlet guide vane subsystem for the main air compressor were replaced in October 1999, with a new third party design (Figure 5.1.1B). Some of the benefits of the new actuators include the following. The new system is designed for all weather conditions, which should eliminate plant downtime associated with moisture. The new design completely eliminates the field electronics inherent with the old system, thus simplifying guide vane control. The new actuators are designed for more cycles of operation than the plant could reasonably require in the course of several decades. All three actuators have a mechanism to allow them to be manually positioned and locked anywhere within their full range of motion providing the capability to perform actuator maintenance while the main air compressor remains on line. The new system incorporates only parts made in the USA, thus reducing cost and delivery lead-times. All three stages now utilize identical components affording a reduction of spare inventory. The actuators have caused no downtime since installation, and are expected to eliminate the air separation unit's largest source of downtime.

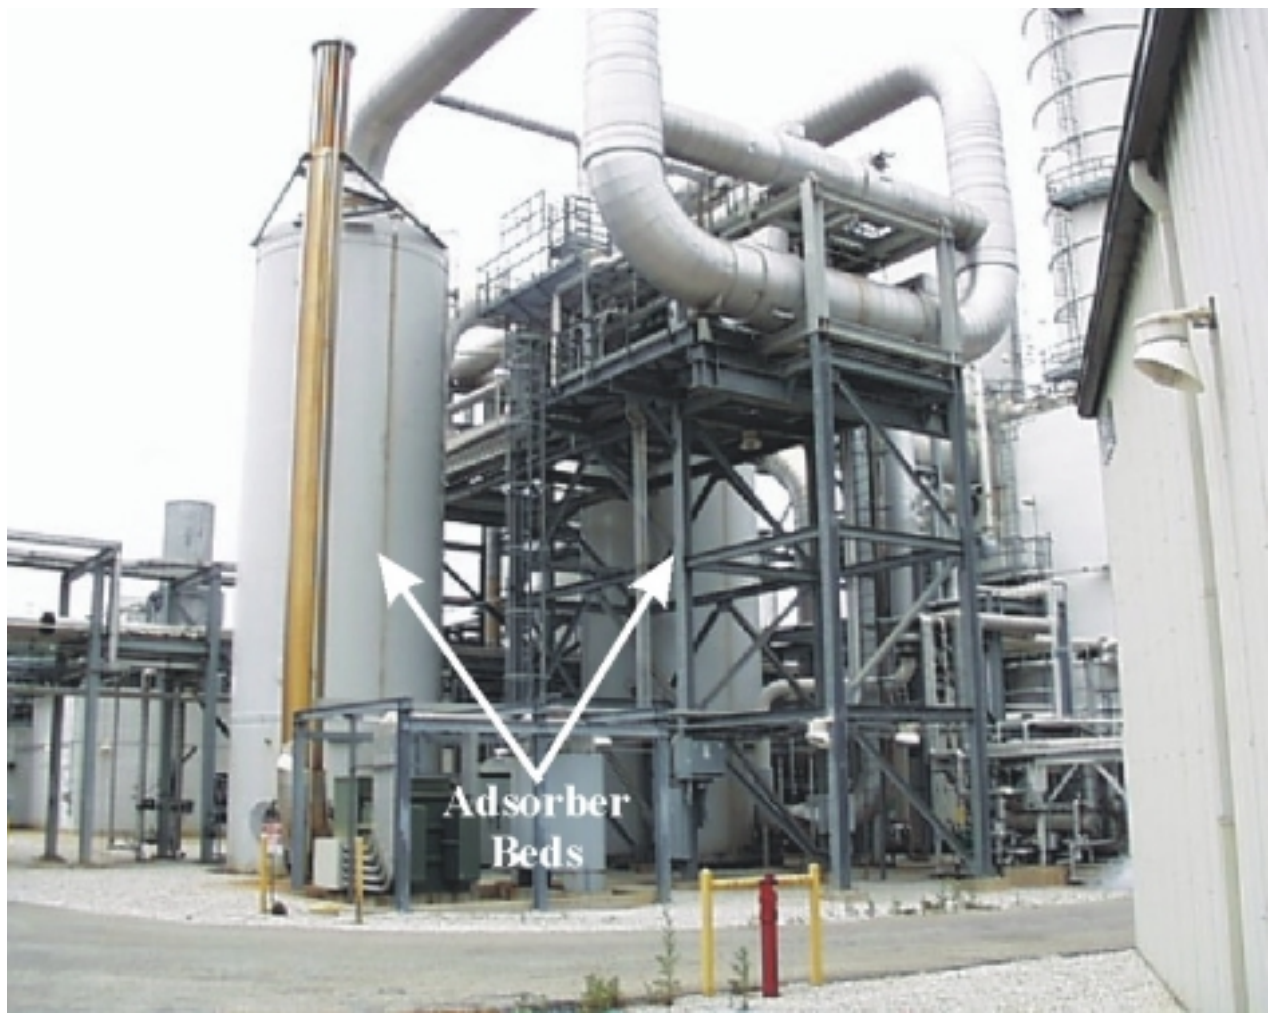
Figure 5.1.3A: Adsorber Beds for the Air Purification System

The adsorbers are two-stage, radial-flow media beds with one adsorber on line at all times while the other is being regenerated off line. Once regenerated and cooled, the off-line bed is brought on line and the other is heated for regeneration. This batch cycle is repeated constantly during plant operation.

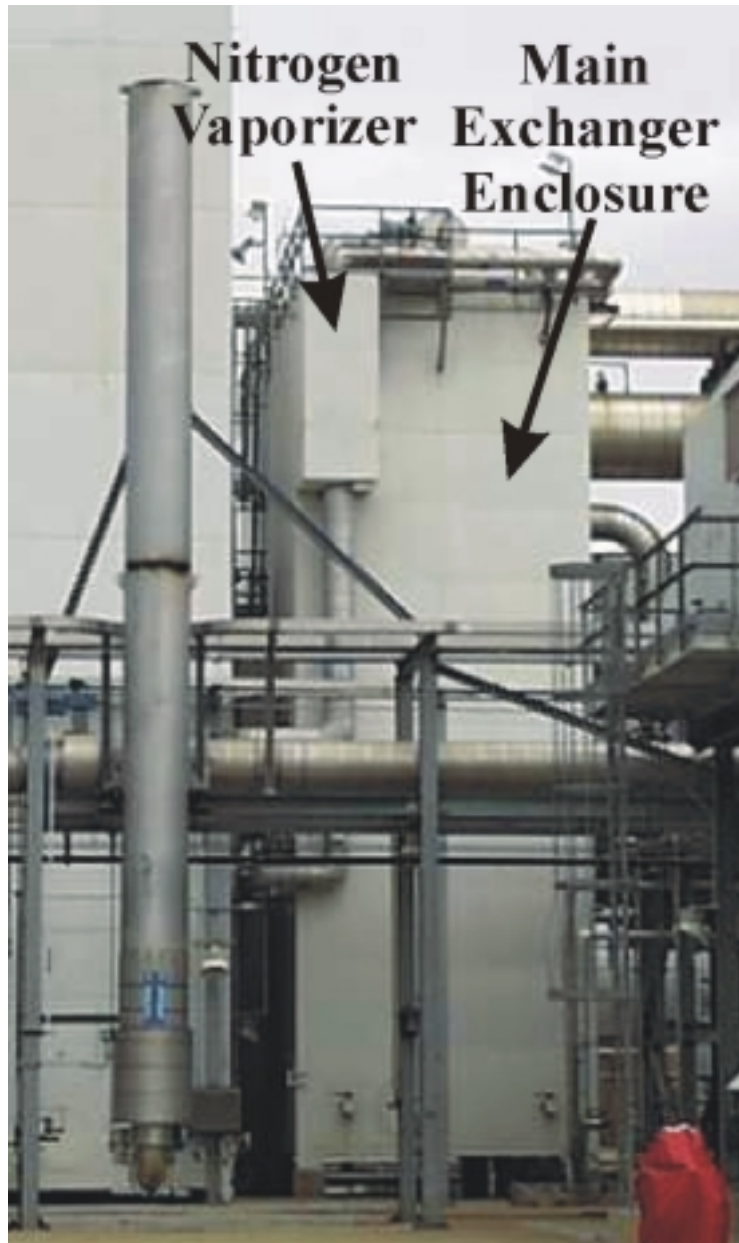
Figure 5.1.4A: Nitrogen Vaporizer and Enclosure for Main Exchangers

Main cryogenic exchangers (Figure 5.1.4A)	Compressor/Expander refrigeration system (Figure 5.1.4B)
Nitrogen vaporizer (Figure 5.1.4B)

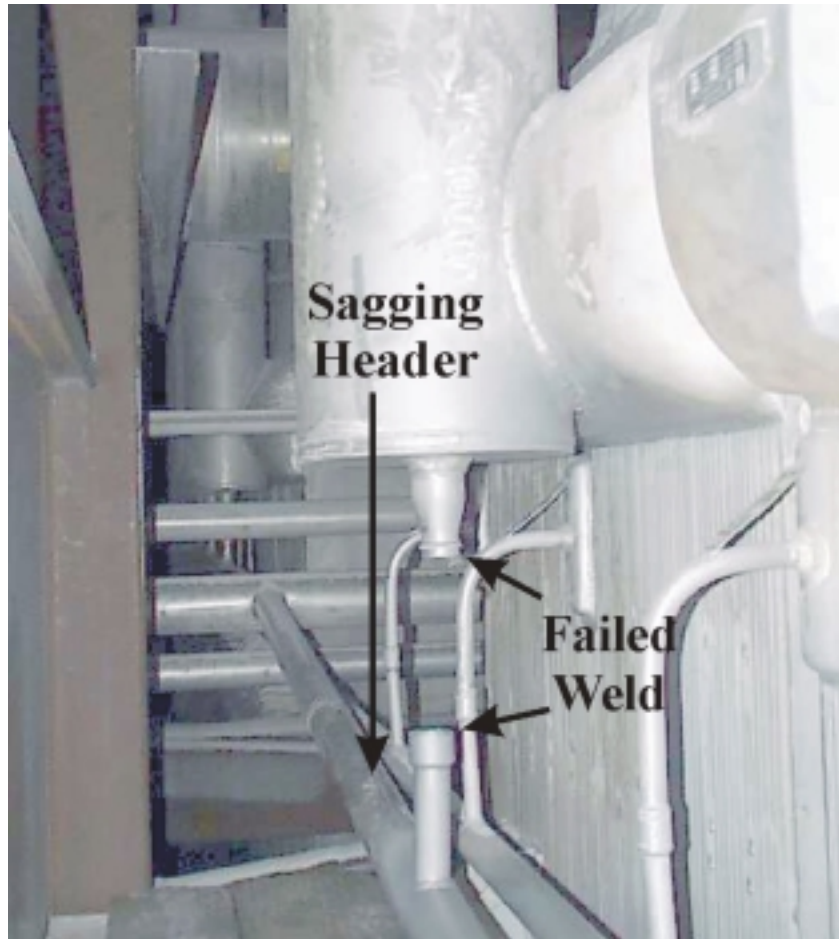
Figure 5.1.4C: Damage Inside Enclosure for Main Exchangers

However, an air leak inside the enclosure that houses the main exchangers forced an unplanned outage resulting in 299 hours of lost production during the 3rd quarter of 1999. Repair of the leak required the complete removal of insulation inside the exchanger housing. The leak was the result of three failed welds on one of four identical headers within the exchanger enclosure (Figures 5.1.4C&D). The three process piping welds on each of the four headers provided the only structural support for the headers, causing the welds to be under constant stress. Furthermore, close inspection of the welds determined that they were not held to acceptable quality control standards during the original installation. Even the welds that had not yet failed displayed the potential for future problems if left uncorrected. The fact that these low quality welds were responsible for both the physical support of the headers as well as maintaining pipe integrity led the investigation team to conclude that equipment design and poor quality control methods employed during installation were the root causes of the incident. As a result, all twelve welds were re-worked and additional structural supports for each of the four headers were installed. No future downtime as the result of similar failures is expected, but it is worth noting that future installations of similar exchanger systems need to incorporate designs that provide sufficient structural support and maintain strict quality control standards when making cryogenic welds.

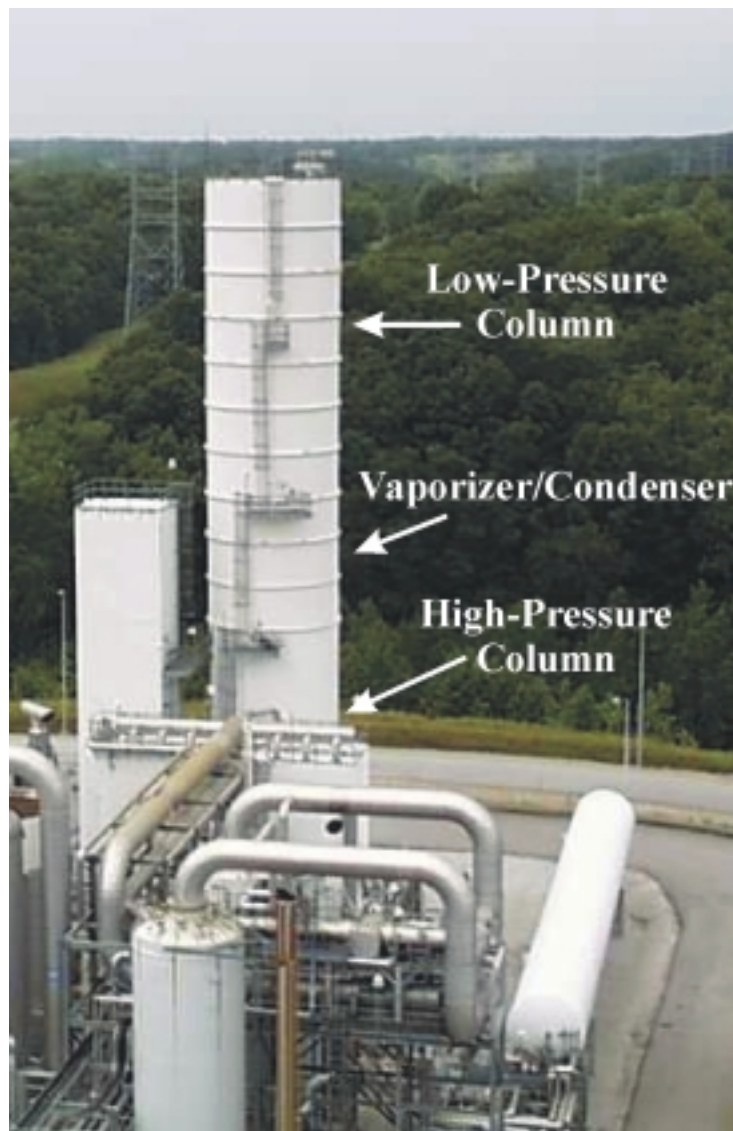
Figure 5.1.5A: High-Pressure and Low-Pressure Columns

High/Low pressure distillation columns (Figure 5.1.5A)	Vaporizer/Condenser (Figure 5.1.5A)
Nitrogen reflux sub-cooler	Rich liquid sub-cooler
Rich liquid separator	Lean oxygen separator

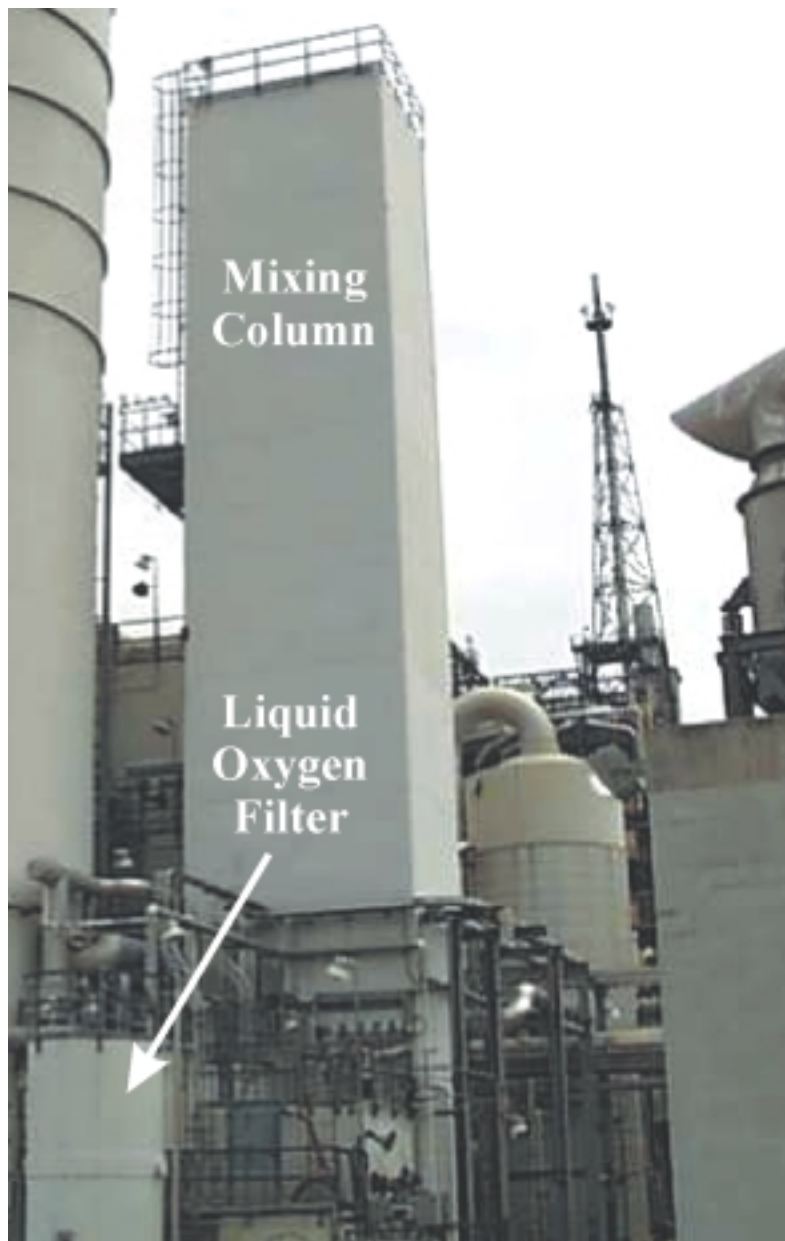
Figure 5.1.6A: Equipment Associated with Oxygen Mixing System

Liquid oxygen pumps	Mixing column (Figure 5.1.6A)
Liquid oxygen filter (Figure 5.1.6A)	Reactivation filter
Lean oxygen sub-cooler	Liquid oxygen reactivation heater

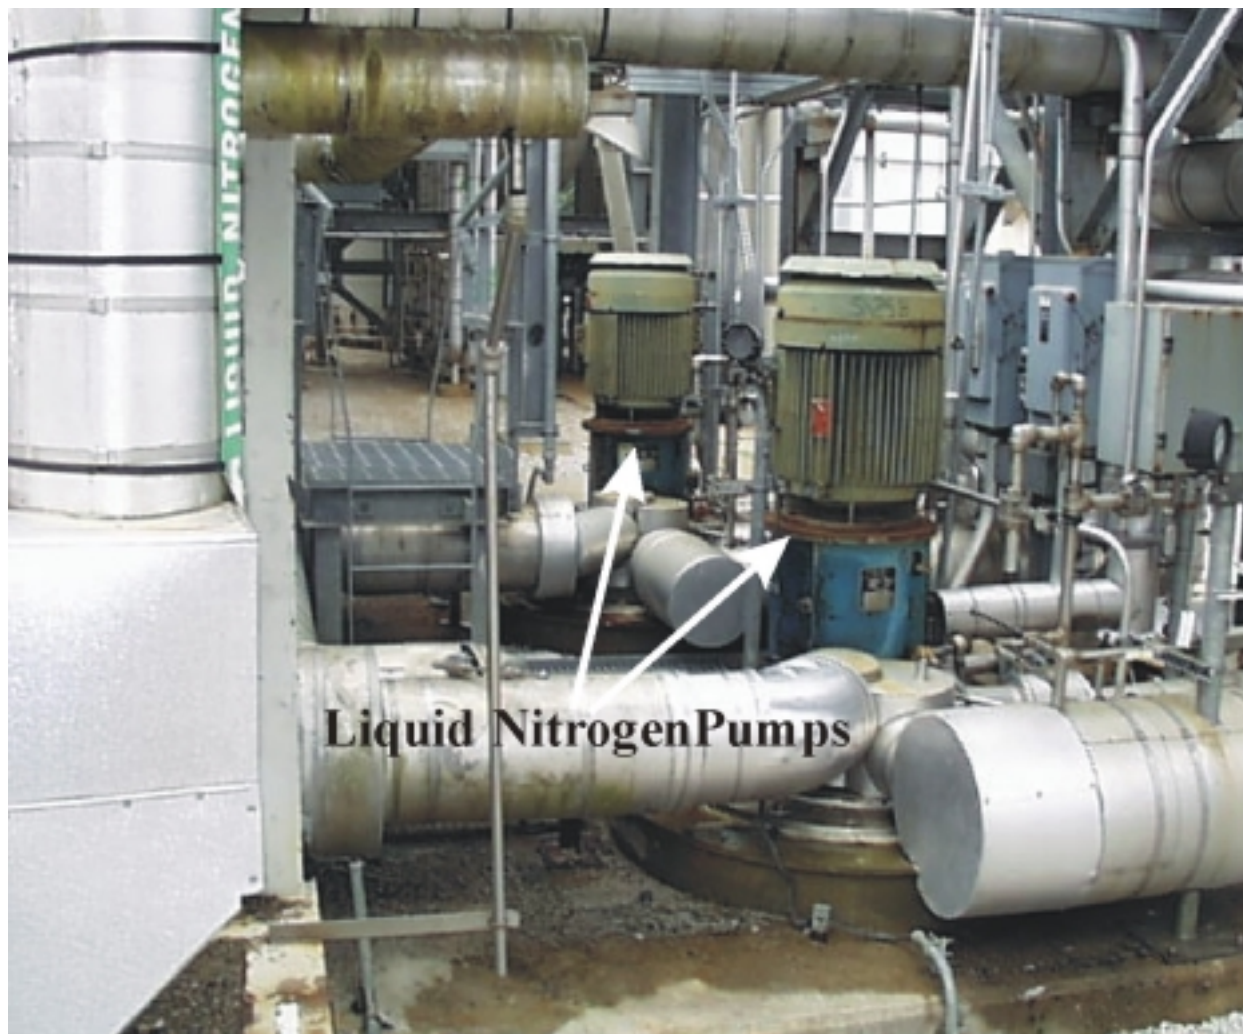
Figure 5.1.7A: Liquid Nitrogen Pumps

Liquid nitrogen storage tank (Figure 5.1.7C)	Liquid nitrogen pumps (Figure 5.1.7A)
Nitrogen steam vaporizer (Figure 5.1.7B)	High-pressure nitrogen fill pump (Figure 5.1.7B)
High-pressure nitrogen cylinders (Figure 5.1.7C)

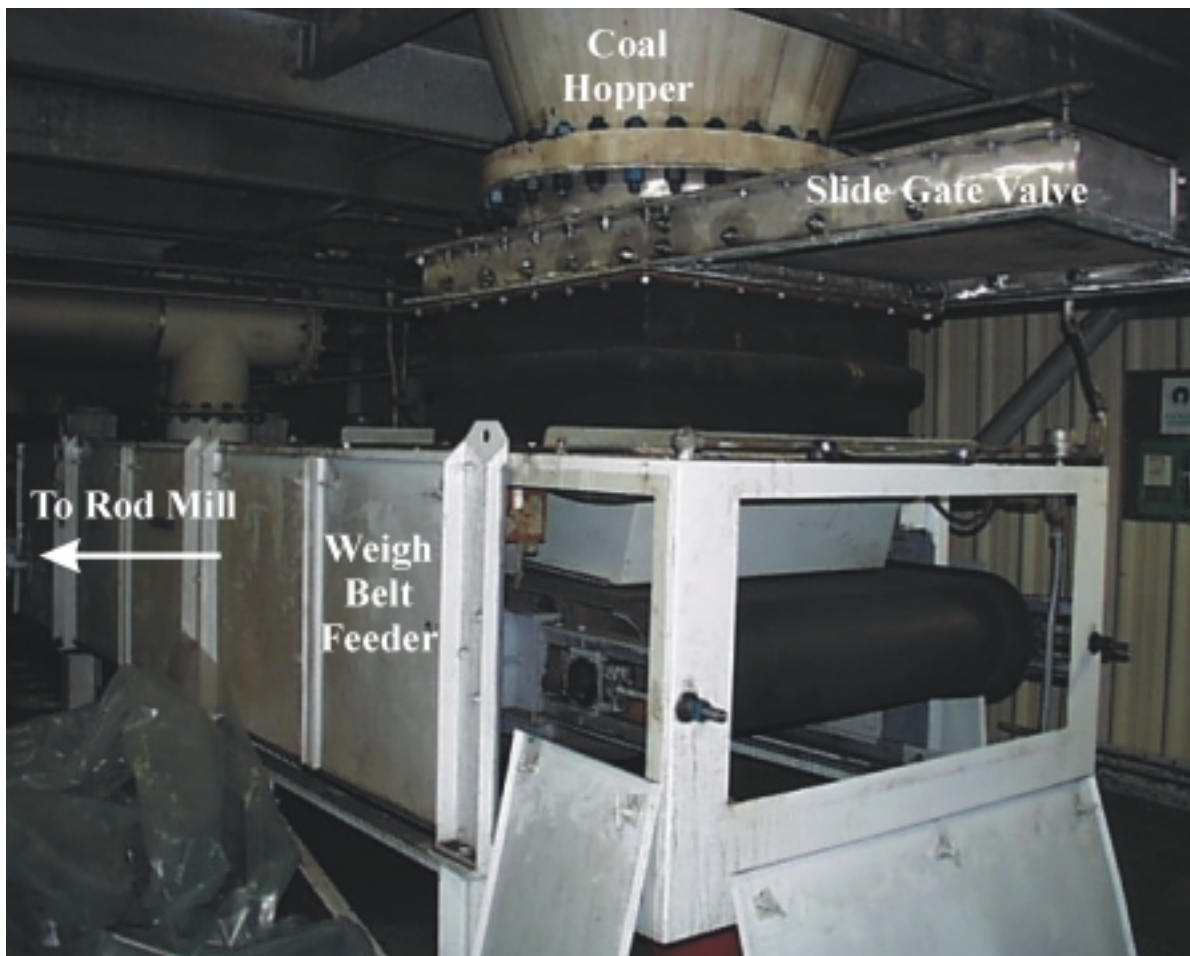
Figure 5.2.1A: Weigh Belt Feeder

Coal sampler	Coal hopper (Figure 5.2.1A)
Weigh belt feeder (Figure 5.2.1A)

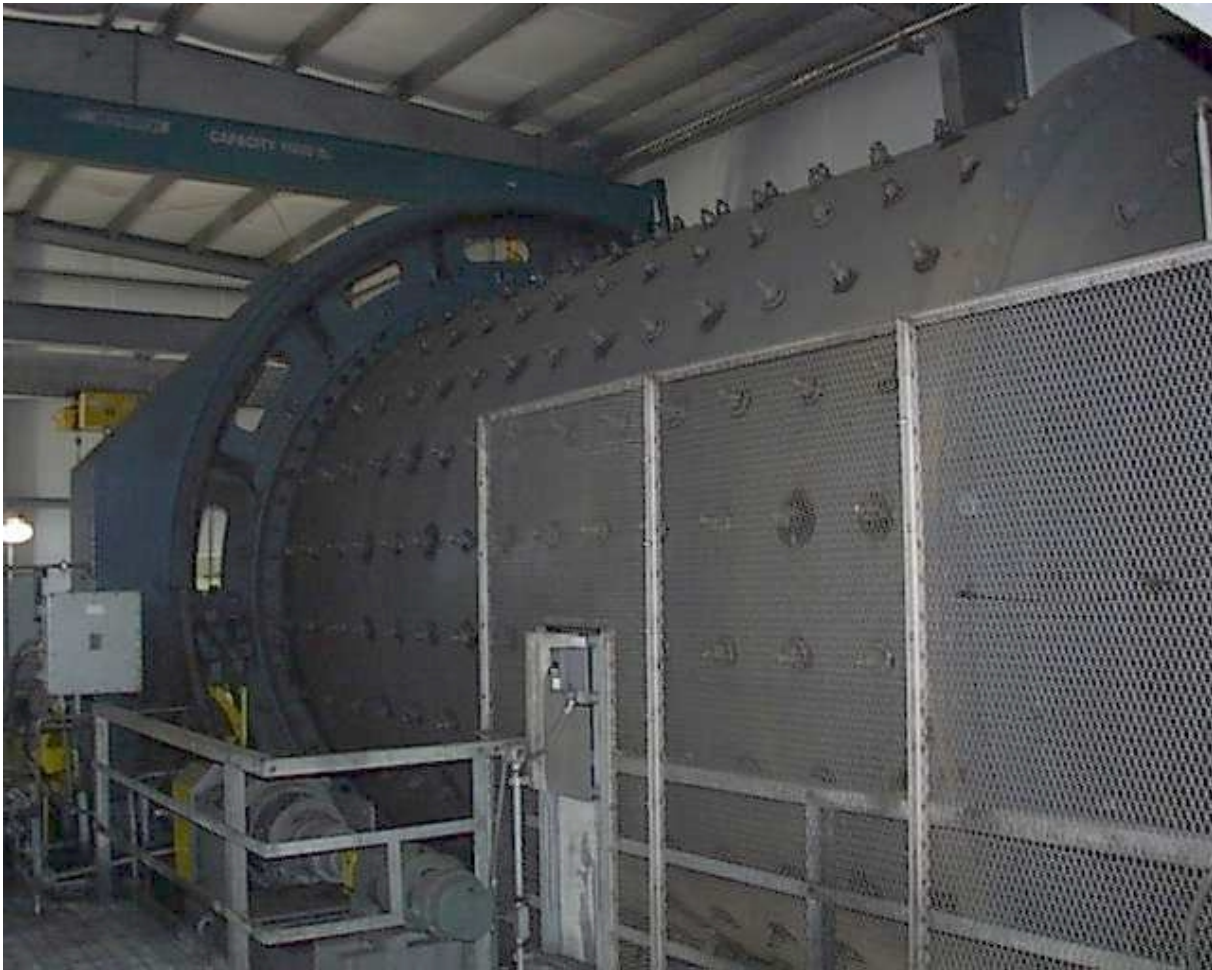
Figure 5.2.2A: Rod Mill

Rod mill (Figure 5.2.2A)	Recycled solids tank
Recycled solids pumps	Recycled water tank
Recycled water pumps	Rod mill product tank
Rod mill product pumps (Figure 5.2.2B)

The rod mill system was installed as part of the original plant design. It has operated as designed with only minor modification.

The rod mill operated as expected during the Operating Period with the exception of holes being worn into the inlet and outlet chutes due to erosion, and contamination of the bearing lube oil system with solids. Erosion-resistant materials were added to the chutes to alleviate the wear and have performed satisfactorily to date. The covers installed over the outboard trunnion bearing and lube oil reservoir (Figure 5.2.2C) to prevent solids contamination of the rod mill lube oil system have also performed satisfactorily. Routine preventative maintenance during the Operating Period included removing of worn grinding rods, installation of new grinding rods, refilling of gaps between the rod mill liner plates, inspection and measurement for wear of the rod mill liner plates, and tightening of rod mill liner plate bolts that loosen over time.

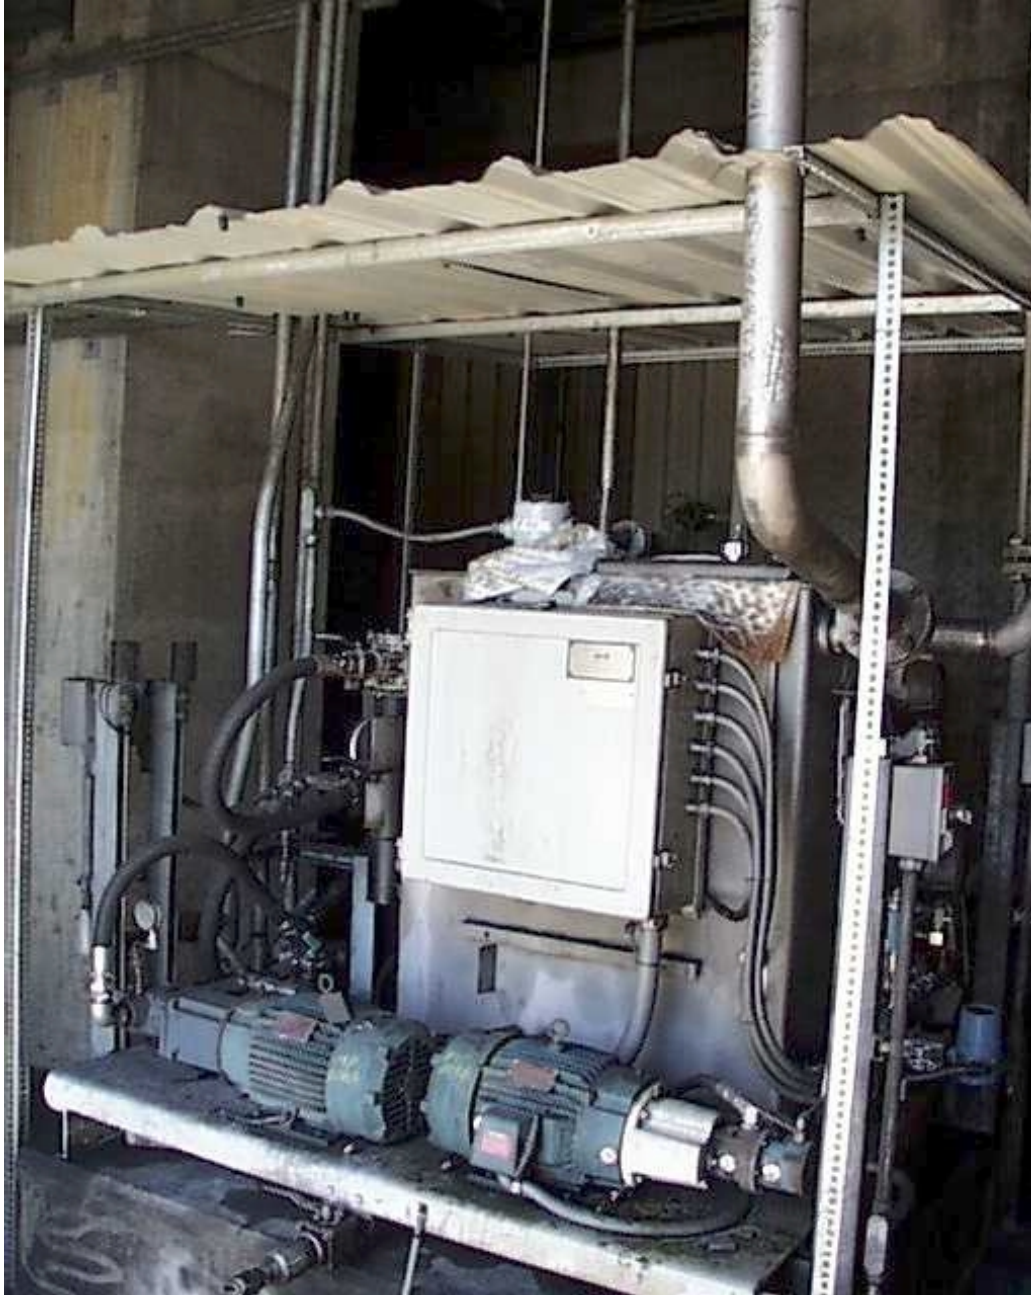
Figure 5.2.2C: Rod Mill Lube Oil Skid

Modifications to this system were limited to installation of erosion-resistant materials in high wear areas due to erosive nature of the coal and coal slurry and installation of covers over the rod mill outboard trunnion bearing and lube oil reservoir (Figure 5.2.2C) to prevent solids contamination of the rod mill bearing lube oil system.

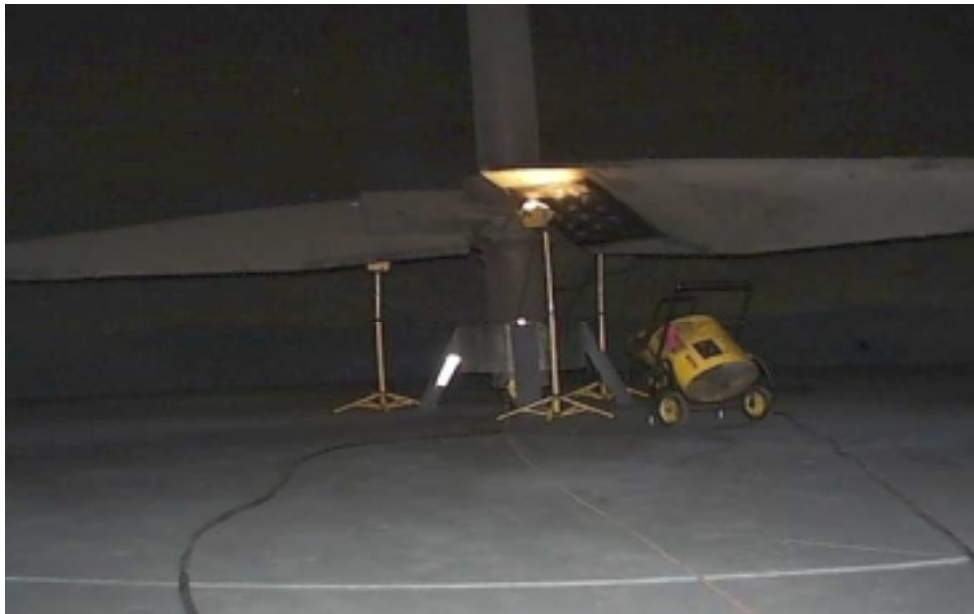
Figure 5.2.3A: Slurry Storage Tank Agitator

Slurry storage tank	Slurry storage tank agitator (Figure 5.2.3A)
Slurry recirculation pumps (Figure 5.2.3B)

No modifications were made since commissioning and start-up of the system prior to the Operating Period. Prior to the Operating Period, on one occasion, the slurry storage tank was emptied for removal of settled solids. Erosion damage to the blades on the slurry storage tank agitator was repaired at that time.

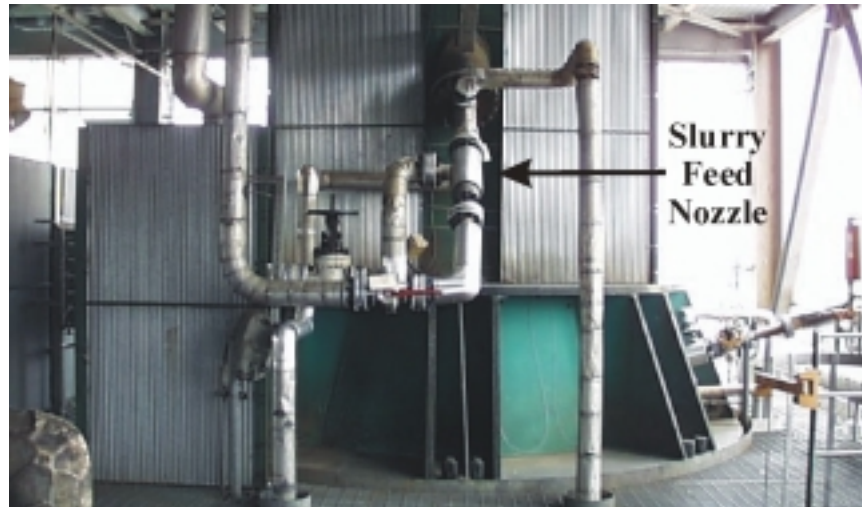
Figure 5.3.2B: Second Stage Gasifier Slurry Feed Nozzle

Maintenance of the second stage gasifier slurry feed nozzle was limited to routine inspections and periodic replacements during the Operating Period. The replacement is dictated by the wear caused by the coal slurry and atomizing gas flows. No downtime was attributed to this equipment during the Operating Period.
