Wabash River Coal Gasification Repowering Project

Final Technical Report

August 2000

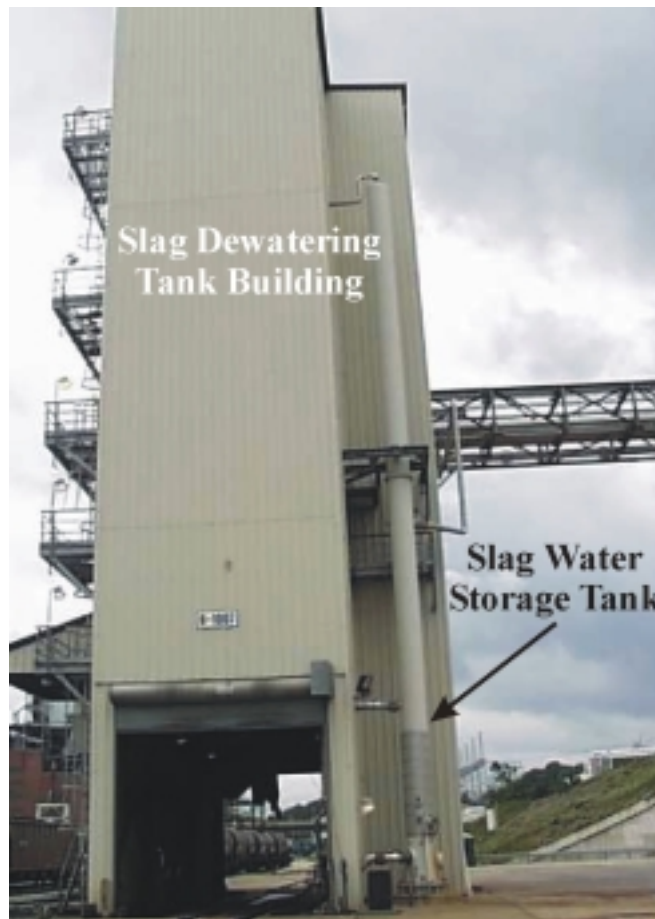
Figure 5.3.4A: Slag Dewatering Tank Building and Slag Water Storage Tank

Slag pre-crusher	Slag fines settler bottoms pumps (Figure 5.3.4C)
Slag crusher	Slag recycle water tank
Slag dewatering tanks	Slag recycle water pumps
Slag water storage tank (Figure 5.3.4A)	Slag recycle water cooler
Slag water pumps	Slag quench feedwater pumps (Figure 5.3.4D)
Slag fines settler (Figure 5.3.4B)

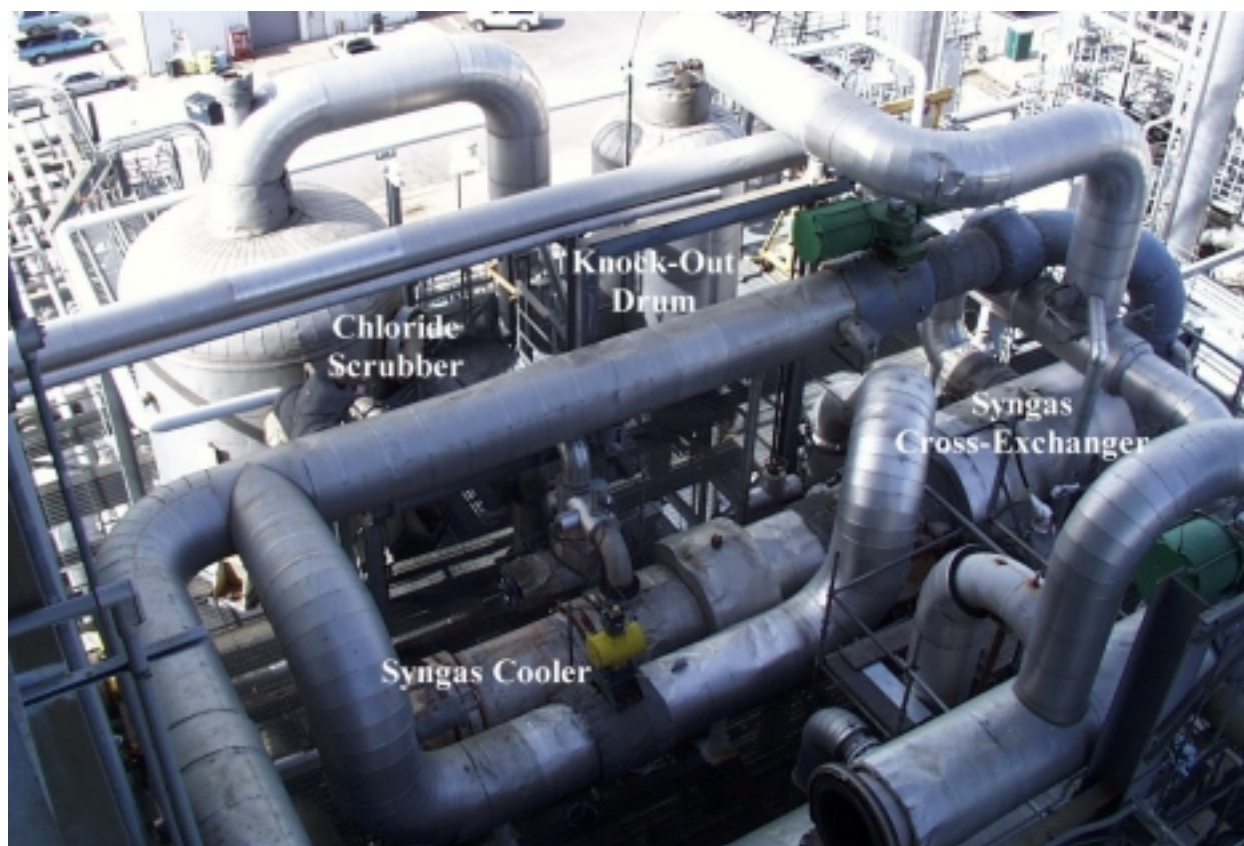
Figure 5.3.7A: Major Equipment Associated with the Chloride Scrubbing System

Syngas cross-exchanger (Figure 5.3.7A)	Syngas cooler (Figure 5.3.7A)
Chloride scrubber (Figure 5.3.7A)	Knockout drum (Figure 5.3.7A)
Scrubber knockout level control drum	Sour water cross-exchangers

The chloride scrubbing system was installed in September of 1996 to eliminate two problems. First, chloride in the gas stream was causing chloride stress-corrosion-cracking of the low temperature heat exchangers and piping systems. Second, the chlorides and trace metals, primarily arsenic, were blinding the carbonyl sulfide (COS) hydrolysis catalyst. Installation of the system successfully eliminated both of these problems.

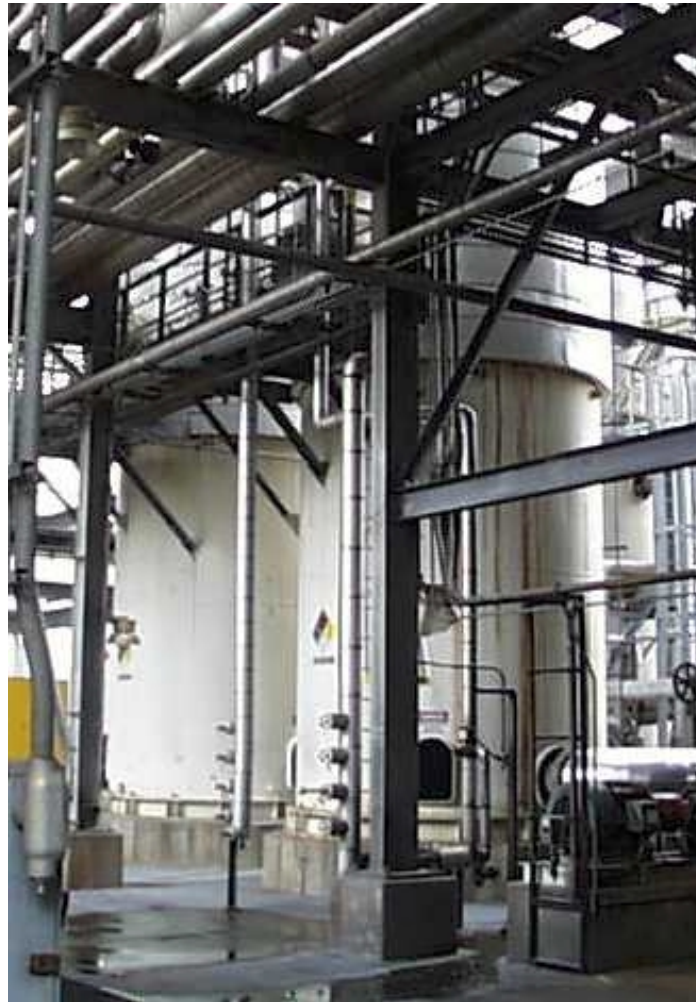
Figure 5.3.8A: Carbonyl Sulfide Reactors

The carbonyl sulfide (COS) hydrolysis system includes two COS reactors. Refer to the process description for more process details of this system.

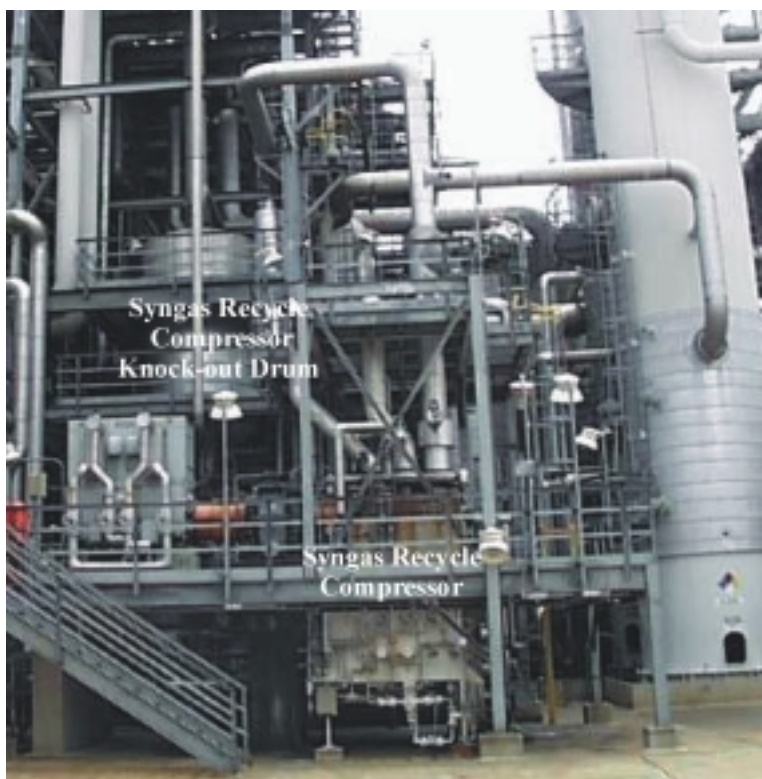
Figure 5.3.9B: Syngas Recycle Compressor and Knockout Drum

The syngas recycle compressor shutdown during methane operations on three different occasions. The compressor tripped each time on low-low first stage flow as a result of start-up conditions, which starved flow to the machine. Because the plant was not on coal operation, none of the trips resulted in downtime. Modification to the start-up procedure as well as operator awareness of the potential low flow condition has alleviated this problem. As mentioned previously, instrument problems associated with the sour gas condensate condenser and the recycle compressor knockout drum forced the syngas recycle compressor off line two times during coal operation. During the latter of these two incidents, the syngas recycle compressor failed to restart on three successive attempts due to high thrust conditions. The root cause of the high thrust could not be determined and the machine started normally on the next attempt after allowing the motor windings to cool for one hour. During a subsequent routine outage, the axial thrust proximity probe was reset in an effort to mitigate the forgoing problem. No other downtime, maintenance or operational problems were associated with the syngas recycle compressor during the Operating Period.

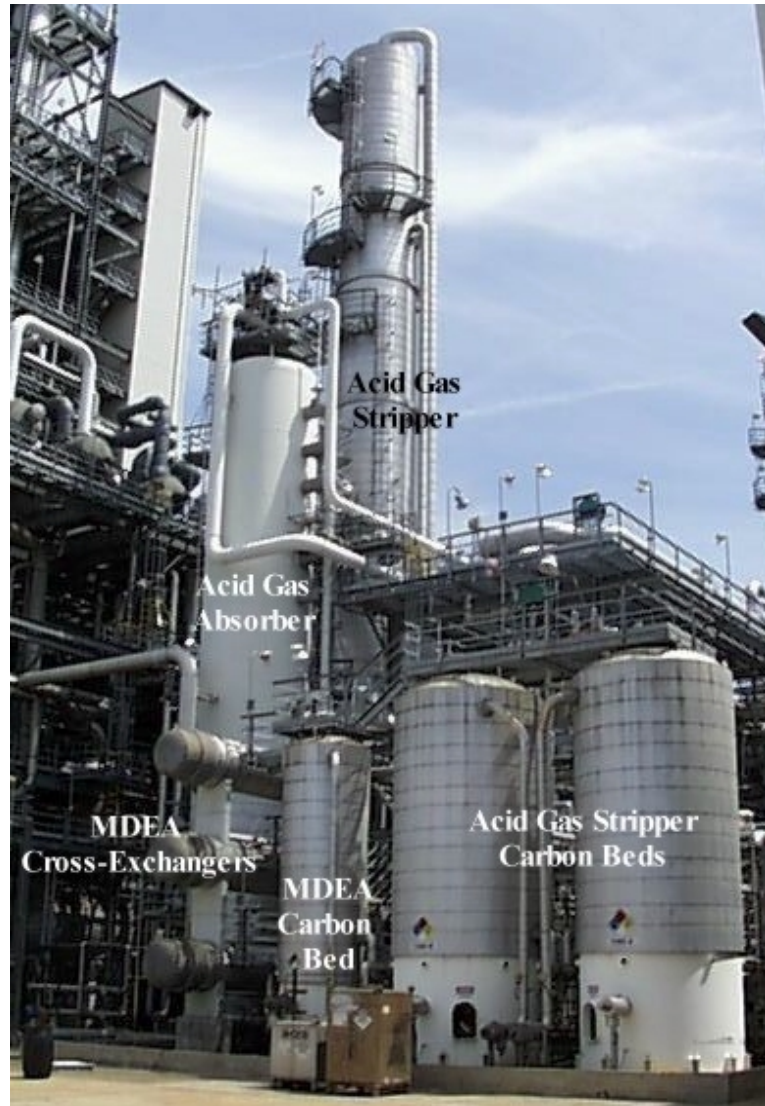
Figure 5.3.11A: Acid Gas Removal System Major Equipment

Acid gas absorber (Figure 5.3.11A)	Acid gas stripper (Figure 5.3.11A)
Lean amine pumps	Acid gas stripper knockout drum
MDEA storage tank	Acid gas stripper reflux drum
MDEA cross-exchangers (Figure 5.3.11A)	Acid gas stripper quench pumps
MDEA pre-filter	Acid gas stripper reboiler
MDEA carbon bed (Figure 5.3.11A)	Acid gas stripper carbon beds
MDEA post-filter	Acid gas stripper recirculation cooler
MDEA CTW coolers	Acid gas preheater
Lean amine transfer pumps	Acid gas stripper overheads filters
MDEA reclaim unit

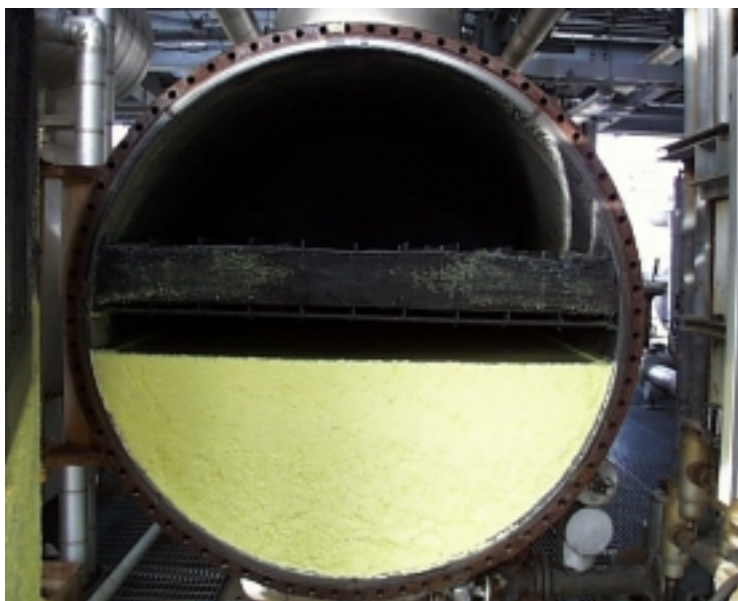
Figure 5.3.12B: Sulfur in No. 4 Sulfur Condenser as a Result of a Plugged Seal Leg

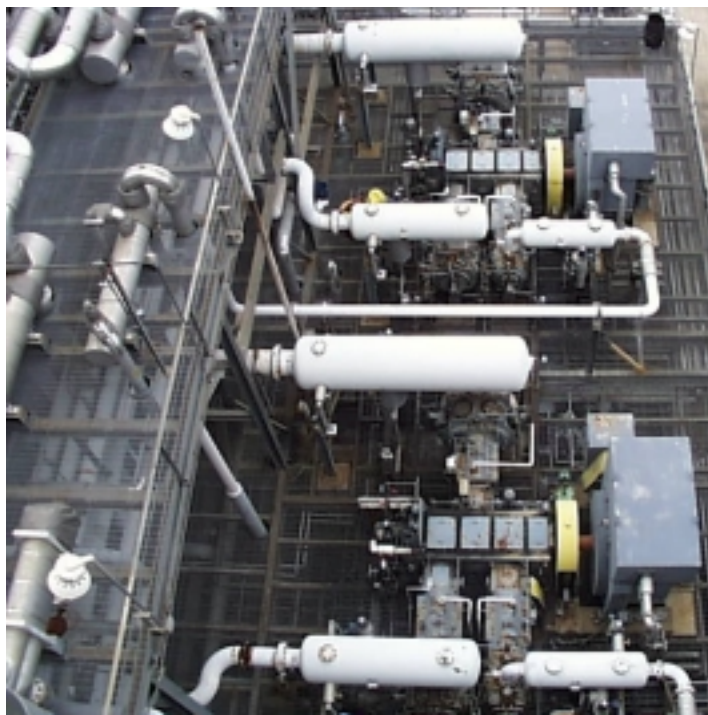
Figure 5.3.12C: Tail Gas Recycle Compressors

The tail gas recycle compressors have been a source of significant maintenance during the Operating Period. Much of the maintenance has been related to the internal check valves within the compressor. Frequent check valve failures have contributed to poor compressor reliability. However, changes in check valve design throughout the Operating Period have helped increase the reliability of the machines.

During the Operating Period, the seal leg on the first stage suction drum to the compressors was extended. Due to small suction pressure fluctuations, the seal leg would de-inventory allowing tail gas to escape to a nearby sump. The seal leg was extended to provide greater resistance to the pressure fluctuations.

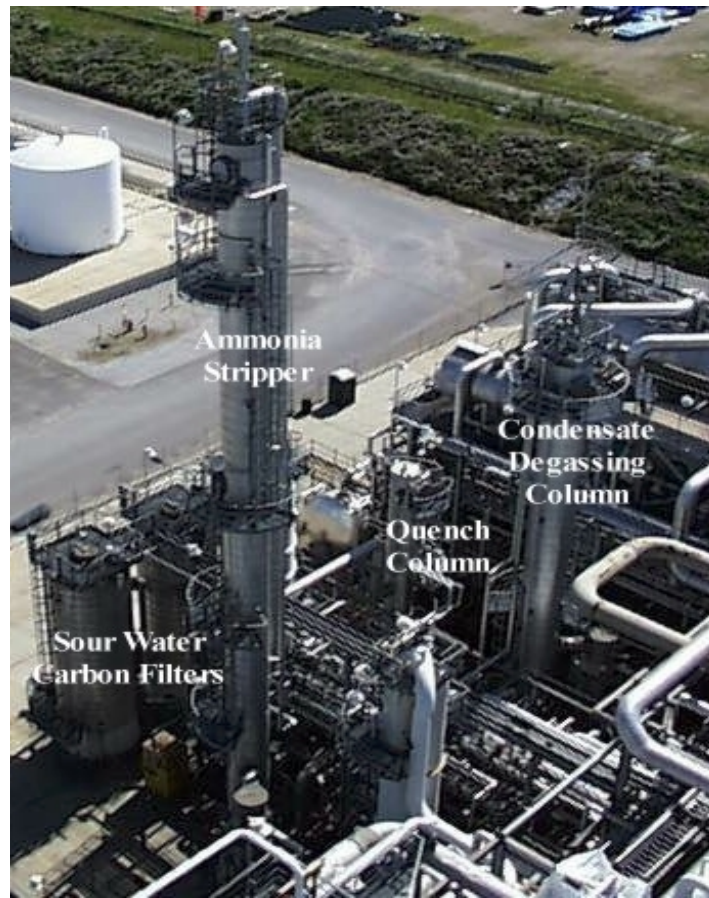
Figure 5.3.13A: Sour Water Treatment System Major Equipment

Sour water carbon filter (Figure 5.3.13A)	Stripped water transfer pumps
Sour water filter	Ammonia stripper bottoms cooler
Condensate degassing column (Figure 5.3.13A)	Quench column (Figure 5.3.13A)
Sour water transfer pumps	Quench water transfer pumps
Degassing column reboiler	Quench column bottoms cooler
Degassing column bottoms cooler	Supplemental quench column bottom cooler
Ammonia stripper (Figure 5.3.13A)	Outfall water day tanks
Ammonia stripper reboiler	Discharge water pumps

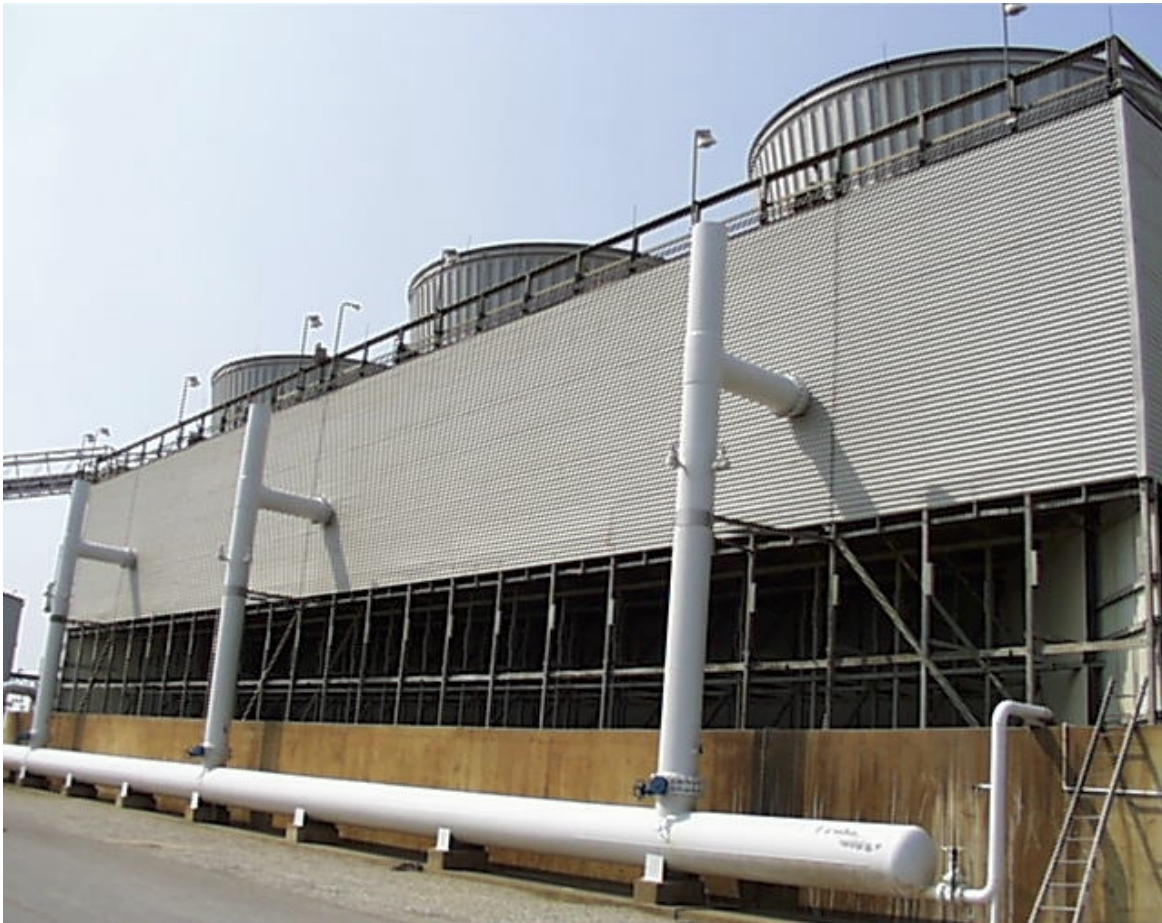
Figure 5.3.14A: Cooling Tower Water System

Cooling water pumps (Figure 5.3.14A)	Cooling tower (Figure 5.3.14A)
--------------------------------------	--------------------------------

The cooling tower is a three-cell, induced-draft, counter-flow type tower used to remove low-energy, non-recyclable waste heat from the air separation unit and gasification process equipment. Two cooling water pumps circulate cooling water to plant process equipment. Air is drawn through the packing by three induced draft fans, located atop each cell within a sealed plenum. Makeup water from PSI's water treatment system is used to replenish water losses from evaporation and cooling tower blowdown.

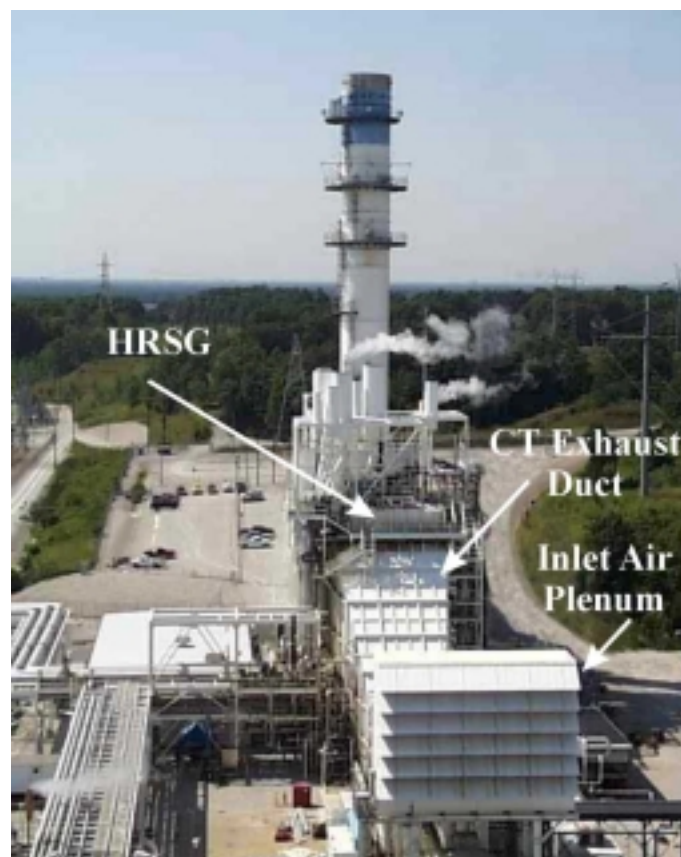
Figure 5.4.1A: Combustion Turbine

The combustion turbine (CT) is a General Electric MS-7001F single-shaft combustion turbine, designed for operation as a simple-cycle unit or in a combined steam and combustion turbine cycle. The MS-7001F combustion turbine assembly contains the following major sections:

Air inlet plenum (Figure 5.4.1A)	Compressor
Combustion system	Turbine/Generator
Exhaust duct (Figure 5.4.1A)

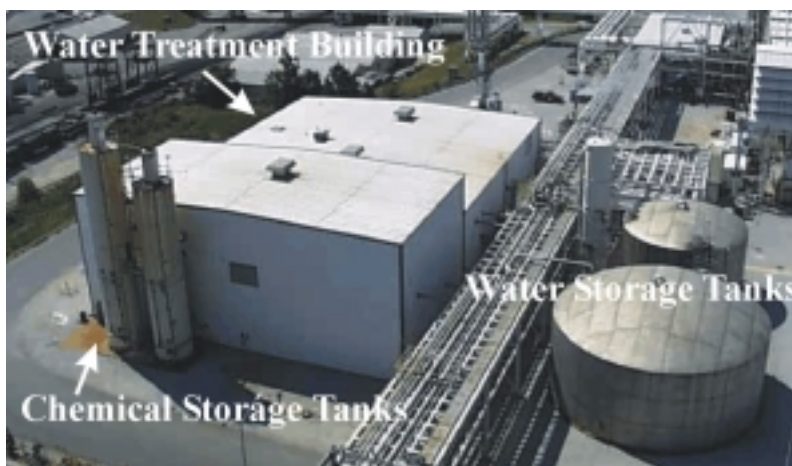
Figure 5.4.3A: Water Treatment/Handling System

The water treatment/handling system consists of the following equipment:

Clarifier	Multimedia filtration
Demineralization	Feedwater supply
Pumping equipment
